## Dilapidation Assessment Report

Prepared for: Cape Cod Australia Pty. Limited  
Job address: 46 Alfred Street, BRONTE.  
Property Owner/s: Bryan and Annie Downes  
Report reference: **WAVERLEY COUNCIL**  
Development Application No: not available  
Date of assessment: 13<sup>th</sup> July 2016

**Re: Dilapidation Report**

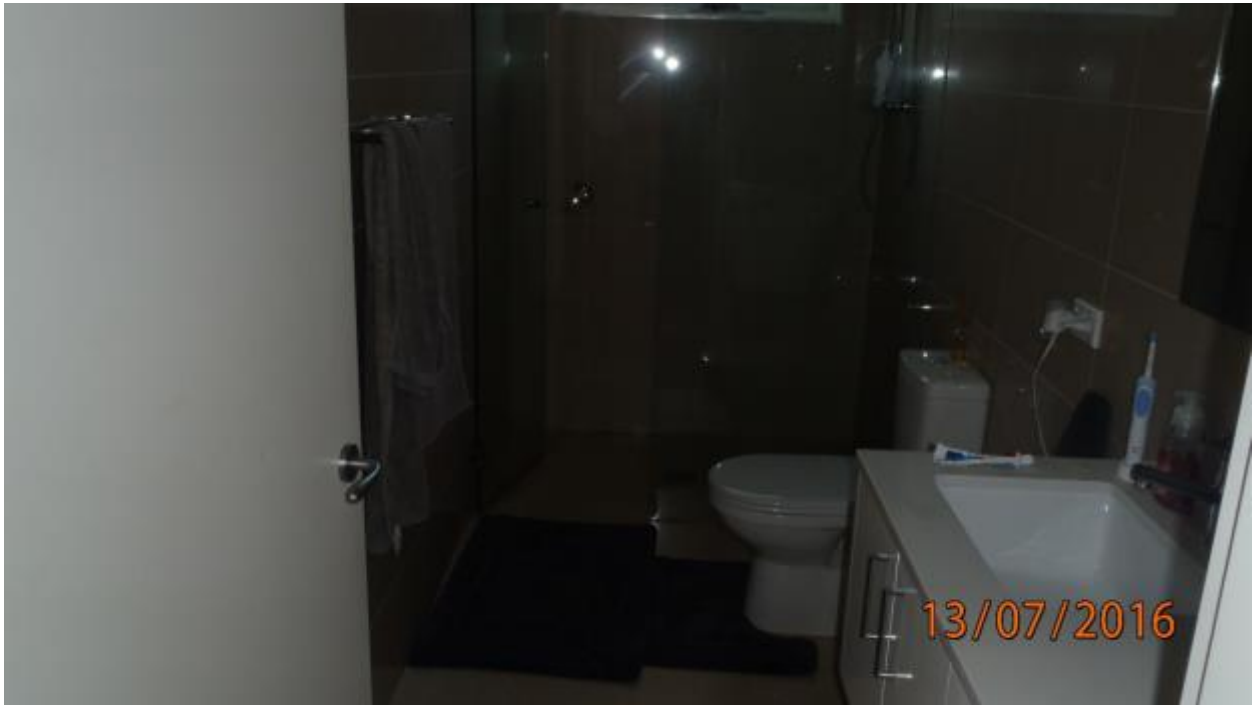
We noted that the grout to the wall and floor tiles is complete and that the wall and floor tiles when randomly “tap” tested appeared to be sound. We did not observe any recent cracking to the tile grout at the wall / wall, wall / floor junctions. [**Photograph 25**]

**Photograph 25** shows the general condition of the ground floor Bathroom.

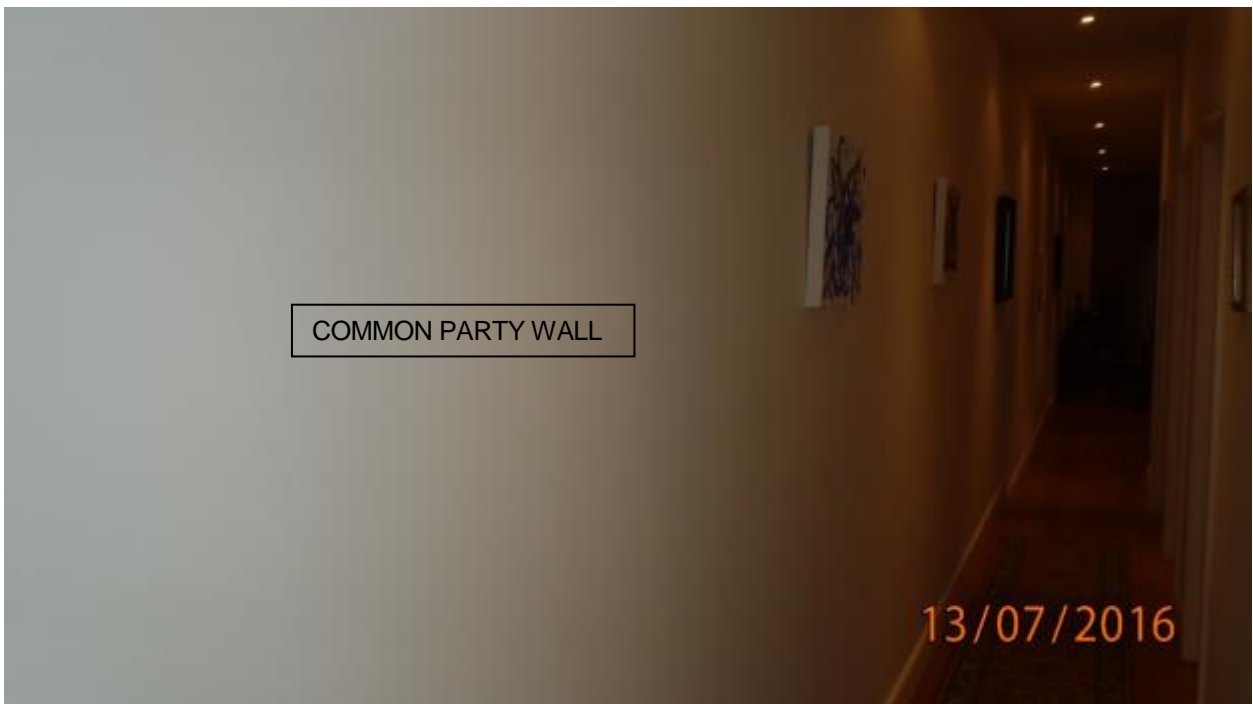
We noted that the brick common party wall has been lined with plasterboard. [**Photograph 26**]

**Photograph 26** shows the general condition of the *common party wall* with adjoining property No.44 Alfred Street.

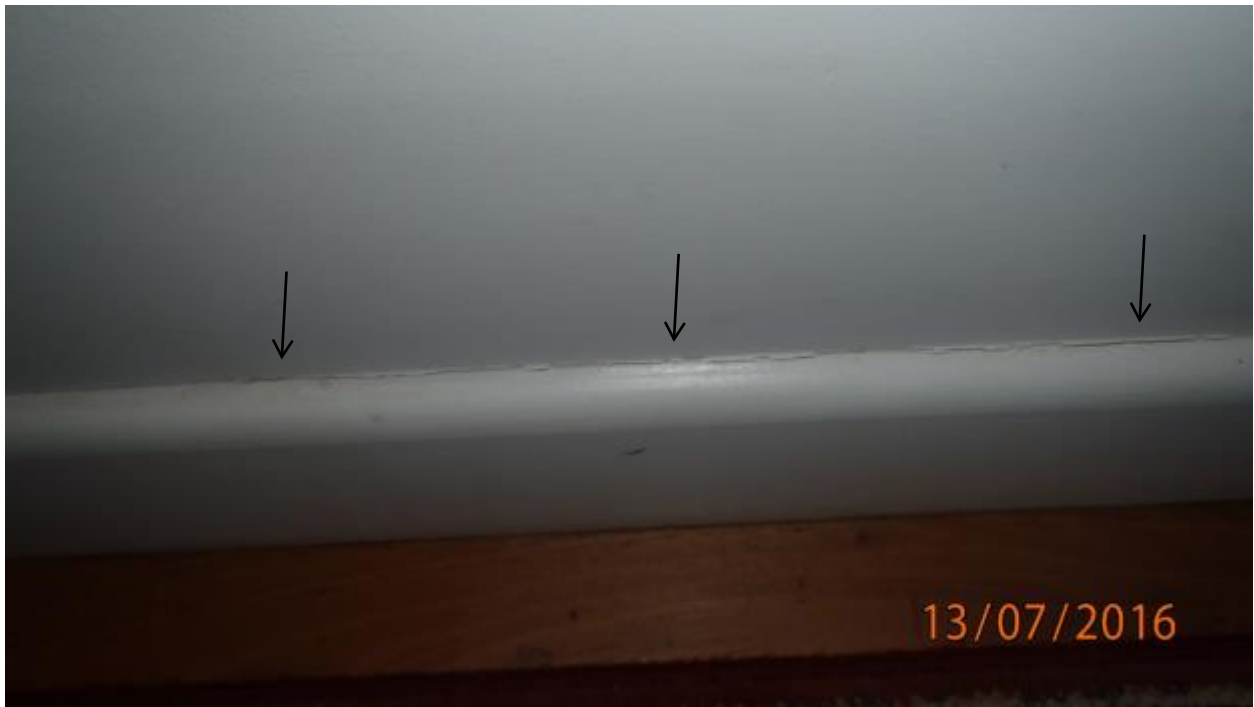
We noted a number of points with separation cracking to the skirting wall junction along the hallway. [**Photograph 27**]

**Photograph 27** shows separation cracking to the skirting wall junction in the hallway.

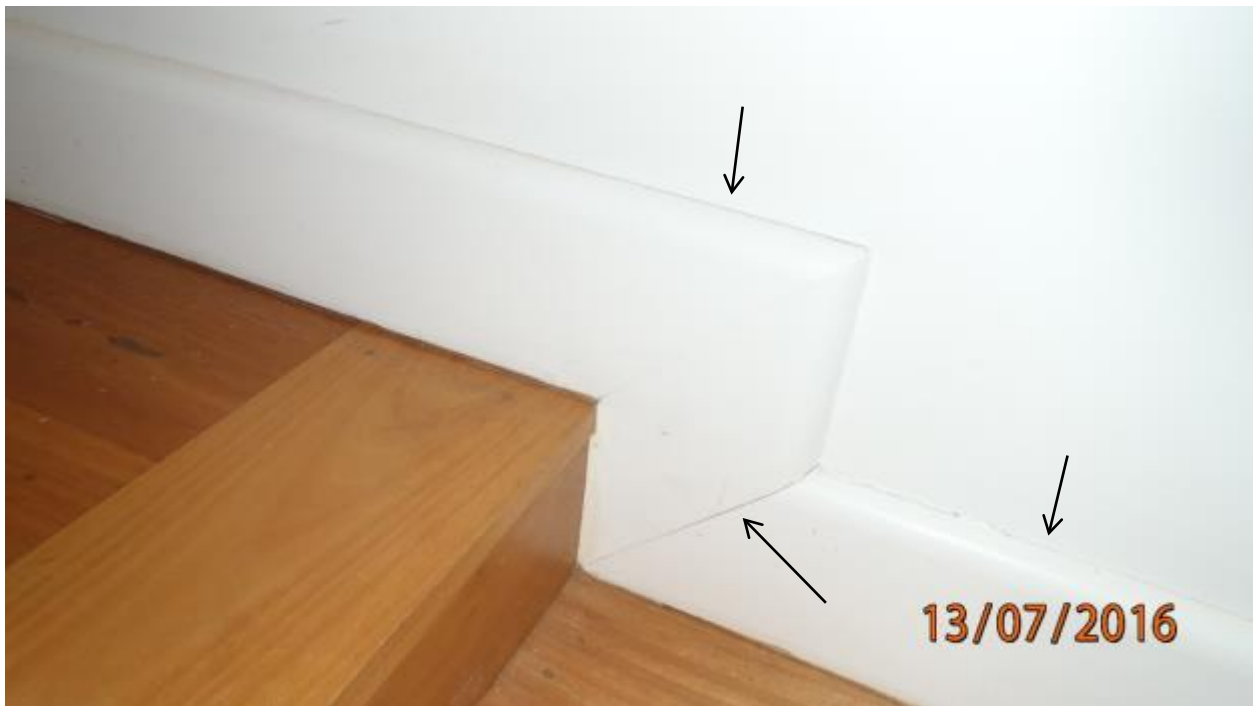
We noted separation cracking to the skirting / wall junction at the step in the hallway and to the mitre joints in the skirting [**Photograph 28**]

**Photograph 28** shows separation cracking to the skirting wall junction at the hallway step and separation of the mitre joint.

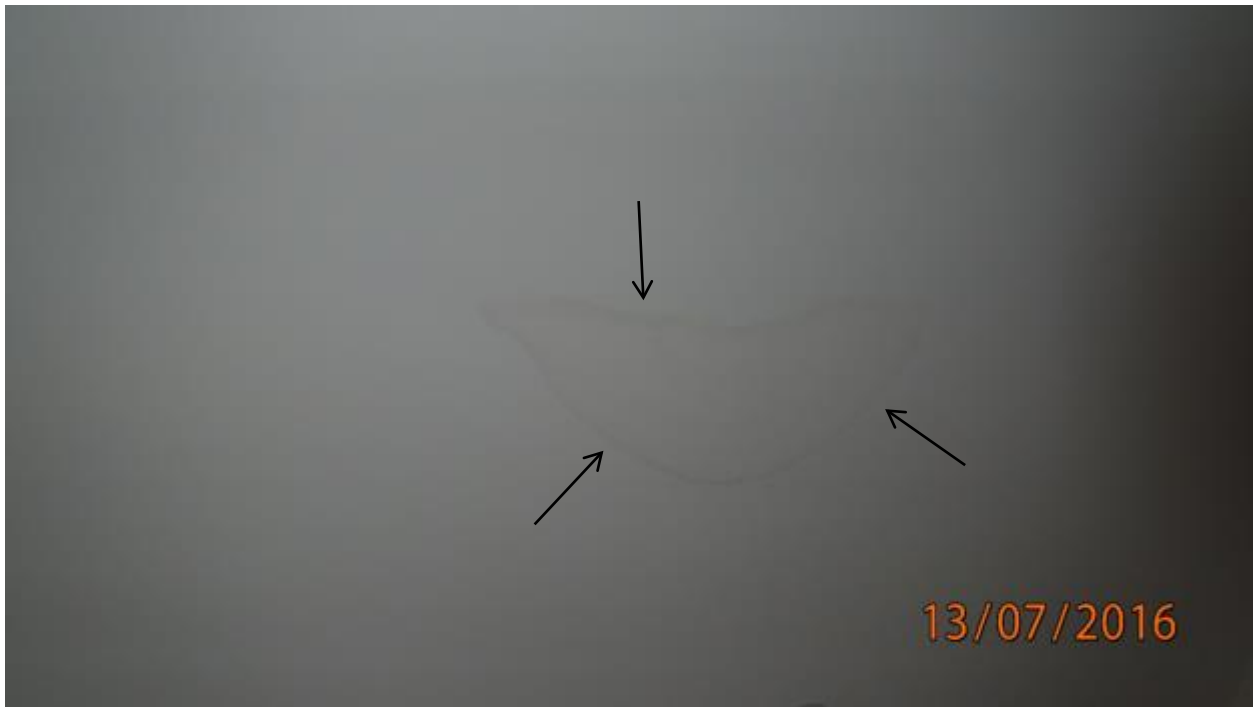
We noted water damage staining to the plasterboard ceiling lining adjacent to the air- conditioning vent [**Photograph 29**]

**Photograph 29** shows water damage adjacent to the Air-conditioning vent in the Lounge Room.

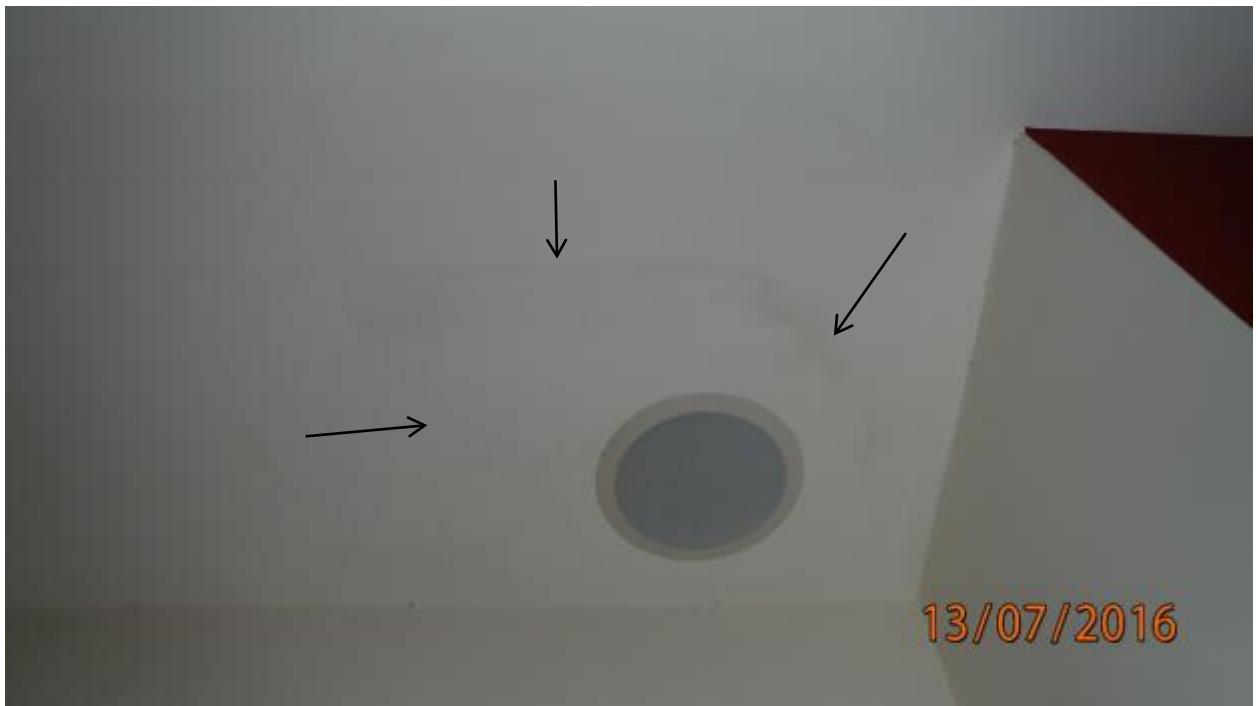
We noted water damage staining to the plasterboard ceiling lining around the speaker in the south west corner. [**Photograph 30**]

**Photograph 30** shows water damage stain around the speaker in Lounge room.

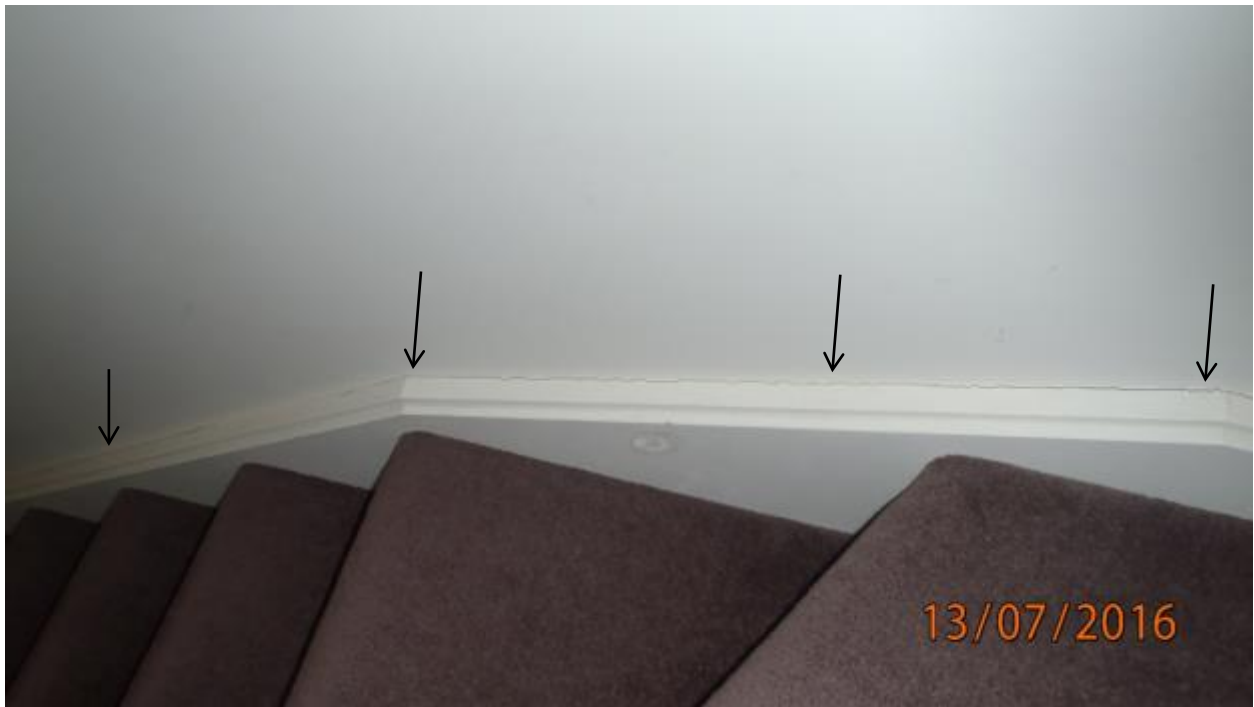
We noted separation cracking to the skirting and the plasterboard wall lining [**Photograph 31**]

**Photograph 31** shows separation cracking in the stairwell.

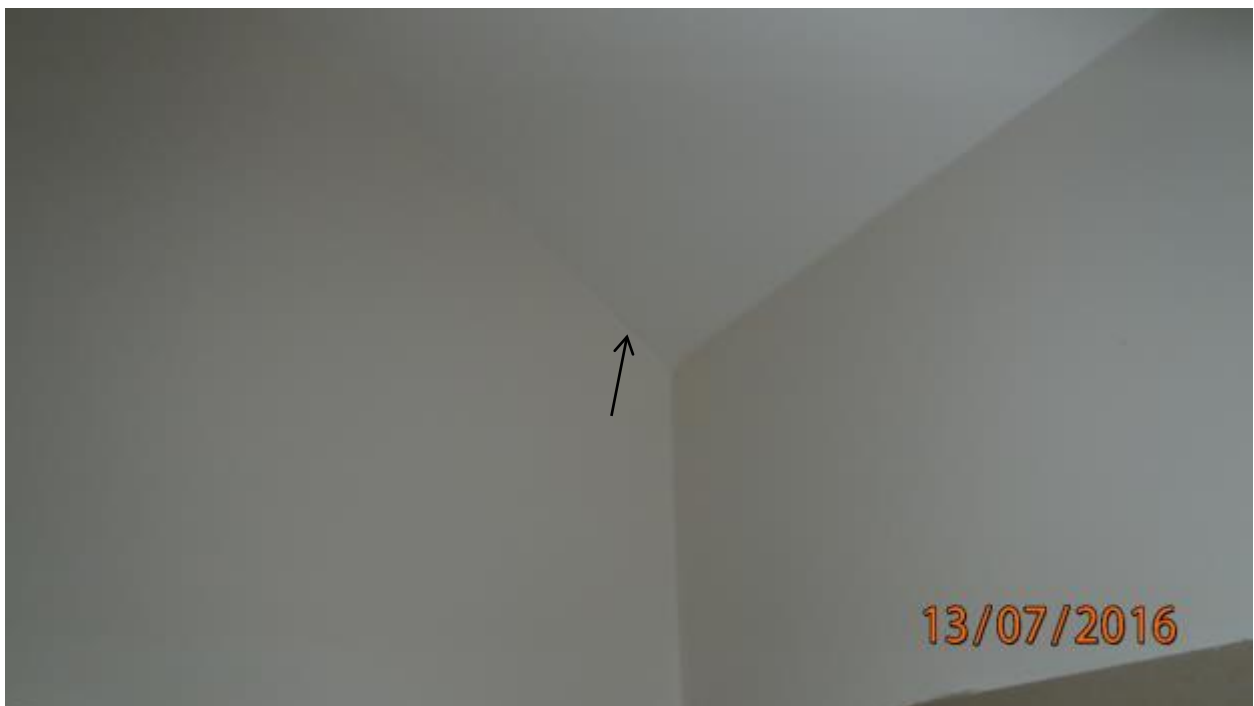
We noted separation/settlement cracking to the square set wall / ceiling junction in the north-west corner [**Photograph 32**]

**Photograph 32** shows settlement cracking in the first floor ensuite.

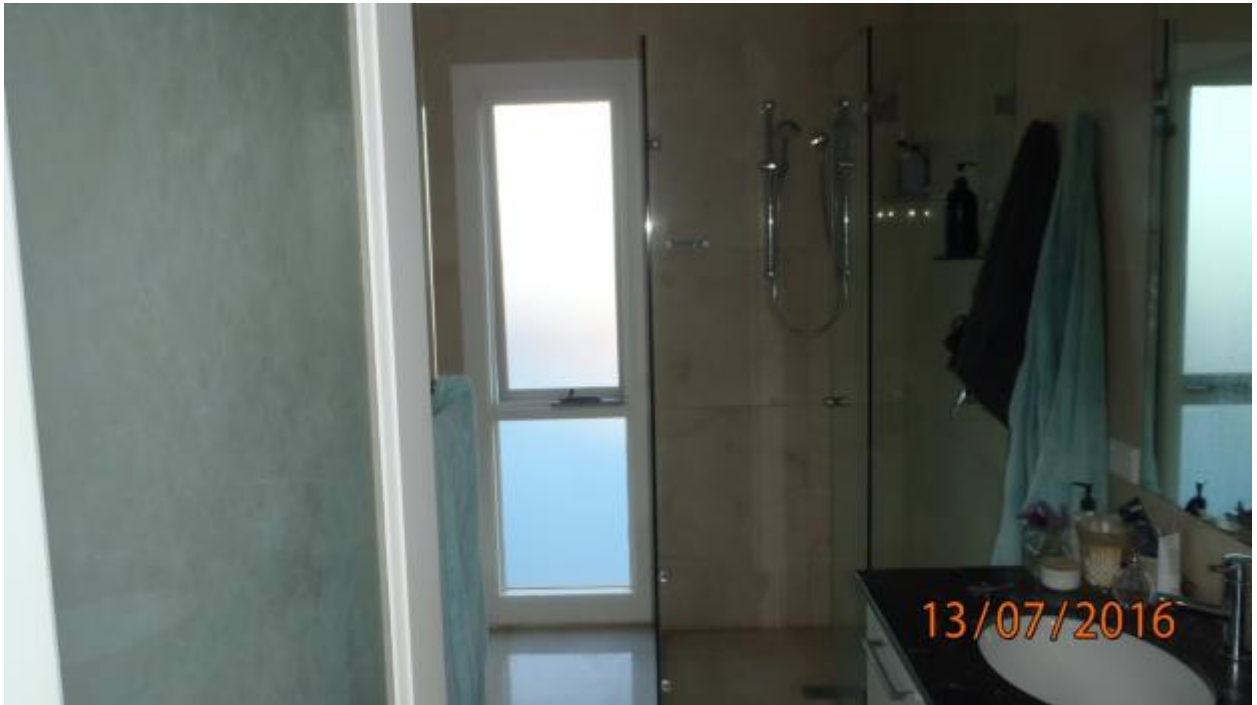
We noted that the grout to the wall and floor tiles is complete and that the wall and floor tiles when randomly “tap” tested appeared to be sound. We did not observe any recent cracking to the tile grout at the wall / wall, wall / floor junctions. [**Photograph 33**]

**Photograph 33** shows the general condition of the first floor Bathroom.

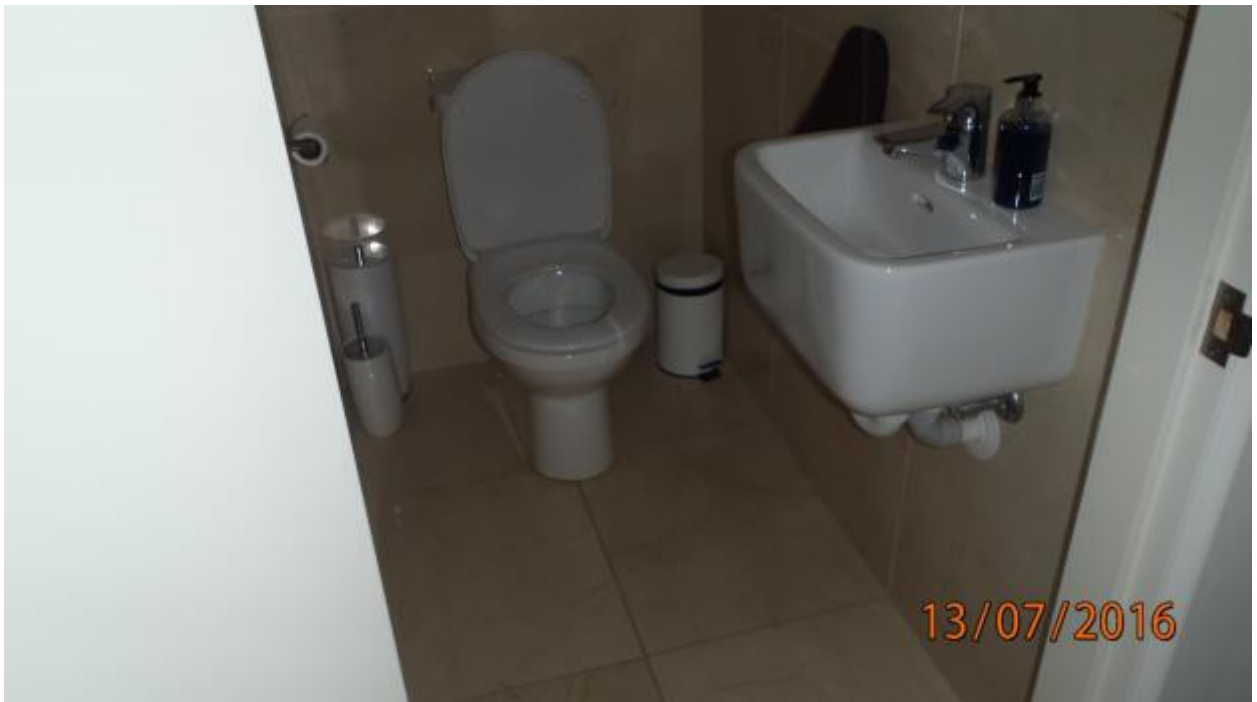
We noted that the grout to the wall and floor tiles is complete and that the wall and floor tiles when randomly “tap” tested appeared to be sound. We did not observe any recent cracking to the tile grout at the wall / wall, wall / floor junctions. [**Photograph 34**]

**Photograph 34** shows the general condition of the Water Closet.

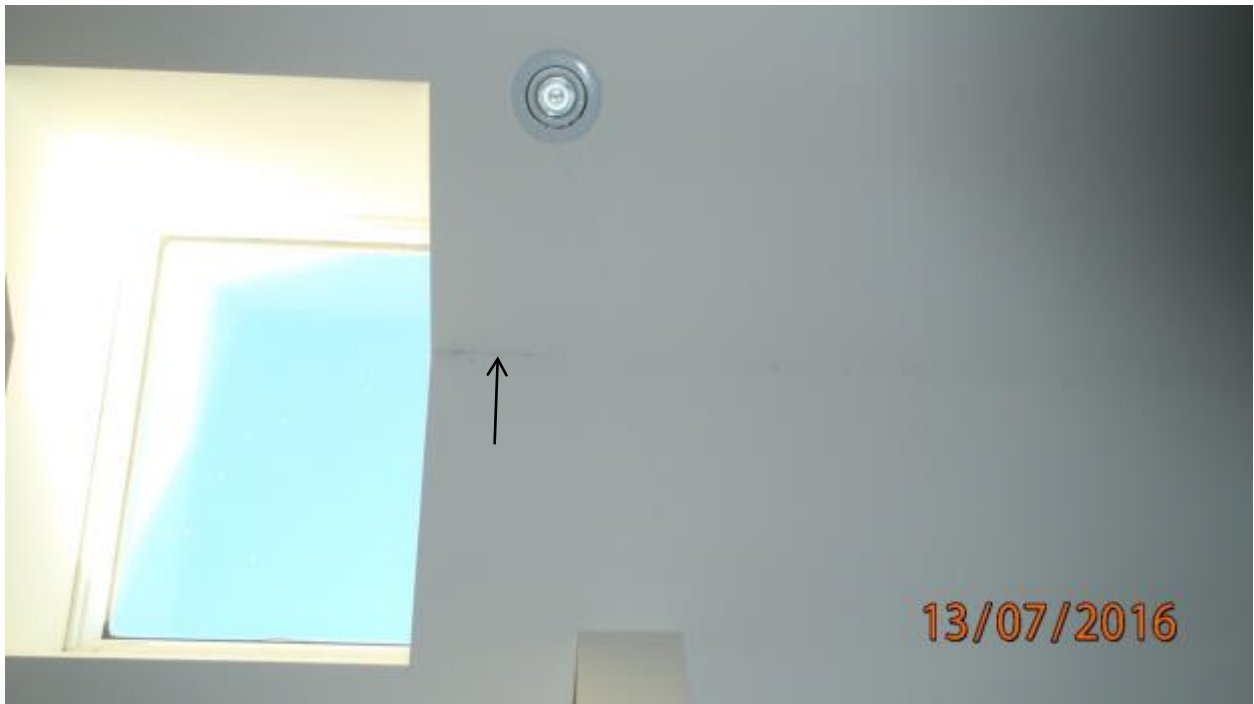
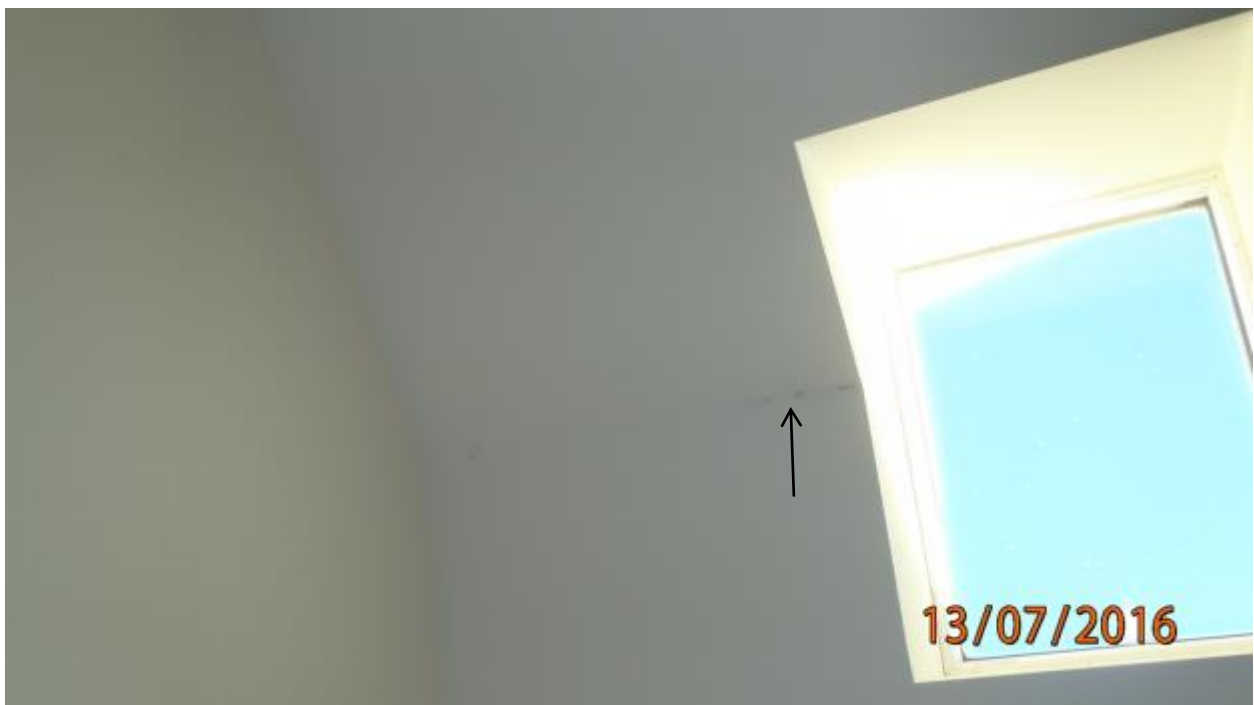
We noted cracks to both sides of the skylight just outside the main bedroom at the square set wall ceiling junctions [**Photographs 36 & 37**]

**Photograph 35** shows cracking to the wall ceiling junction to the right of the skylight.

**Photograph 36** shows cracking to the wall ceiling junction to the left of the skylight.
