## Dilapidation Assessment Report

Prepared for: Cape Cod Australia Pty. Limited  
Job address: 1A Paradise Avenue, ROSEVILLE.  
Property Owner/s: Mr. Nathan Round  
Report reference: **WILLOUGHBY CITY COUNCIL**  
Development Application No: not available  
Date of assessment: Saturday 11<sup>th</sup> June 2016

**Re: Dilapidation Report – 1A Paradise Avenue, ROSEVILLE.**

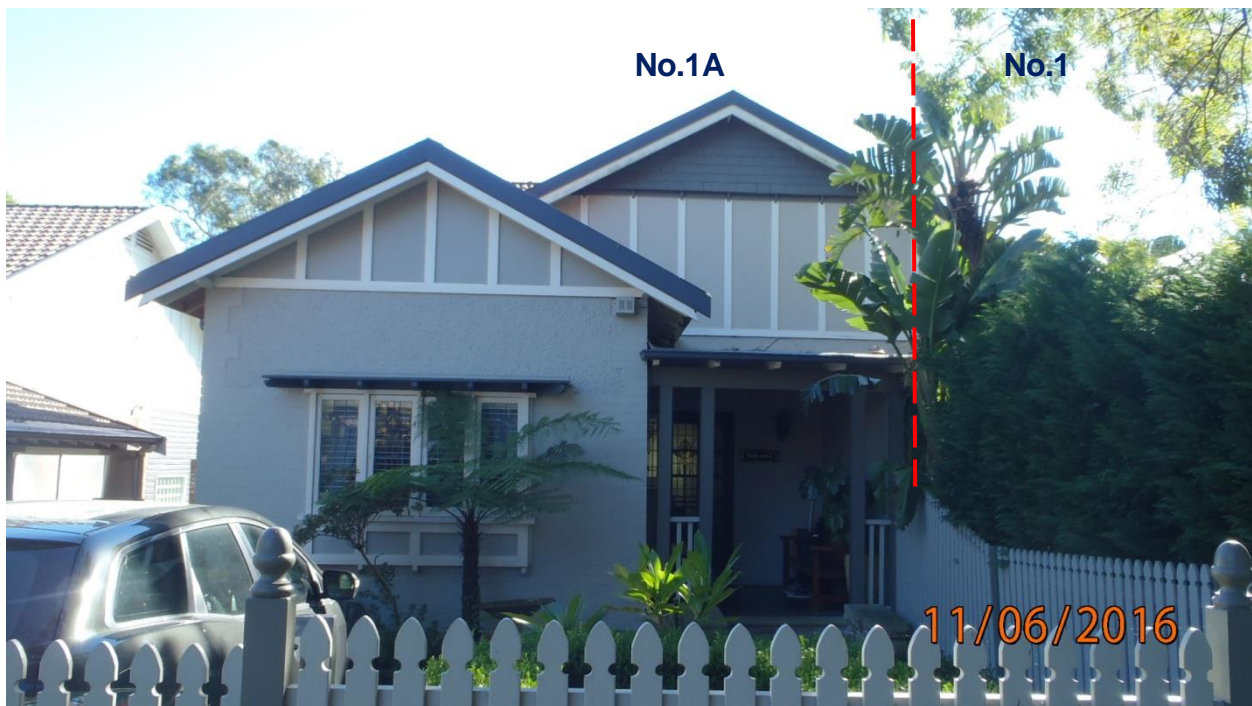
Shows the front southern elevation of the adjoining properties:  
No.1A and No.1 Paradise Avenue, ROSEVILLE.

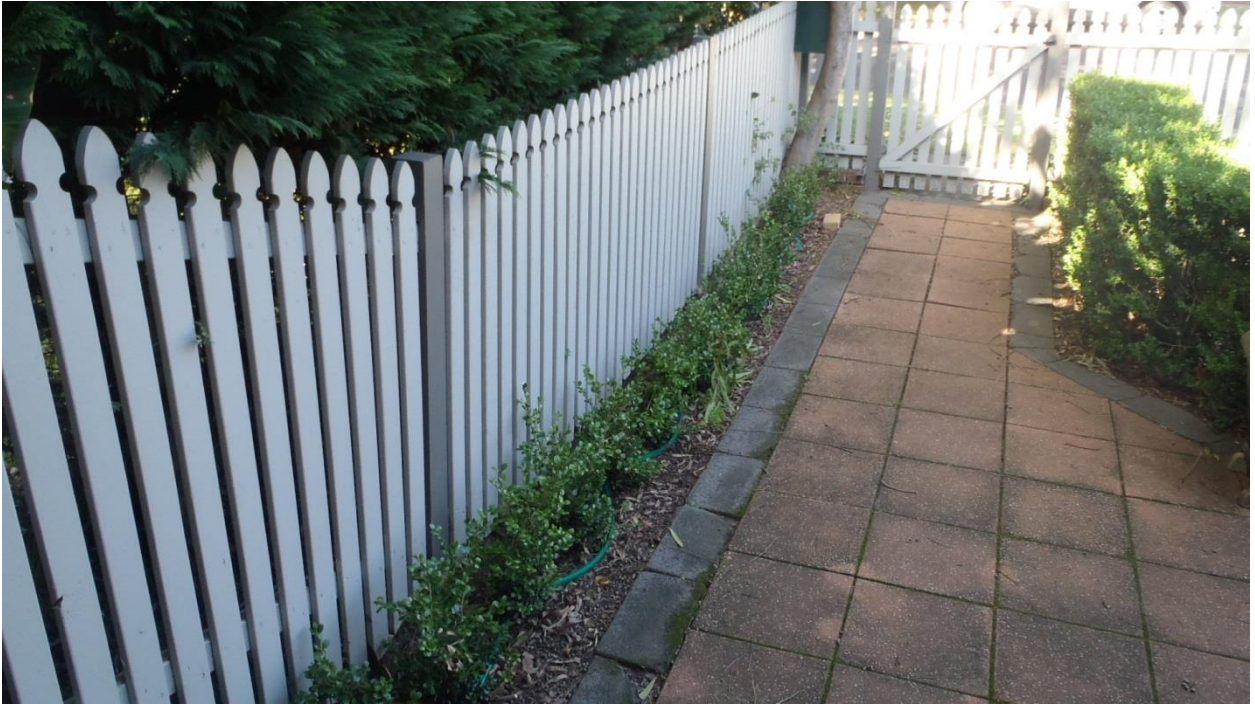
We noted that the common boundary fence and the paving at the front of the property were generally sound. **[Photograph 1]**

**Photograph 1** shows the common boundary fence to the adjoining property 1 Paradise Avenue, ROSEVILLE and the general condition of the front paving.

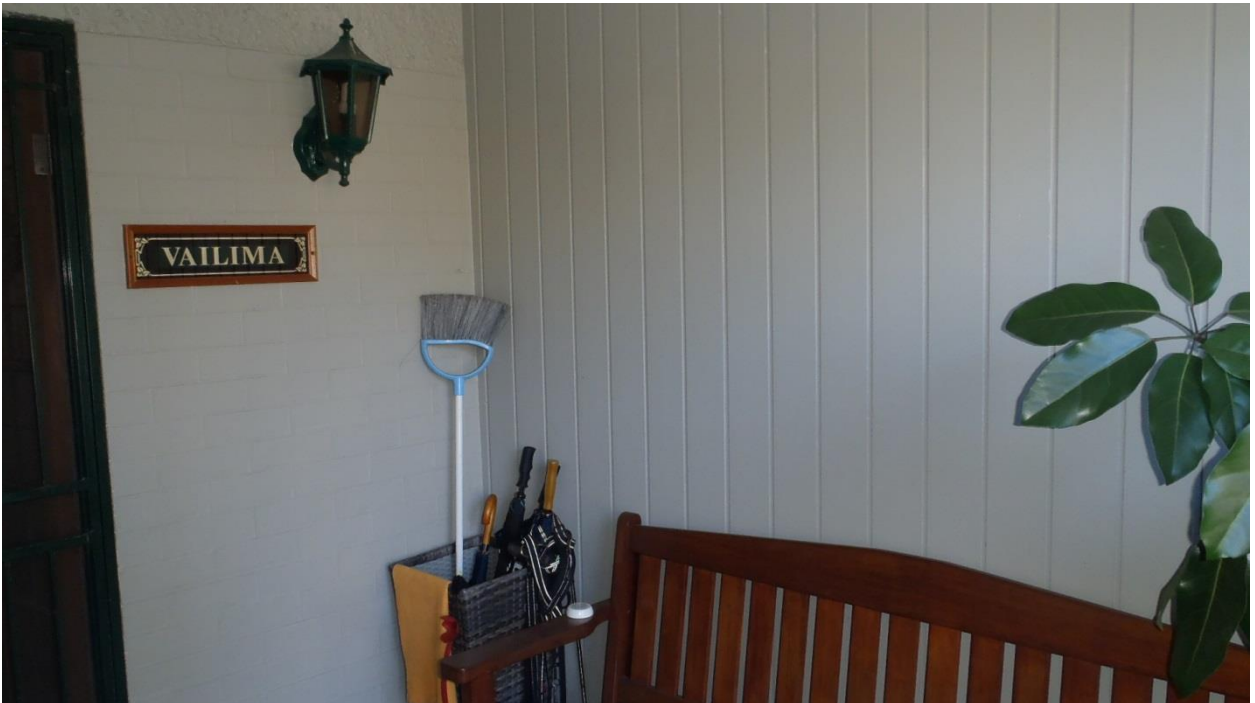
We noted that the *common privacy wall* is clad with a surface coated weatherboard lining and the brickwork to the frontal southern elevation is also surface coated. **[Photograph 2]**

**Photograph 2** shows the general condition of the front porch *common privacy wall*.

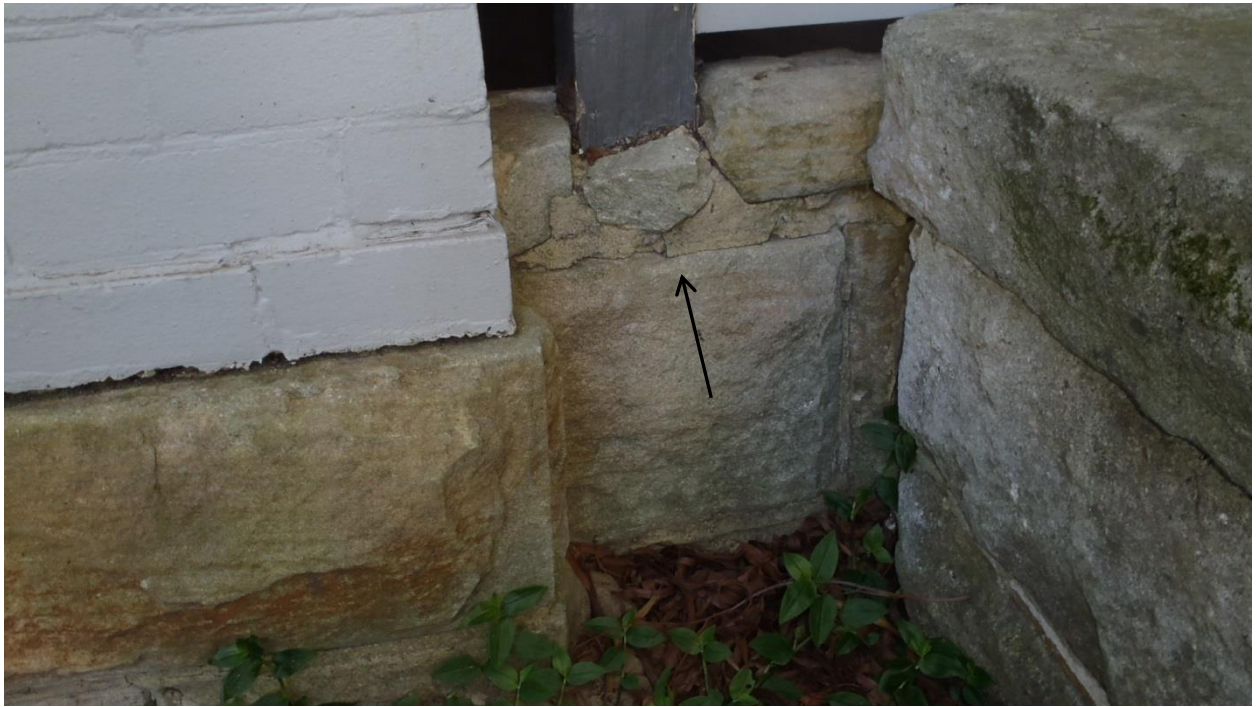
We noted cracking to the sandstone block footings around the front steps **[Photographs 3 and 4]**

**Photograph 3** shows cracking to the sandstone footings at the entry adjacent to the steps.

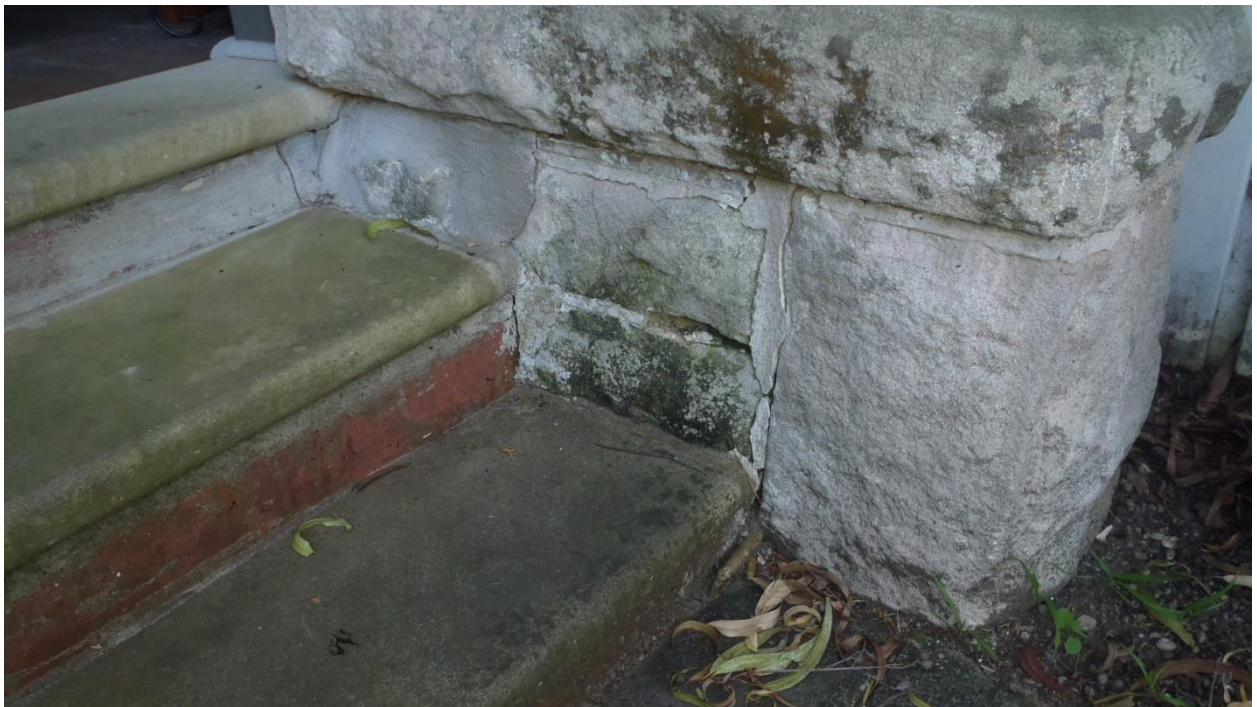
**Photograph 4** shows cracking and re-pointing to the block footings at the front steps adjacent to the boundary fence.

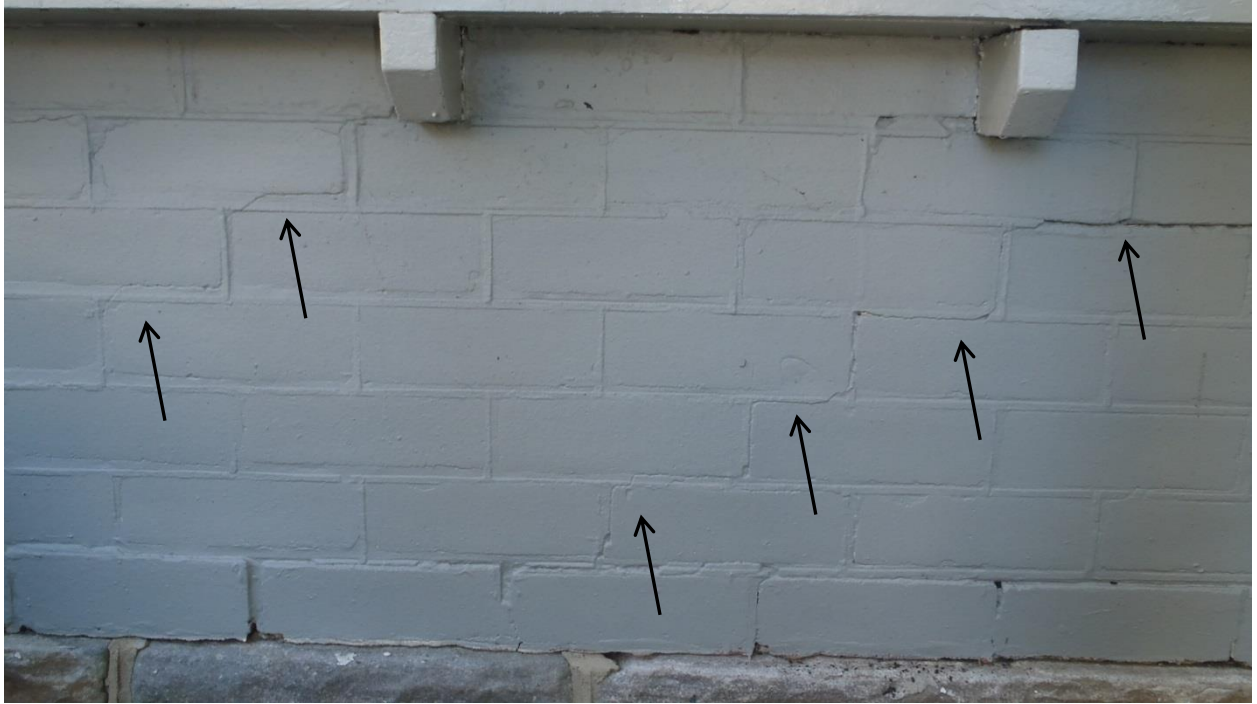
We noted step cracking of the surface coated brickwork extending from below the Bedroom 1 window sill. **[Photograph 5]**

**Photograph 5** shows hairline step cracking extending from below the Bedroom 1 window sill on the front southern elevation.

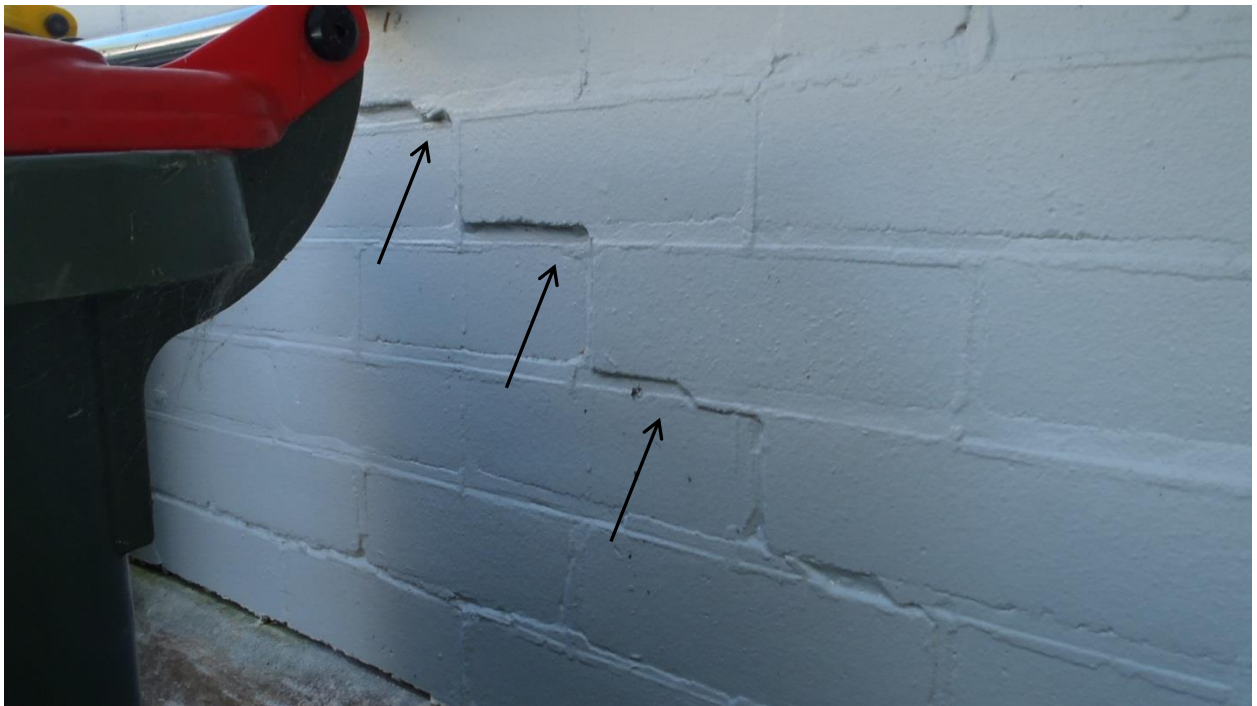
We noted step cracking and displacement of the surface coated brickwork extending from below the Bedroom 1 window sill. **[Photograph 6]**

**Photograph 6** shows step cracking and displacement of brickwork extending from the left hand side of the window sill.

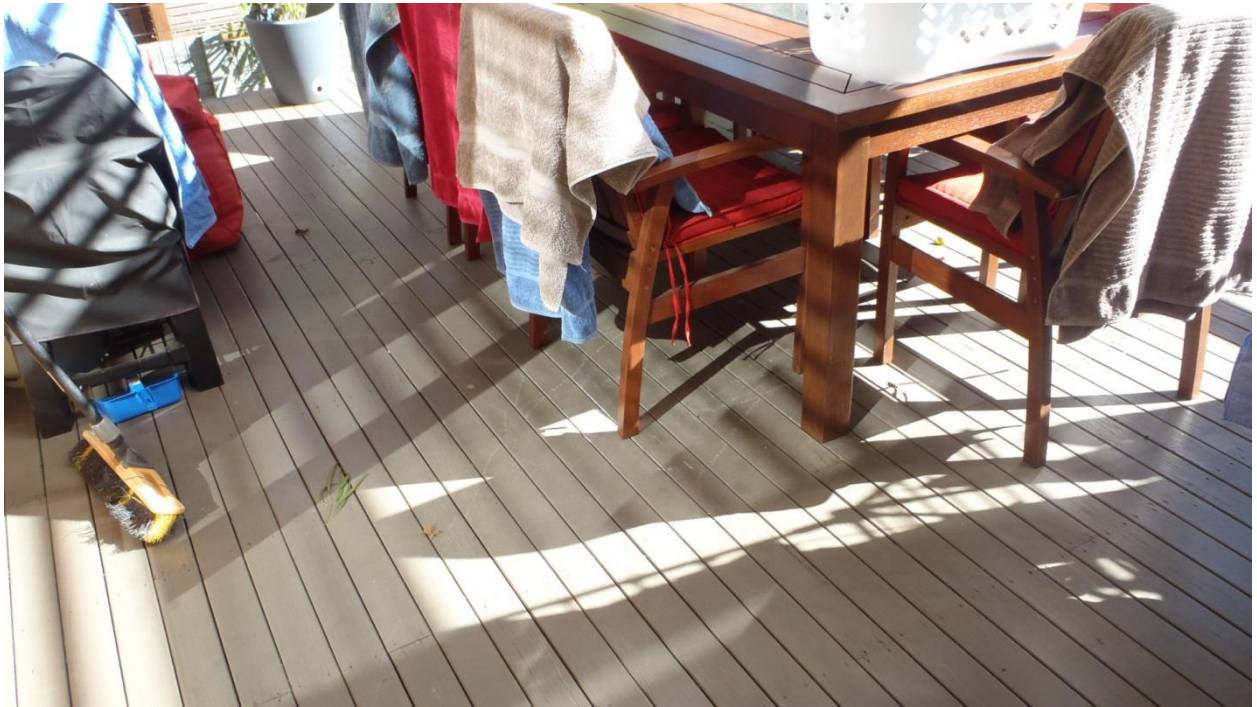
**Photograph 7** shows the general condition of the rear verandah

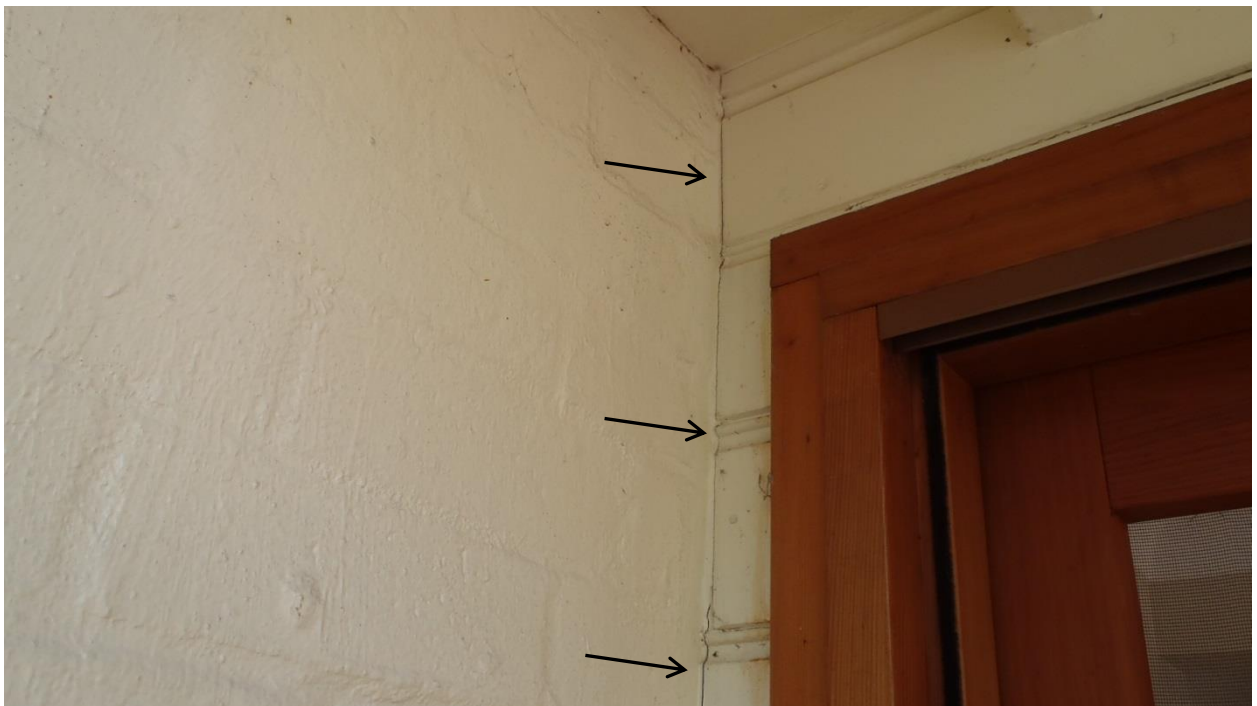
We noted separation cracking between the *common privacy wall* and the back weatherboard clad wall. **[Photograph 8]**

**Photograph 8** shows separation cracking between the *common privacy wall* and the back weatherboard wall cladding.

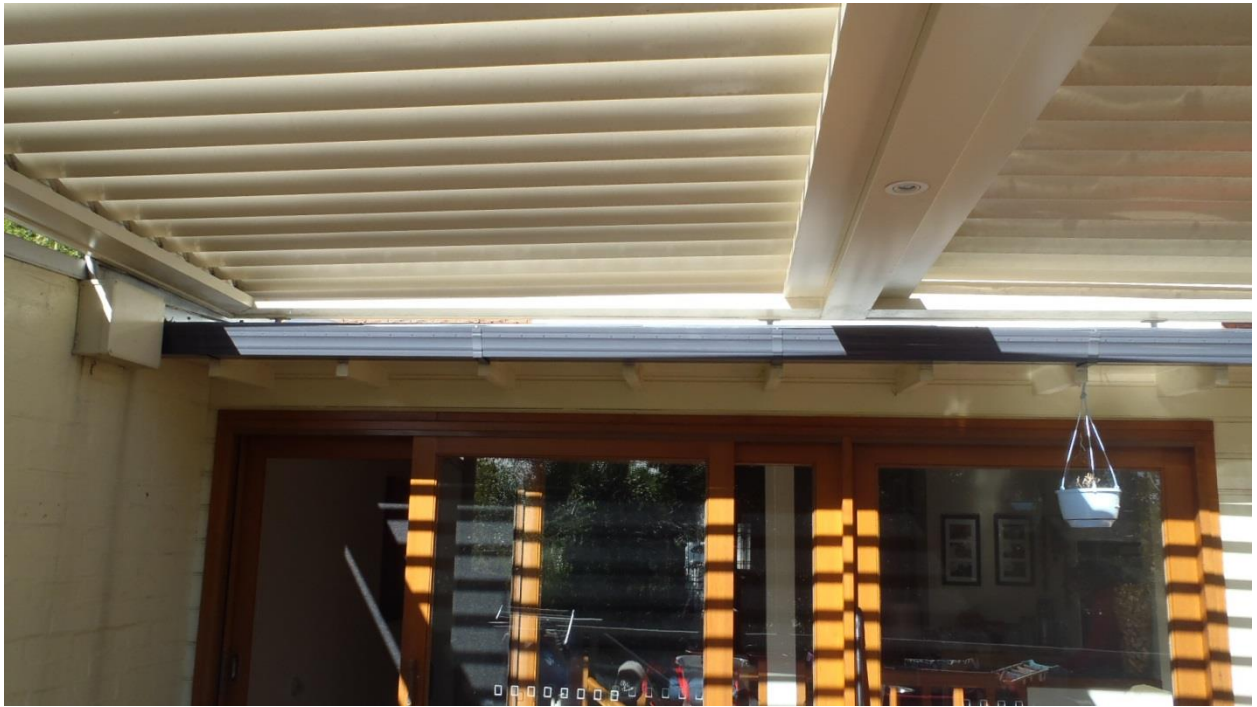
**Photograph 9** shows the general condition of the verandah and the rear extension section of the premises.

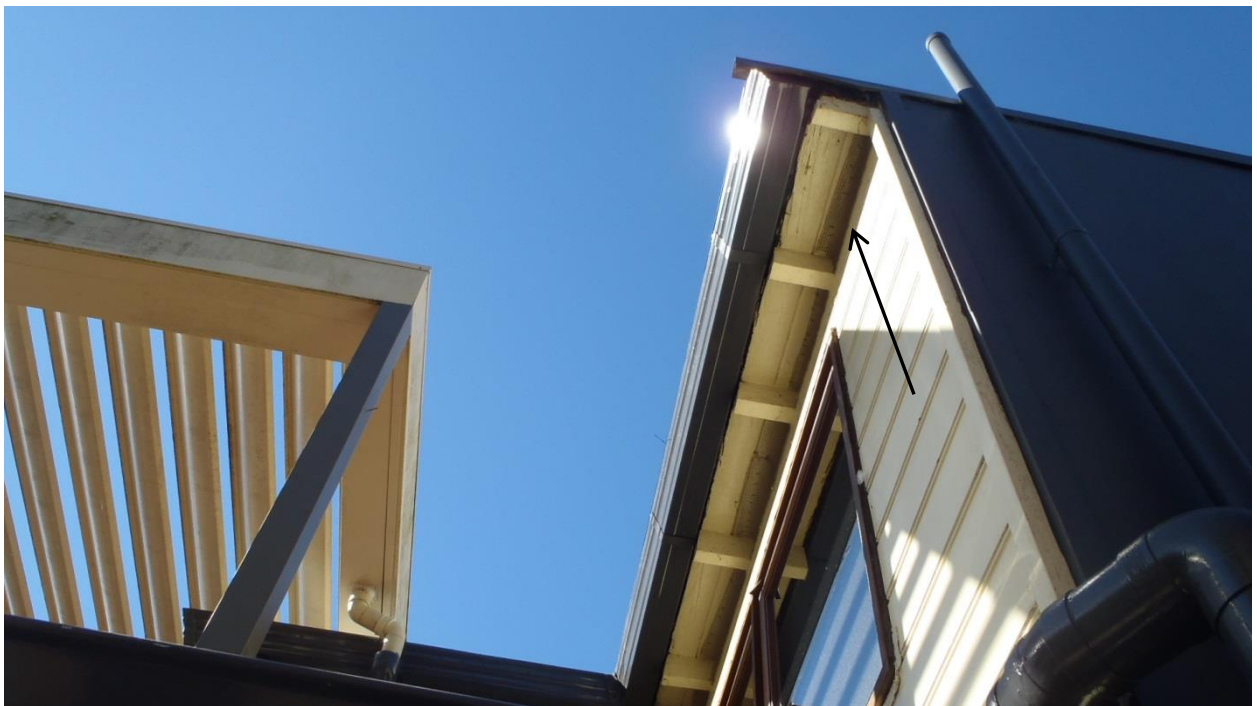
We noted gaps in the timber lining boards to the eave soffit at the rear to the north western corner. **[Photograph 10]**

**Photograph 10** shows gaps in the timber lining boards to the eave soffit at the rear to the north western corner.

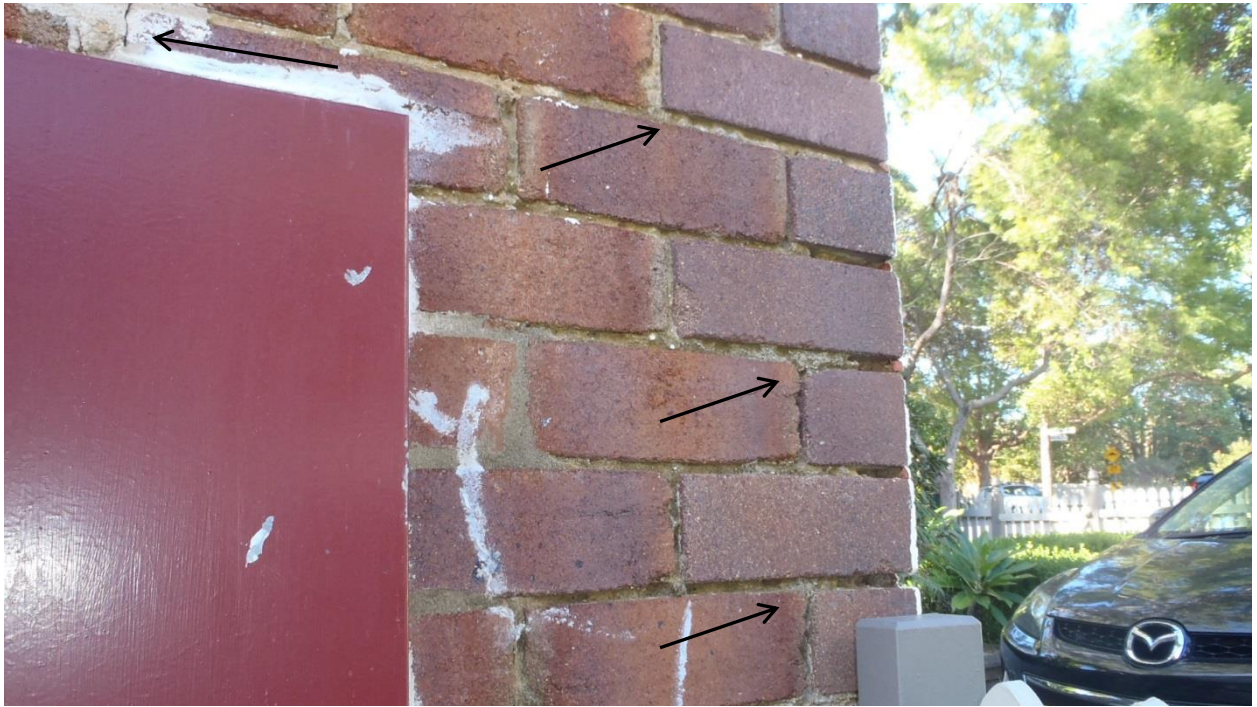
We noted displaced mortar (fretting) of the brickwork to the front south western elevation **[Photograph 11]**

We noted a previous repair to the brickwork above the electrical meter box **[Photograph 11]**

**Photograph 11** shows displaced (fretting) mortar to the brickwork at the front south western corner and previous repairs above the electrical meter board

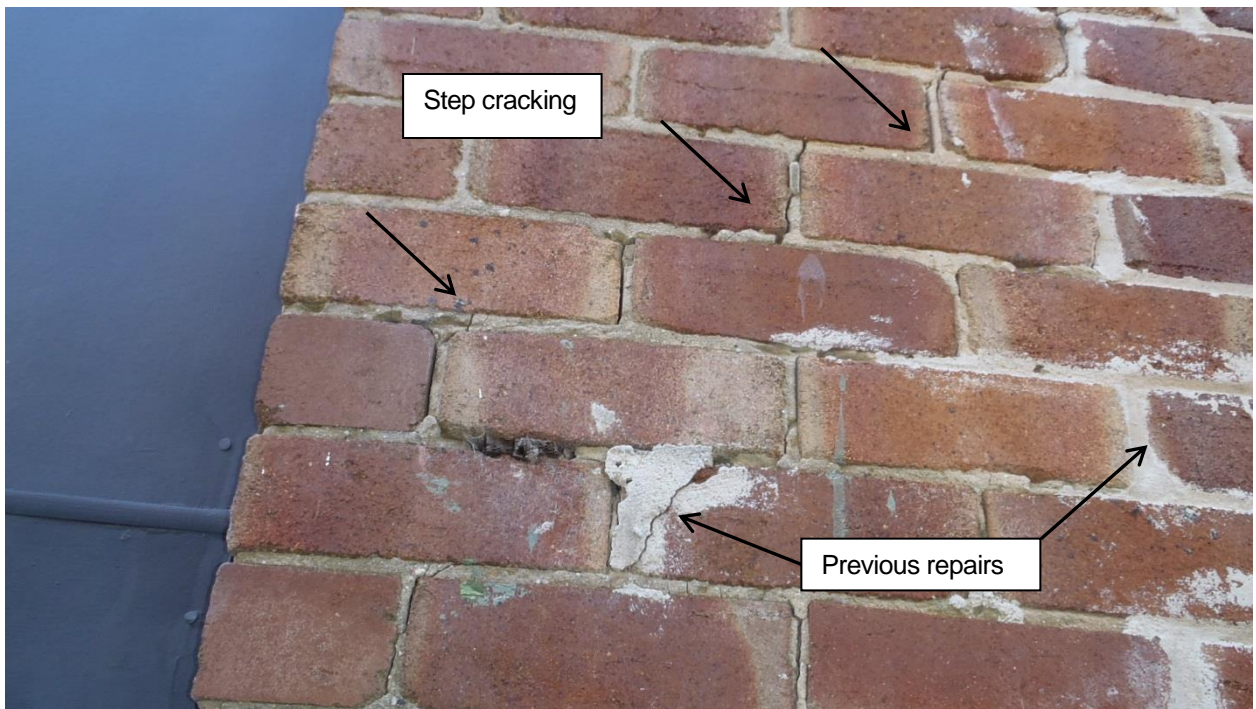
We noted step cracking of the brickwork and displaced mortar (fretting) to the rear north western corner of the original residence **[Photograph 12]**

We noted previous repairs and re-pointing of the brickwork to the rear north western corner of the original residence **[Photograph 12]**

**Photograph 12** shows step cracking, previous repairs and re-pointing of the brickwork to the north western corner of the original residence.

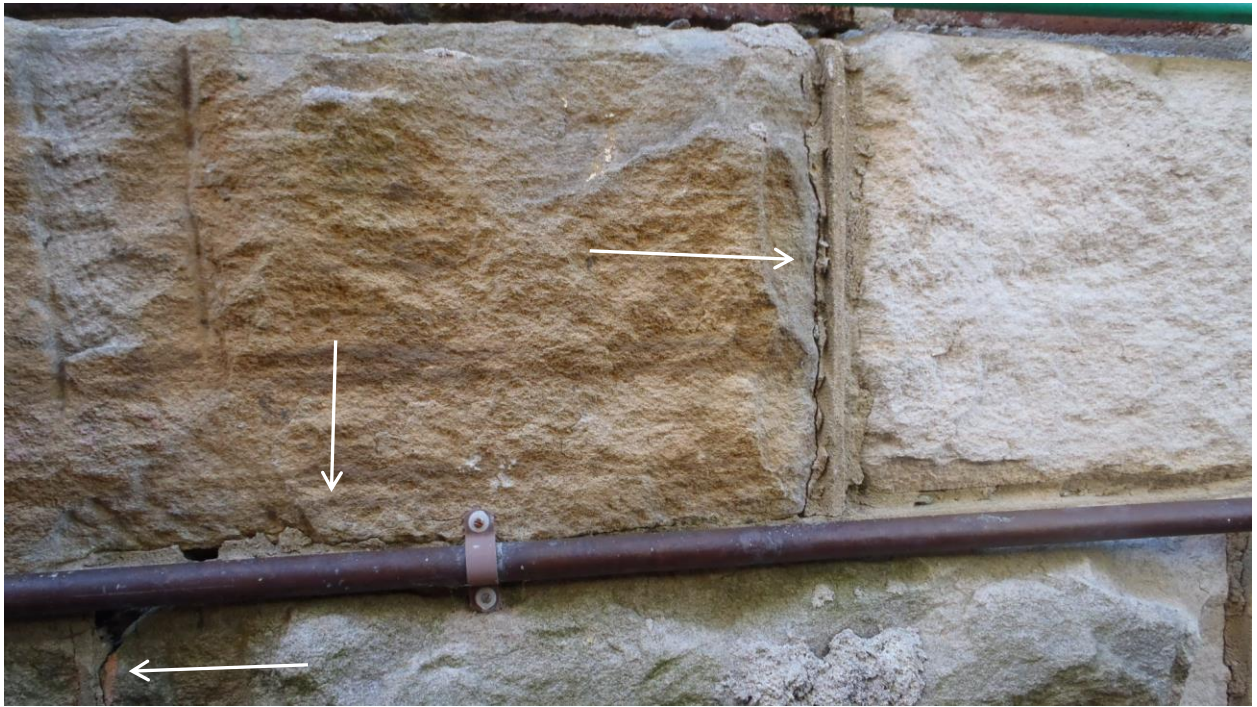
We noted step cracking to the sandstone block footings at the north western corner of the original residence **[Photograph 13]**

**Photograph 13** shows step cracking to the sandstone block footings at the north western corner of the original residence.

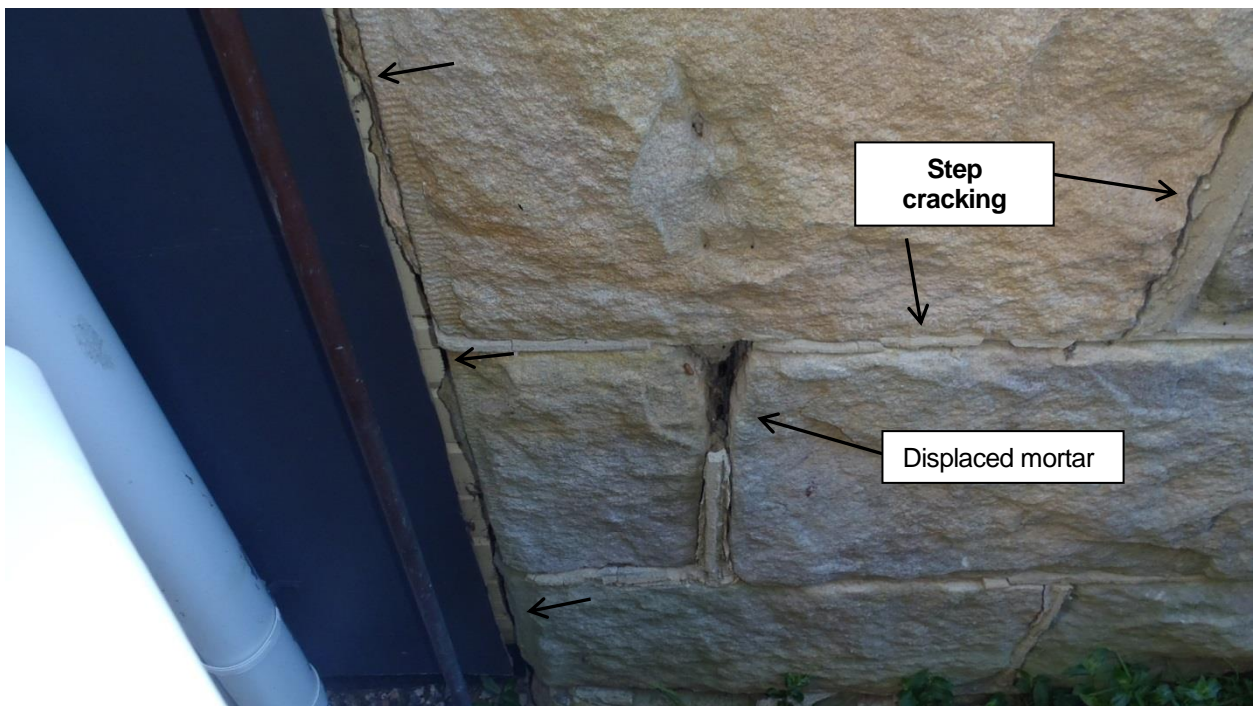
We noted step cracking of the sandstone footings and displaced mortar (fretting) to the rear north western corner of the original residence. **[Photograph 14]**

We noted vertical separation cracking to the junction between the weatherboard and sandstone block footings. **[Photograph 14]**

**Photograph 14** shows displaced (fretting) mortar and step cracking to the brickwork at the rear north western corner and separation cracking to the joint between the weatherboard and block wall.

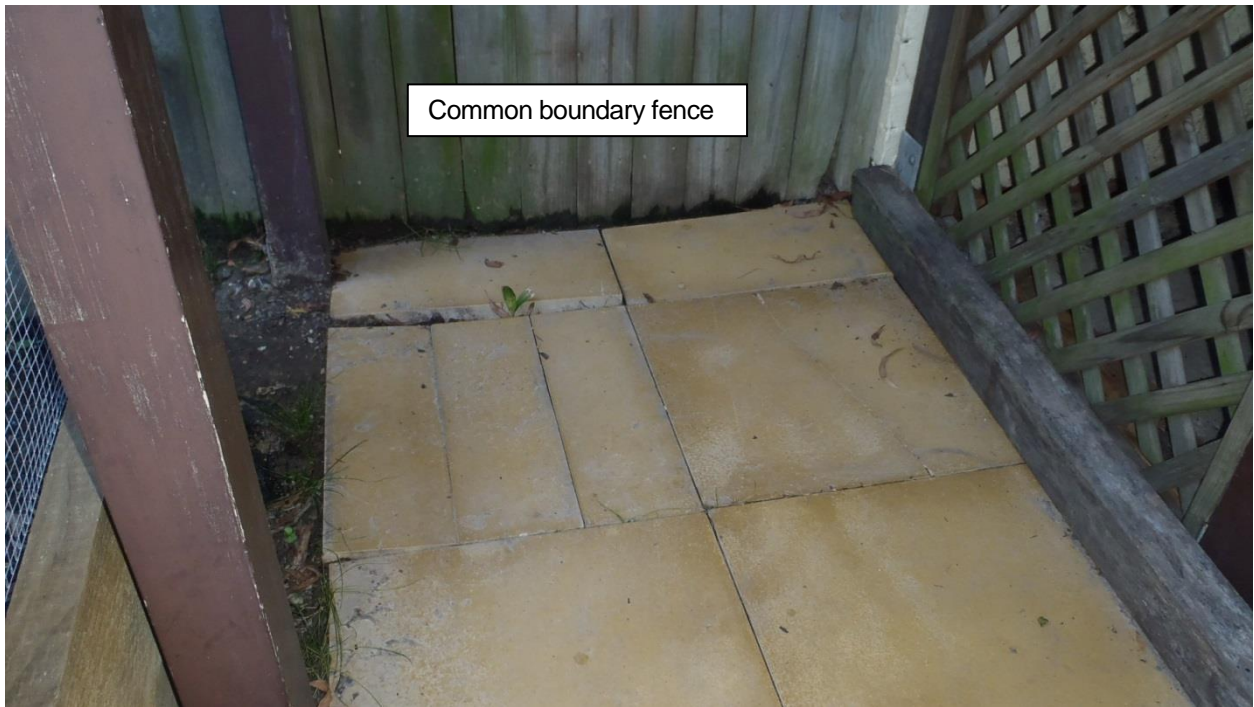
We noted displacement to the pavers adjacent to the rear common boundary fence. **[Photograph 15]**

**Photograph 15** shows displaced pavers adjacent to the rear common boundary fence .

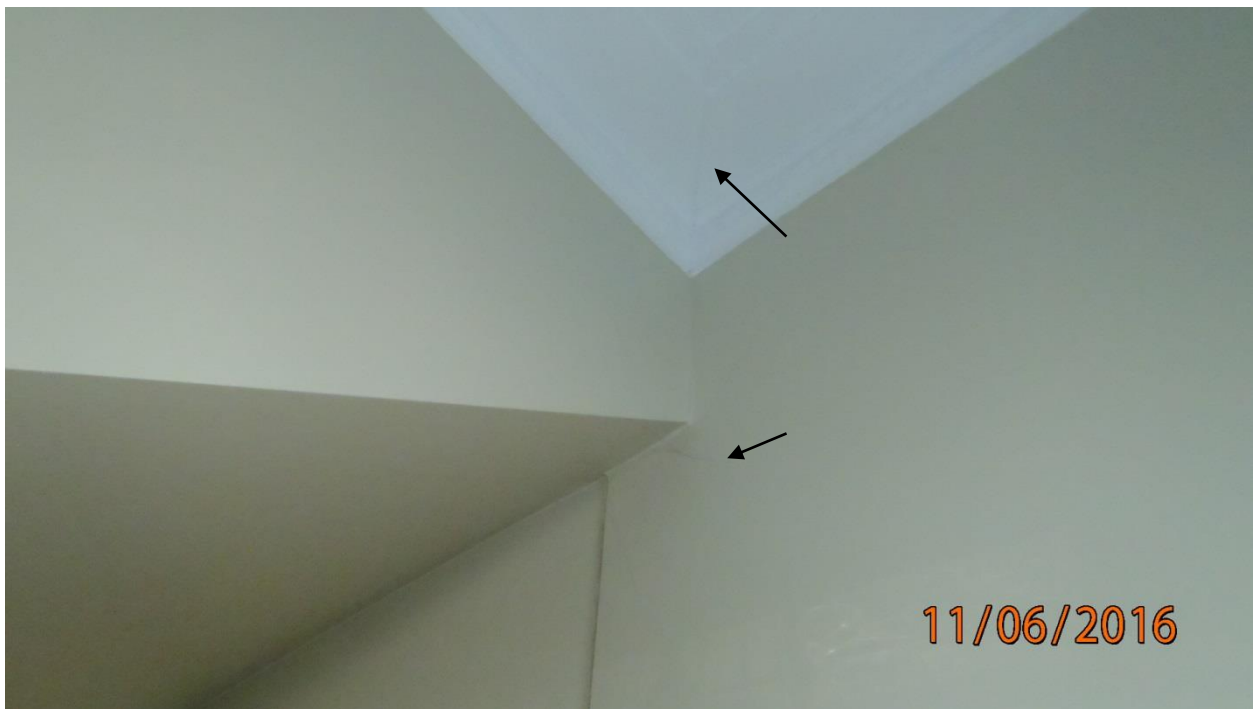
We noted a hairline radial crack [ $<1.0\text{mm}$ ] extending from the underside of the stair lining towards the door opening. **[Photograph 16]**

We noted a hairline crack [ $<1.0\text{mm}$ ] to the mitre joint of the cornice in the north eastern corner. **[Photograph 16]**

**Photograph 16** shows a hairline radial crack extending from the bottom of the under stair lining towards the door opening and cracking to the mitre joint of the cornice in Bedroom 1

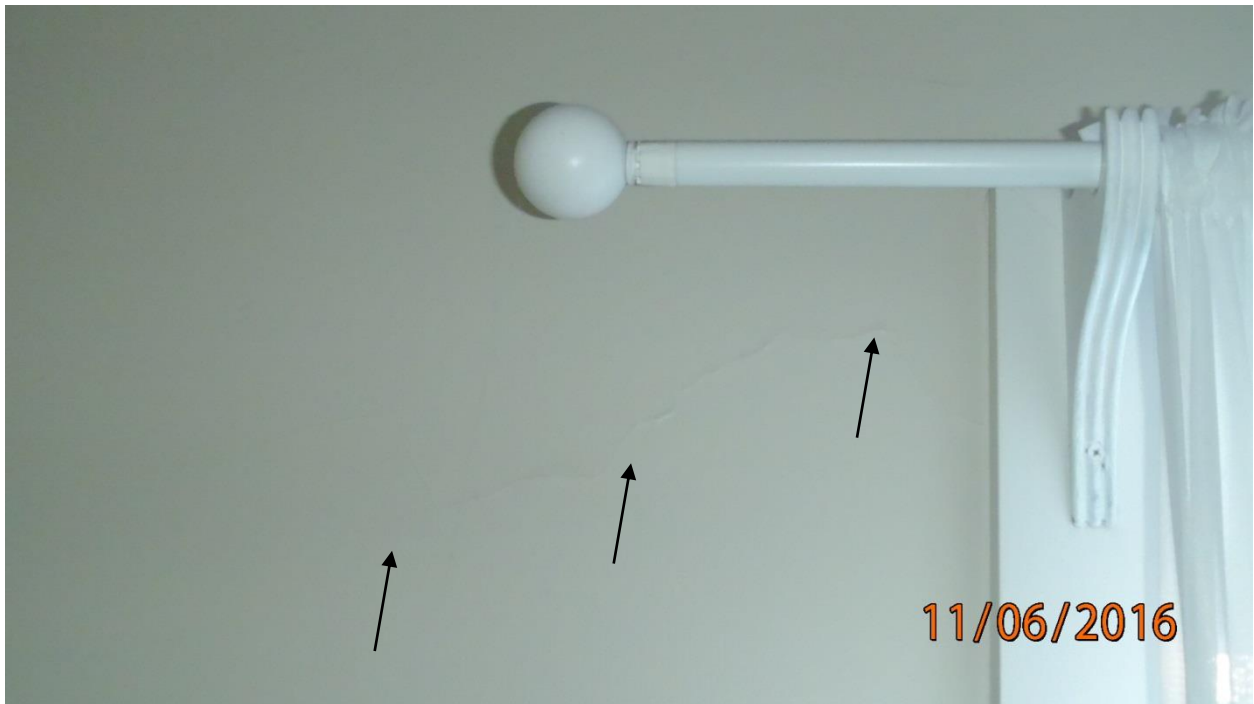
We noted a hairline radial crack [ $<1.0\text{mm}$ ] extending from the left hand side of the window head. **[Photograph 17]**

**Photograph 17** shows a hairline radial crack extending downward from the window head in Bedroom 1

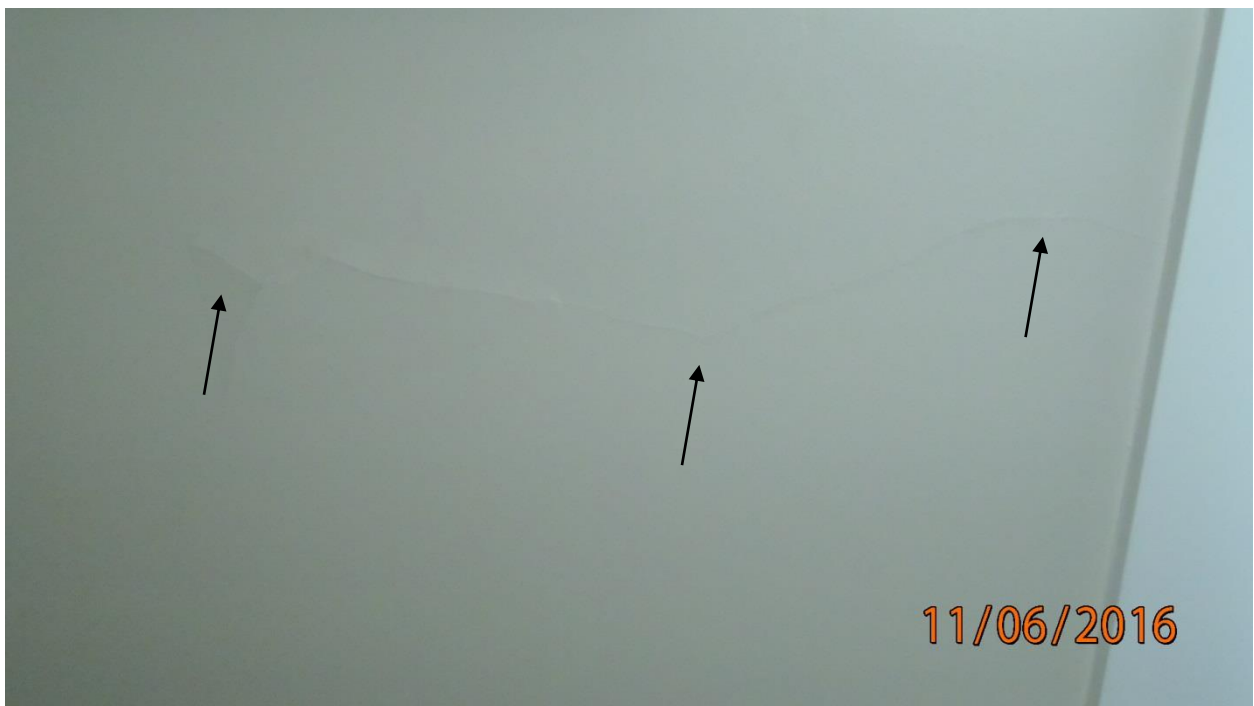
We noted a hairline radial crack [ $<1.0\text{mm}$ ] extending from the left hand side of the window reveal. **[Photograph 18]**

**Photograph 18** shows a hairline radial crack extending outward from the left hand side window reveal in Bedroom 1

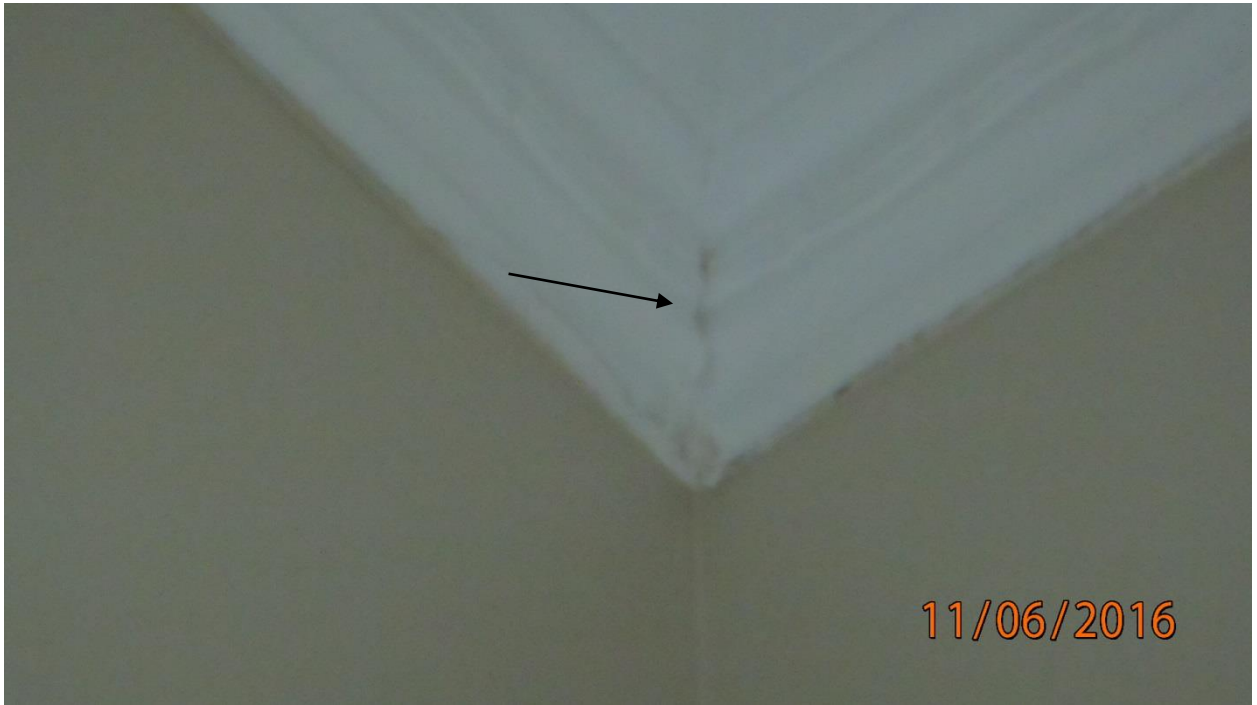
We noted a hairline crack [ $<1.0\text{mm}$ ] to the mitre joint of the cornice in the south western corner. **[Photograph 19]**

**Photograph 19** shows a crack to the mitre joint of the cornice in the south western corner of Bedroom 1

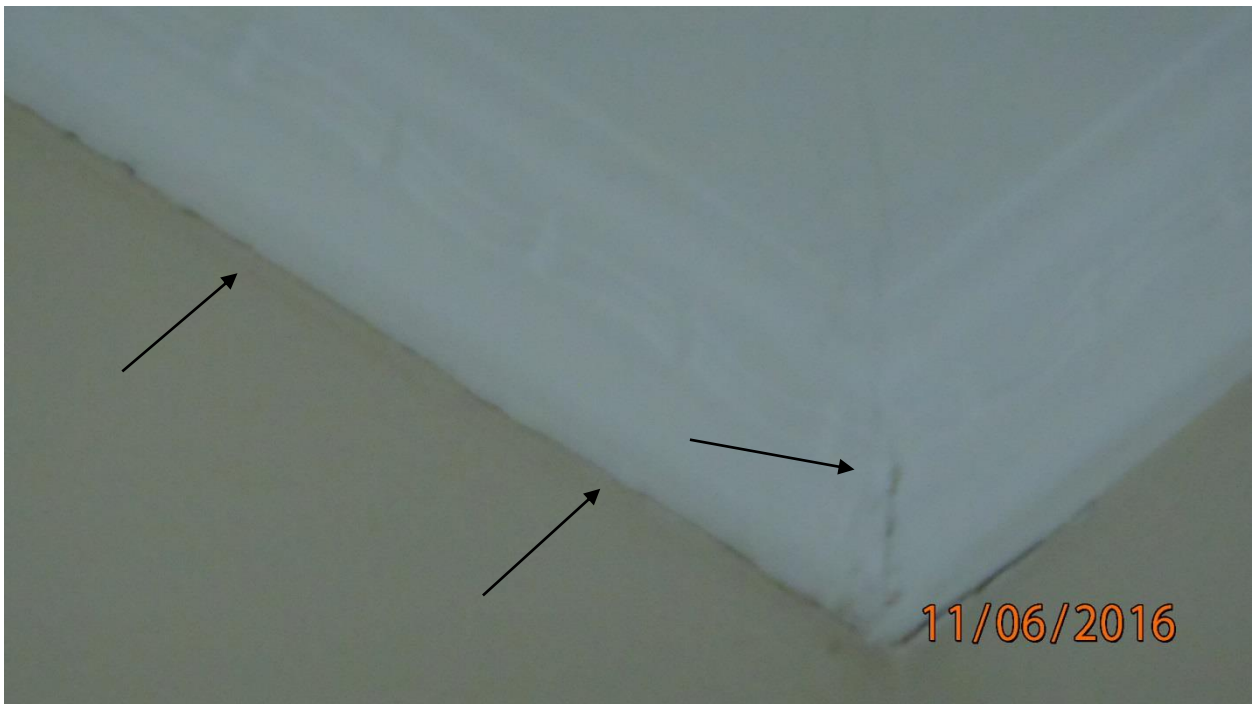
We noted a hairline crack [ $<1.0\text{mm}$ ] to the mitre joint of the cornice in the south western corner. **[Photograph 20]**

We noted separation cracking [ $<1.0\text{mm}$ ] to the wall / cornice junction in the north western corner **[Photograph 20]**

**Photograph 20** shows a crack to the mitre joint of the cornice in the north western corner and separation cracking at the wall / cornice junction of Bedroom 1

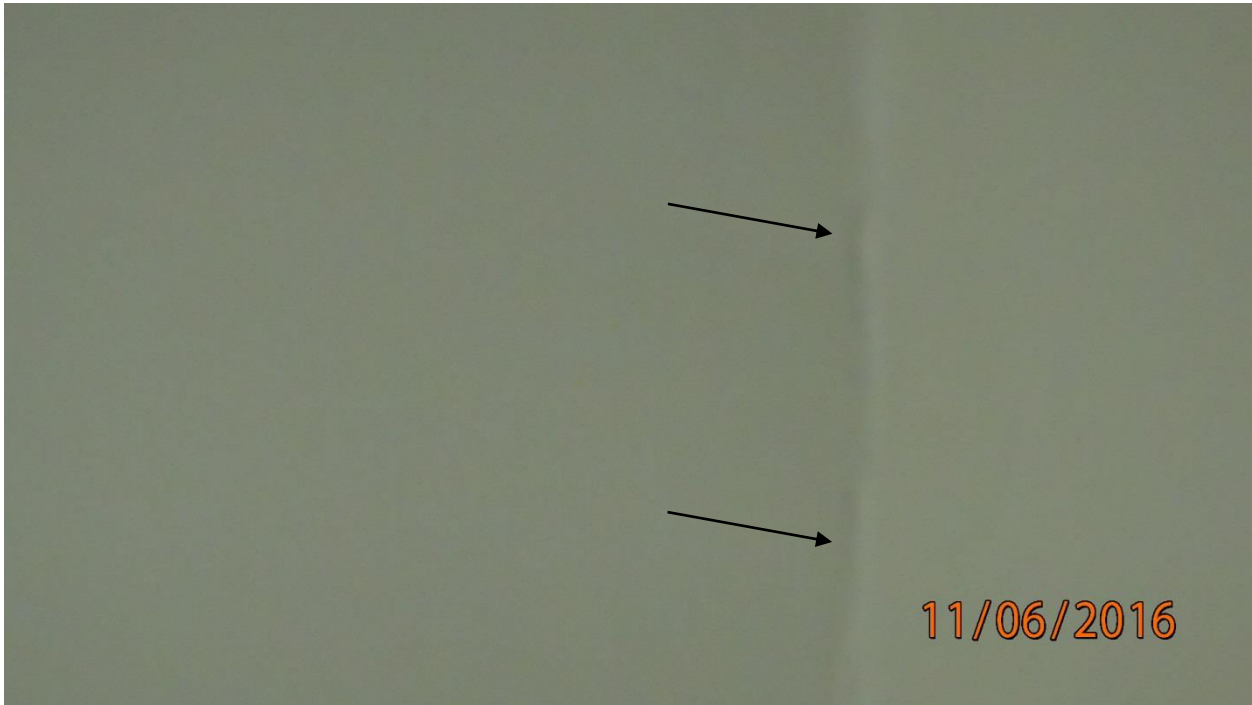
We noted a hairline vertical crack [ $<1.0\text{mm}$ ] to the wall intersection in the north western corner of Bedroom 1. **[Photograph 21]**

**Photograph 21** shows a hairline vertical crack to the wall intersection in the north western corner of Bedroom 1

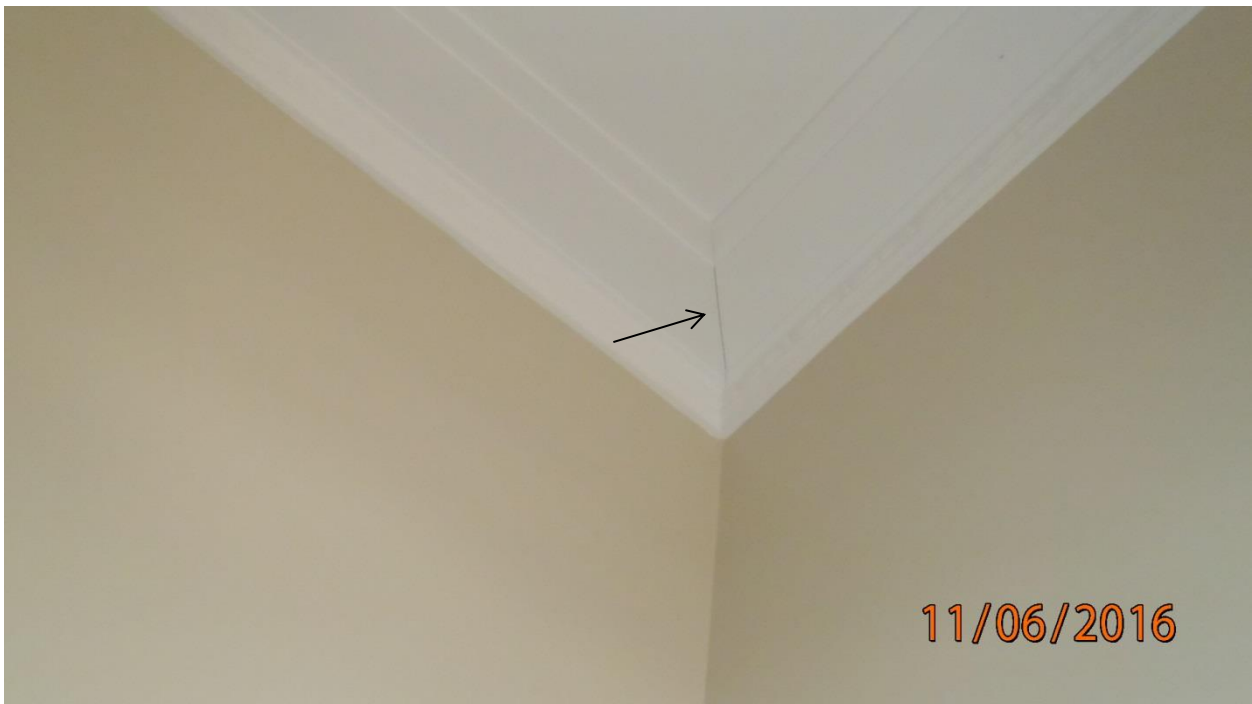
We noted a hairline crack [ $<1.0\text{mm}$ ] to the mitre joint of the cornice in the south western corner. **[Photograph 22]**

**Photograph 22** shows a crack to the mitre joint of the cornice in the south western corner of Bedroom 2.

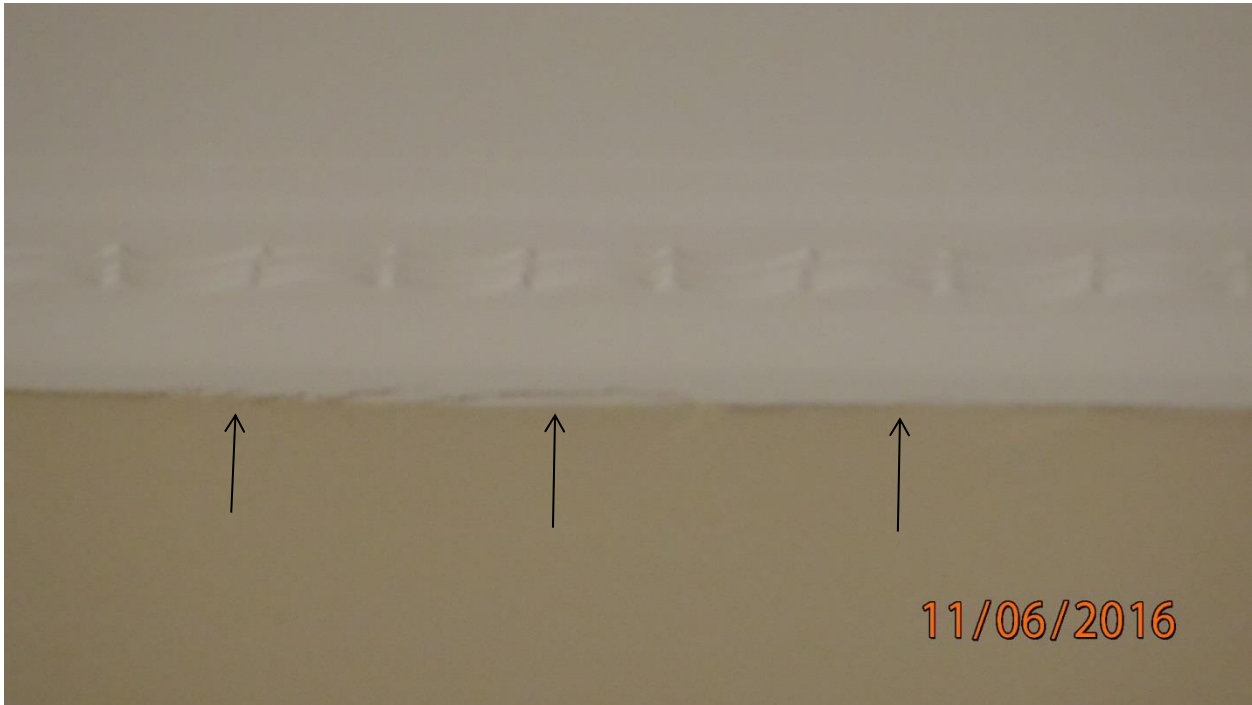
We noted separation cracking [ $<1.0\text{mm}$ ] to the wall / cornice junction to the southern wall **[Photograph 23]**

**Photograph 23** shows separation cracking at the southern wall / cornice junction of Bedroom 2.
