## Dilapidation Assessment Report

Prepared for: Cape Cod Australia Pty. Limited  
Job address: 1A Paradise Avenue, ROSEVILLE.  
Property Owner/s: Mr. Nathan Round  
Report reference: **WILLOUGHBY CITY COUNCIL**  
Development Application No: not available  
Date of assessment: Saturday 11<sup>th</sup> June 2016

**Re: Dilapidation Report – 1A Paradise Avenue, ROSEVILLE.**

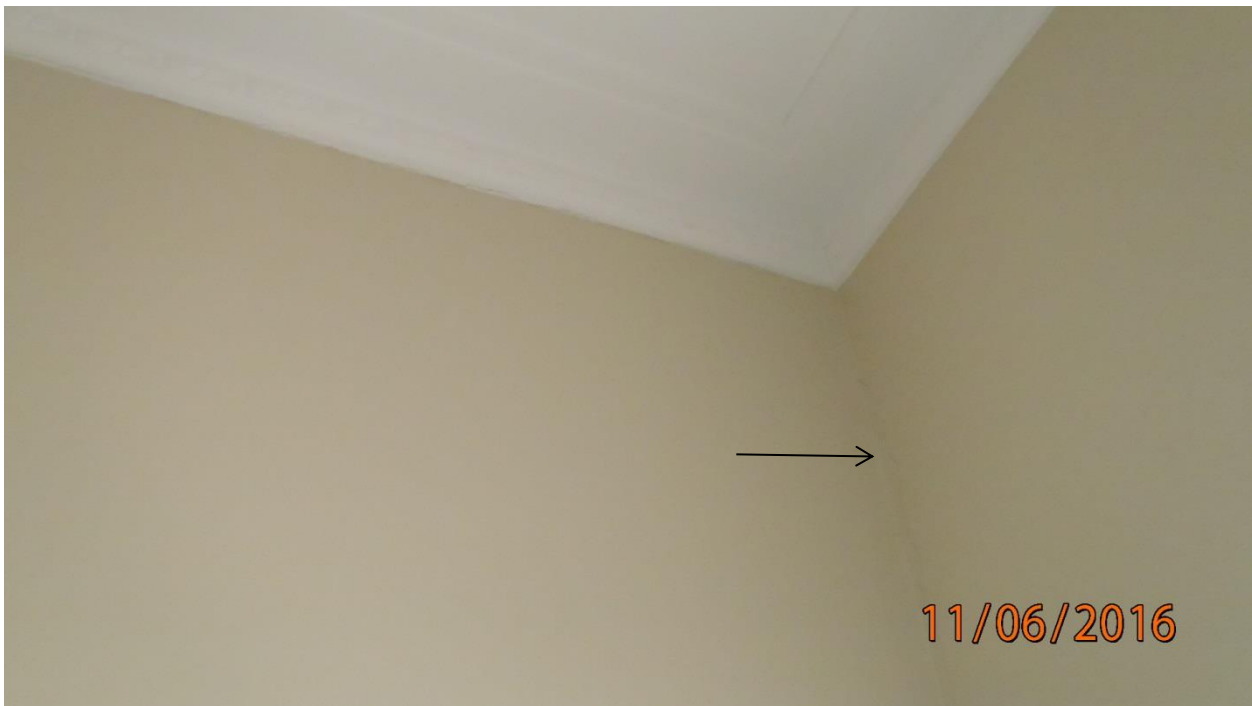
We noted a vertical hairline crack [ $<1.0\text{mm}$ ] to the wall intersection in the south western corner of Bedroom 2. **[Photograph 24]**

**Photograph 24** shows a hairline vertical crack to the wall intersection in the south western corner of Bedroom 2

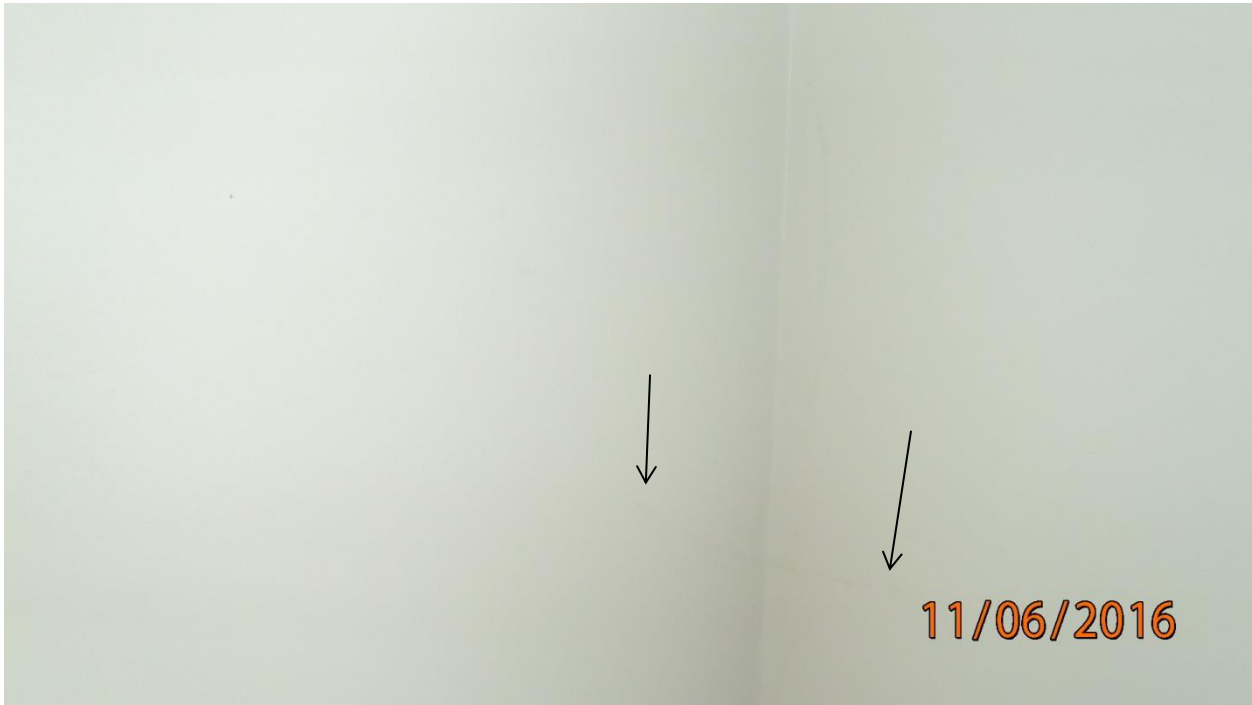
We noted a horizontal hairline crack [ $<1.0\text{mm}$ ] extending both sides of the wall intersection in the north western corner of Bedroom 2. **[Photograph 25]**

**Photograph 25** shows a hairline horizontal cracking extending outwards (both sides) to the wall intersection in the north western corner of Bedroom 2.

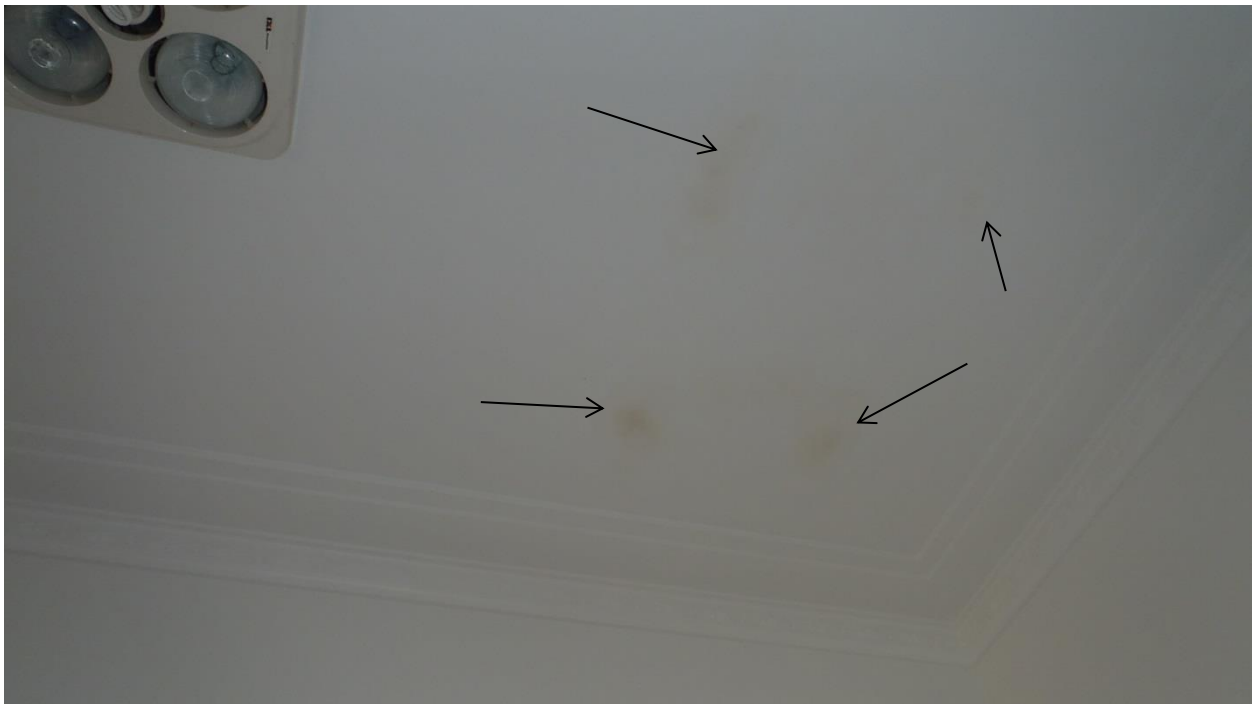
We observed staining to the ceiling lining adjacent to the fan/heater/light fitting **[Photograph 26]**

**Photograph 26** shows staining to the ceiling lining adjacent to the fan/heater/light fitting in the Bathroom.

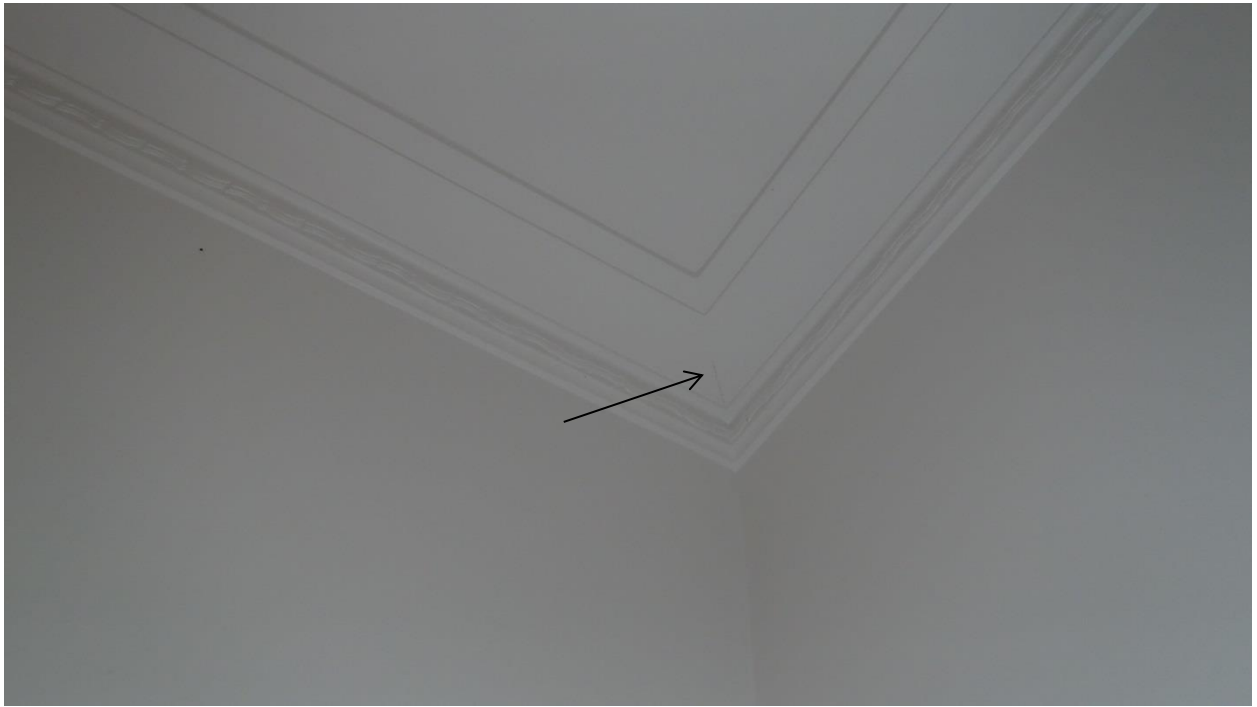
We noted a hairline crack [ $<1.0\text{mm}$ ] to the mitre joint of the cornice in the north western corner. **[Photograph 27]**

**Photograph 27** shows a crack to the mitre joint of the cornice in the north western corner of the Bathroom.

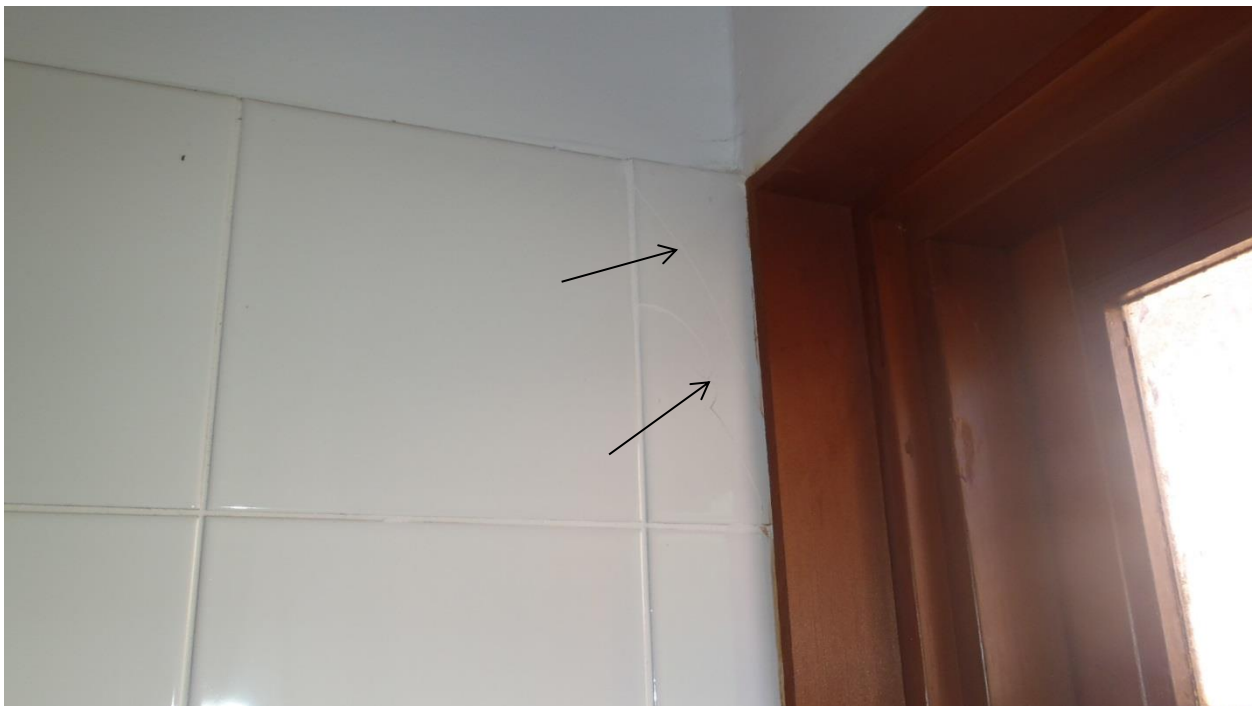
We noted radial cracking to the wall tiles adjacent to the window **[Photograph 28]**

**Photograph 28** shows cracking to the wall tiles radiating from the top left hand side of the window in the Bathroom.

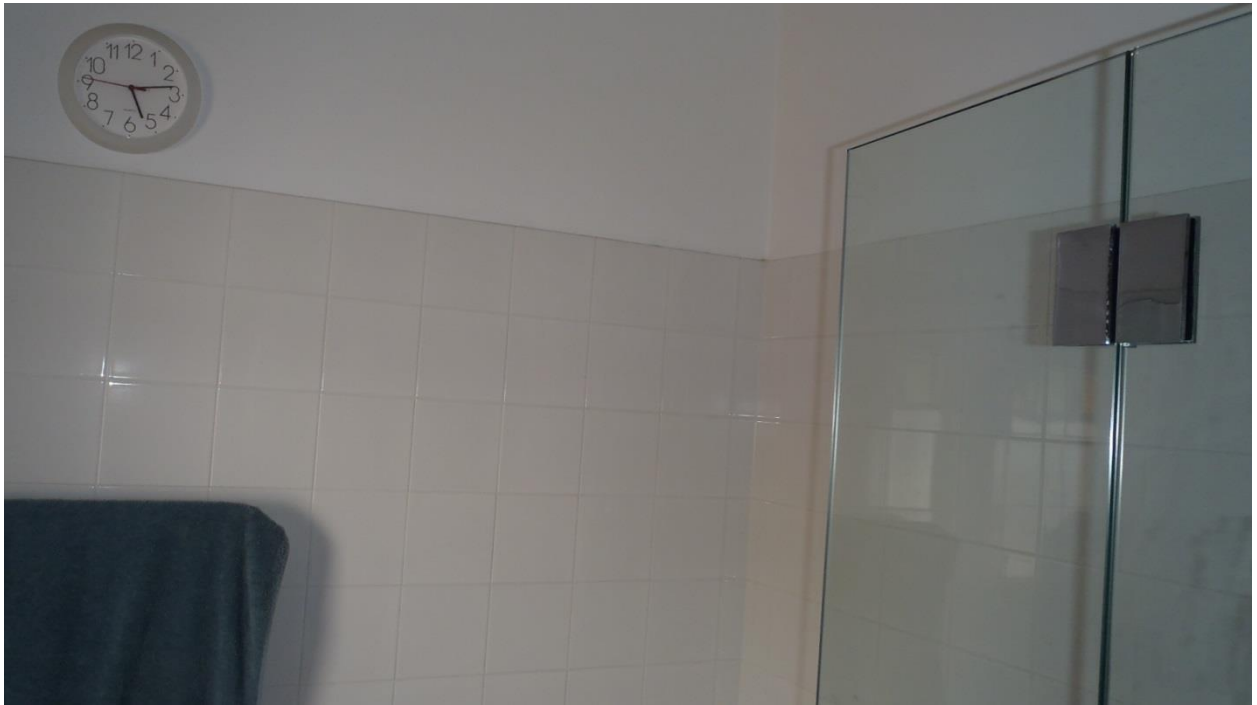
**Photograph 29** shows the general condition of the Bathroom.

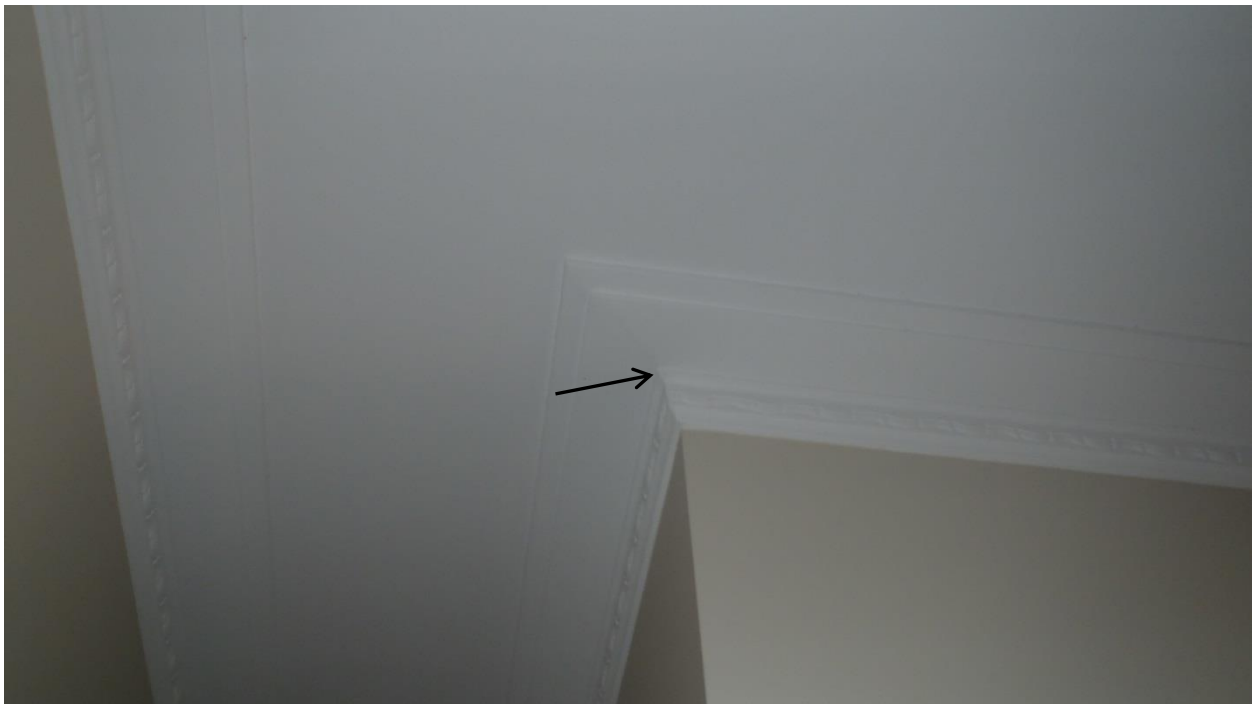
We noted a hairline crack [ $<1.0\text{mm}$ ] to the mitre joint of the cornice in the south western corner. **[Photograph 30]**

**Photograph 30** shows a crack to the mitre joint of the cornice in the south western corner of the Lounge room (common with the Bathroom).

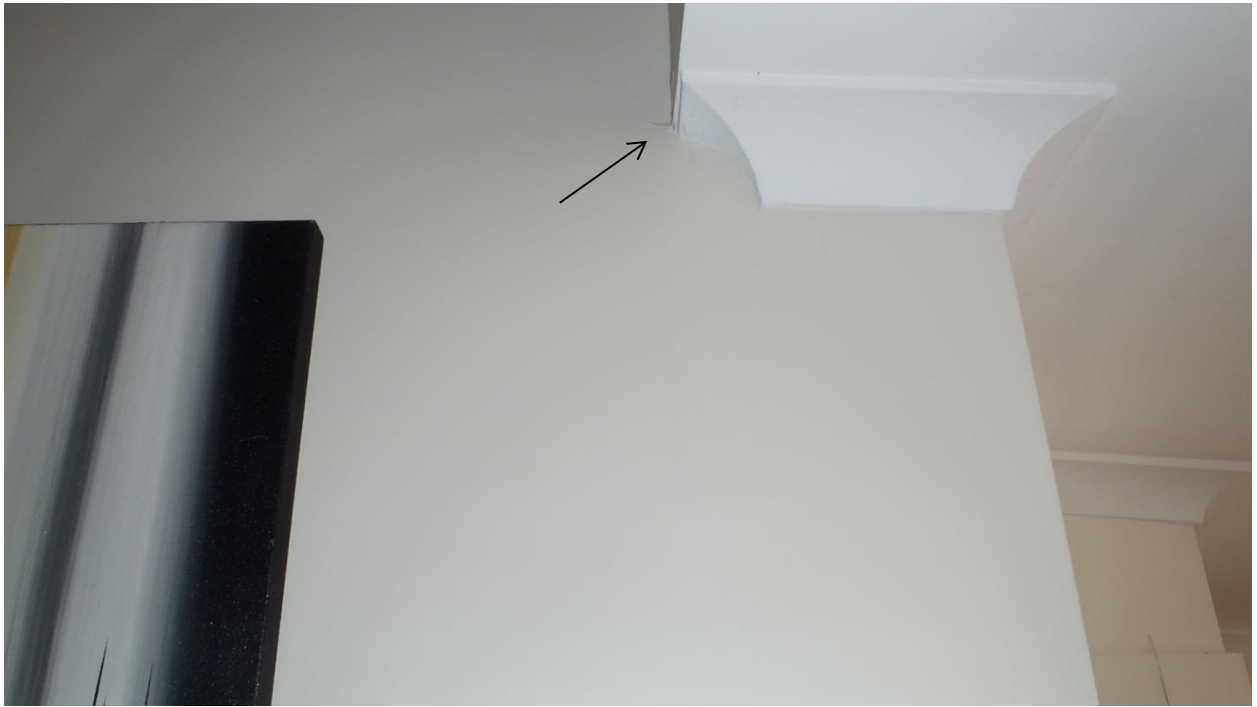
We noted a hairline crack [ $<1.0\text{mm}$ ] to the wall lining extending from the cornice in the north western corner. **[Photograph 31]**

**Photograph 31** shows a crack to the wall lining from the cornice in the north western corner of the Lounge room (common with the Bathroom).

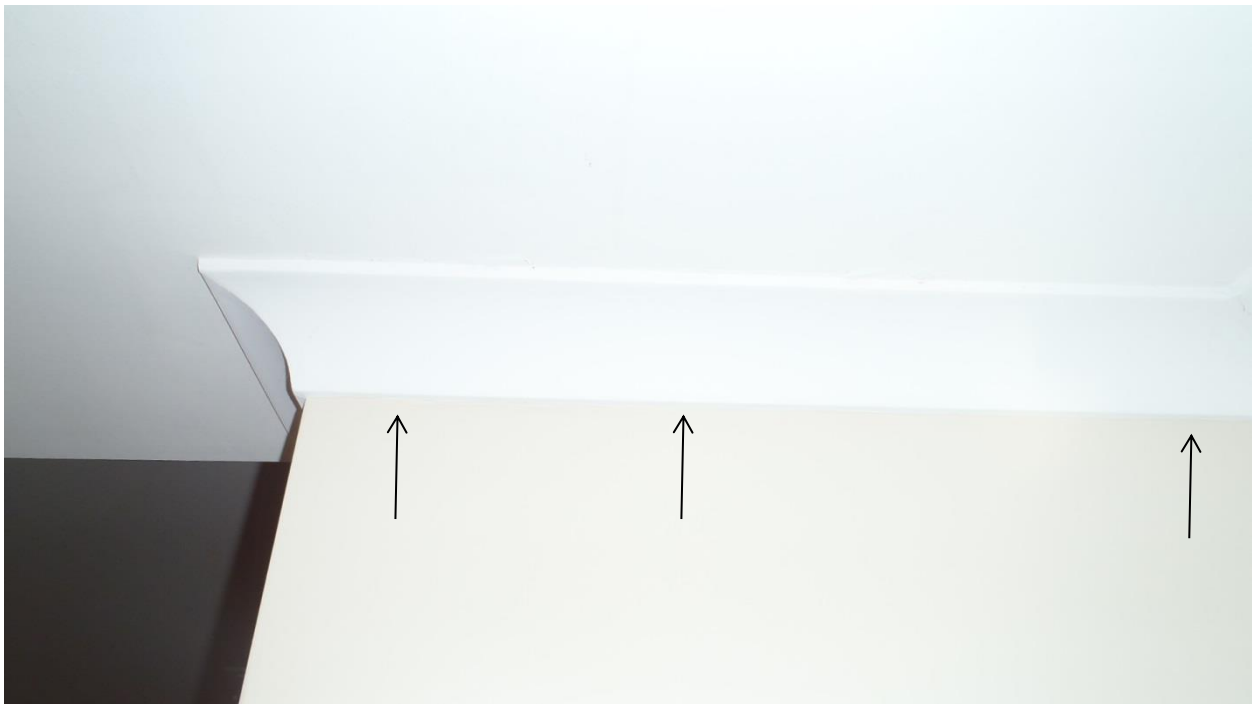
We noted separation cracking [ $<1.0\text{mm}$ ] to the wall / cornice junction to the southern wall **[Photograph 32]**

**Photograph 32** shows separation cracking at the southern wall / cornice junction of the Kitchen.

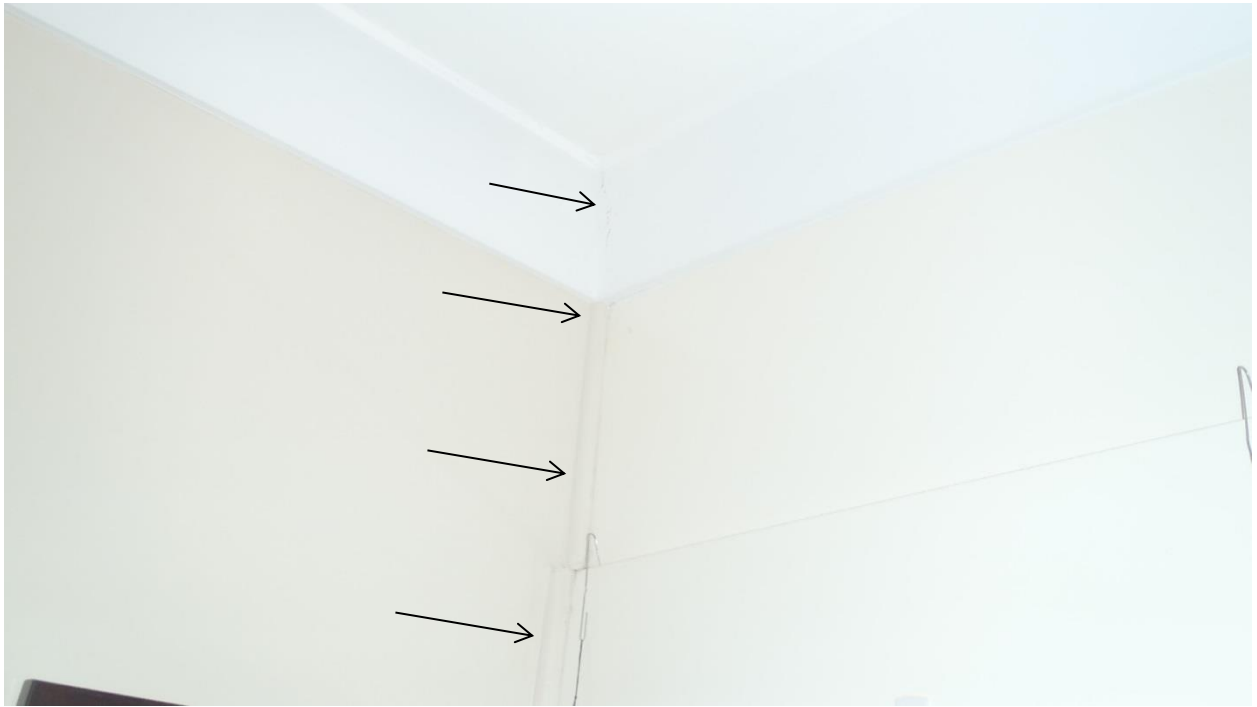
We noted separation cracking [ $<1.0\text{mm}$ ] between the wall and trim moulding to the southern western corner **[Photograph 33]**

We noted a hairline crack [ $<1.0\text{mm}$ ] to the mitre joint of the cornice in the south western corner. **[Photograph 33]**

**Photograph 33** shows crack to the mitre joint of the cornice in the south western corner of the Kitchen and separation between the wall and moulding trim.

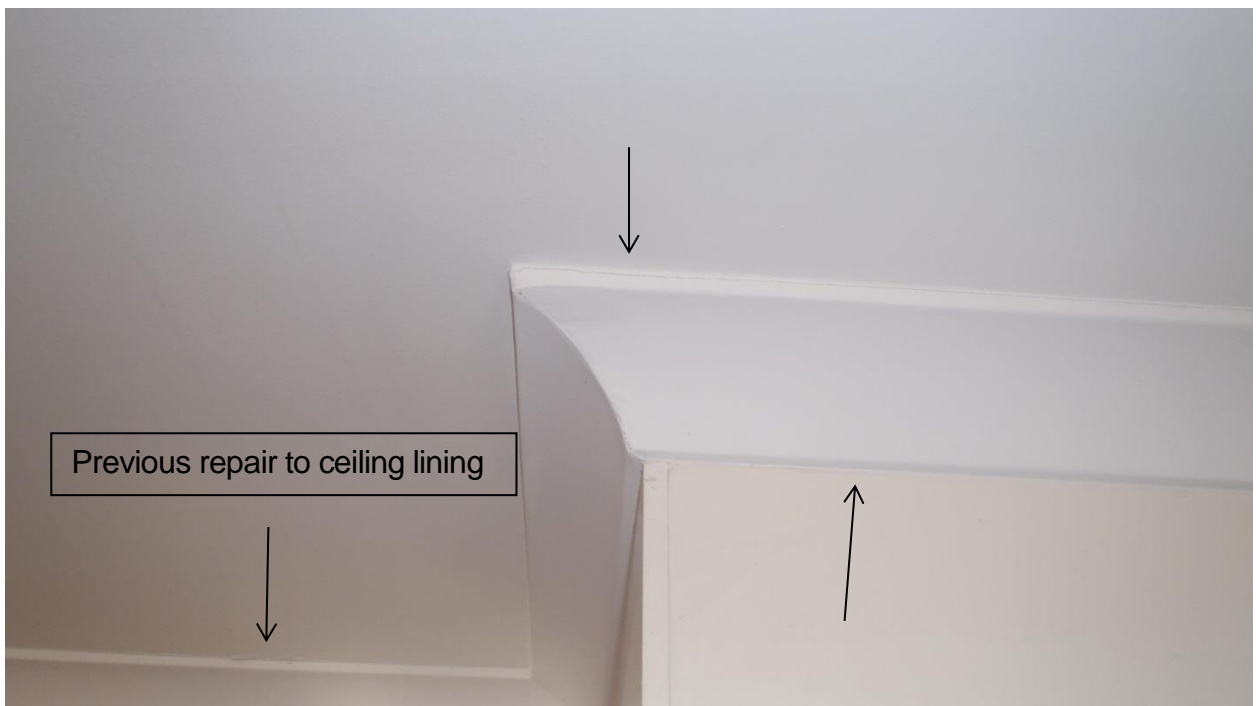
We noted separation cracking [ $<1.0\text{mm}$ ] to the ceiling / cornice junction to the southern western corner **[Photograph 34]**

We noted separation cracking [ $<1.0\text{mm}$ ] to the wall / cornice junction to the south western corner **[Photograph 34]**

We noted a previous repair to the ceiling lining to the south western corner **[Photograph 34]**

**Photograph 34** shows a separation crack to the ceiling / cornice joint in the south western corner of the Kitchen, separation cracking between the wall and the plaster cornice and a previous repair to the ceiling lining in the Kitchen.

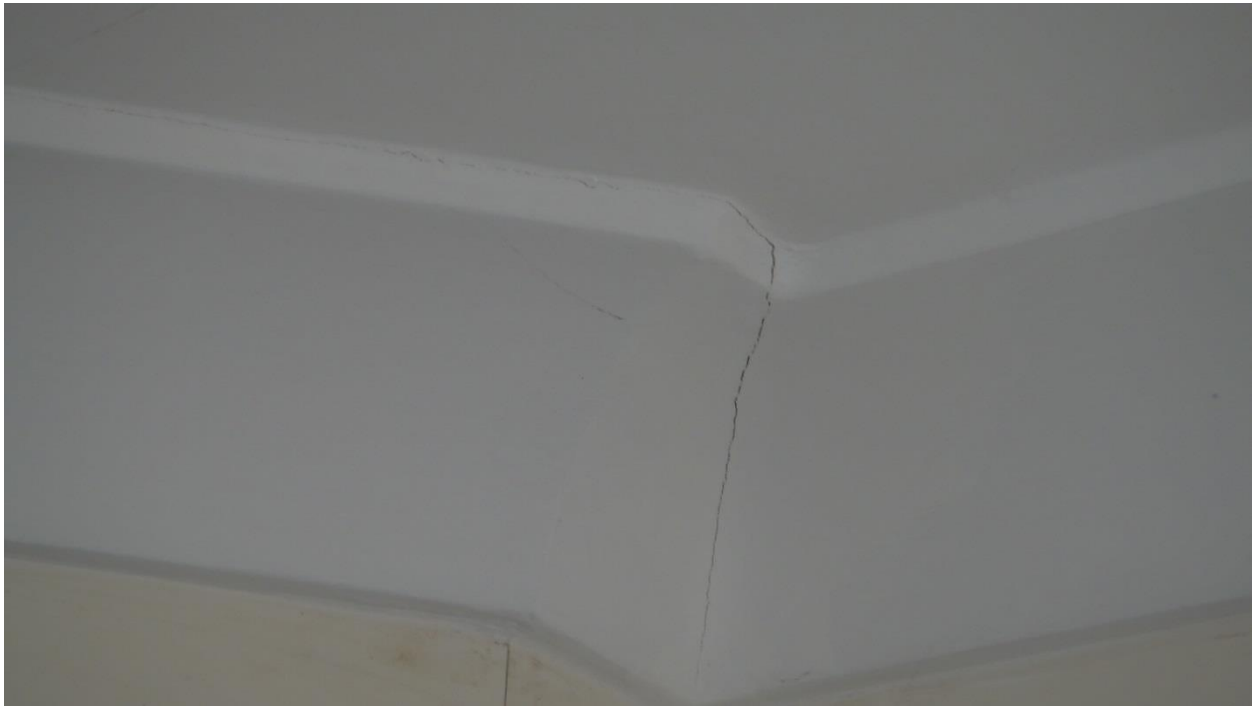
We noted a hairline crack [ $<1.0\text{mm}$ ] to the mitre joint of the cornice in the south western corner. **[Photograph 35]**

**Photograph 35** shows a crack to the mitre joint of the cornice in the south western corner of the Kitchen.

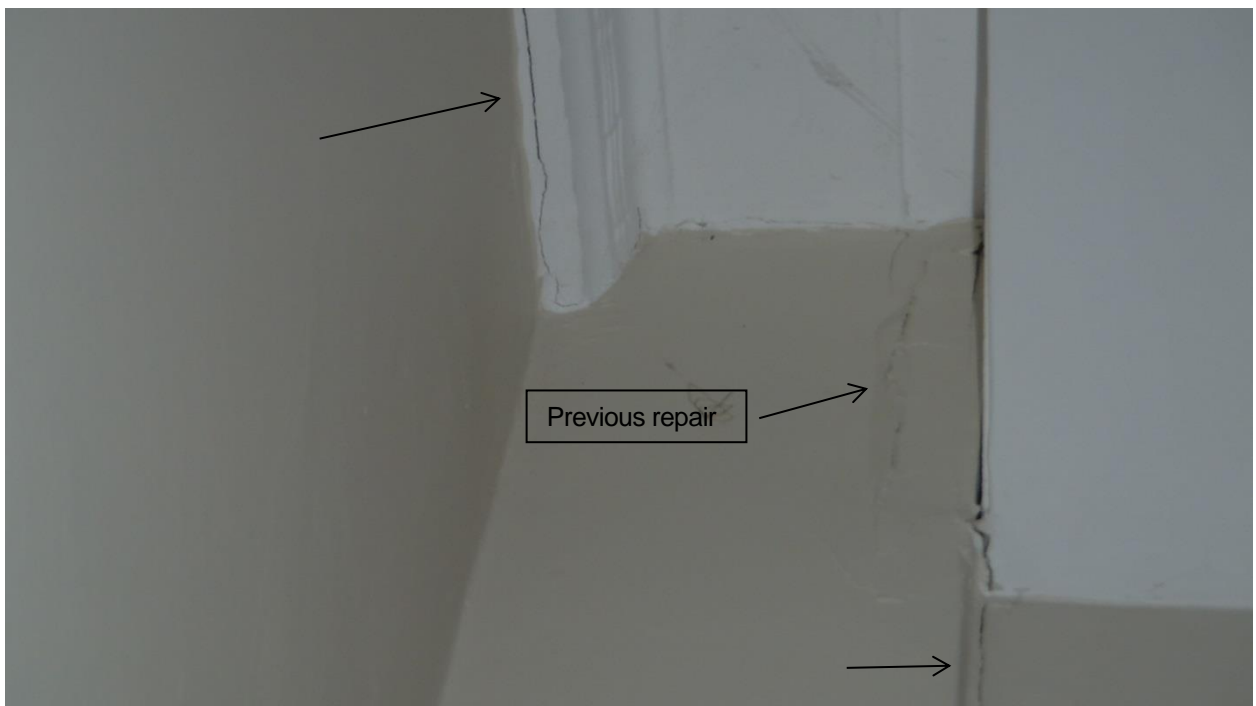
We noted separation cracking and vertical cracking [ $<1.0\text{mm}$ ] to the wall / cornice junction to the western wall. We also noted a previous repair to the wall lining **[Photograph 36]**

**Photograph 36** shows separation cracking to the wall / cornice junction in the western wall of the Hallway and vertical cracking and a previous repair.

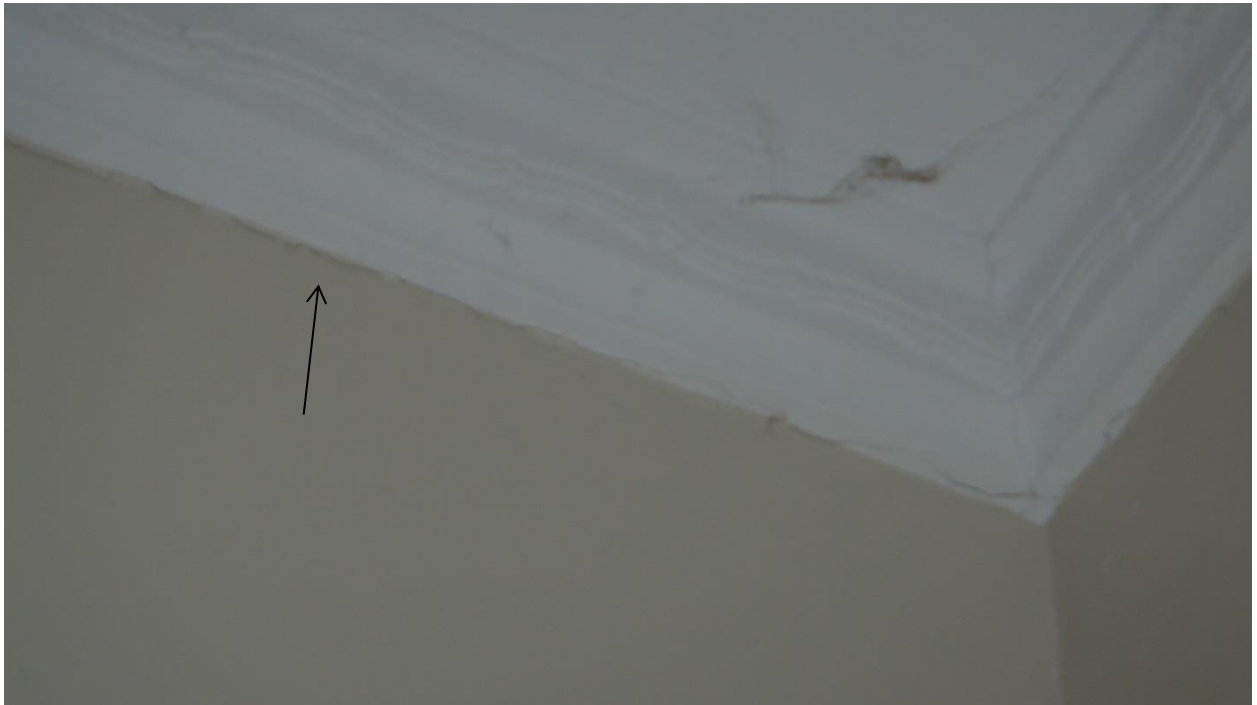
We noted separation cracking [ $<1.0\text{mm}$ ] to the wall / cornice junction to the common party wall (eastern wall) **[Photograph 37, 38 and 39]**

**Photograph 37** shows separation cracking to the wall / cornice junction of the *common party wall* (eastern wall of the Hallway).

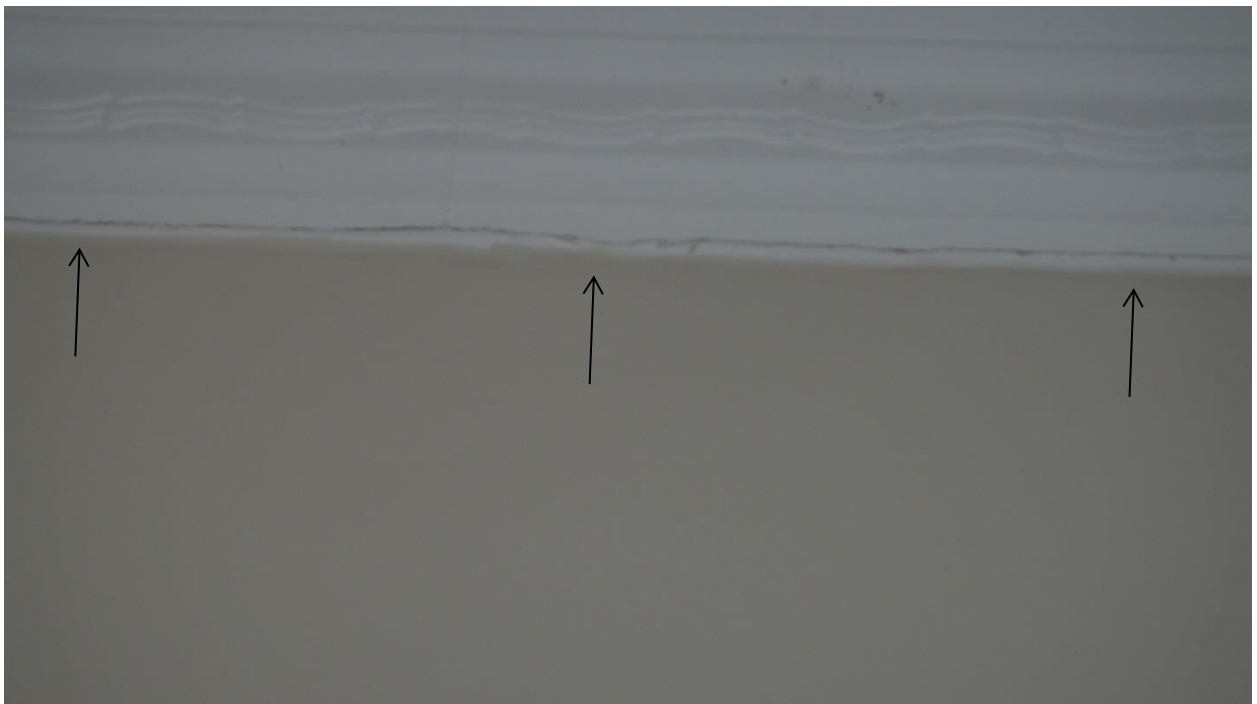
**Photograph 38** shows separation cracking to the wall / cornice junction of the *common party wall* (eastern wall of the Hallway).

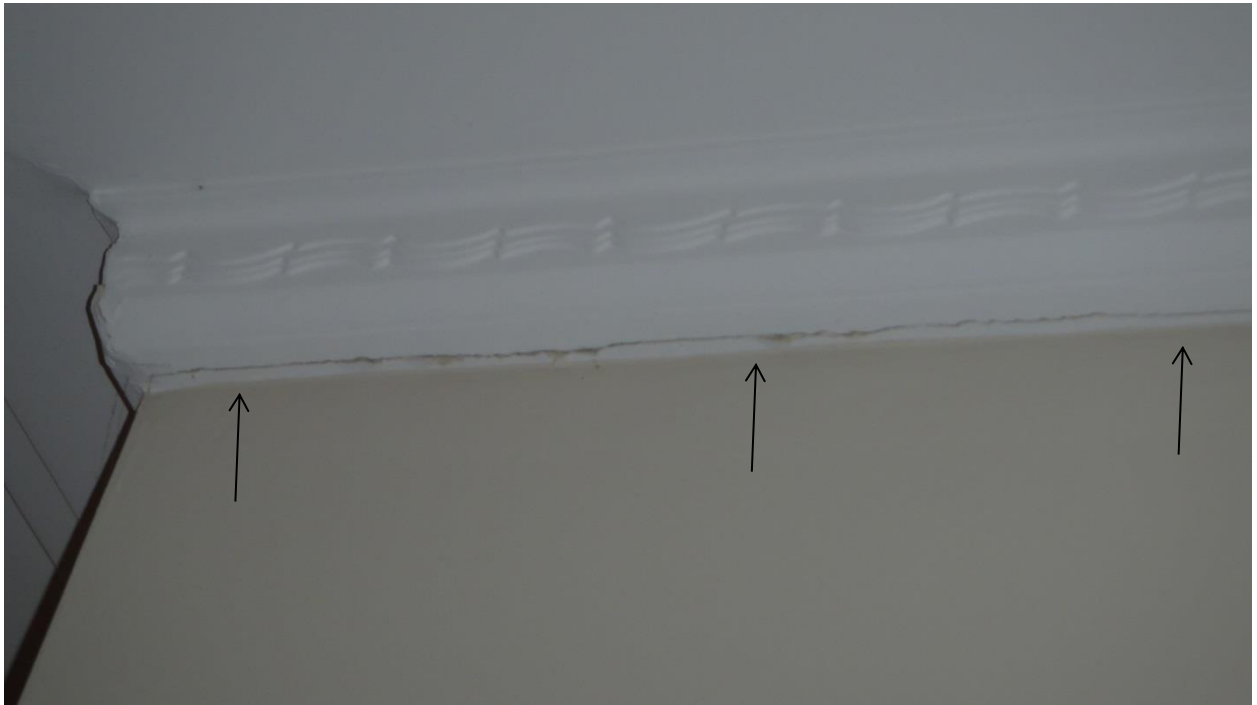
**Photograph 39** shows separation cracking to the wall / cornice junction of the *common party wall* (eastern wall of the Hallway).

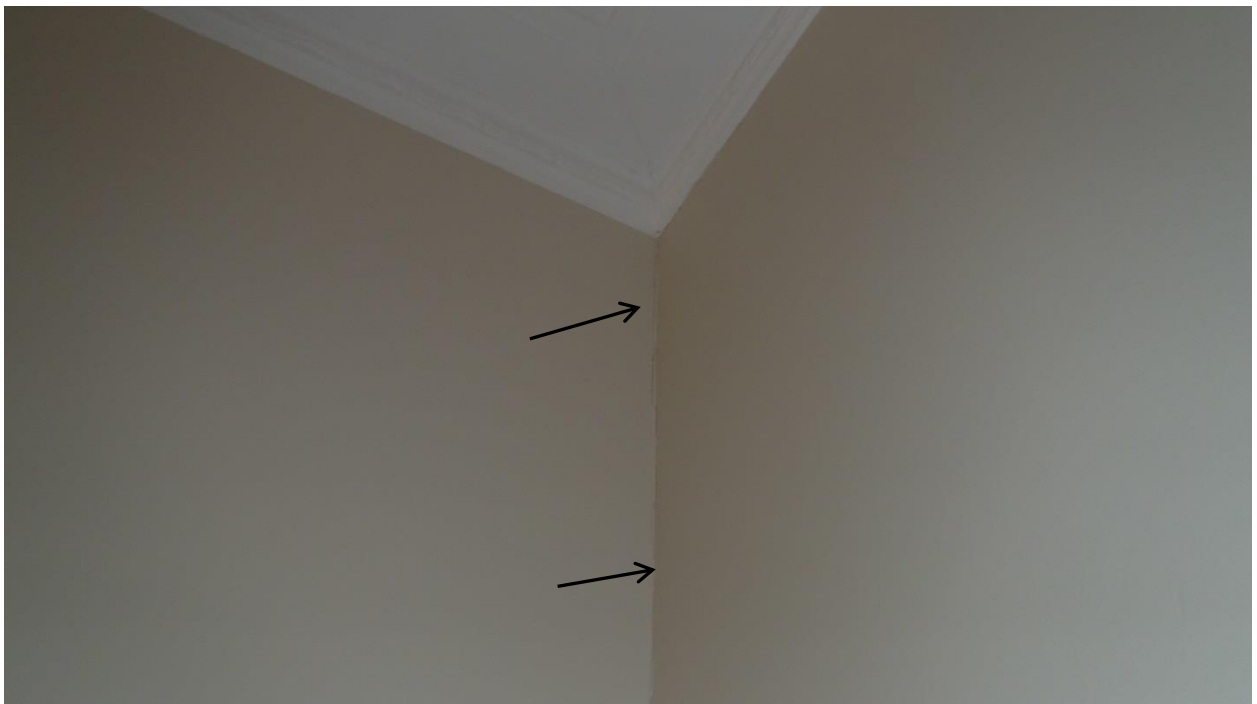
We noted a vertical hairline crack [ $<1.0\text{mm}$ ] to the wall intersection in the *common party wall* (south eastern corner) **[Photograph 40]**

**Photograph 40** shows vertical cracking the wall junction of the *common party wall* (south eastern corner of the dining room).

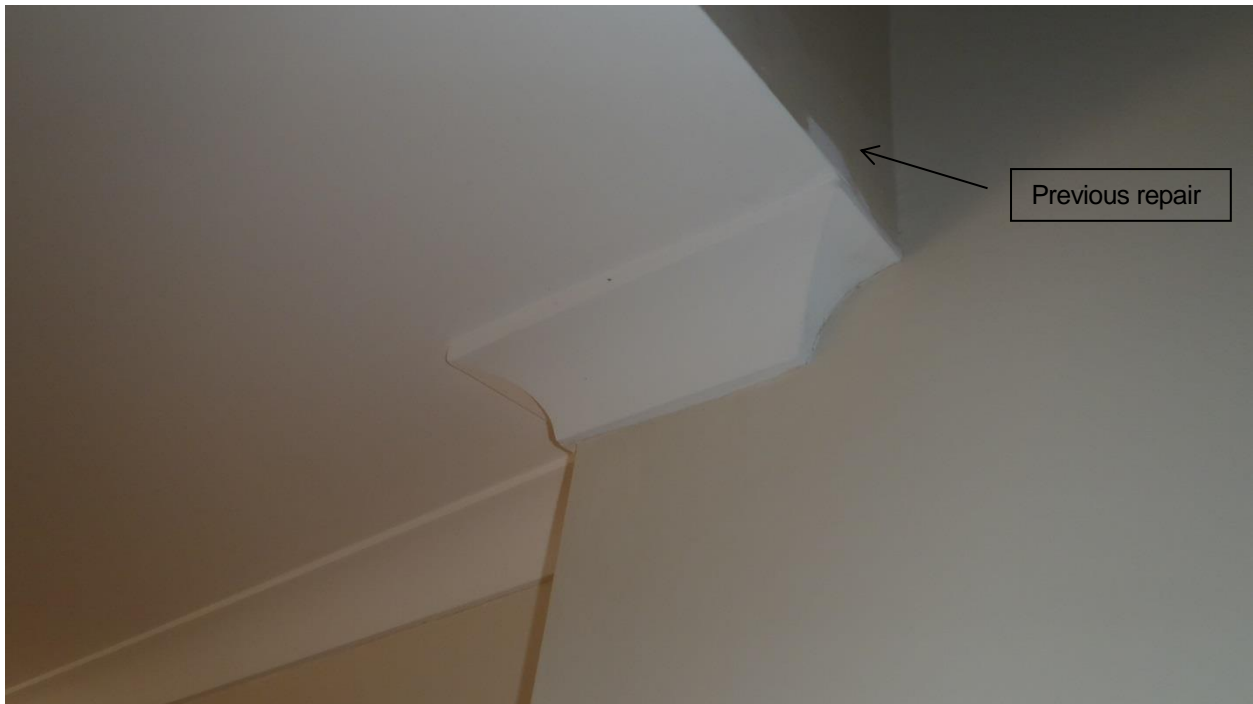
We noted a previous repair to the bulkhead wall at the northern end **[Photograph 41]**

**Photograph 41** shows a previous repair to the bulkhead at the northern end of the dining room.

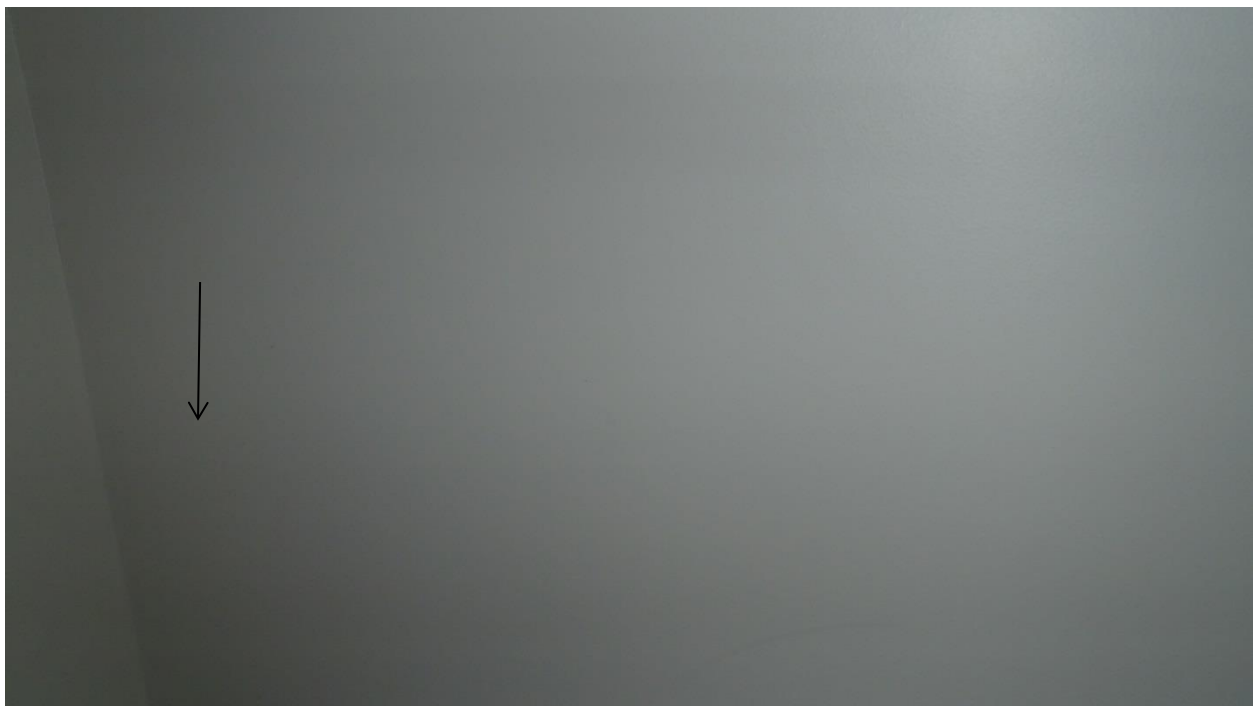
We noted a horizontal hairline crack [ $<1.0\text{mm}$ ] extending from the wall intersection on the north western wall **[Photograph 42]**

**Photograph 42** shows a hairline horizontal crack radiating from the wall junction in the north western wall of the stairwell.

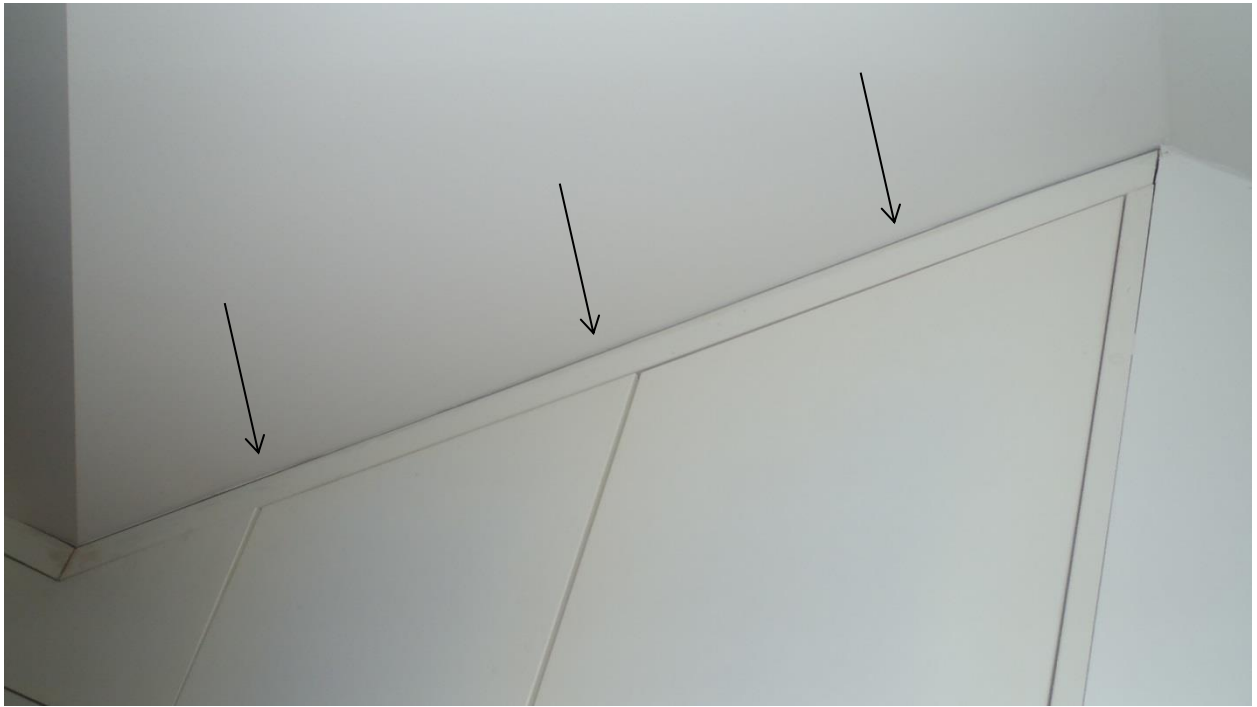
We noted a gap above the cupboard in the entry **[Photograph 43]**

**Photograph 43** shows the gap above cupboards in the entry to upstairs bedroom.

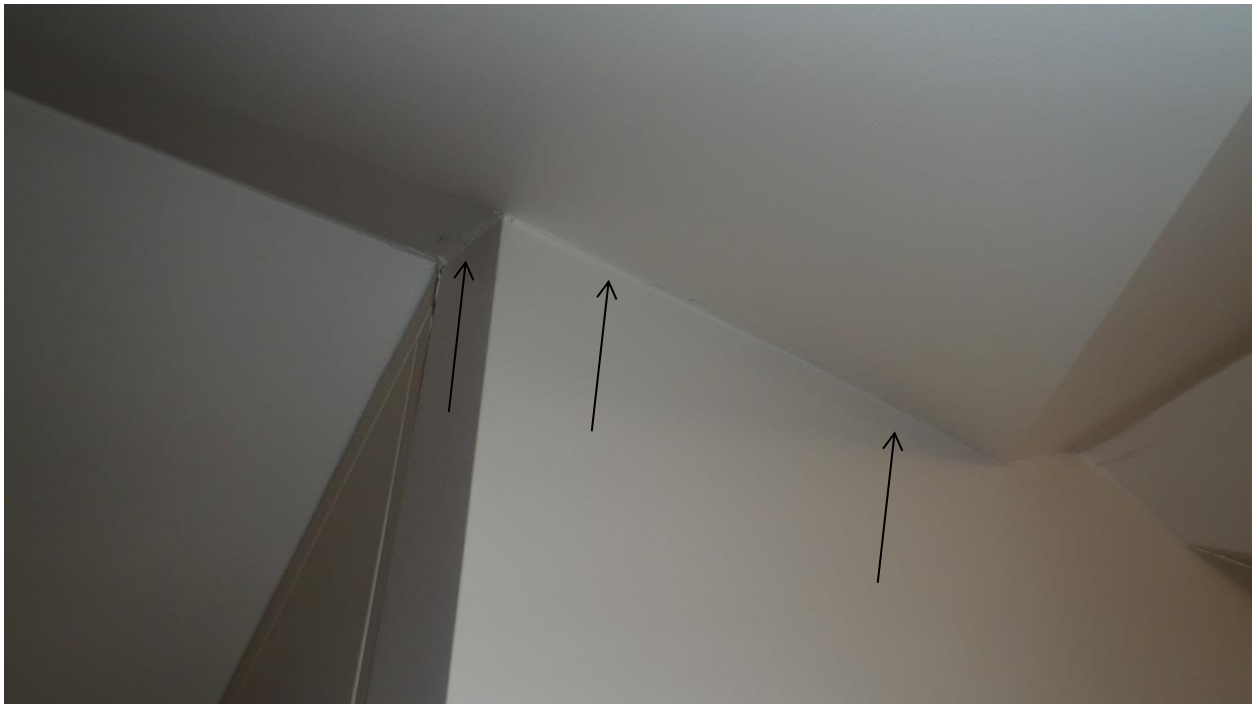
We noted hairline cracking [ $<1.0\text{mm}$ ] to the square set ceiling / wall junction on the southern wall **[Photograph 44]**

**Photograph 44** shows cracking to the square set ceiling wall / junction on the southern wall of the upstairs bedroom.

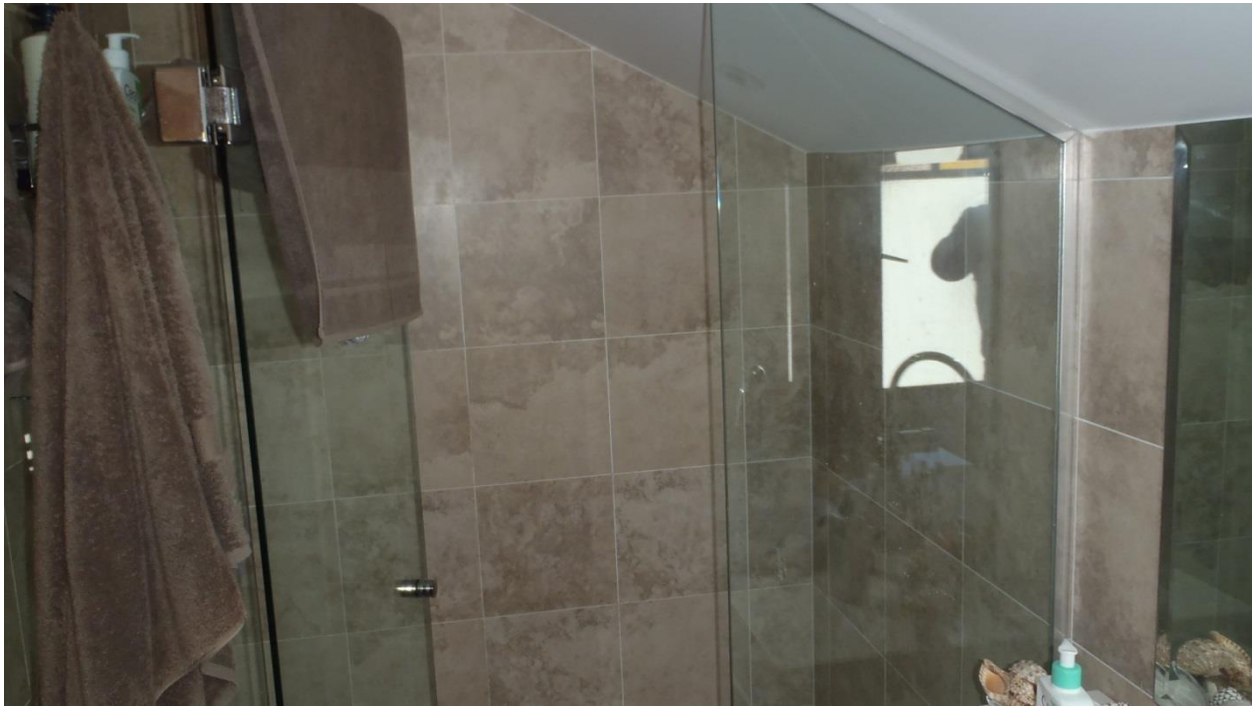
**Photograph 45** shows the general condition of the upstairs ensuite.

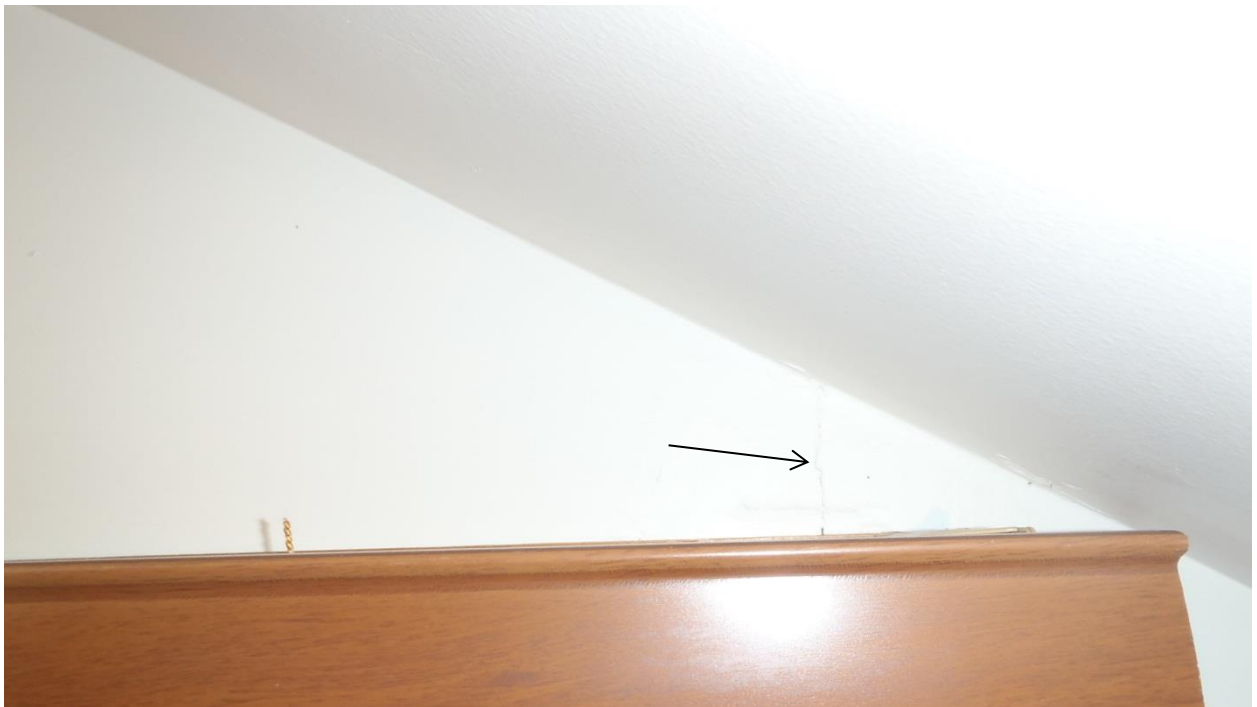
We noted a vertical hairline crack [ $<1.0\text{mm}$ ] extending from the right hand side window head to the ceiling / wall junction on the north western wall **[Photograph 46]**

**Photograph 46** shows a vertical crack extending upwards from the window head to the ceiling on the northern wall of the upstairs bedroom.

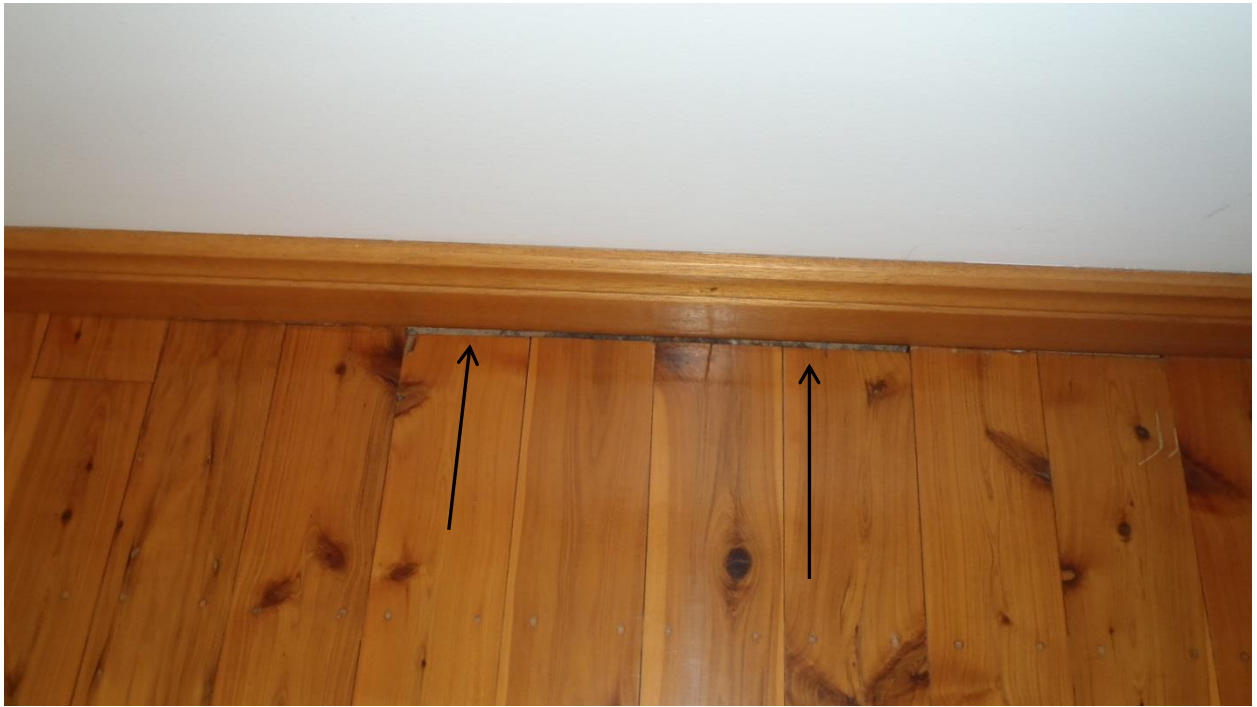
We noted a gap between the skirting and the strip timber flooring on the eastern wall **[Photograph 47]**

**Photograph 47** shows a gap between the skirting and the strip timber flooring on the eastern wall of the upstairs bedroom.
