## Dilapidation Assessment Report

Prepared for: Cape Cod Australia Pty. Limited  
Job address: 1A Paradise Avenue, ROSEVILLE.  
Property Owner/s: Mr. Nathan Round  
Report reference: **WILLOUGHBY CITY COUNCIL**  
Development Application No: not available  
Date of assessment: Saturday 11<sup>th</sup> June 2016

**Re: Dilapidation Report – 1A Paradise Avenue, ROSEVILLE.**

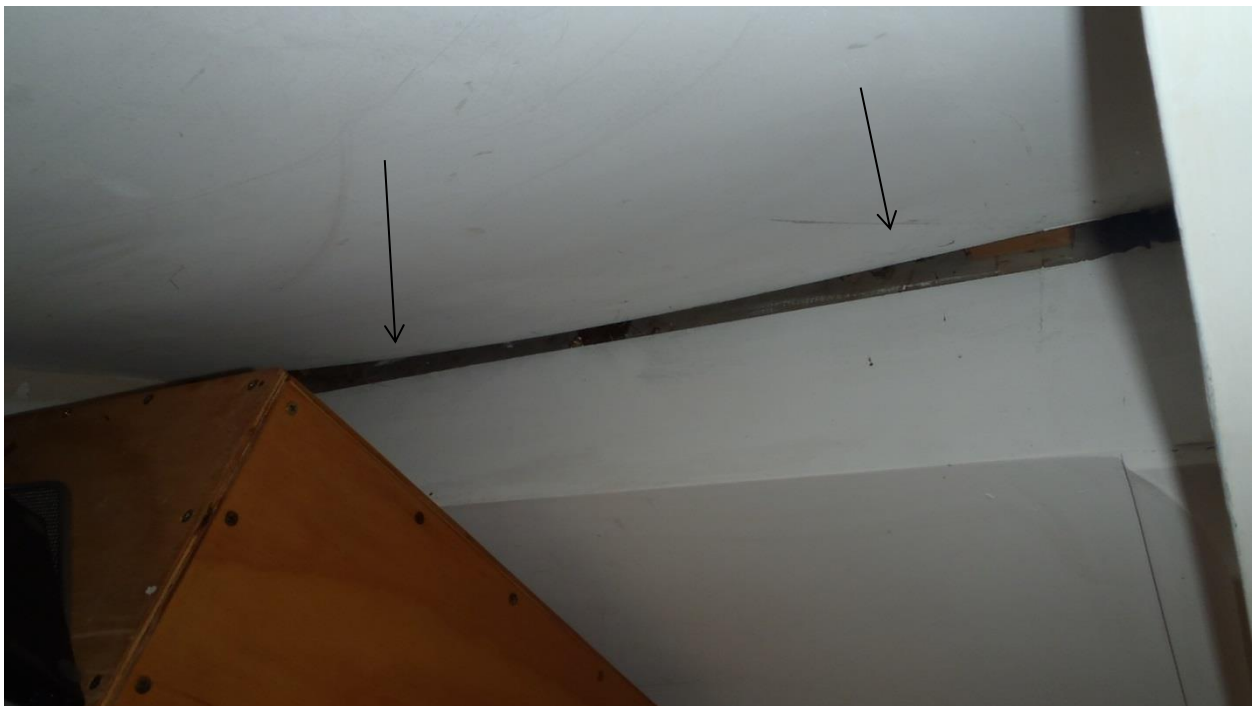
We noted a gap between the under-stairs lining and the bulkhead wall under the basement staircase. **[Photograph 48]**

**Photograph 48** shows a gap between the under-stairs lining and the bulkhead wall under the basement staircase.

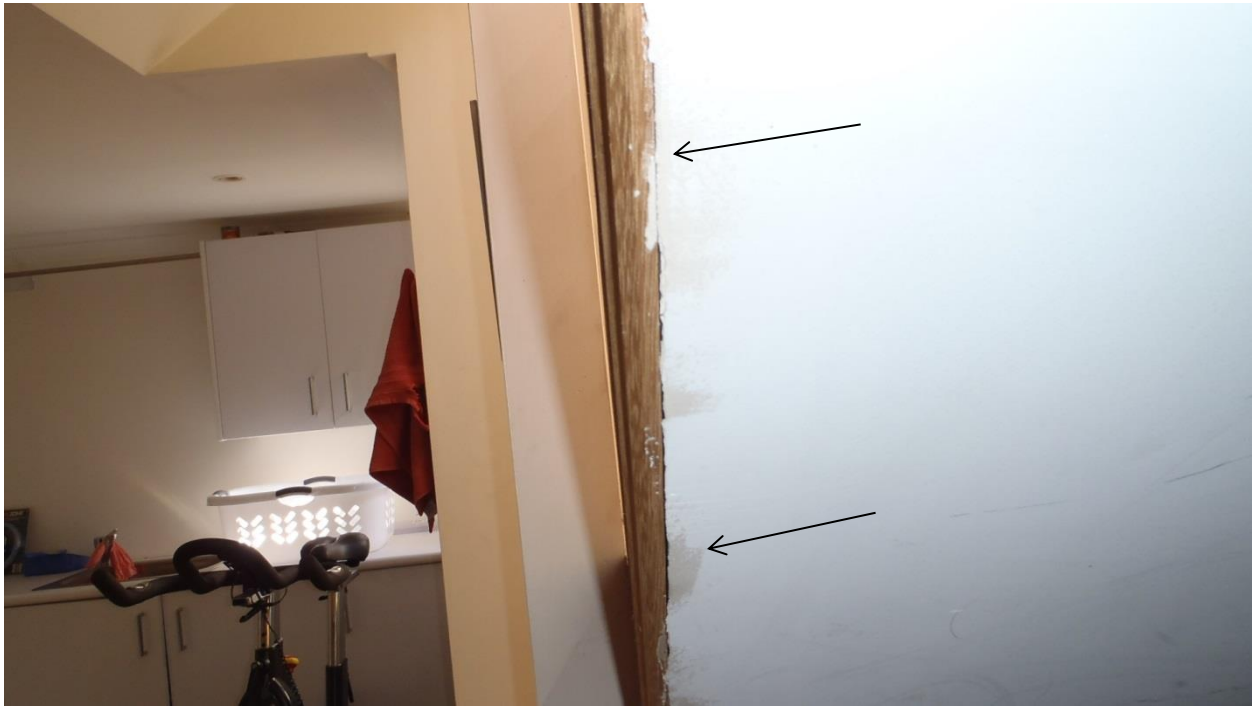
We noted a gap to the under-stairs lining under the basement staircase. **[Photograph 49]**

**Photograph 49** shows a gap and the finish to the under-stairs lining under the basement staircase.

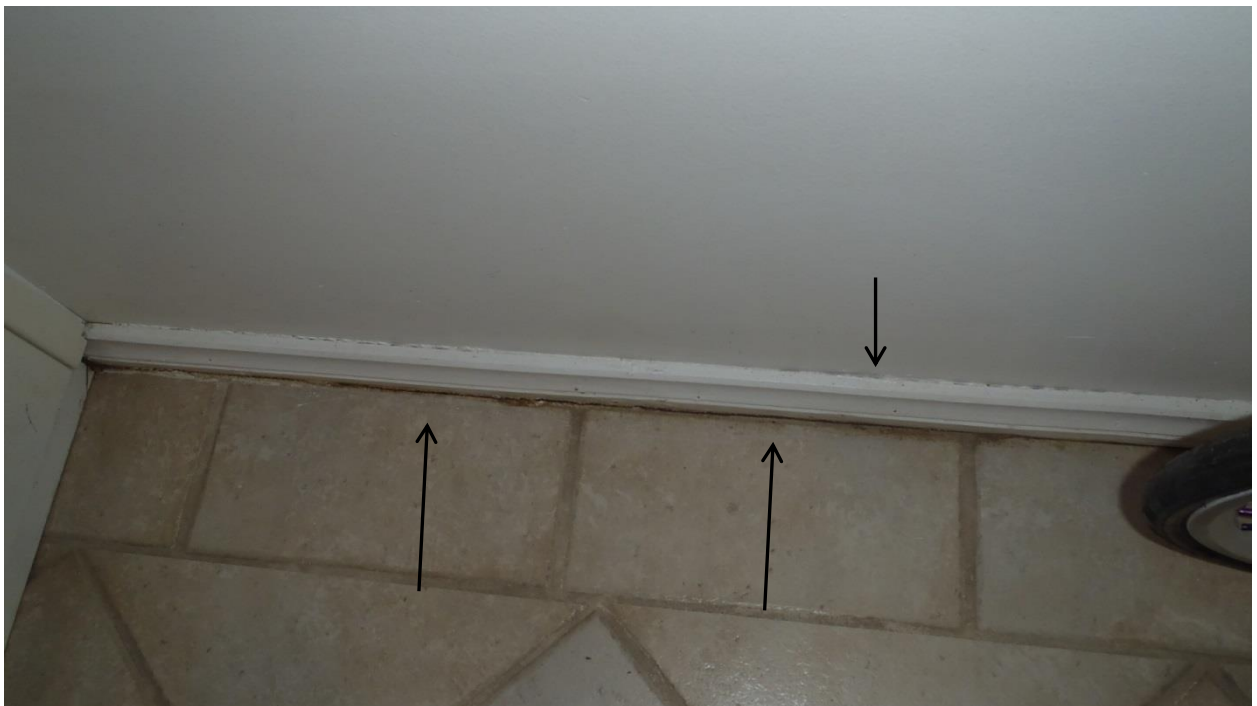
We noted differential movement cracking between the floor tiles and the skirting on the eastern wall **[Photograph 50]**

We noted separation cracking between the skirting and the wall on the eastern wall **[Photograph 50]**

**Photograph 50** shows differential movement cracking between the floor tiles and the skirting and separation cracking between the skirting and the wall on the eastern wall of the basement (Laundry).

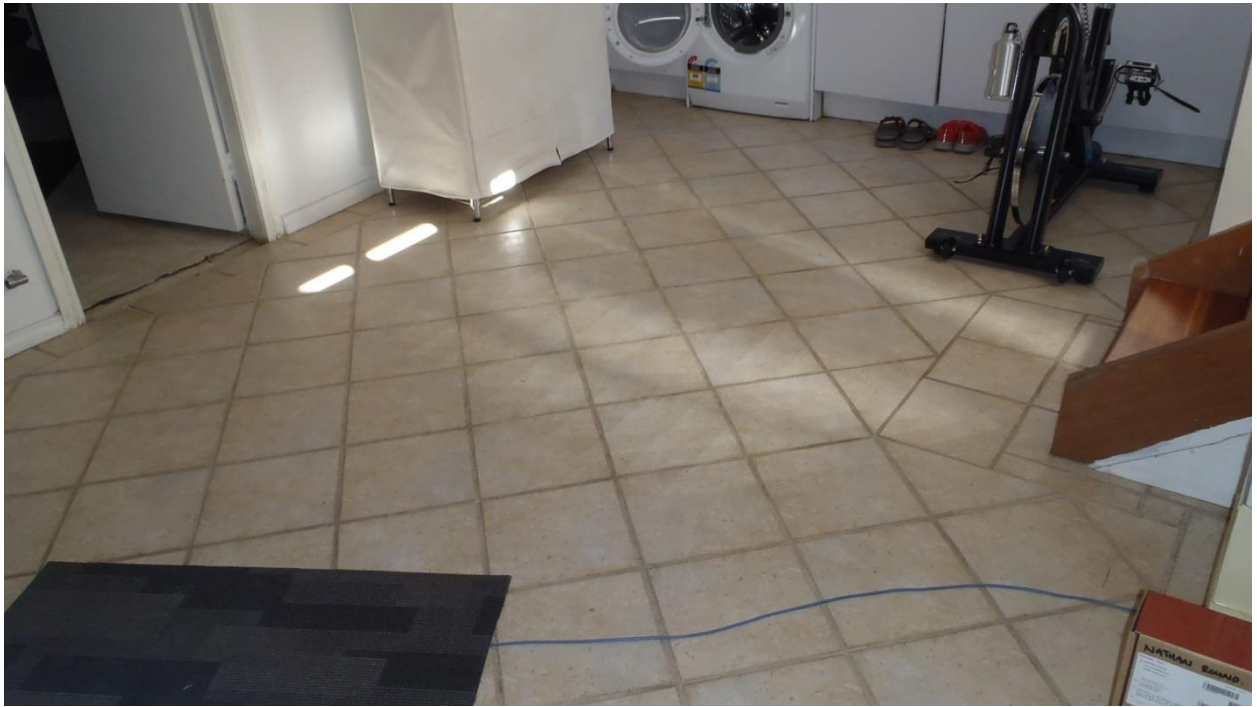
**Photograph 51** shows the general condition of the basement laundry tiles.
