## **HAZARDOUS MATERIALS ASSESSMENT REPORT**

**Job details:** Owner/s: Mr. F. Rashid & Ms. S. Saarela  
Location: 33A Murray Street, Bronte

**Date of assessment:** 8<sup>th</sup> October 2014

**Our reference:** HM03380914

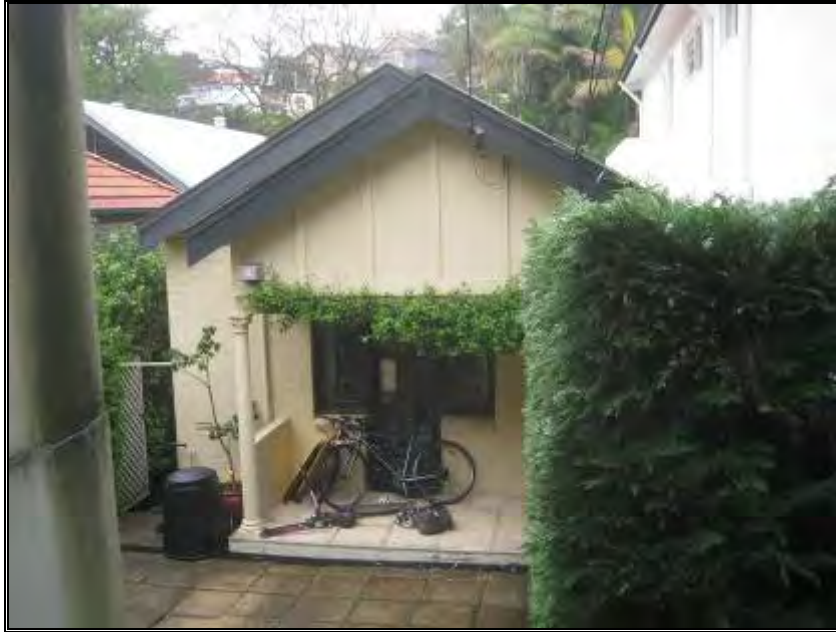
**Front northern elevation of the residence**
