HAZARDOUS MATERIALS ASSESSMENT REPORT

Job details: Owner/s: Mr. P & Mrs. K. O'Meally
Location: 266A Burns Bay Road, Lane Cove

Plans for Job No: 7565/14 Revision No: F Dated: 29-09-14

Our reference: HM03390914

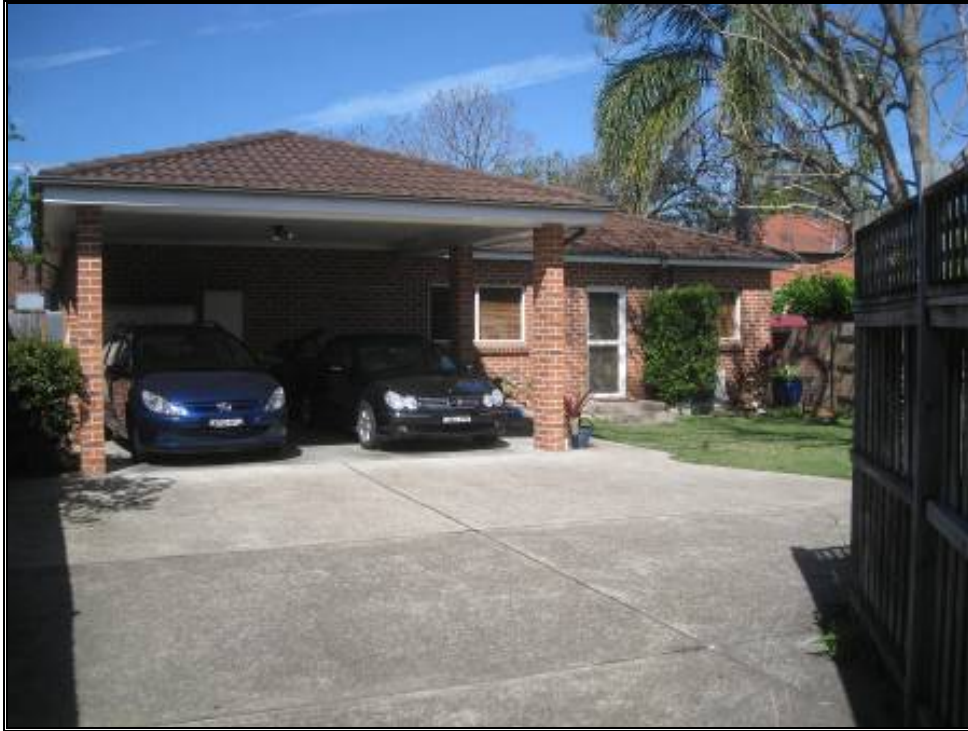
Front western elevation of the residence
