## **HAZARDOUS MATERIALS ASSESSMENT REPORT**

**Job details:** Owner: Mr. T. Ip & Ms. E. Leung.  
Location: 93 Austin Street, Lane Cove.

**Our reference:** HM05770617

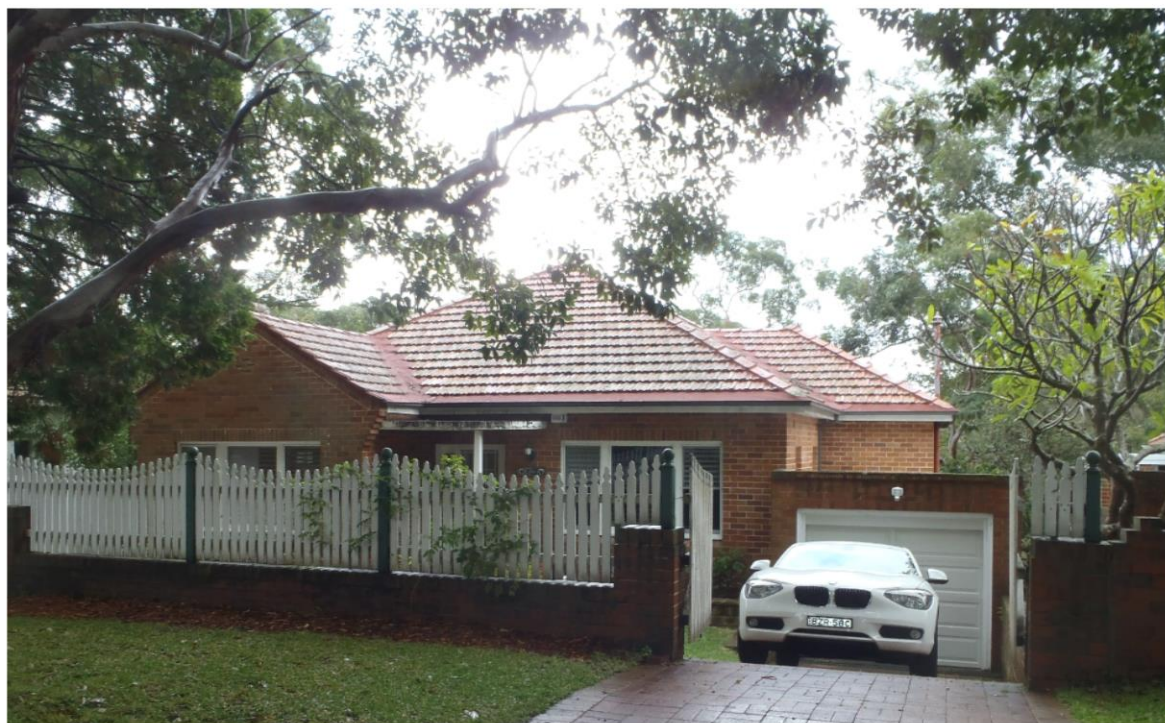
Front north east elevation of the residence
