## Dilapidation Assessment Report

Prepared for: Cape Cod Australia Pty. Limited.  
Job address: 34 Edgecliff Avenue, South Coogee.  
Property Owner/s: Mrs Jeannine Lew.  
Report reference: **RANDWICK COUNCIL**  
Development Application No: not available  
Date of assessment: 9<sup>th</sup> November 2017

**Re: Dilapidation Report – 34 Edgecliff Avenue, South Coogee.**

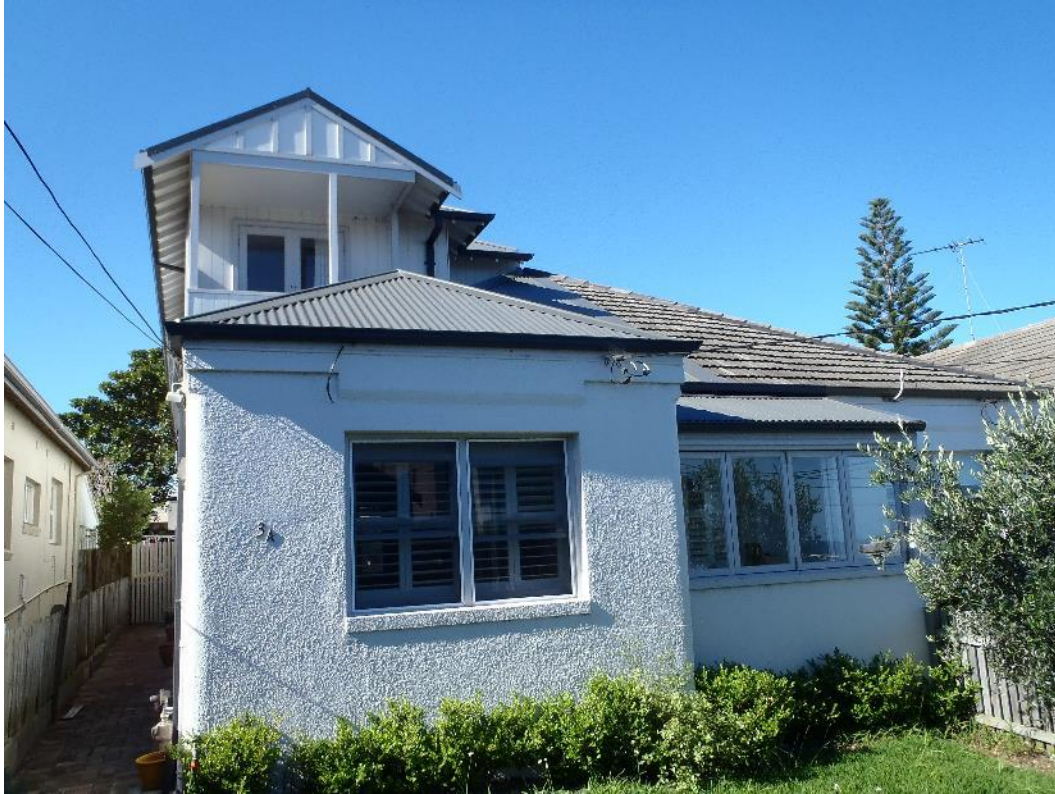
We noted that the pre-finished corrugated profile sheet metal roofing to the roof surfaces is in good condition and is securely fixed, in our opinion forming a weather resistant cover to the residence.

**Photograph 1** shows the general condition of the front southern elevation sheet metal roof surface.

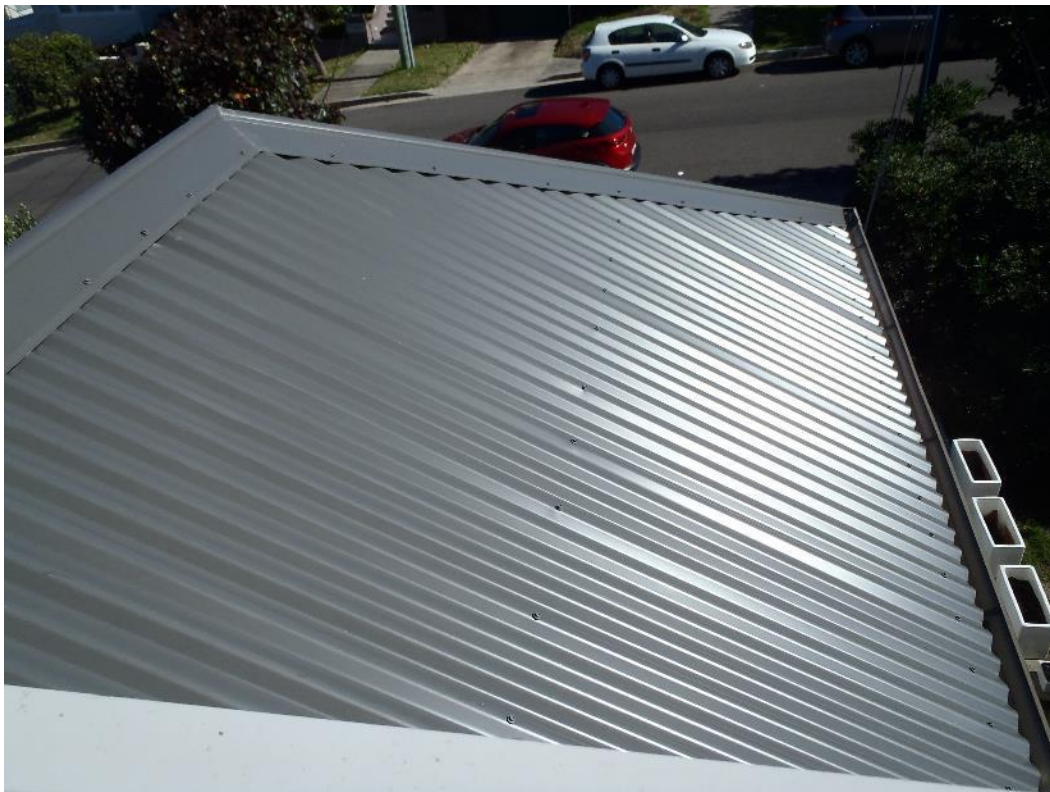
**Photograph 2** shows the general condition of the front south-western elevation sheet metal roof surface.

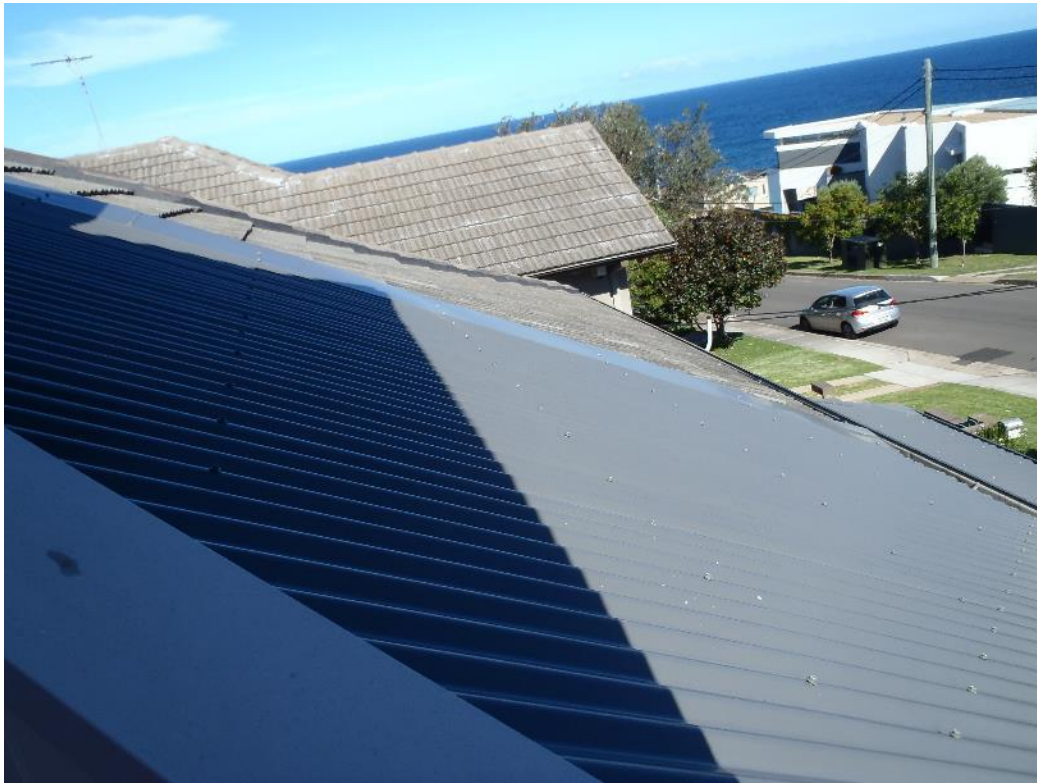
**Photograph 3** shows the general condition of the front south-eastern elevation sheet metal roof surface.

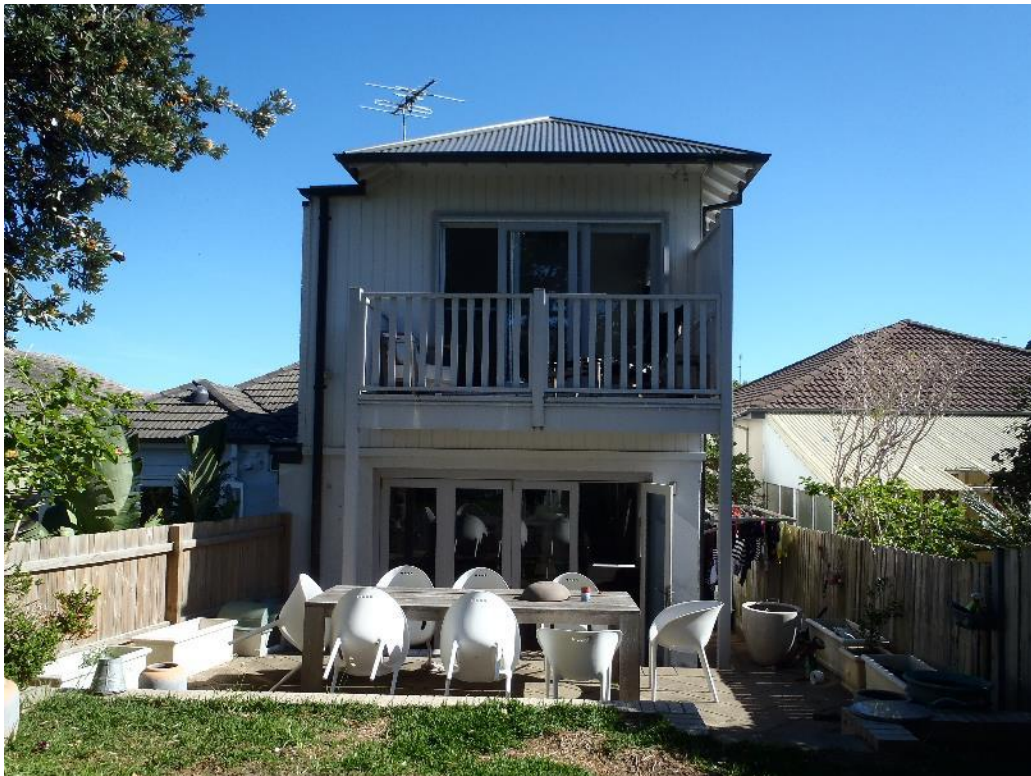
**Photograph 4** shows the general condition of the front south-western elevation sheet metal roof surface.

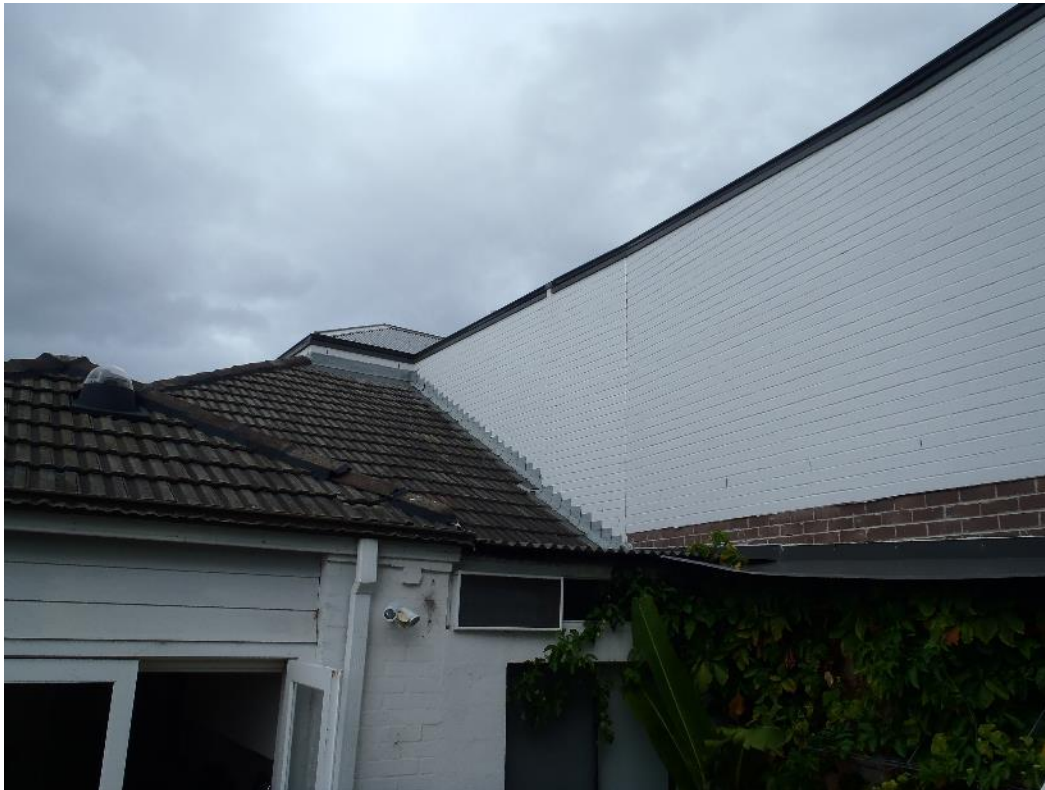
We also noted that the side flashing between the brick wall of upper floor addition and the tiled roof surface of the adjoining property, 34A Edgecliff Avenue, South Coogee is generally intact and forming a weather resistant seal between the wall and the roof surface. **[Photograph 5]**

**Photograph 5** shows the general condition of the side flashing between the brick wall of upper floor addition and the tiled roof surface of the adjoining property, 34A Edgecliff Avenue, South Coogee.

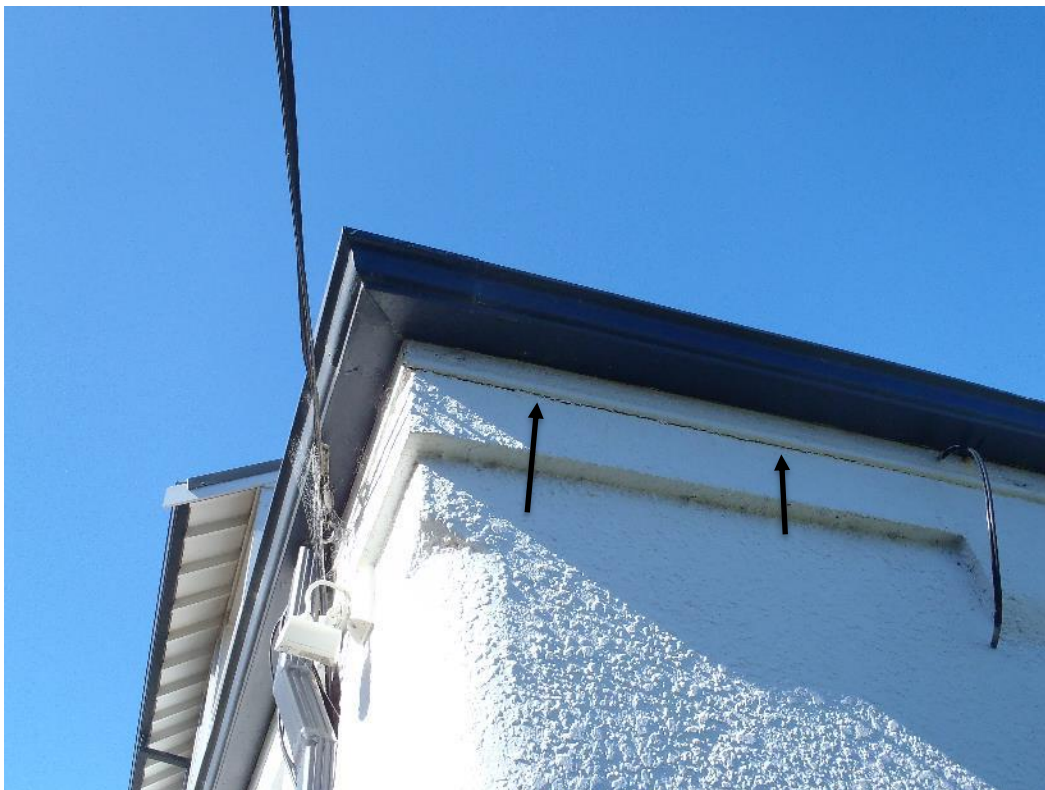
We noted separation cracking between the timber fascia and the surface coated clay masonry brickwork in the south-western corner. **[Photograph 6]**

**Photograph 6** shows separation cracking between the timber fascia and the wall surface in the south-western corner outside of Bedroom 1.

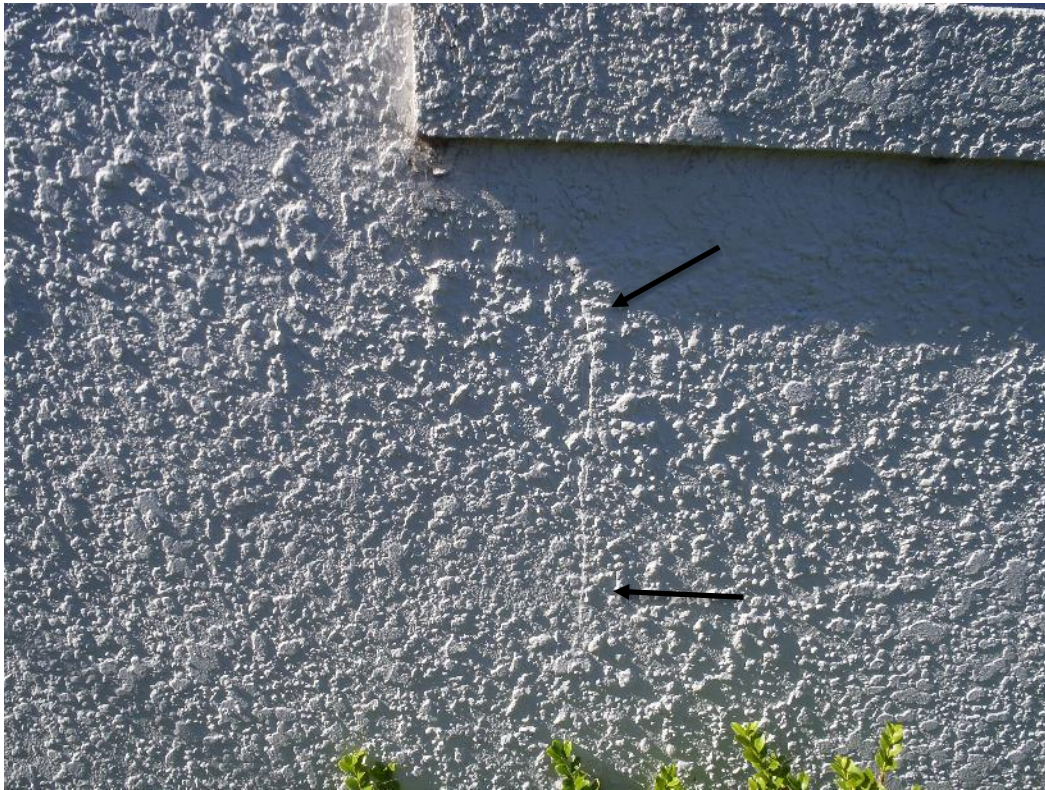
We noted vertical cracking from the Bedroom 1 window sill toward the ground. **[Photograph 7]**

**Photograph 7** shows vertical cracking from the Bedroom 1 window sill toward the ground.

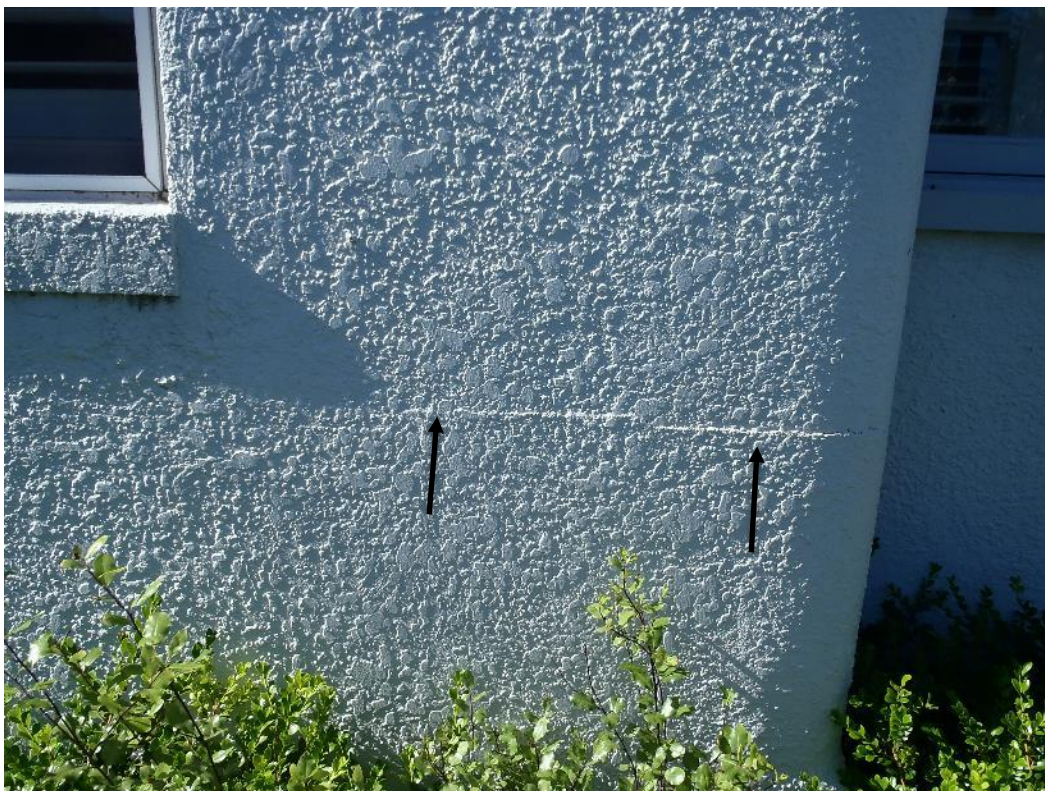
We noted horizontal cracking from the Bedroom 1 window sill toward the Sunroom. **[Photograph 8]**

**Photograph 8** shows horizontal cracking from the Bedroom 1 window sill toward the Sunroom.

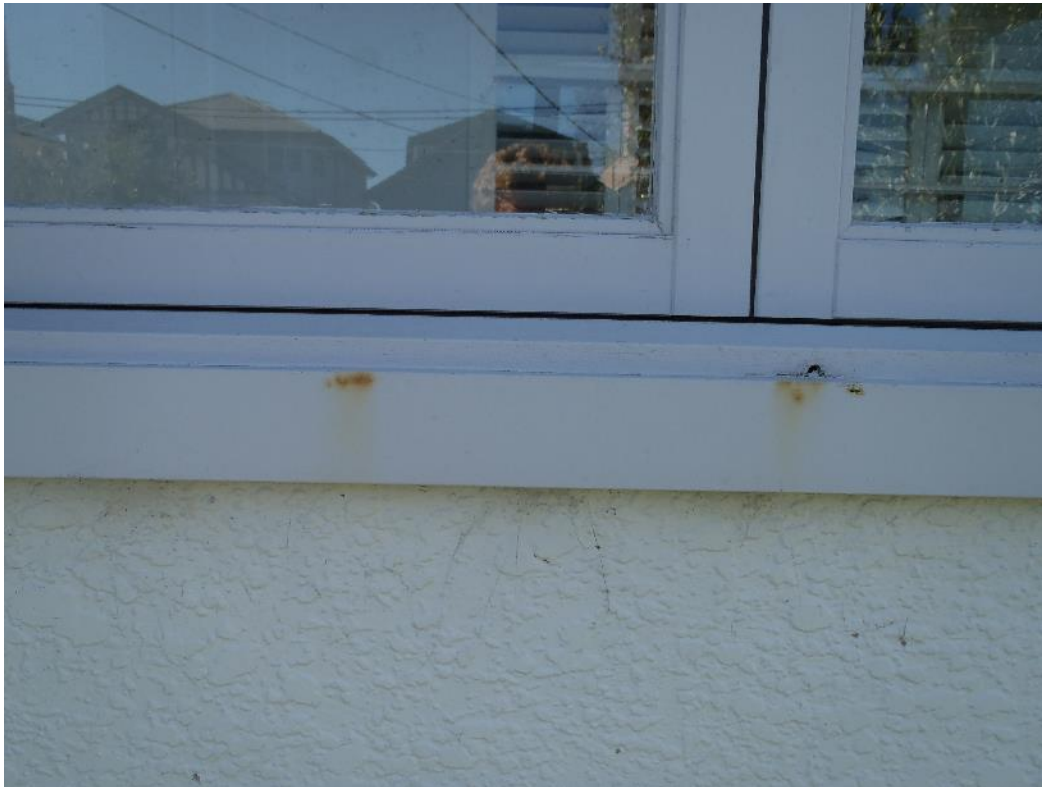
We noted rust staining to the timber window sill trim outside the Sunroom window. **[Photograph 9]**

**Photograph 9** shows rust staining to the timber window sill trim outside the Sunroom window.

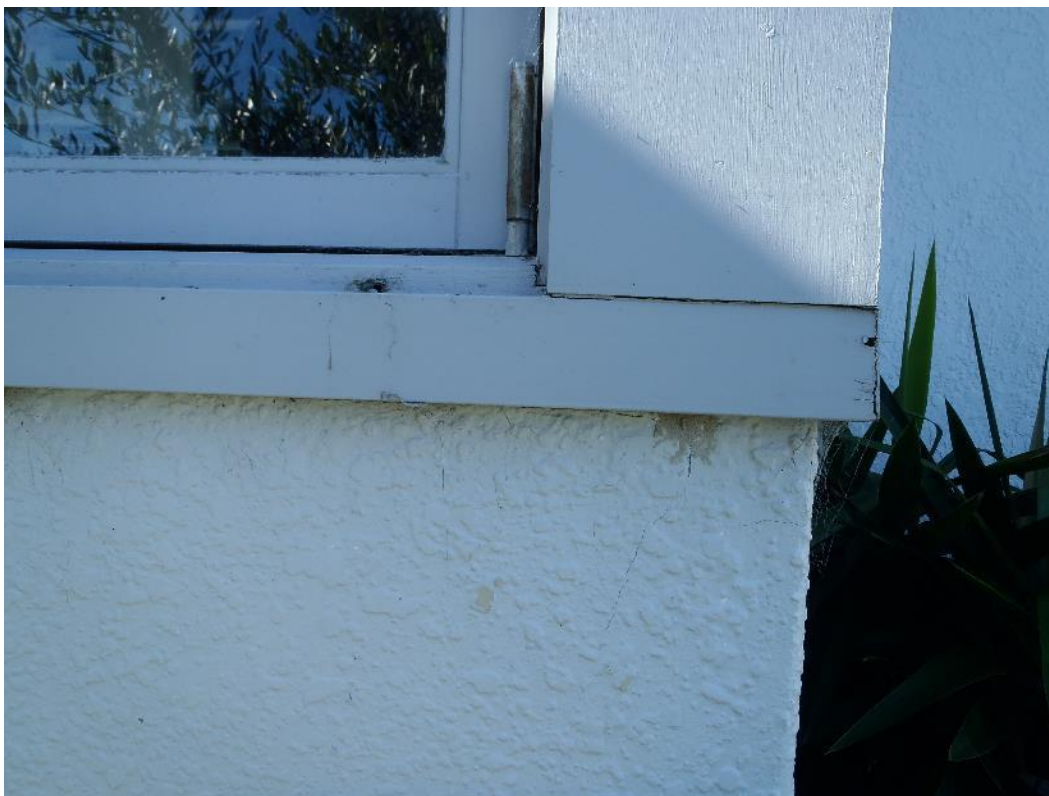
We noted radial cracking from the Sunroom window sill toward the ground. We also noted separation cracking to the timber trim around the window adjacent to the common boundary. We further noted deterioration / flaking paint to the window. **[Photograph 10]**

**Photograph 10** shows radial cracking around the Sunroom window sill and deterioration / flaking paint to the window.

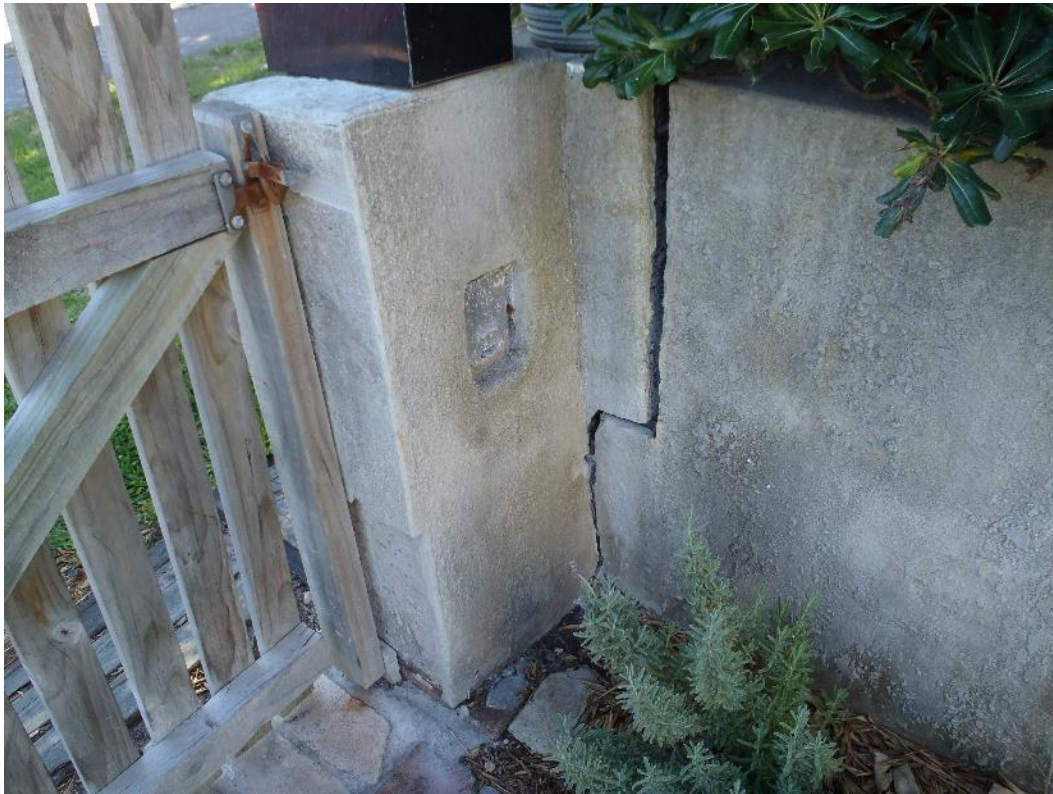
We noted separation cracking to the rendered side wall adjacent to the front gate. **[Photograph 11]**

**Photograph 11** shows separation cracking to the rendered side wall adjacent to the front gate.

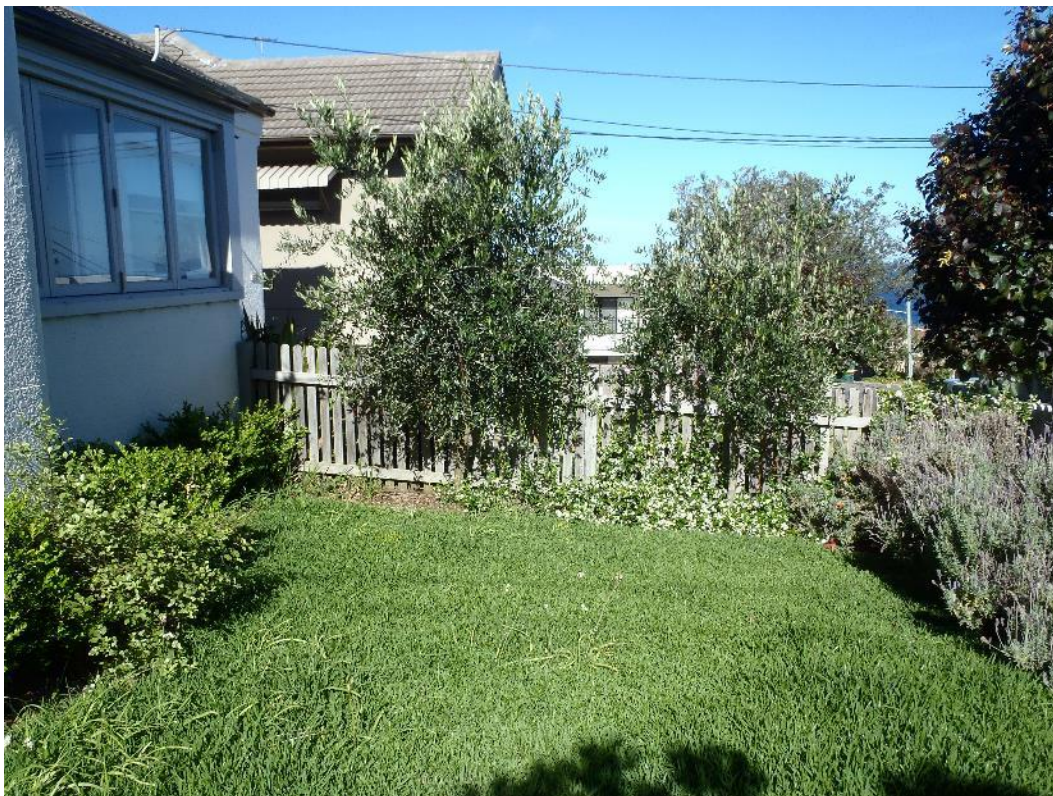
We noted that the front common boundary fence with the adjoining property, 34A Edgecliff Avenue, South Coogee was of timber post and rail construction with timber palings. We further noted vegetation growth along the fence. **[Photograph 12]**

**Photograph 12** shows the general condition of the front *common* boundary fence.

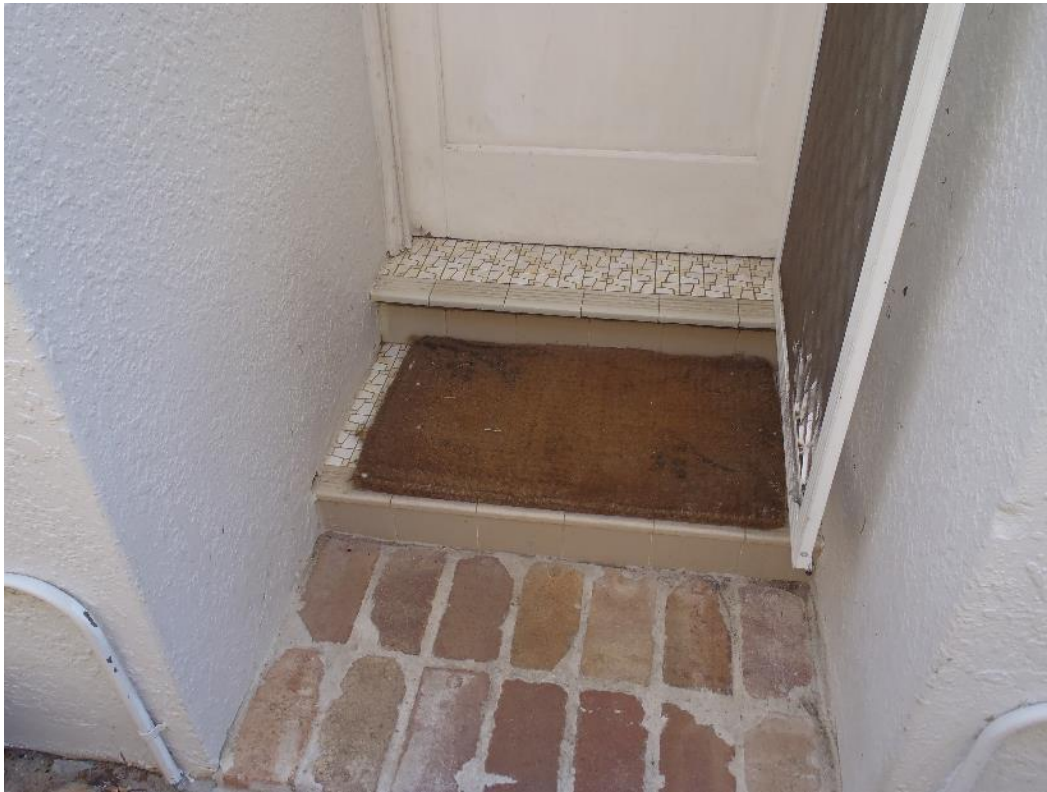
We noted that the patterned vitrified clay tiles to the side entry were generally sound with the grout complete. **[Photograph 13]**

**Photograph 13** shows the general condition of the front porch.

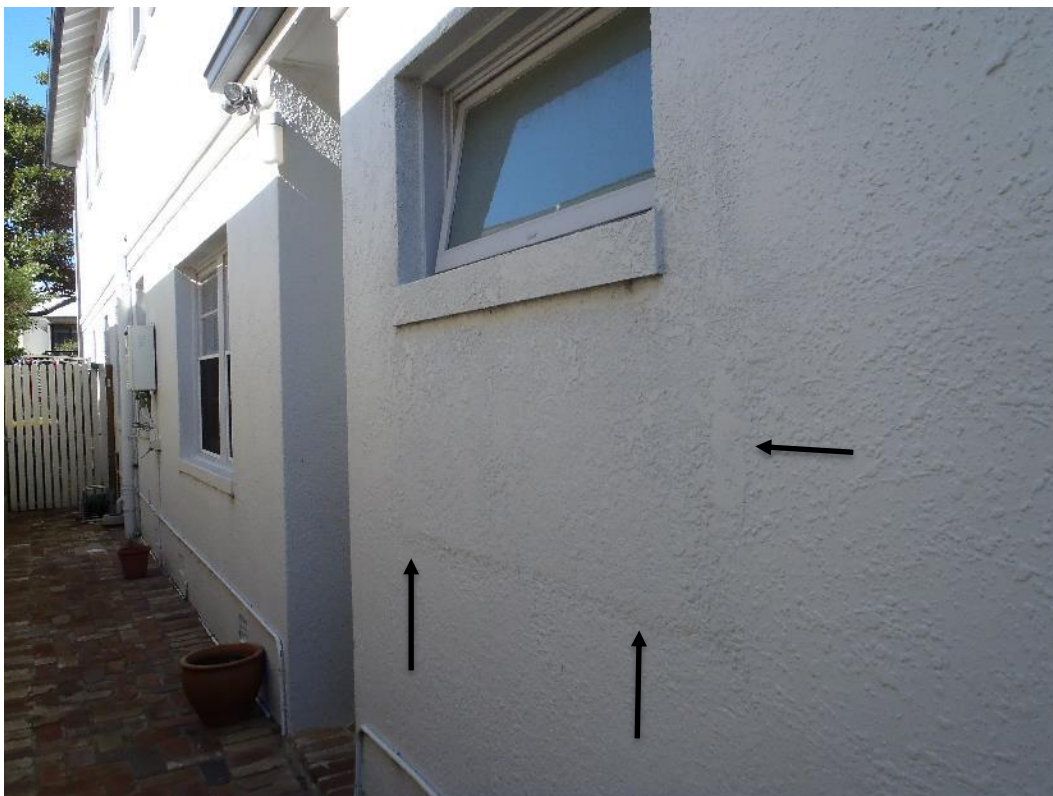
We noted evidence of a previous repair around the Bathroom window. **[Photograph 14]**

**Photograph 14** shows evidence of a previous repair around the Bathroom window.

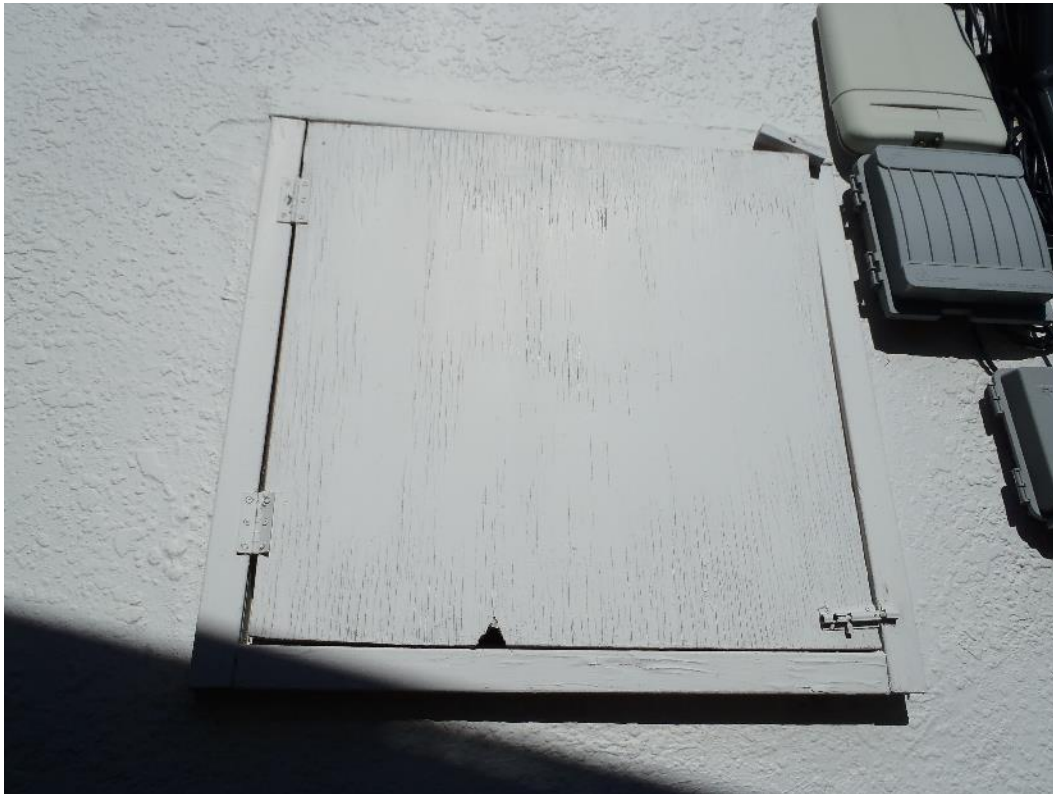
We noted deterioration to the surface coating of the electrical meter box door. **[Photograph 15]**

**Photograph 15** shows deterioration to the surface coating of the electrical meter box door.

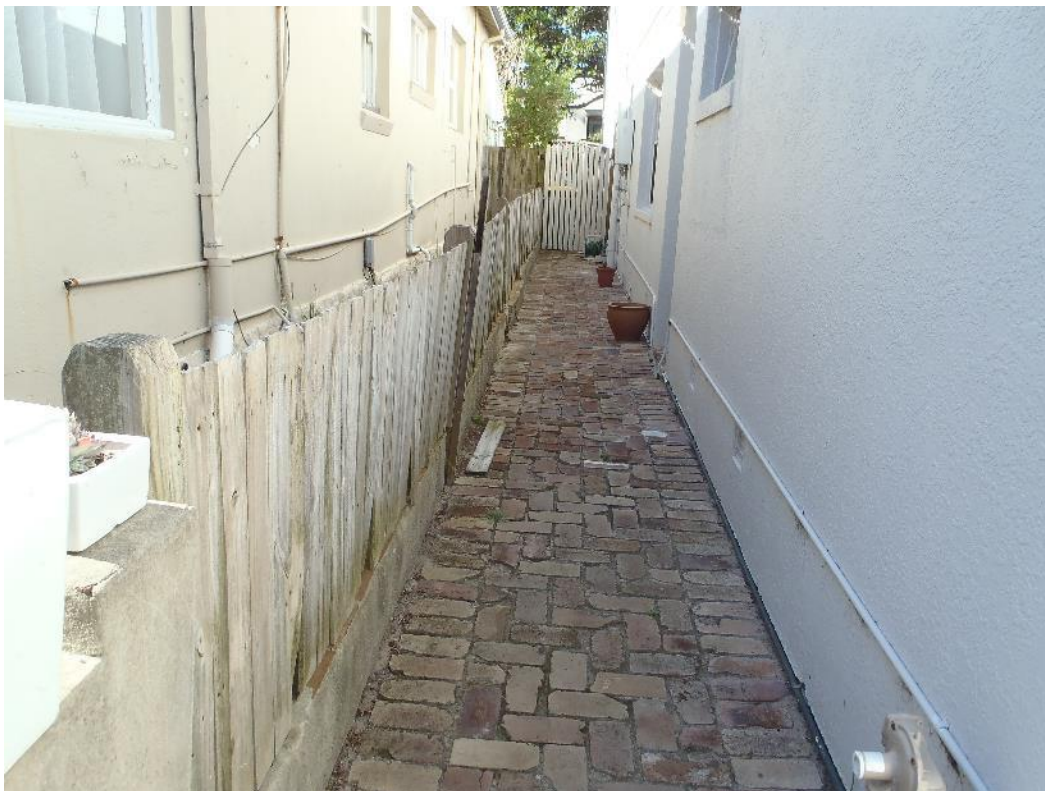
We noted that the side pathway is constructed of clay masonry pavers. Due to concealment we are unable to comment on the base strata to the pavers. **[Photograph 16]**

**Photograph 16** shows the general condition of the side paved pathway.

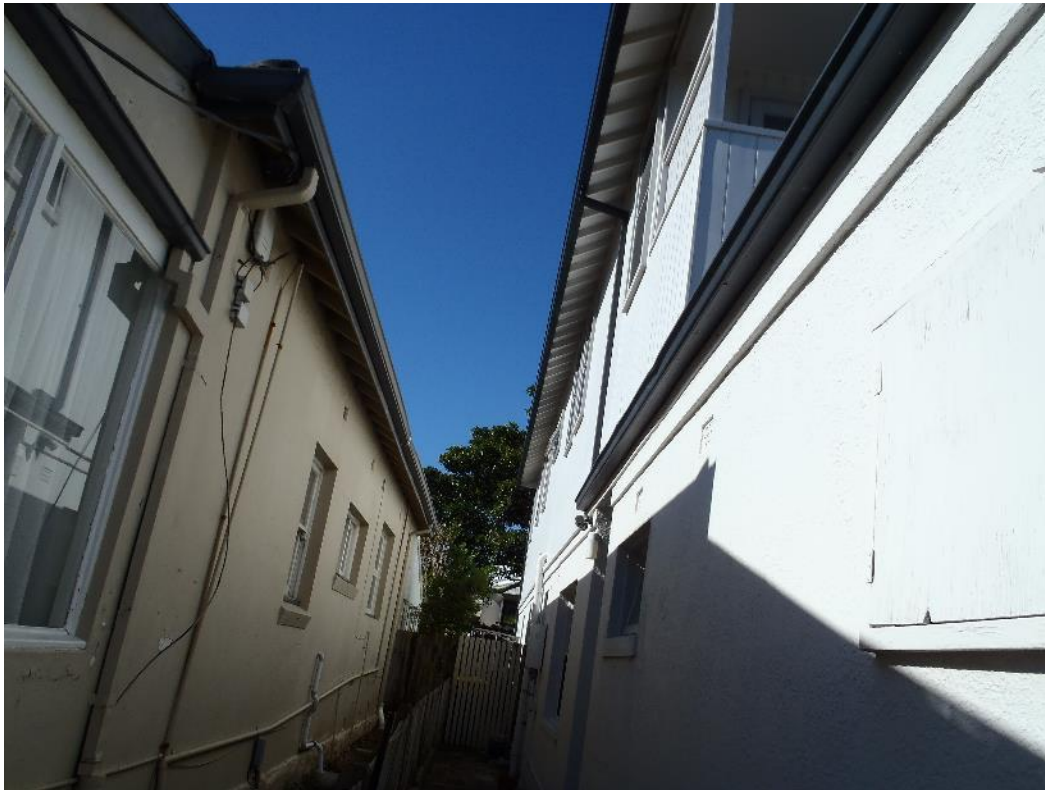
We did not observe any recent cracking to the surface coated clay masonry brickwork. **[Photograph 17]**

**Photograph 17** shows the general condition of the side elevation wall surfaces.

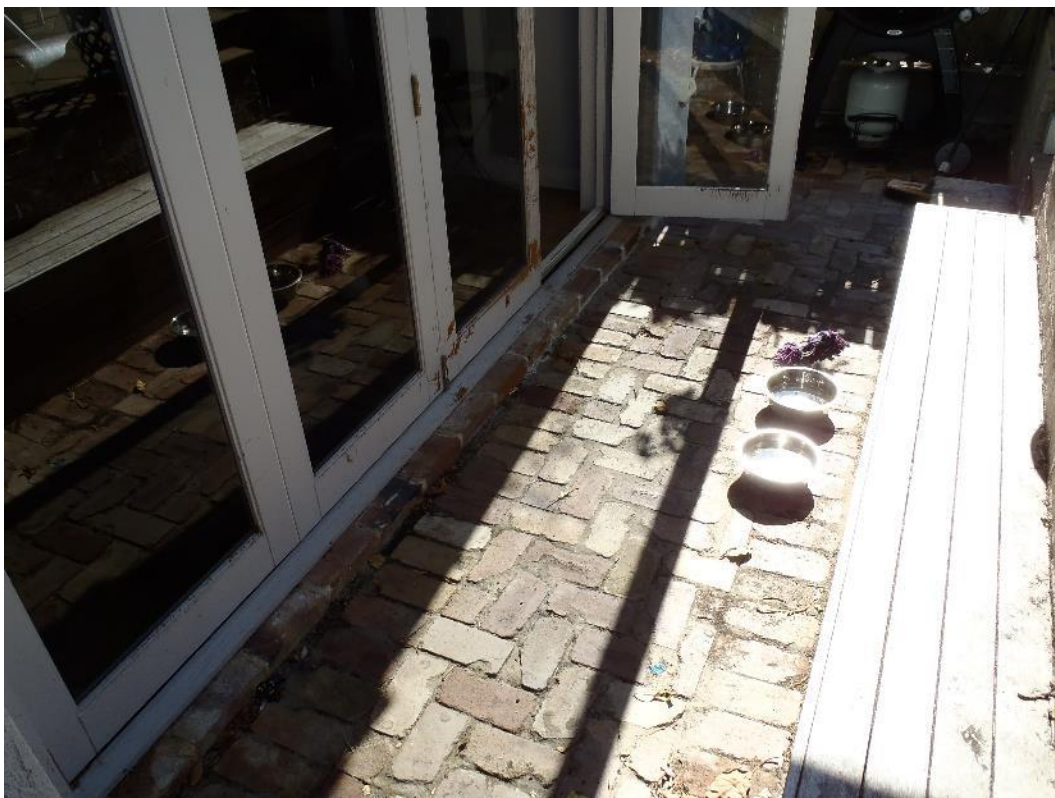
We noted that the rear patio structure is finished with clay masonry pavers. Due to concealment we are unable to comment on the base strata to the pavers. **[Photograph 18]**

**Photograph 18** shows the general condition of the rear patio paved floor.

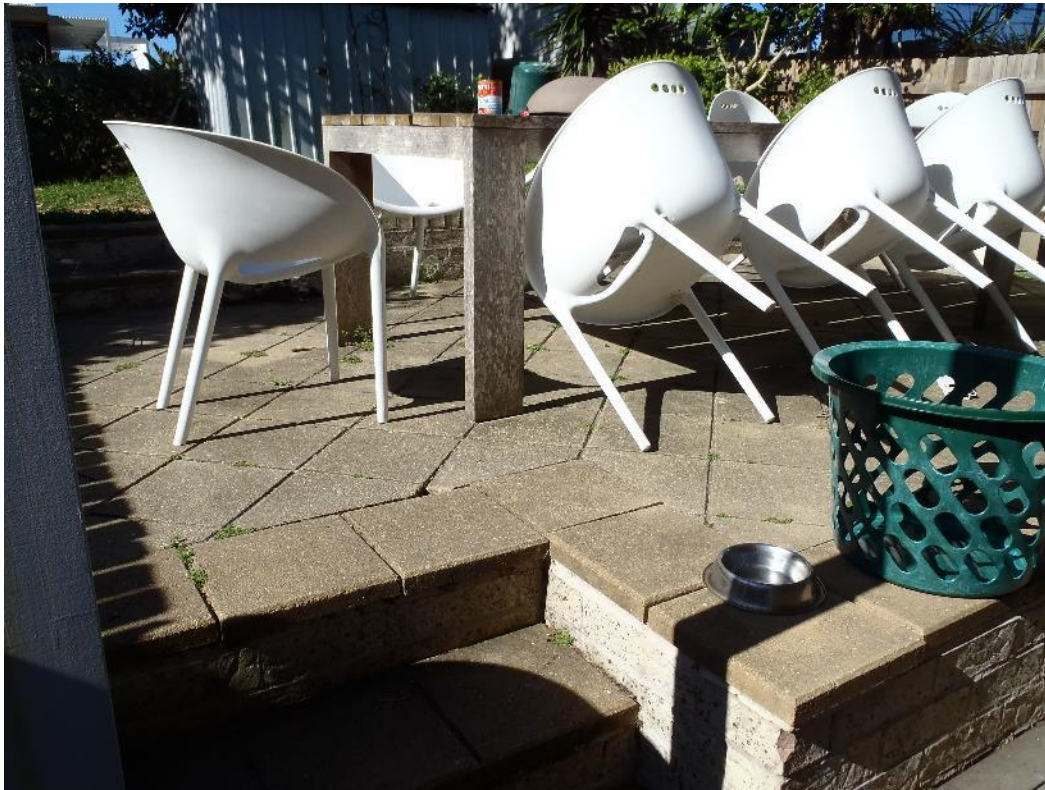
We noted that the rear courtyard is finished with concrete pavers. We further noted some vegetation growth through the paver grout. Due to concealment we are unable to comment on the base strata to the concrete pavers. **[Photograph 19]**

**Photograph 19** shows the general condition of the rear courtyard paved surface.

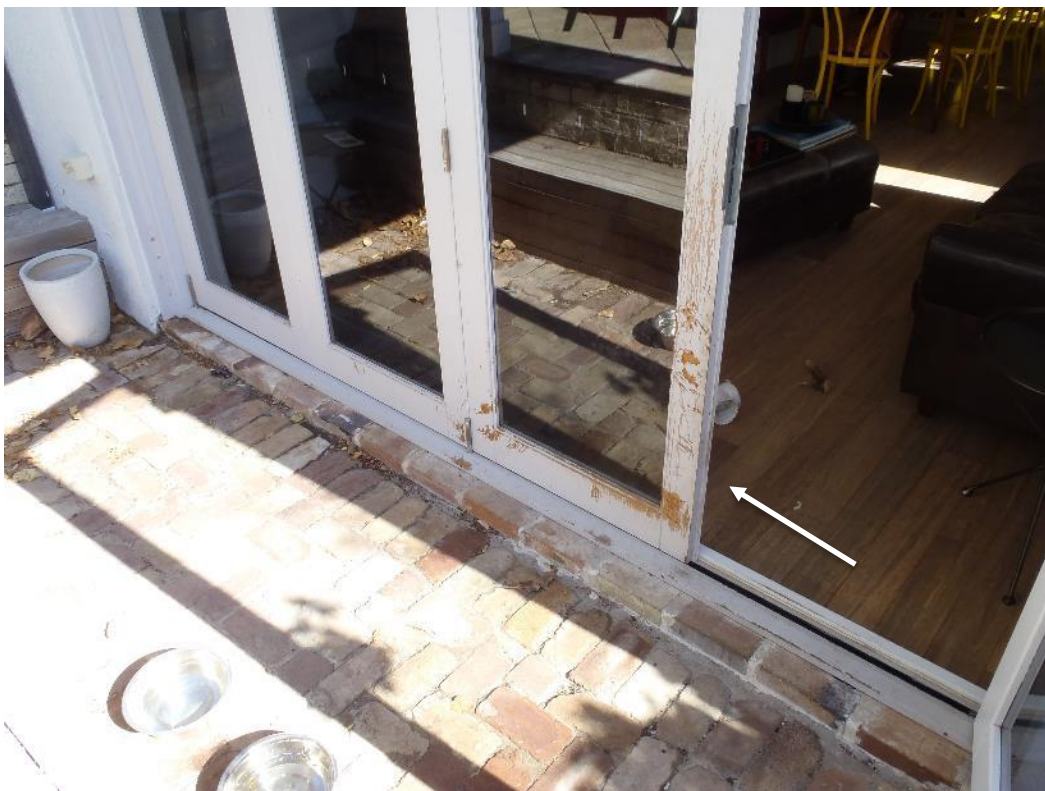
We noted damage / scratching to the rear stacking door unit. **[Photograph 20]**

**Photograph 20** shows damage / scratching to the rear stacking door unit.

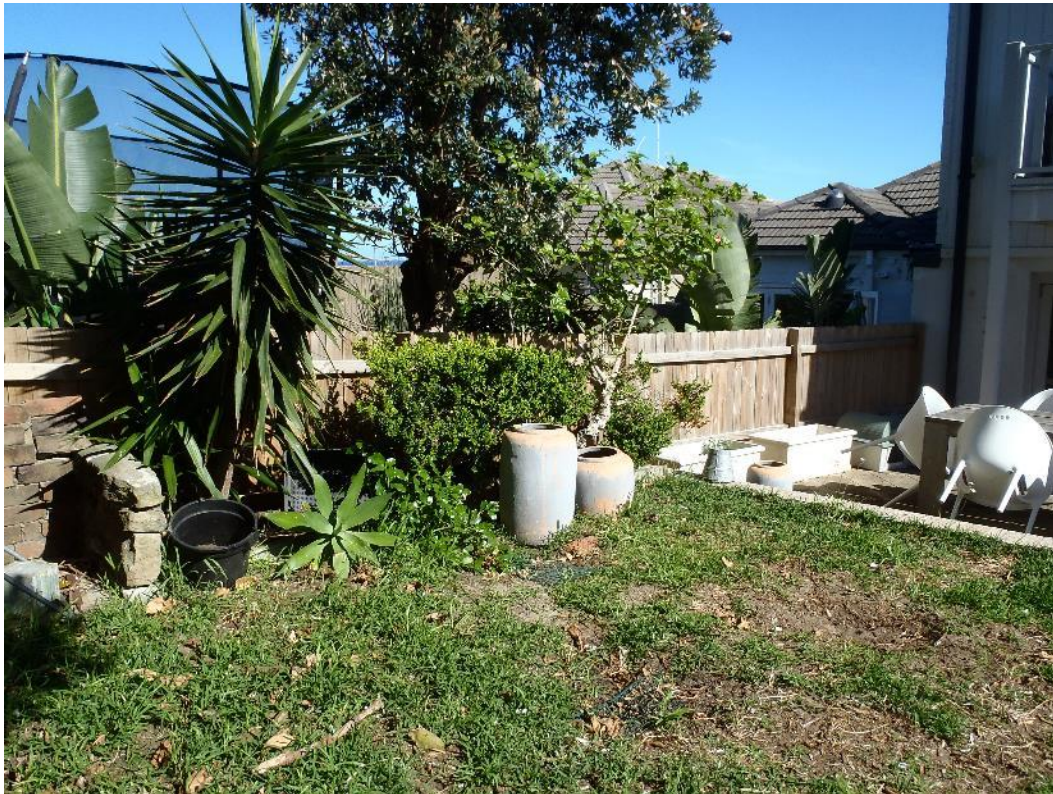
We noted that the rear common boundary fence with the adjoining property, 34A Edgecliff Avenue, South Coogee was of timber post and rail construction with timber palings. **[Photograph 21]**

**Photograph 21** shows the general condition of the rear *common* boundary fence.

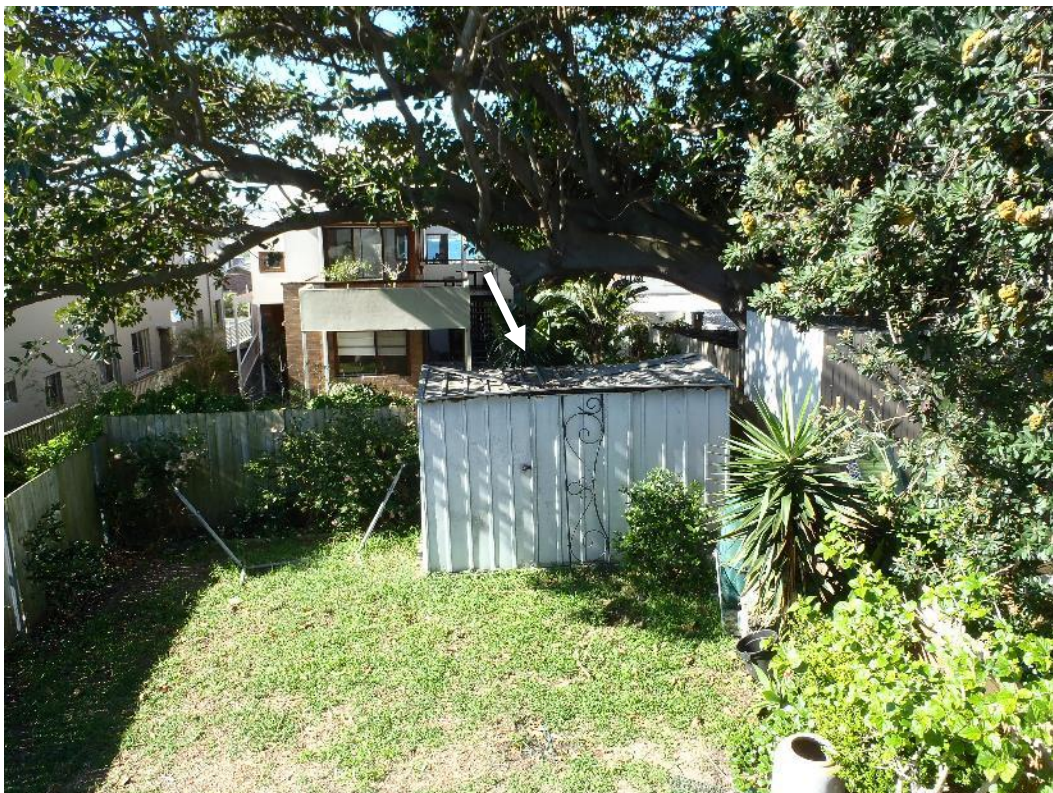
We noted damage to the roof surface of the lightweight metal shed at the rear. **[Photograph 22]**

**Photograph 22** shows the damage to the roof surface of the lightweight metal shed.

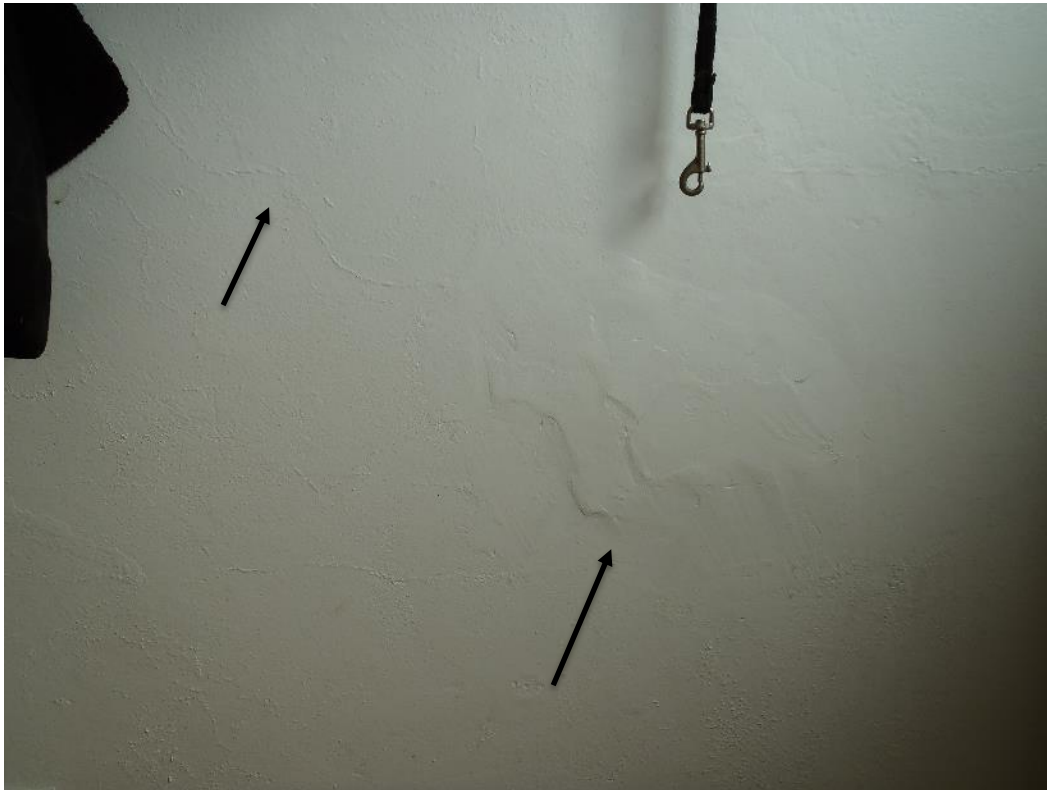
We observed evidence of a previous repair [different surface texture] to the cement rendered wall common with the Bathroom. **[Photograph 23]**

**Photograph 23** shows evidence of a previous repair to the cement rendered wall common with the Bathroom in the Entry.

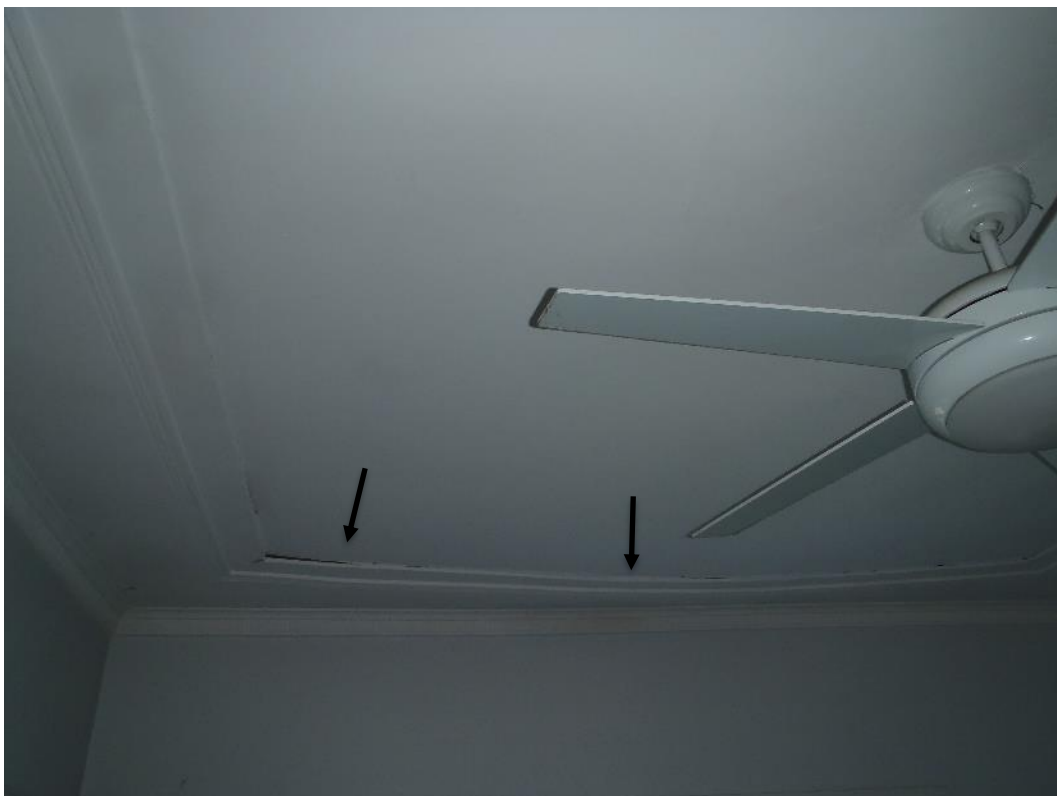
We noted damage (sinking) to the recessed plaster ceiling lining. **[Photograph 24]**

**Photograph 24** shows damage (sinking) to the recessed plater ceiling lining in the Front Bedroom 1.

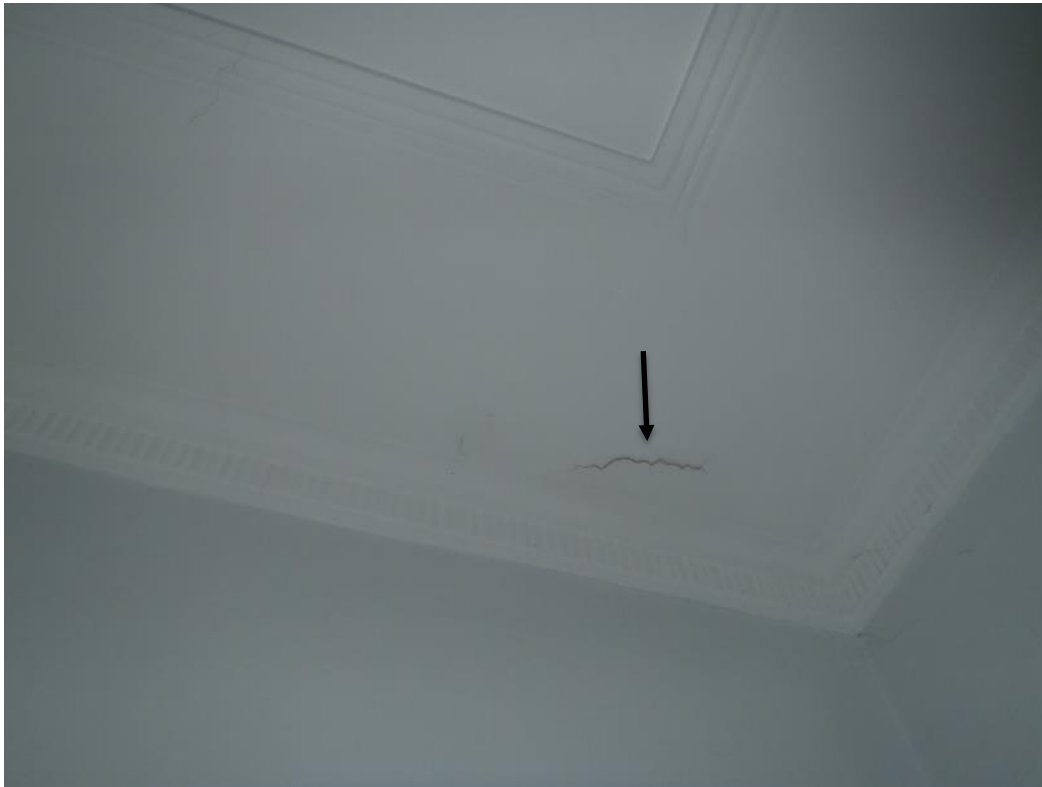
We noted flaking paint to the plaster ceiling in the south-eastern corner. **[Photograph 25]**

**Photograph 25** shows flaking paint to the plaster ceiling in the south-eastern corner of Bedroom 1.
