## Dilapidation Assessment Report

Prepared for: Cape Cod Australia Pty. Limited.  
Job address: 34 Edgecliff Avenue, South Coogee.  
Property Owner/s: Mrs Jeannine Lew.  
Report reference: **RANDWICK COUNCIL**  
Development Application No: not available  
Date of assessment: 9<sup>th</sup> November 2017

**Re: Dilapidation Report – 34 Edgecliff Avenue, South Coogee.**

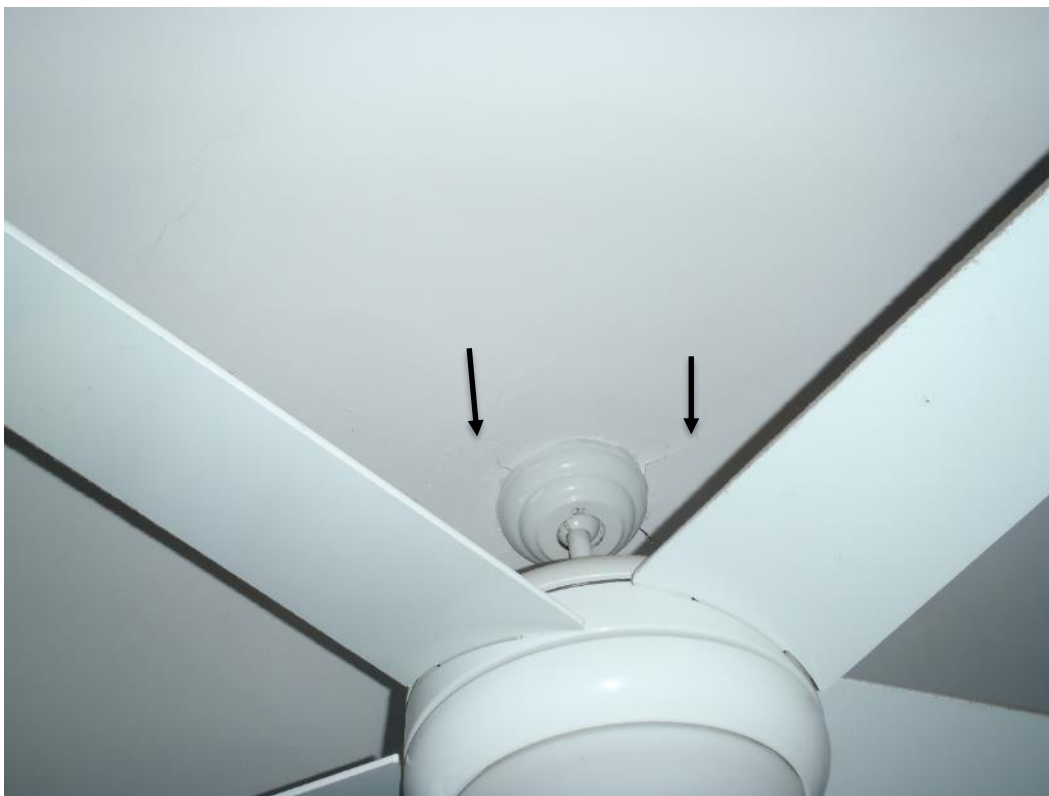
We noted radial cracking to the fibrous plaster ceiling lining around the ceiling fan. **[Photograph 26]**

**Photograph 26** shows radial cracking to the ceiling lining around the ceiling fan in Bedroom 1.

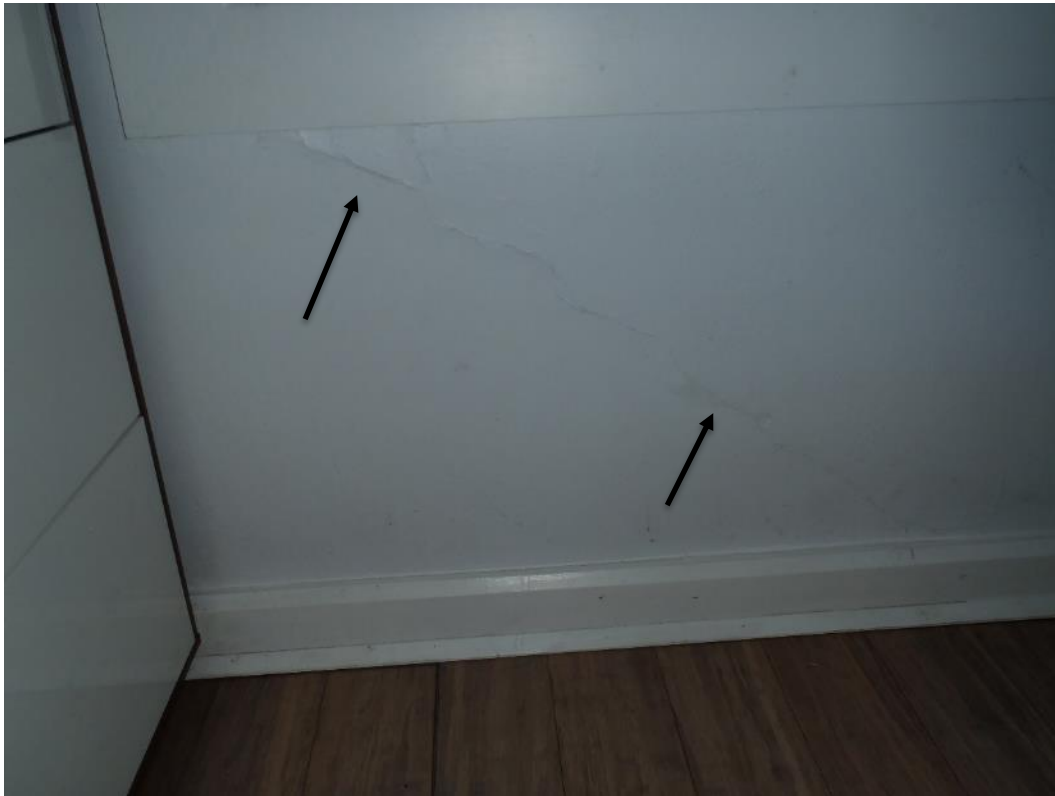
We noted radial cracking [ $< 1.0$  mm] to the cement rendered wall surface below the window. **[Photograph 27]**

**Photograph 27** shows radial cracking to the cement rendered wall surface below the window in Bedroom 1.

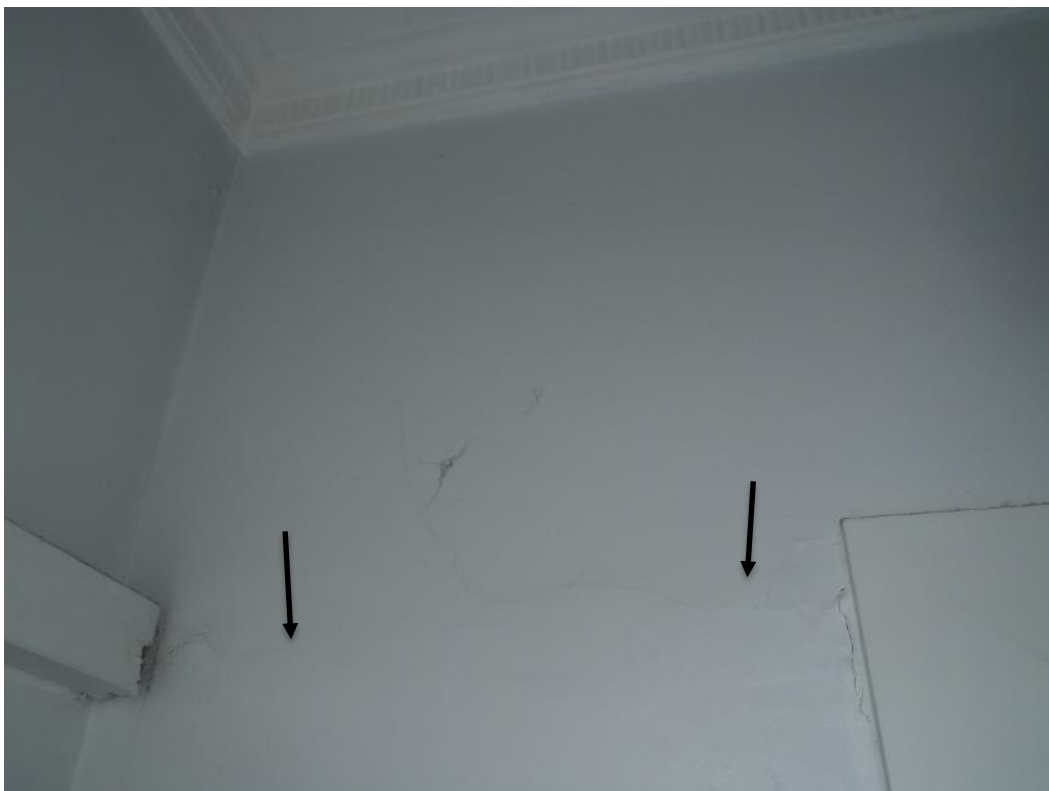
We noted radial cracking [ $< 1.0$  mm] to the cement rendered wall surface extending from the left-hand side of the window head. **[Photograph 28]**

**Photograph 28** shows radial cracking to the cement rendered wall surface extending from the left-hand side of the window head in Bedroom 1.

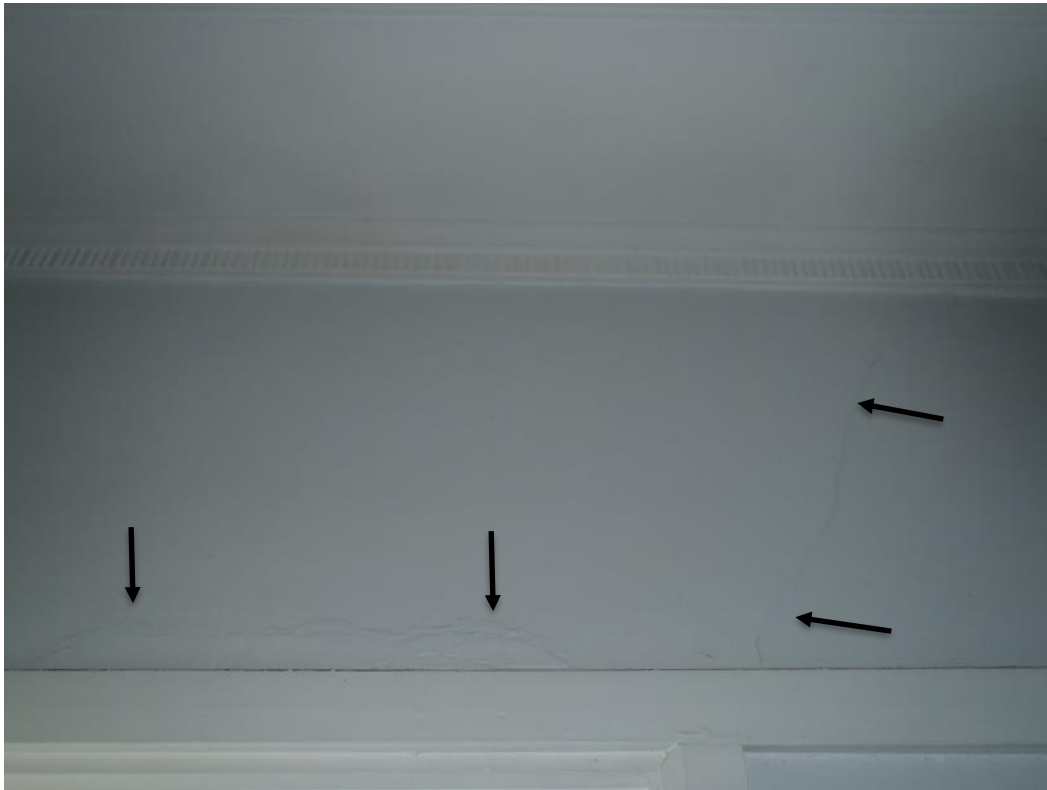
We observed evidence of a previous repair [different surface texture] to the cement rendered wall above the Sunroom door head. We also noted radial cracking [ $< 1.0$  mm] to the cement rendered wall surface extending up from the door head toward the cornice. **[Photograph 29]**

**Photograph 29** shows evidence of a previous repair wall above the Sunroom door head and radial cracking to the wall surface extending up from the door head toward the cornice in Bedroom 1.

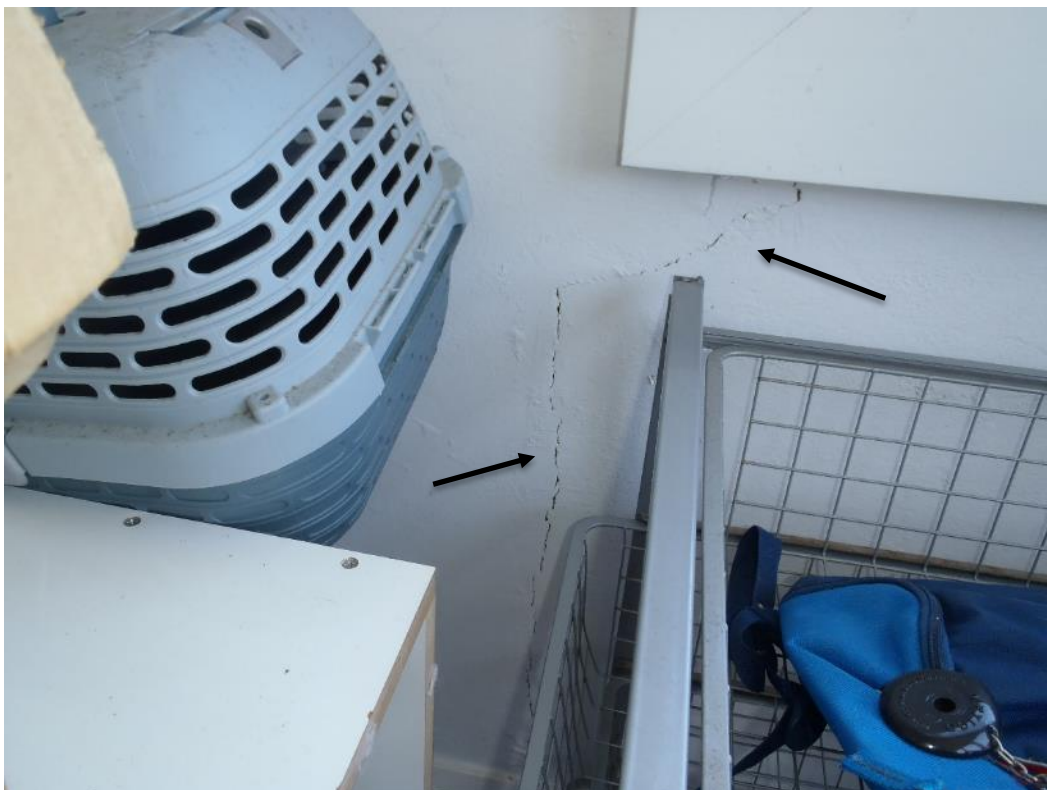
We noted radial and vertical cracking [1.0 mm – 3.0 mm] to the cement rendered wall surface below the eastern window. **[Photograph 30]**

**Photograph 30** shows radial and vertical cracking to the cement rendered wall surface below the eastern window in the Sunroom.

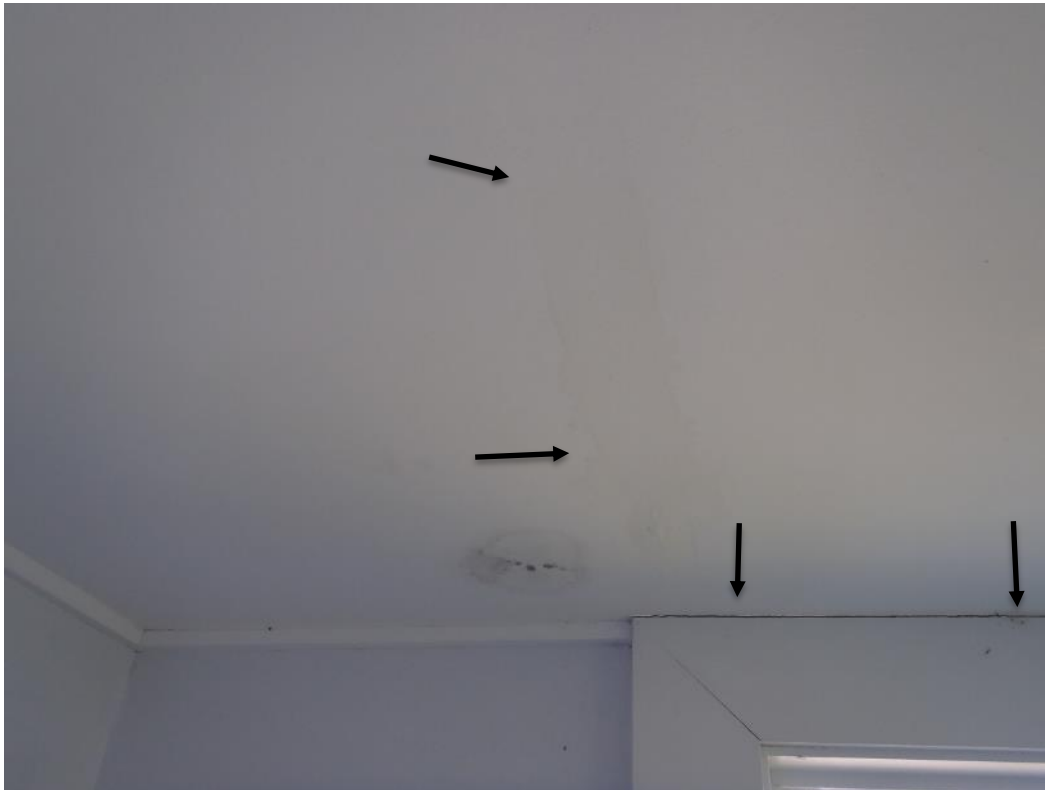
We observed staining to the plaster ceiling lining above the eastern window. We also noted separation cracking between the window architrave and the plaster ceiling lining. **[Photograph 31]**

**Photograph 31** shows staining to the plaster ceiling lining above the eastern window and separation cracking between the window architrave and the ceiling in the Sunroom.

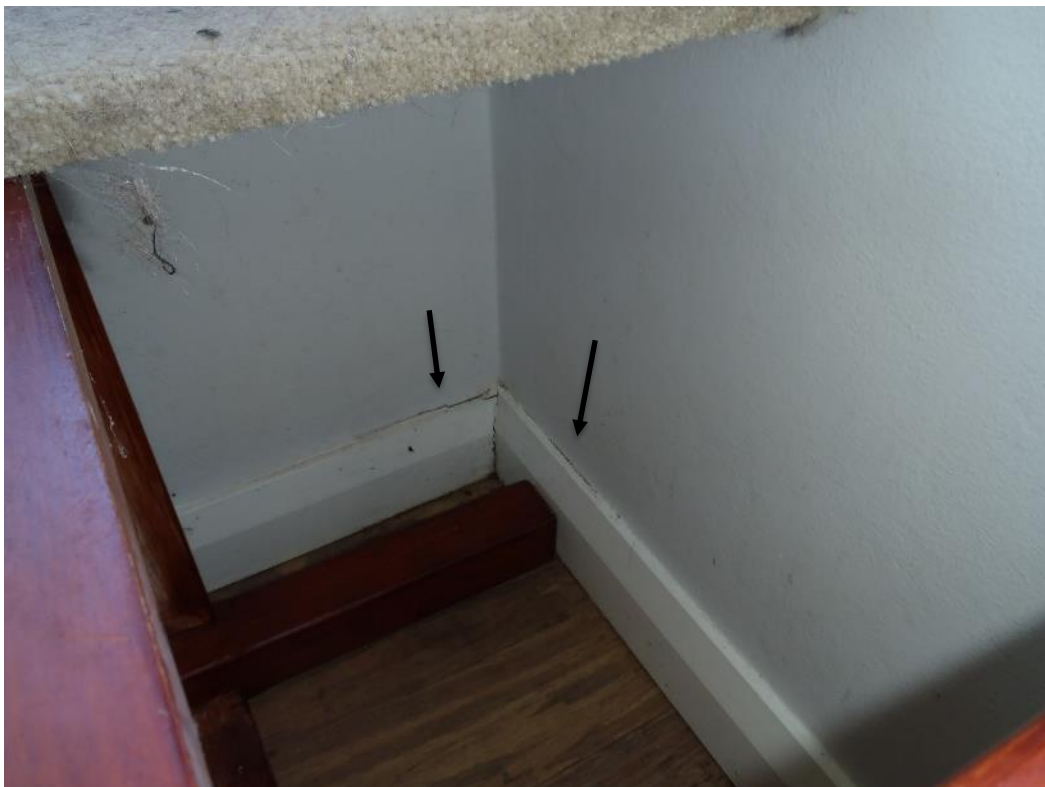
We noted separation cracking between the cement rendered wall surface and the timber skirting in the south-eastern corner. **[Photograph 32]**

**Photograph 32** shows separation cracking between the wall surface and the timber skirting in the south-eastern corner of the Sunroom.

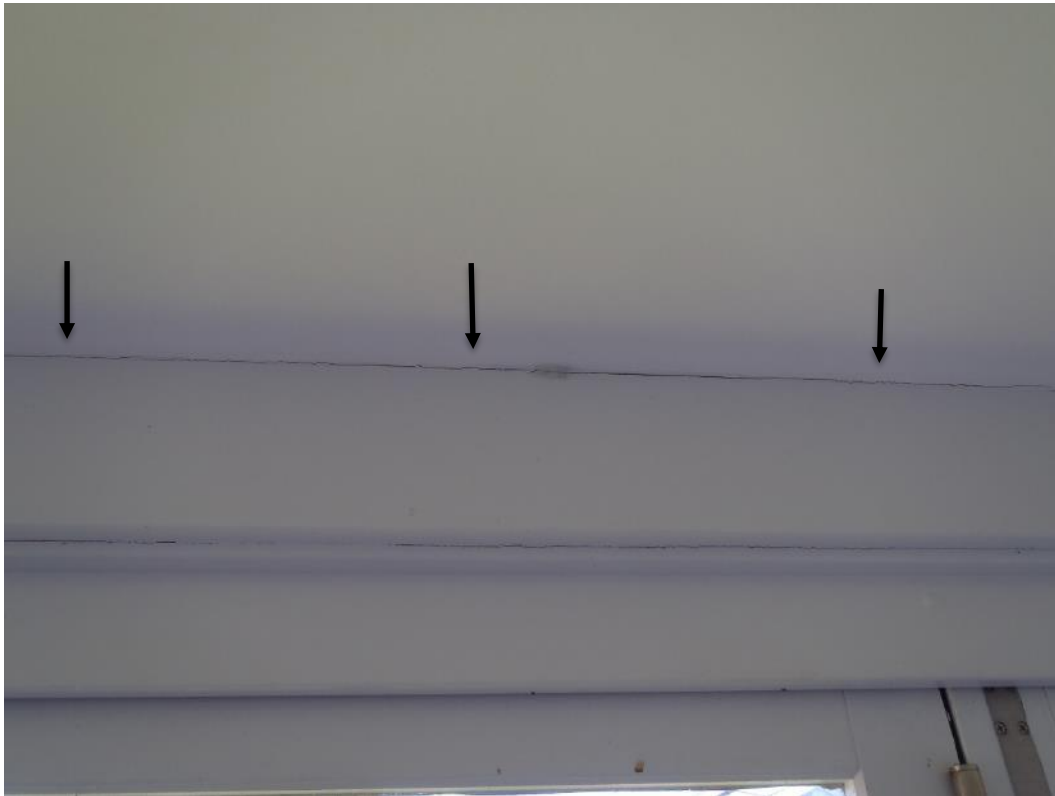
We noted general separation cracking between the timber trims and the ceiling lining. **[Photograph 33]**

**Photograph 33** shows typical separation cracking between the timber trims and the ceiling lining in the Sunroom.

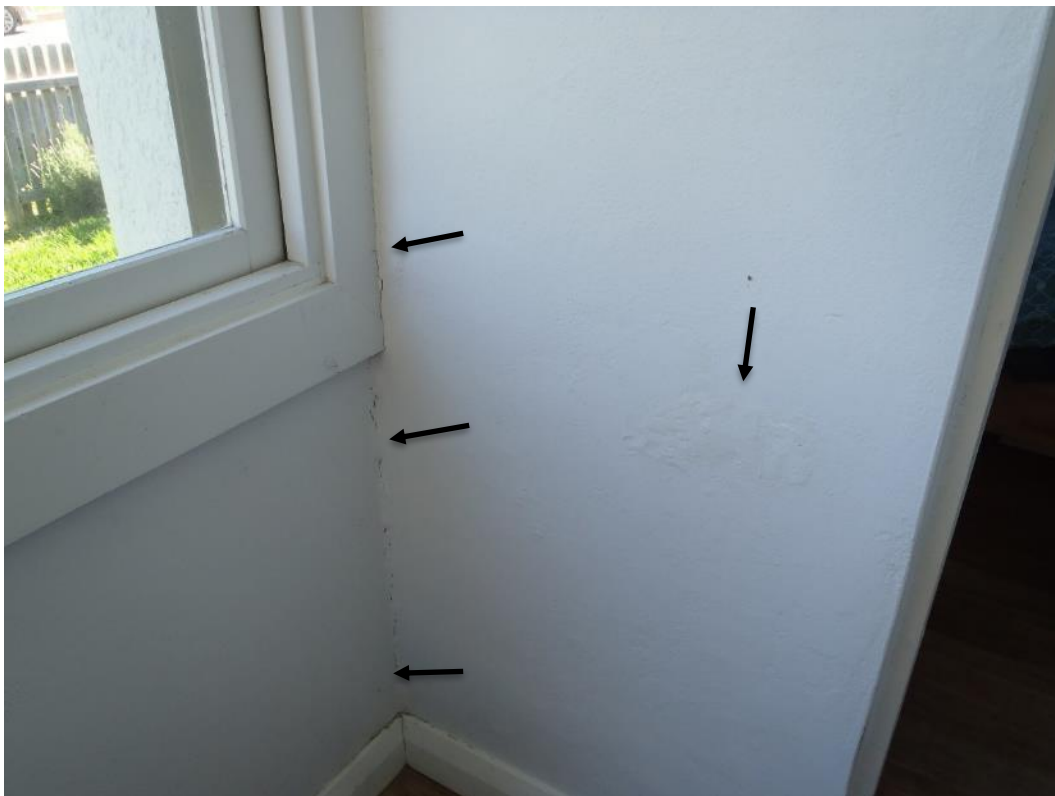
We noted separation cracking [ $< 1.0$  mm] between the cement rendered wall surfaces in the south-western corner. We further noted evidence of a previous repair [different surface texture] to the cement rendered wall common with Bedroom 1. **[Photograph 34]**

**Photograph 34** shows separation cracking between the wall surfaces in the south-western corner and evidence of a previous repair to the wall common with Bedroom 1 in the Sunroom.

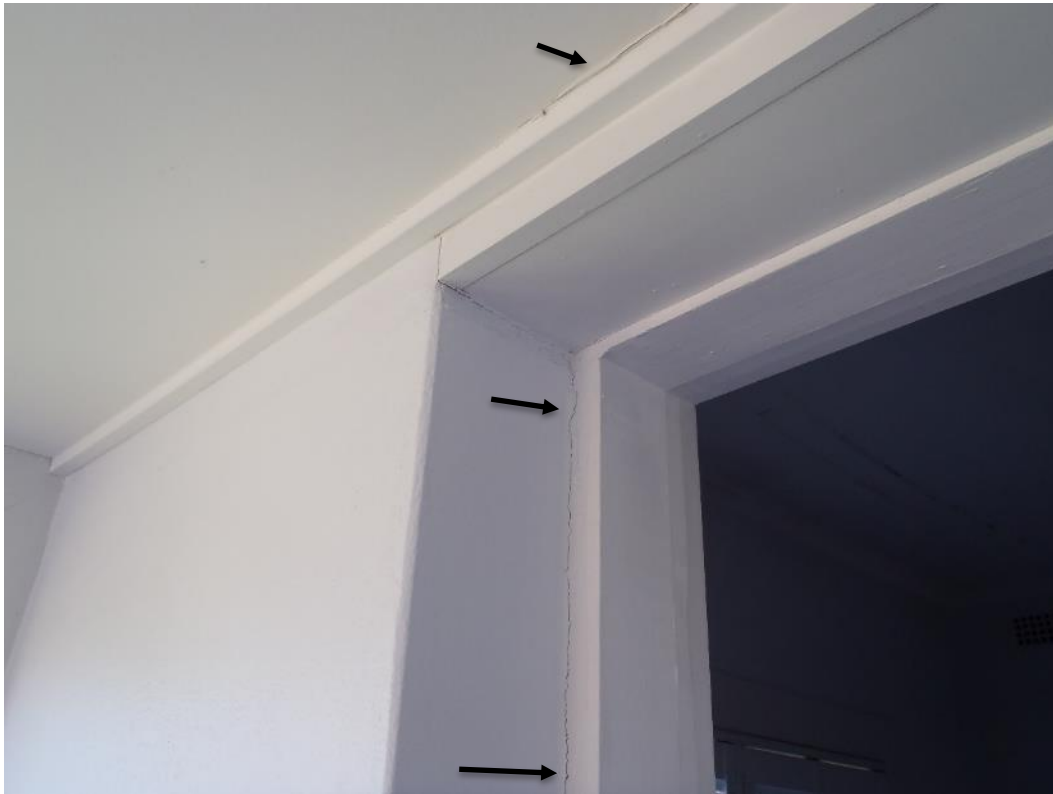
We noted separation cracking [ $< 1.0$  mm] between the cement rendered wall surfaces, timber trims and ceiling lining around the door to Bedroom 1. **[Photograph 35]**

**Photograph 35** shows separation cracking between the wall surfaces, timber trims and ceiling lining around the door to Bedroom 1 in the Sunroom.

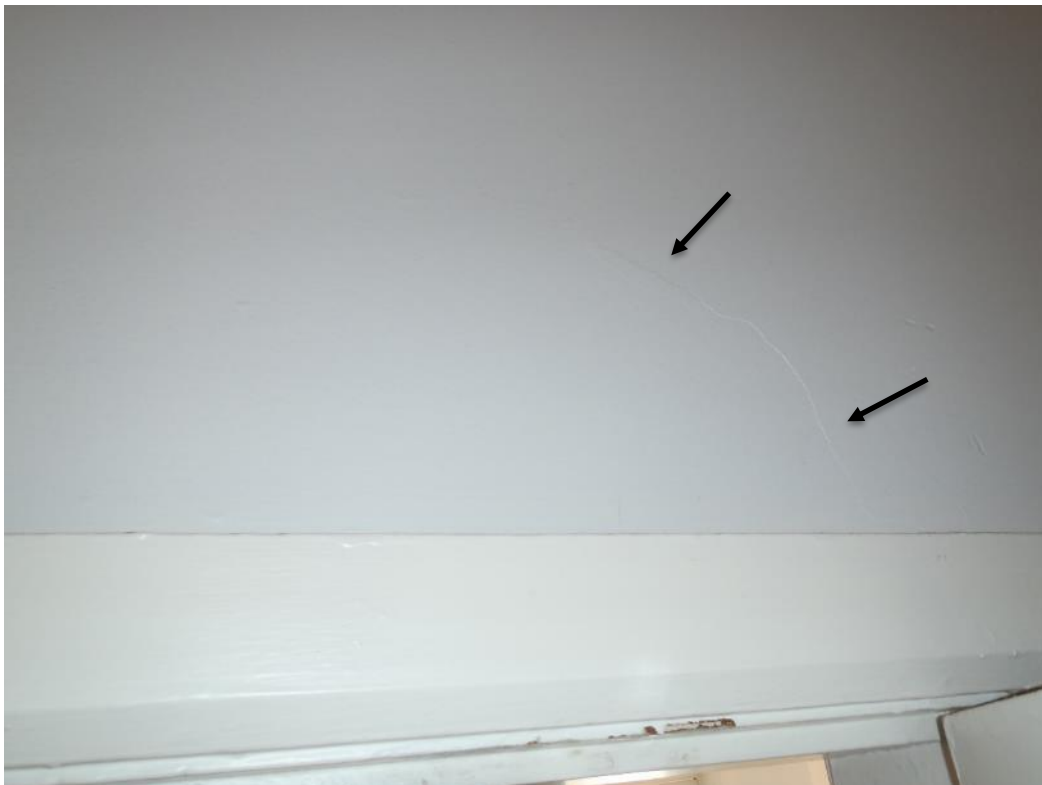
We noted radial cracking [1.0 mm] to the cement rendered wall surface above the door head extending toward the ceiling. **[Photograph 36]**

**Photograph 36** shows radial cracking to the wall surface above the door head extending toward the ceiling in the Study.

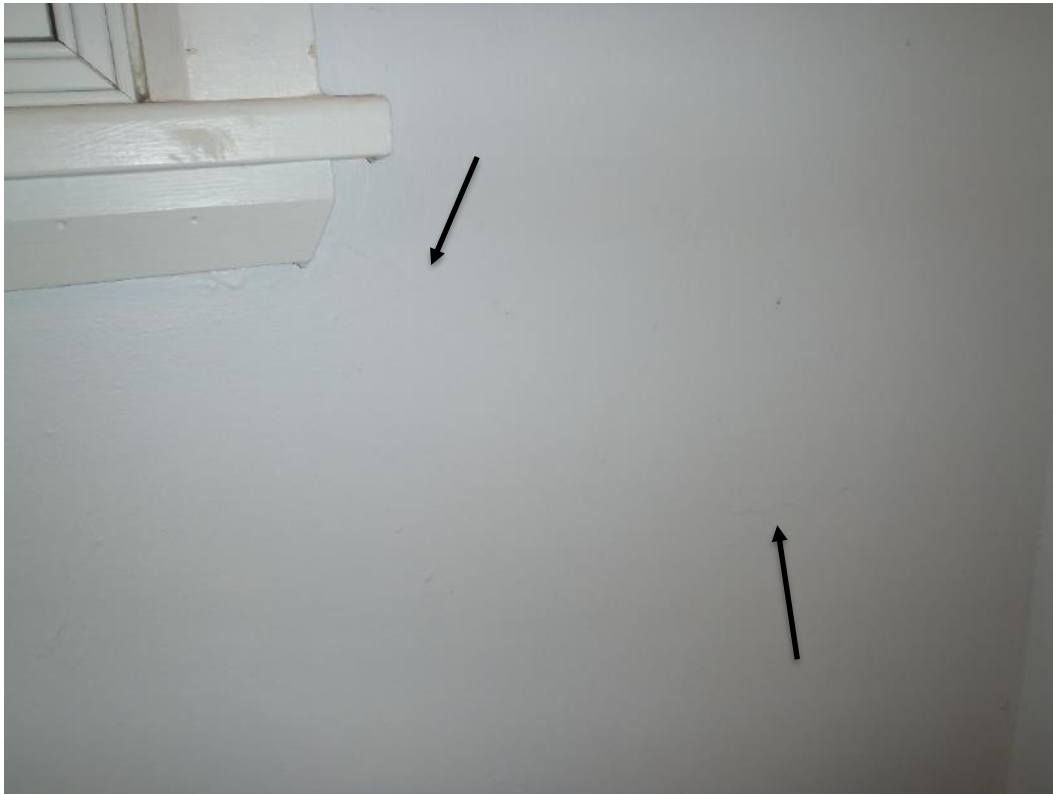
We noted radial cracking [1.0 mm] to the cement rendered wall surface extending from the right-hand side of the Sunroom window toward the floor. **[Photograph 37]**

**Photograph 37** shows radial cracking to the wall surface extending from the right-hand side of the Sunroom window toward the floor in the Study.

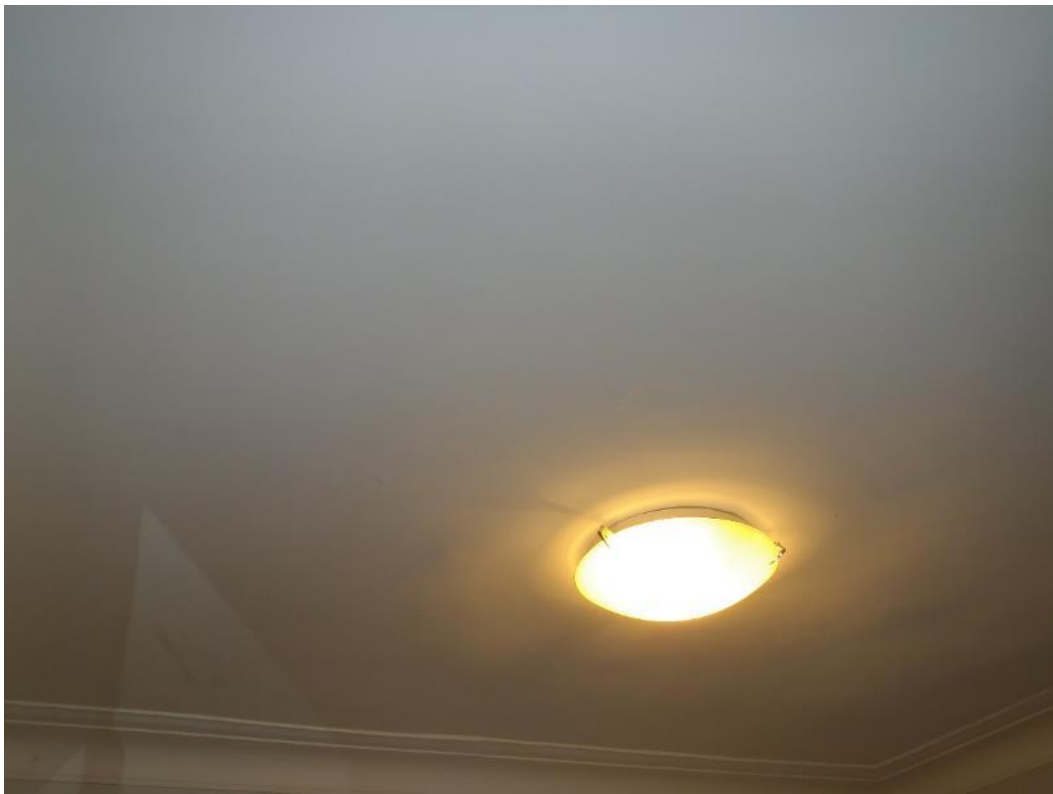
We observed evidence of a general previous repairs [different surface textures] to the fibrous plaster ceiling lining. **[Photograph 38]**

**Photograph 38** shows the general condition of the ceiling in the Study.

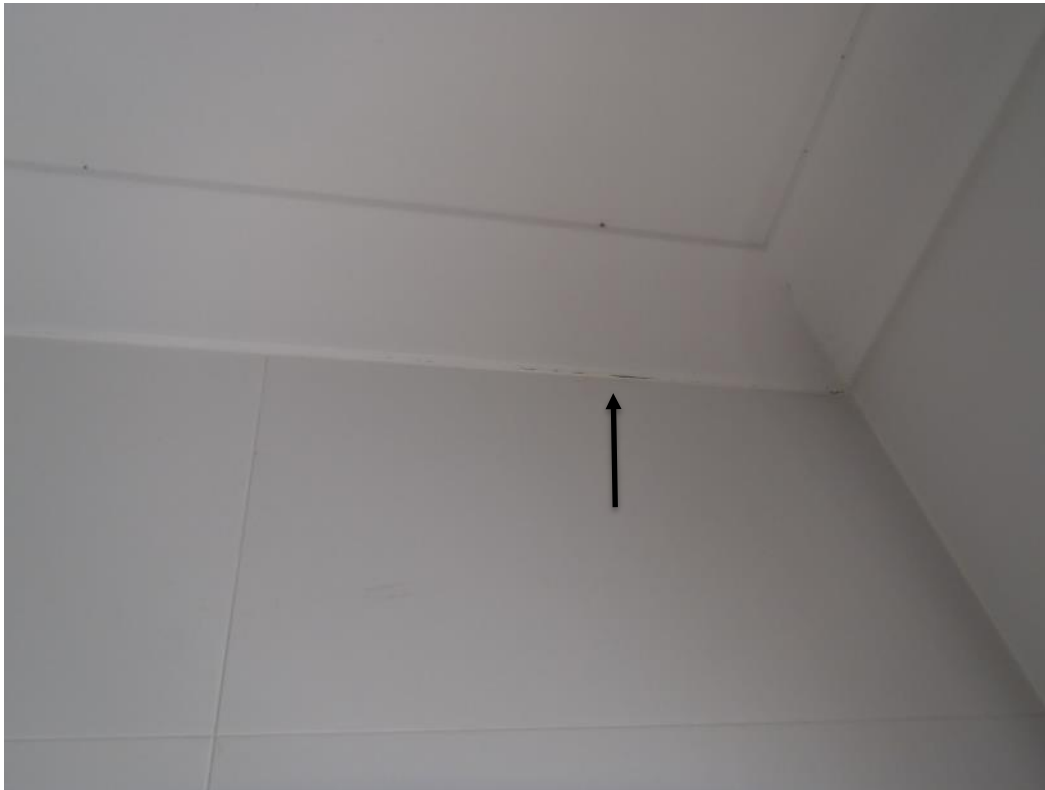
We noted separation cracking between the tiled wall surface and the cove profiled plaster cornice in the south-western corner. **[Photograph 39]**

**Photograph 39** shows separation cracking between the tiled wall surface and the cove profiled plaster cornice in the south-western corner of the Bathroom.

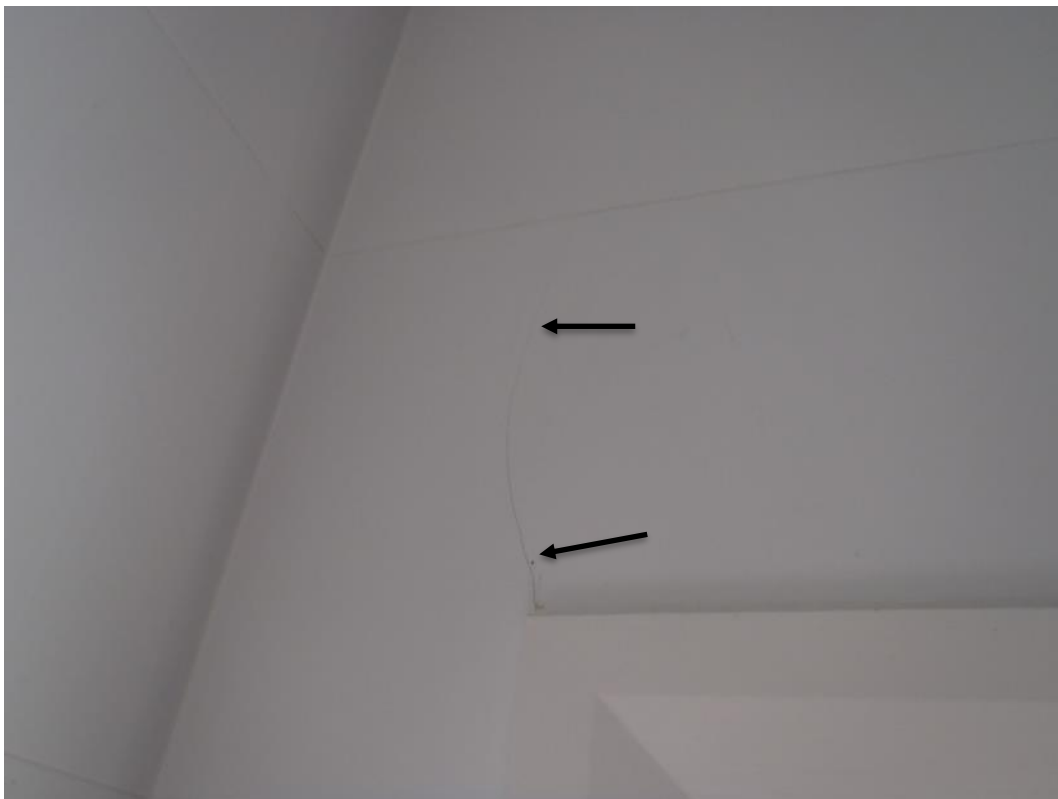
We noted vertical cracking [1.0 mm] to the tiles extending from the left-hand side of the window head toward the ceiling. **[Photograph 40]**

**Photograph 40** shows vertical cracking to the tiles extending from the left-hand side of the window head toward the ceiling in the Bathroom.

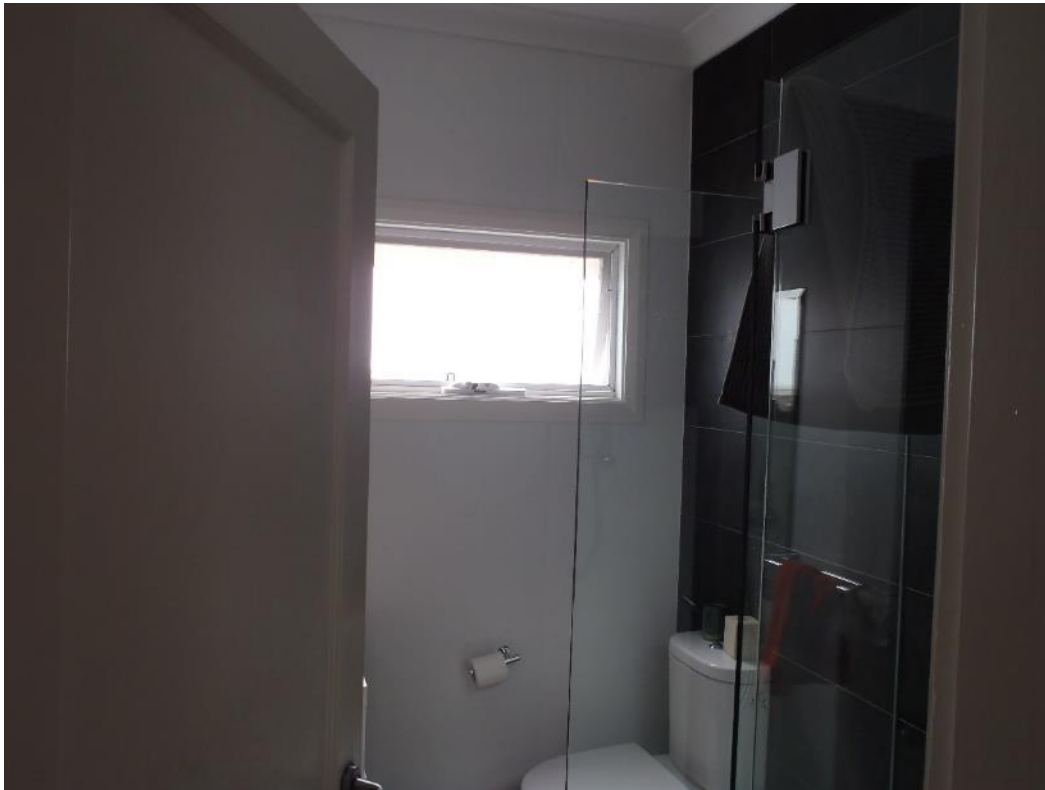
We noted that the grout to the wall and floor tiles is complete and that the wall and floor tiles when randomly “tap” tested appeared to be sound. We did not observe any recent cracking to the tile grout at the wall / wall, wall / floor junctions. **[Photograph 41]**

**Photograph 41** shows the general condition of the Bathroom.

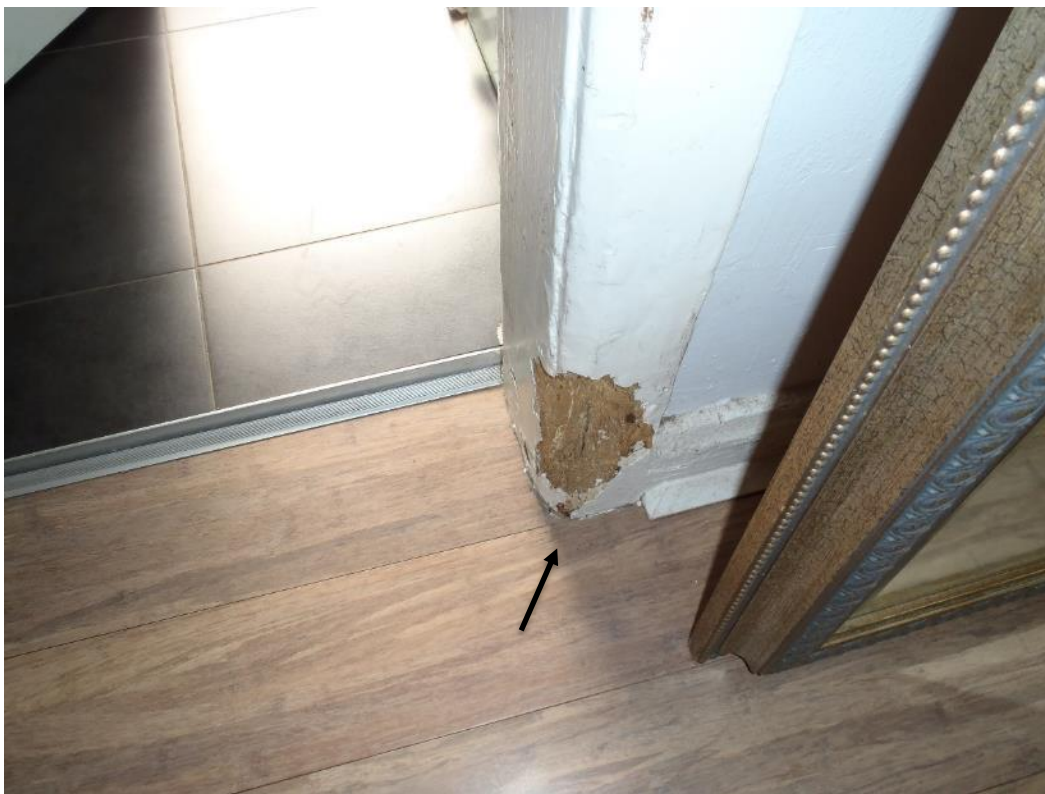
We noted damage to the architrave trim to the Bathroom door. **[Photograph 42]**

**Photograph 42** shows damage to the architrave trim to the Bathroom door in the Hallway.

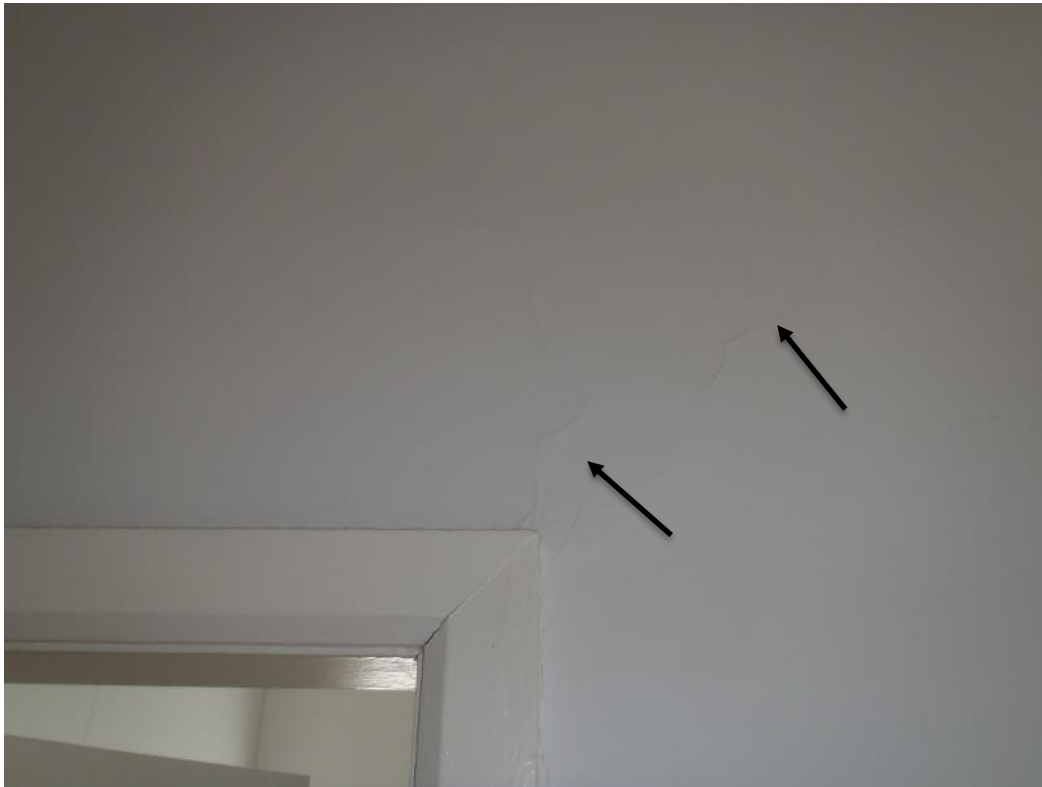
We noted radial cracking [ $< 1.0\text{ mm}$ ] to the cement rendered wall surface extending from the right-hand side of the Bathroom door head. **[Photograph 43]**

**Photograph 43** shows radial cracking to the wall surface extending from the right-hand side of the Bathroom door head in the Hallway.

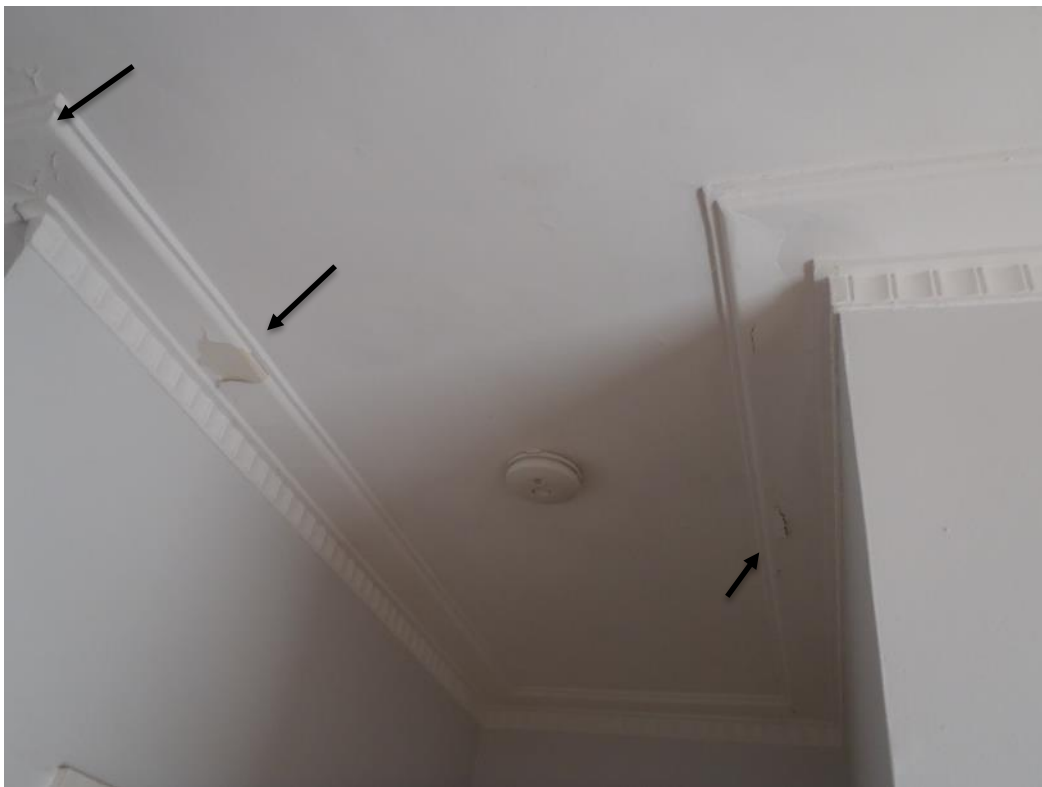
We noted general flaking paint to the decorative cornice and the plaster ceiling lining outside the stairwell and the Bathroom. **[Photograph 44]**

**Photograph 44** shows general flaking paint to the cornice and the ceiling outside the stairwell and the Bathroom.

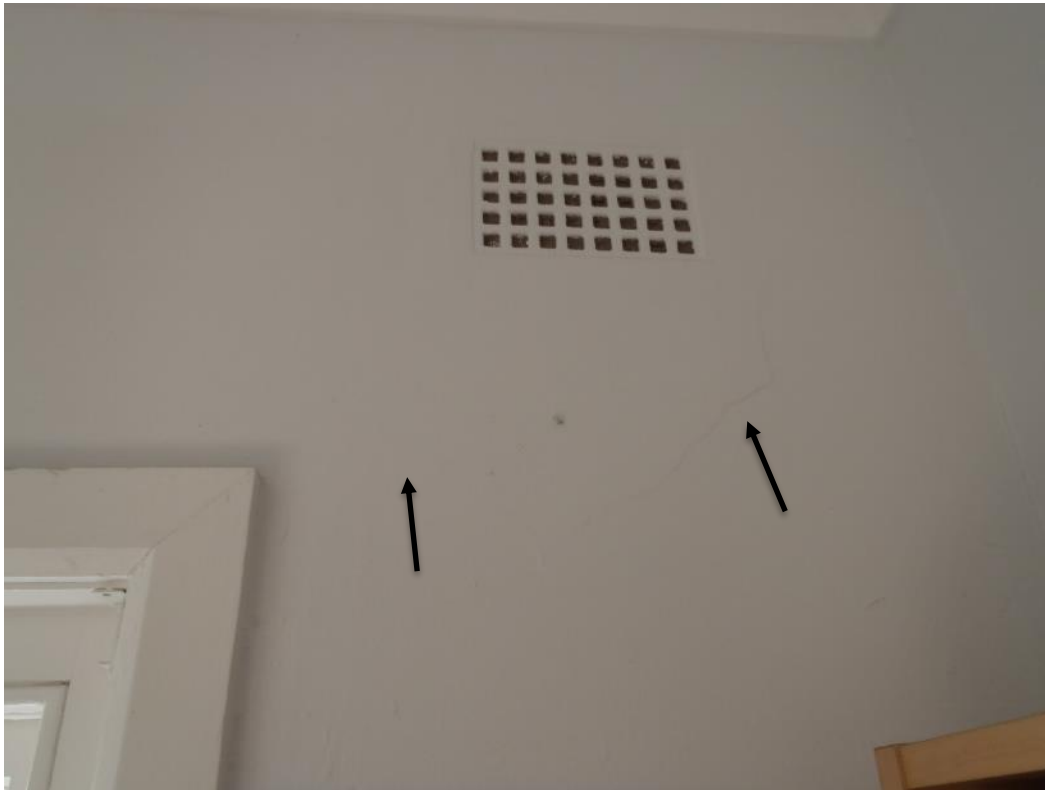
We noted radial cracking [ $< 1.0\text{ mm}$ ] to the cement rendered wall surface extending from the right-hand side of the window head toward the wall vent. **[Photograph 45]**

**Photograph 45** shows radial cracking to the wall surface extending from the right-hand side of the window head toward the wall vent in the Hallway.

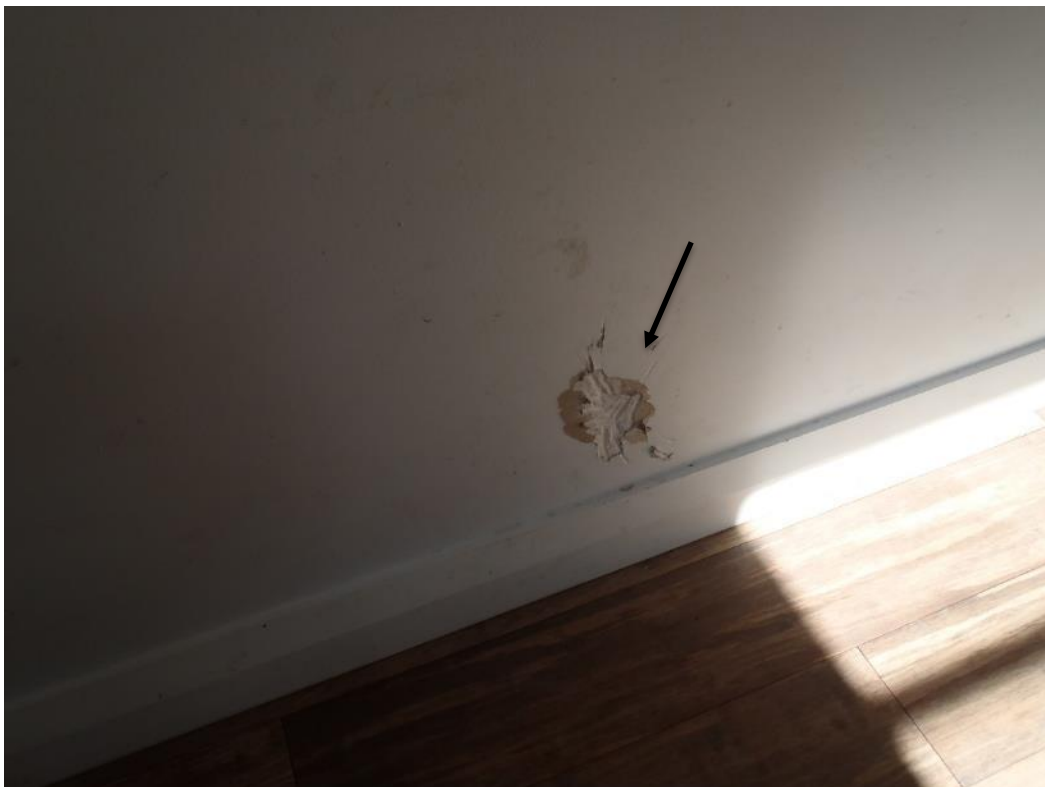
We noted damage to the plasterboard wall lining on the eastern wall common with the pantry. **[Photograph 46]**

**Photograph 46** shows damage to the plasterboard wall lining on the eastern wall common with the Pantry in the Hallway.

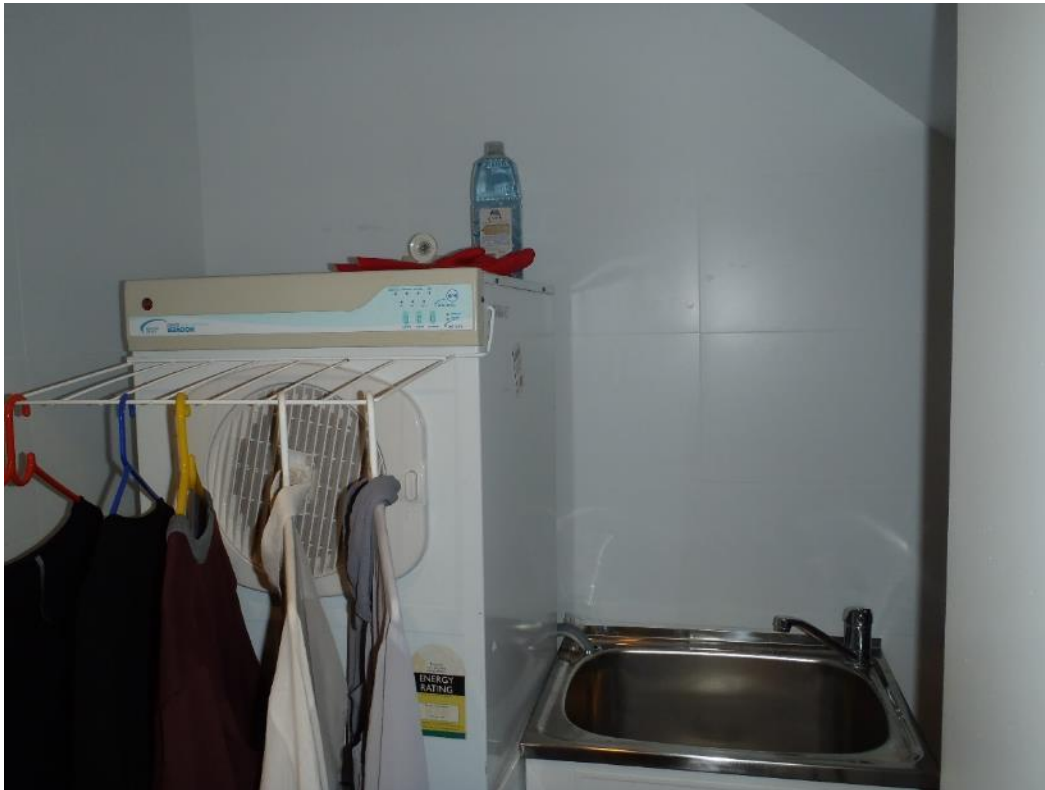
We did not observe any recent cracking to the ceramic wall tiles. **[Photograph 47]**

**Photograph 47** shows the general condition of the Laundry: **Note:** under stairwell.

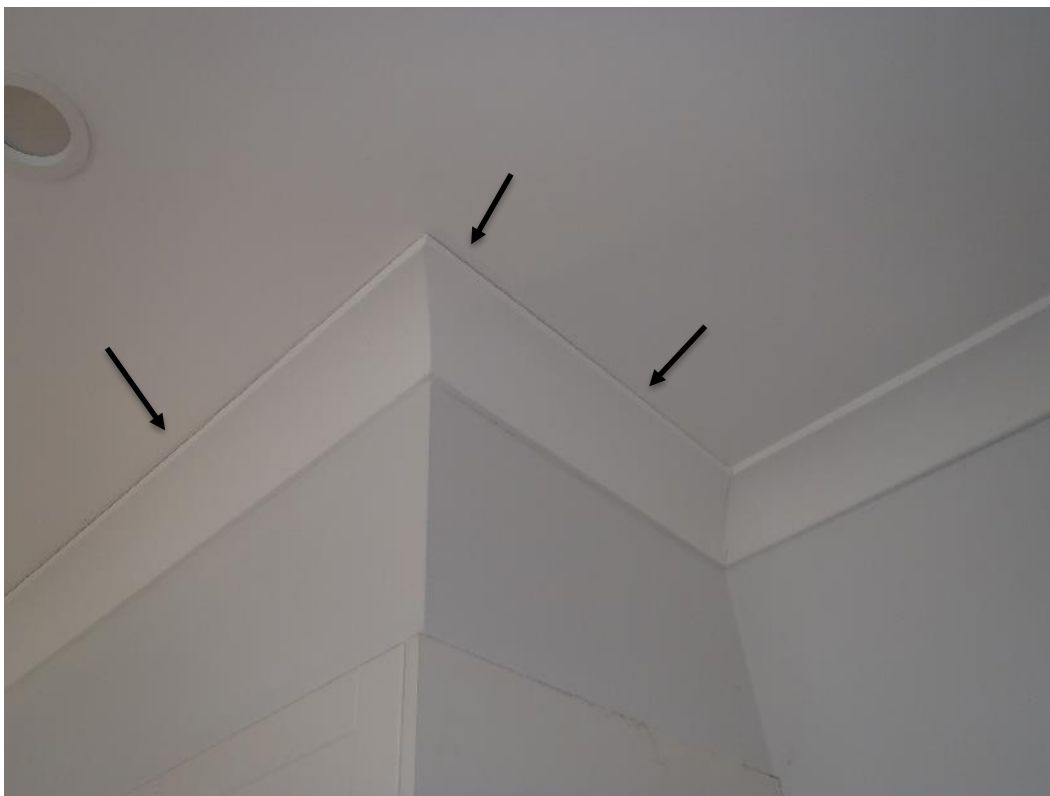
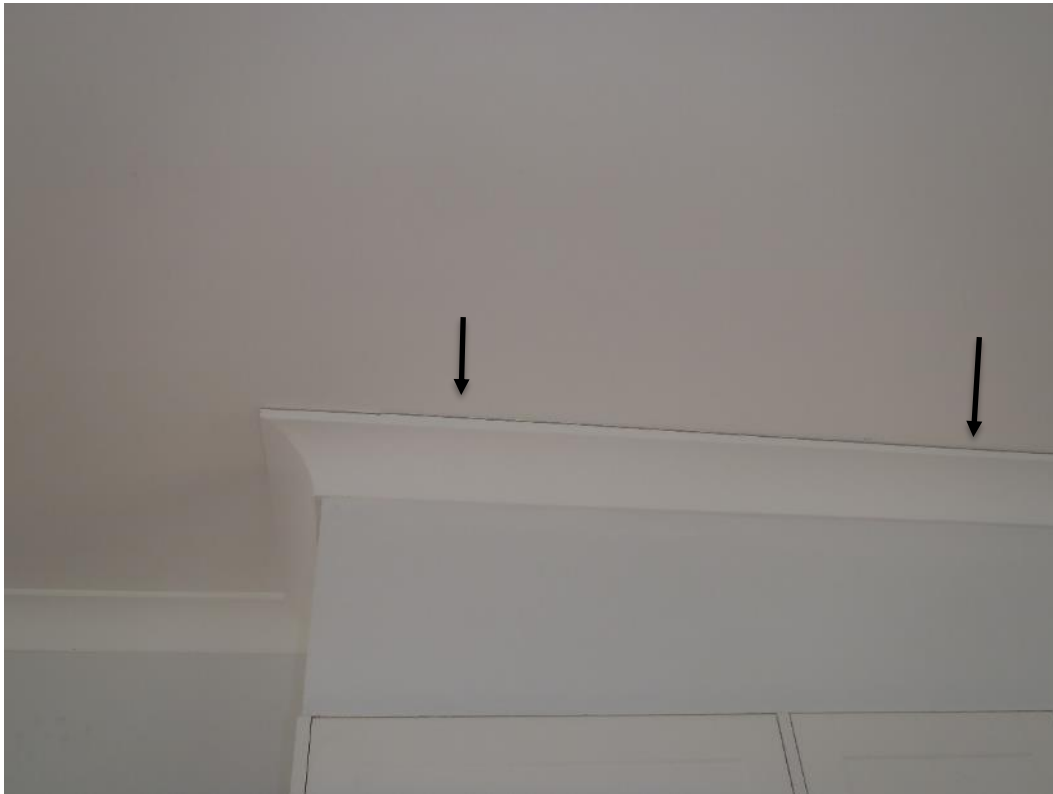
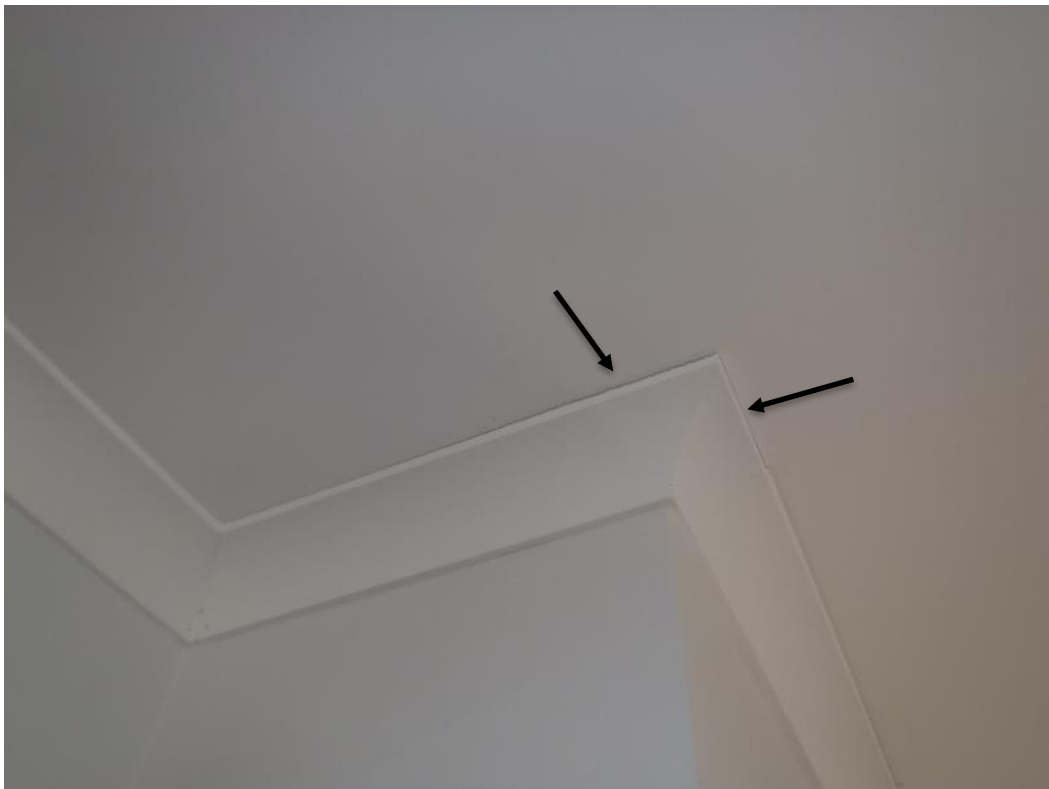
We noted separation cracking [ $< 1.0$  mm] between the plaster ceiling lining and the cove profiled plaster cornice along the *common party / separation* wall with the adjoining property, 34A Edgecliff Avenue, South Coogee. **[Photograph 48, 49 and 50]**

**Photograph 48** shows separation between the ceiling and the cornice along the *common party / separation* wall with the adjoining property, 34A Edgecliff Avenue, South Coogee of the Kitchen.

**Photograph 49** shows separation between the ceiling and the cornice along the *common party / separation* wall with the adjoining property, 34A Edgecliff Avenue, South Coogee of the Kitchen.

**Photograph 50** shows separation between the ceiling and the cornice along the *common party / separation* wall with the adjoining property, 34A Edgecliff Avenue, South Coogee of the Kitchen.
