## Dilapidation Assessment Report

Prepared for: Cape Cod Australia Pty. Limited.  
Job address: 34 Edgecliff Avenue, South Coogee.  
Property Owner/s: Mrs Jeannine Lew.  
Report reference: **RANDWICK COUNCIL**  
Development Application No: not available  
Date of assessment: 9<sup>th</sup> November 2017

**Re: Dilapidation Report – 34 Edgecliff Avenue, South Coogee.**

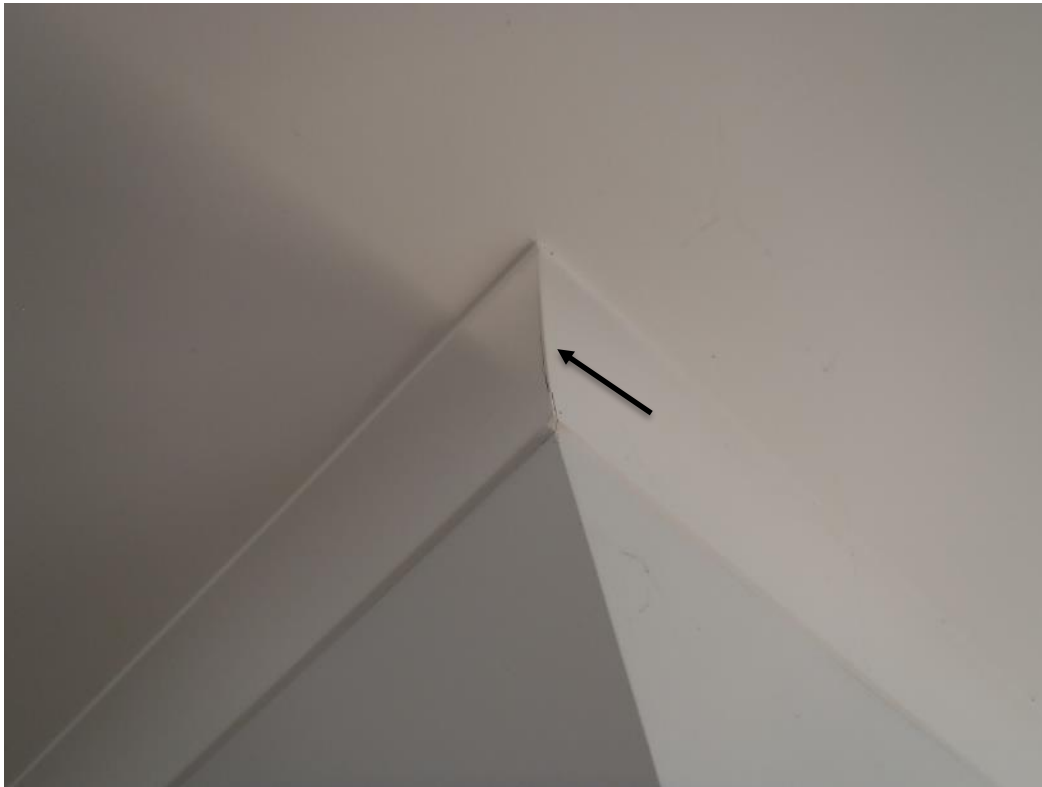
We noted separation cracking [ $< 1.0$  mm] to the mitre joints in the cove profiled plaster cornice in the south-western corner. **[Photograph 51]**

**Photograph 51** shows separation cracking to the mitre joints in the cornice in the south-western corner of the Kitchen.

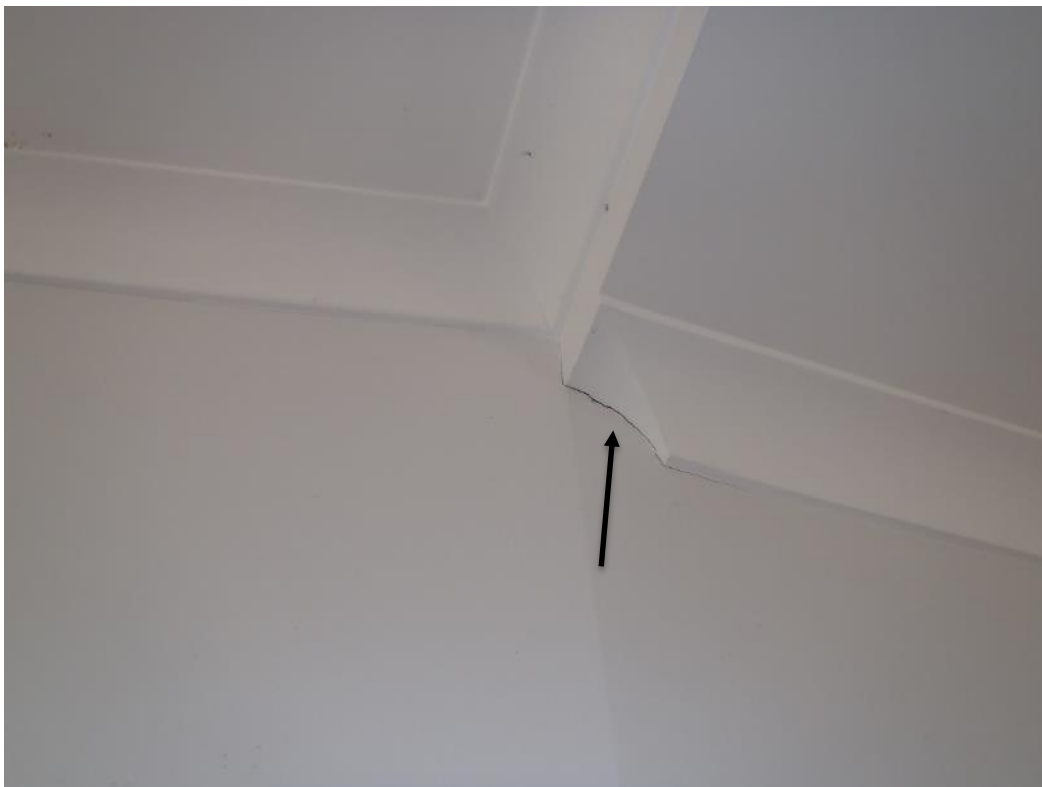
We did not observe any cracking to the plasterboard lined wall surfaces and in particular to the *common party / separation* wall with the adjoining property, 34A Edgecliff Avenue, South Coogee. We observed separation cracking of the cornice from the wall surface along the *common party / separation* wall with the adjoining property, 34A Edgecliff Avenue, South Coogee. **[Photograph 52]**

**Photograph 52** shows separation cracking of the cornice from the wall surface along the *common party / separation* wall with the adjoining property, 34A Edgecliff Avenue, South Coogee in the Dining Room.

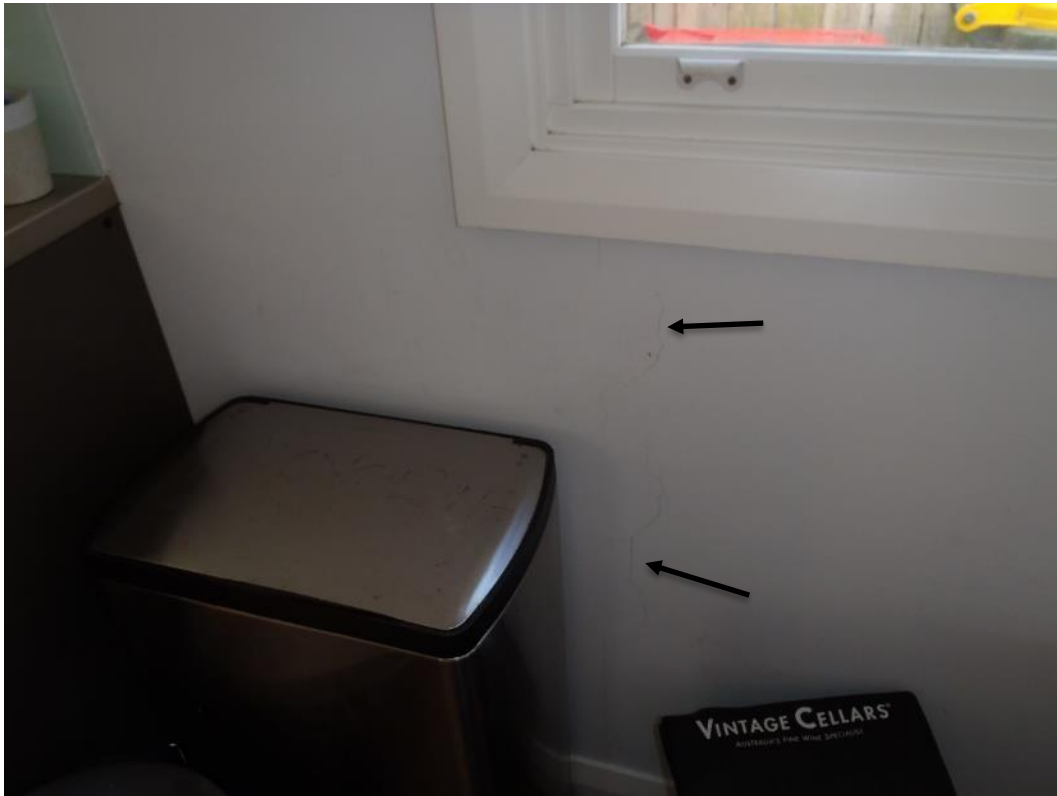
We noted radial and vertical cracking [ $< 1.0$  mm] to the cement rendered wall surface below the window extending toward the timber skirting. **[Photograph 53]**

**Photograph 53** shows radial and vertical cracking to the wall surface below the window extending toward the timber skirting in the Dining Room.

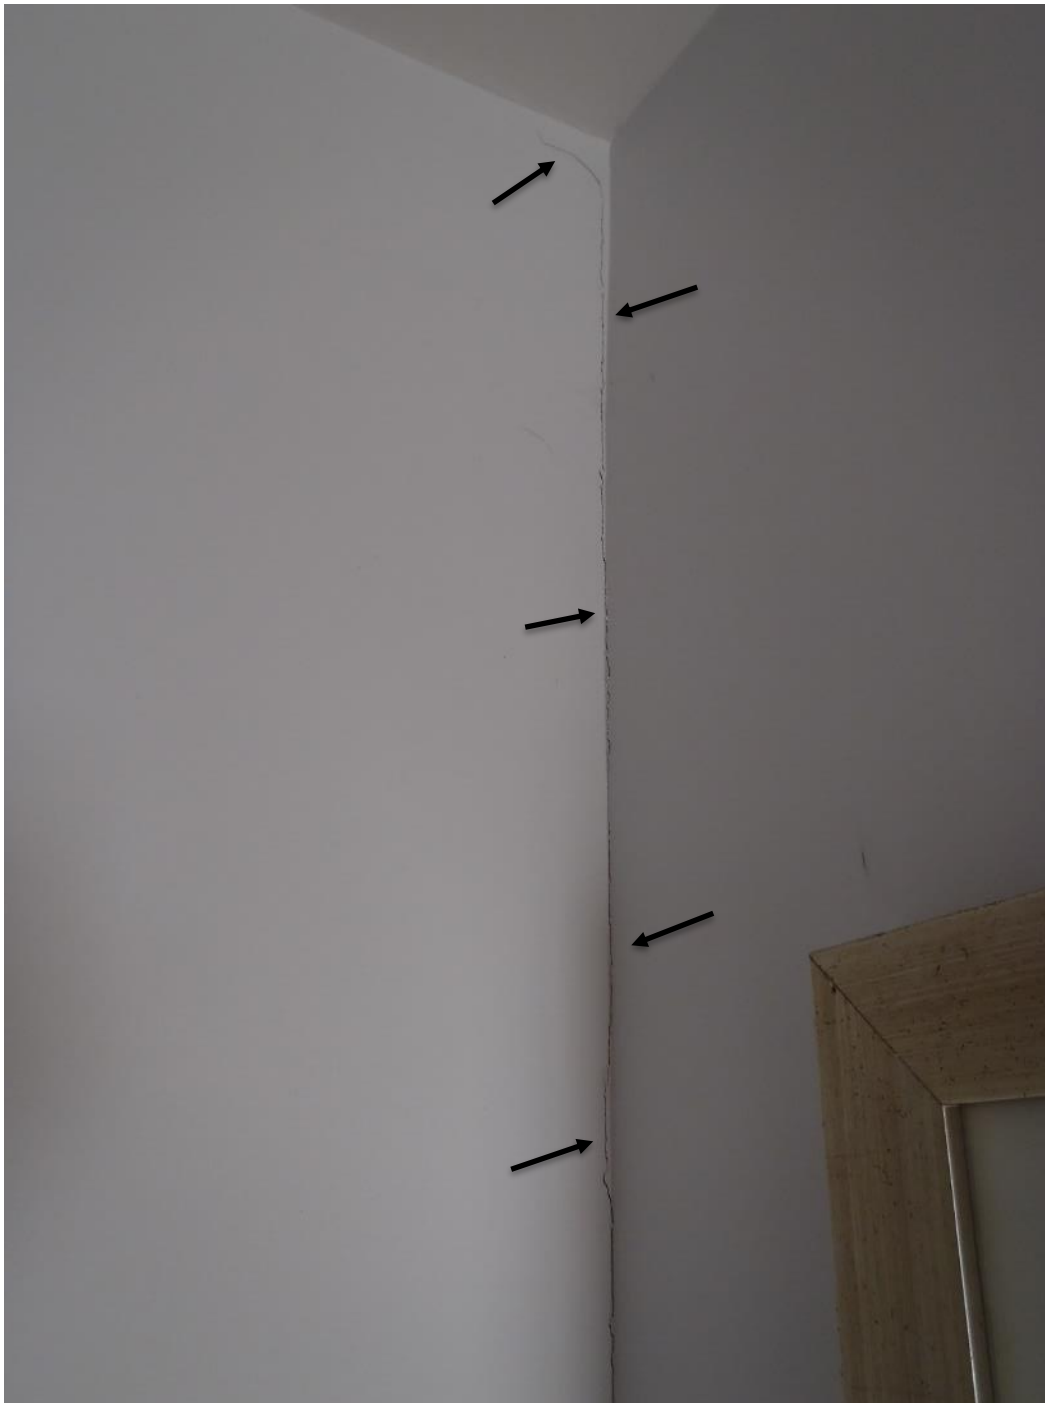
We noted separation cracking at the wall to wall junction in the south-eastern corner abutting the *common party / separation* wall with the adjoining property, 34A Edgecliff Avenue, South Coogee.

**Photograph 54** shows separation cracking at the wall to wall junction in the south-eastern corner abutting the *common party / separation* wall with the adjoining property, 34A Edgecliff Avenue, South Coogee in the Stairwell.

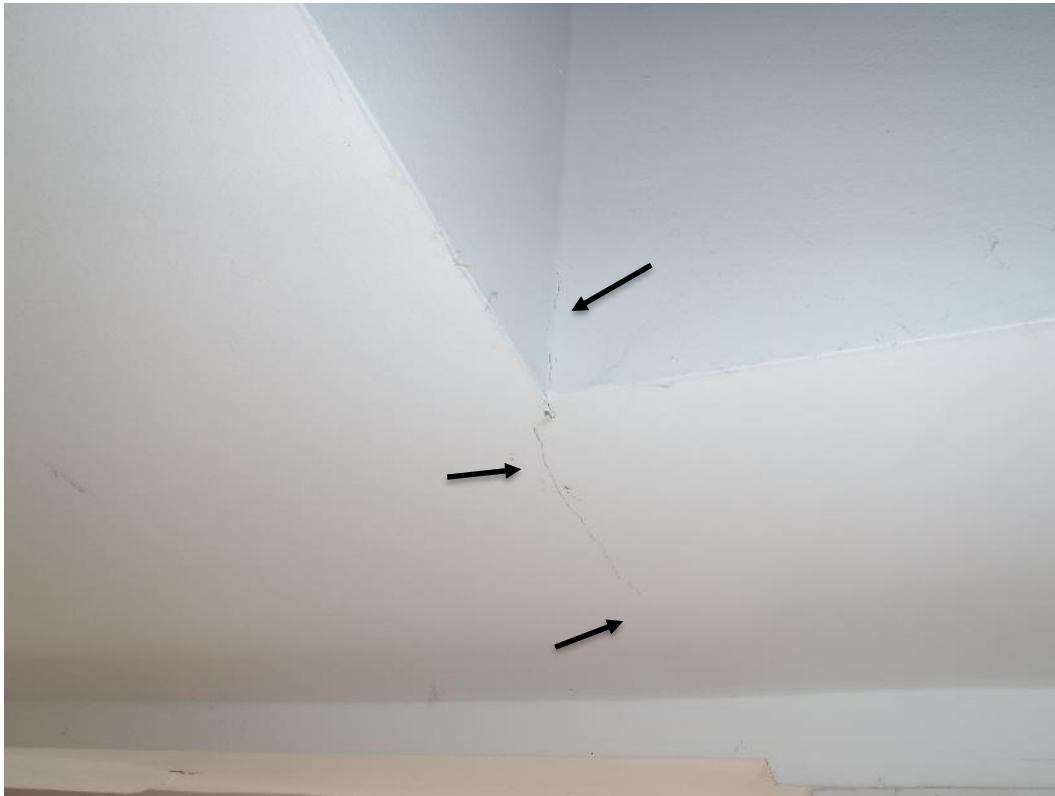
We noted shrinkage cracking [ $<1.0\text{mm}$ ] to the plasterboard ceiling lining extending toward the front door. We further noted separation cracking [ $<1.0\text{mm}$ ] at the wall to wall junction above.

**Photograph 55** shows shrinkage cracking to the ceiling lining extending toward the front door and separation cracking at the wall to wall junction above in the Stairwell.

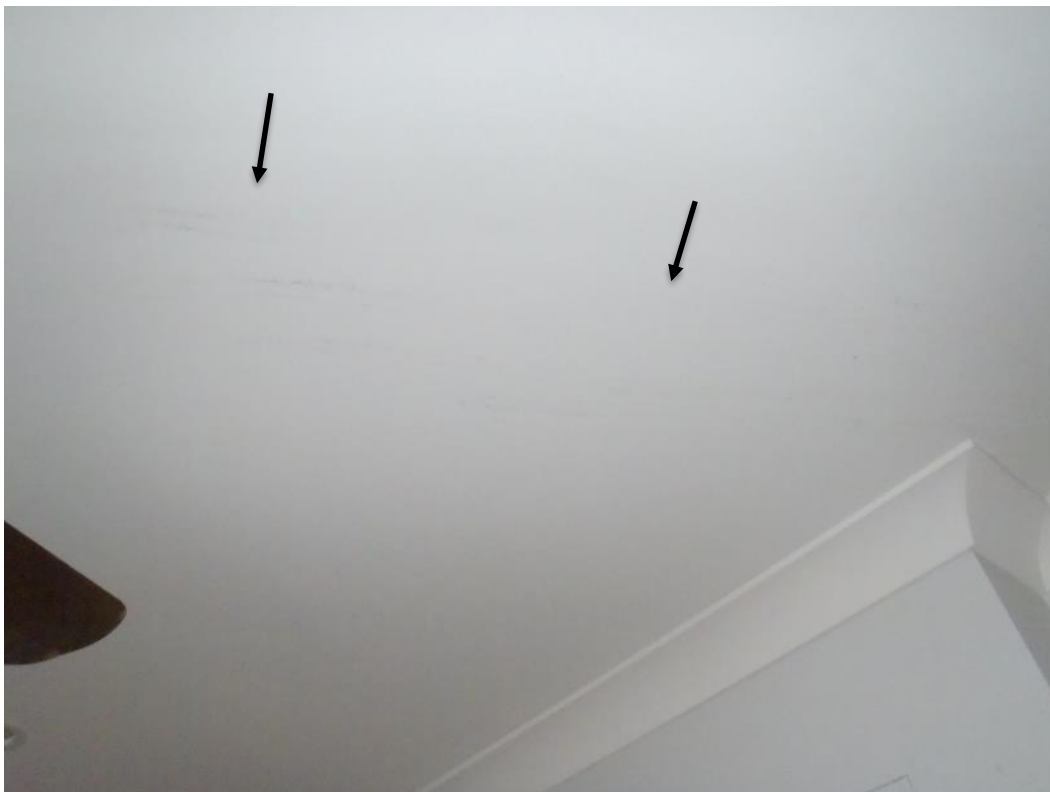
We noted staining to the plasterboard ceiling lining adjacent to the south-eastern window.

**Photograph 56** shows staining to the ceiling lining adjacent to the south-eastern window of Bedroom 2.

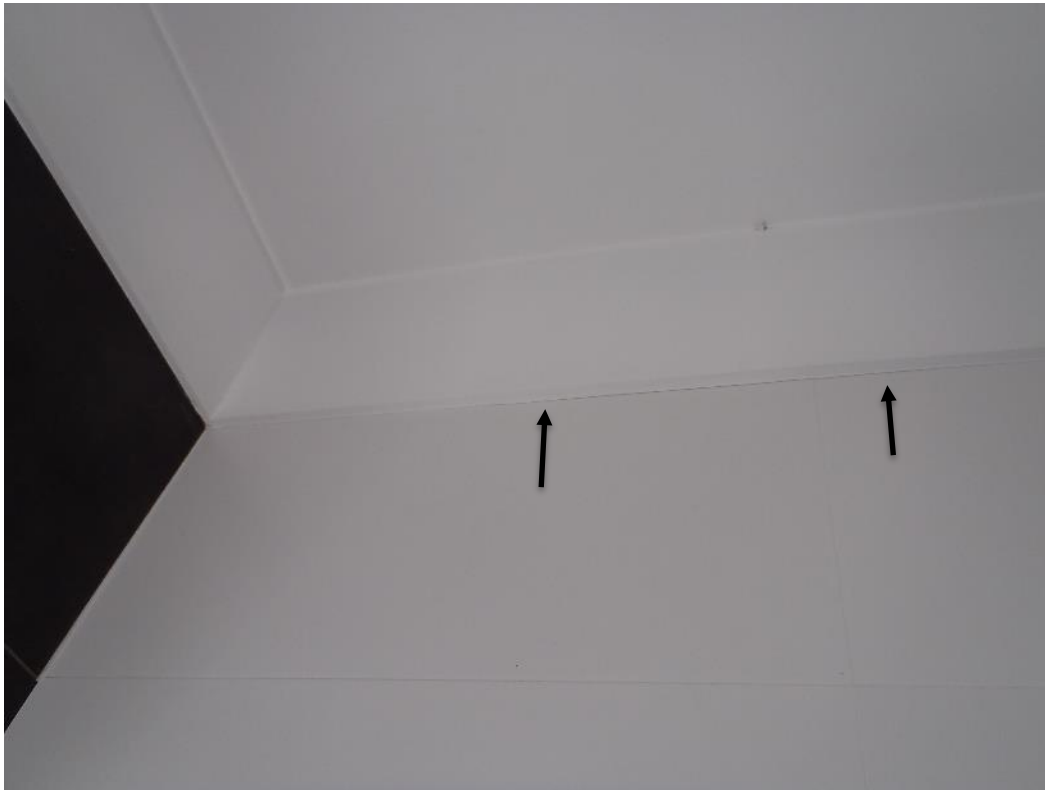
We noted separation cracking between the tiled wall surface and the cove profiled plaster cornice in the north-eastern corner. **[Photograph 57]**

**Photograph 57** shows separation cracking between the tiled wall surface and the cornice in the north-eastern corner of the Bathroom.

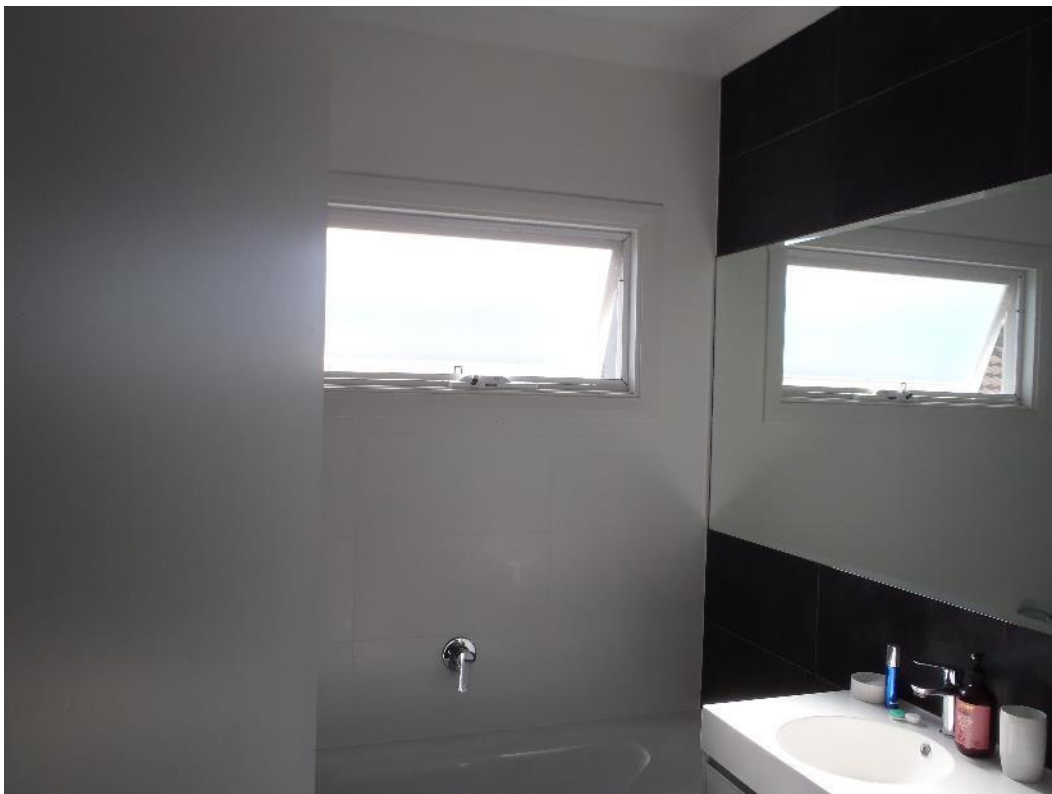
**Photograph 58** shows the general condition of the Bathroom.

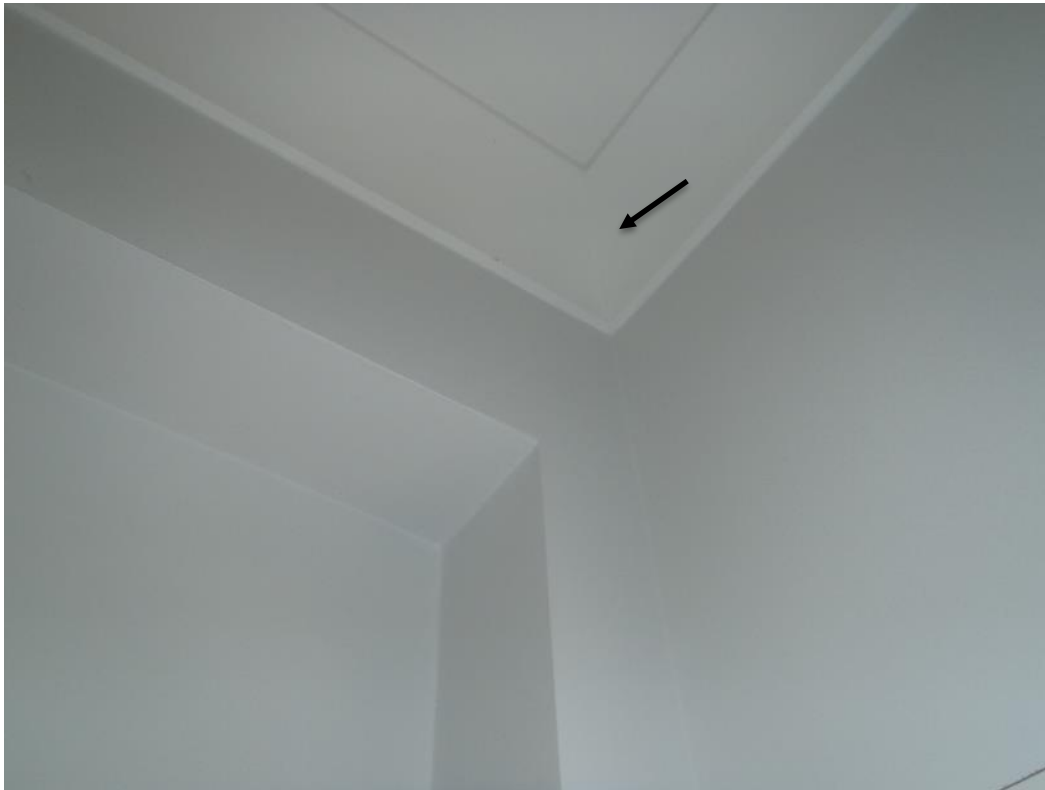
**Photograph 59** shows hairline shrinkage cracking to the mitred joints in the cornice in the south-eastern corner abutting the *common party / separation* wall with the adjoining property, 34A Edgecliff Avenue, South Coogee in the Study.

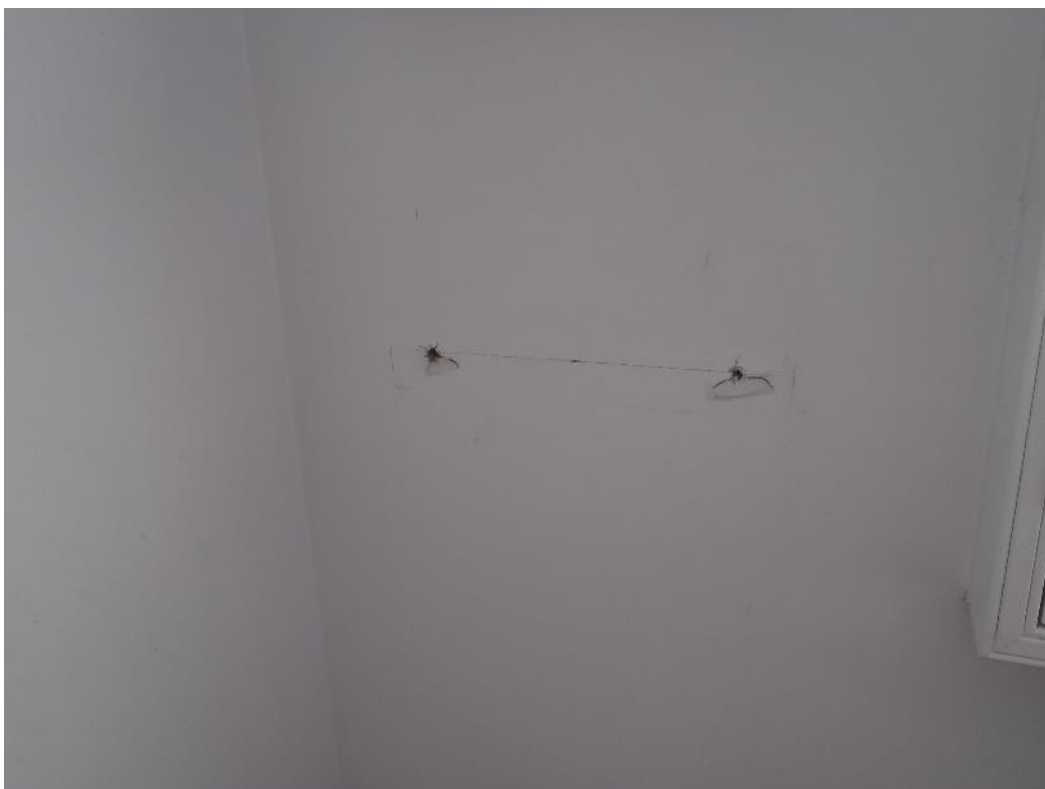
**Photograph 60** shows damage to the wall lining from a dislodged shelf in the south-western corner of Bedroom 3.

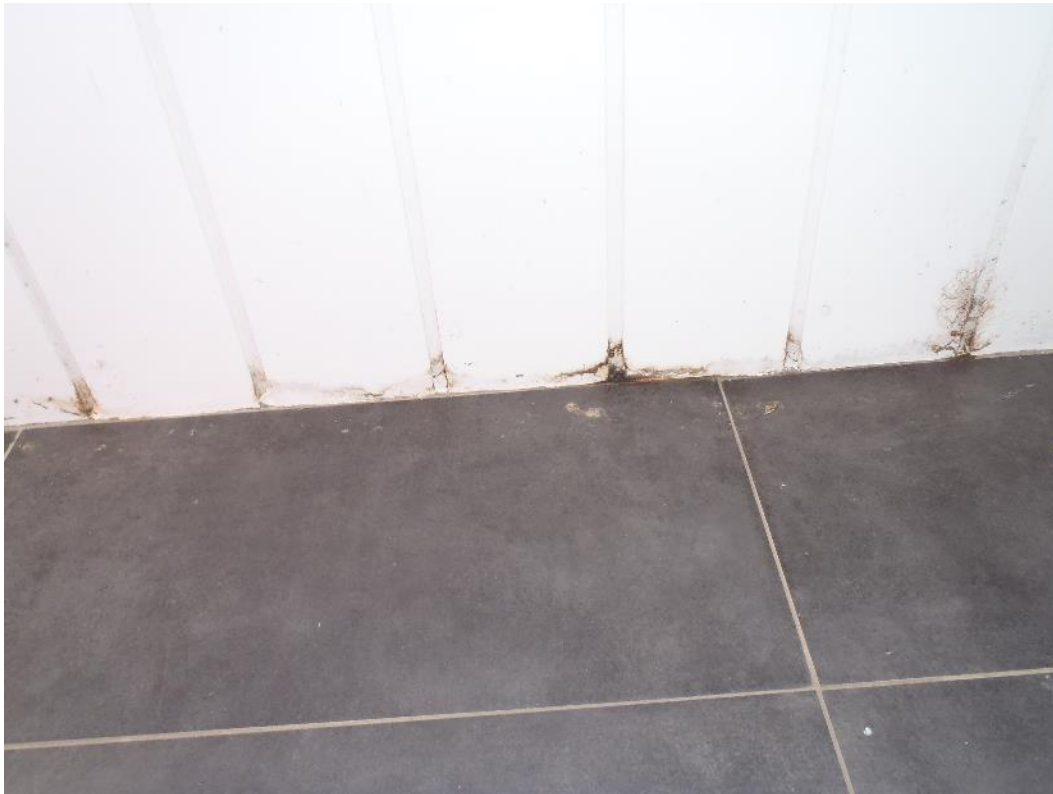
**Photograph 61** shows staining to the weatherboard lined balustrade wall on the front Balcony.

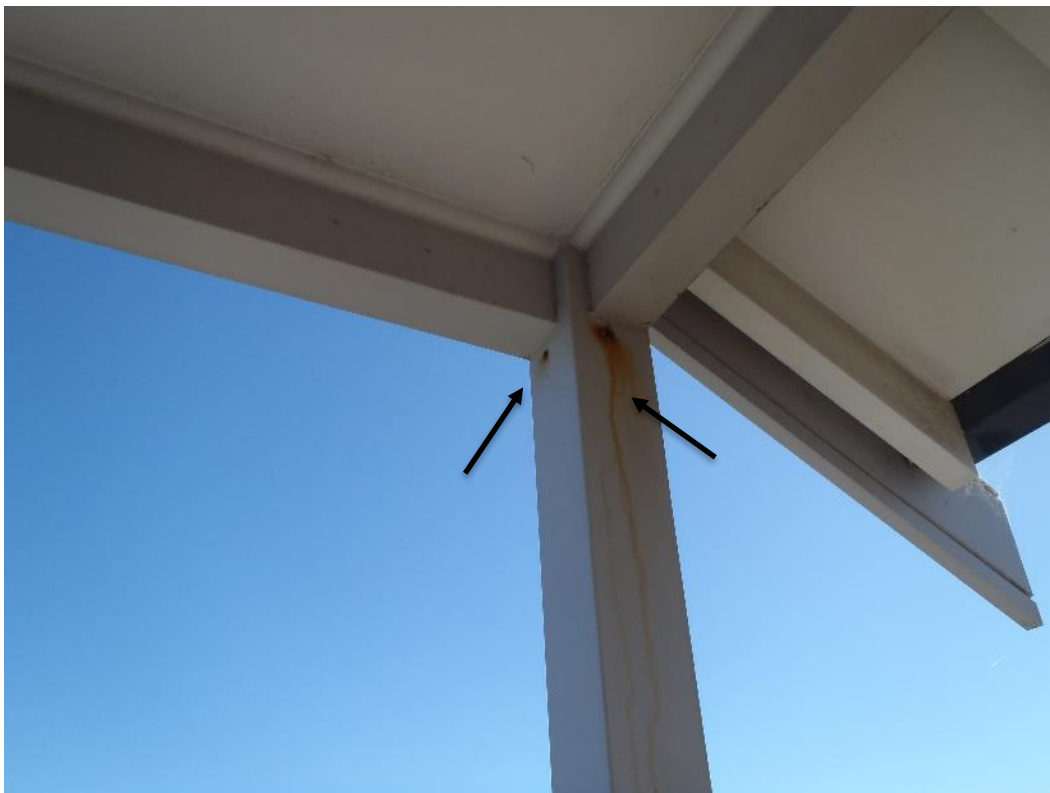
**Photograph 62** shows rust staining to the timber support post in the south-western corner on the front Balcony.

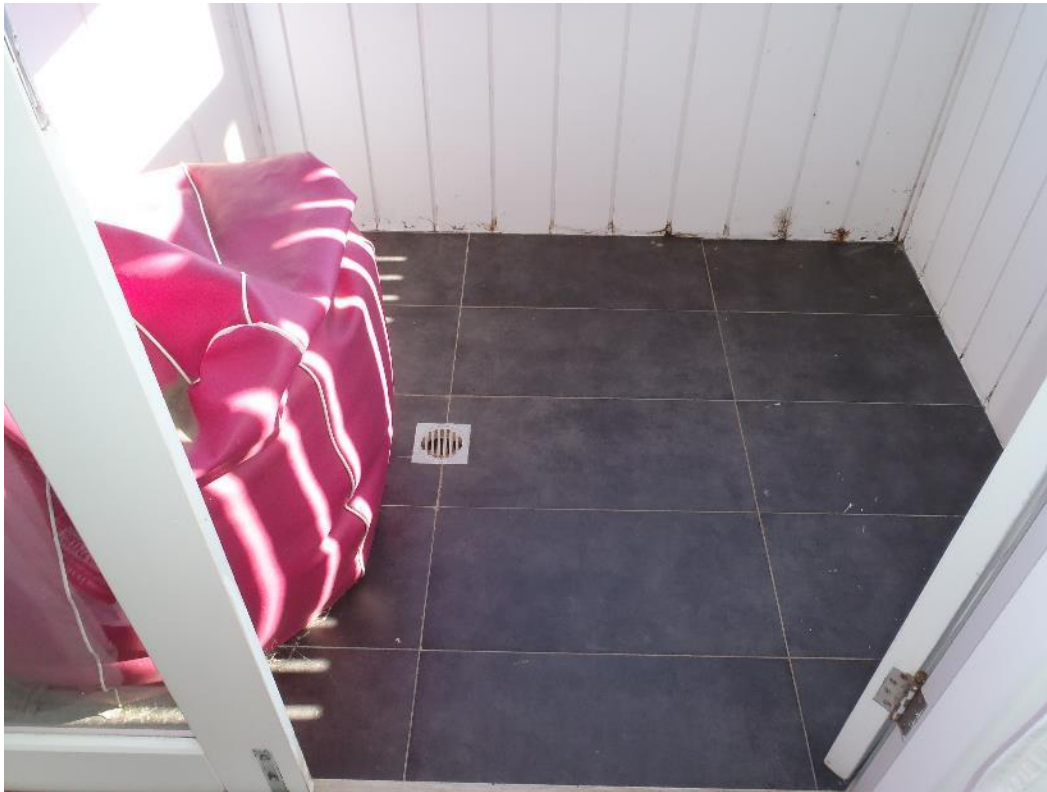
**Photograph 63** shows the general condition of the front balcony floor tiles.

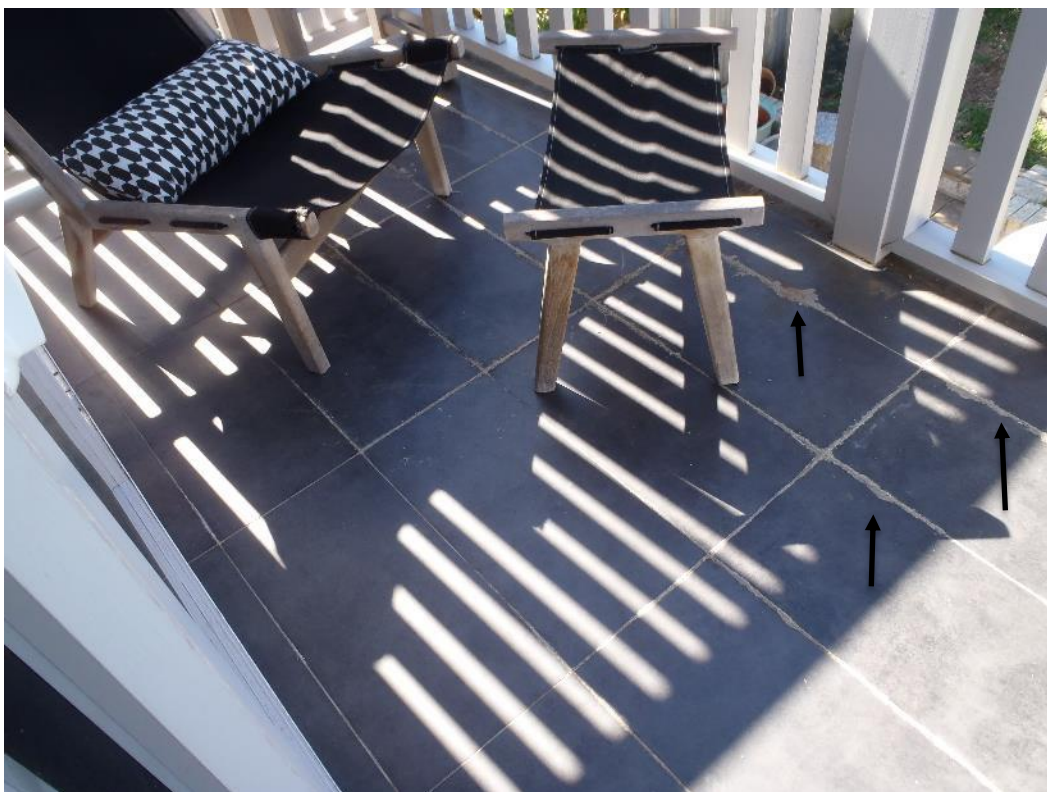
**Photograph 64** shows the efflorescence of the floor tile grout to the rear Balcony.
