HAZARDOUS MATERIALS ASSESSMENT REPORT

Job details: Owner/s: Mr. D. & Mrs. M. Tough
Location: 2 Meymott Street, Coogee NSW

Date of assessment: 23rd July 2014

Our reference: HM03200714

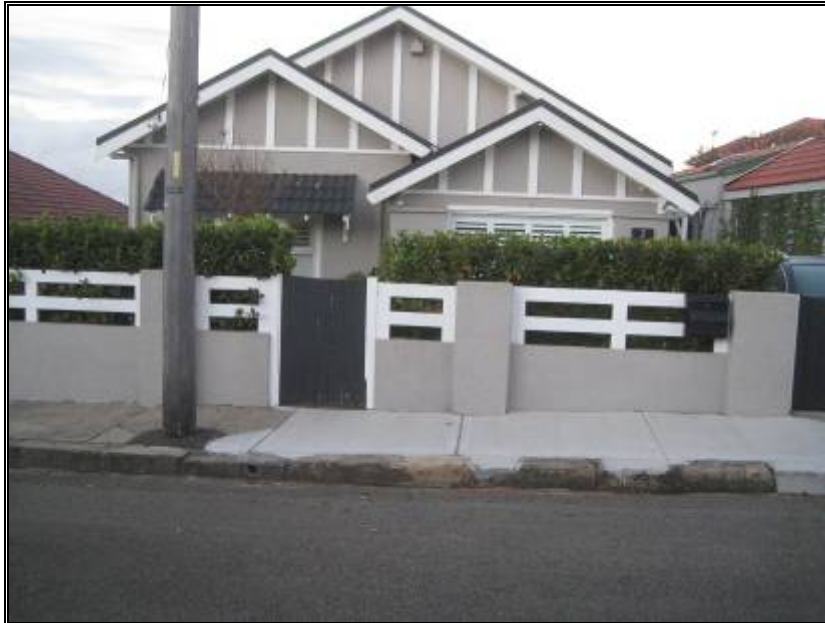
Front northern elevation of the residence
