Dilapidation Assessment Report

Prepared for: Cape Cod Australia Pty. Limited
Job address: 12 College Street, Gladesville.
Property Owner/s: Mr. Reece & Mr. Ryan Yule.
Report reference: **RYDE CITY COUNCIL**
Development Application No: not available
Date of assessment: 1st July 2017

Re: Dilapidation Report – No. 12 College Street, Gladesville.

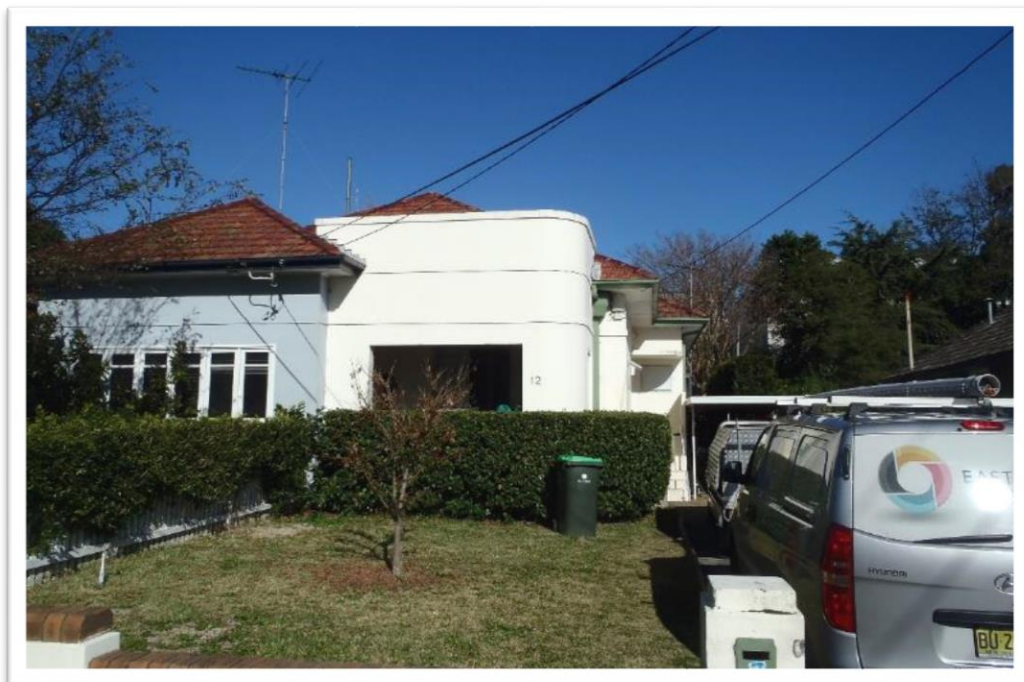
Shows the front north- eastern elevation of the adjoining properties:
No.10 and No.12 College Street, Gladesville.

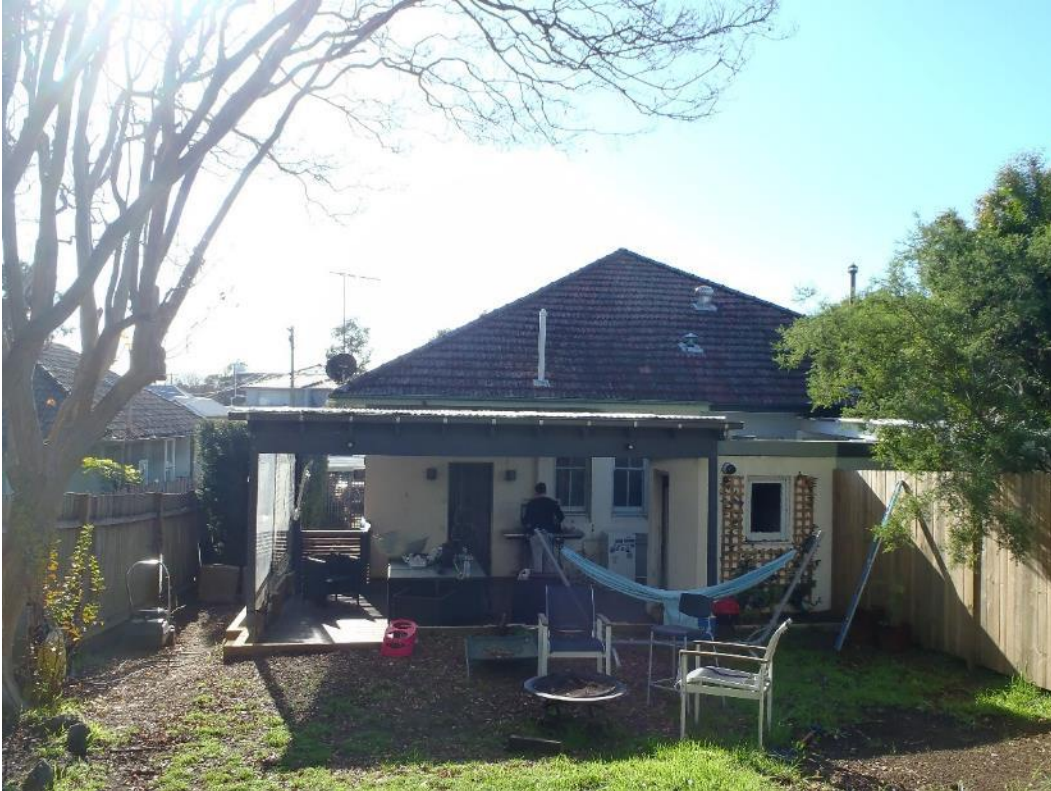
We observed that the terra cotta roof tiles to the original roof surfaces are generally interlinked and securely bedded, in our opinion forming a weather resistant cover to the residence. **[Photograph 1]**

Photograph 1 shows the rear elevation of the residence.

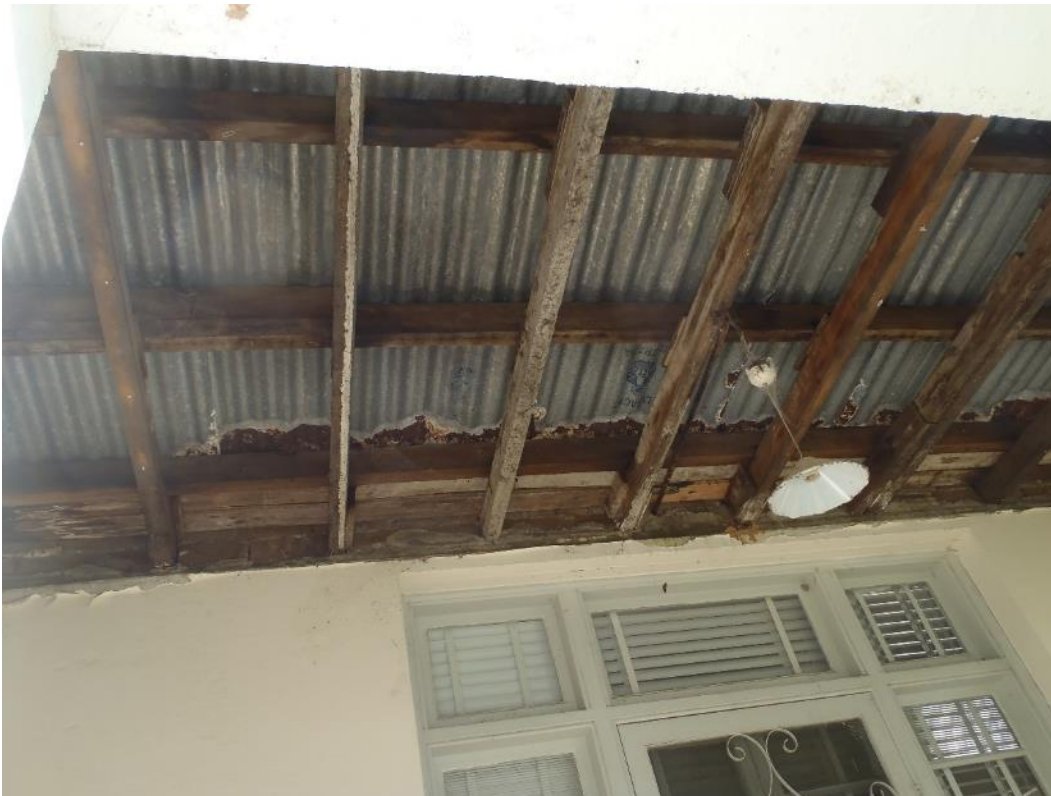
We noted that the front verandah was finished with corrugated profile sheet metal roofing. We further noted that the underside of the galvanised sheeting was rusted. **[Photograph 2]**

Photograph 2 shows rusting to the underside of the front verandah roof sheets.

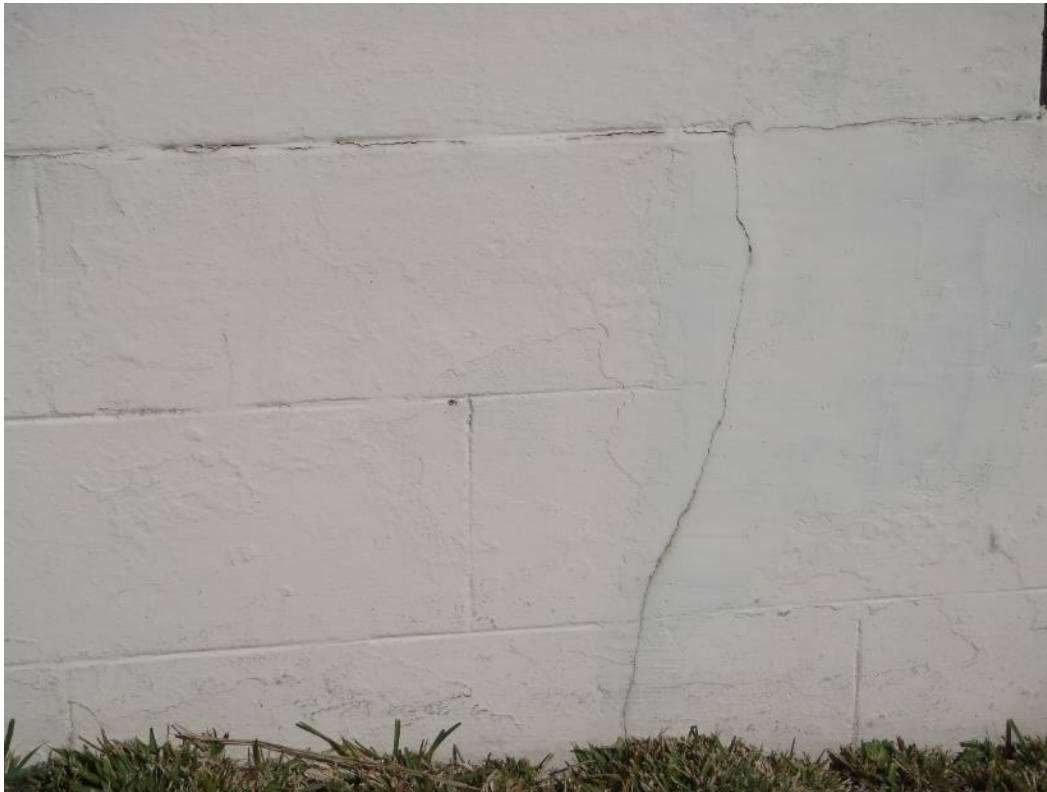
We noted radial and horizontal cracking to the front clay masonry brick fence / wall. **[Photograph 3]**. We further noted radial and horizontal cracking to the rear elevation of the front clay masonry brick fence / wall. **[Photograph 4]**

Photograph 3 shows radial and horizontal cracking to the front clay masonry brick fence / wall.

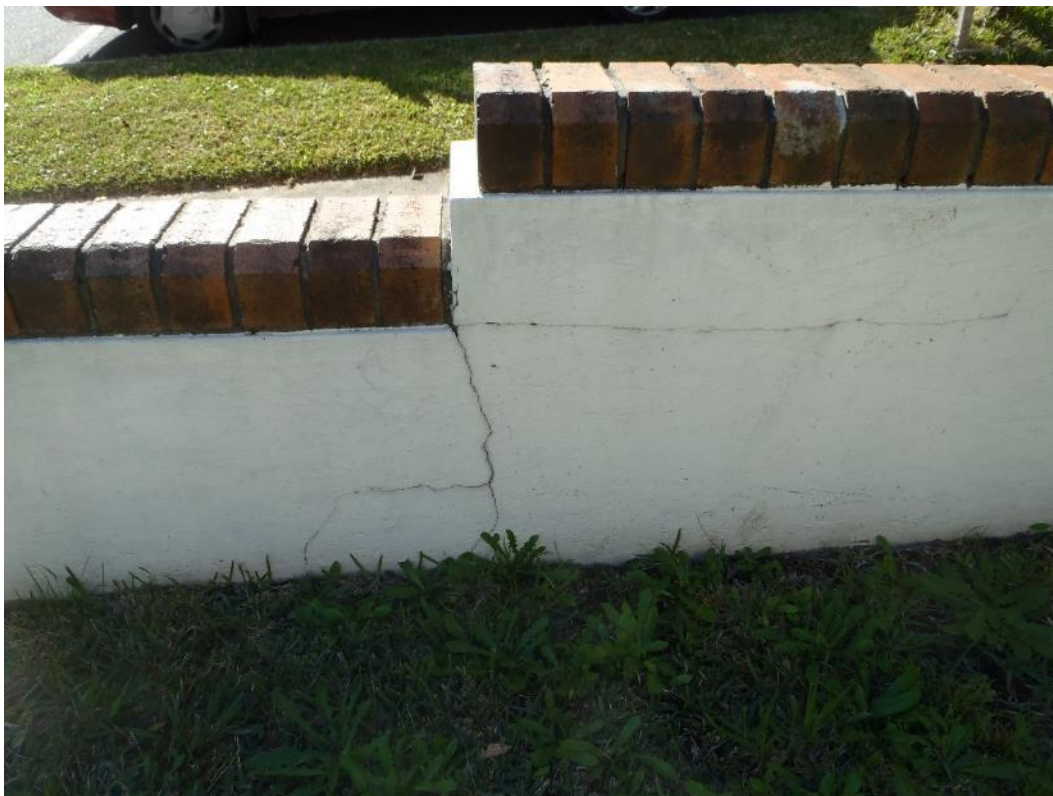
Photograph 4 shows radial and horizontal cracking to the rear elevation of the front clay masonry brick fence / wall

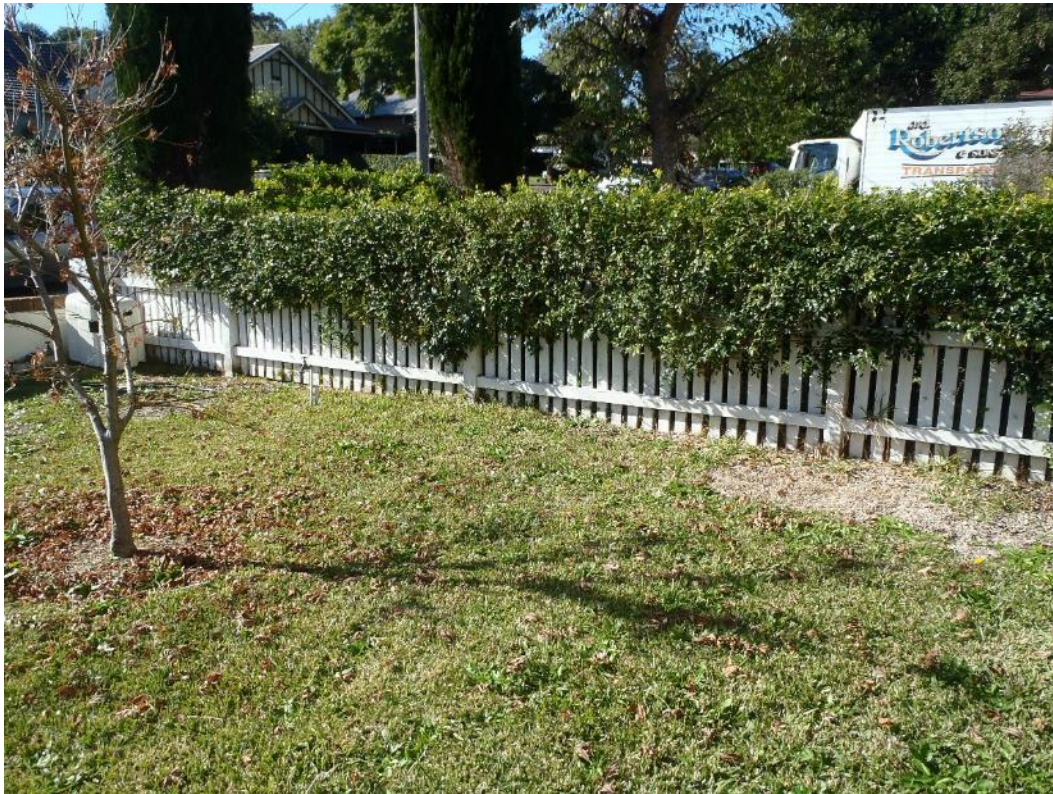
We noted that the front *common* boundary fence with the adjoining property, No. 10 College Street, Gladesville, is of timber post and rail construction. **[Photograph 5]**

Photograph 5 shows the front *common* boundary fence with the adjoining property, No. 10 College Street, Gladesville.

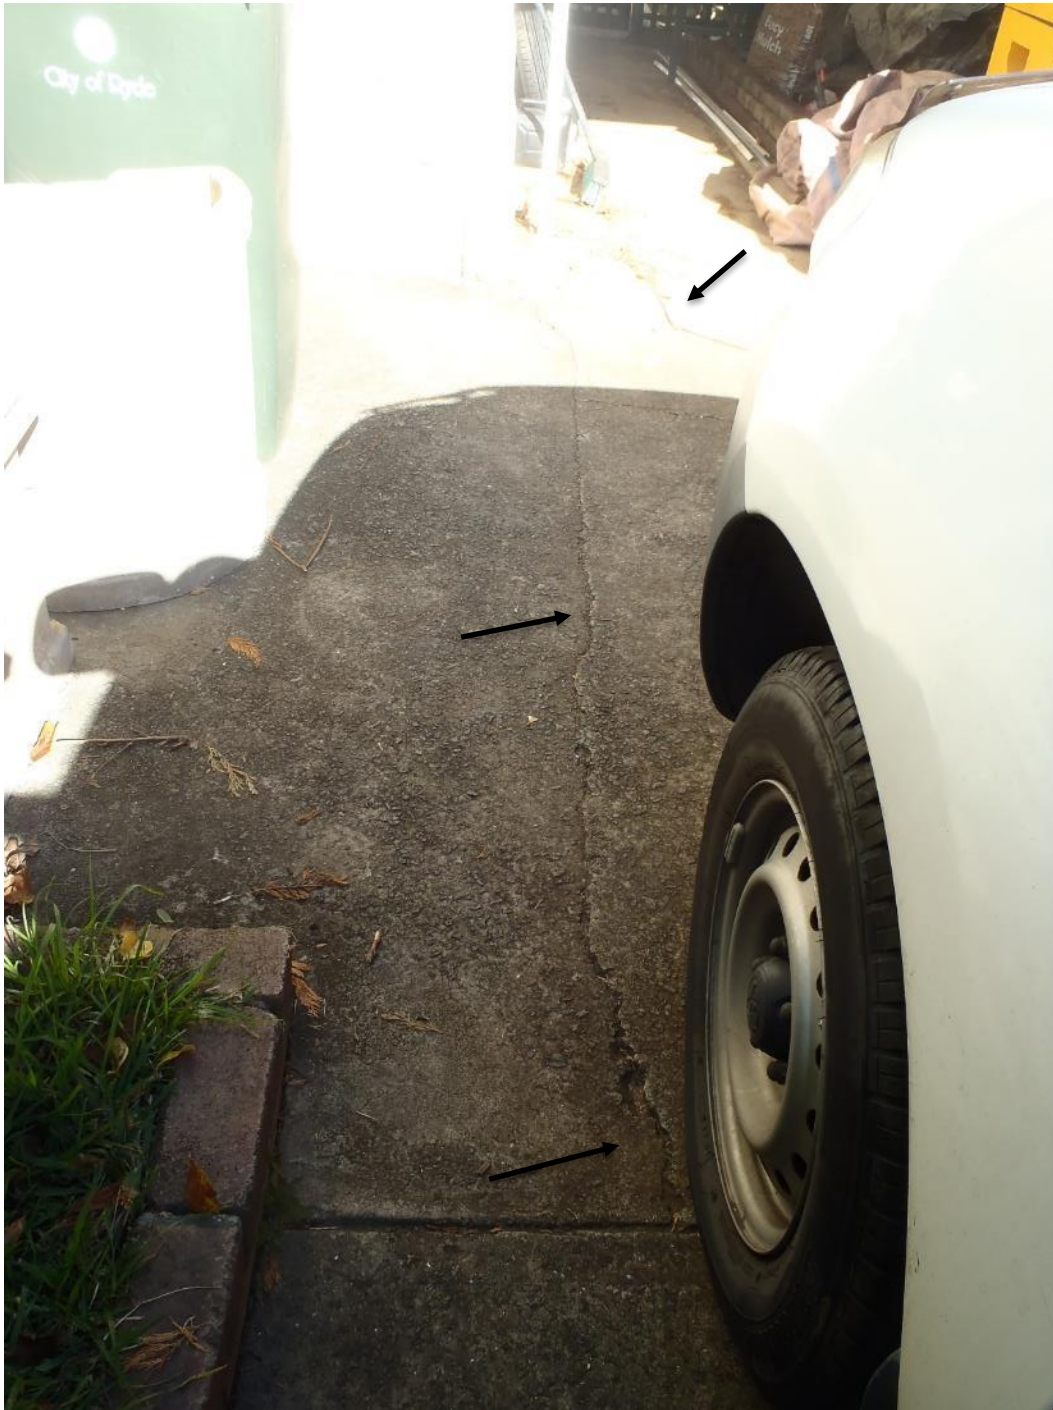
We noted hairline shrinkage cracking to concrete slab driveway and Carport floor. **[Photographs 6 & 7]**

Photograph 6 shows hairline shrinkage cracking to concrete slab driveway.

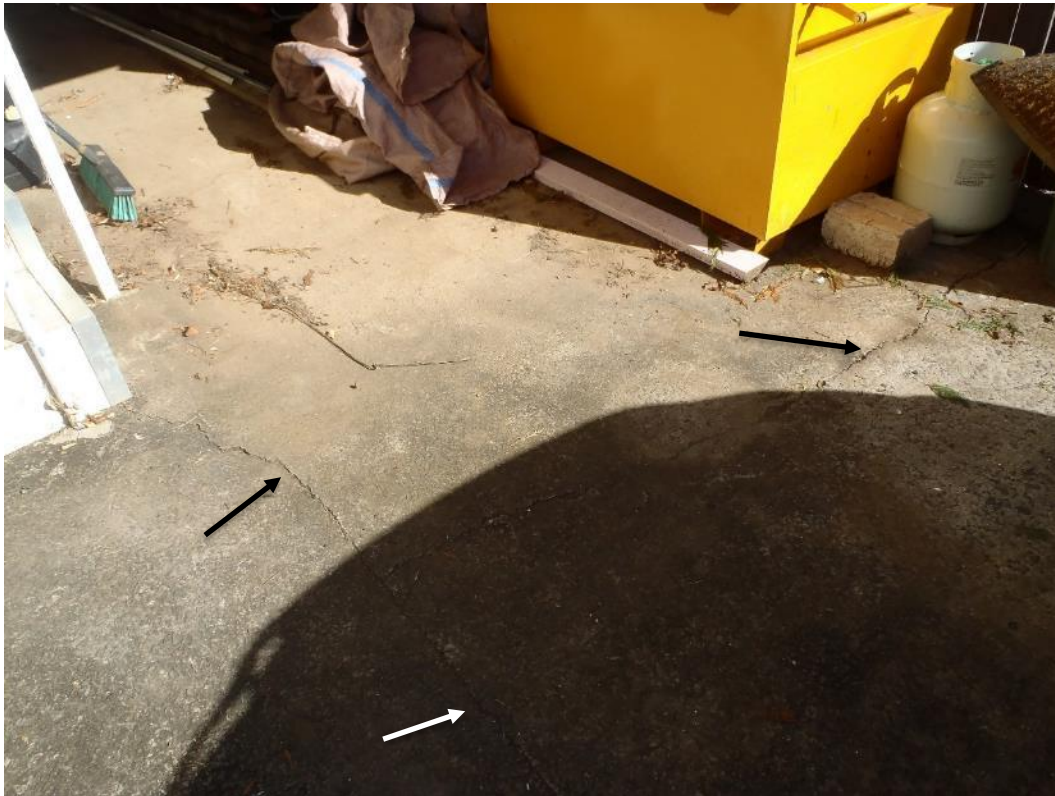
Photograph 7 shows hairline shrinkage cracking to concrete slab driveway and Carport floor.

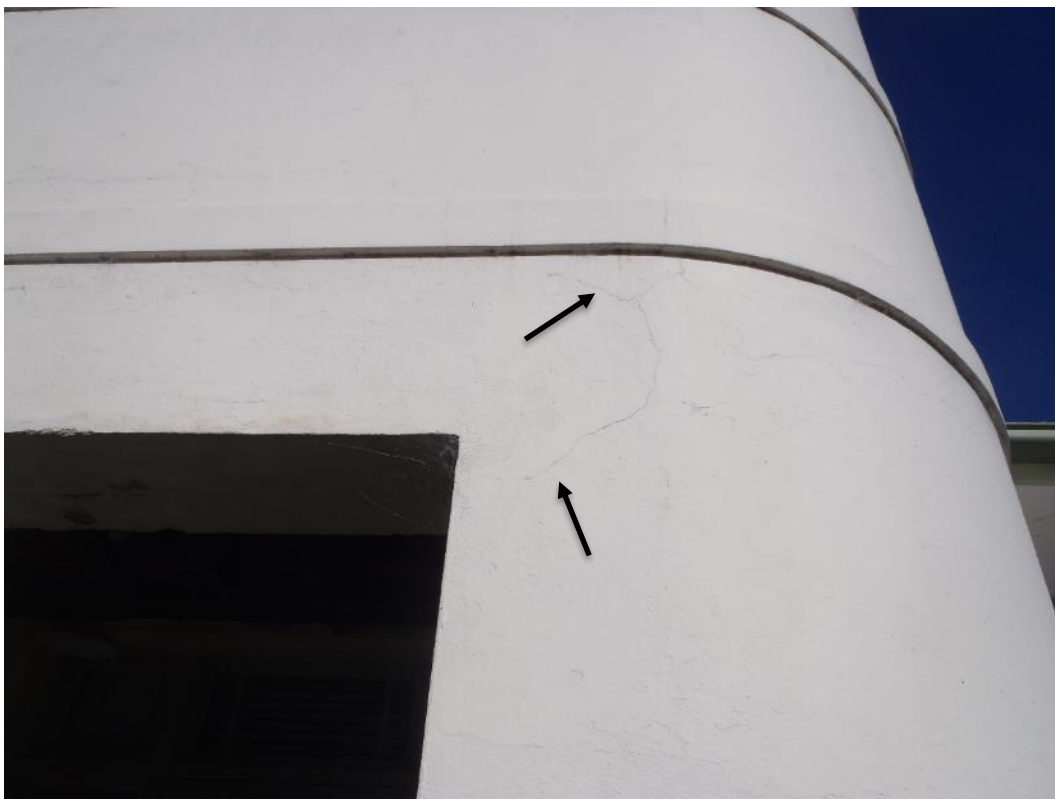
We noted radial cracking [< 1 mm] to the cement rendered wall extending from the front verandah window opening. **[Photograph 8]**

Photograph 8 shows radial cracking to the cement rendered wall from the front verandah window opening.

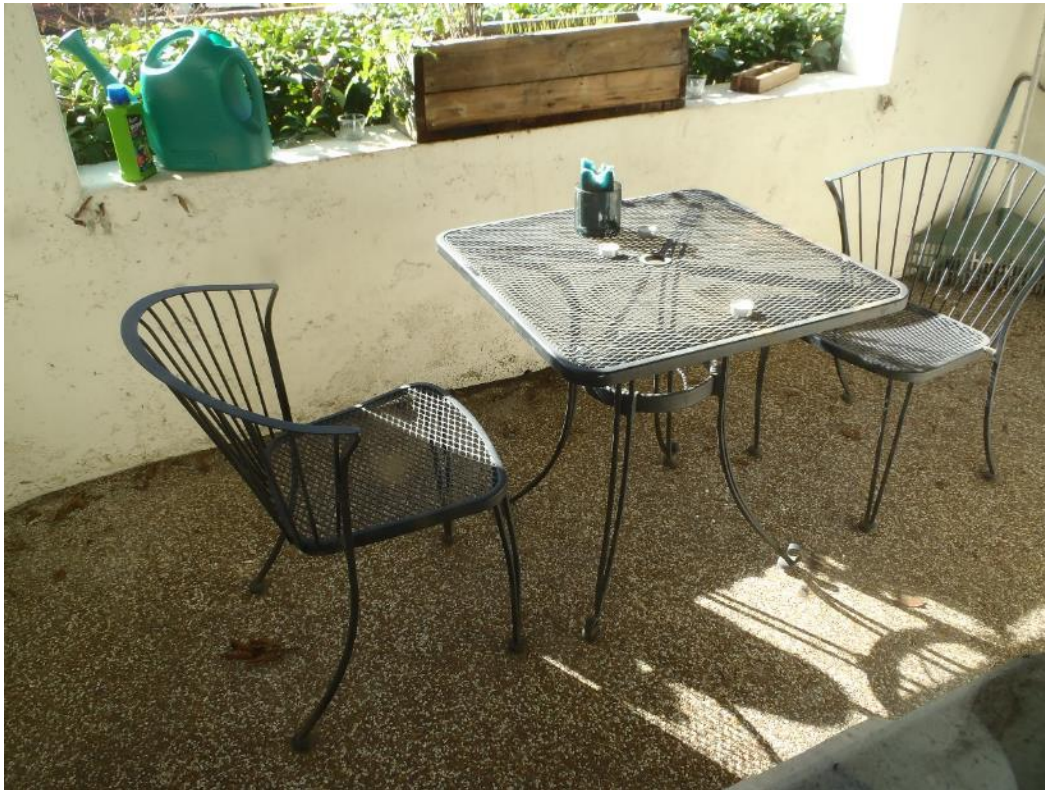
We noted that the front verandah was finished with pebblecrete floor. **[Photograph 9]**

Photograph 9 shows the general condition of the verandah.

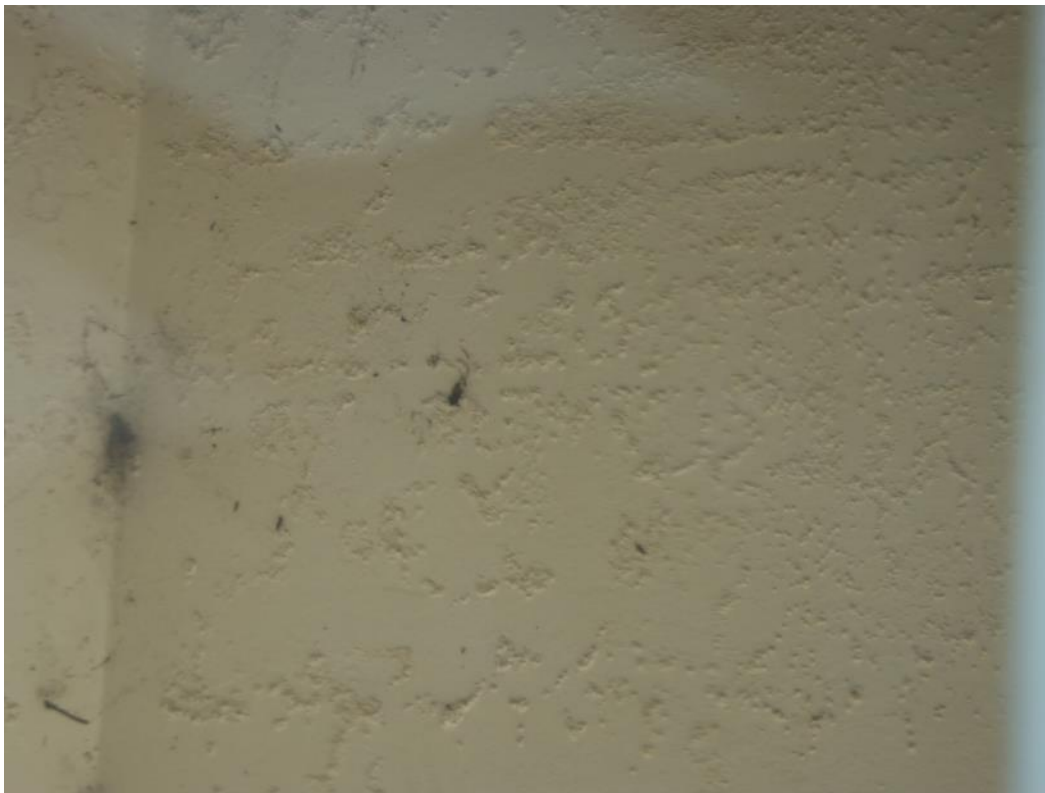
We noted areas of bubbling / lifting paint to the internal common privacy wall with the adjoining property, No. 10 College Street, Gladesville. This, in our experience, is consistent with rising damp. **[Photograph 10]**

Photograph 10 shows bubbling / lifting paint to the internal common privacy wall with the adjoining property, No. 10 College Street, Gladesville.

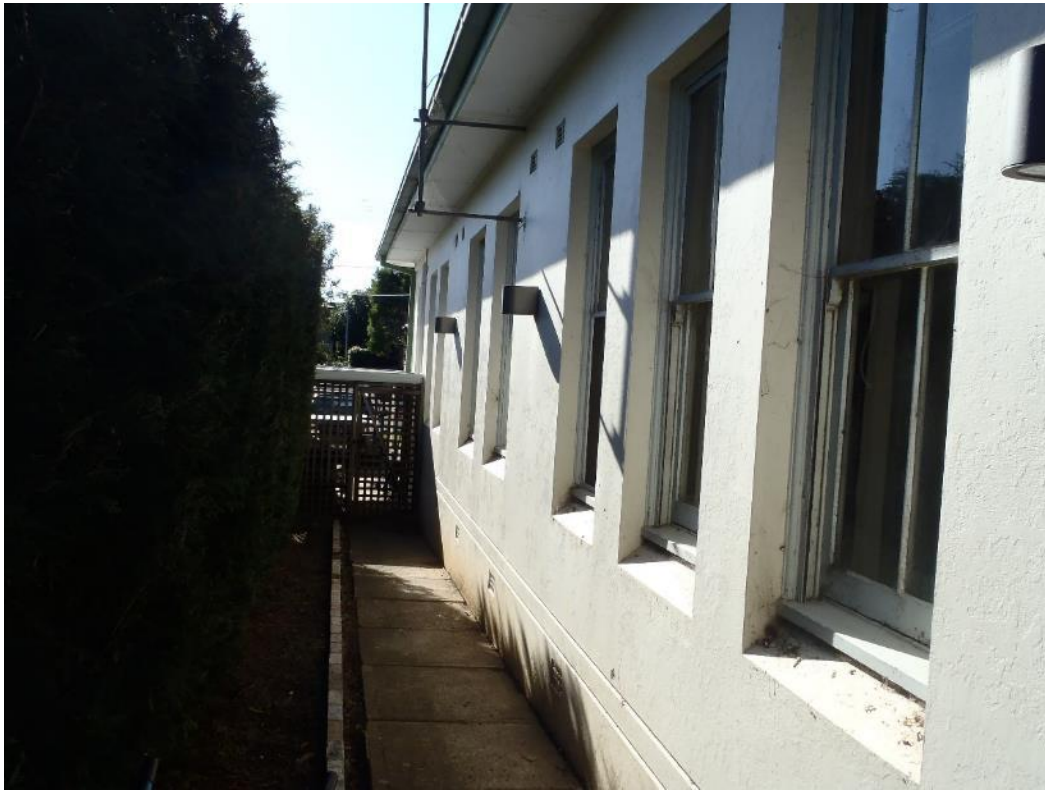
We noted that the side elevation has a concrete pathway down its entirety. **[Photograph 11]**

Photograph 11 shows the general condition of the side north-western elevation.

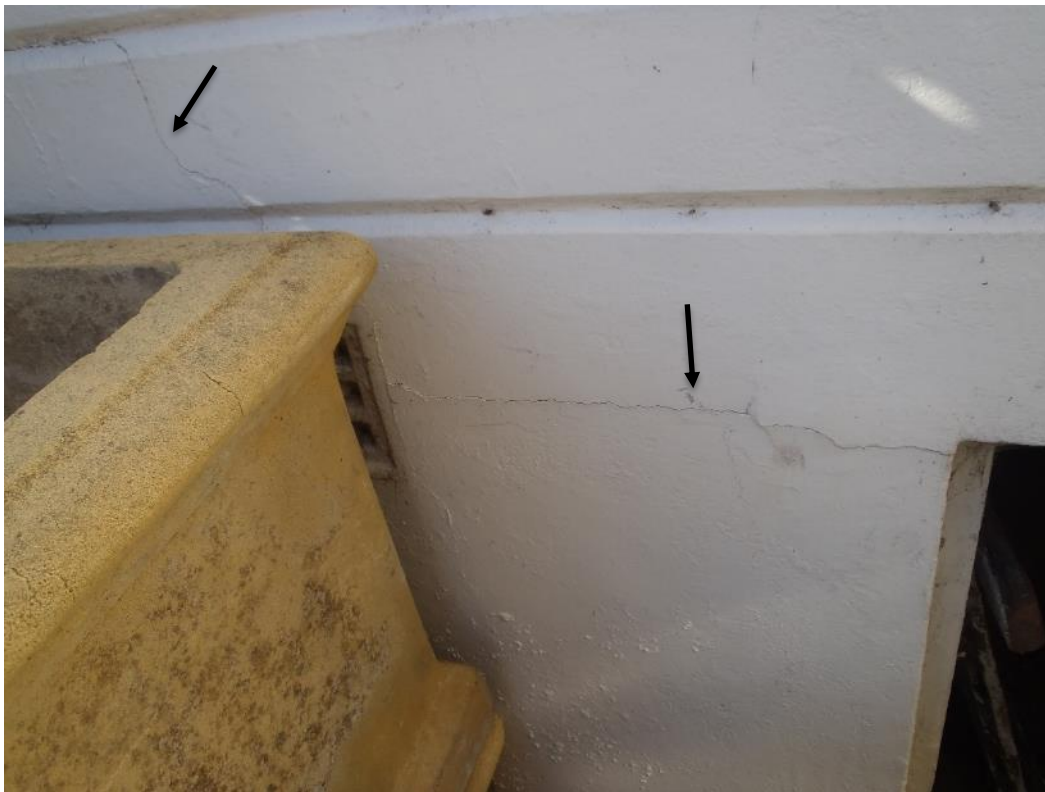
We noted step cracking [1 – 3 mm] extending upward from the under-floor access door. **[Photograph 12]**

Photograph 12 shows step cracking extending upward from the under-floor access door.

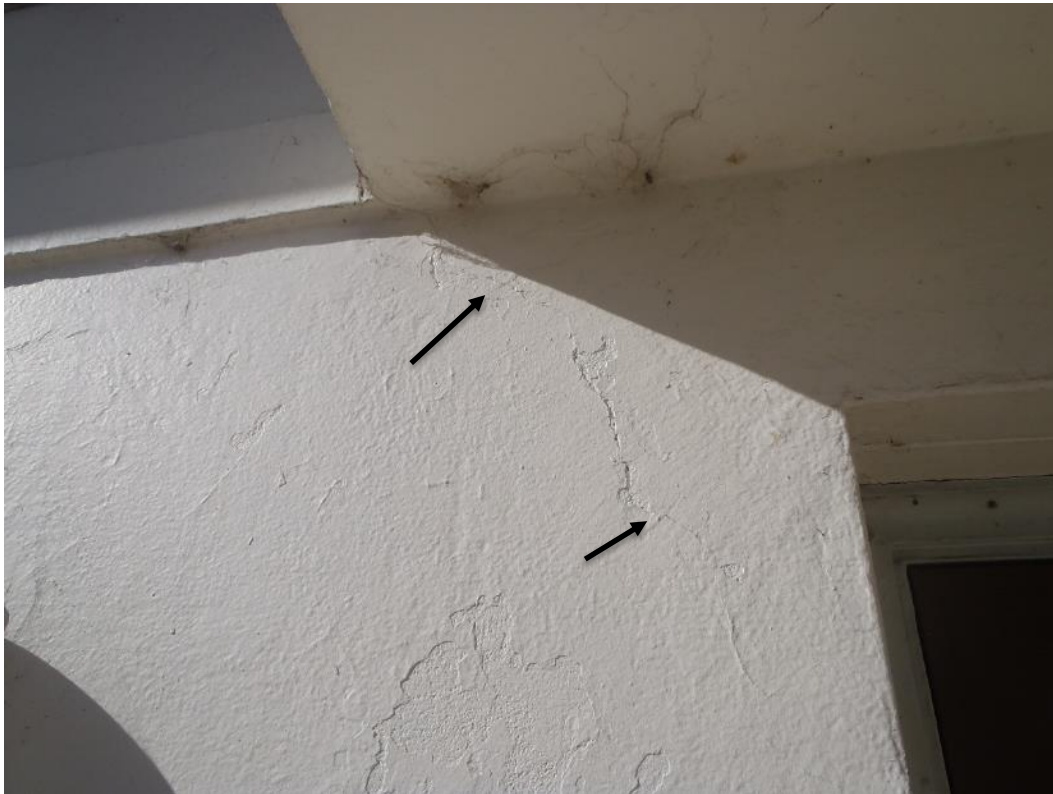
We noted radial cracking [< 1mm] extending upwards from the front door head. **[Photograph 13]**

Photograph 13 shows radial cracking extending upwards from the front door head.

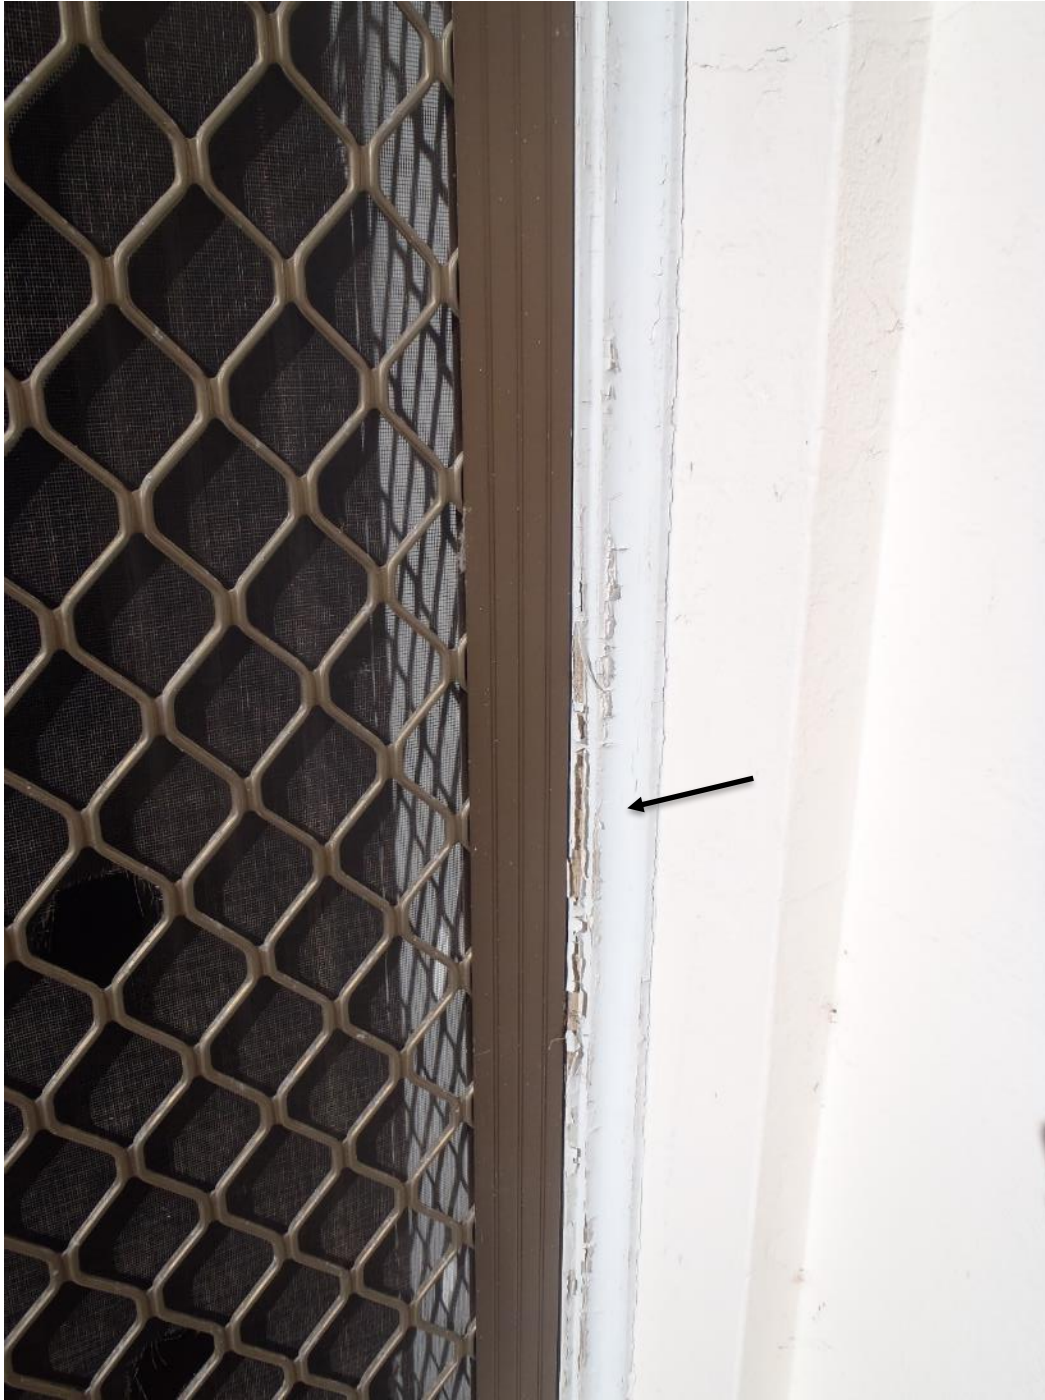
We noted deterioration and flaking paint around the front door. **[Photograph 14]**

Photograph 14 shows deterioration and flaking paint around the front door.

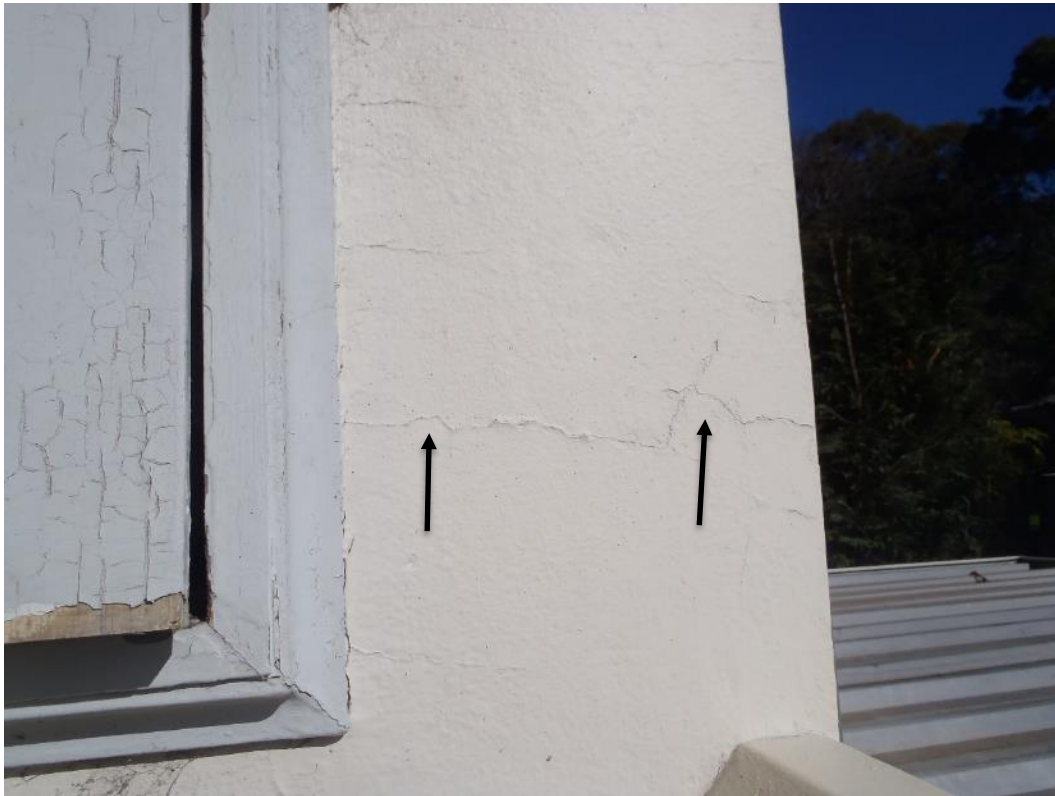
We noted horizontal cracking [< 1mm] extending from the front porch window. **[Photograph 15]**

Photograph 15 shows horizontal cracking extending from the front porch window.

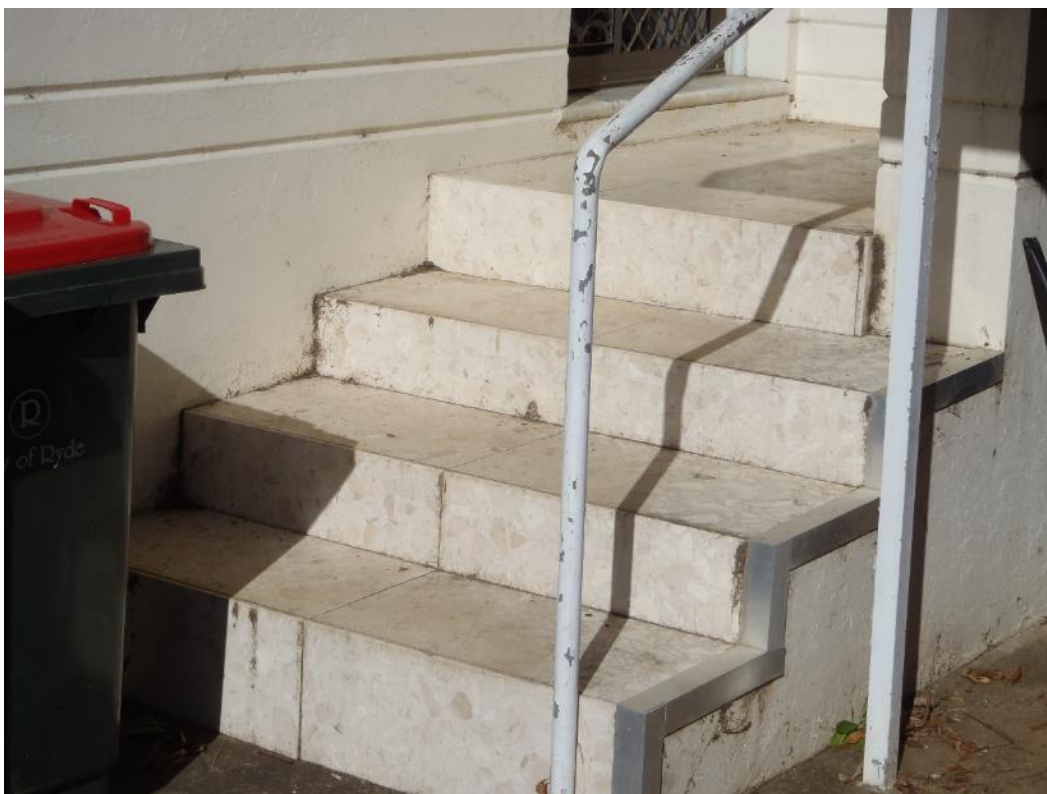
We noted that the front porch was finished with ceramic tiles. We noted that the grout to the tiles is complete and that the tiles when randomly “tap” tested appeared to be sound. **[Photograph 16]**

Photograph 16 shows the general condition of the front porch.

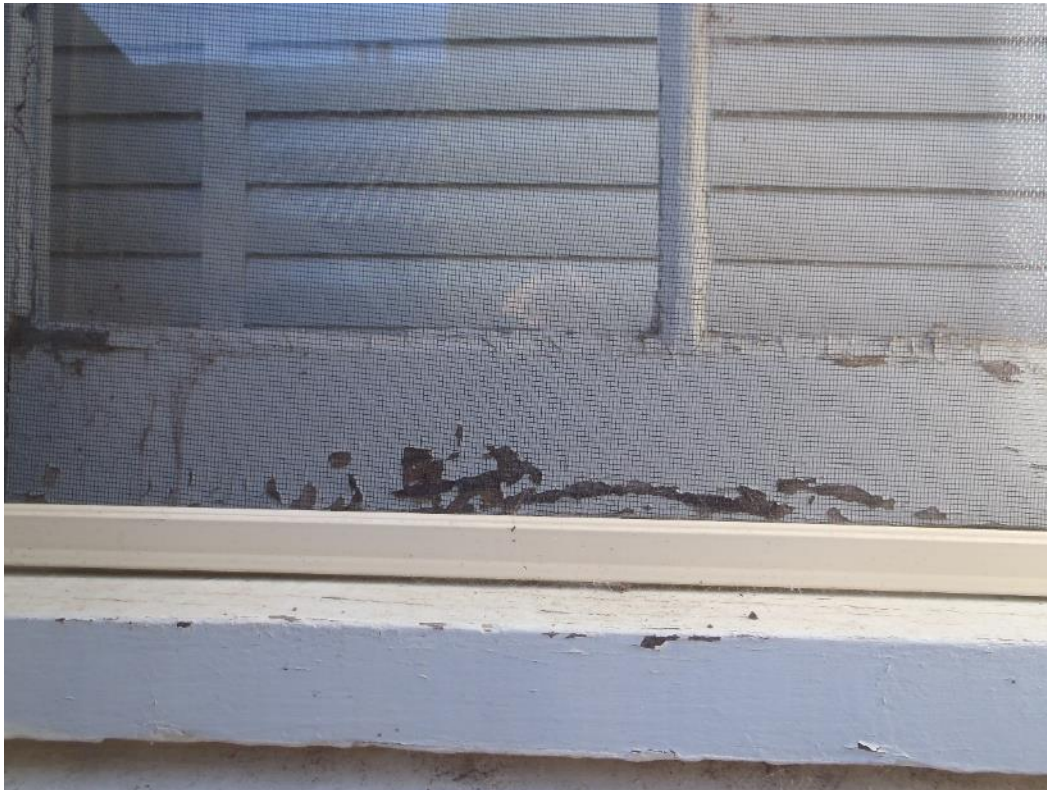
We noted deterioration and flaking paint around the windows and frames. **[Photograph 17]**

Photograph 17 shows general deterioration and flaking paint around the windows and frames.

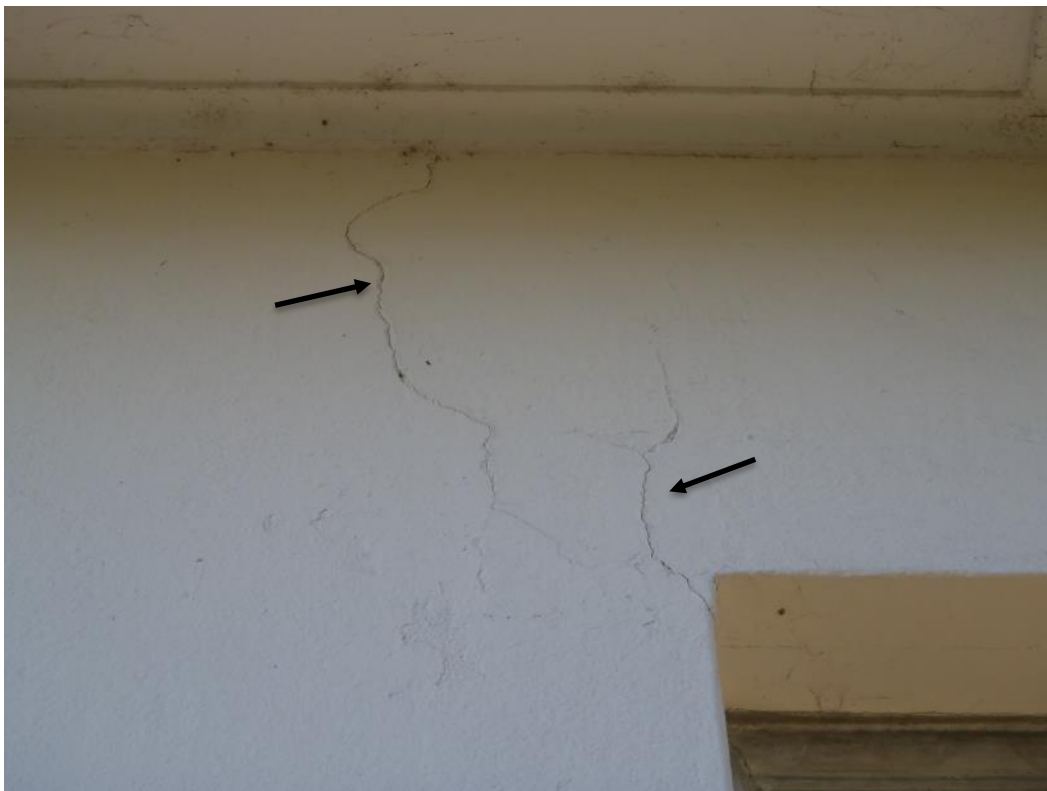
We noted radial cracking [< 1mm] extending upwards from the window head outside the Lounge Room. **[Photograph 18]**

Photograph 18 shows radial cracking extending upwards from the window head outside the Lounge Room.

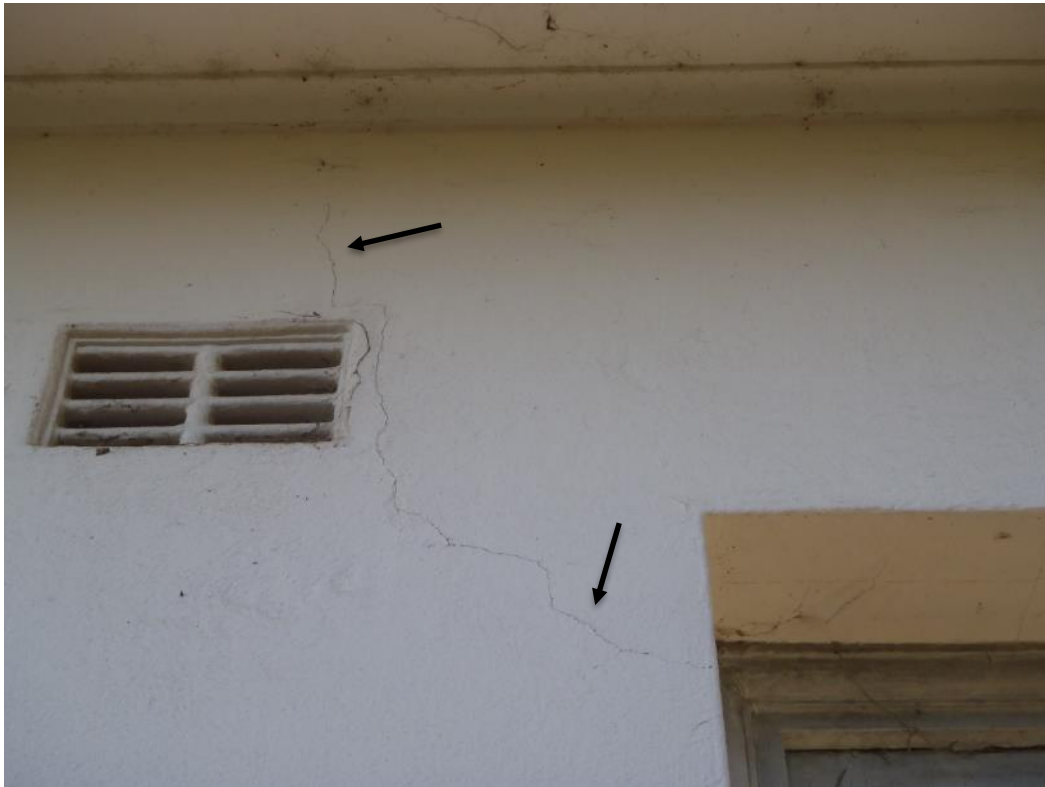
We noted radial cracking [< 1mm] extending upwards from the window head and around the wall vent outside the Sunroom. **[Photograph 19]**

Photograph 19 shows radial cracking extending upwards from the window head and around the wall vent outside the Sunroom.

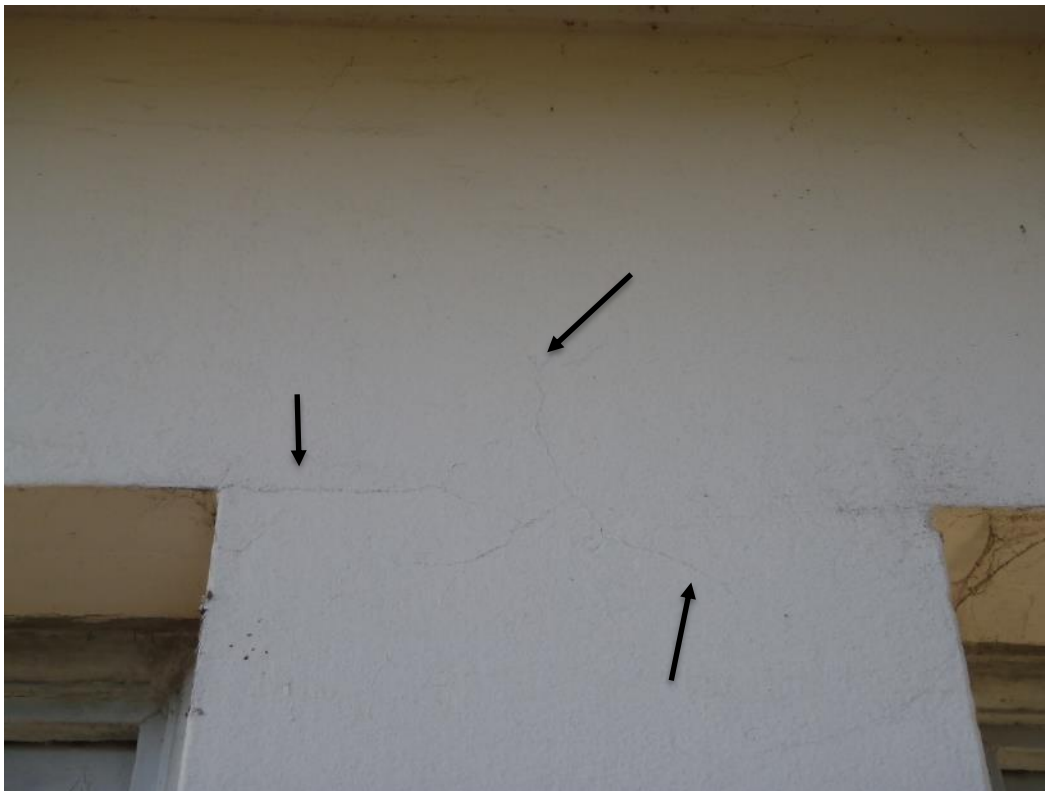
We noted hairline radial and horizontal cracking [< 1mm] extending between the windows outside the Sunroom. **[Photograph 20]**

Photograph 20 shows hairline radial and horizontal cracking extending between the windows outside the Sunroom.

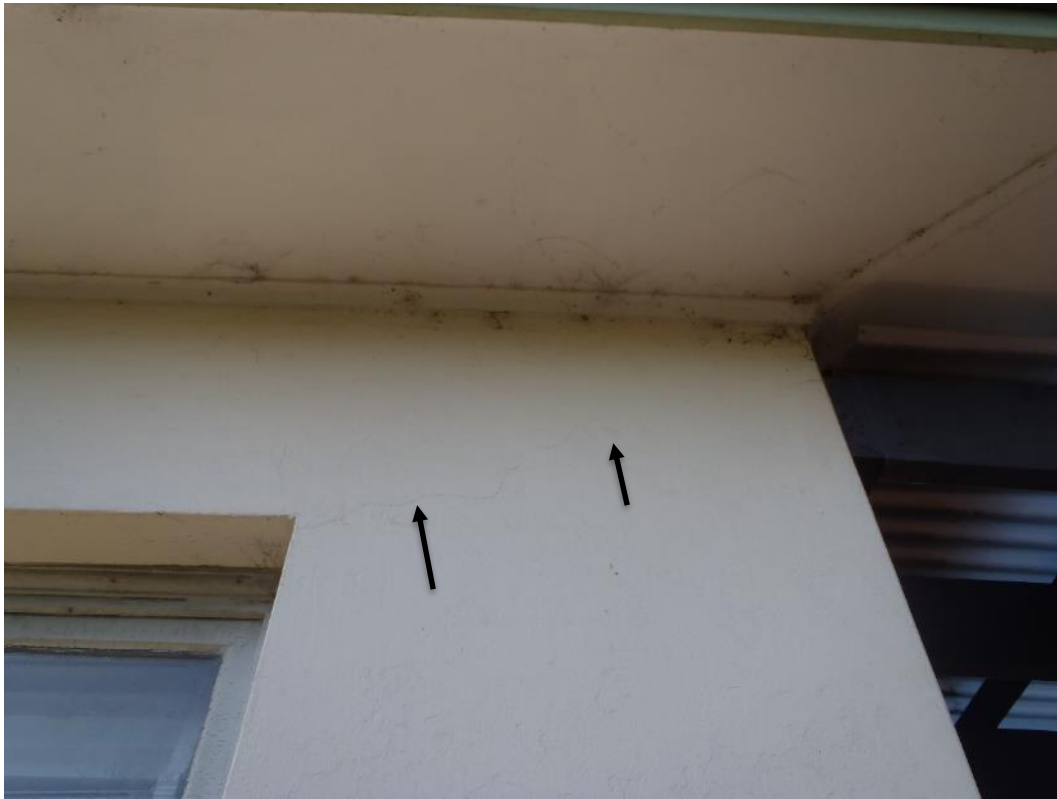
We noted hairline radial and horizontal cracking [< 1mm] extending from the Sunroom window. **[Photograph 21]**

Photograph 21 shows hairline radial and horizontal cracking [$< 1\text{mm}$] extending from Sunroom window.

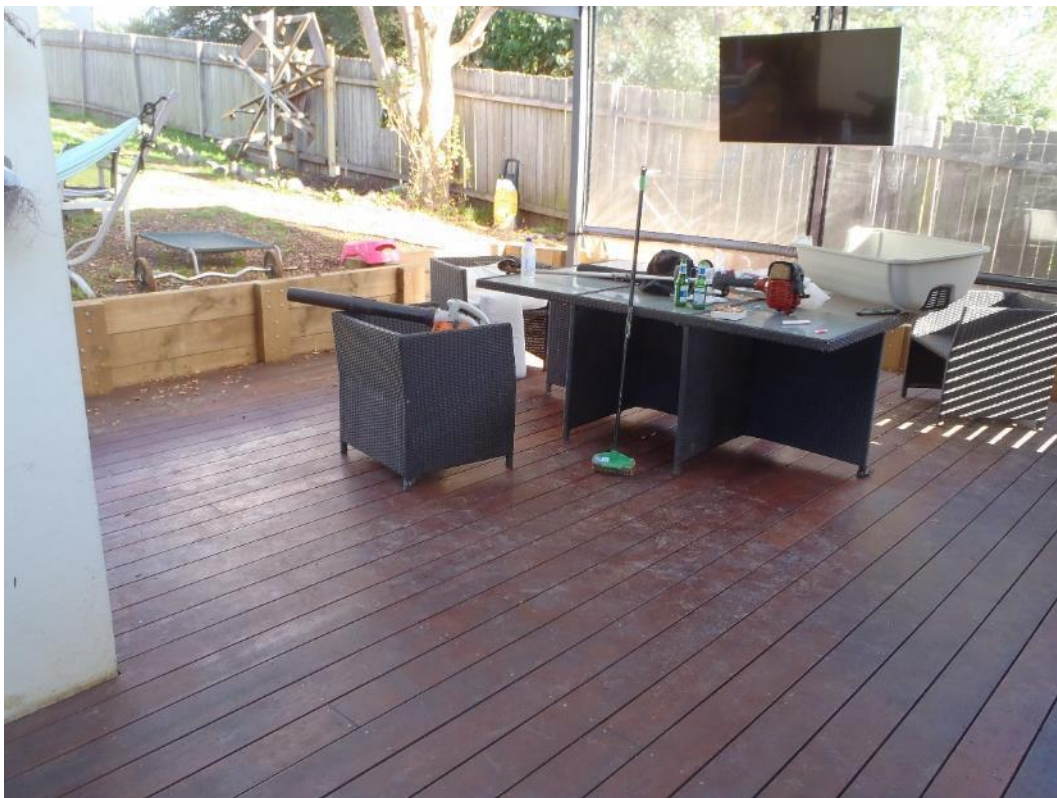
We noted that the timber pergola structure with corrugated profile acrylic roofing. **[Photographs 2 & 22]**

Photograph 22 shows the general condition of the rear pergola area.

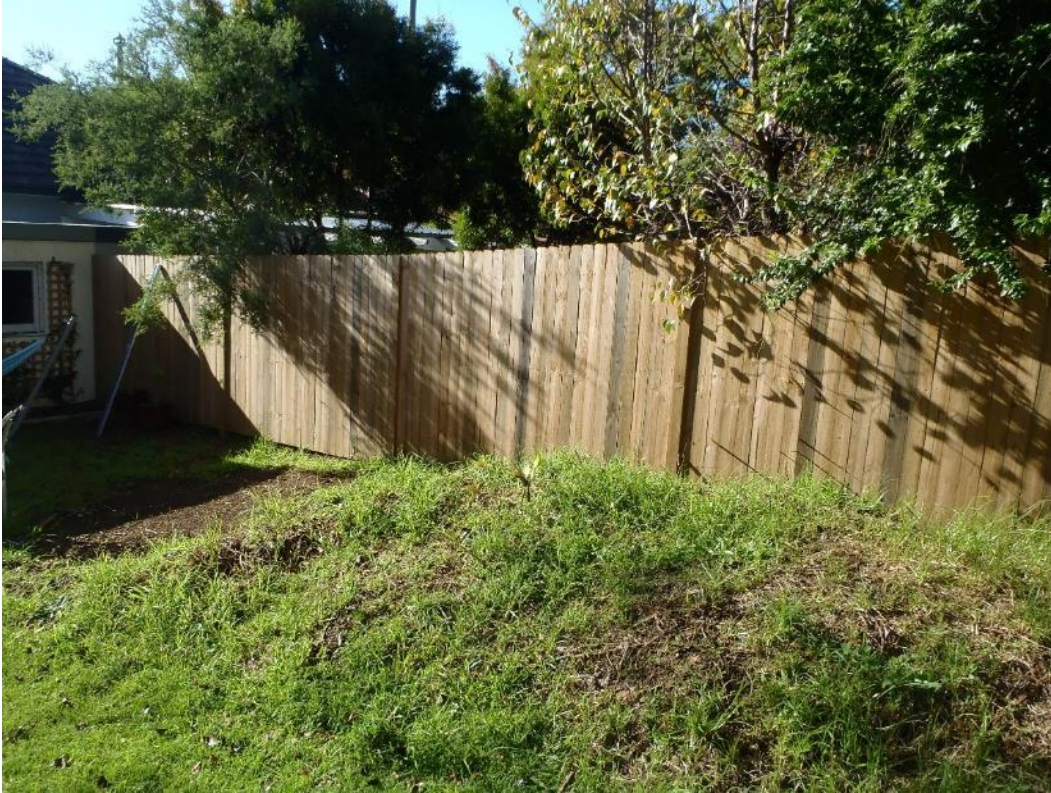
We noted that the rear *common* boundary fence with the adjoining property, No. 10 College Street, Gladesville, is of timber post and rail construction. **[Photograph 23]**

Photograph 23 shows the rear *common* boundary fence with the adjoining property, No. 10 College Street, Gladesville.
