Dilapidation Assessment Report

Prepared for: Cape Cod Australia Pty. Limited
Job address: 12 College Street, Gladesville.
Property Owner/s: Mr. Reece & Mr. Ryan Yule.
Report reference: **RYDE CITY COUNCIL**
Development Application No: not available
Date of assessment: 1st July 2017

Re: Dilapidation Report – No. 12 College Street, Gladesville.

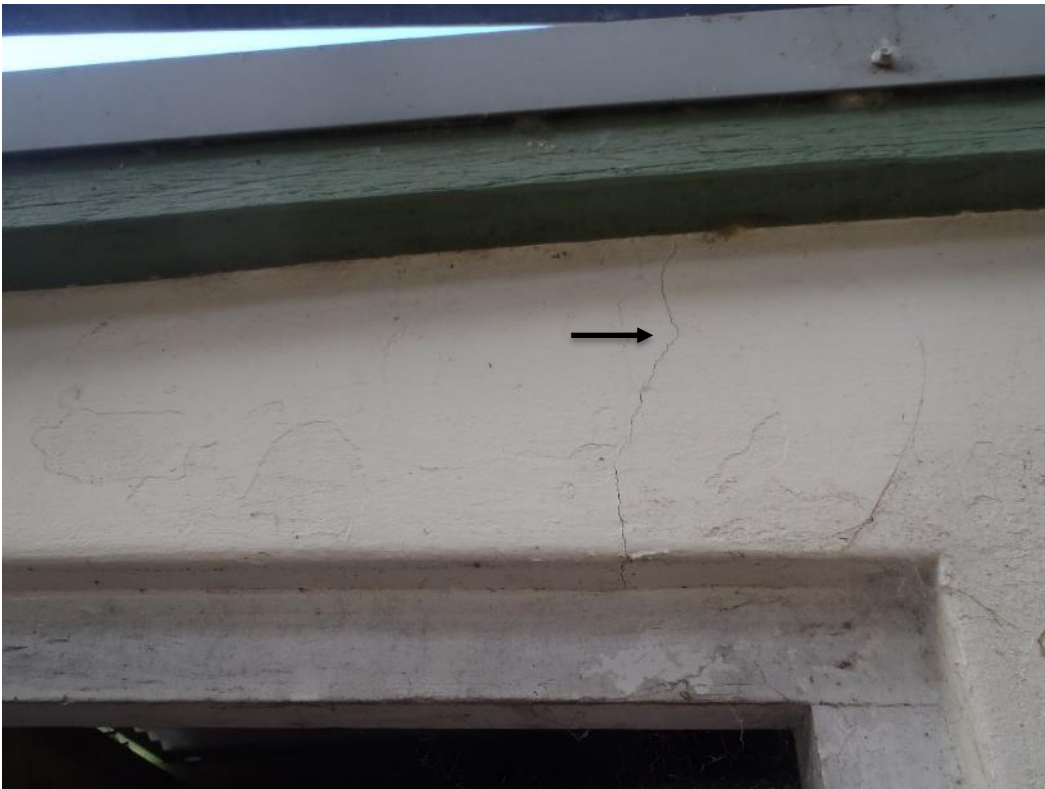
We noted vertical cracking [< 1mm] extending upwards from the door head of the Laundry. **[Photograph 24]**

Photograph 24 shows vertical cracking extending upwards from the door head of the Laundry.

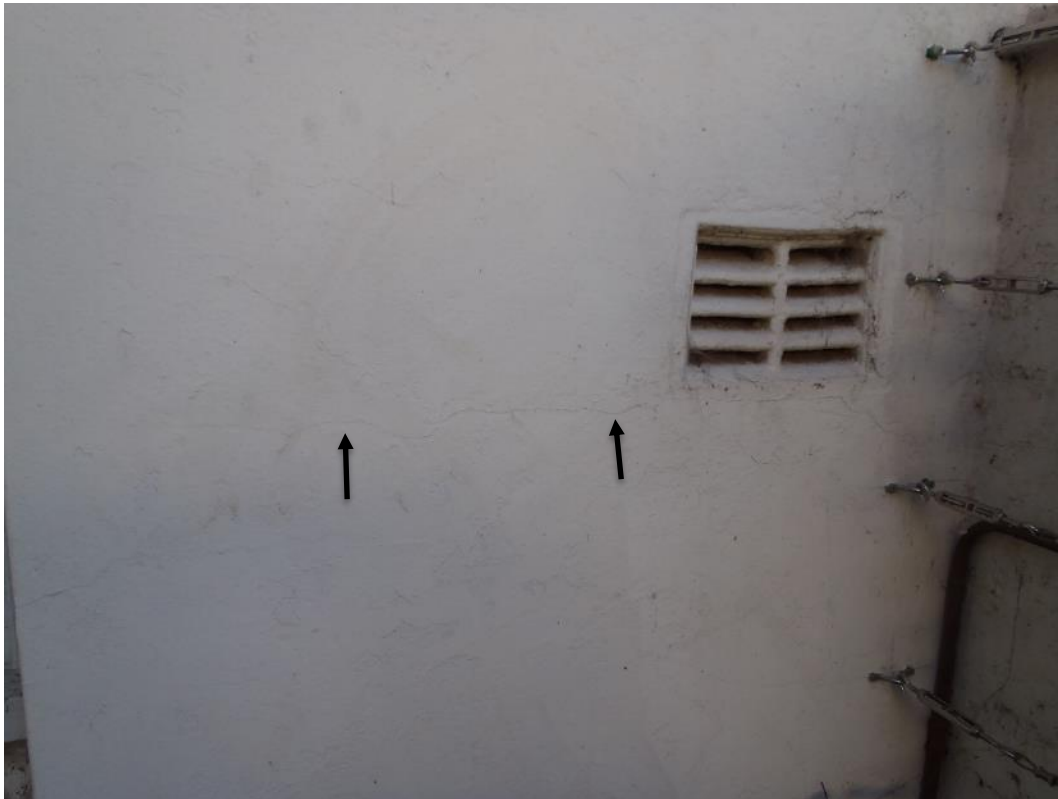
We noted radial and horizontal cracking [< 1mm] extending from the common privacy wall with the adjoining property, No. 10 College Street, Gladesville. **[Photograph 25]**

Photograph 25 shows radial and horizontal cracking extending from the common privacy wall with the adjoining property, No. 10 College Street, Gladesville.

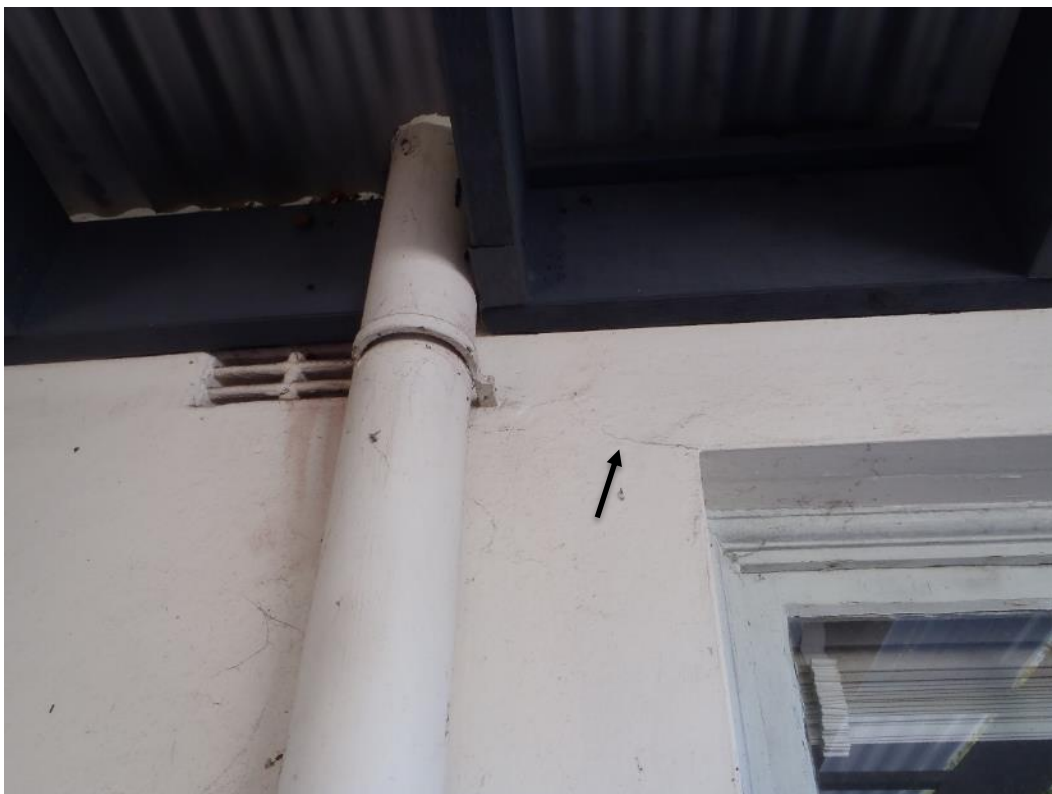
We noted radial cracking [< 1mm] extending upwards from the window head toward the wall vent outside the Kitchen. **[Photograph 26]**

Photograph 26 shows radial cracking extending upwards from the window head toward the wall vent outside the Kitchen.

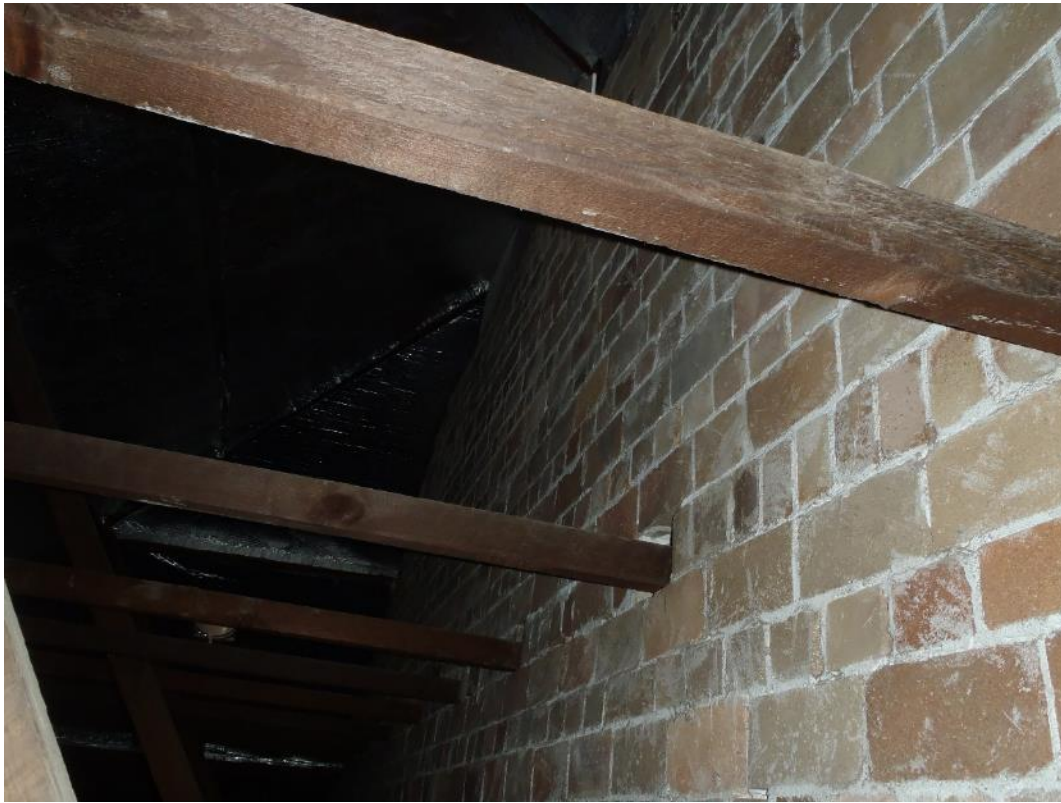
We noted that the timber ceiling braces are built into the *common party / separation* wall. We also noted that the clay brick common party wall extends to the just under the rafters. **[Photograph 27]**

Photograph 27 shows the general condition of the *common party / separation* wall in the roof space.

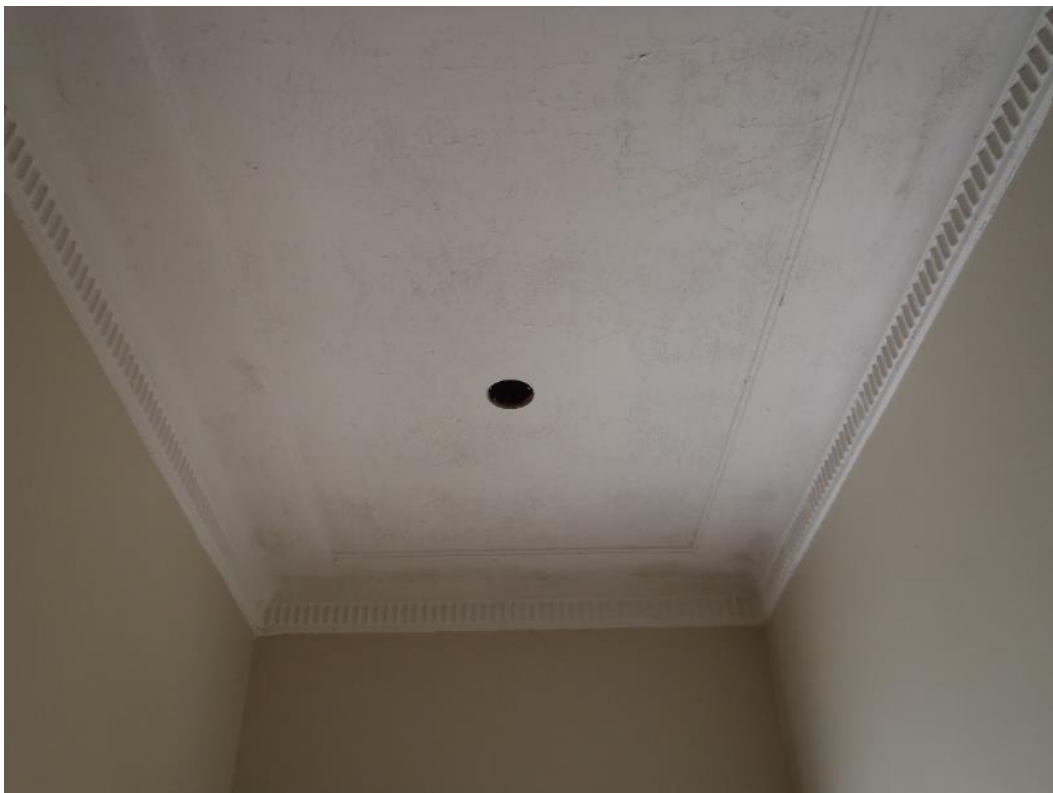
We noted deterioration and flaking paint to the plaster ceiling. **[Photograph 28]**

Photograph 28 shows deterioration and flaking paint to the plaster ceiling in the Entry.

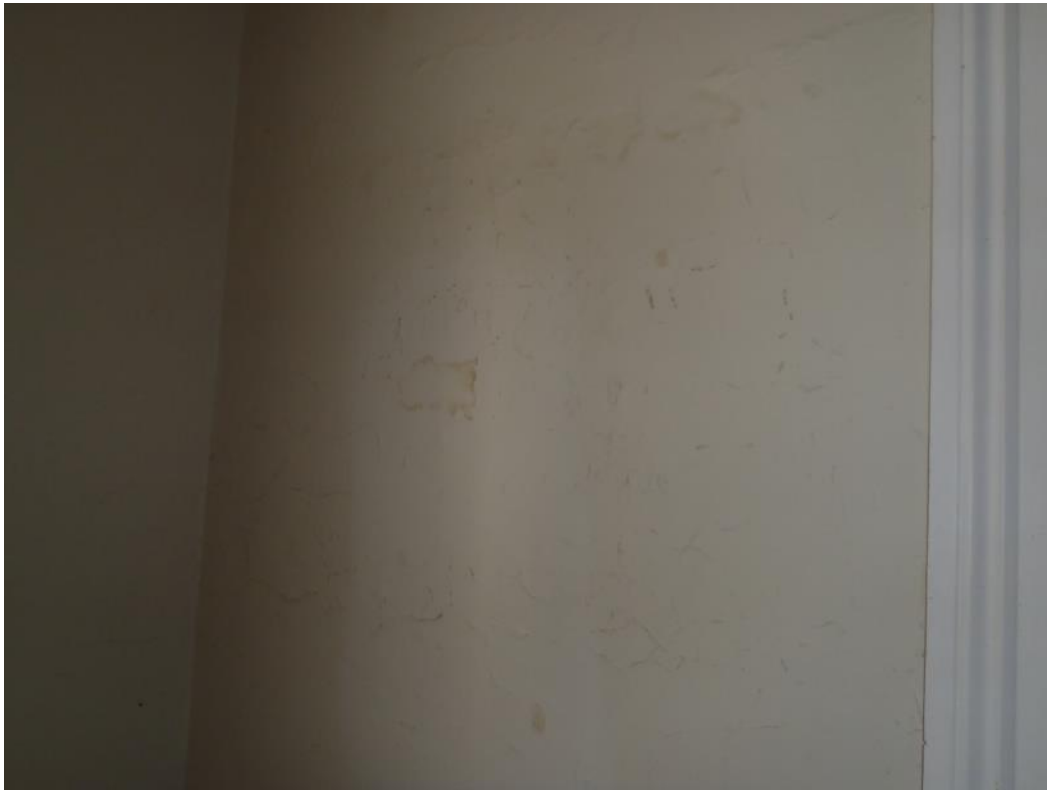
We noted deterioration and flaking paint to the surface coated cement rendered wall in the northern corner. **[Photograph 29]**

Photograph 29 shows deterioration and flaking paint to the surface coated cement rendered wall in the northern corner of the Front Bedroom.

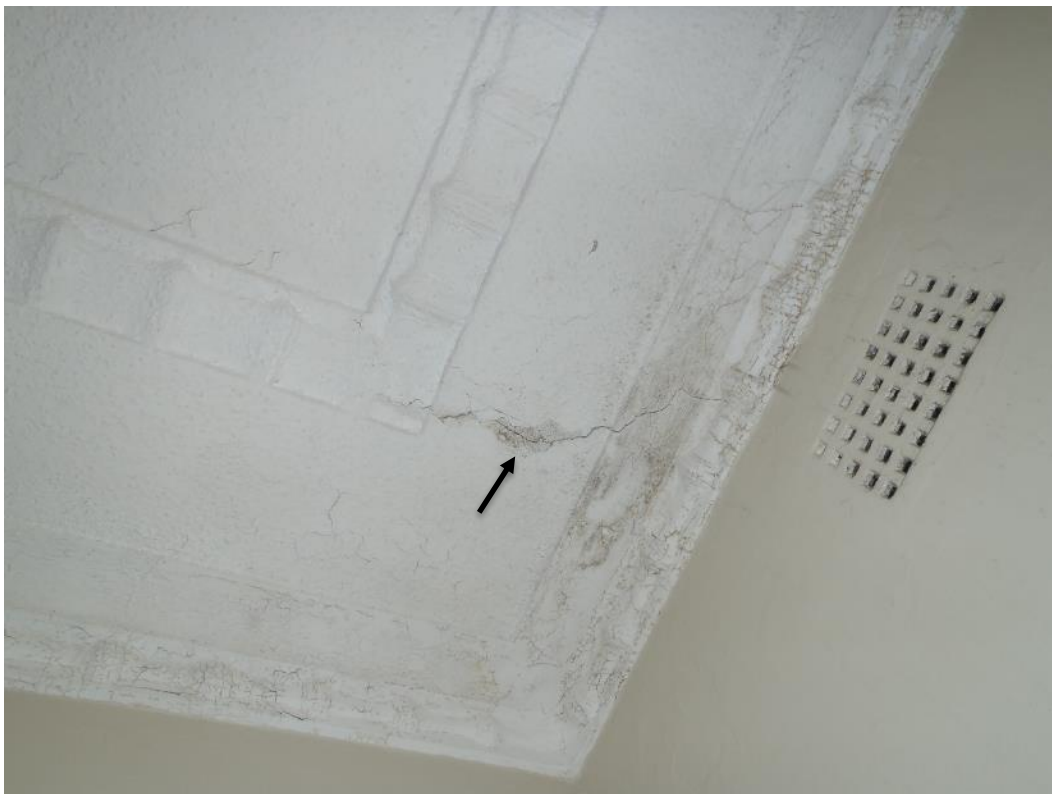
We noted cracking [1 – 3 mm] and flaking paint to the wide profiled plaster cornice in the western corner. **[Photograph 30]**

Photograph 30 shows cracking and flaking paint to the wide profiled plaster cornice in the western corner of the Front Bedroom.

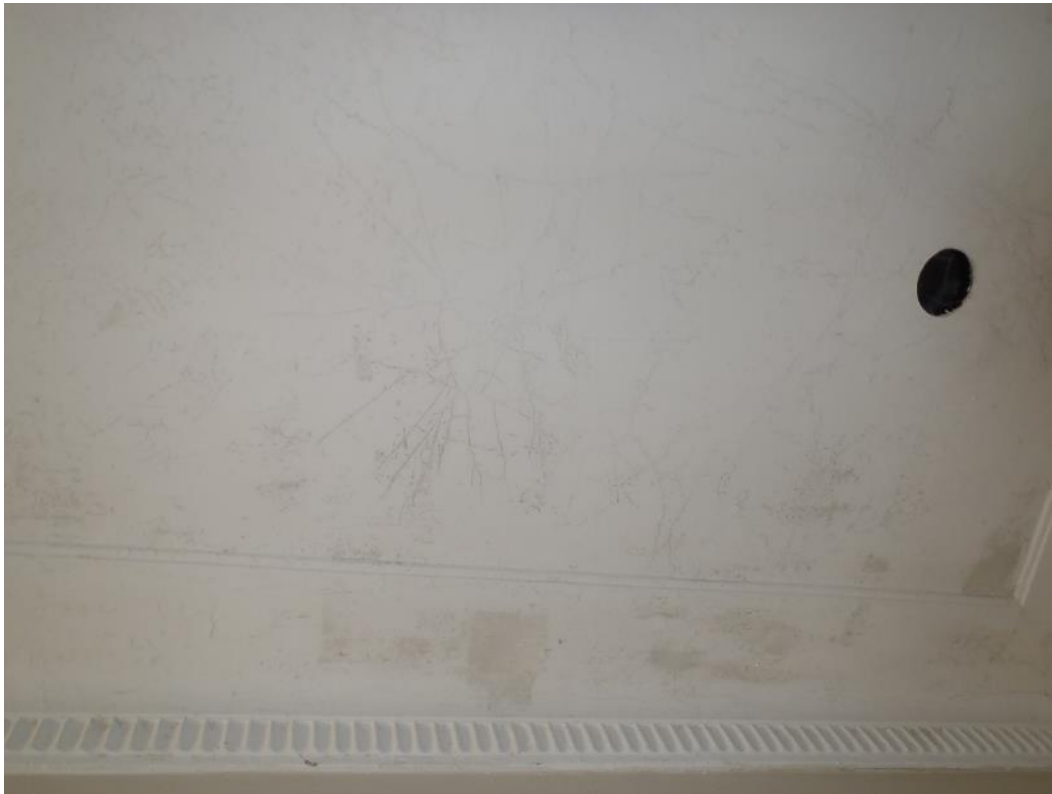
We noted deterioration and flaking paint to the plaster ceiling and cornice adjacent to the *common party / separation* wall with the adjoining property, No. 10 College Street, Gladesville in the eastern corner. **[Photograph 31]**

Photograph 31 shows deterioration and flaking paint to the plaster ceiling and cornice adjacent to the common party / separation wall with the adjoining property, No. 10 College Street, Gladesville in the Hallway.

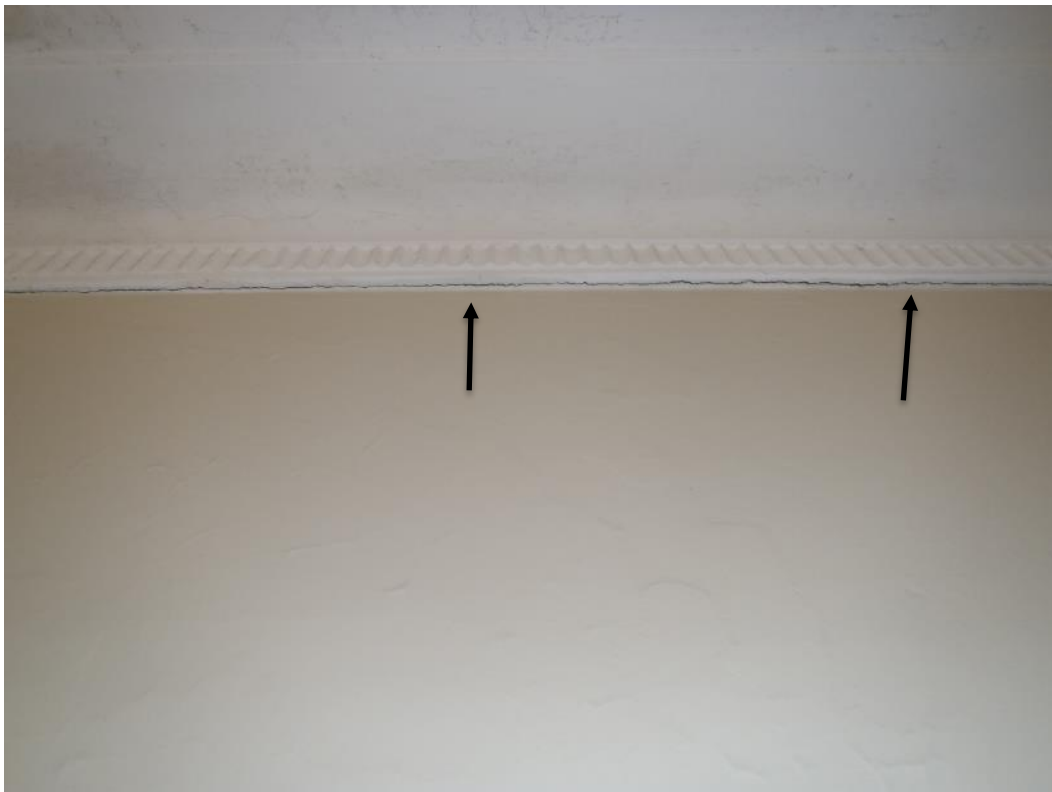
We noted separation cracking of the cornice from the wall surface along the *common party / separation* wall with the adjoining property, No. 10 College Street, Gladesville. **[Photograph 32]**

Photograph 32 shows separation cracking of the cornice from the wall surface along the *common party / separation* wall with the adjoining property, No. 10 College Street, Gladesville in the Hallway.

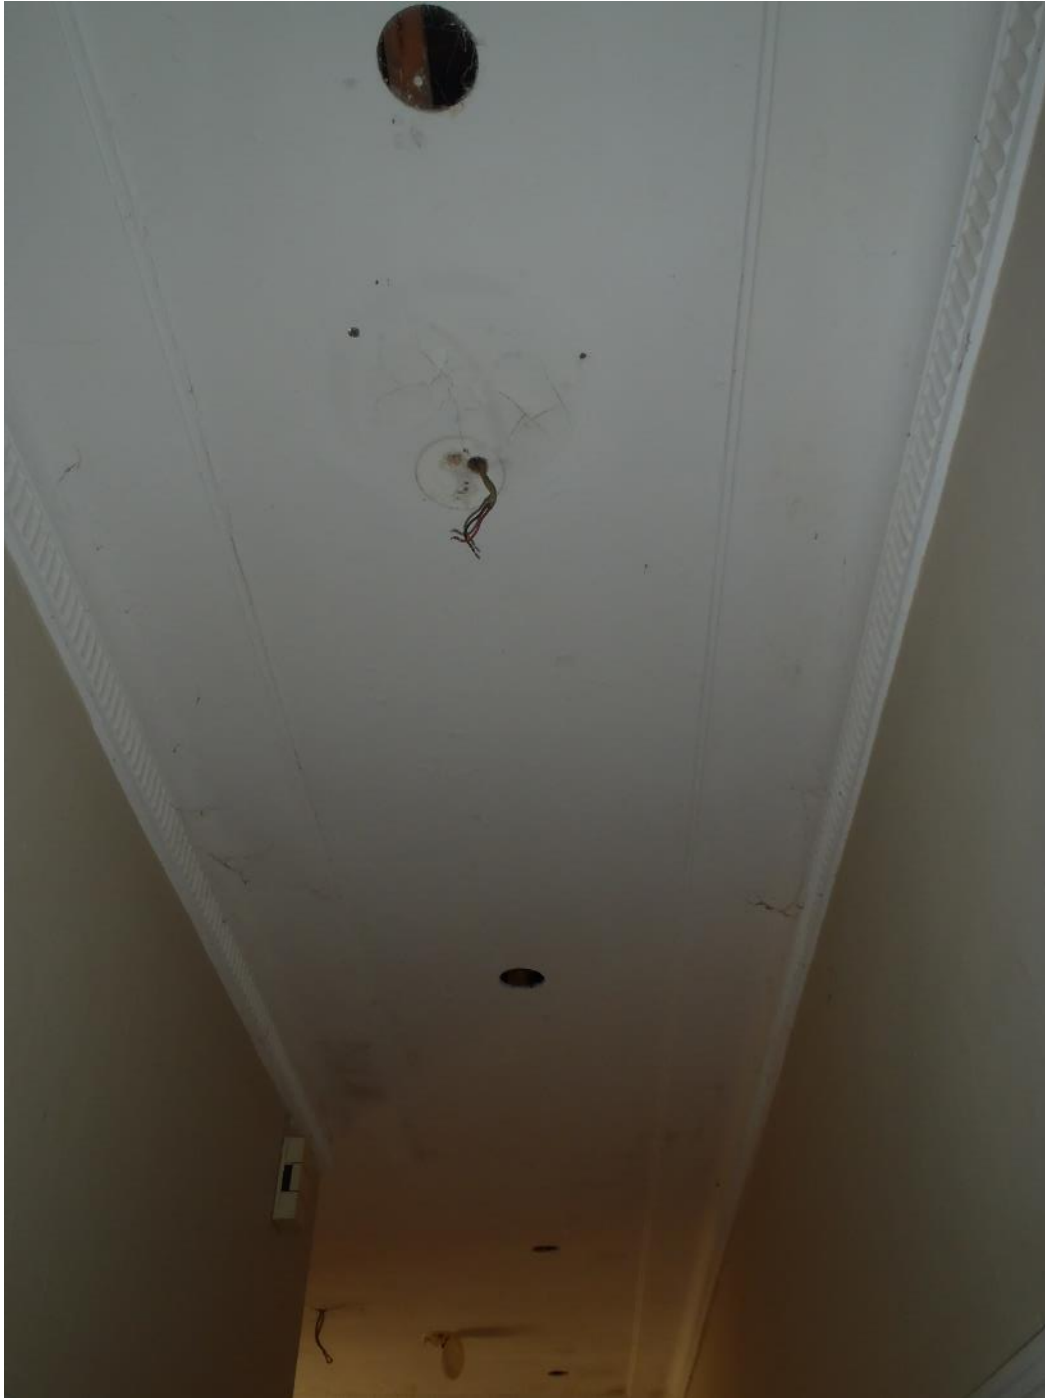
We noted deterioration and flaking paint to the plaster ceiling and cornice along the hallway. **[Photograph 33]**

Photograph 33 shows deterioration and flaking paint to the plaster ceiling and cornice along the hallway

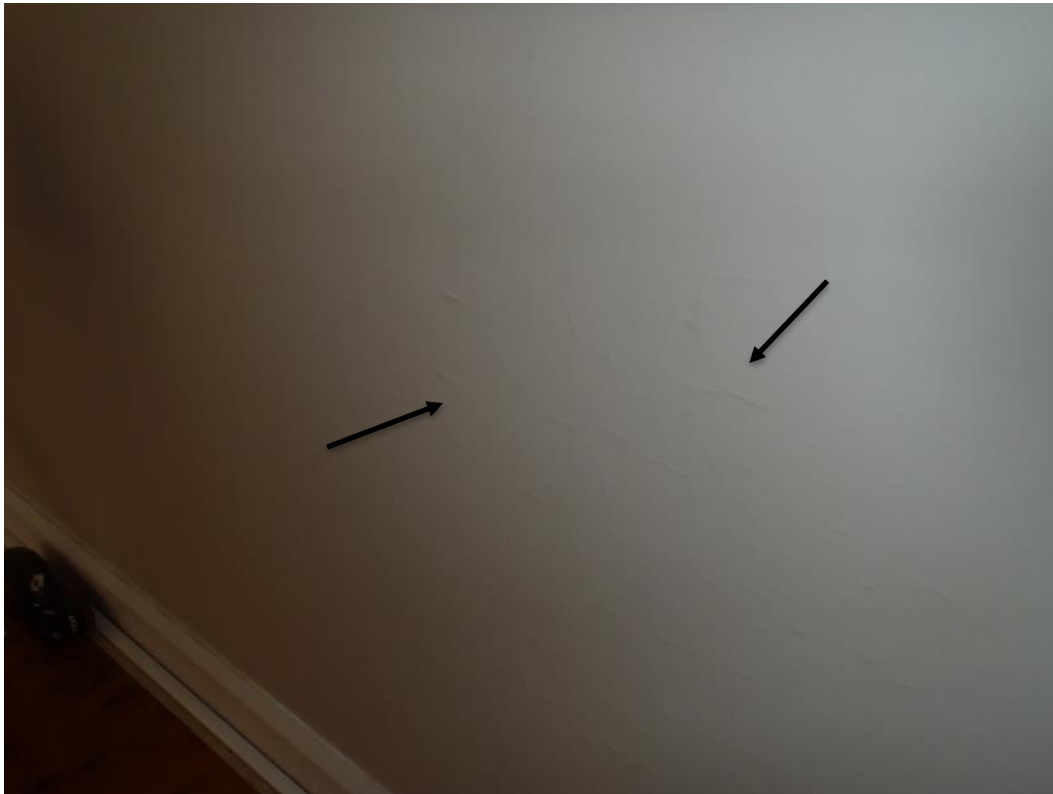
We noted flaking paint along the *common party / separation wall* with the adjoining property, No. 10 College Street, Gladesville outside Bedroom 2. **[Photograph 34]**

Photograph 34 shows flaking paint along the *common party / separation wall* with the adjoining property, No. 10 College Street, Gladesville outside Bedroom 2.

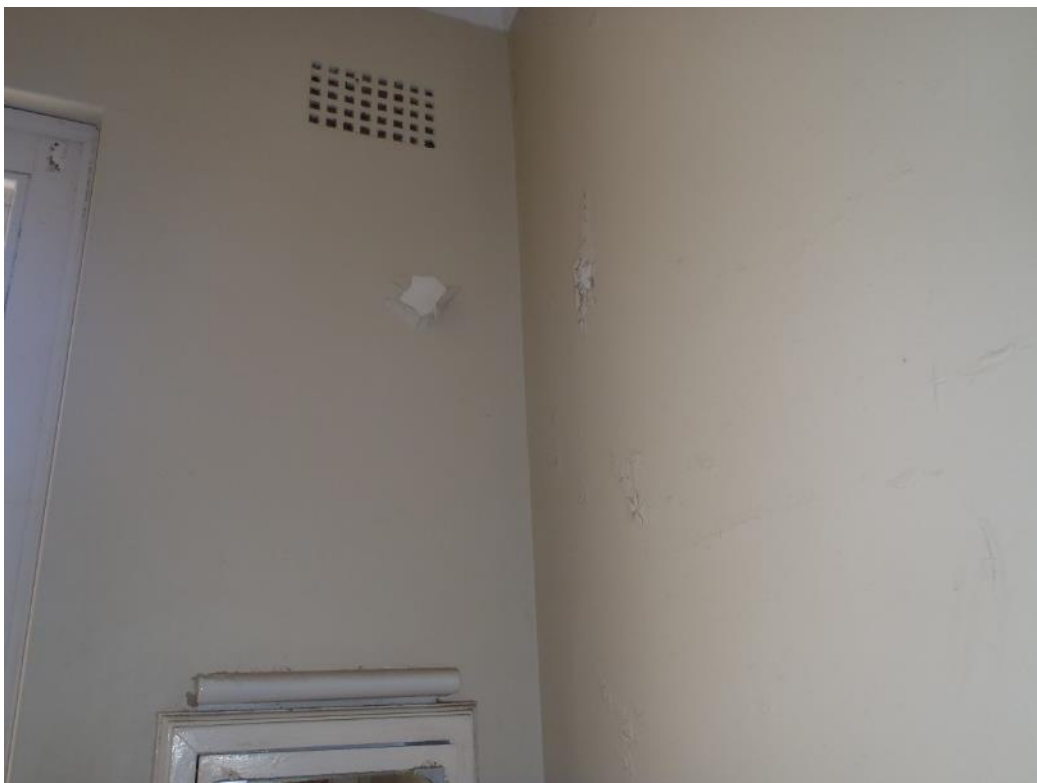
We noted deterioration / flaking paint to the cement rendered wall in the northern corner above the sink. **[Photograph 35]**

Photograph 35 shows deterioration / flaking paint to the cement rendered wall in the northern corner above the sink in the Bathroom.

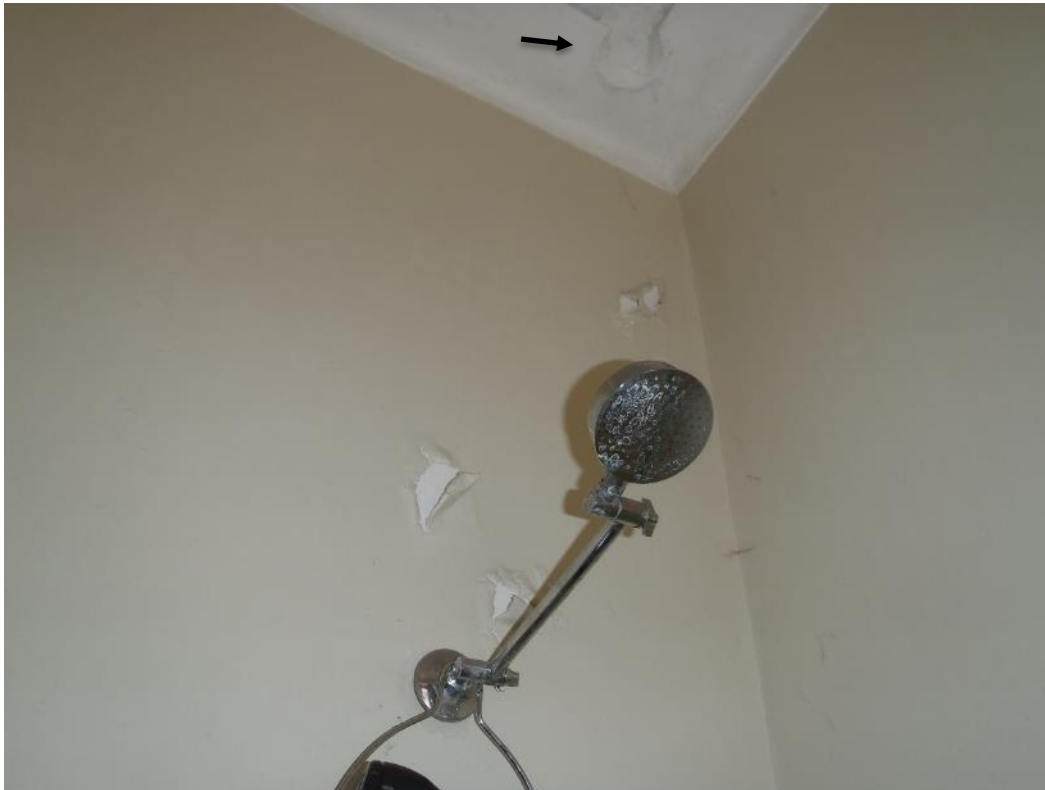
We noted deterioration / flaking paint to the cement rendered wall in the southern corner above the shower. We further noted previous repairs to the cove profiled plaster cornice. **[Photograph 36]**

Photograph 36 shows deterioration / flaking paint to the cement rendered wall in the southern corner above the shower and previous repairs to the cove profiled plaster cornice in the Bathroom.

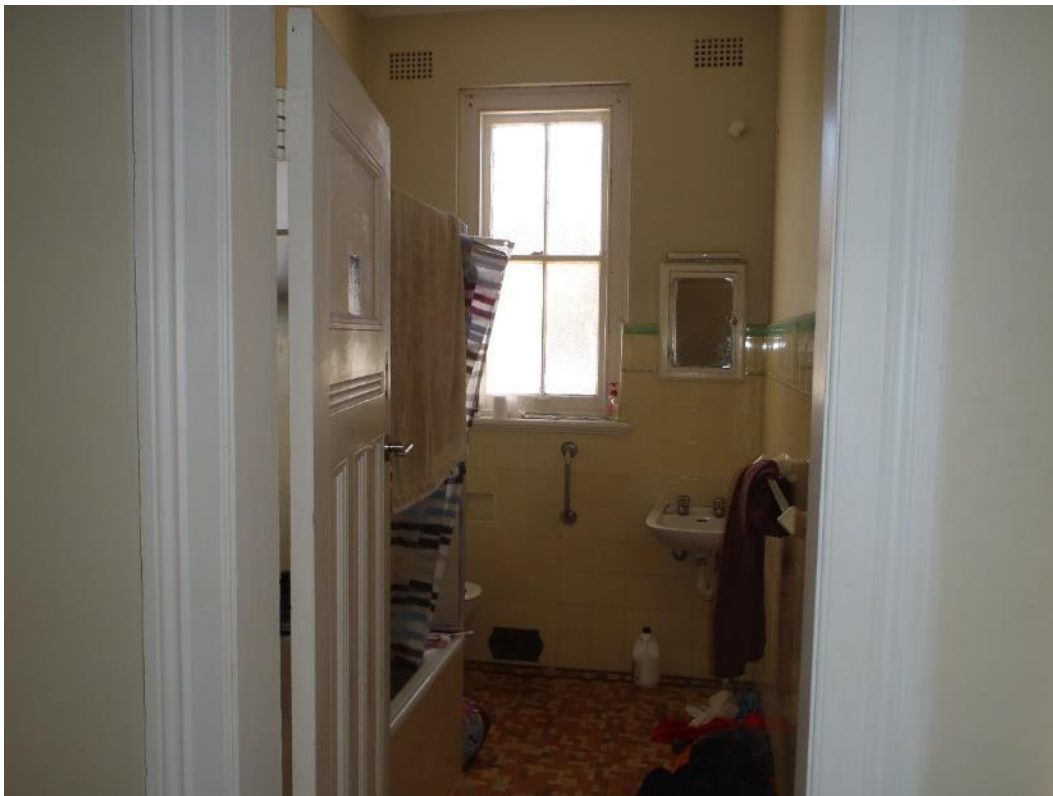
We noted that the grout to the wall and floor tiles is largely complete and that the wall and floor tiles when randomly “tap” tested appeared to be sound. We did not observe any recent cracking to the tile grout at the wall / wall, wall / floor junctions. **[Photograph 37]**

Photograph 37 shows the general layout of the Bathroom.

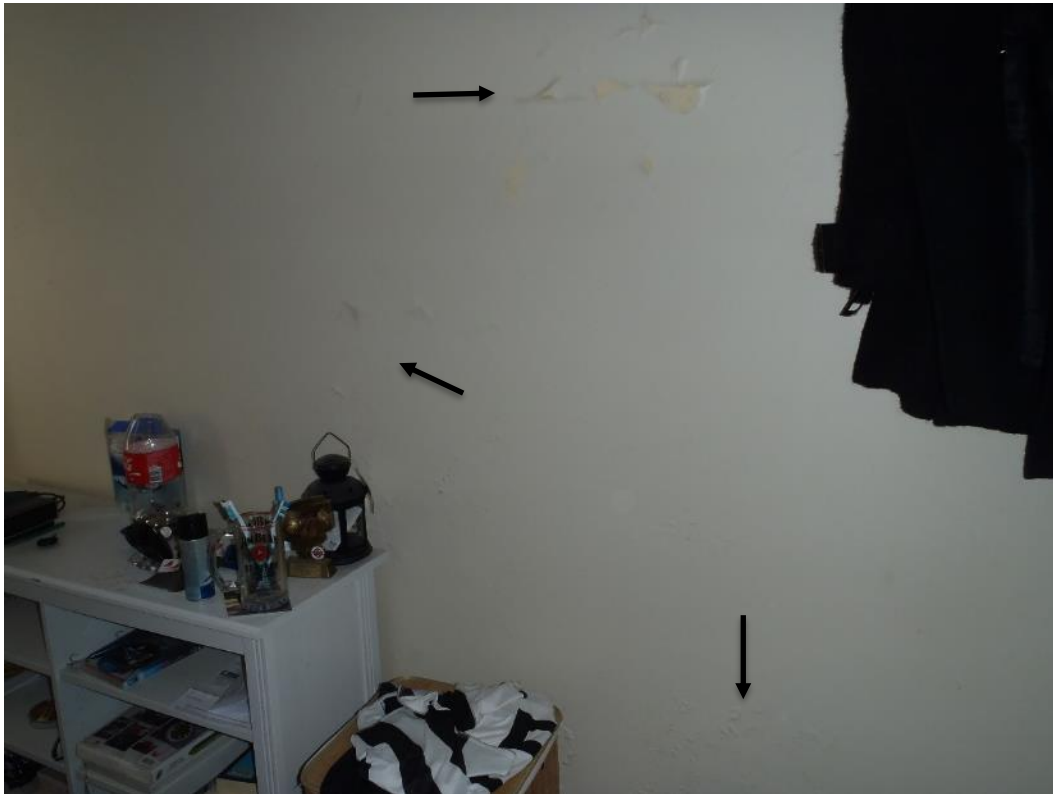
We noted areas of flaking / lifting paint to the internal north-eastern wall common with the Bathroom. This, in our experience, is consistent with rising damp. **[Photograph 38]**

Photograph 38 shows flaking / lifting paint to the internal north-eastern wall common with the Bathroom in Bedroom 2.

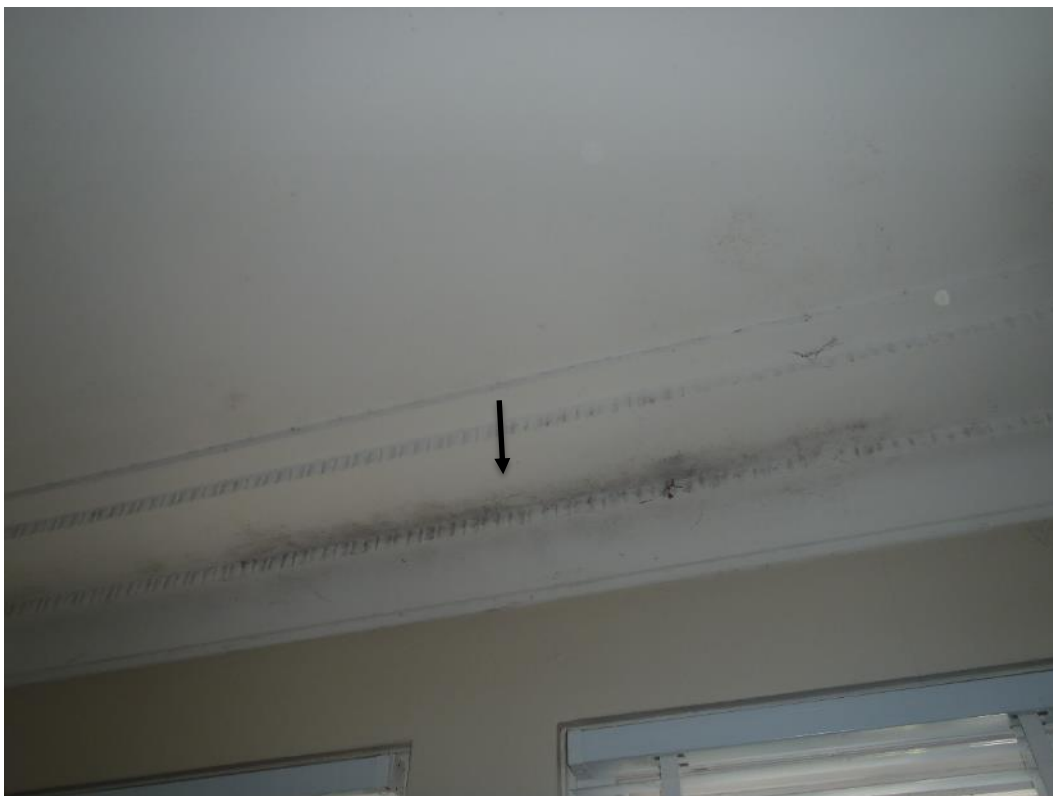
We noted mould growth to the decorative profiled plaster cornice above the windows. **[Photograph 39]**

Photograph 39 shows mould growth to the decorative profiled plaster cornice above the windows in Bedroom 2.

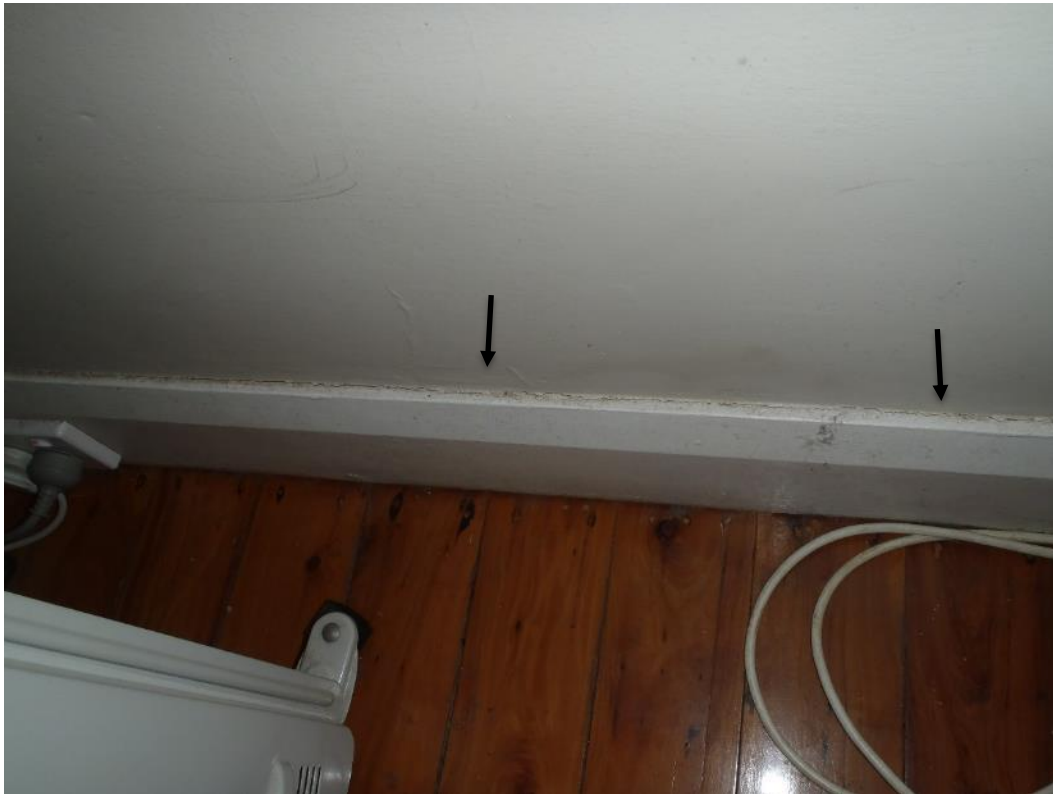
We noted separation cracking of the skirting from the wall surface along the north-western wall under the windows. **[Photograph 40]**

Photograph 40 shows separation cracking of the skirting from the wall surface along the north-western wall under the windows in Bedroom 2.

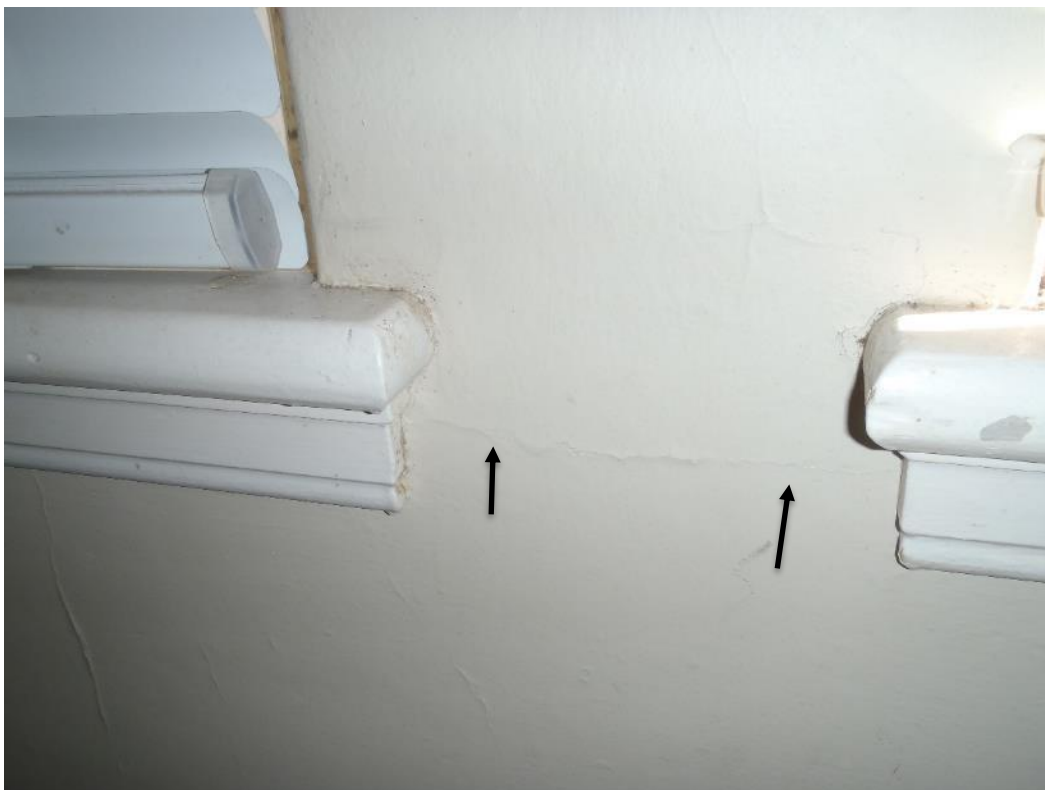
We noted hairline horizontal cracking [< 1 mm] between the window sills. **[Photograph 41]**

Photograph 41 shows hairline horizontal cracking between the window sills in Bedroom 2.

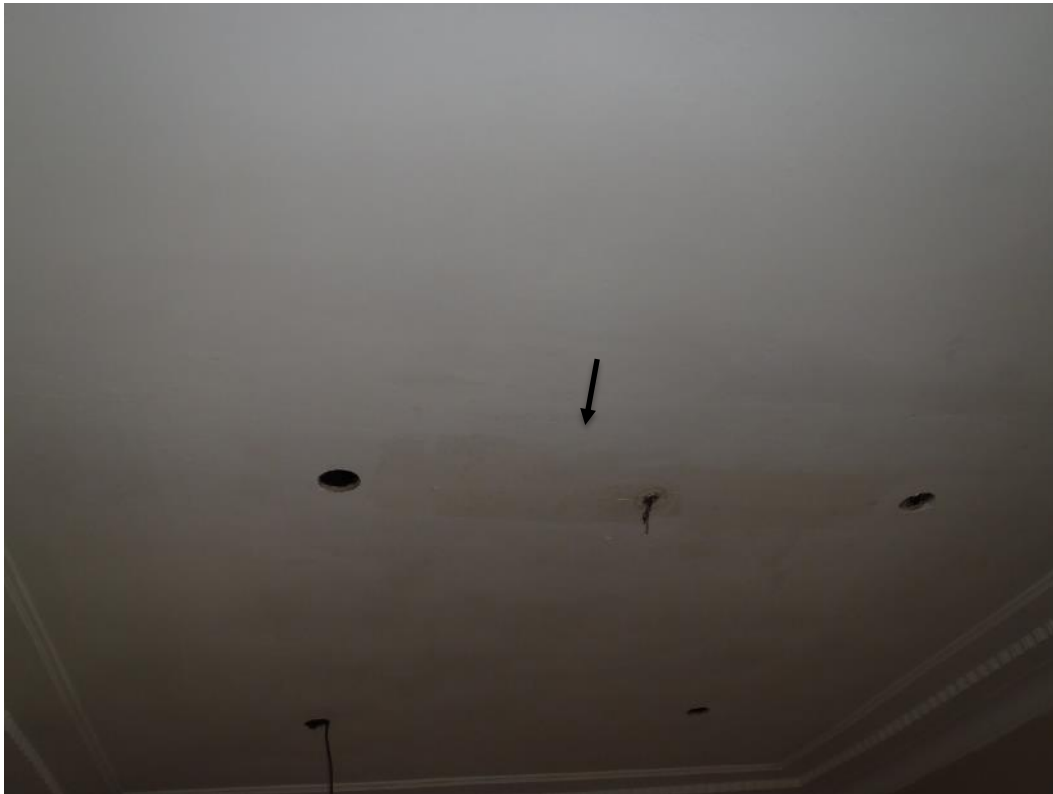
We noted evidence of previous repairs to the plaster ceiling lining across the centre of the room. **[Photograph 42]**

Photograph 42 shows evidence of previous repairs to the plaster ceiling lining across the centre of the Lounge room.

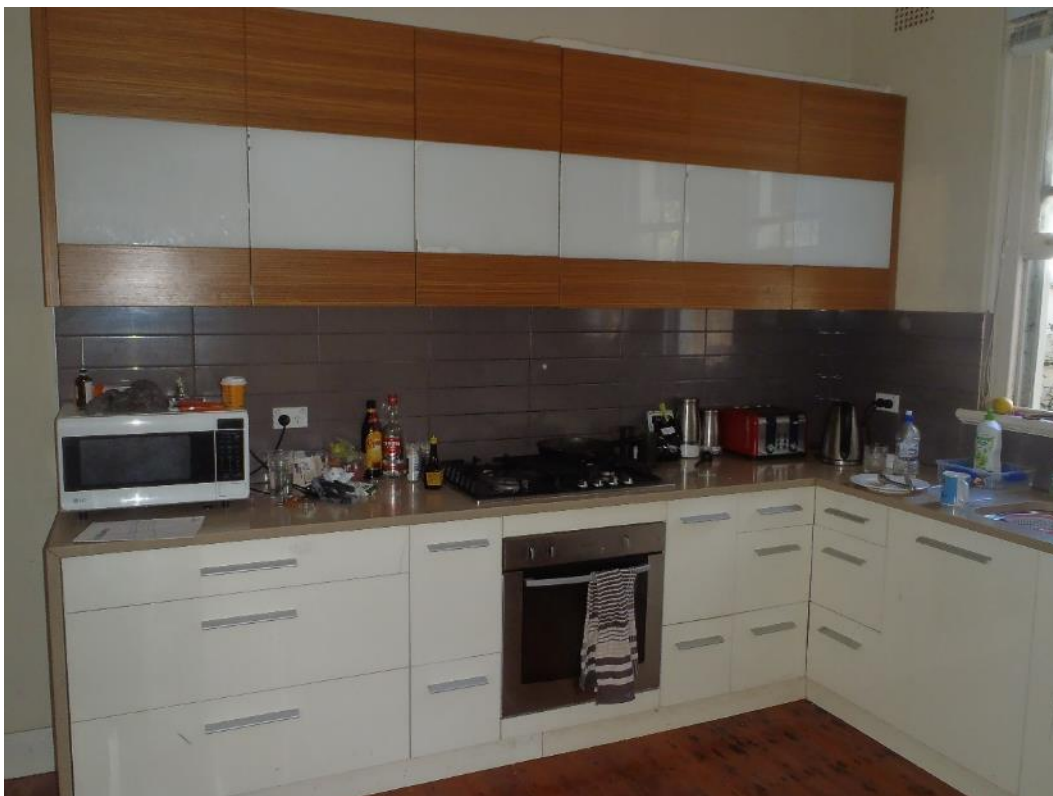
We noted that the room is open plan design. **[Photograph 43]**

Photograph 43 shows the general layout of the Kitchen.

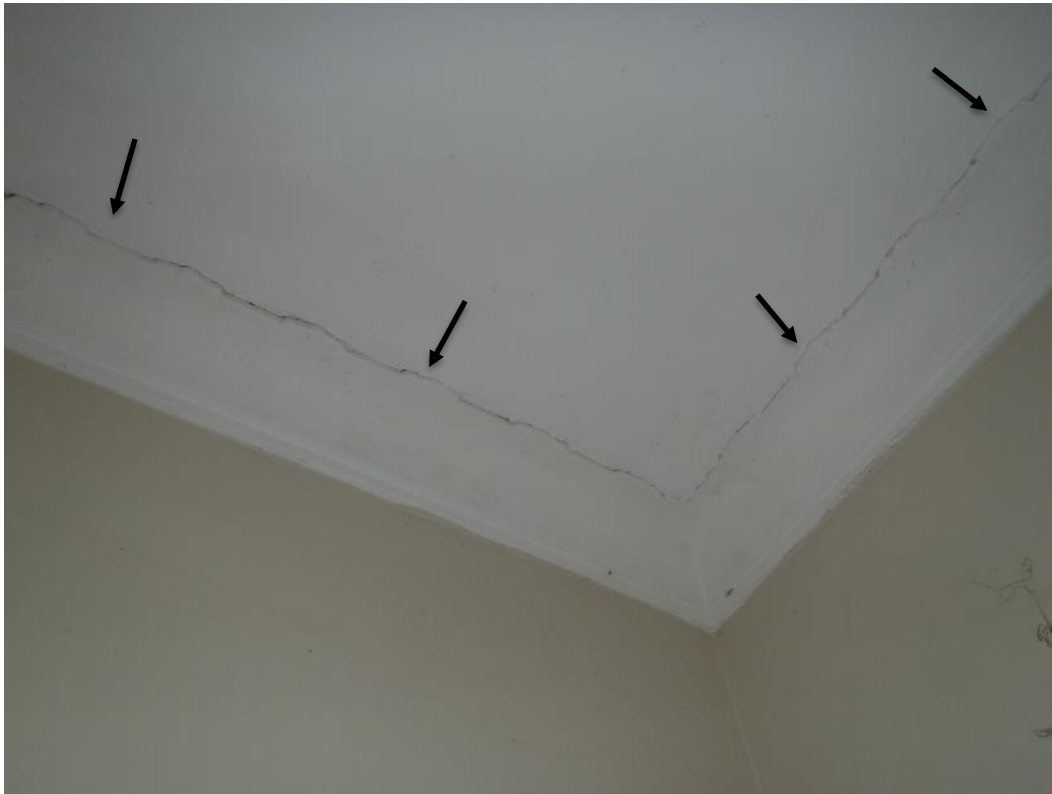
We noted separation cracking of the cornice from the plaster ceiling lining in the eastern corner adjacent to the *common party / separation* wall with the adjoining property, No. 10 College Street, Gladesville. **[Photograph 44]**

Photograph 44 shows separation cracking of the cornice from the plaster ceiling lining in the eastern corner adjacent to the *common party / separation* wall with the adjoining property, No. 10 College Street, Gladesville in the Kitchen.

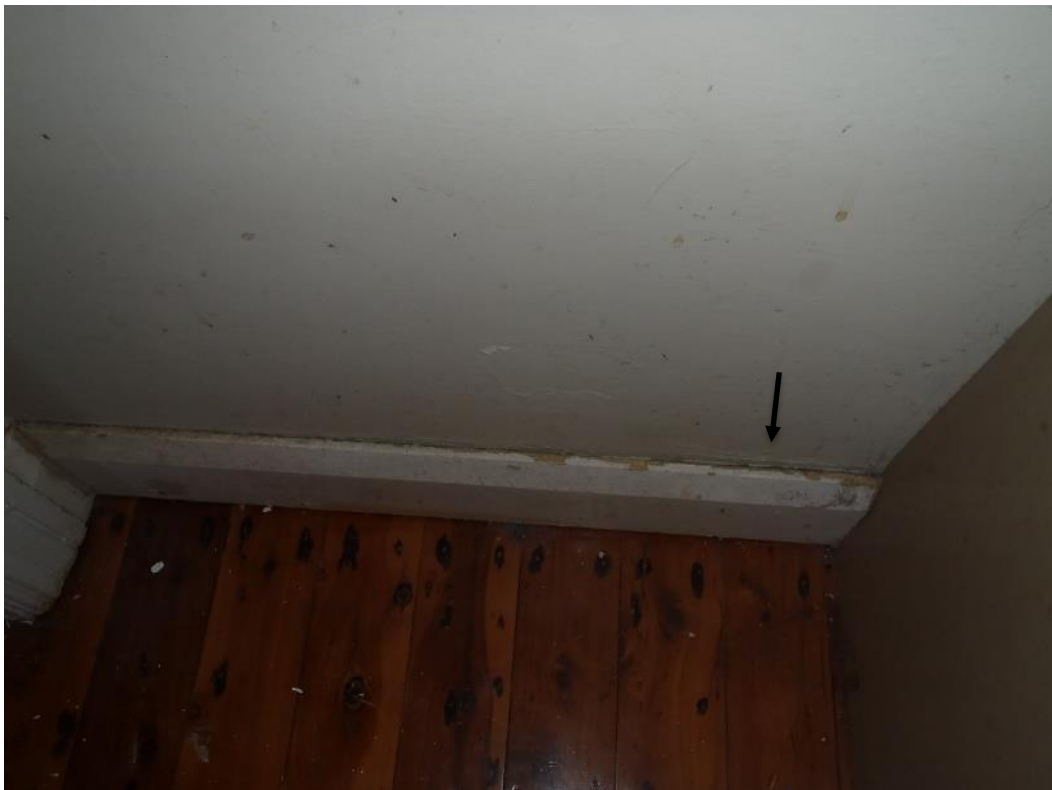
We noted separation cracking of the timber skirting from the cement rendered wall along the *common party / separation* wall with the adjoining property, No. 10 College Street, Gladesville. **[Photograph 45]**

Photograph 45 shows separation cracking of the timber skirting from the cement rendered wall along the *common party / separation* wall with the adjoining property, No. 10 College Street, Gladesville in the Kitchen.

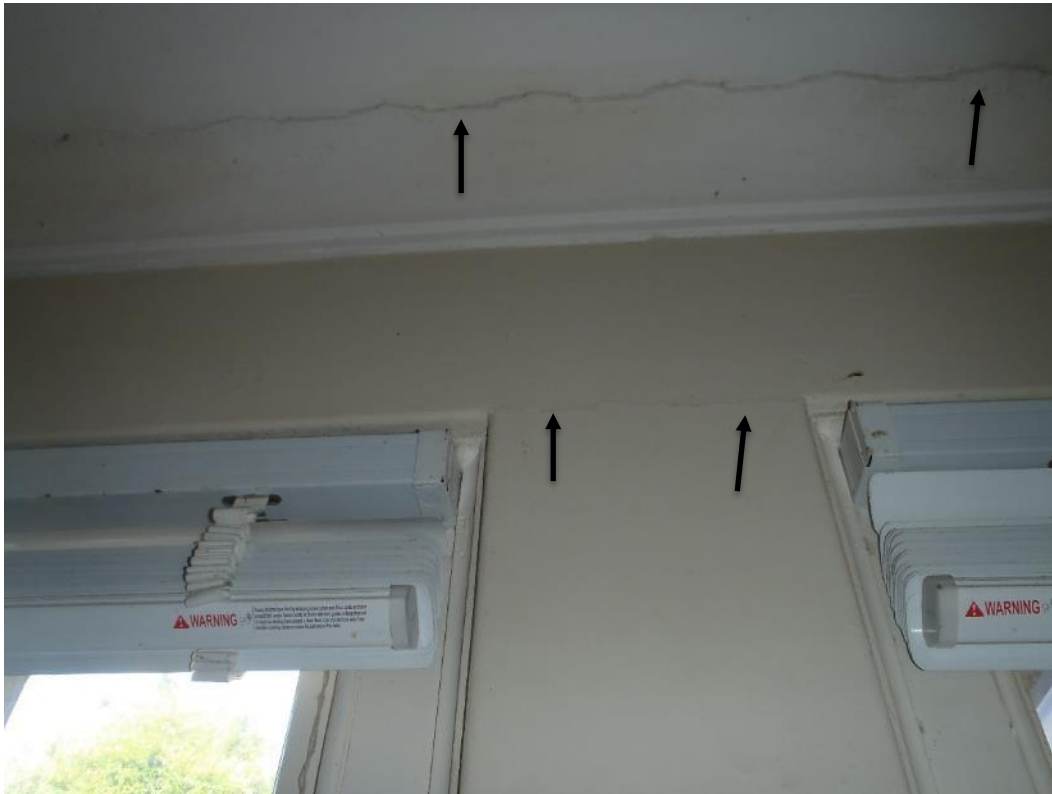
We noted horizontal cracking [< 1.0 mm] between the window heads. We further noted separation cracking of the plaster cornice from the plaster ceiling lining above the windows. **[Photograph 46]**

Photograph 46 shows horizontal cracking between the window heads and separation cracking of the plaster cornice from the plaster ceiling lining above the windows in the Kitchen.

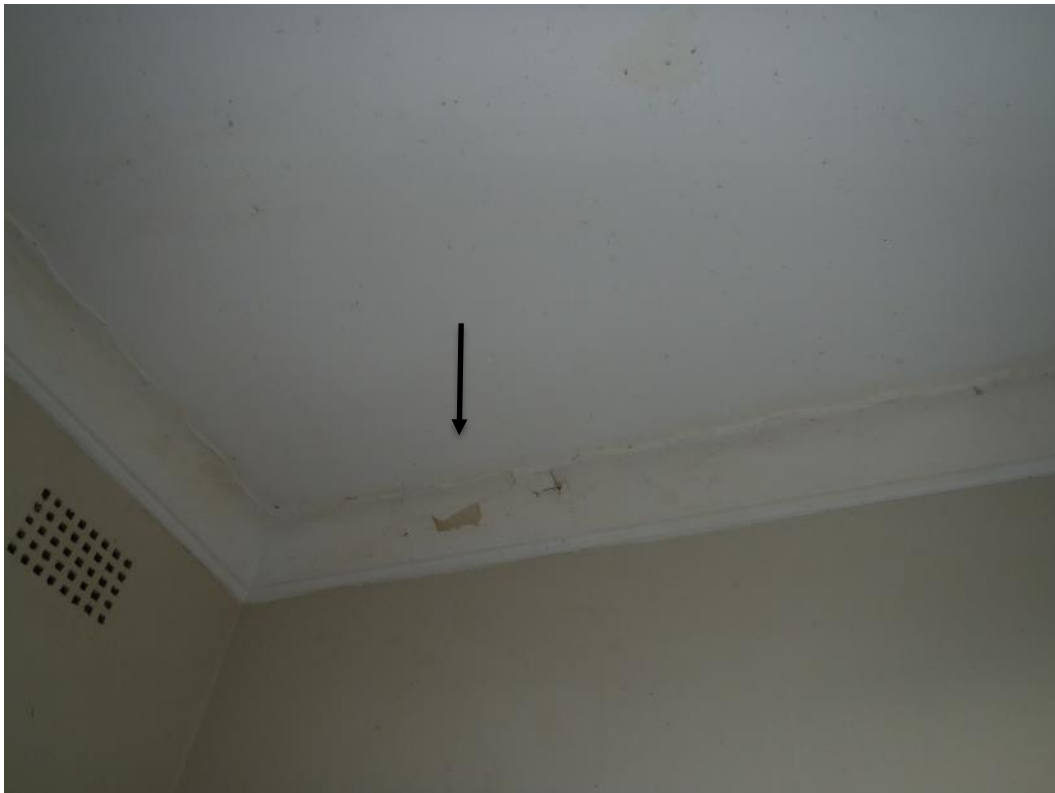
We noted deterioration / flaking paint to the decorative profiled plaster cornice and plaster ceiling lining in the western corner. **[Photograph 47]**

Photograph 47 shows deterioration / flaking paint to the decorative profiled plaster cornice and plaster ceiling lining in the western corner of the Kitchen.
