Dilapidation Assessment Report

Prepared for: Cape Cod Australia Pty. Limited
Job address: 12 College Street, Gladesville.
Property Owner/s: Mr. Reece & Mr. Ryan Yule.
Report reference: **RYDE CITY COUNCIL**
Development Application No: not available
Date of assessment: 1st July 2017

Re: Dilapidation Report – No. 12 College Street, Gladesville.

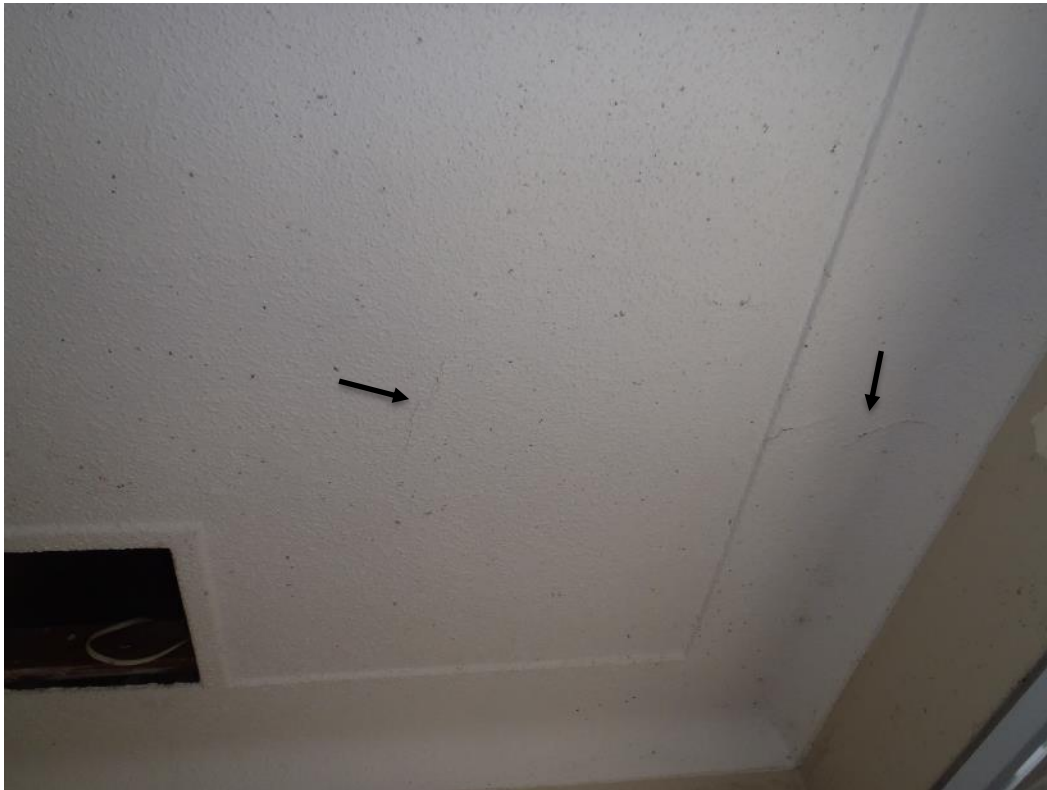
We noted hairline cracking to the plaster ceiling lining and the wide profiled plaster cornice. **[Photograph 48]**

Photograph 48 shows hairline cracking to the plaster ceiling lining and the wide profiled plaster cornice in the Sunroom.

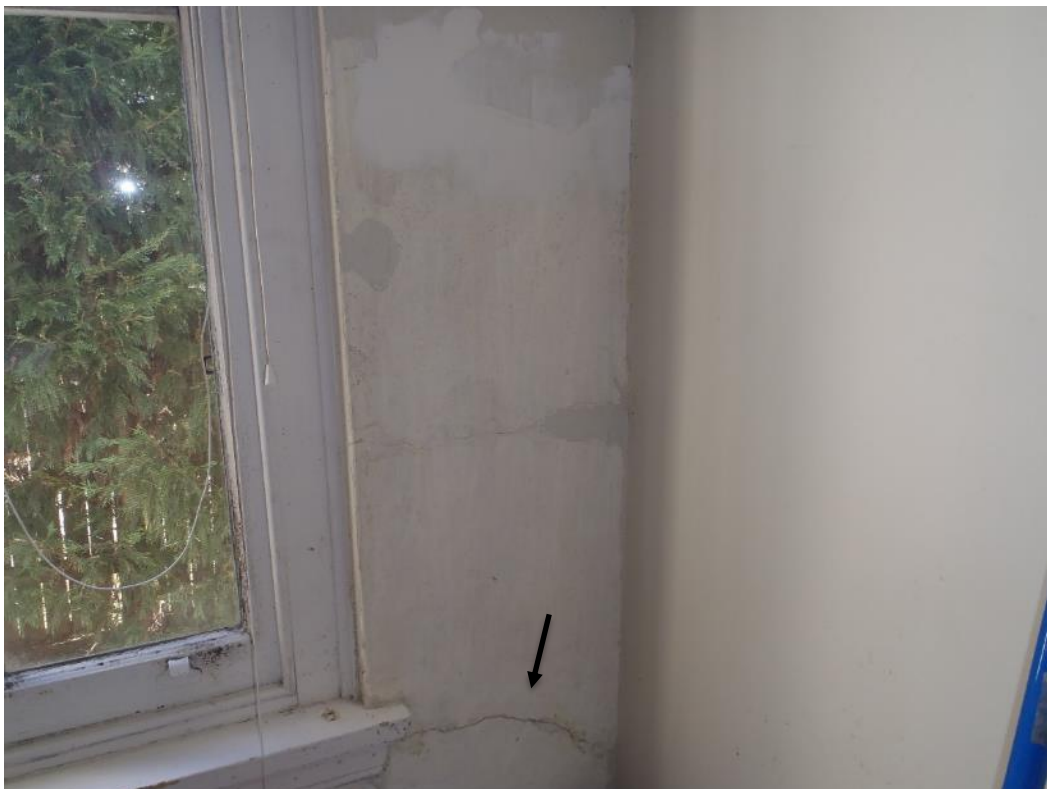
We noted radial cracking [< 1 mm] and evidence of previous repairs to the northern corner extending from the window reveals. **[Photograph 49]**

Photograph 49 shows radial cracking and evidence of previous repairs to the northern corner extending from the window reveals in the Sunroom.

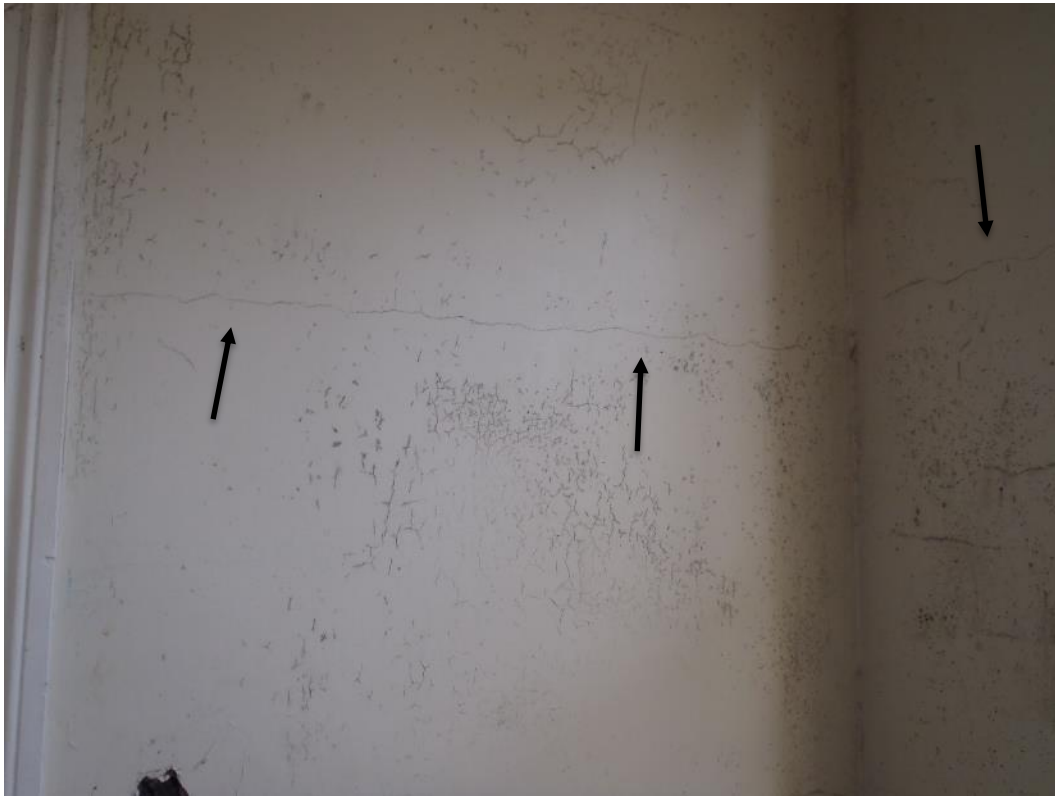
We noted horizontal cracking [< 1 mm] and deterioration / flaking paint to the western corner. **[Photograph 50]**

Photograph 50 shows horizontal cracking and deterioration / flaking paint to the western corner of the Sunroom.

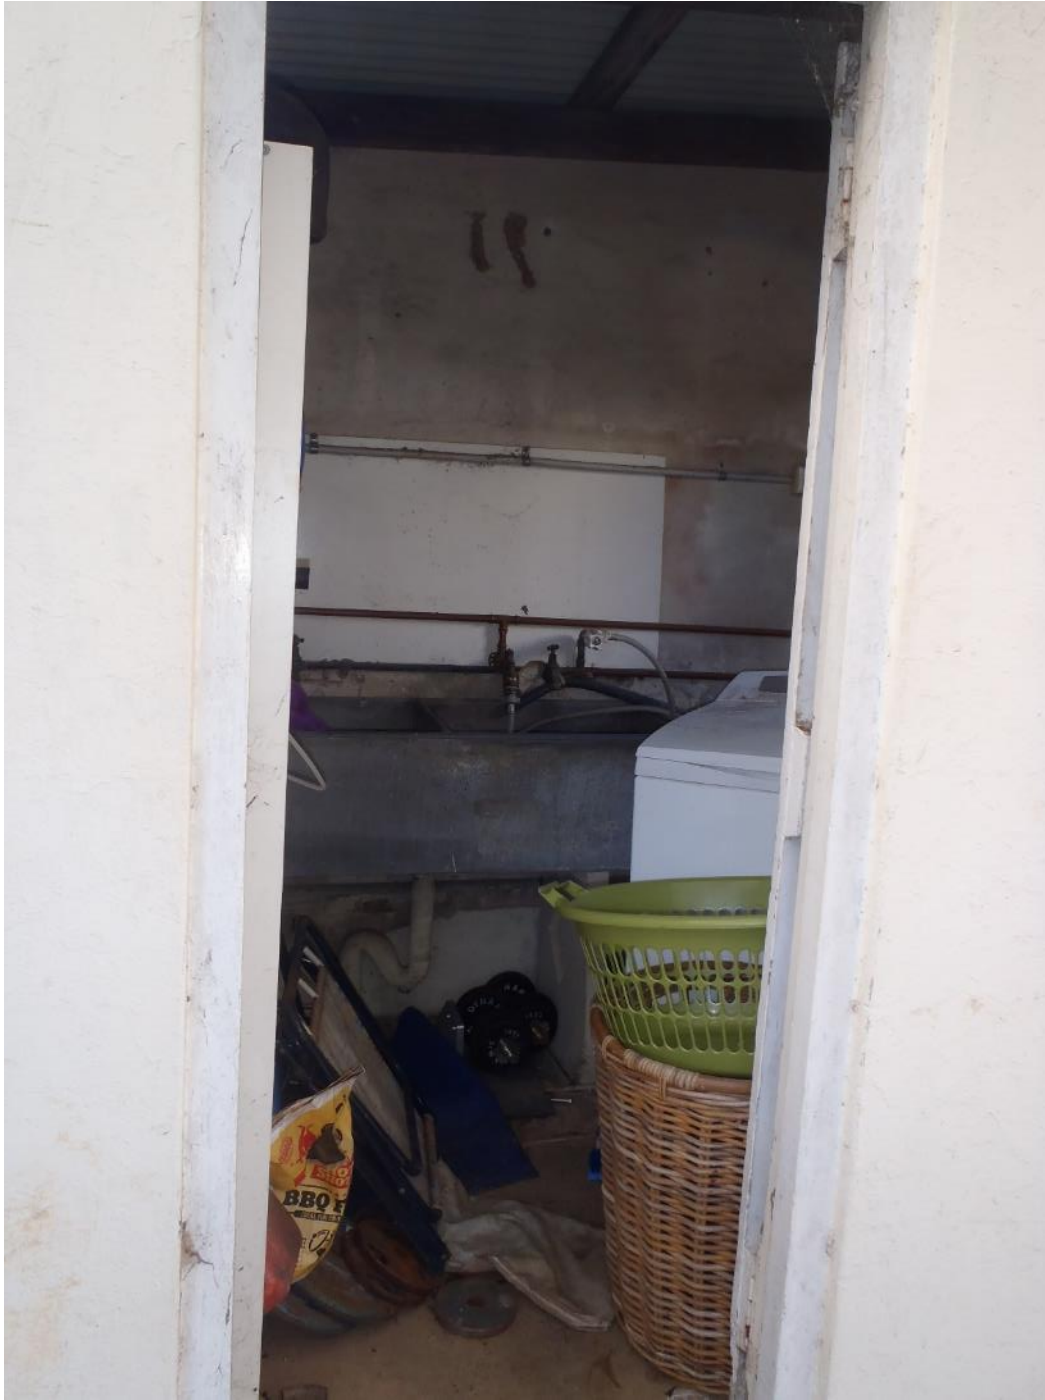
We did not observe any recent cracking to the cement rendered walls. **[Photograph 51]**

Photograph 51 shows the general condition of the Laundry.
