HAZARDOUS MATERIALS ASSESSMENT REPORT

Job details: Owner/s: Mr. C. & Mrs. A. Murray
Location: 19 Vista Avenue, Balgowlah Heights

Date of assessment: 5th August 2015

Our reference: HM04150715

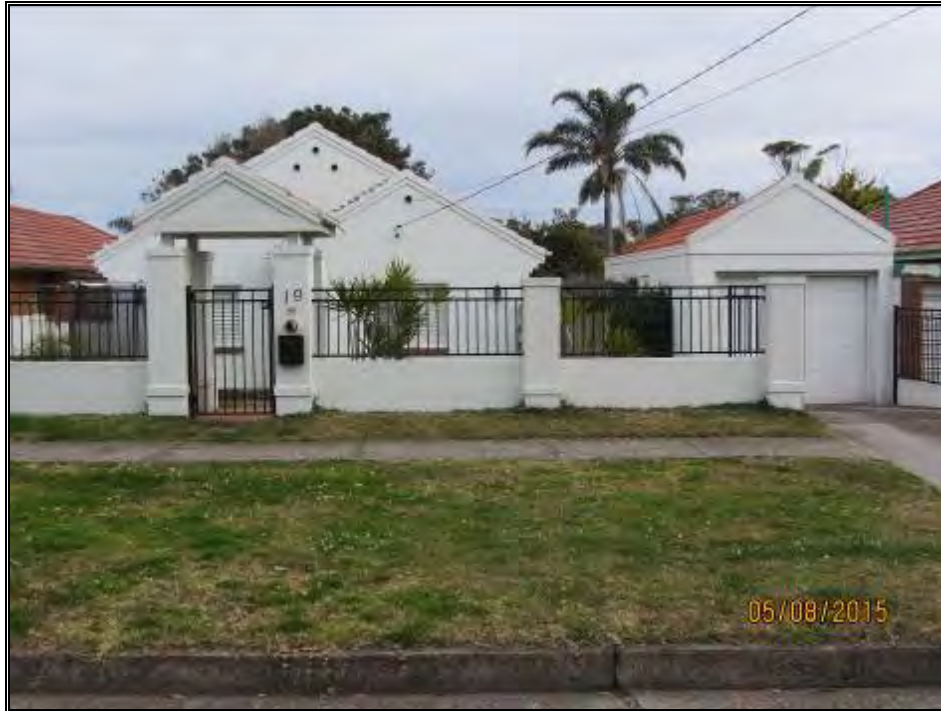
Front eastern elevation of the residence
