Dilapidation Assessment Report

Prepared for: Cape Cod Australia Pty. Limited
Job address: 29 Knowles Avenue, North Bondi.
Property Owner/s: Unknown. Access via Tenant.
Report reference: **WAVERLEY COUNCIL**
Development Application No: not available
Date of assessment: 15th December 2016

Re: Dilapidation Report – No. 29 Knowles Avenue, North Bondi.

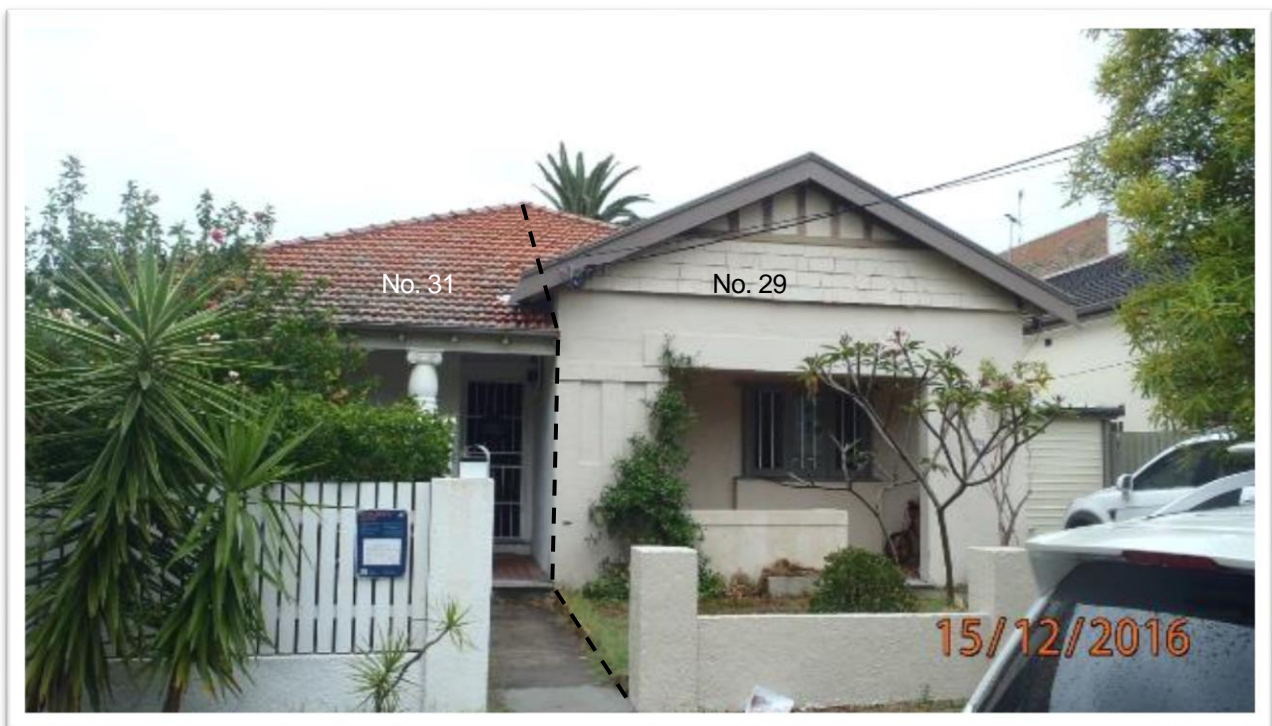
Shows the front eastern elevation of the adjoining properties:
No. 31 and No.29 Knowles Avenue, North Bondi.

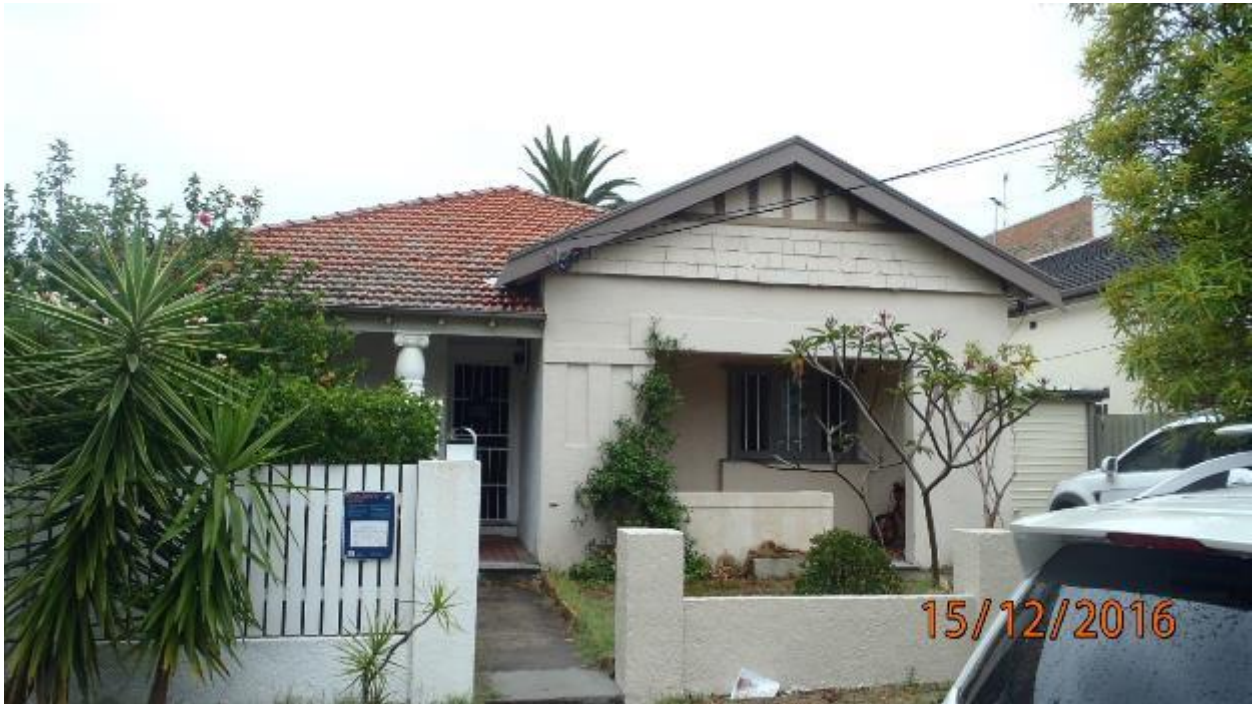
We observed that the terracotta roof tiles to the roof surfaces are generally interlinked and securely bedded, in our opinion forming a weather resistant cover to the residence. **[Photographs 1 and 2]**

Photograph 1 shows the general condition of the front roof surface.

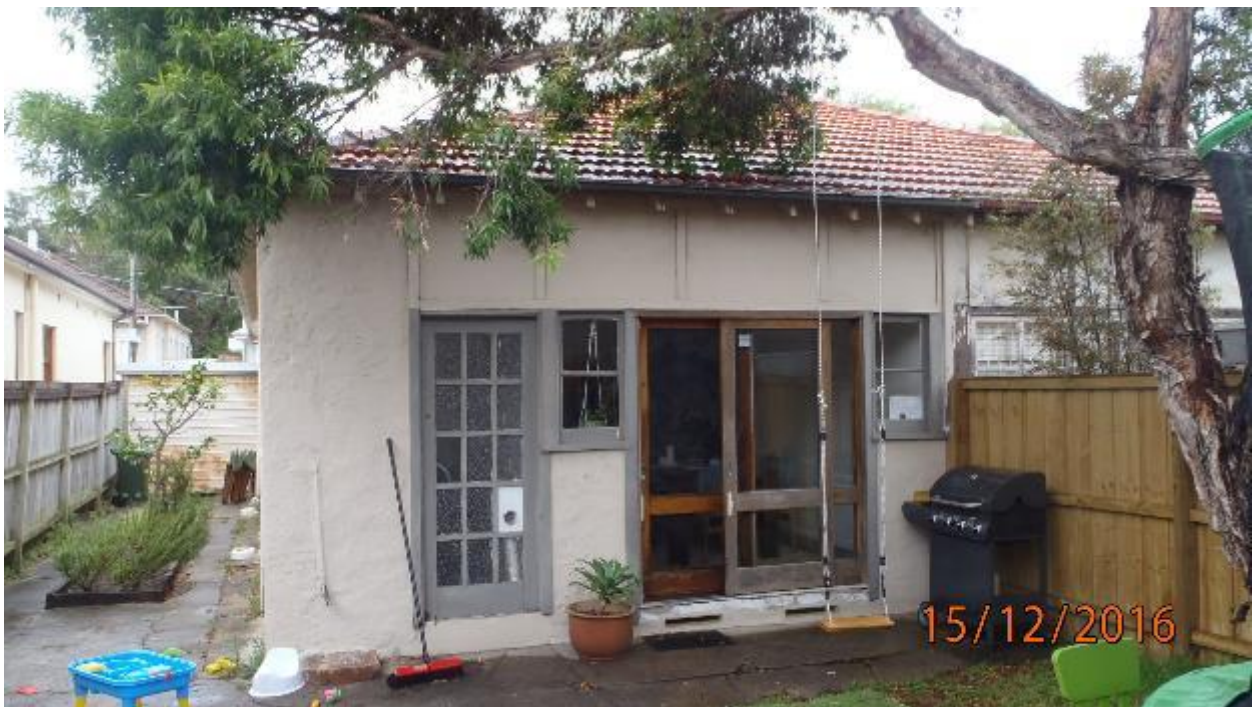
Photograph 2 shows the general condition of the rear roof surface and the rear western elevation.

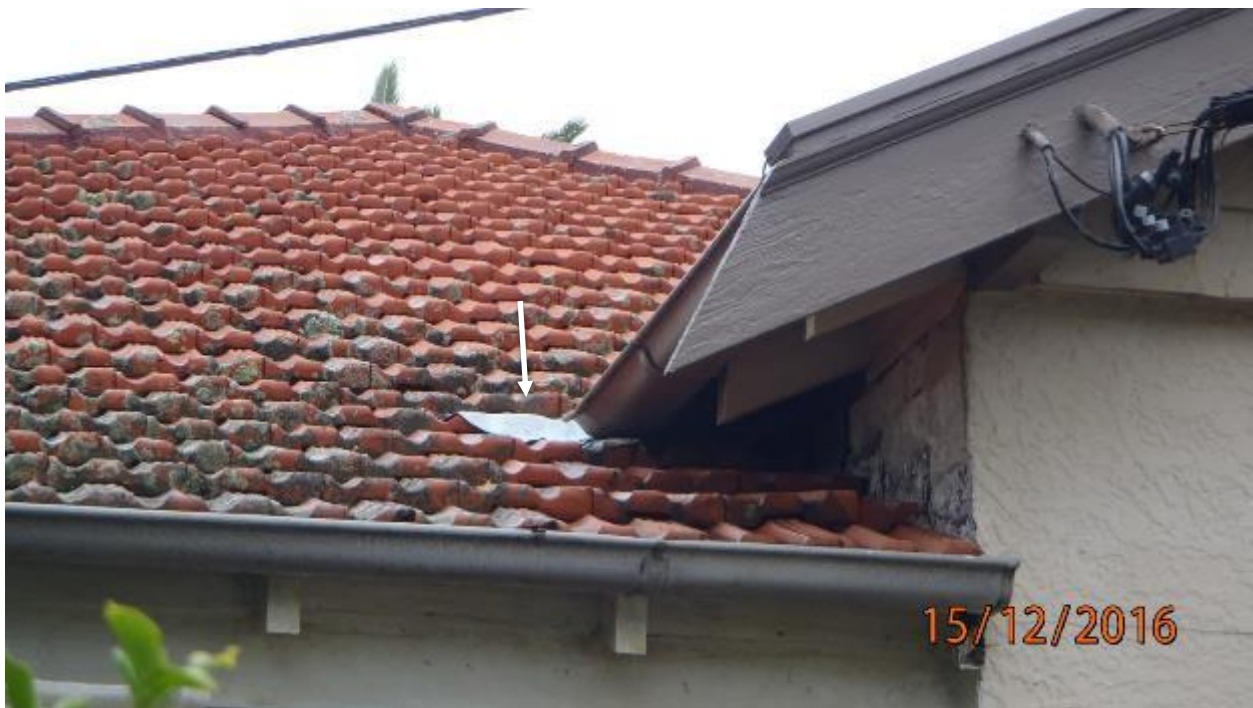
We noted that the surface water from the front gable ended pitched section of the roof discharges directly onto the front porch roof section of the adjoining property, No. 31 Knowles Avenue, North Bondi. **[Photograph 3]**

Photograph 3 shows where the surface water from the front gable ended pitched section of the roof discharges directly onto the front porch roof section of the adjoining property.

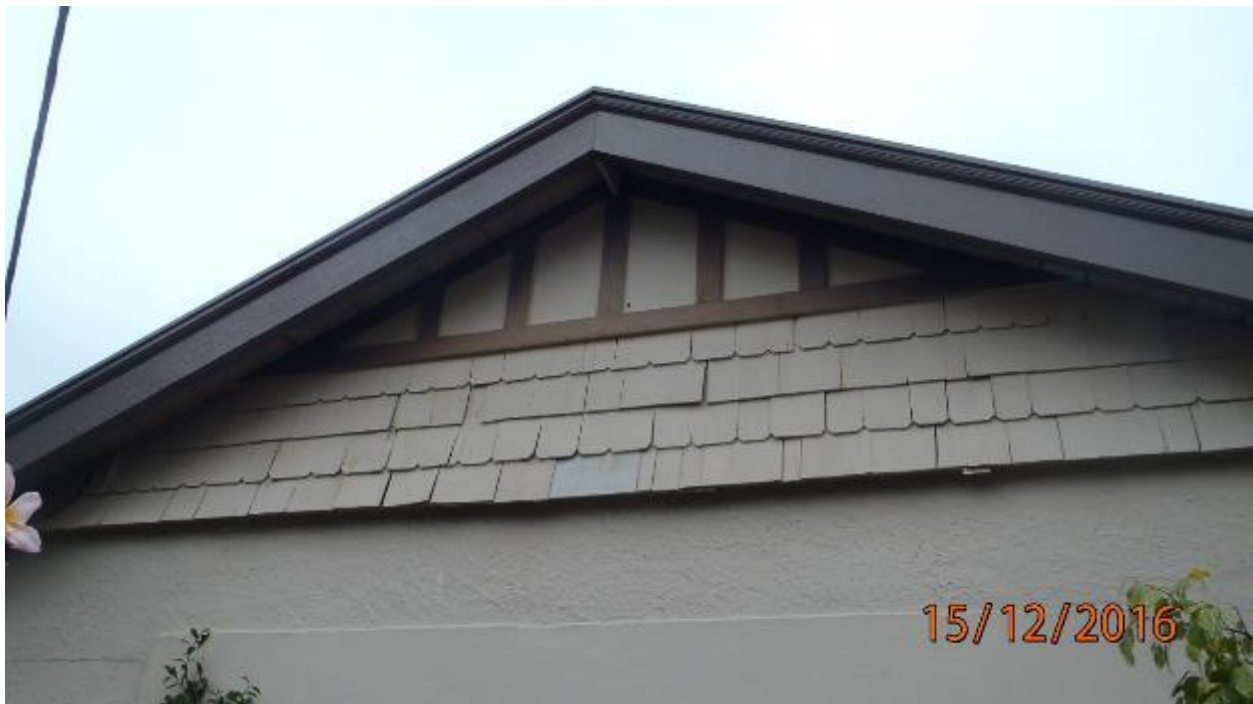
We noted displacement and deterioration to the shingle cladding on the front gable end. **[Photograph 4]**

Photograph 4 shows displacement and deterioration to the shingle cladding on the front gable end.

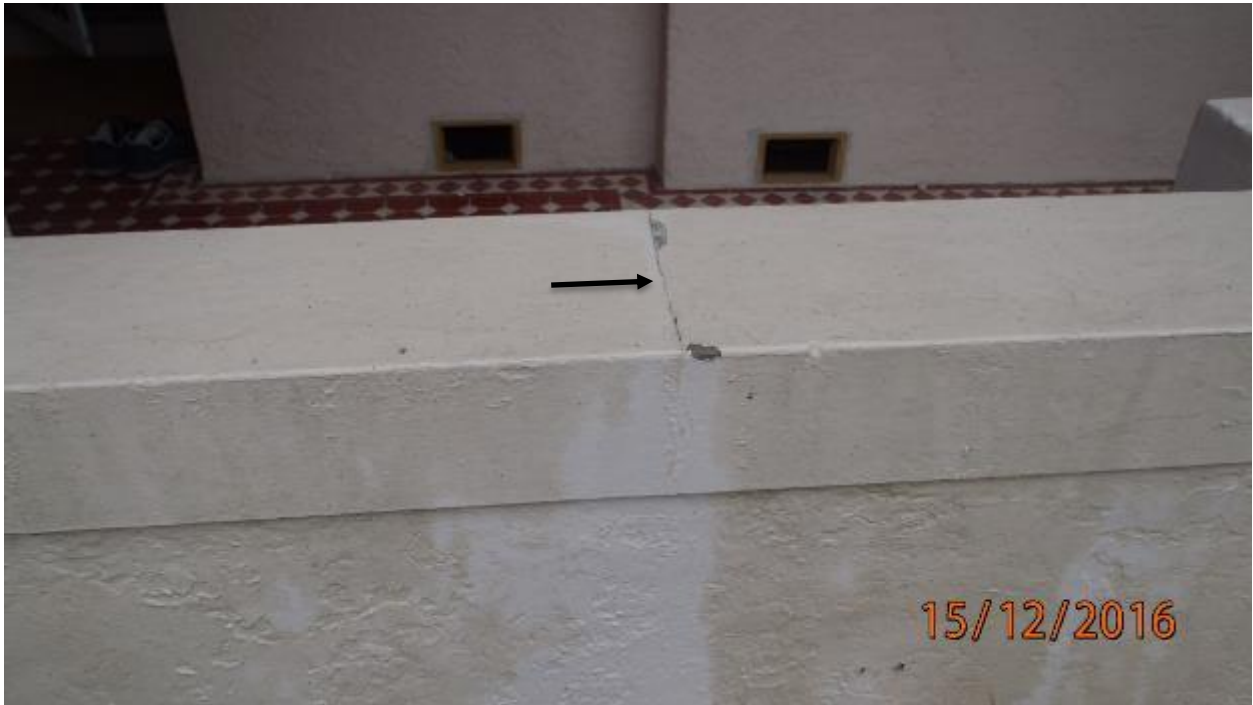
We noted cracking to the cement rendered brick balustrade wall to the front porch. **[Photograph 5]**

Photograph 5 shows cracking to the cement rendered brick balustrade wall to the front porch.

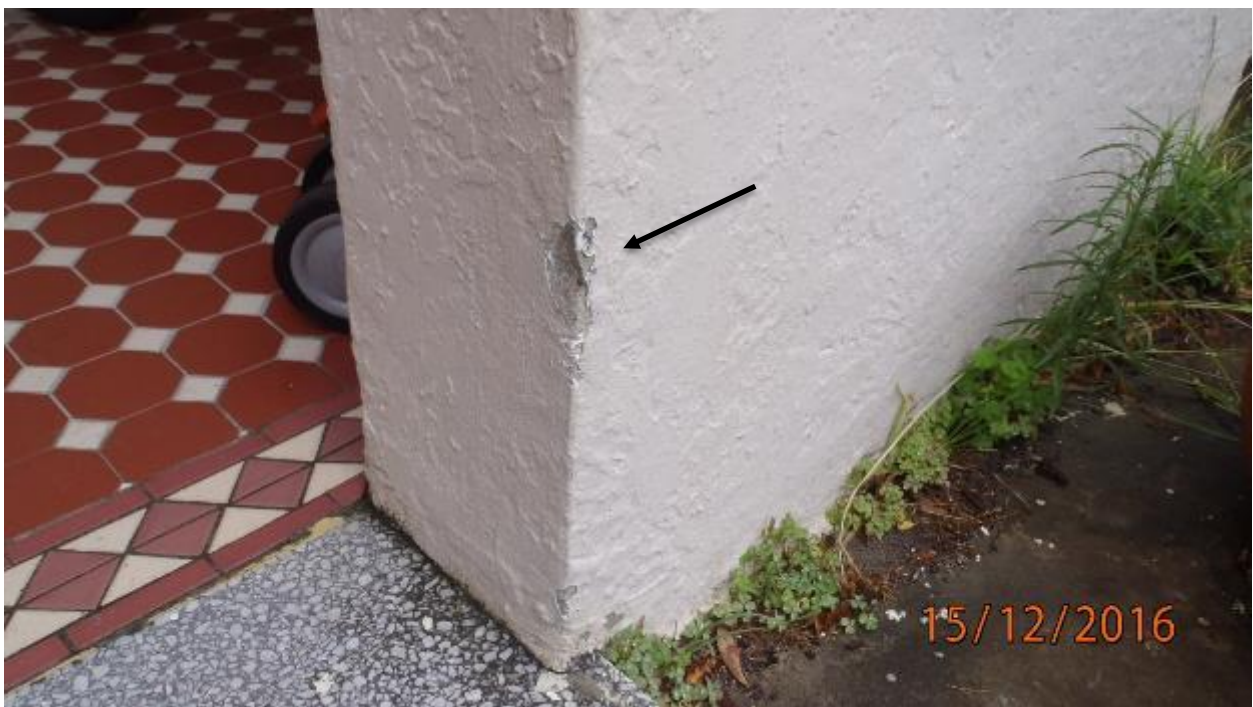
We noted damage to the cement rendered brick surface on the porch entry. **[Photograph 6]**

Photograph 6 shows the damage to the cement rendered brick surface on the porch entry.

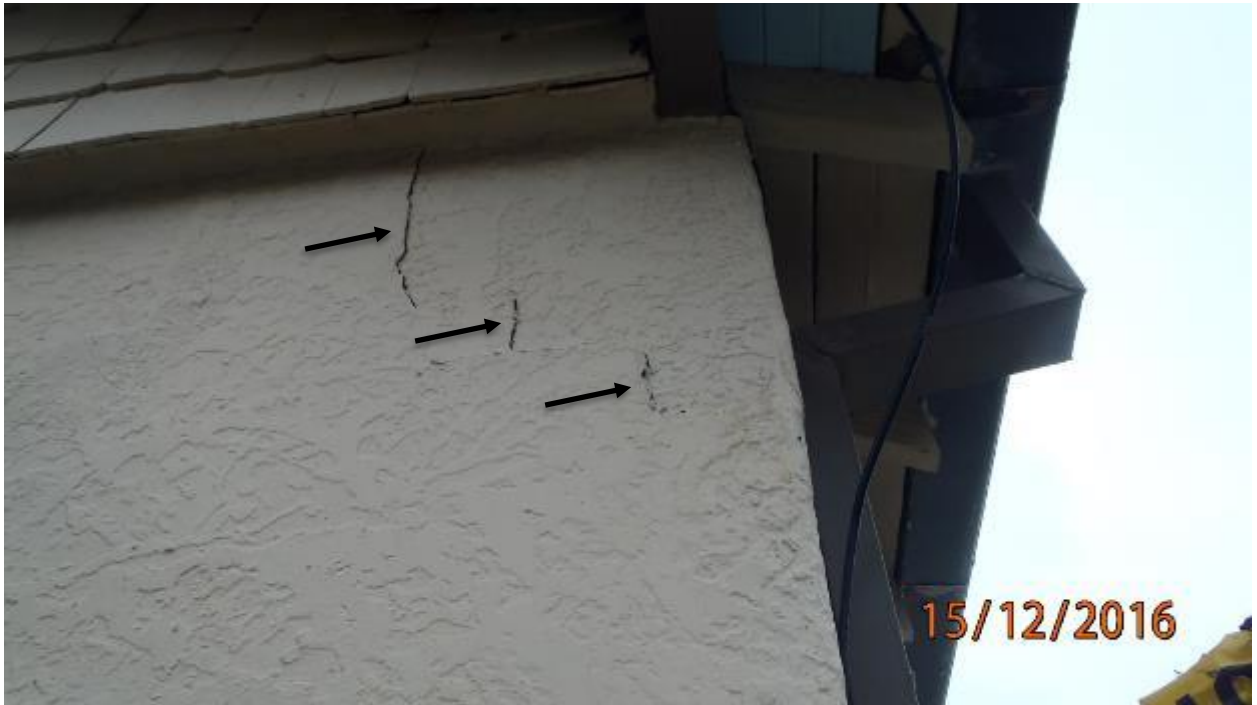
We noted step cracking to the cement rendered brick surface in the north-eastern corner. **[Photograph 7]**

Photograph 7 shows step cracking to the cement rendered brick surface in the north-eastern corner.

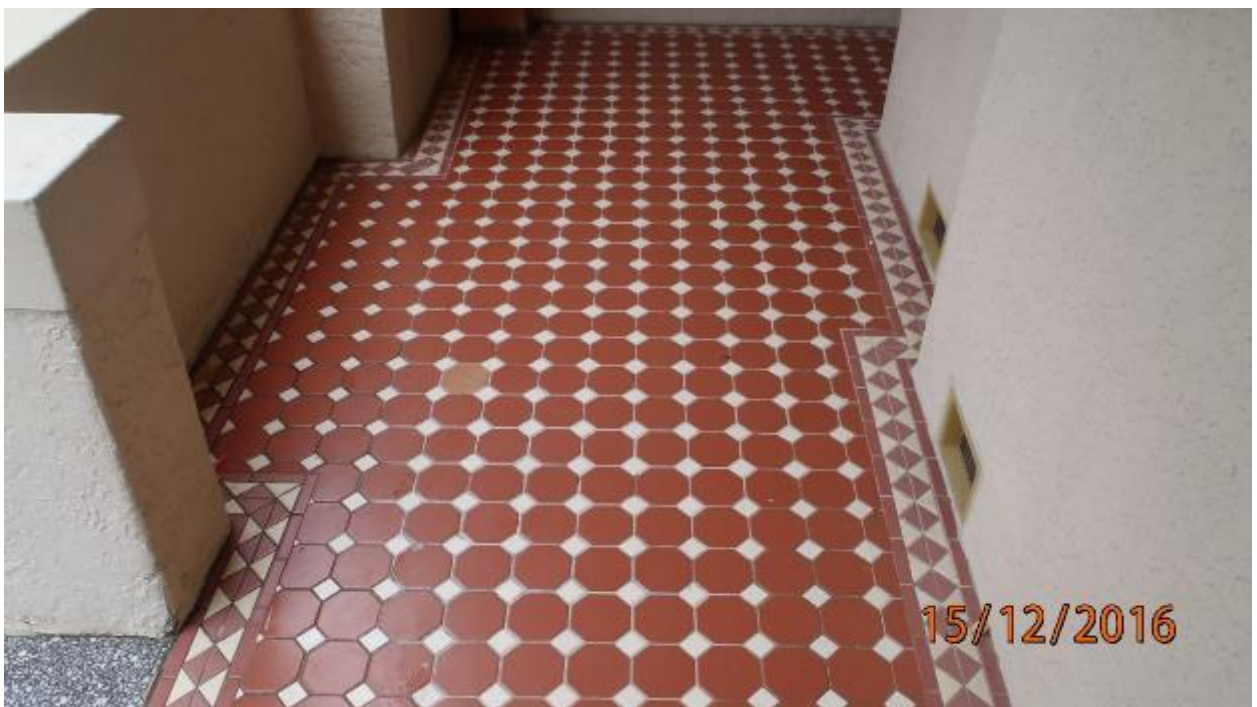
We noted that the patterned vitrified clay tiles to the front verandah were generally sound with the grout complete. **[Photograph 8]**

Photograph 8 shows the general condition of the porch tiles.

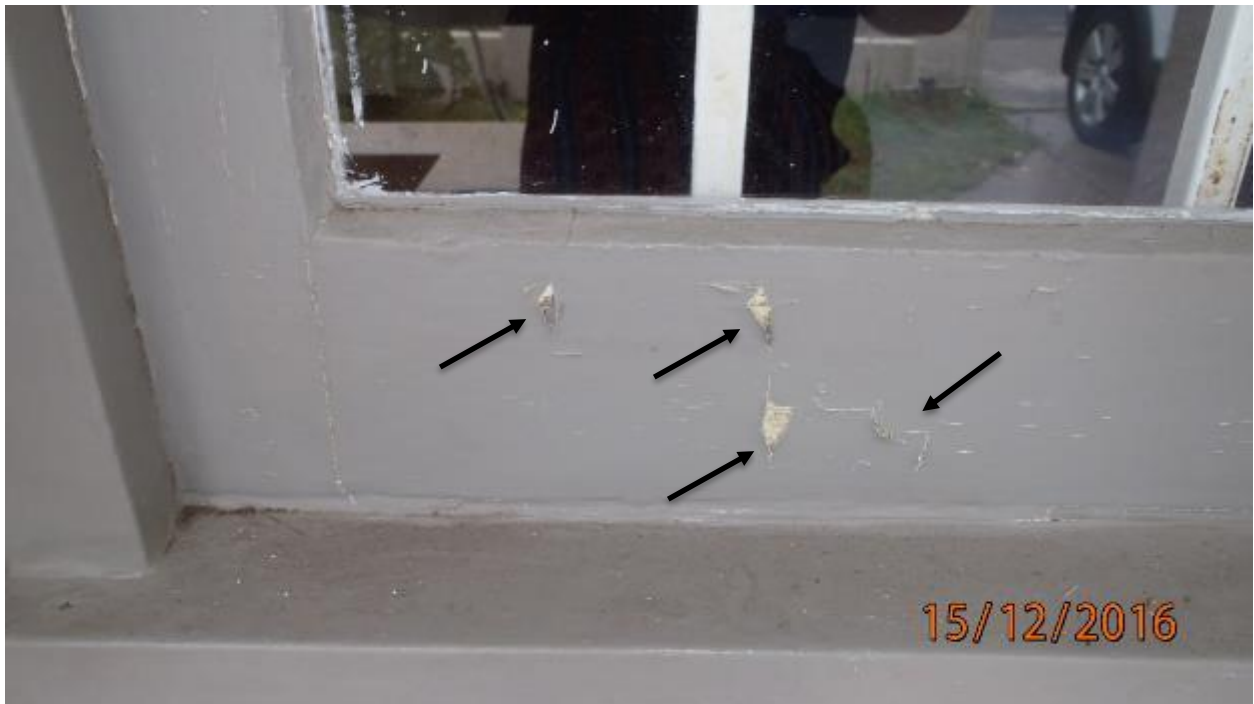
We noted that there is flaking paint to the front window outside Bedroom 1. **[Photograph 9]**

Photograph 9 shows flaking paint to the front window outside Bedroom 1.

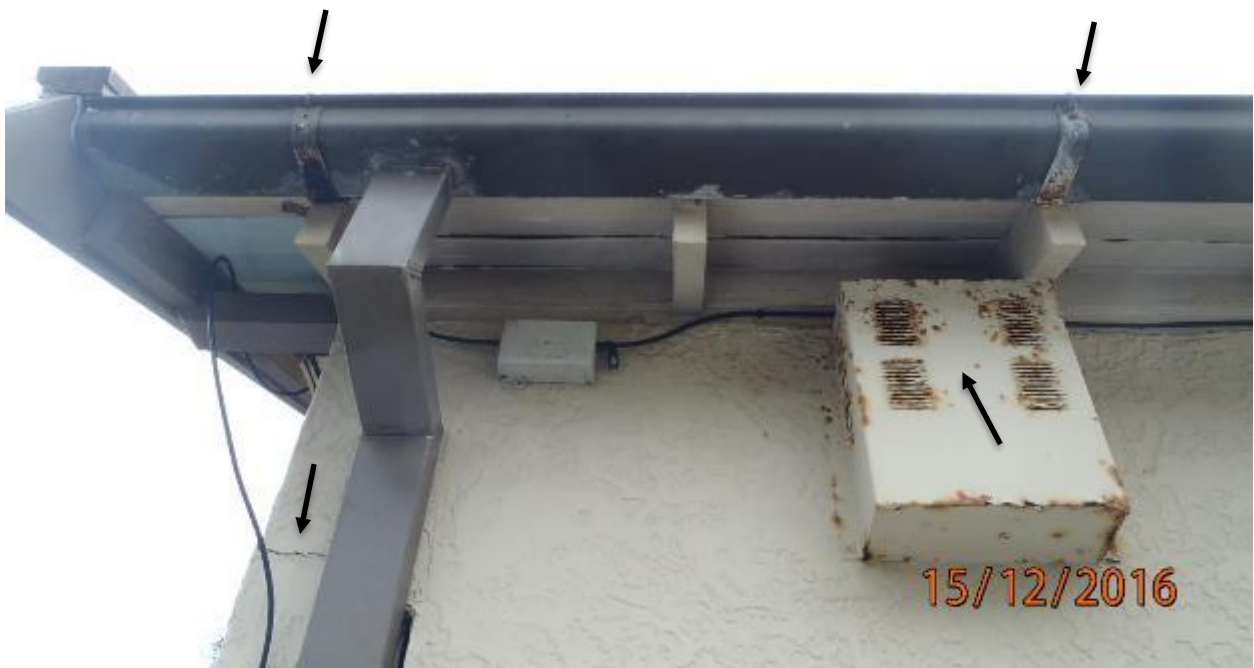
We noted step cracking to the cement rendered brick surface adjacent to the downpipe in the north-eastern corner. **[Photograph 10]**

We noted rusting to the gutter system and transformer box in the north-eastern corner. **[Photograph 10]**

Photograph 10 shows step cracking to the cement rendered brick surface and rusting to the gutter system and transformer box

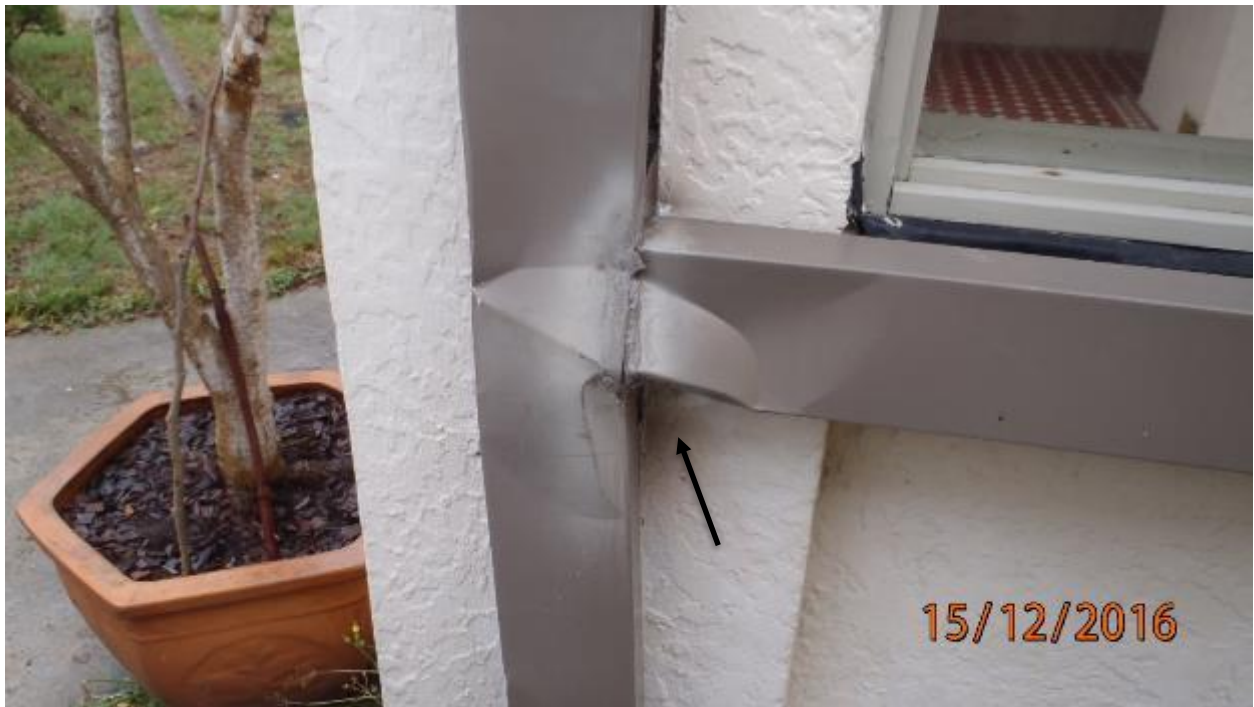
We noted damage to the downpipe system in the north-eastern corner. **[Photograph 11]**

Photograph 11 shows damage to the downpipe system in the north-eastern corner.

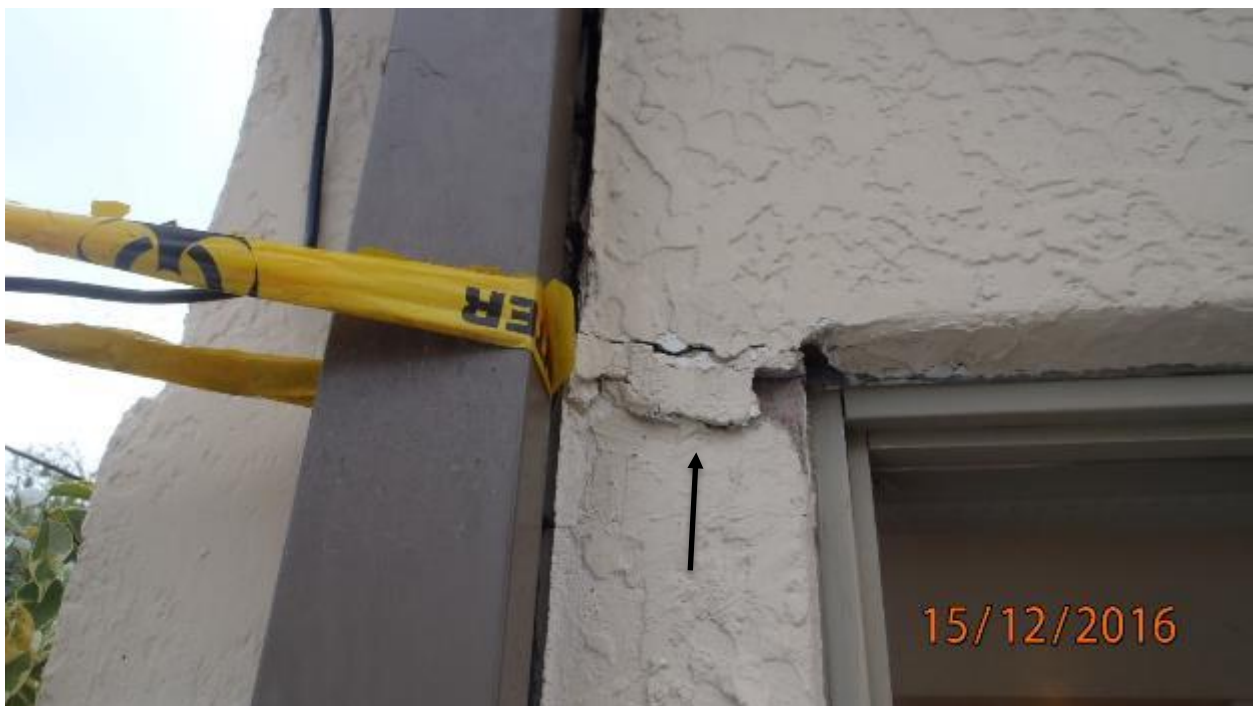
We noted horizontal cracking to the cement rendered brick surface extending from the front porch window head. **[Photograph 12]**

Photograph 12 shows horizontal cracking to the cement rendered brick surface extending from the front porch window head.

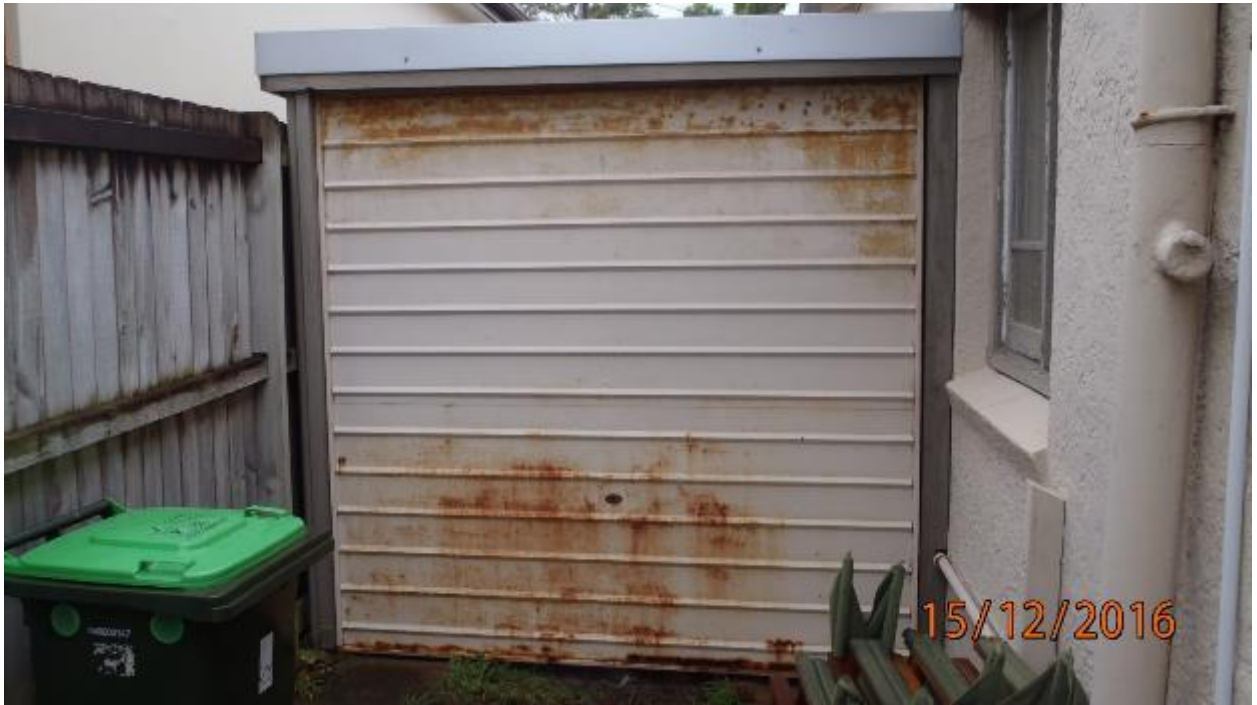
We noted rusting to the rear garage door. **[Photograph 13]**

Photograph 13 shows rusting to the rear garage door.

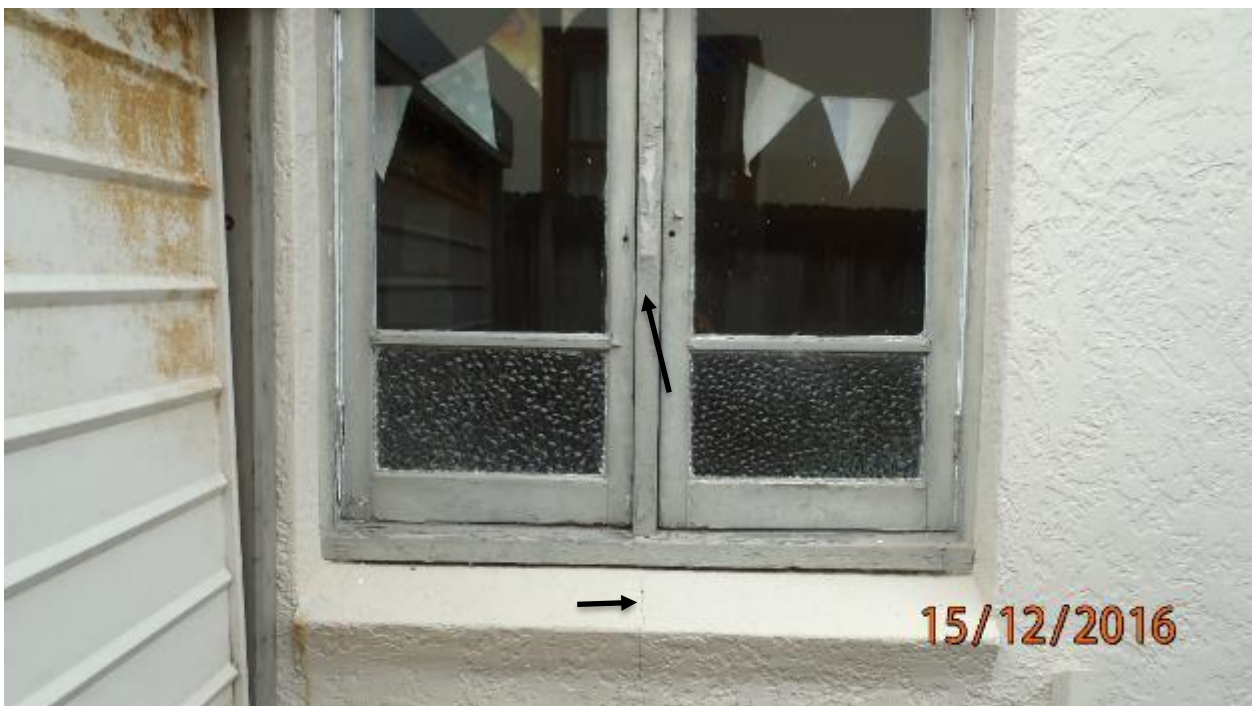
We noted that there is flaking paint to the Bedroom 2 window. We further noted cracking to the cement rendered brick window sill. **[Photograph 14]**

Photograph 14 shows flaking paint to the Bedroom 2 window and cracking to the cement rendered brick window sill.

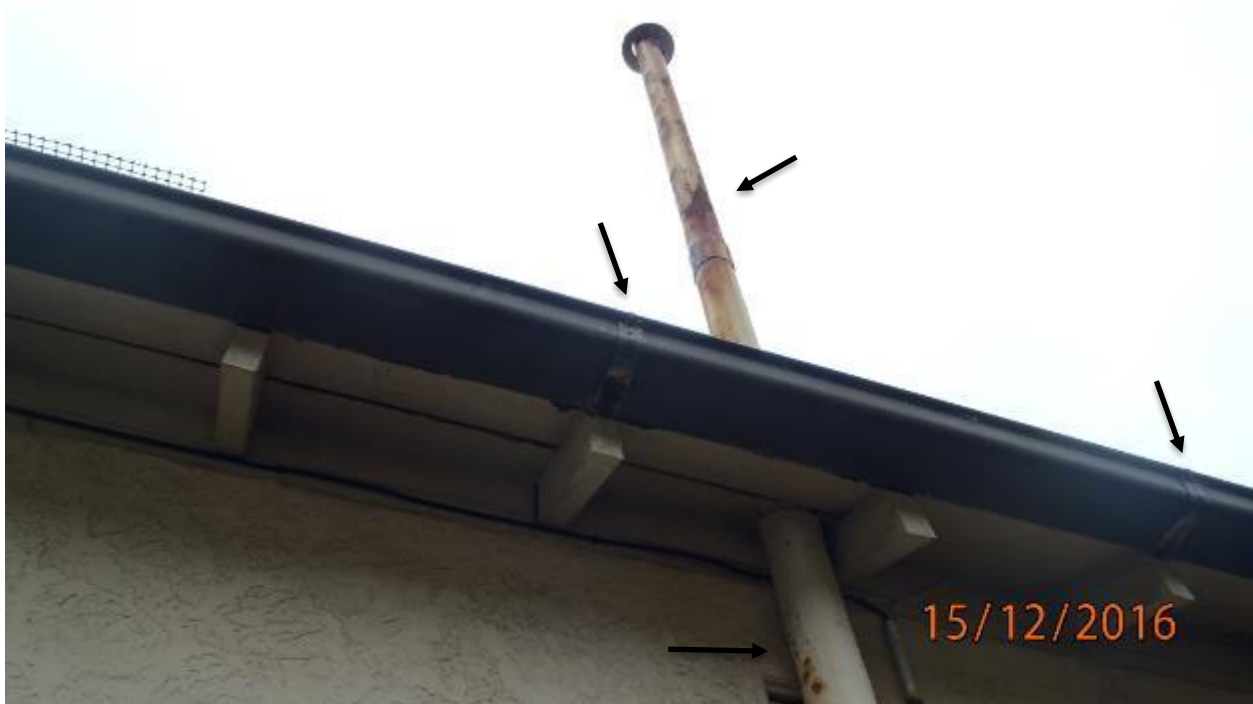
We noted rusting to the vent pipe and gutter system outside Bedroom 2. **[Photograph 15]**

Photograph 15 shows rusting to the vent pipe and gutter system outside Bedroom 2.

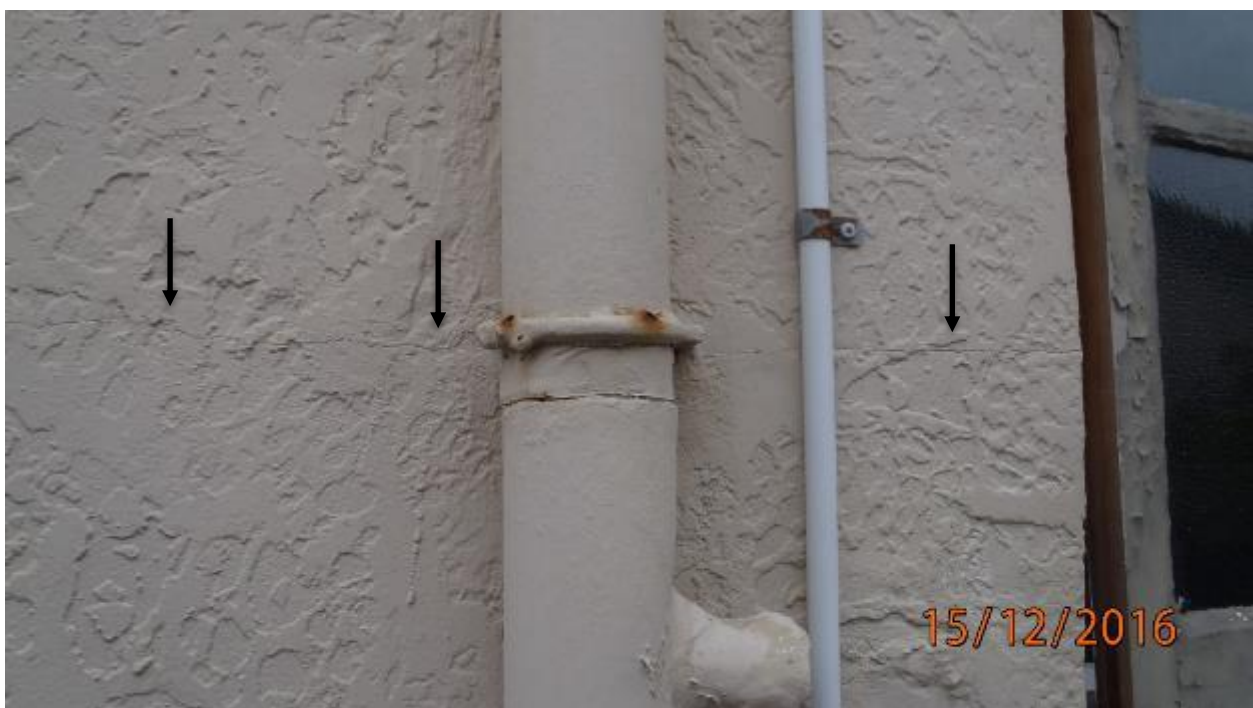
We noted horizontal cracking to the cement rendered brick surface extending between the Bedroom 2 and Bathroom windows. **[Photograph 16]**

Photograph 16 shows horizontal cracking to the cement rendered brick surface extending between the Bedroom 2 and Bathroom windows.

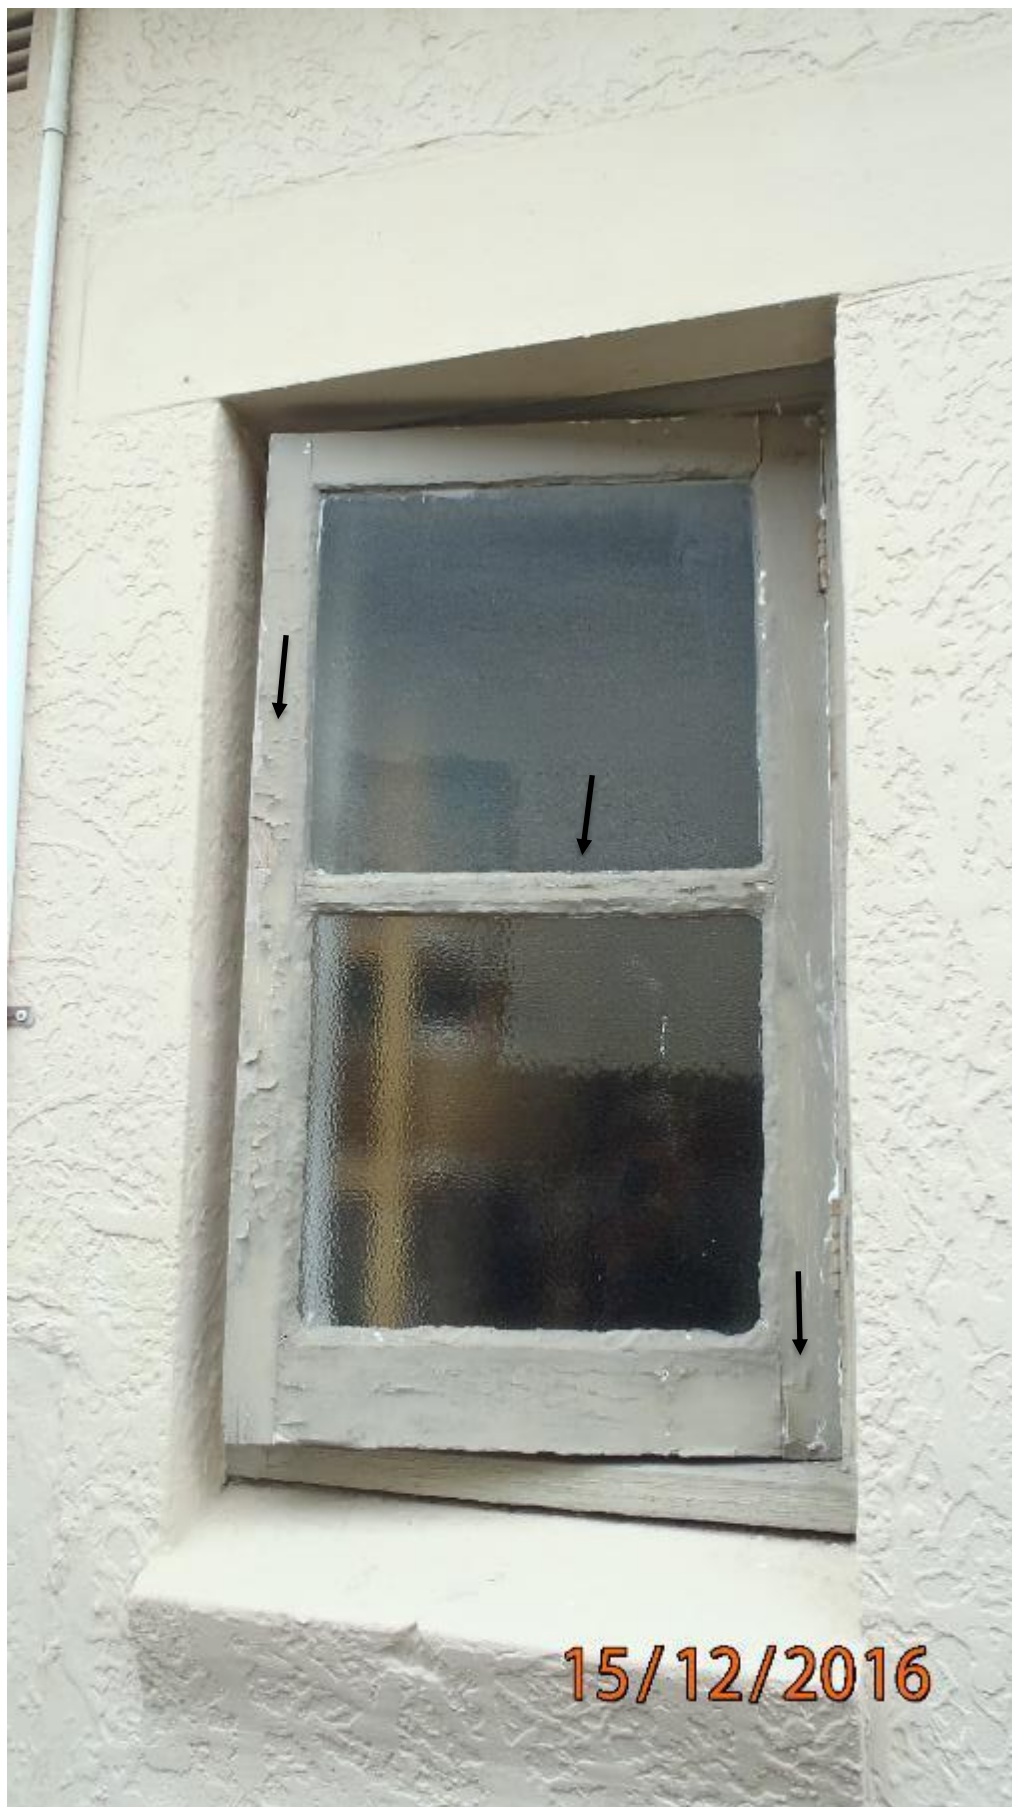
We noted that there is flaking paint to the Bathroom window. **[Photograph 17]**

Photograph 17 shows the flaking paint to the Bathroom window.

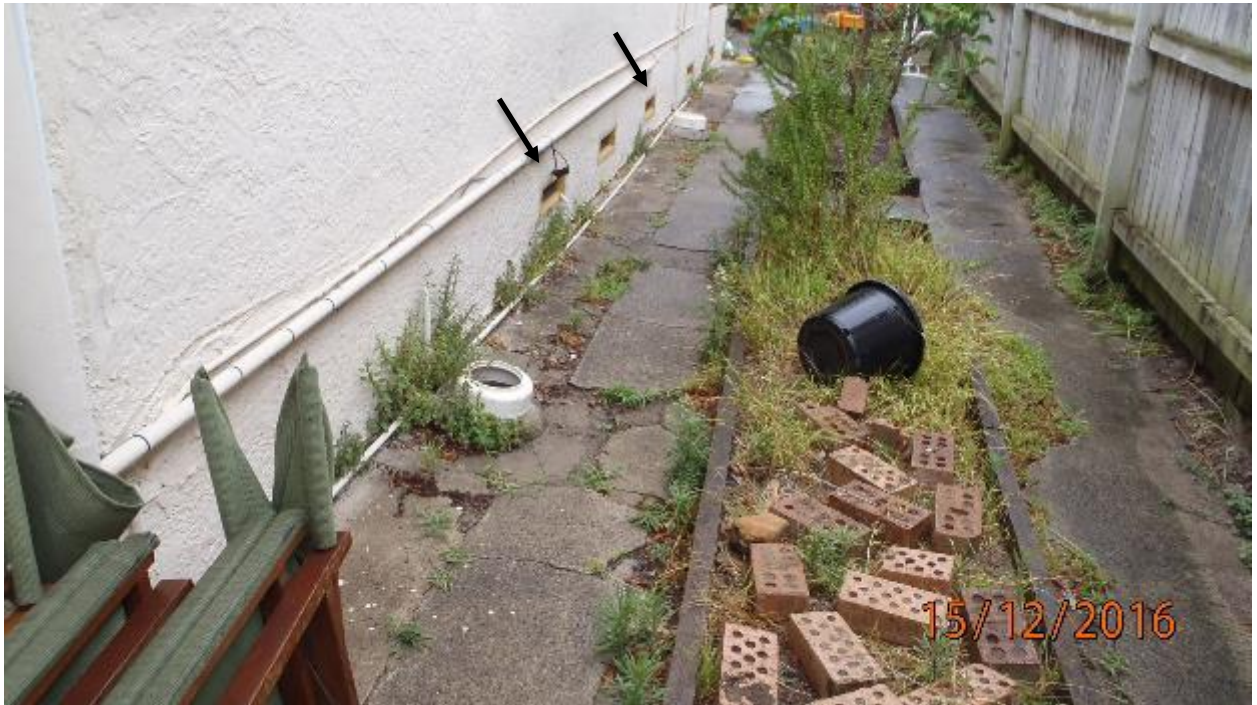
We noted general cracking to the concrete pathway / driveway and vegetation growth between the cracks. **[Photograph 18]**

We noted general rusting to the under-floor vents along the northern wall. **[Photograph 18]**

Photograph 18 shows general cracking to the concrete pathway / driveway, vegetation growth between the cracks and rusting to the under-floor vents.

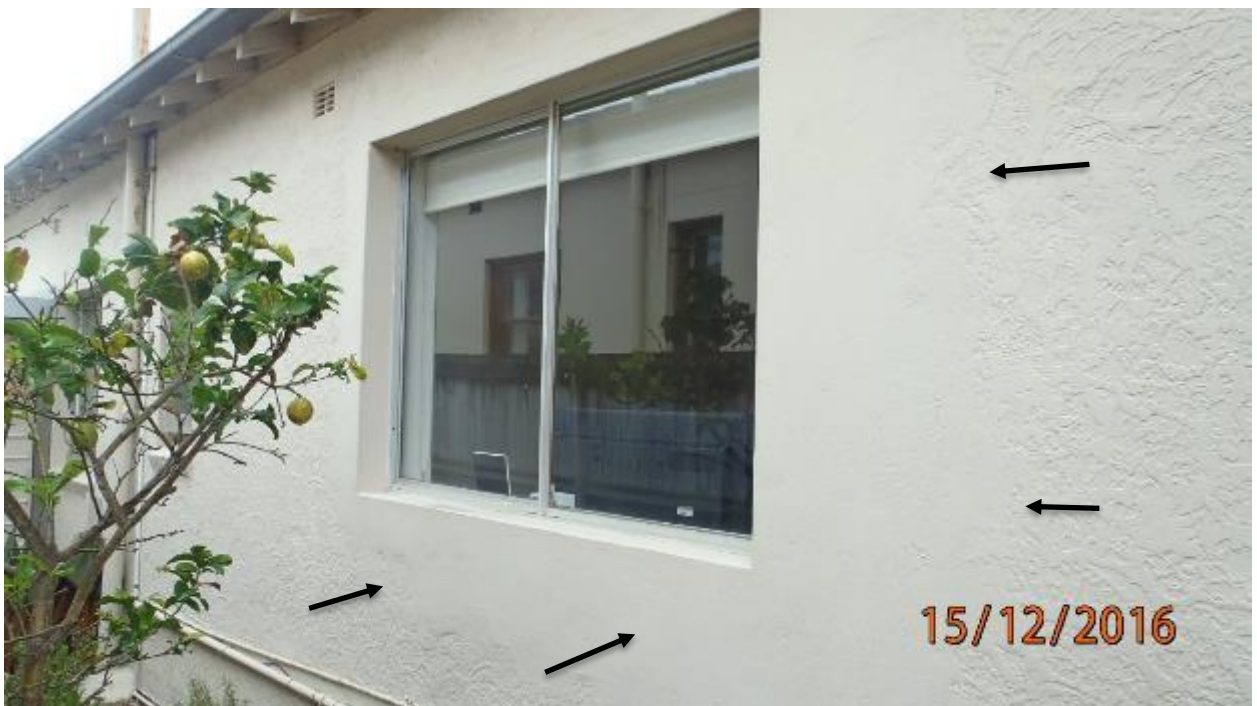
We noted evidence of previous repairs (different surface texture) around the Lounge Room window. **[Photograph 19]**

Photograph 19 shows evidence of previous repairs around the Lounge Room window.

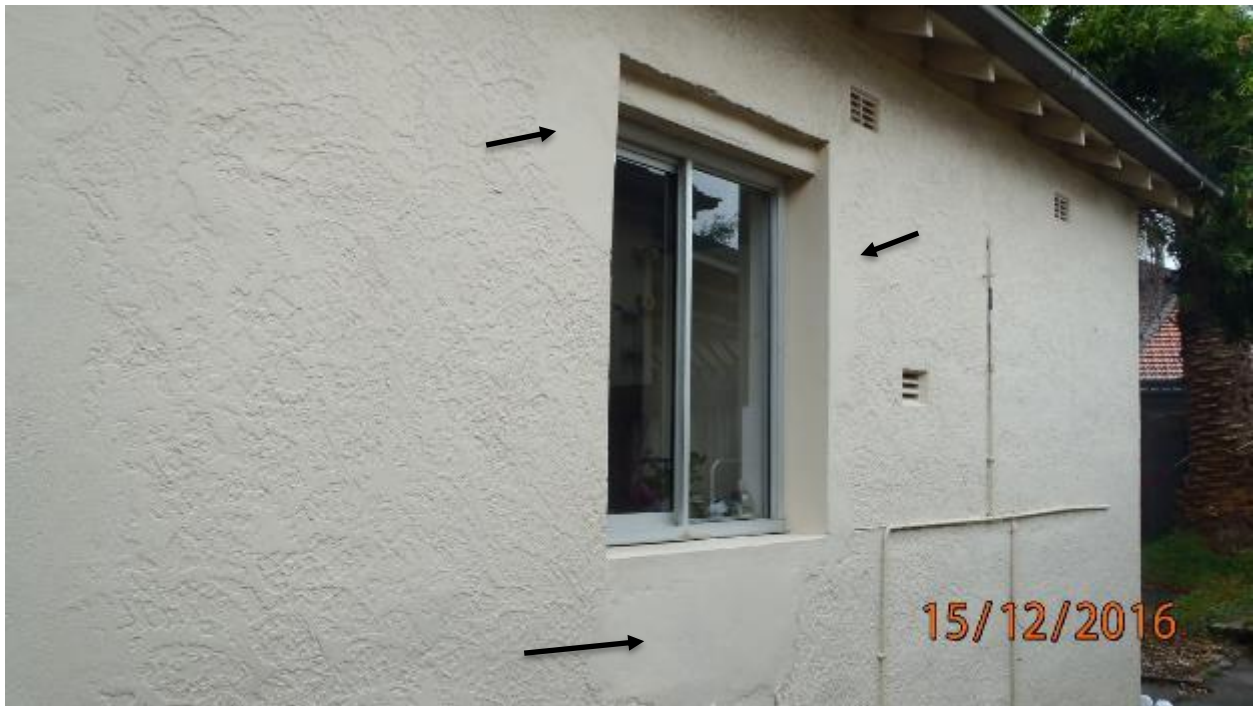
We noted evidence of previous repairs (different surface texture) around the Kitchen window. **[Photograph 20]**

Photograph 20 shows evidence of previous repairs around the Kitchen window.

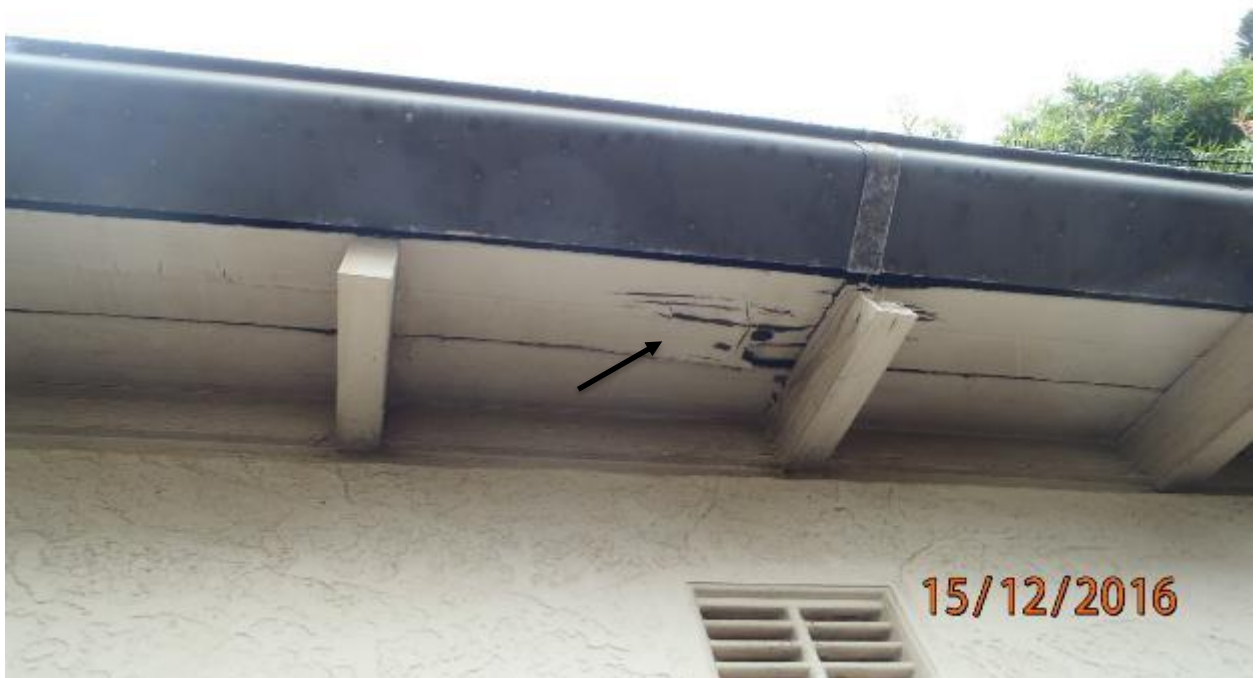
We noted deterioration to the timber lined eave soffits in the north-western corner. **[Photograph 21]**

Photograph 21 shows deterioration to the timber lined eave soffits in the north-western corner.
