Dilapidation Assessment Report

Prepared for: Cape Cod Australia Pty. Limited
Job address: 29 Knowles Avenue, North Bondi.
Property Owner/s: Unknown. Access via Tenant.
Report reference: **WAVERLEY COUNCIL**
Development Application No: not available
Date of assessment: 15th December 2016

Re: Dilapidation Report – No. 29 Knowles Avenue, North Bondi.

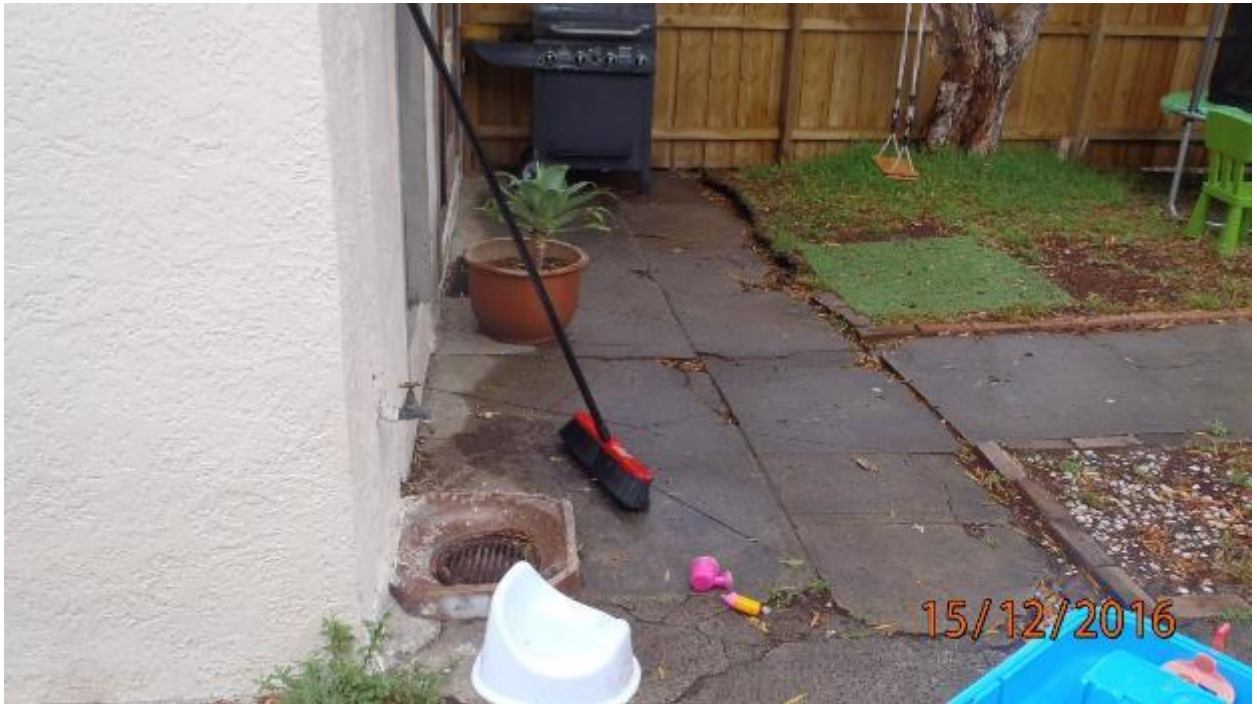
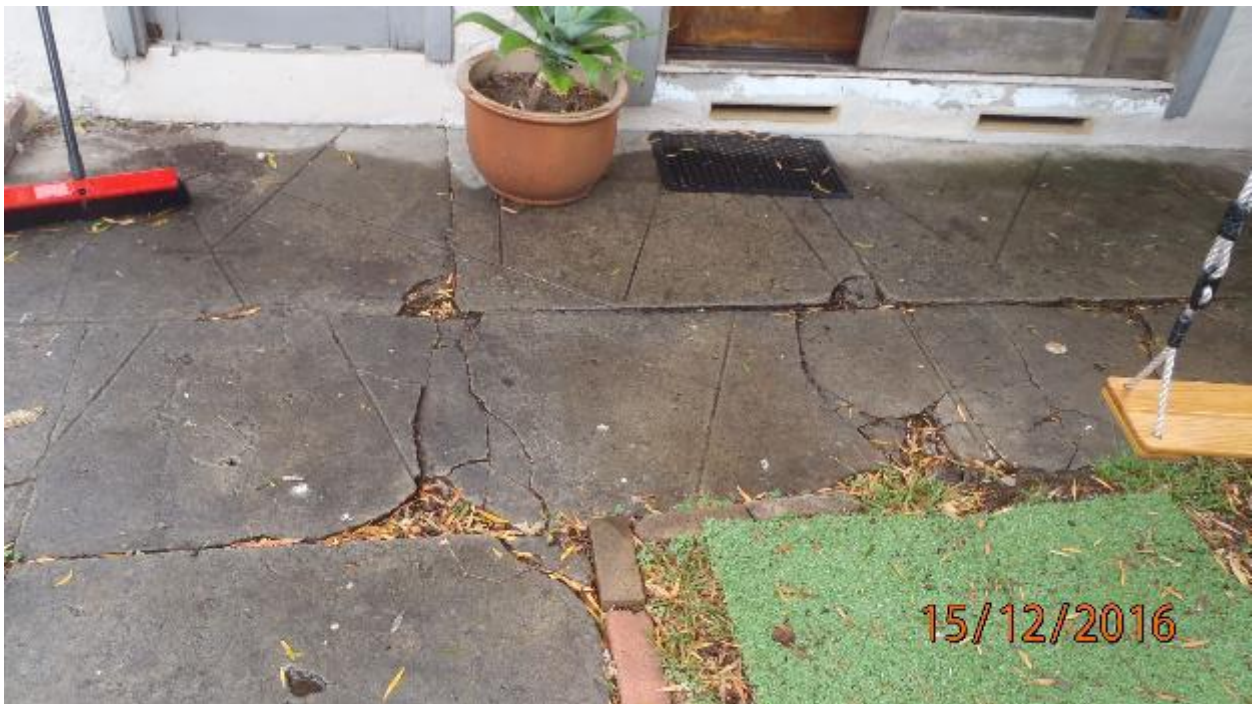
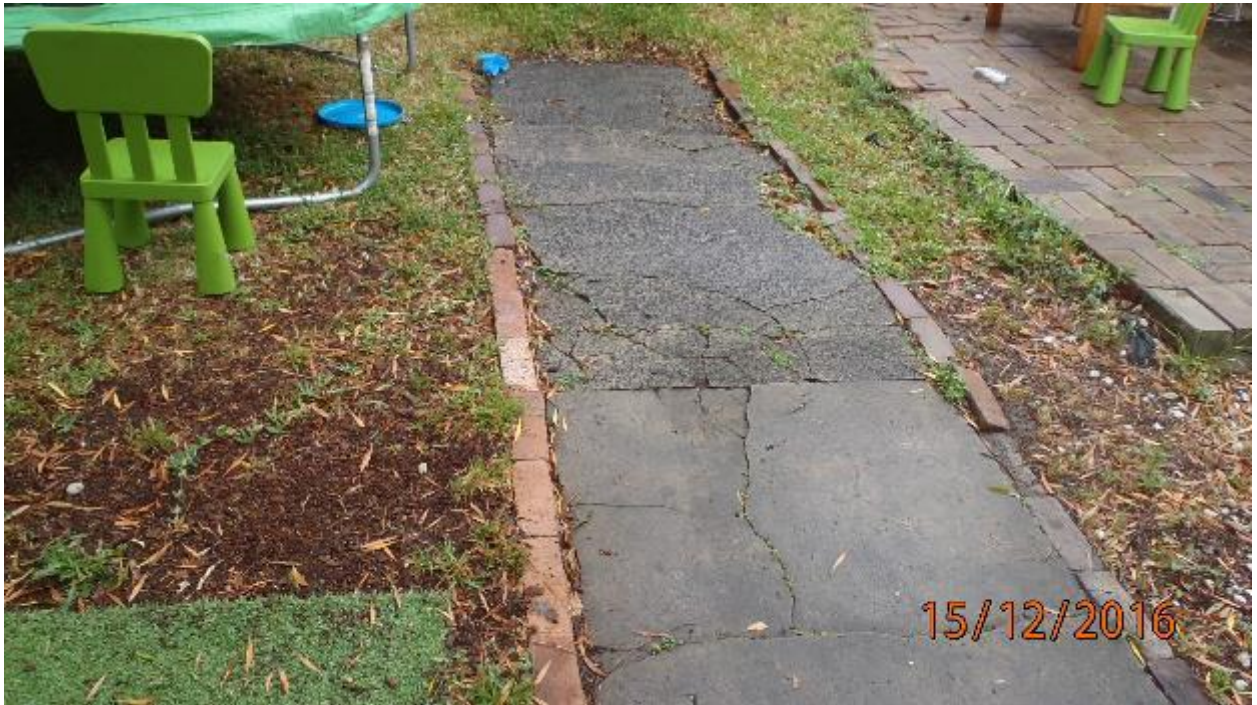
We noted general cracking to the concrete pathways. **[Photographs 22, 23 & 24]**

Photograph 22 shows the general condition of the rear the concrete pathways.

Photograph 23 shows the general condition of the rear the concrete pathways.

Photograph 24 shows the general condition of the rear the concrete pathways.

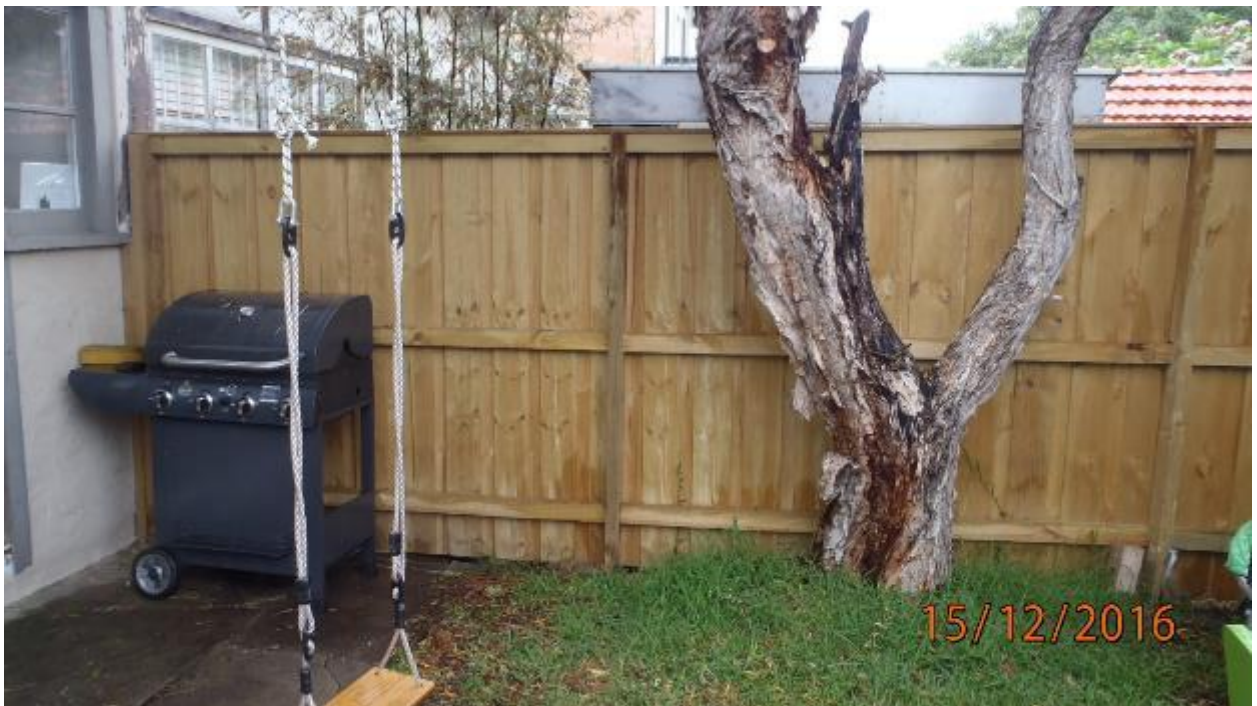
We noted that there is a timber post and rail fence constructed on the *common* boundary between the adjoining property, No. 31 Knowles Avenue, North Bondi. **[Photograph 25]**

Photograph 25 shows the general condition of the *common* boundary between the adjoining property, No. 31 Knowles Avenue, North Bondi.

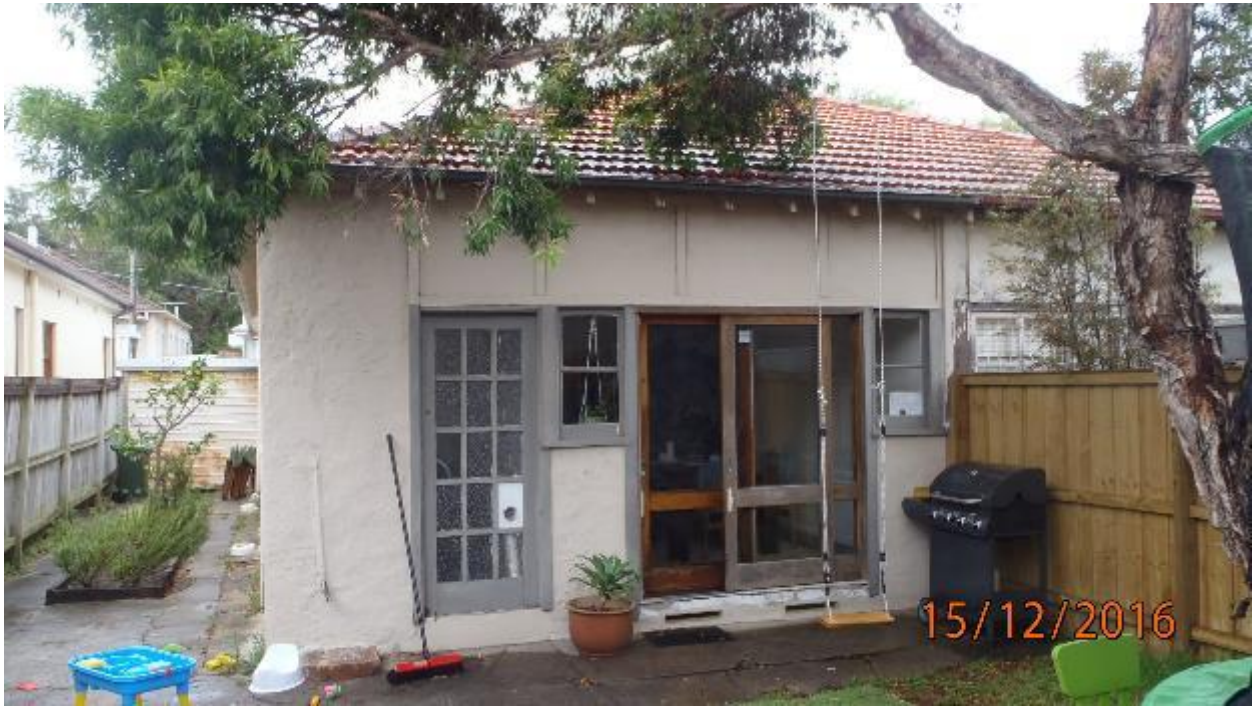
We did not observe any recent cracking to the surface coated clay masonry brickwork. **[Photograph 26]**

Photograph 26 shows the general condition of the rear western elevation.

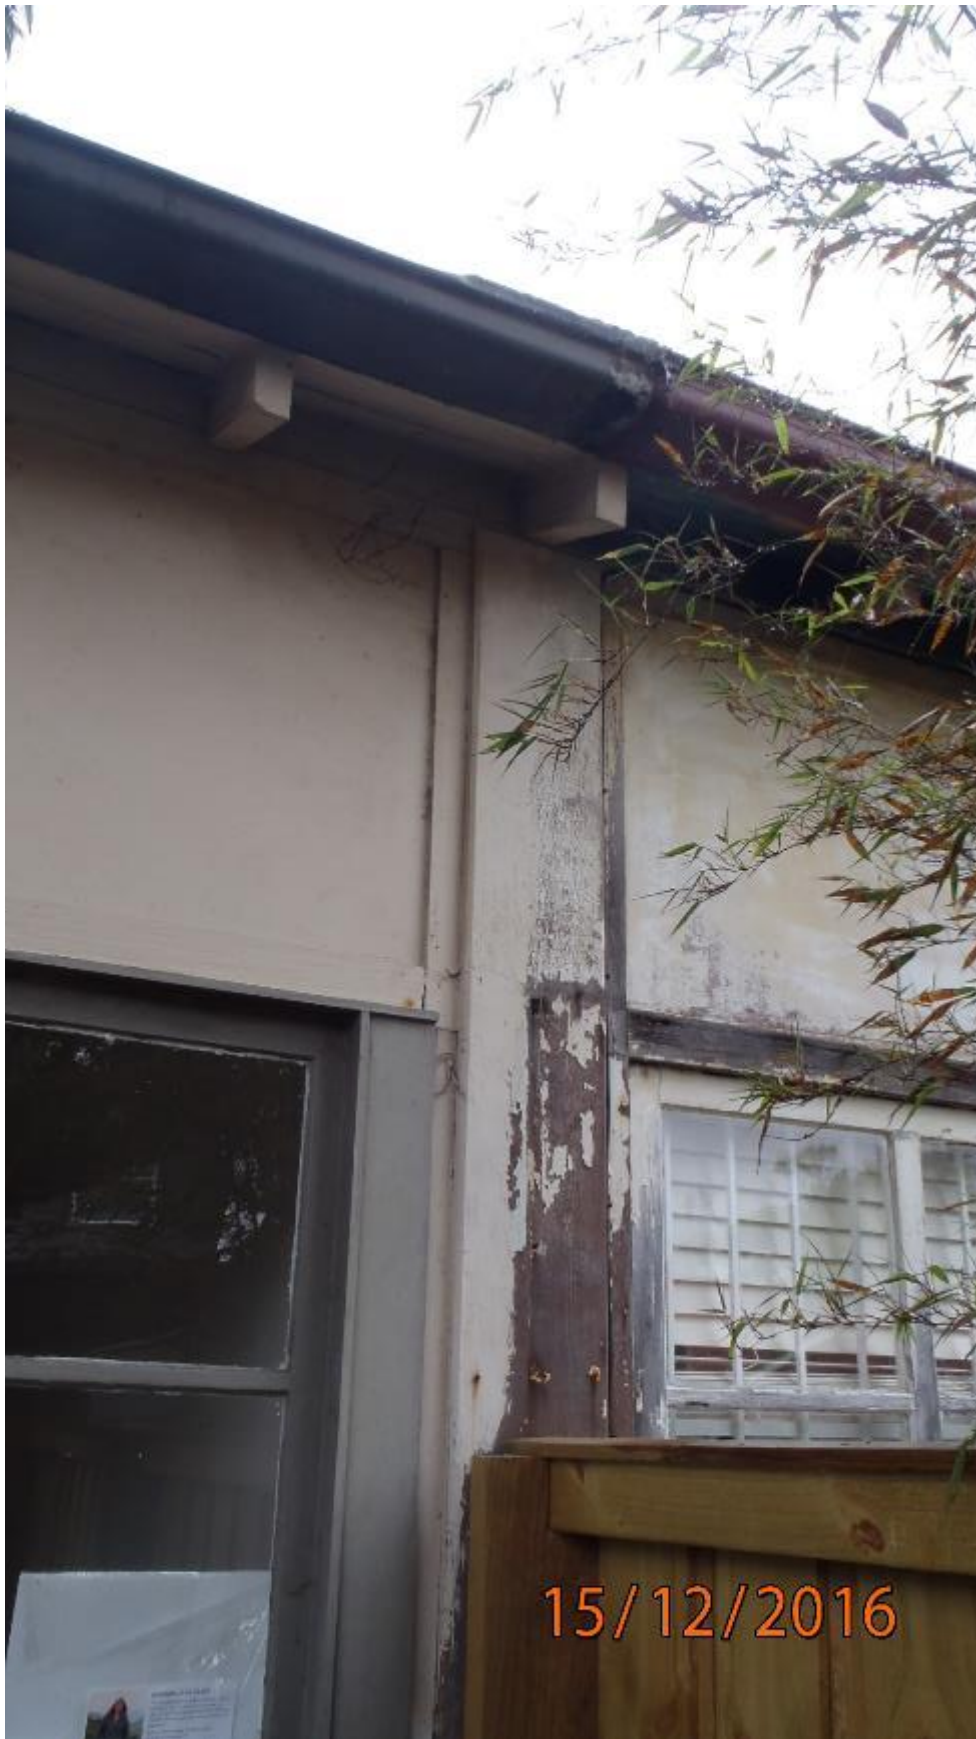
We noted that there is flaking paint to the timber trim above the *common* boundary fence between the adjoining property, No. 31 Knowles Avenue, North Bondi. **[Photograph 27]**

Photograph 27 shows flaking paint to the timber trim above the *common* boundary fence between the adjoining property, No. 31 Knowles Avenue, North Bondi

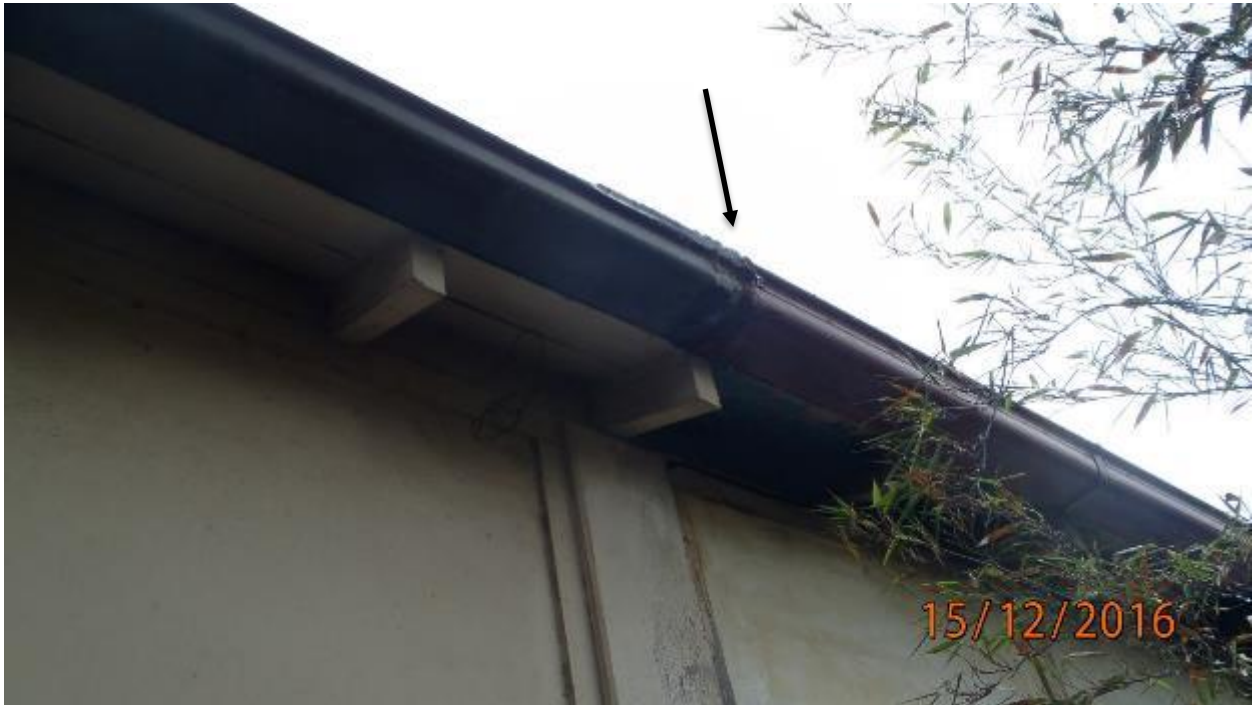
We noted rusting to the gutter system above the *common* boundary fence between the adjoining property, No. 31 Knowles Avenue, North Bondi. **[Photograph 28]**

Photograph 28 shows rusting to the gutter system above the *common* boundary fence between the adjoining property, No. 31 Knowles Avenue, North Bondi.

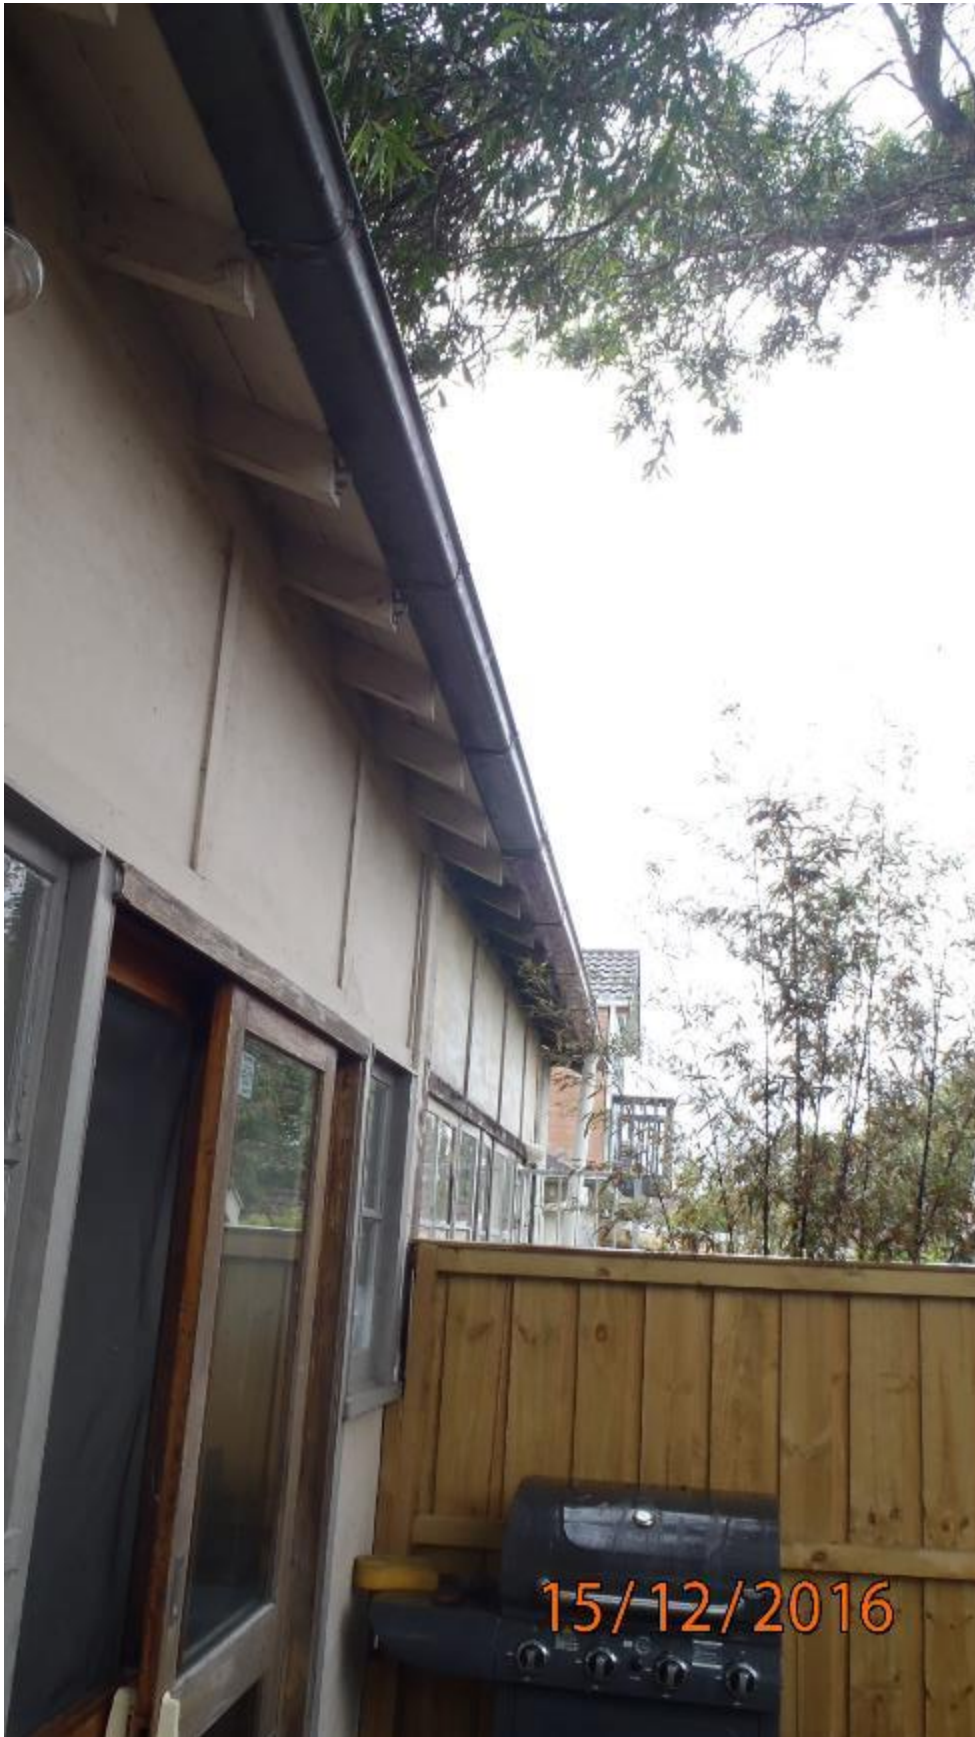
We noted that the rear gutter system has no connection the stormwater and discharges via the common gutter system with the adjoining property, No. 31 Knowles Avenue, North Bondi. **[Photograph 29]**

Photograph 29 shows the rear gutter system has no connection the stormwater and discharges via the common gutter system with the adjoining property, No. 31 Knowles Avenue, North Bondi.

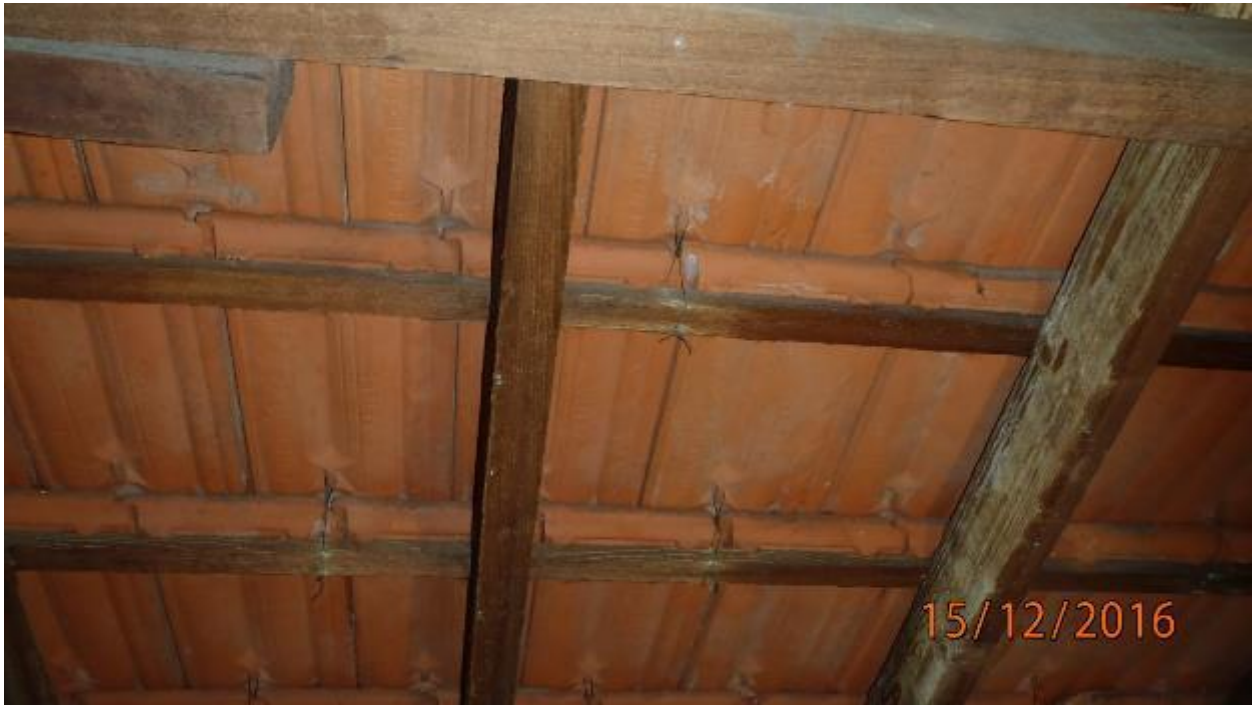
We noted that there is no sarking provided to the underside of the roofing tiles. We further noted that the roof and ceiling timbers that are accessible are generally in good condition. **[Photograph 30]**

Photograph 30 shows there is no sarking provided to the underside of the roofing tiles and the general condition of the roofing timbers.

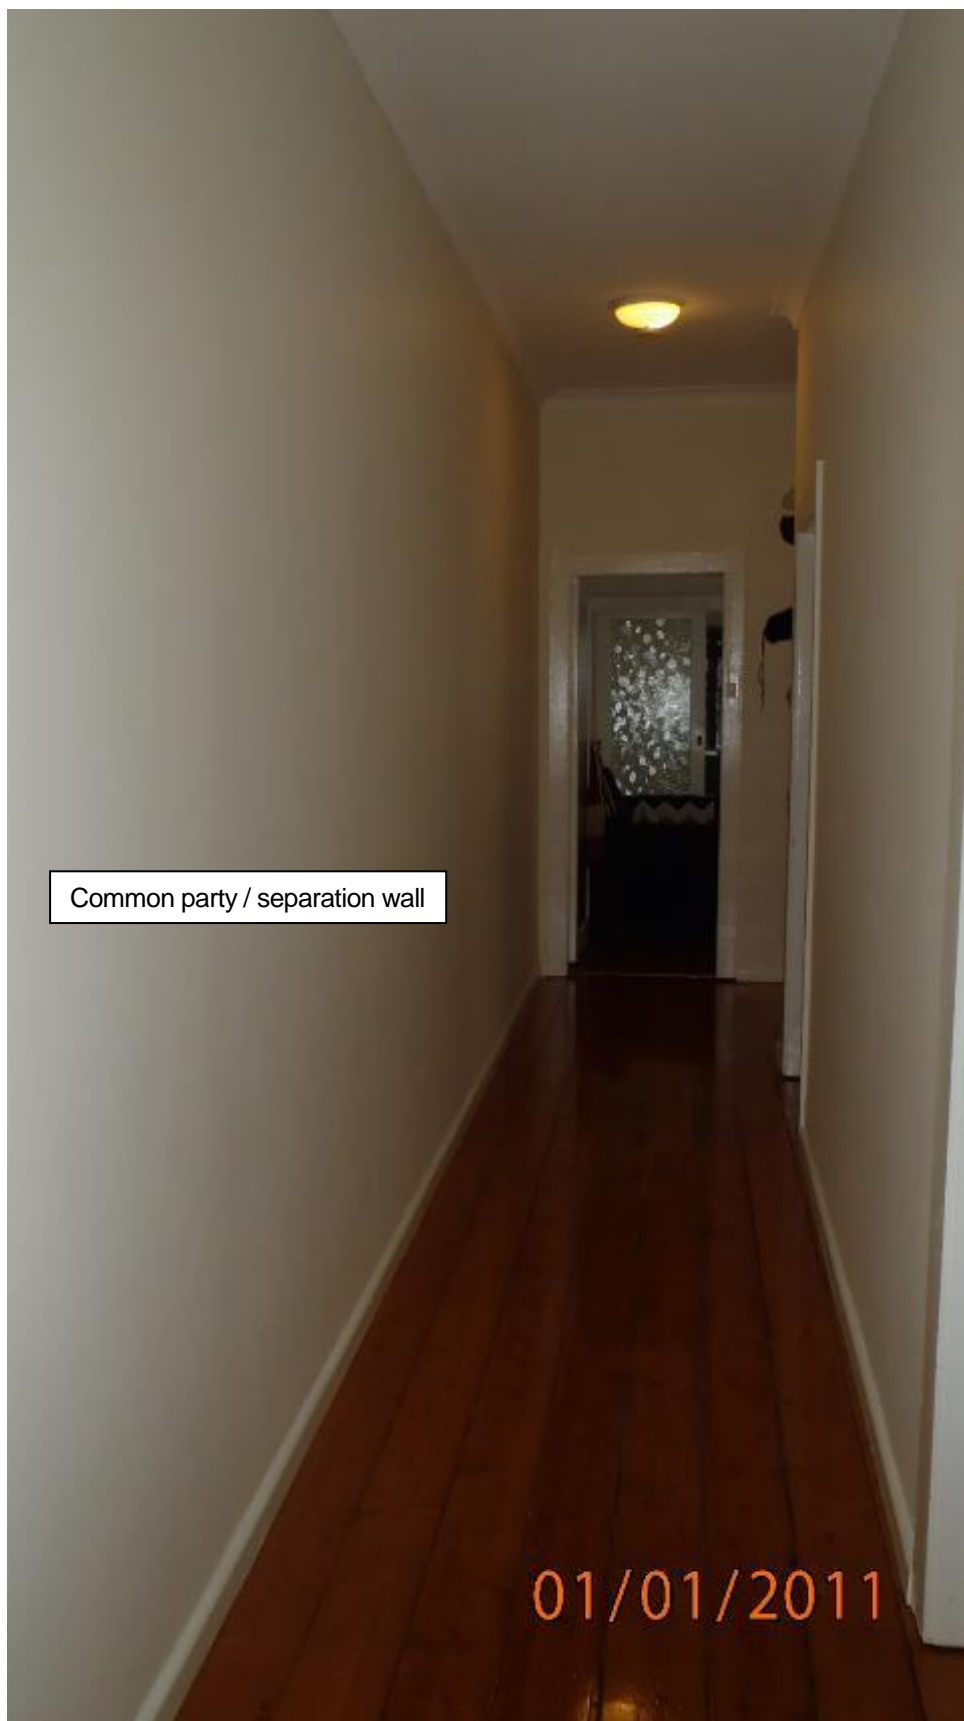
We noted that the hallway is lined with strip timber flooring. **[Photograph 31]**

Photograph 31 shows the general condition of the hallway. Note: *Common party / separation wall* between the adjoining property, No. 31 Knowles Avenue, North Bondi.

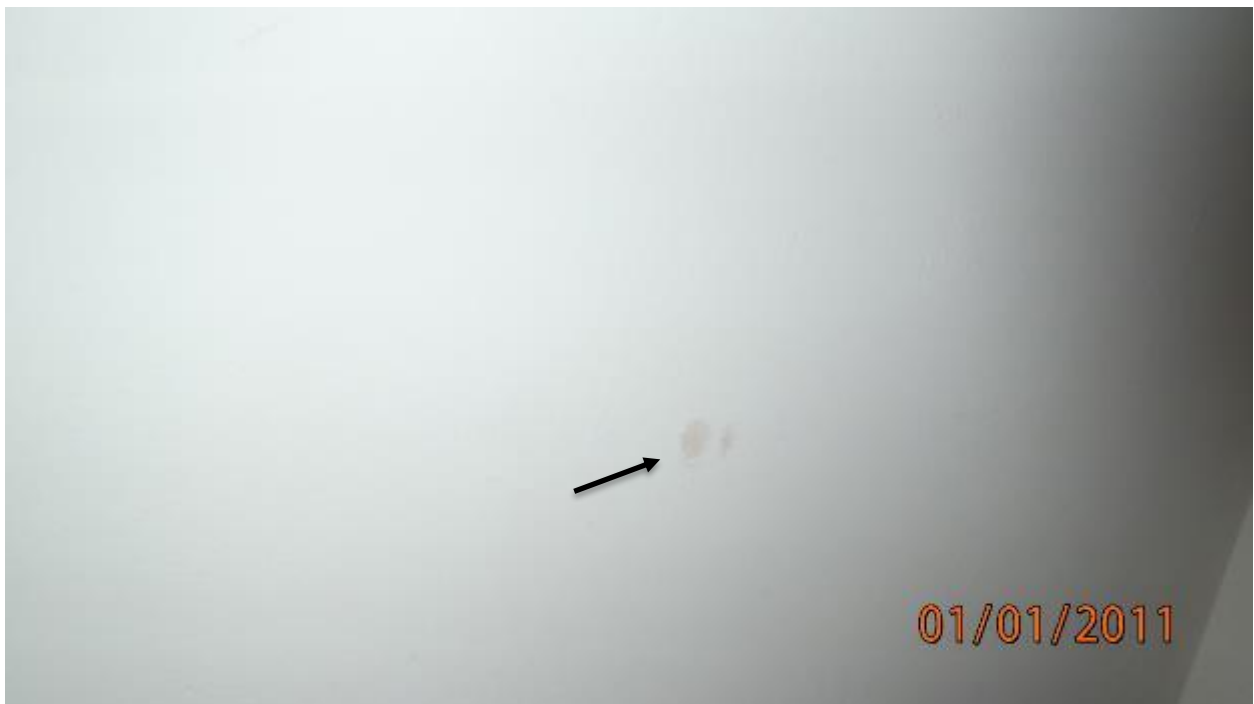
We noted flaking paint to the cement rendered wall outside Bedroom 1. **[Photograph 33]**

Photograph 33 shows flaking paint to the cement rendered wall outside Bedroom 1.

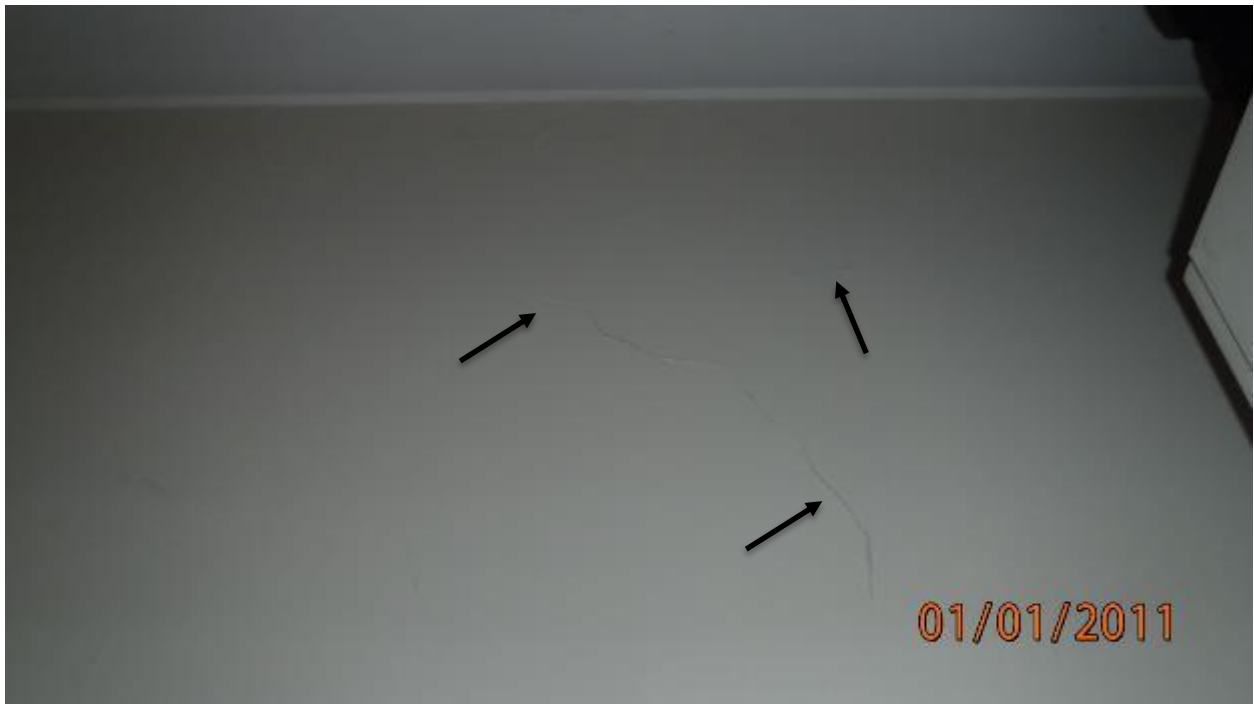
We noted radial cracking [1.0 mm] and flaking paint to painted cement rendered eastern wall. **[Photograph 36]**

Photograph 36 shows radial cracking and flaking paint to painted cement rendered eastern wall of Bedroom 1.

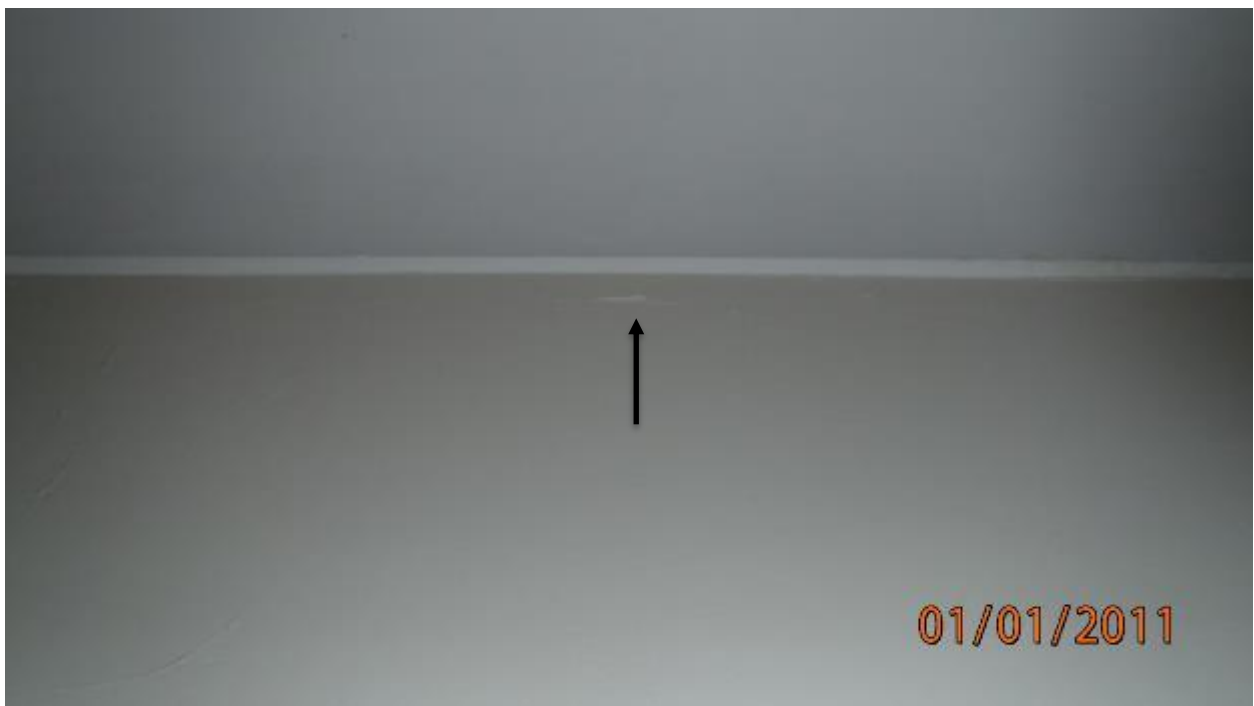
We noted flaking paint to painted cement rendered eastern wall under the wide profiled plaster cornice. **[Photograph 37]**

Photograph 37 shows flaking paint to painted cement rendered eastern wall under the wide profiled plaster cornice in Bedroom 1.

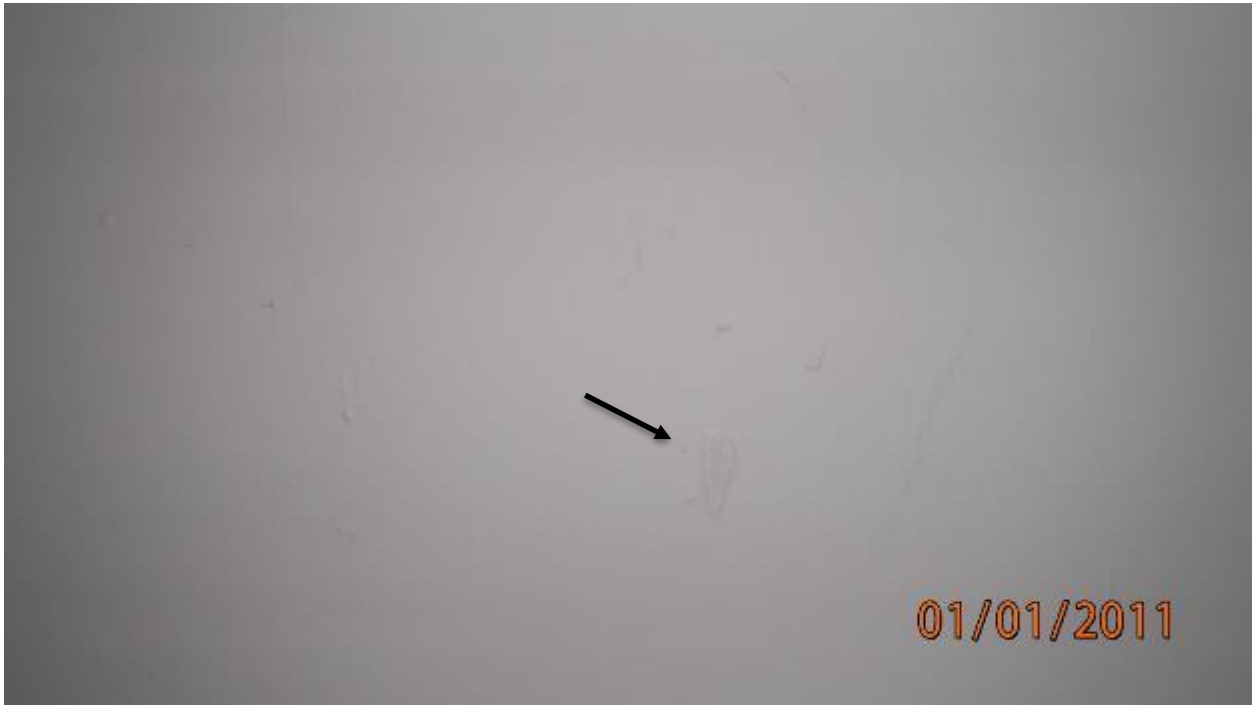
We noted flaking paint to painted cement rendered northern external wall. **[Photograph 38]**

Photograph 38 shows flaking paint to painted cement rendered northern external wall in Bedroom 1.

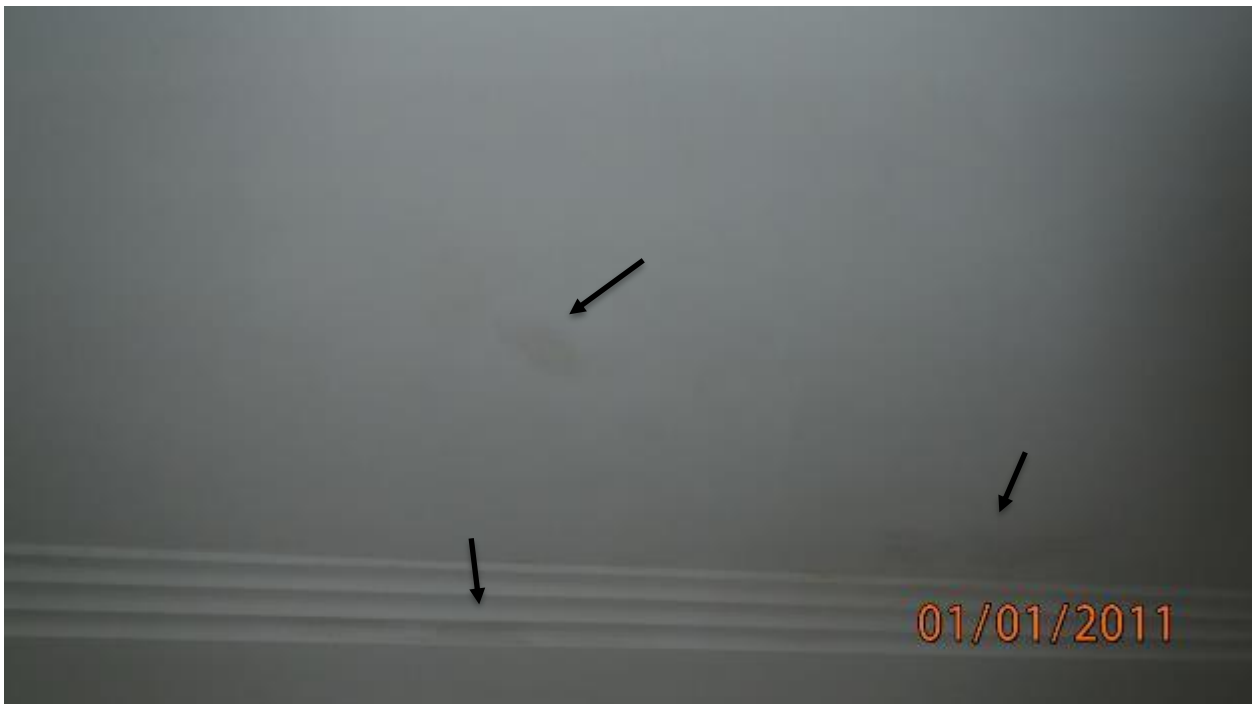
We noted staining to the plaster ceiling lining and cornice in the north-western corner. **[Photograph 39]**

Photograph 39 shows staining to the plaster ceiling lining and cornice in the north-western corner of Bedroom 1.

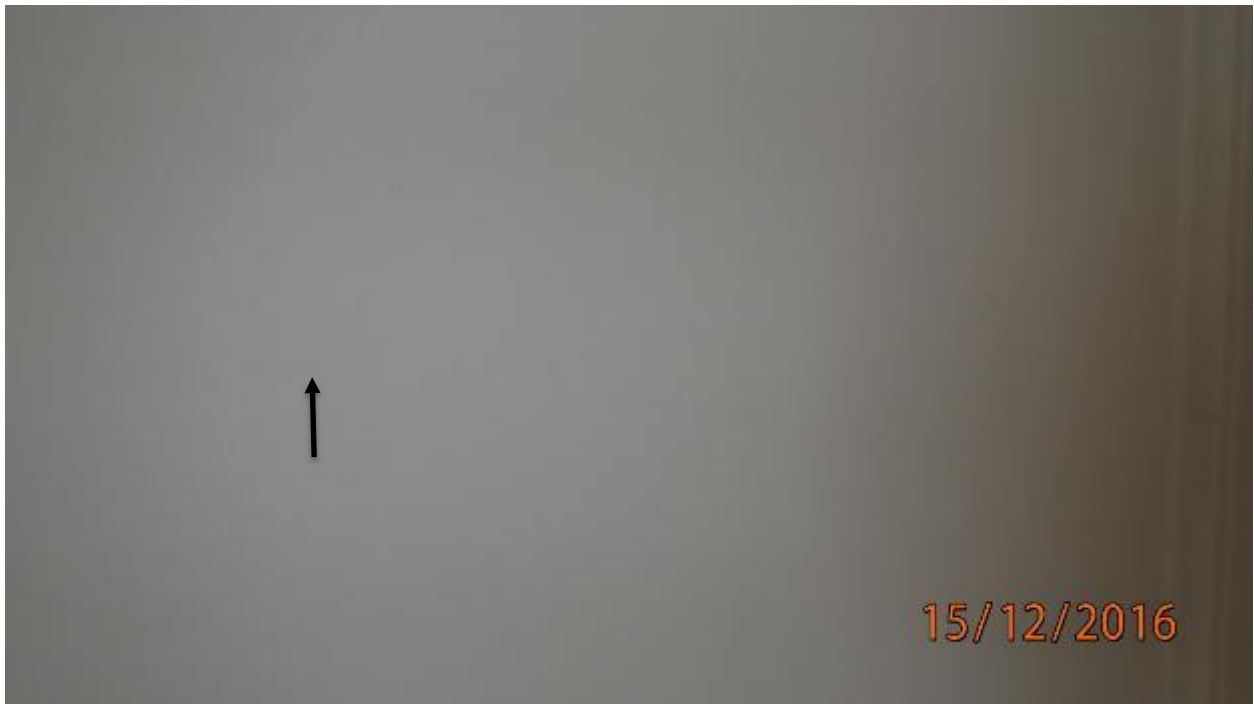
We noted hairline separation cracking [< 0.1 mm] to the fibrous plaster ceiling running east-west down the centre of the room. **[Photograph 40]**

Photograph 40 shows separation cracking to the fibrous plaster ceiling running east-west down the centre of the Bedroom 2.

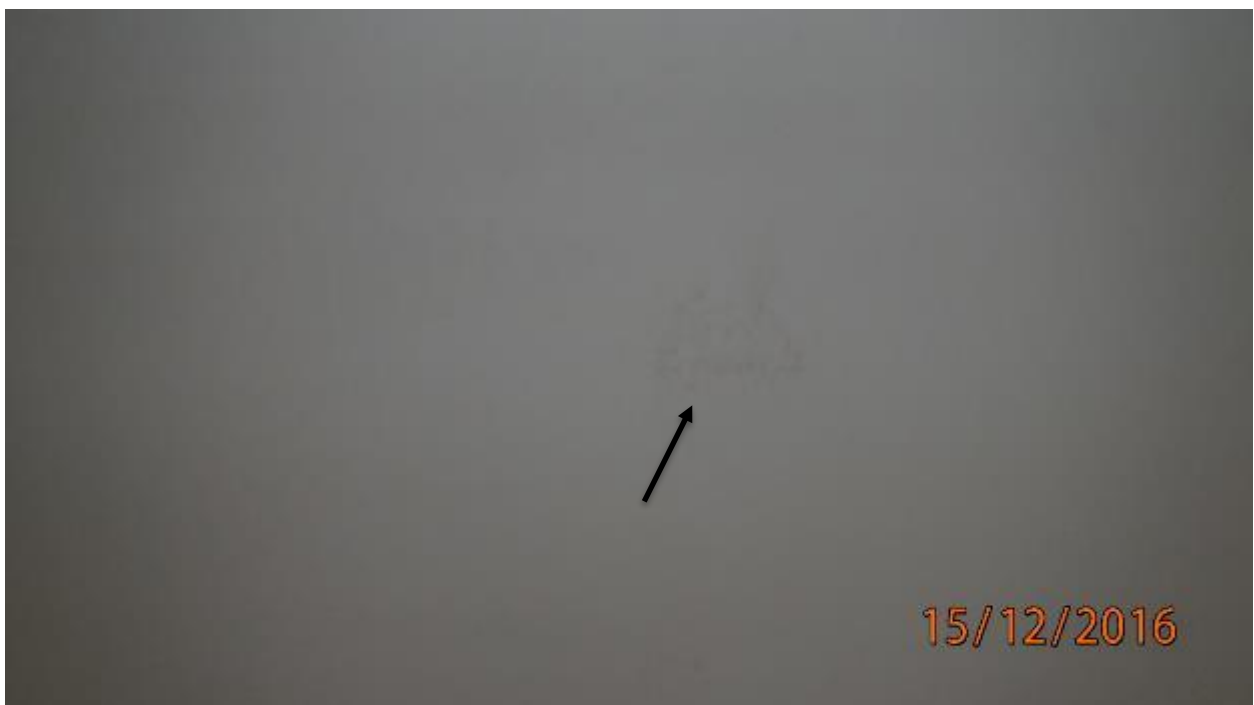
We noted staining to the plaster ceiling lining in the south-western corner. **[Photograph 41]**

Photograph 41 shows staining to the plaster ceiling lining in the south-western corner of Bedroom 2.

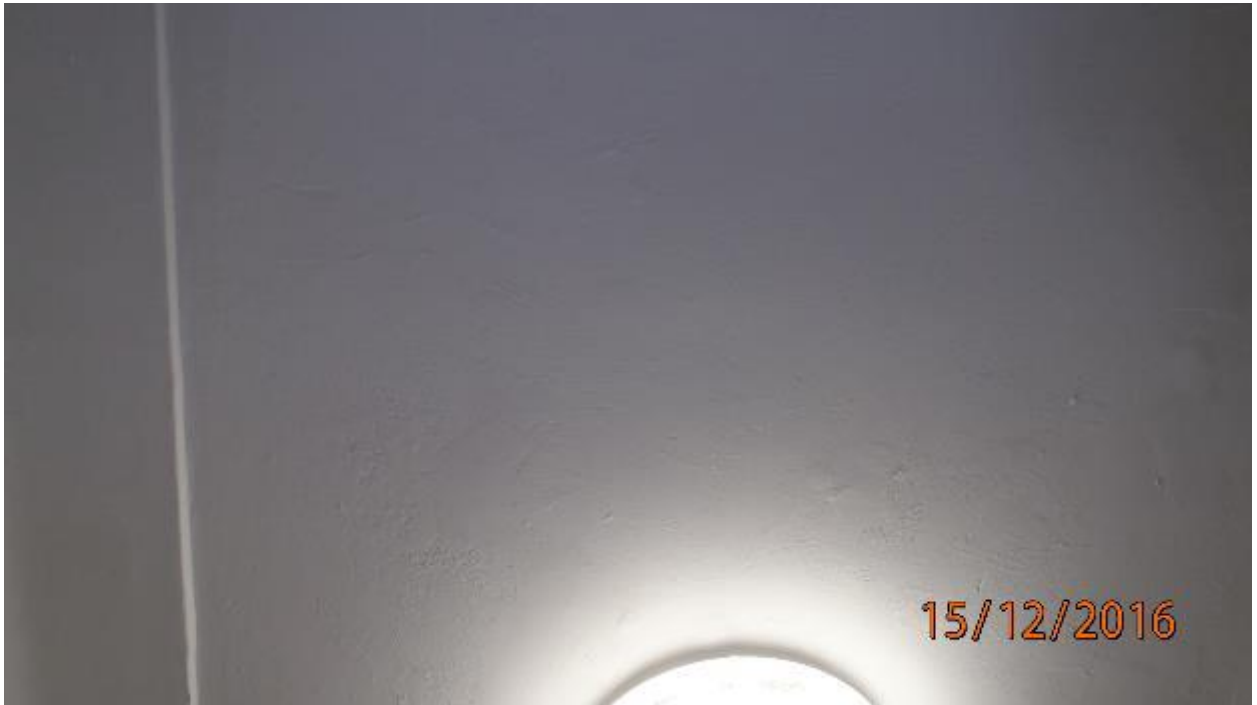
We noted evidence of previous repairs to the fibrous plaster ceiling lining. **[Photograph 42]**

Photograph 42 shows evidence of previous repairs to the fibrous plaster ceiling lining in the Bathroom.

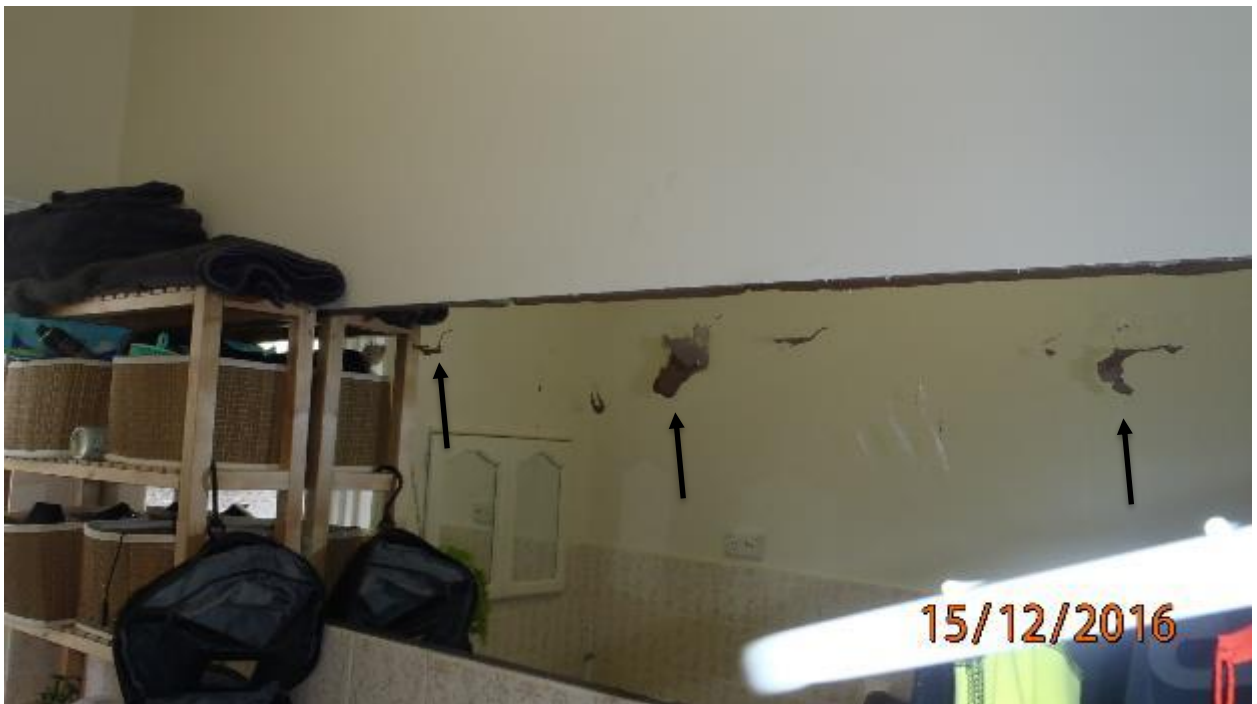
We noted deterioration to the mirrored surface on the eastern wall. **[Photograph 43]**

Photograph 43 shows deterioration to the mirrored surface on the eastern wall in the Bathroom.

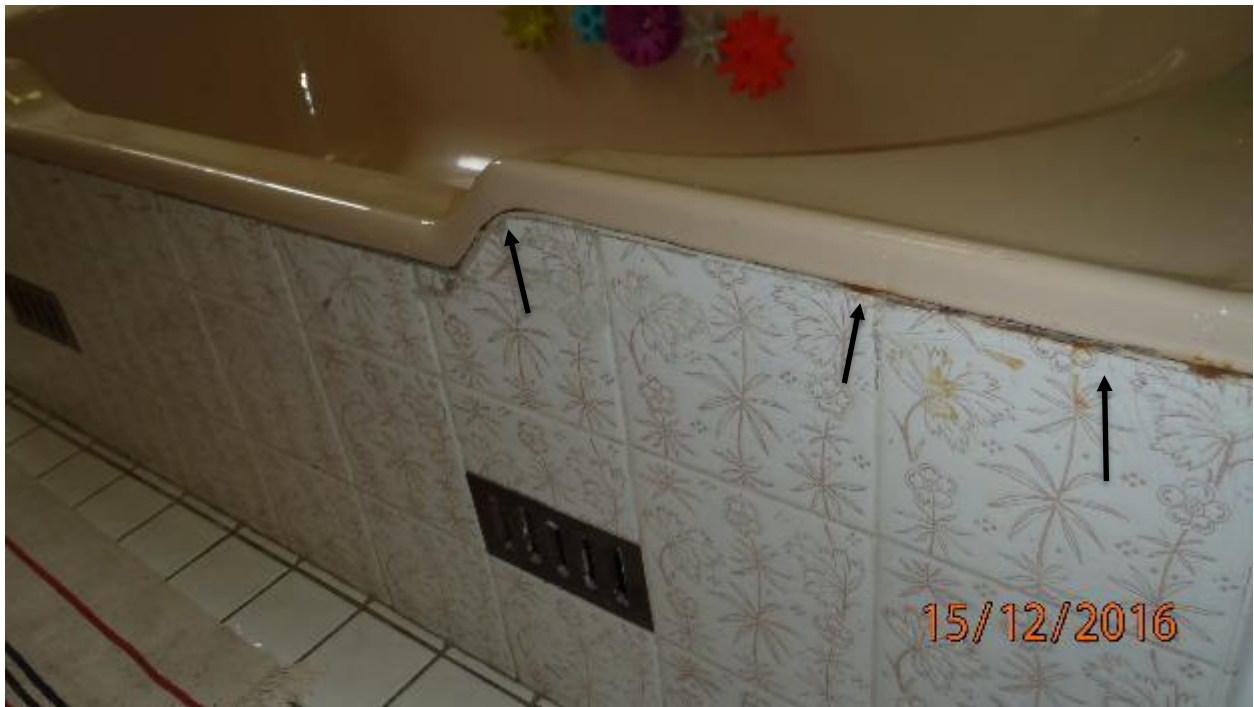
We noted cracking and staining to the grout on the bath plinth. **[Photograph 44]**

Photograph 44 shows cracking and staining to the grout on the bath plinth.

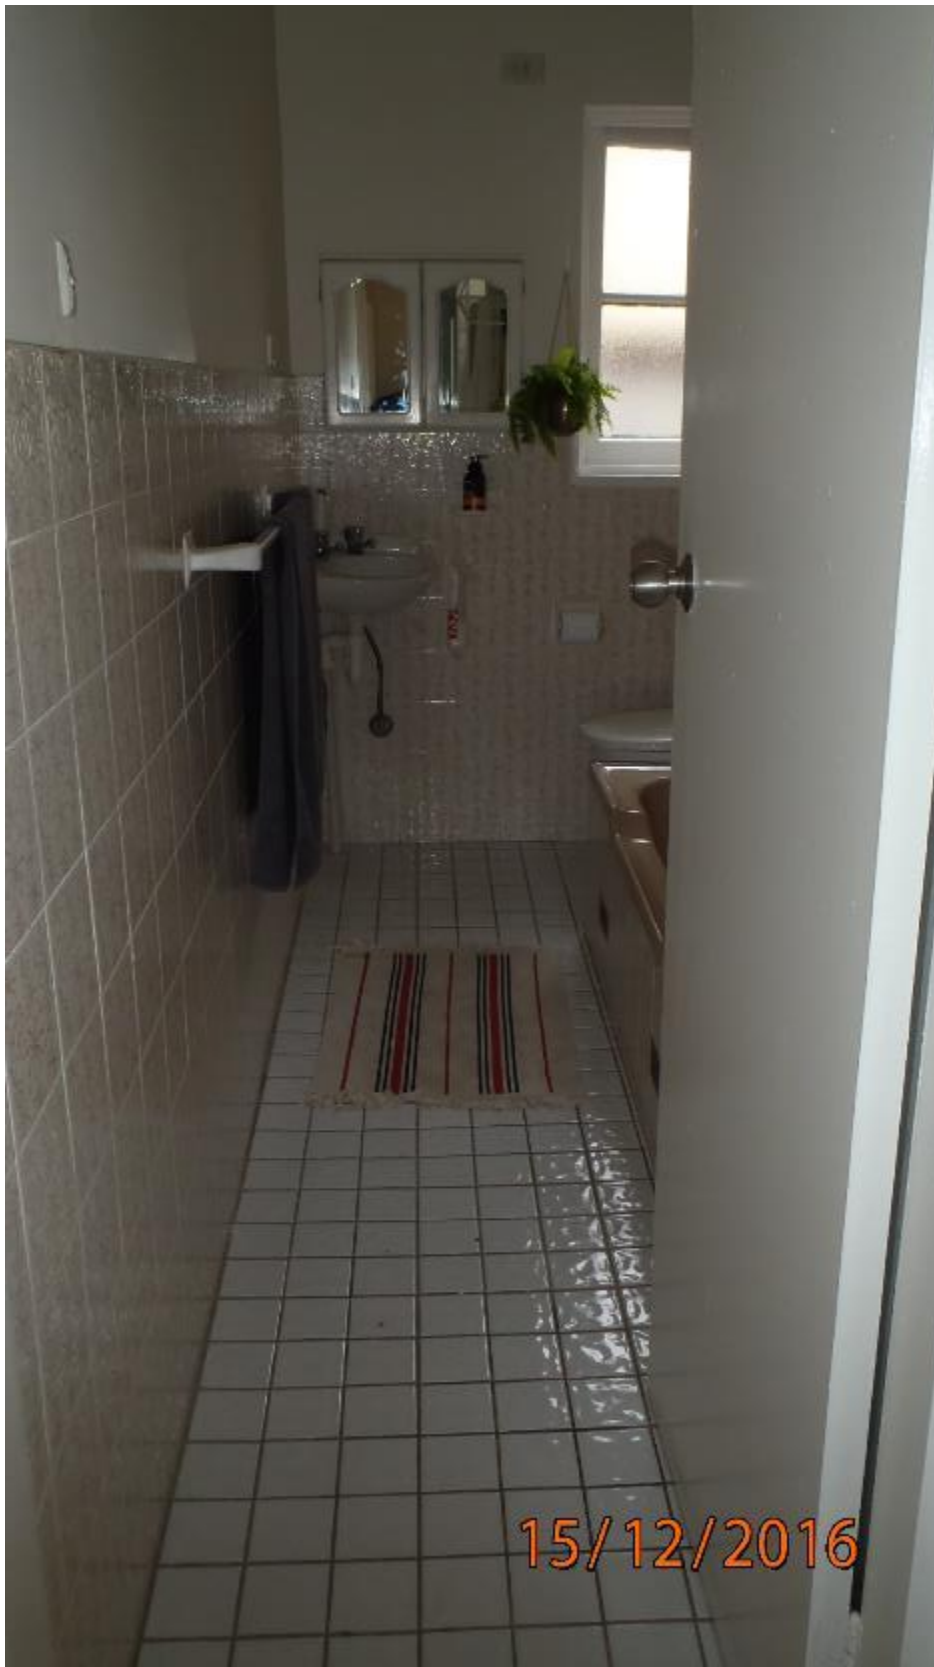
We noted that the grout to the wall and floor tiles is complete and that the wall and floor tiles when randomly "tap" tested appeared to be sound. We did not observe any recent cracking to the tile grout at the wall / wall, wall / floor junctions. **[Photograph 45]**

Photograph 45 shows the general condition of the bathroom.
