Dilapidation Assessment Report

Prepared for: Cape Cod Australia Pty. Limited
Job address: 29 Knowles Avenue, North Bondi.
Property Owner/s: Unknown. Access via Tenant.
Report reference: **WAVERLEY COUNCIL**
Development Application No: not available
Date of assessment: 15th December 2016

Re: Dilapidation Report – No. 29 Knowles Avenue, North Bondi.

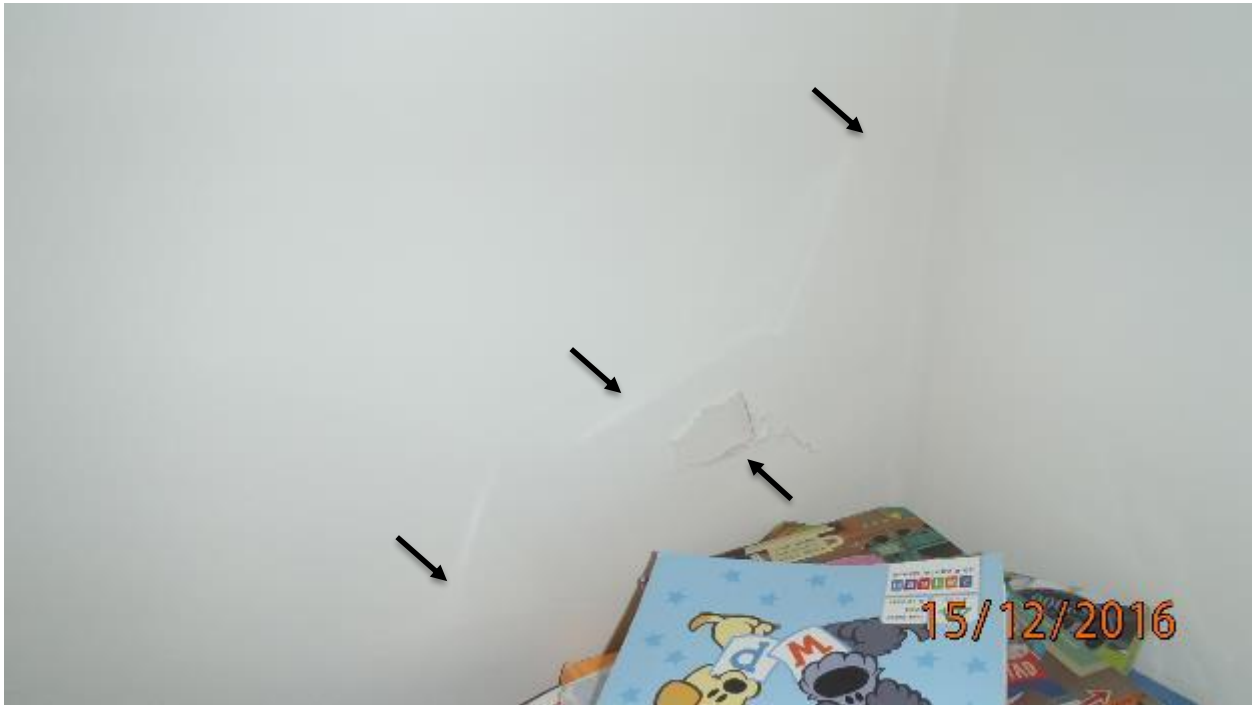
We noted flaking paint and evidence of previous repairs to the painted cement rendered wall in the north-eastern corner. **[Photograph 46]**

Photograph 46 shows flaking paint and evidence of previous repairs to the painted cement rendered wall in the north-eastern corner of the Lounge Room.

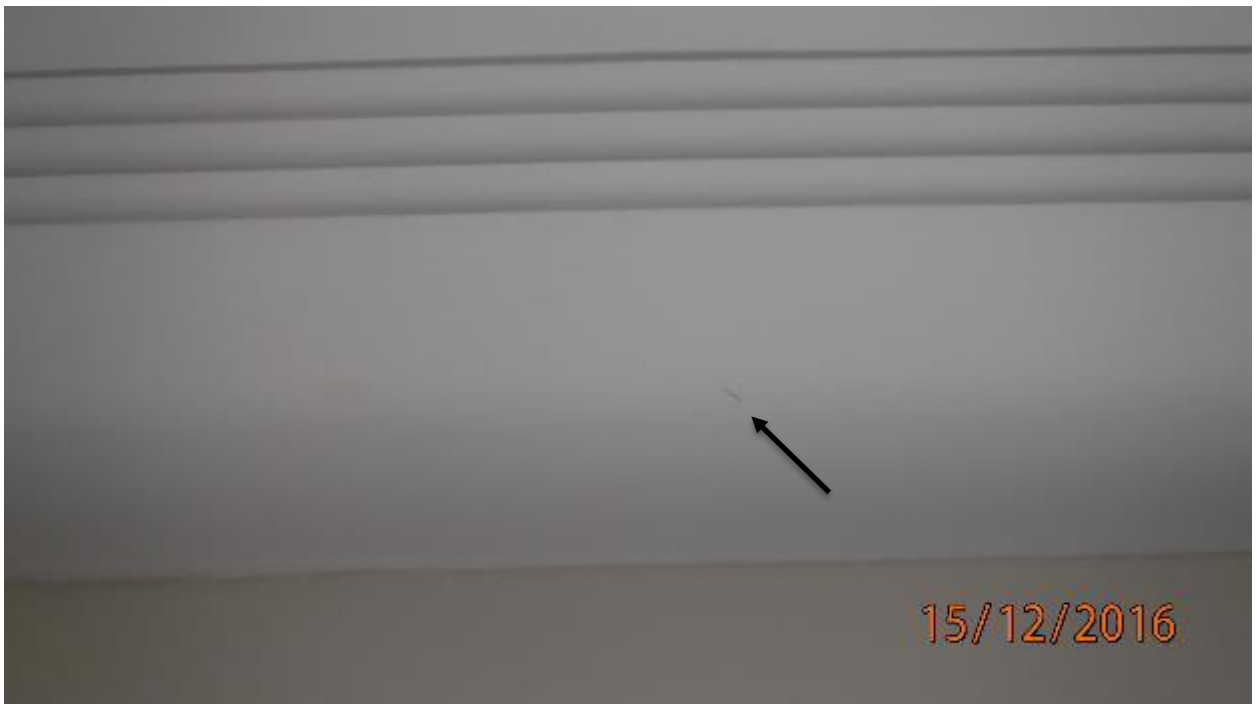
We noted flaking paint to the wide profiled plaster cornice above the window. **[Photograph 47]**

Photograph 47 shows flaking paint to the wide profiled plaster cornice above the window in the Lounge Room.

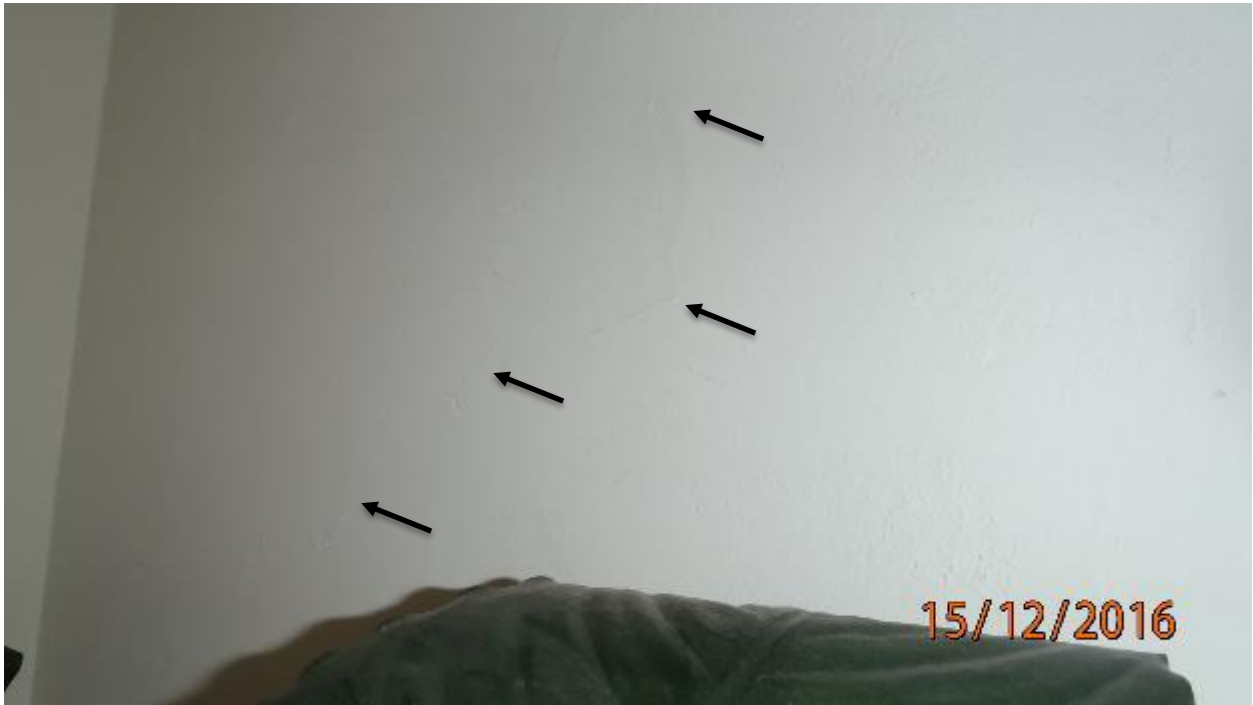
We noted evidence of previous repairs to the painted cement rendered wall in the north-western corner. **[Photograph 48]**

Photograph 48 shows evidence of previous repairs to the painted cement rendered wall in the north-western corner of the Lounge Room.

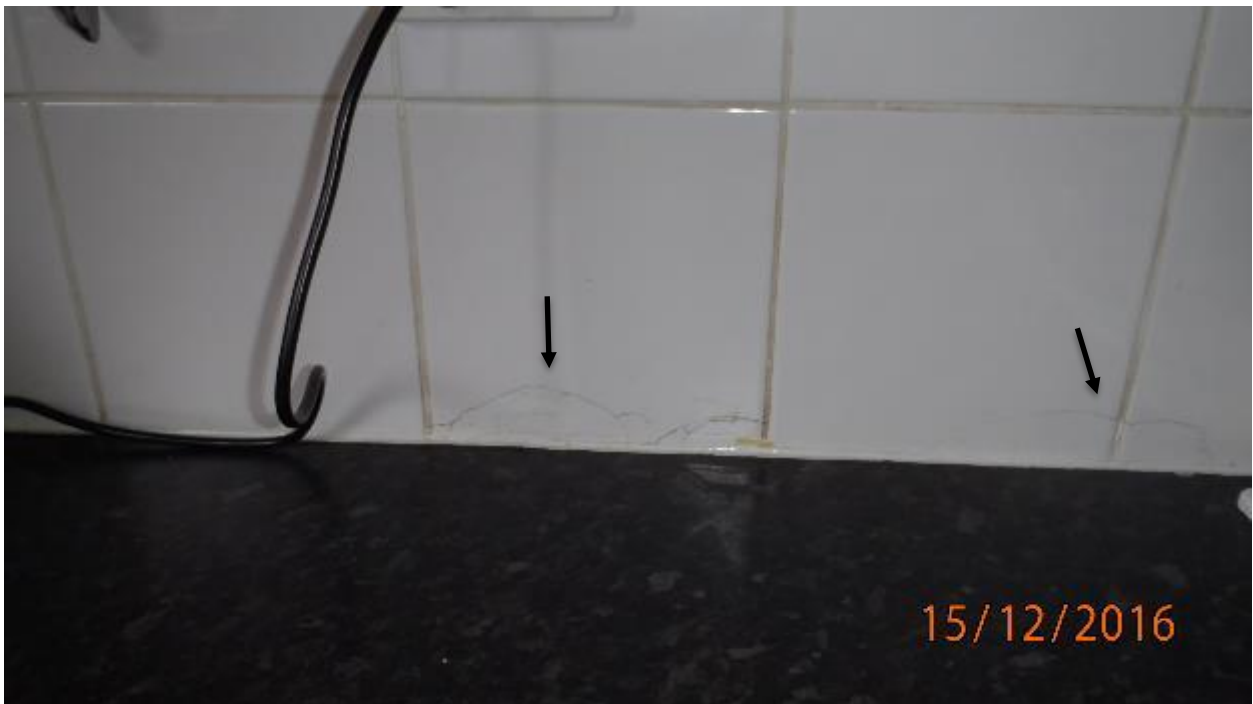
We noted cracked tiles abutting the benchtop on the eastern wall. **[Photograph 49]**

Photograph 49 shows cracked tiles abutting the benchtop on the eastern wall of the Kitchen.

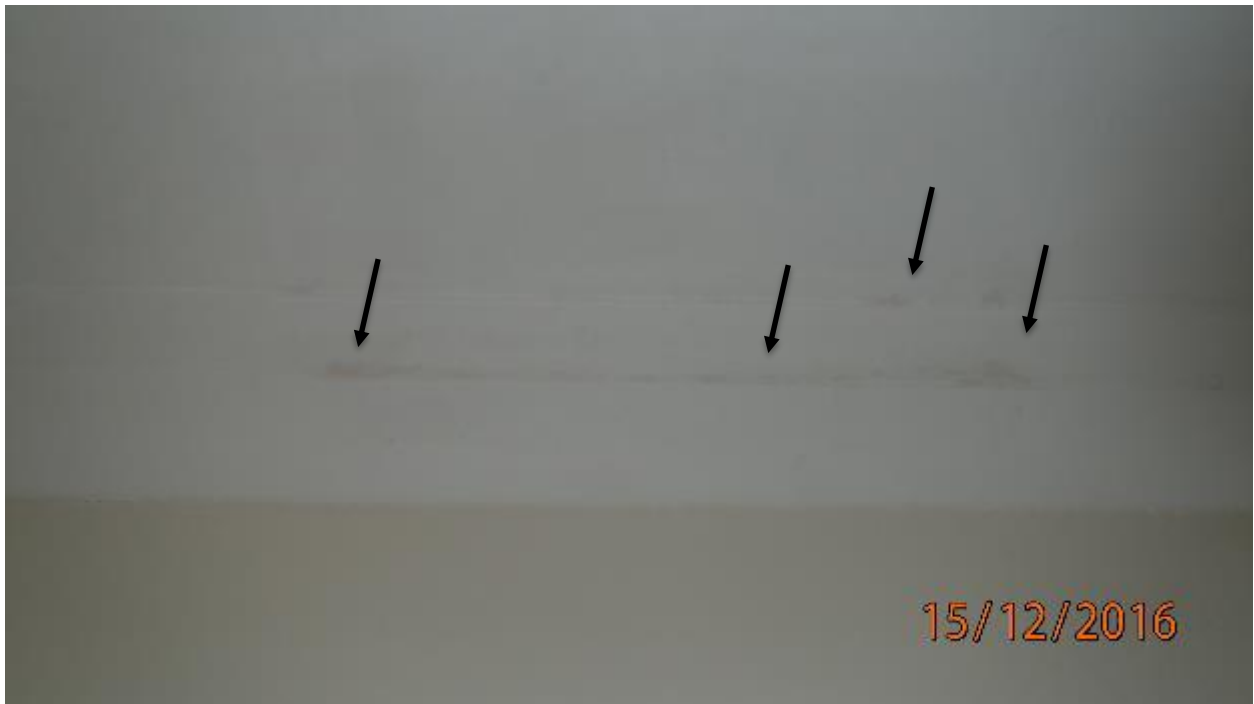
We noted staining to the wide profiled plaster cornice on the eastern wall. **[Photograph 50]**

Photograph 50 shows staining to the wide profiled plaster cornice on the eastern wall of the Kitchen.

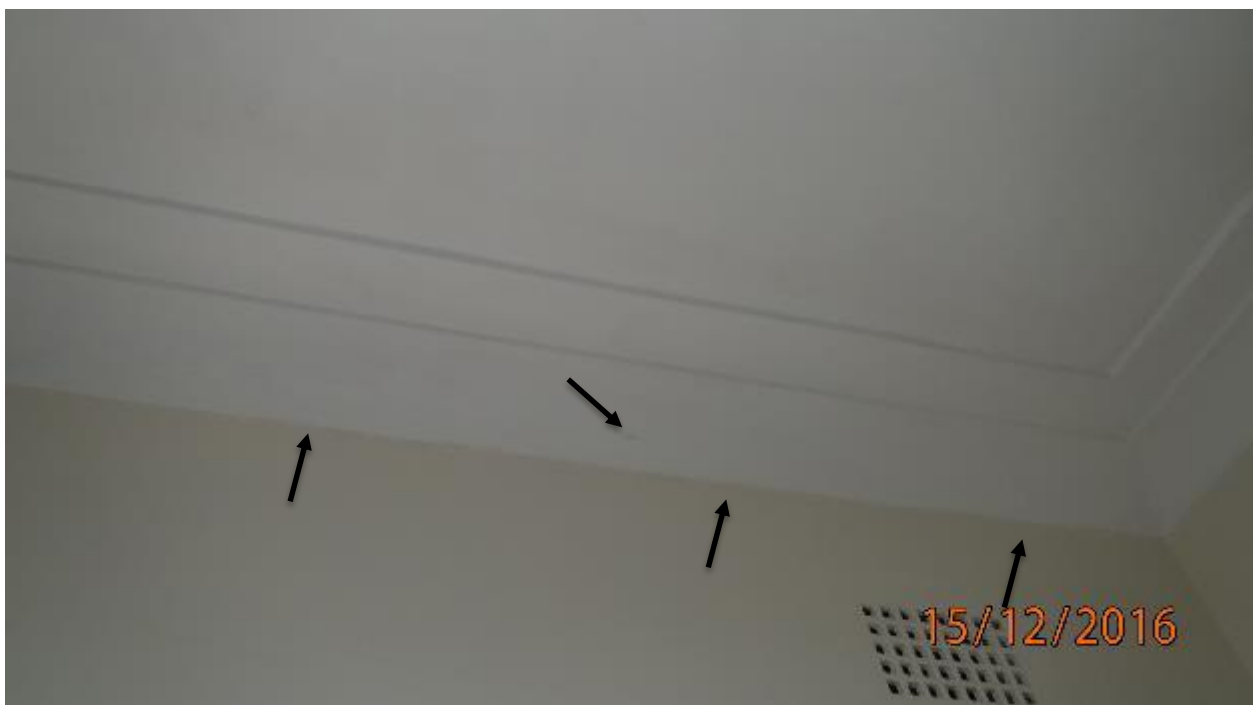
We noted flaking paint and separation cracking [$< 1.0\text{mm}$] between the painted cement rendered wall / cornice junction in the north-eastern corner. **[Photograph 51]**

Photograph 51 shows flaking paint and separation cracking between the painted cement rendered wall / cornice junction in the north-eastern corner of the Kitchen.

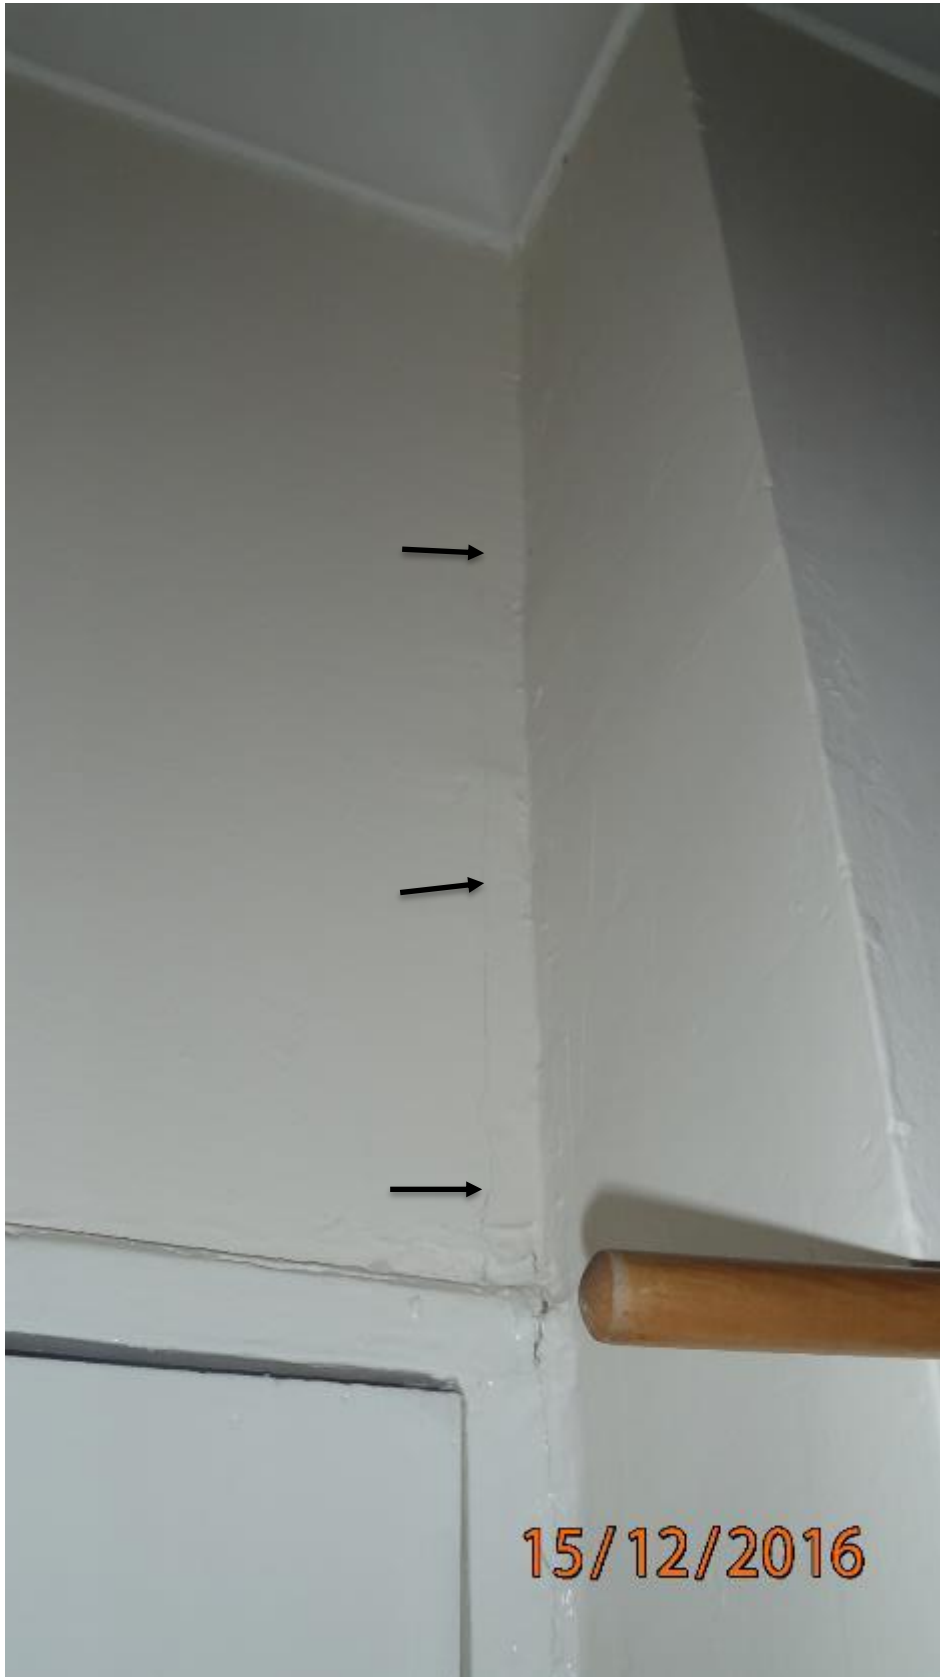
We noted hairline vertical cracking [$< 0.1\text{ mm}$] to the painted cement rendered wall above the door. **[Photograph 52]**

Photograph 52 shows hairline vertical cracking to the painted cement rendered wall above the door in the Laundry.
