HAZARDOUS MATERIALS ASSESSMENT REPORT

Job details: Owner/s: Mr. A. & Mrs. S. Woolstencroft
Location: 11 Thomas Street, Seven Hills NSW

Date of assessment: 27th January 2016

Our reference: HM04600116

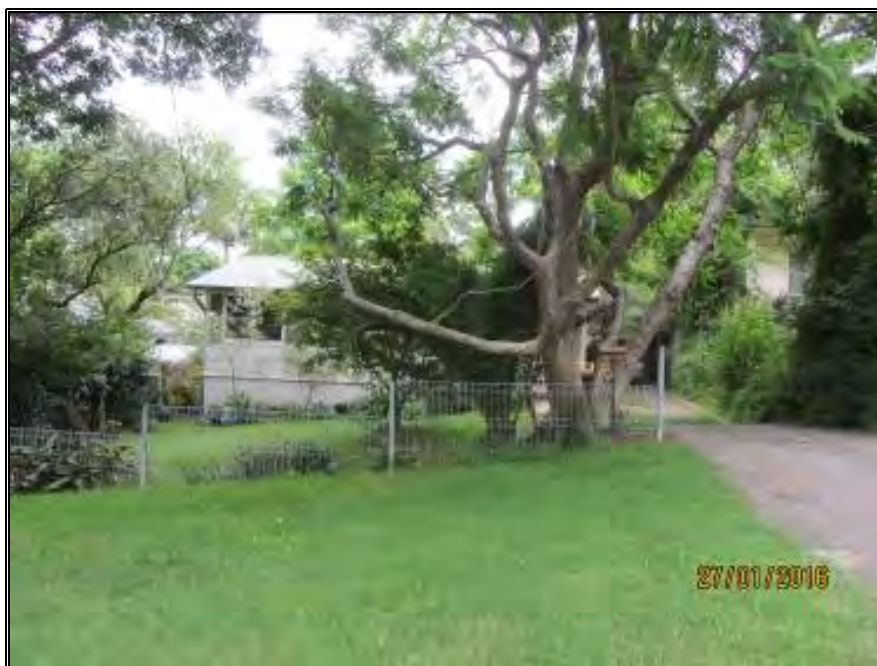
Front south eastern elevation of the residence
