HAZARDOUS MATERIALS ASSESSMENT REPORT

Job details: Owner: Ms. C. Pismiris
Location: 65A Stewart Street, Paddington NSW

Plans for Job No: 7558/14 Revision No: C Dated: 01-08-14

Our reference: HM03260814

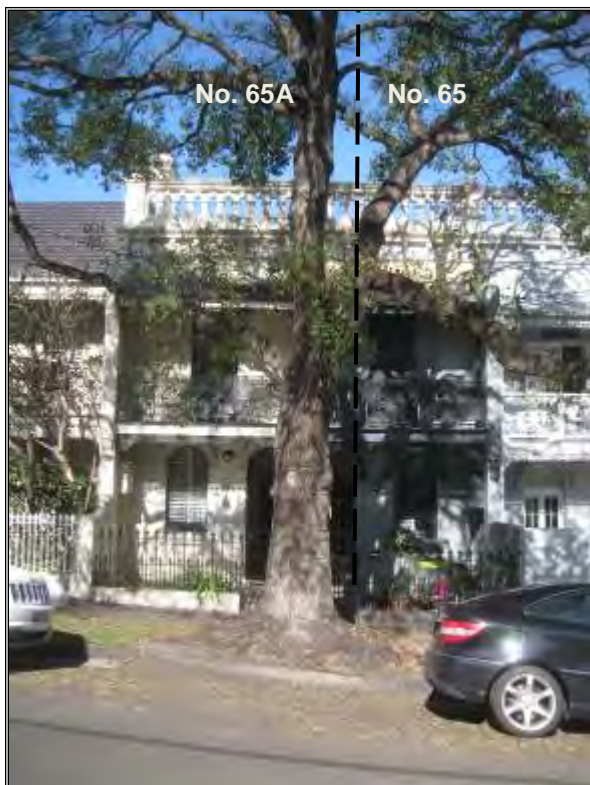
Front northeast elevation of the adjoining properties: No. 65 and No. 65A Stewart Street, Paddington

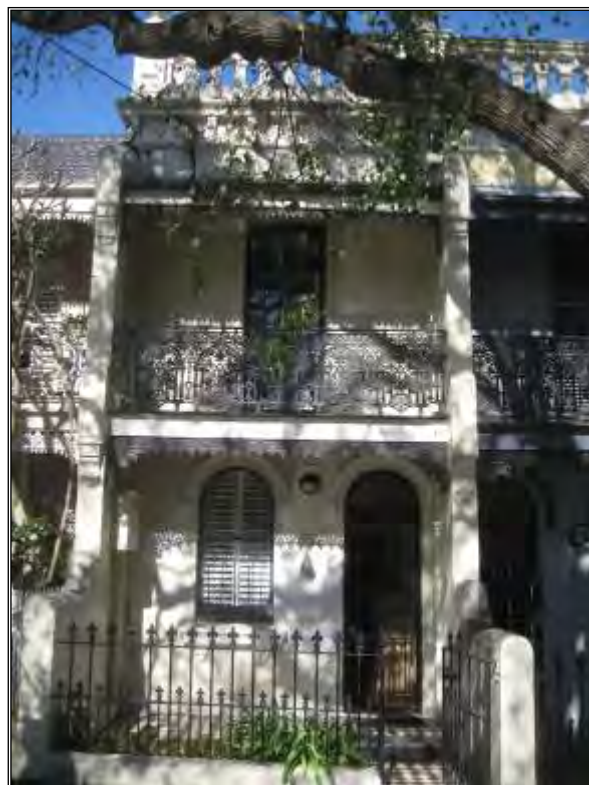
Front northeast elevation of this property:
No. 65A Stewart Street, Paddington
