HAZARDOUS MATERIALS ASSESSMENT REPORT

Job details: Owner: Mr. S. M^cAdam
Location: 50 Park Street, Narrabeen NSW

Date of assessment: 21st May 2015

Our reference: HM03990515

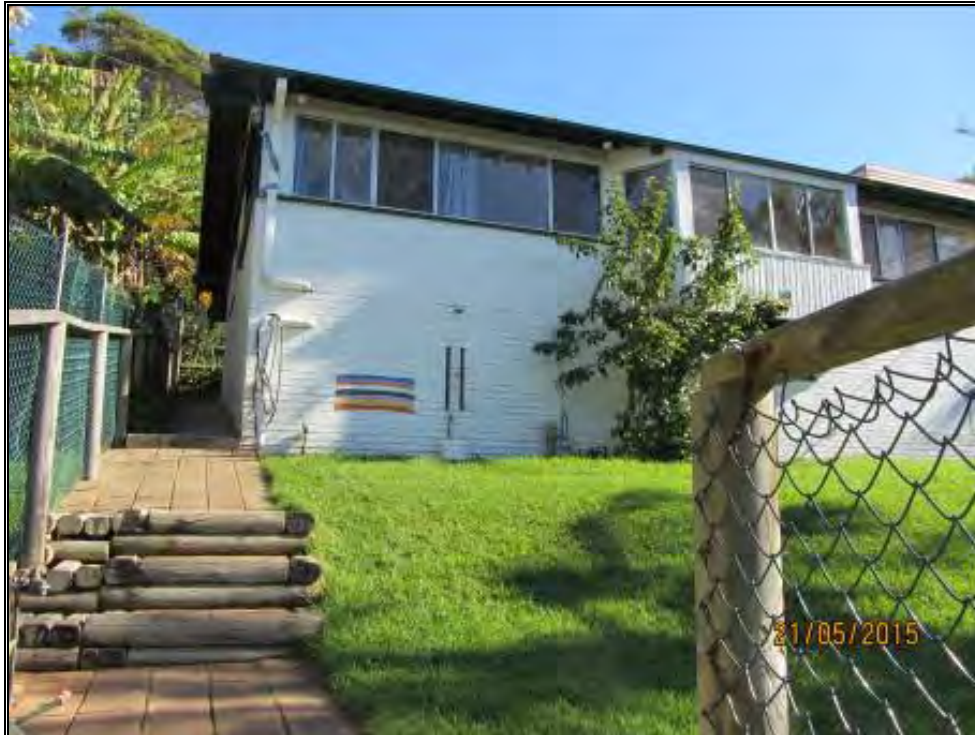
Front eastern elevation of the residence
