HAZARDOUS MATERIALS ASSESSMENT REPORT

Job details: Owner/s: Mr. G. Hampton & Mr. A Grulich
Location: 25 Bathurst Street, Woollahra NSW

Date of assessment: 13th November 2013

Our reference: HM02610913

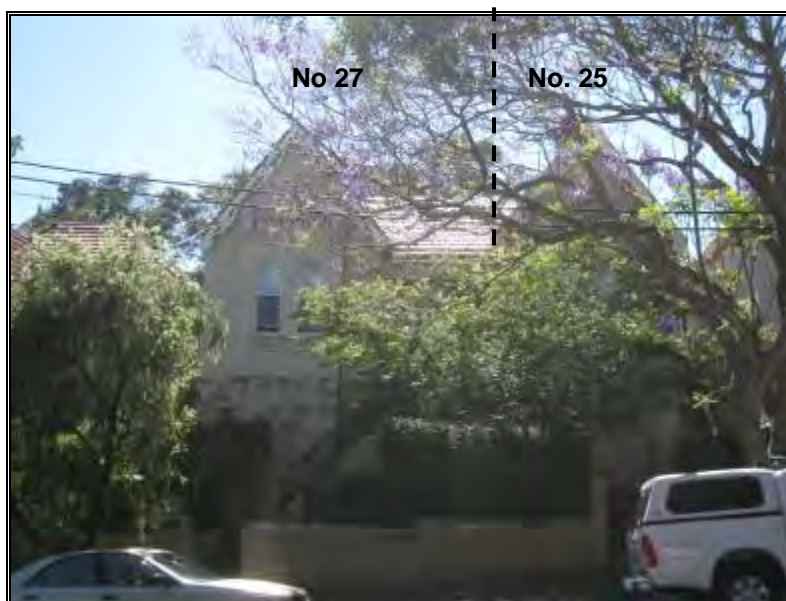
Front west elevation of the adjoining properties: No.25 and No. 27 Bathurst Street, Woollahra
