Asbestos Survey 2013

The Owners Corporation for
Church Street Corporate Centre
410 - 422 Church Street
Parramatta NSW 2151

Strata Plan 58457

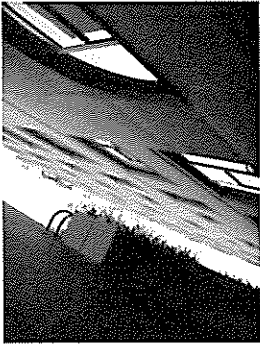
Common Property	No asbestos containing materials (ACM) identified.						
Photo 4: External surfaces

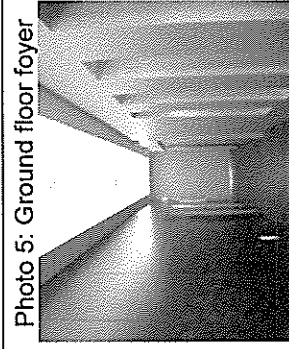
Common Property	No asbestos containing materials (ACM) identified.

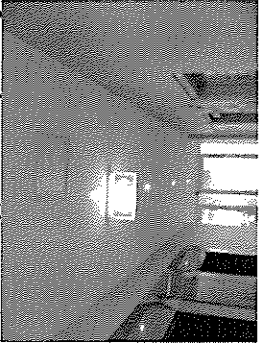
Common Property	No asbestos containing materials (ACM) identified.						
Photo 7: Lobby Ross Street foyer

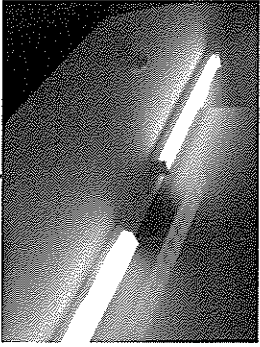
Common Property	No asbestos containing materials (ACM) identified.						
Photo 8: Level 1 fire stairs fire door

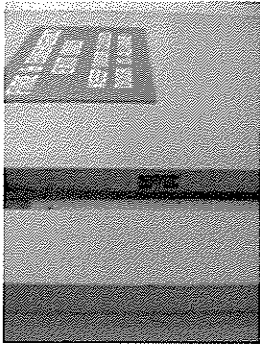
Common Property	The fire rated door at fire stairs on level 1 is presumed to contain asbestos, although it is not possible to test the encapsulated material to determine its composition without removing and breaking the door frame.	GOOD - No signs of damage or deterioration due to weather, non-friable	General repairs and maintenance	None	P3	Administrative control or remove access

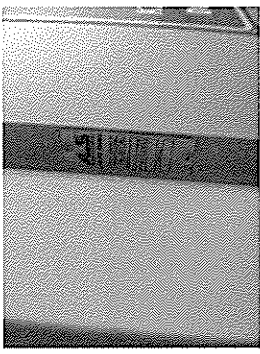
Common Property	No asbestos containing materials (ACM) identified.						
Photo 10: Level 3 fire stairs fire door

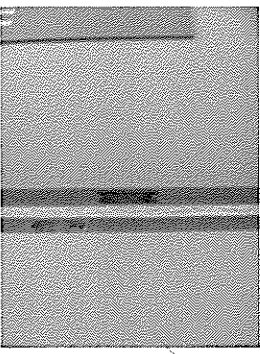
Common Property	The fire rated door at fire stairs on level 3 is presumed to contain asbestos, although it is not possible to test the encapsulated material to determine its composition without removing and breaking the door frame.	GOOD - No signs of damage or deterioration due to weather, non-friable	General repairs and due maintenance	None	P3	Administrate, control or remove access	
Photo 11: Level 4 fire stairs fire door

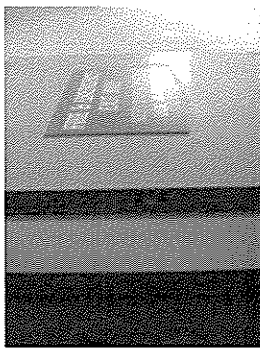
Common Property	The fire rated door at fire stairs on level 4 is presumed to contain asbestos, although it is not possible to test the encapsulated material to determine its composition without removing and breaking the door frame.	GOOD - No signs of damage or deterioration due to weather, non-friable	General repairs and due maintenance	None	P3	Administrate, control or remove access

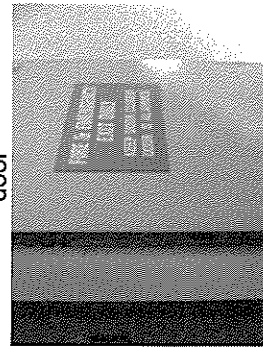
Common Property	The fire rated door at fire stairs on level 6 is presumed to contain asbestos, although it is not possible to test the encapsulated material to determine its composition without removing and breaking the door frame.	GOOD - No signs of damage or deterioration due to weather, non-friable	General repairs and maintenance	None	P3	Administrative, control or remove access	
Photo 14: Basement fire stairs fire door

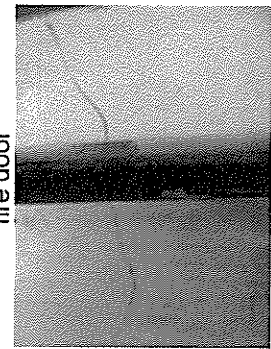
Common Property	The fire rated door at fire stairs at basement is presumed to contain asbestos, although it is not possible to test the encapsulated material to determine its composition without removing and breaking the door frame.	GOOD - No signs of damage or deterioration due to weather, non-friable	General repairs and maintenance	None	P3	Administrative, control or remove access

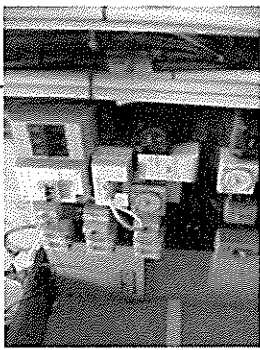
Common Property	The electrical meter backing panel on ground floor is presumed to contain asbestos.	GOOD - No signs of damage or deterioration due to weather, non-friable	Electrical	None	P4	Administrative, control access	
Photo 22: Main switch room electrical back board panel

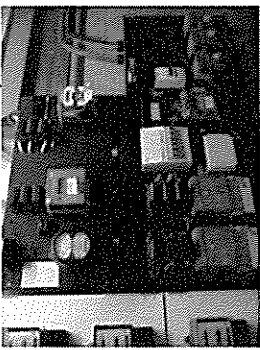
Common Property	The electrical meter backing panel in the main electrical back board panel is presumed to contain asbestos.	GOOD - No signs of damage or deterioration due to weather, non-friable	Electrical	None	P4	Administrative, control access	
Photo 23: Suite 61 office area

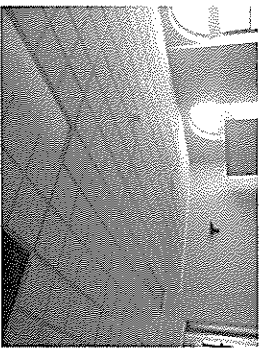
Internal Inspection	No asbestos containing materials (ACM) identified.

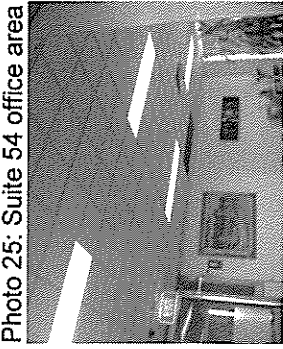
Internal Inspection	No asbestos containing materials (ACM) identified.						
Photo 26: Suite 52 training and kitchen area

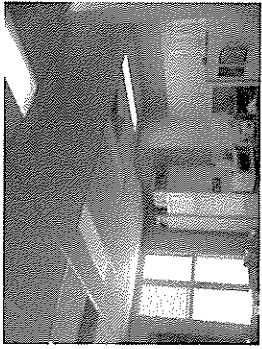
Internal Inspection	No asbestos containing materials (ACM) identified.

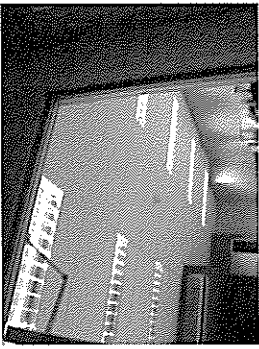
Internal Inspection	No asbestos containing materials (ACM) identified.						
Photo 40: Ross Street level 3 foyer

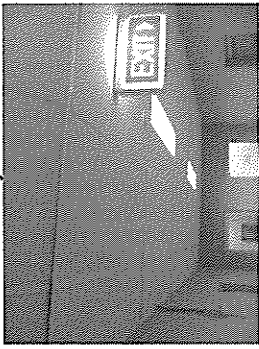
Common Property	No asbestos containing materials (ACM) identified.						
Photo 41: Stone ink general office

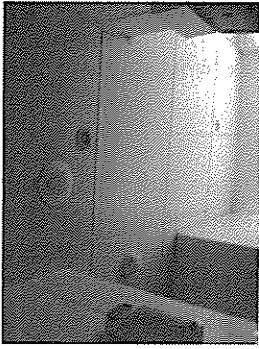
Common Property	No asbestos containing materials (ACM) identified.						
Photo 49: Toilet ceilings common to all levels

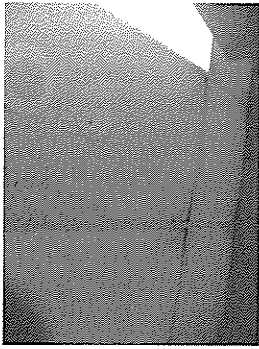
Common Property	No asbestos containing materials (ACM) identified.						
Photo 50: ACM sign fixed to main switchboard entry door
