HAZARDOUS MATERIALS ASSESSMENT REPORT

Client: Cape Cod Australia Pty. Limited

Job details: Owner: Mrs. S. Pather
Location: 22 Kinnard Way, Kellyville, NSW. 2155.

Our reference: HM04580116

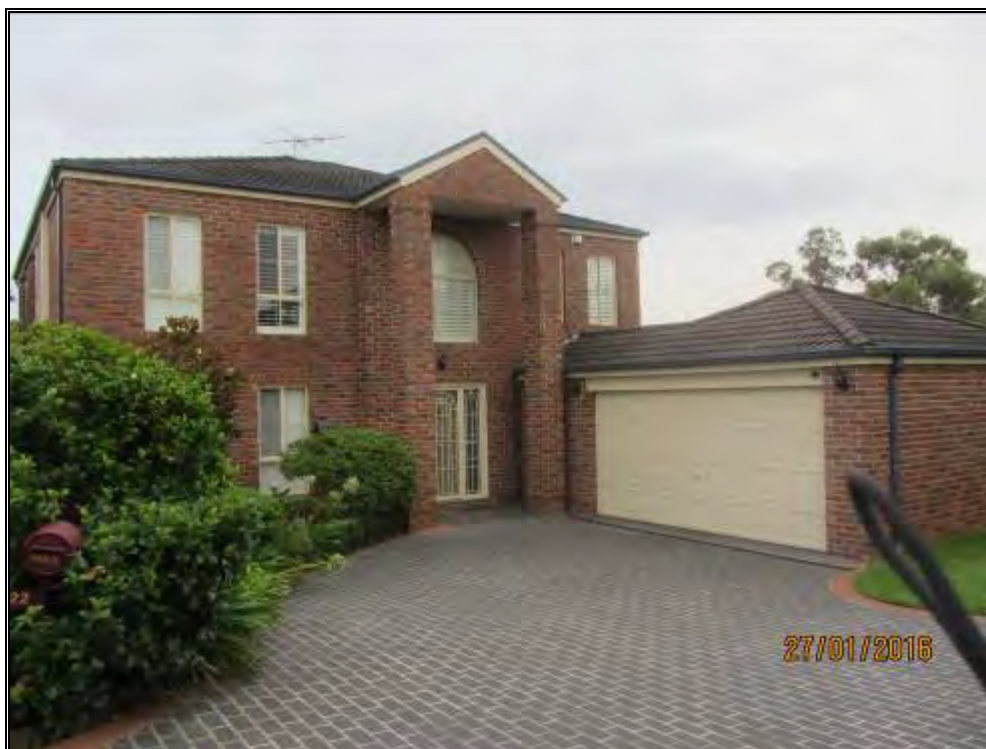
Front southern elevation of the residence
