HAZARDOUS MATERIALS ASSESSMENT REPORT

Job details: Owner/s: Mr. D. Hanafi & Ms. C. Prasadhi
Location: 83 Maroubra Road, Maroubra NSW

Date of assessment: 22nd February 2016

Our reference: HM04640216

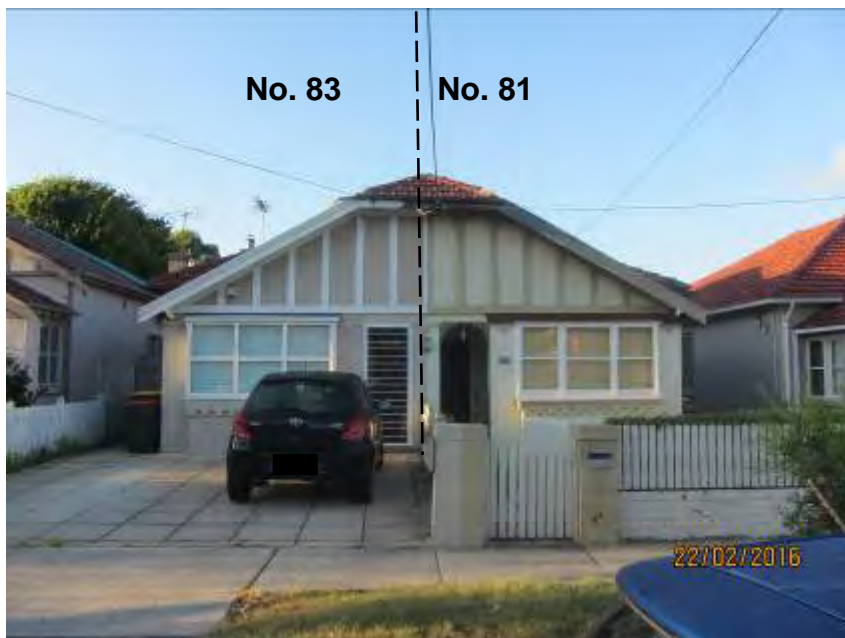
Front northern elevation of the adjoining properties:
No. 81 & No. 83 Maroubra Road, Maroubra
