## **Dilapidation Assessment Report**

Job address: **25 Thornton Street Fairlight**

Report reference: **MANLY COUNCIL**  
Development Application No. not available

Date of attendance: **29 September 2015**

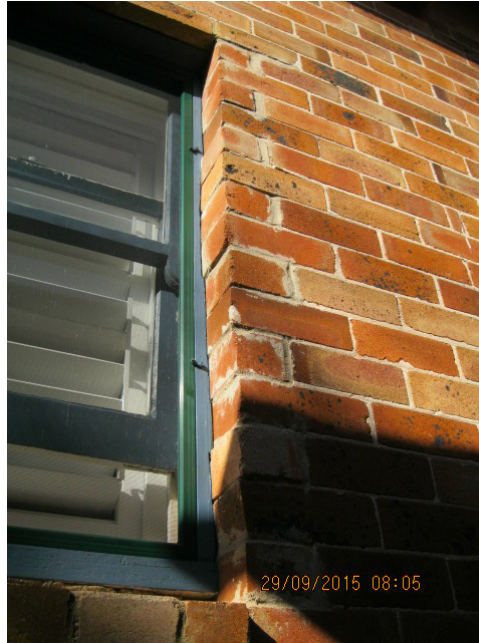
Print 1

The window to bedroom 1 has been patched and it appears that the window has been cut in after the dwelling was completed.

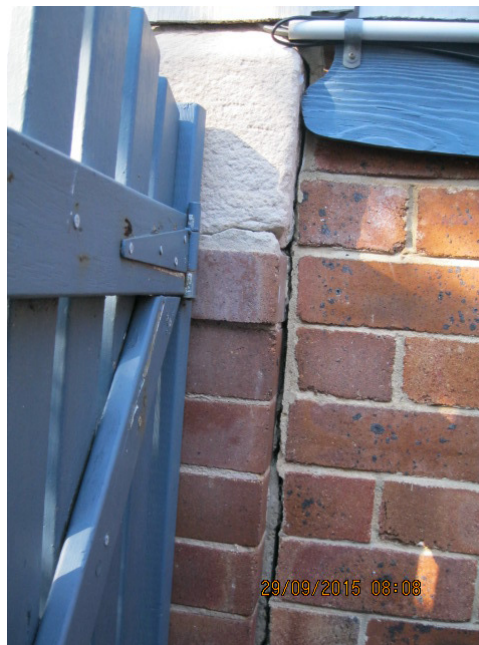
Print 2

Movement [ $<10$ ] is evident in the brickwork at the front of the dwelling adjacent to the side gate

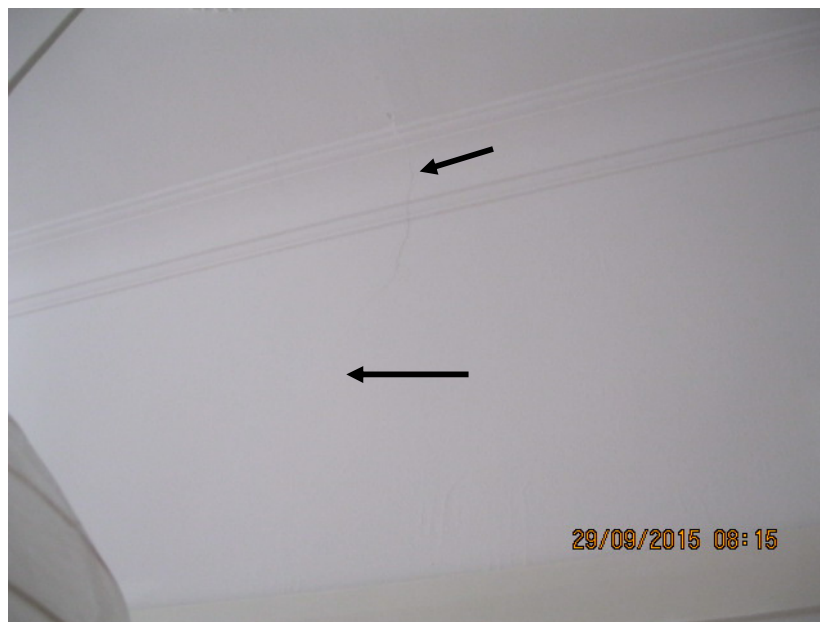
Print 3

Hairline cracking [ $< 1$ ] is evident above bedroom 1 door through the cornice approx. 600 long

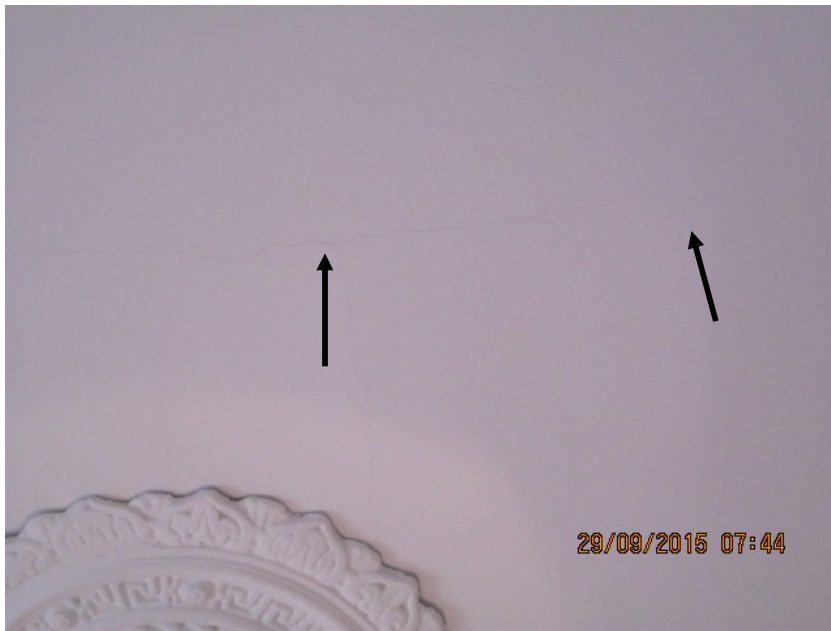
Print 4

Hairline cracking [ $< 1$ ] in lath and plaster ceiling typical for this age of dwelling.

Four [4] cracks are within 1000 of ceiling rose generally parallel with north south walls and up to 1000 long

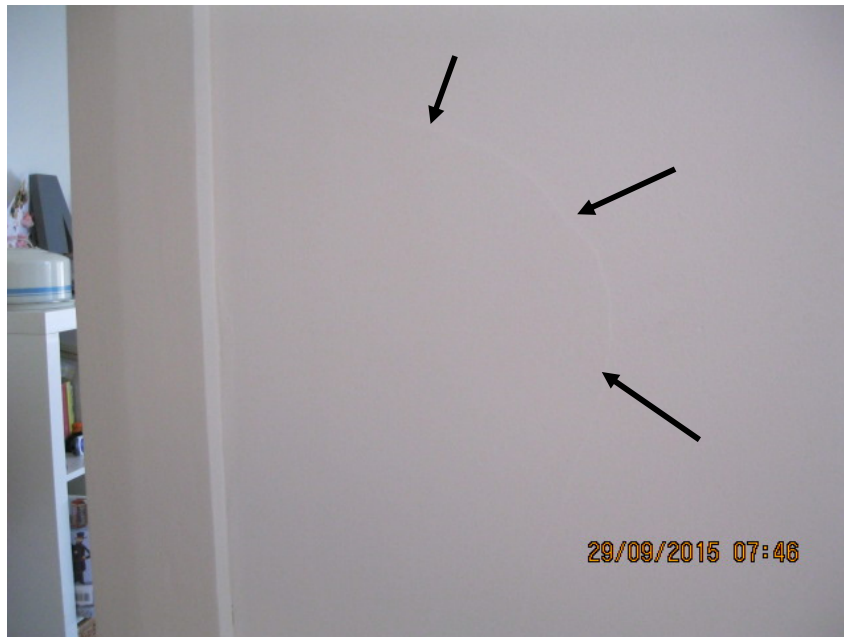
Print 5

Drummy plaster was detected and visible to RHS of the meals room door, 1600 above FL approximately 500 diameter.

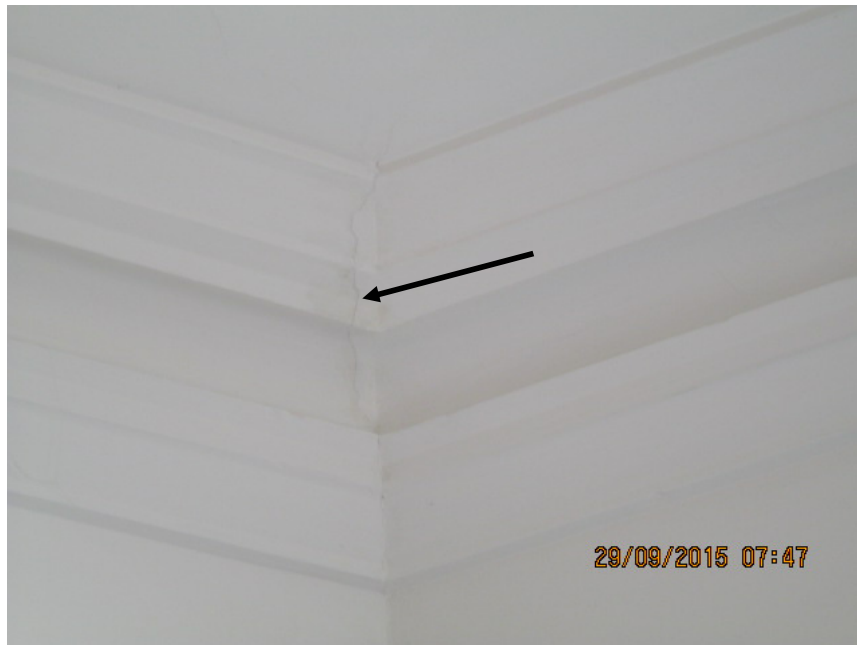
Print 6

Hairline cracking [ $<1$ ] visible LHS open fire place at cornice junction.

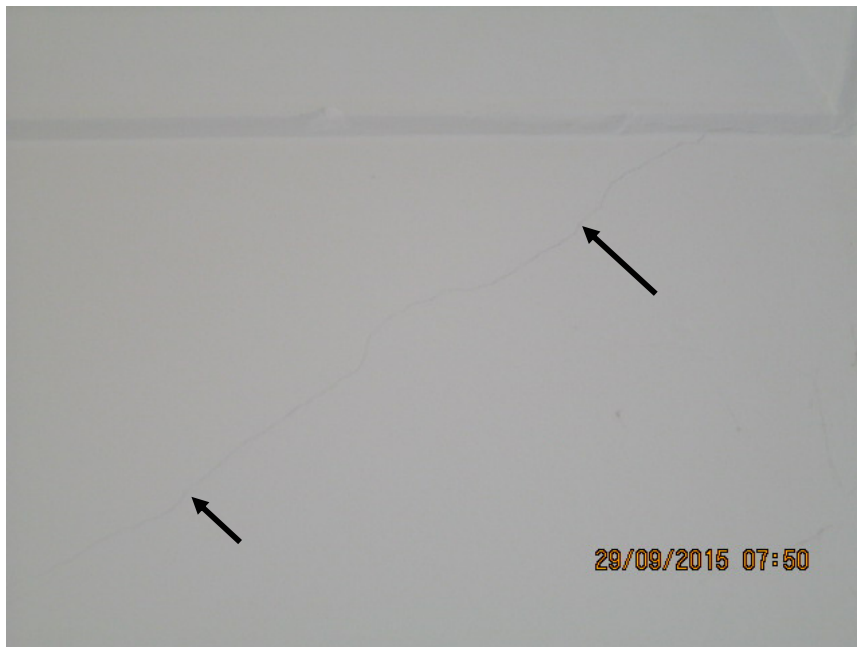
Print 7

Hairline cracking [ $<1$ ] visible RHS above hall door from the cornice down at 45 degrees down to top of door.

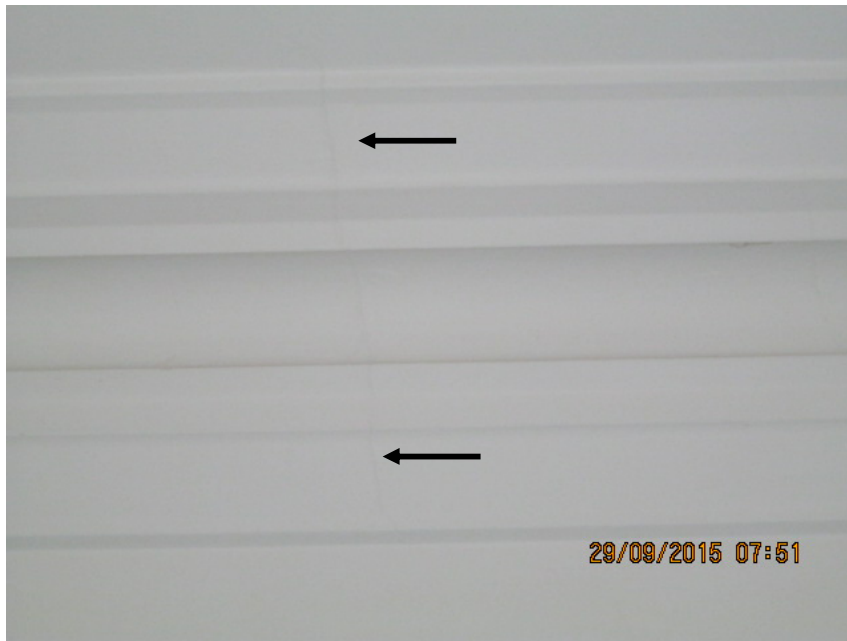
Print 8

Hairline cracking in cornice [ $<1$ ] visible at living / meals wall [x2]

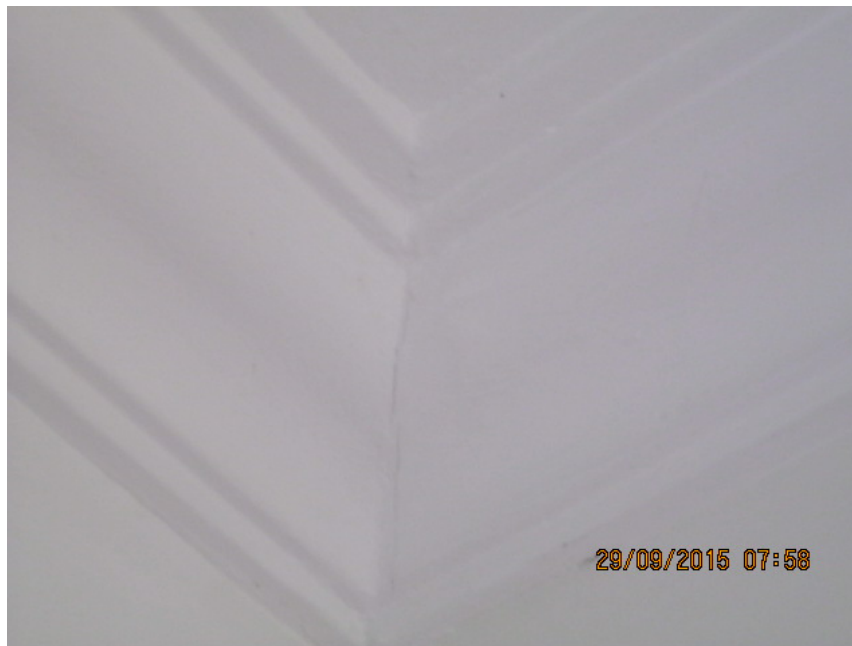
Print 9

Hairline cracking [ $>1$ ] at both cornice mitres over bi-fold doors
