HAZARDOUS MATERIALS ASSESSMENT REPORT

Job details: Owner/s: Mr. W. & Mrs. A. Poetscher
Location: 39 Clovelly Road, Randwick NSW

Date of assessment: 17th December 2014

Our reference: HM03571214

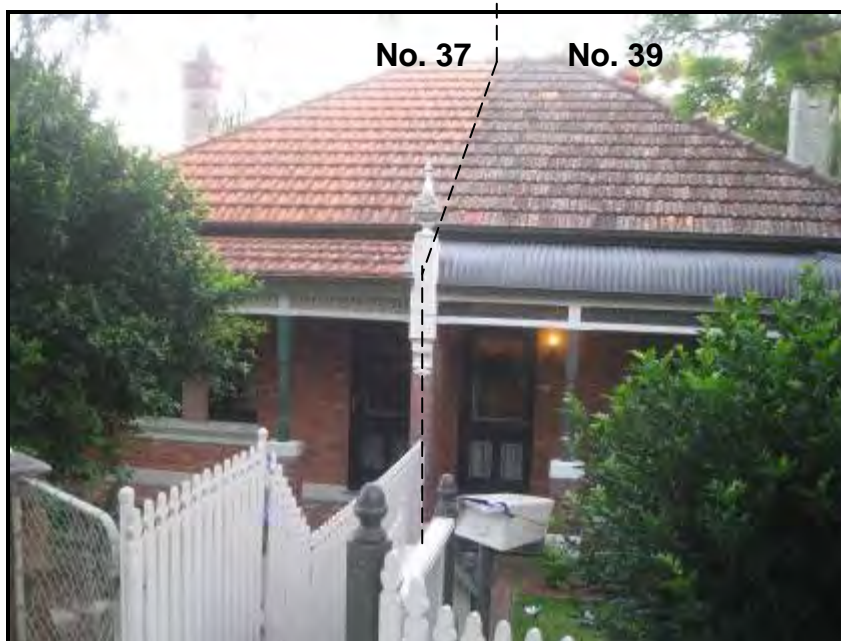
Front southern elevation of the adjoining properties:
No.37 & No. 39 Clovelly Road, Randwick
