## **HAZARDOUS MATERIALS ASSESSMENT REPORT**

**Job details:** Owner/s: Mr. J. Wilson & Ms. J. Varcoe  
Location: 3 Howley Street, Five Dock NSW

**Date of assessment:** 19<sup>th</sup> May 2015

**Our reference:** HM03940515

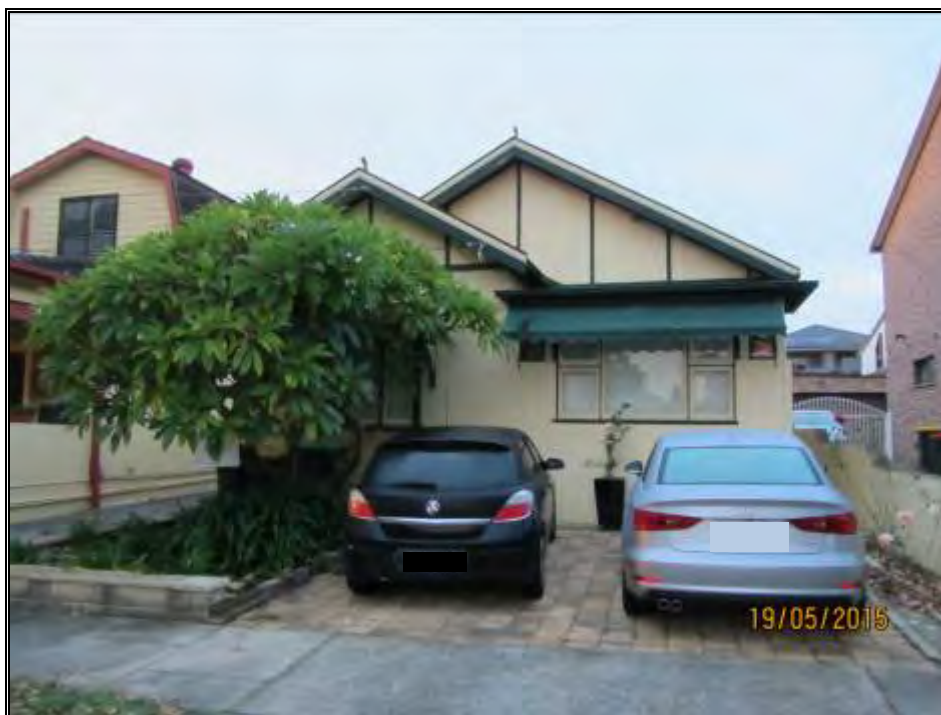
Front northern elevation of the residence
