## Dilapidation Assessment Report

Job address: Unit 6 / 59 Gould Street, Bondi Beach NSW 2026

Date of assessment: 11<sup>th</sup> March 2015

**Re: Dilapidation Report – Unit 6 / 59 Gould Street, Bondi Beach**

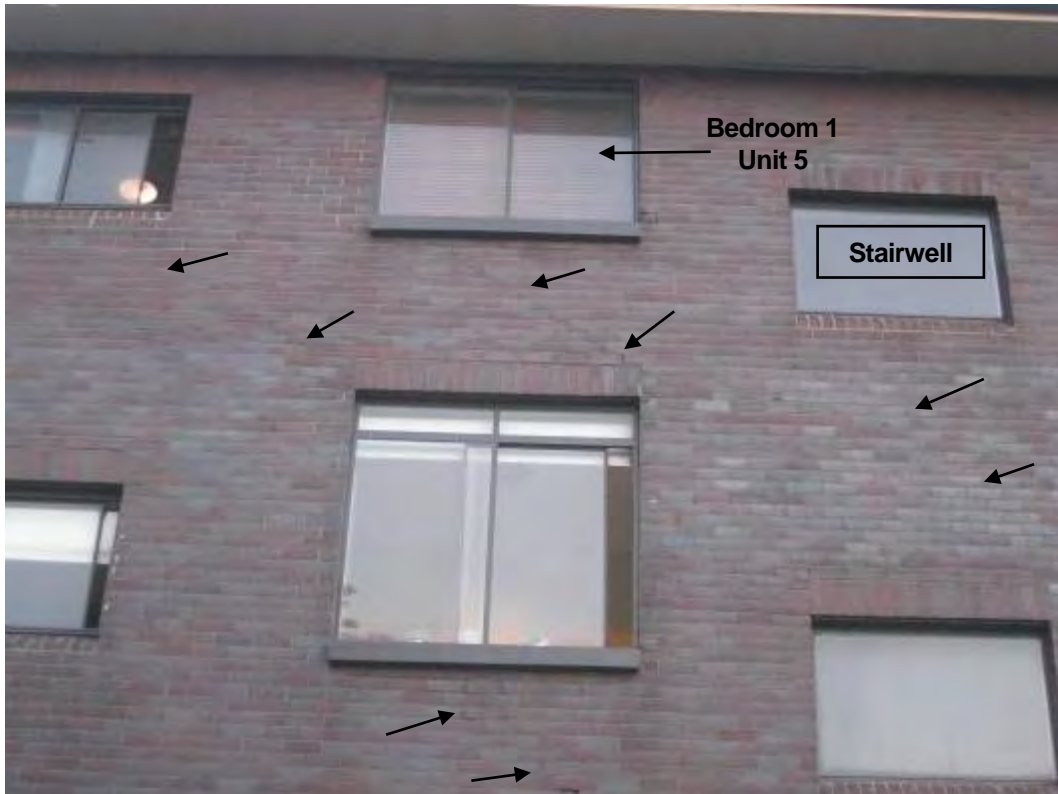
We noted that there is stepped cracking above and below the window openings to the front south eastern elevation of the building. [**Photographs 1, 2 and 3**]

**Photograph 1** shows a stepped cracking to the brickwork to the front south east elevation

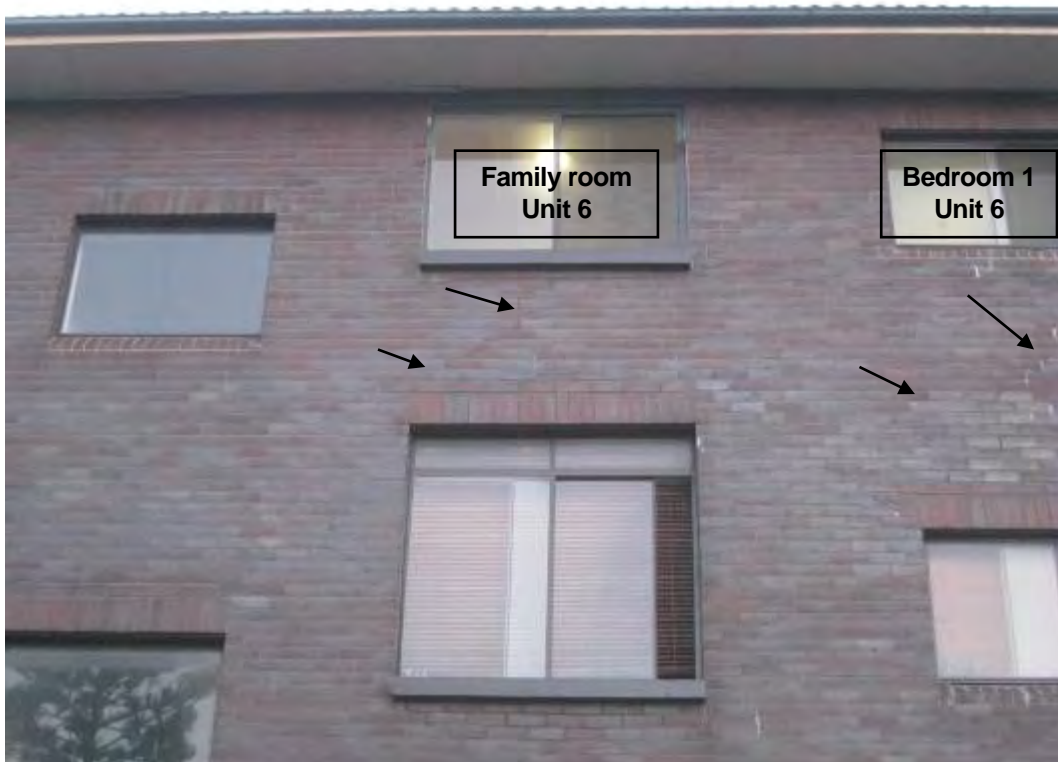
**Photograph 2** shows cracking to the brickwork to the front, south east elevation

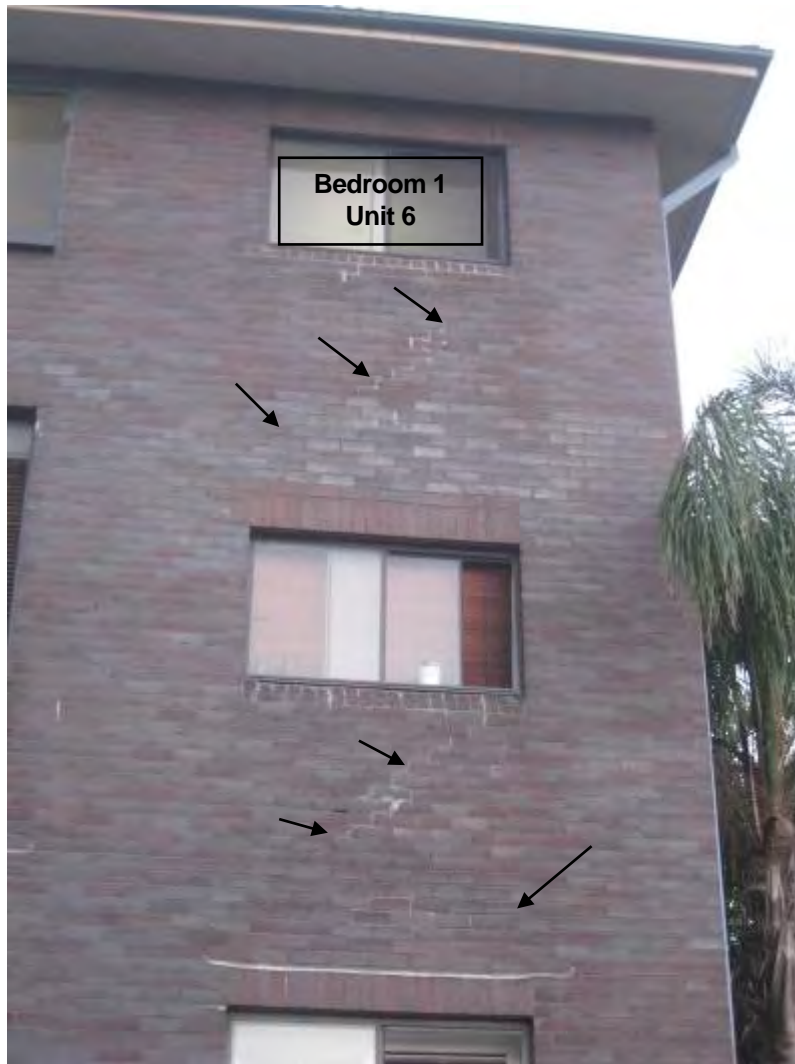
**Photograph 3** shows cracking to the brickwork to the south east elevation

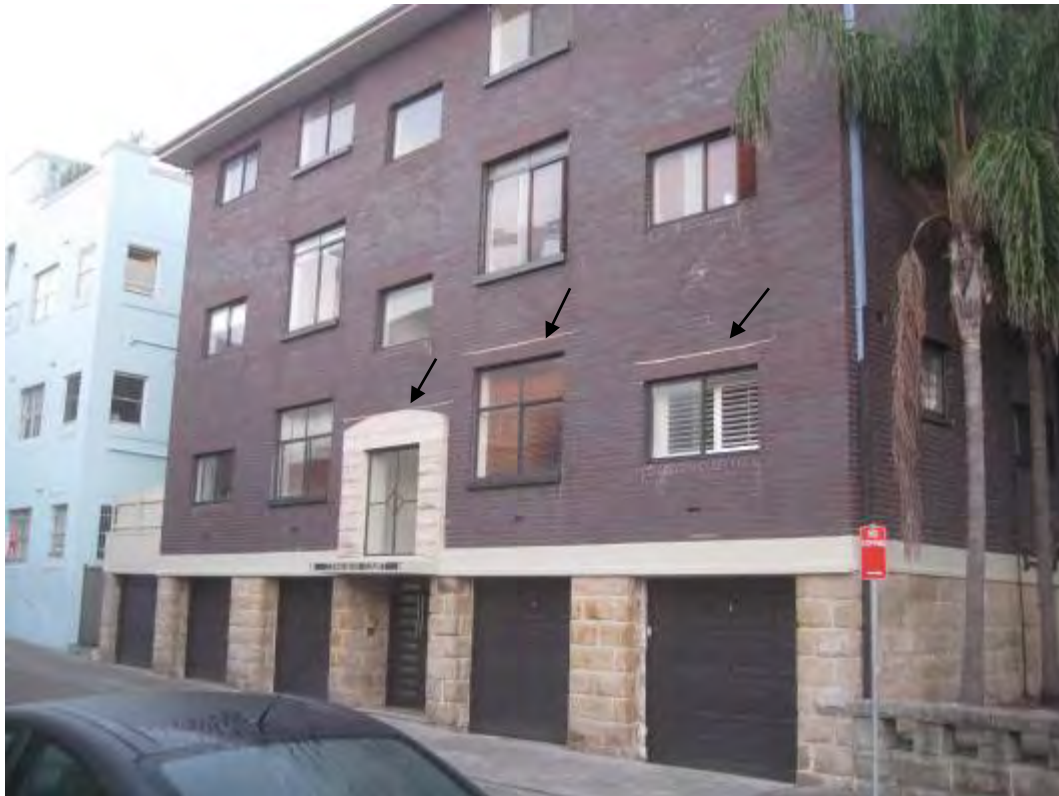
We noted that the window frames are aluminium and that there is a difference in profile of the sill bricks. We further noted that a head flashing to two windows to the first floor Unit 2 had been replaced as well as the head flashing over the front entry foyer opening. [**Photograph 4**]

From our experience this is indicative of possible replacement being undertaken during the renovations / refurbishment works undertaken in 1999.

**Photograph 4** shows the front south east elevation of the building

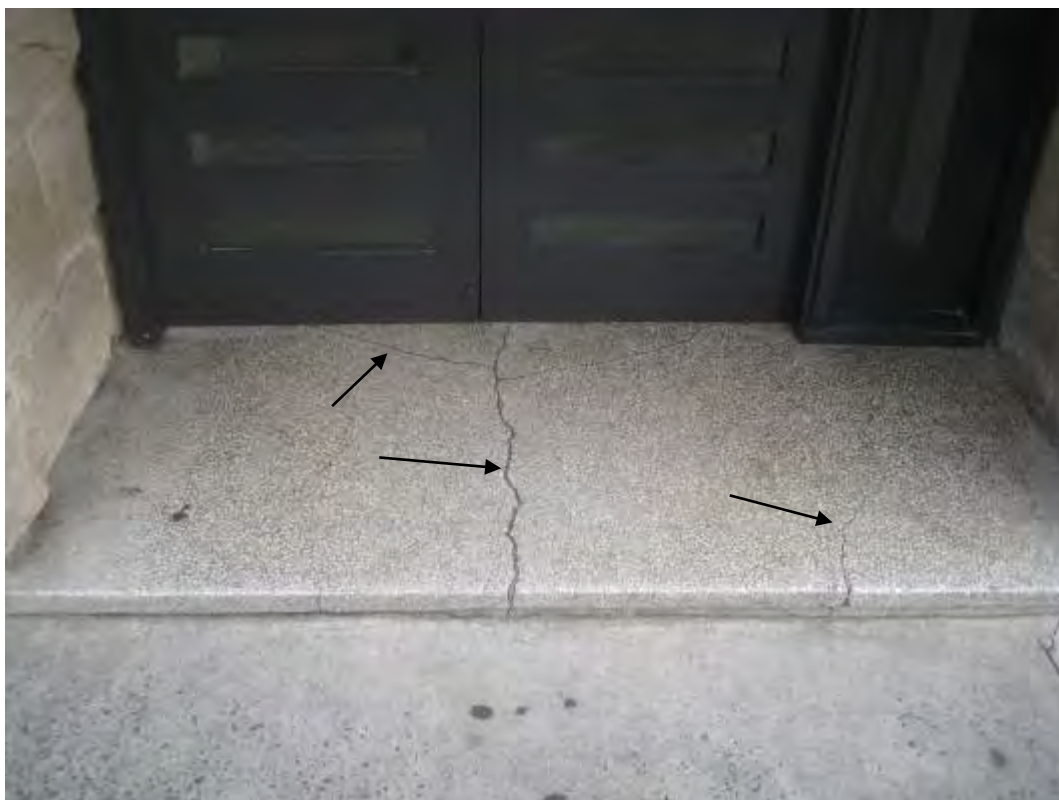
We noted cracking to the terrazzo entry foyer floor including at entry door way. [**Photographs 5 and 6**]

**Photograph 5** shows cracking to the terrazzo of the common property entry Foyer

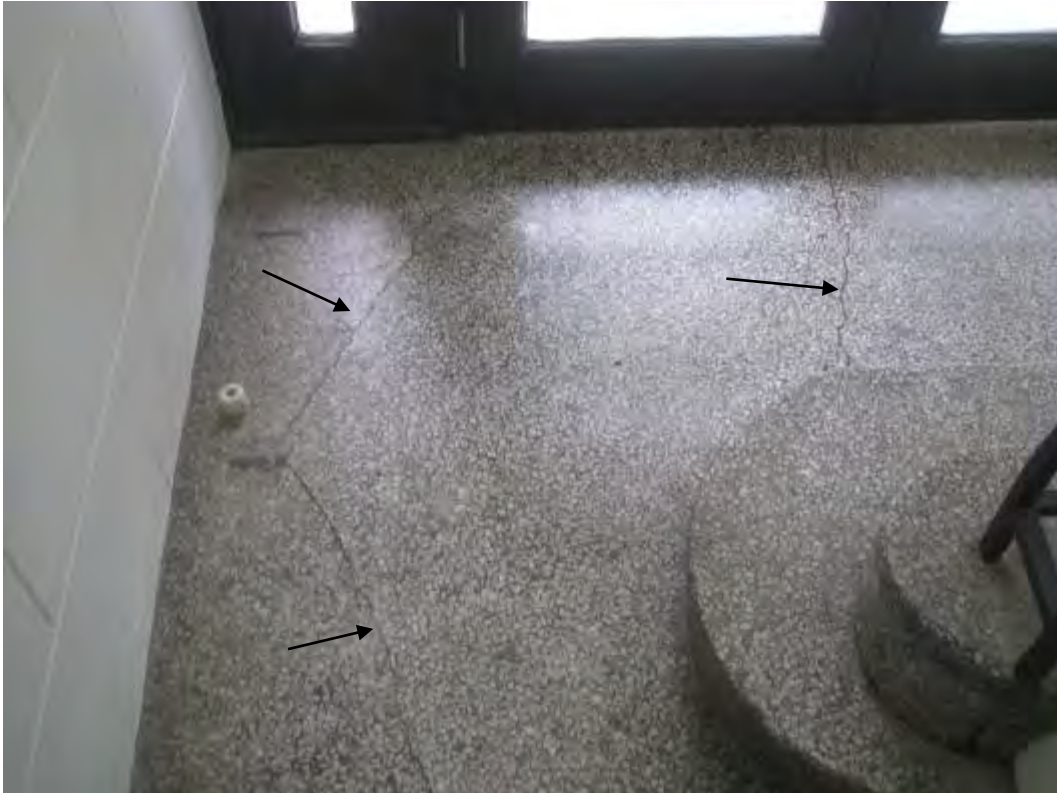
**Photograph 6** shows cracking to the terrazzo to the entry foyer to the *common* property stairwell

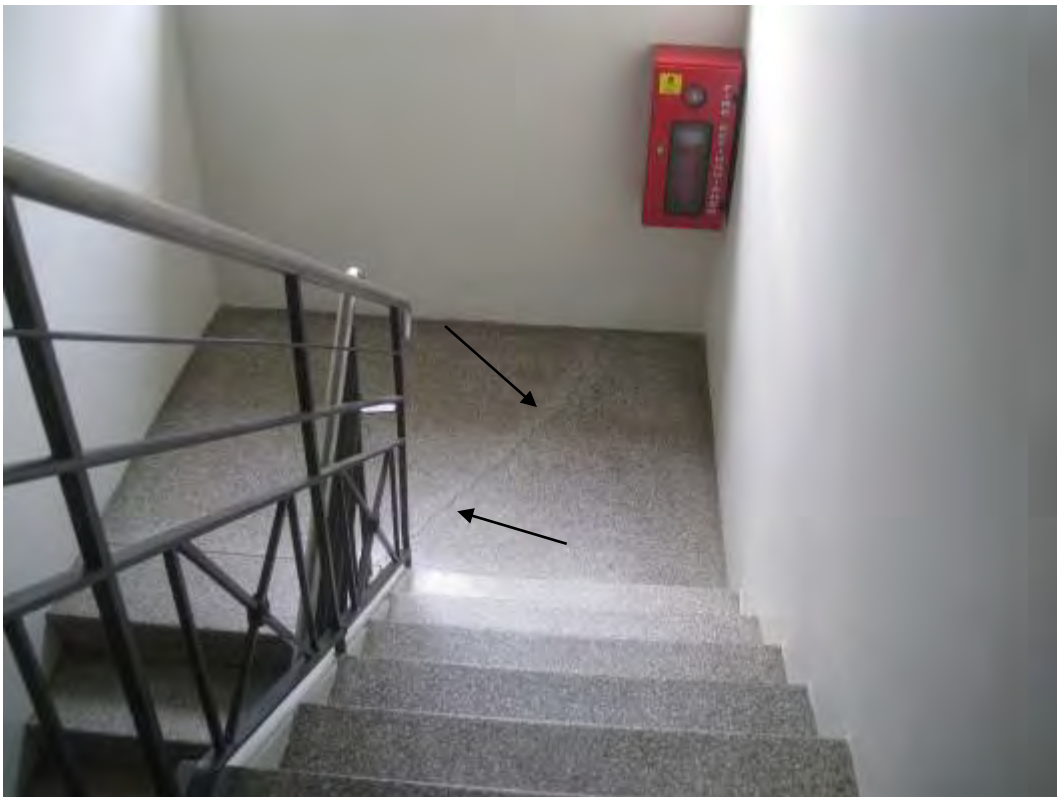
We also noted to the terrazzo second floor level landing cracking. **[Photographs 7 and 8]**

**Photograph 7** shows cracking to the terrazzo to the second floor landing to the *common* property stair

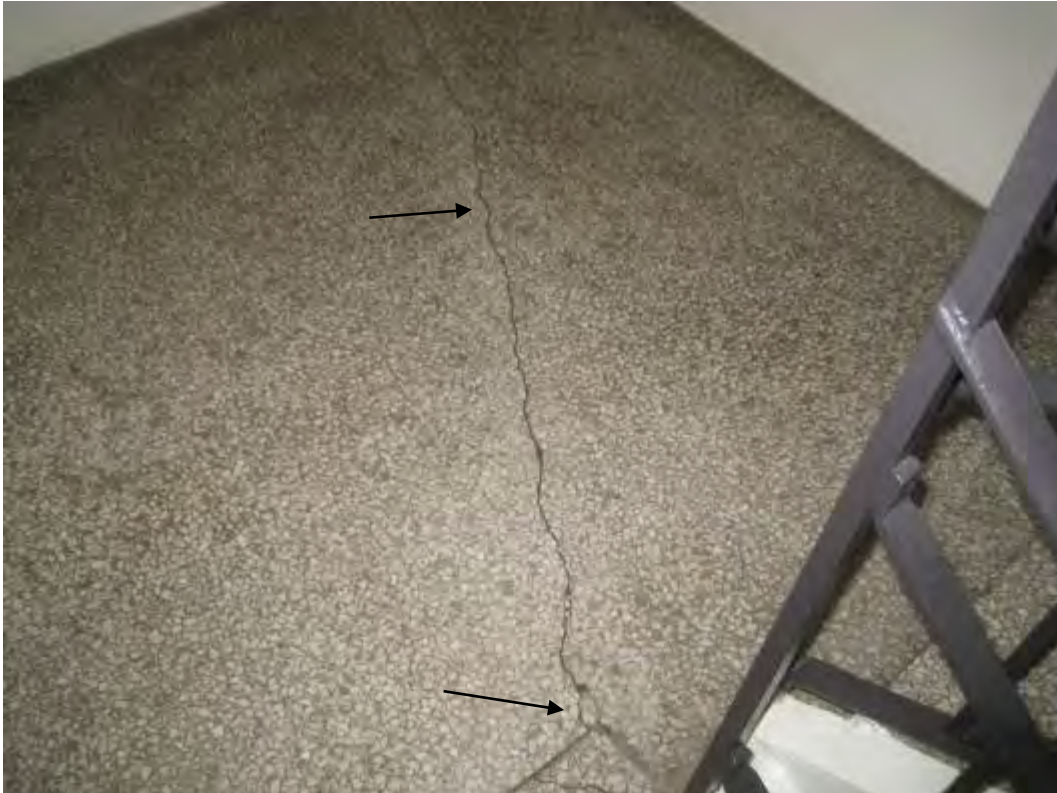
**Photograph 8** shows cracking to the second floor terrazzo landing to the *common* property stairwell

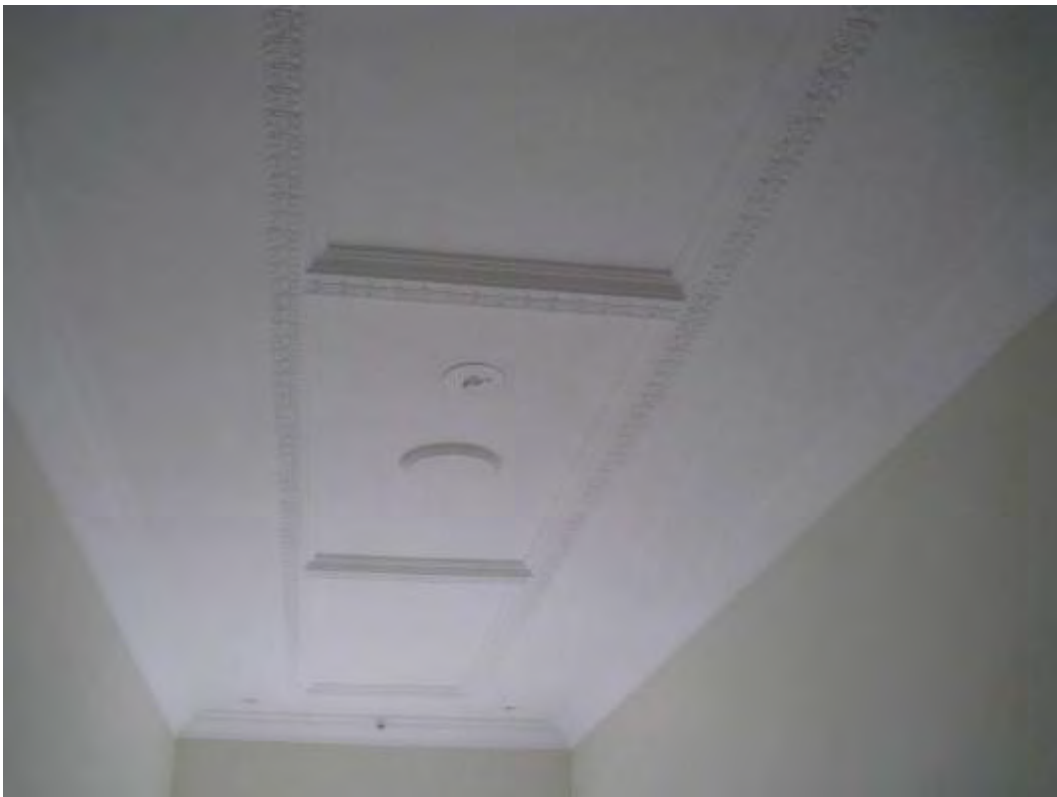
We did not observe any cracking to the decorative panel fibrous plaster ceiling lining or to the decorative profiled plaster cornices. **[Photograph 9]**

**Photograph 9** shows the condition of the ceiling to the *common* property stairwell

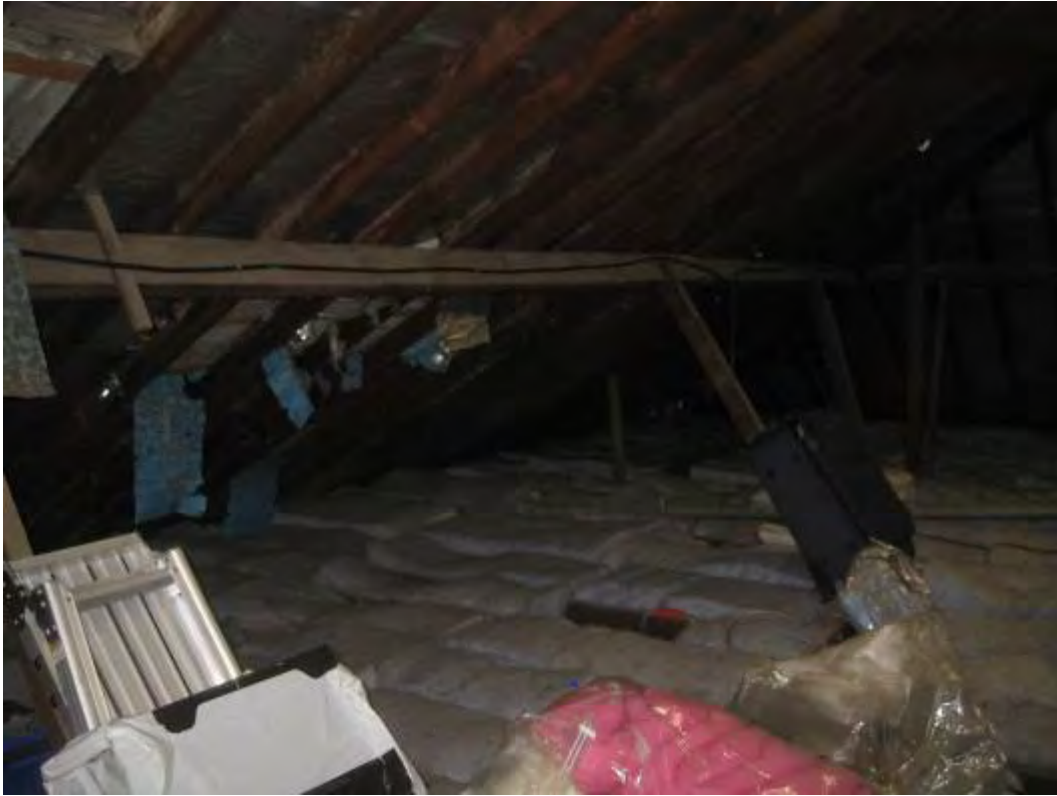
We accessed the roof space from within Unit 6 and we observed that the *common* roof structure is of traditional cut and pitched timber construction. **[Photograph 10]**

We noted that there is sarking to the underside of the concrete roofing tiles and synthetic mineral fibre batt insulation over the ceiling area of this Unit 6 only. **[Photograph 10]**

**Photograph 10** shows the roof space over Unit 6

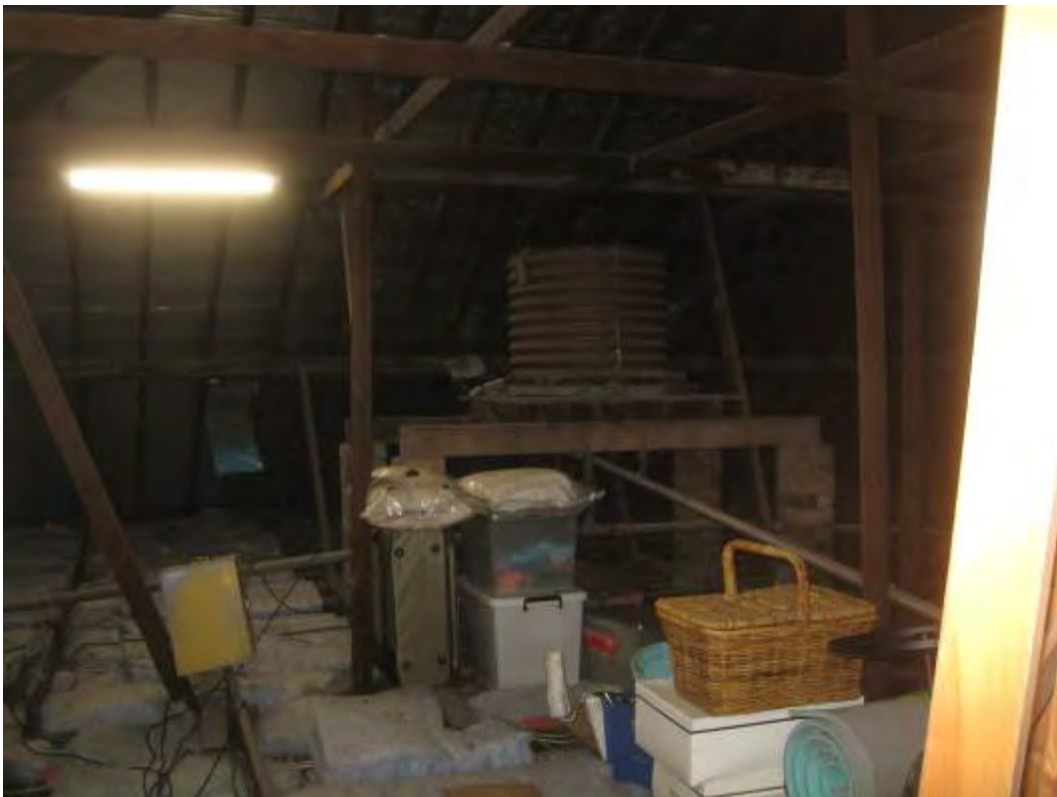
We noted that there is no *common party / separation* wall within the roof space to delineate the boundary between this Unit 6 and the abutting Unit 5. **[Photographs 11 and 12]**

**Photograph 11** shows the roof space and water tank located over the *common* property stairwell

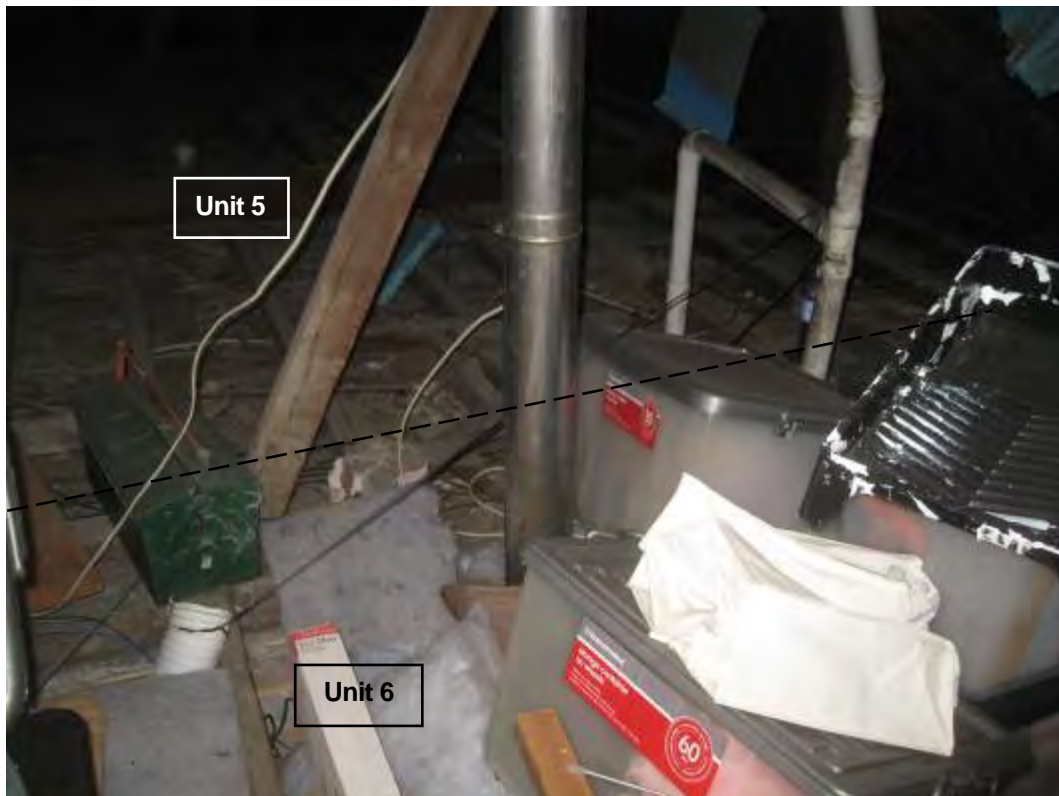
**Photograph 12** shows that no *common party / separation* wall is within the roof space

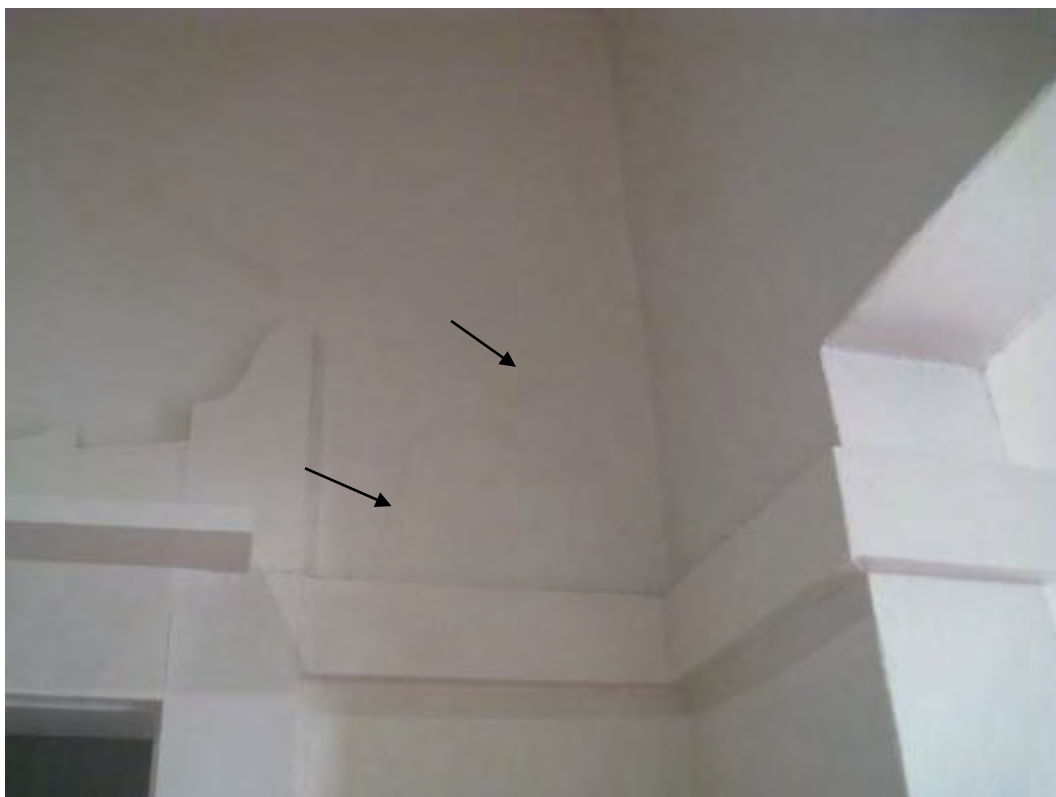
We noted a radial crack [ $<0.5\text{mm}$ ] above picture rail to the right hand side of the Kitchen doorhead. **[Photograph 13]**

**Photograph 13** shows a hairline radial crack above the picture rail to the right hand side of the doorhead into Bedroom 2 from the Living room

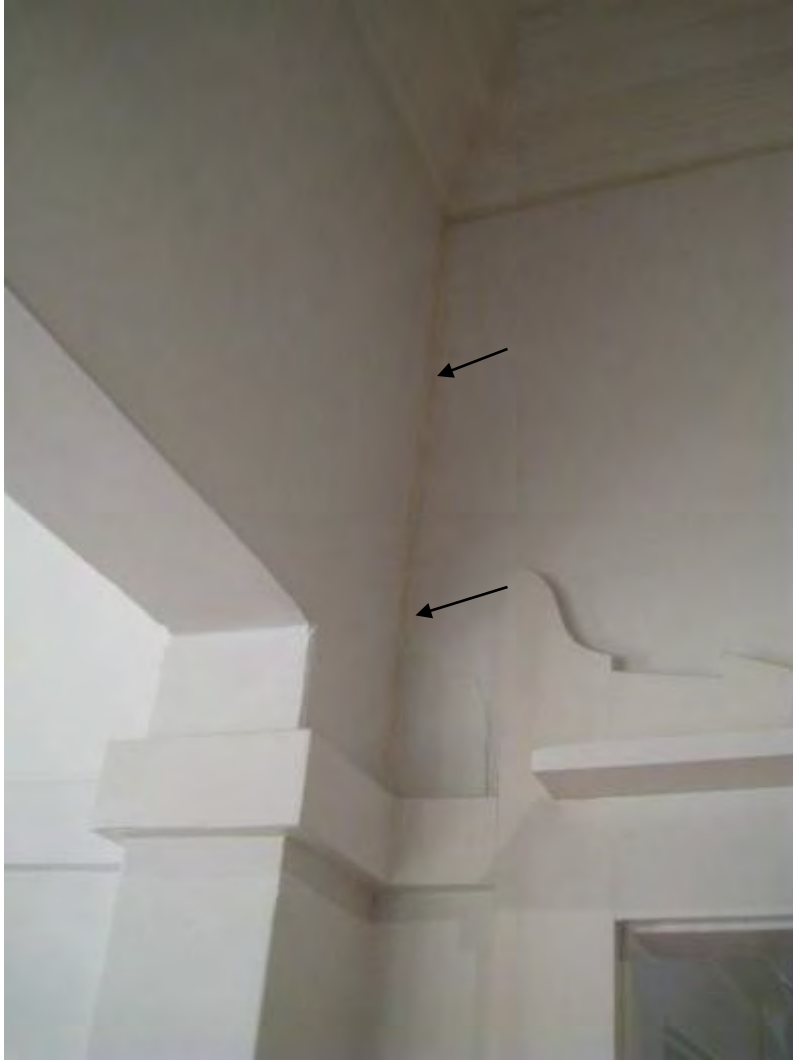
We noted a hairline vertical crack [ $<1.0\text{mm}$ ] to the eastern corner extending from above the picture rail and including through the mitre joint in the cornice. **[Photograph 14]**

**Photograph 14** shows a vertical crack to the corner and cornice at the eastern corner of the Living room

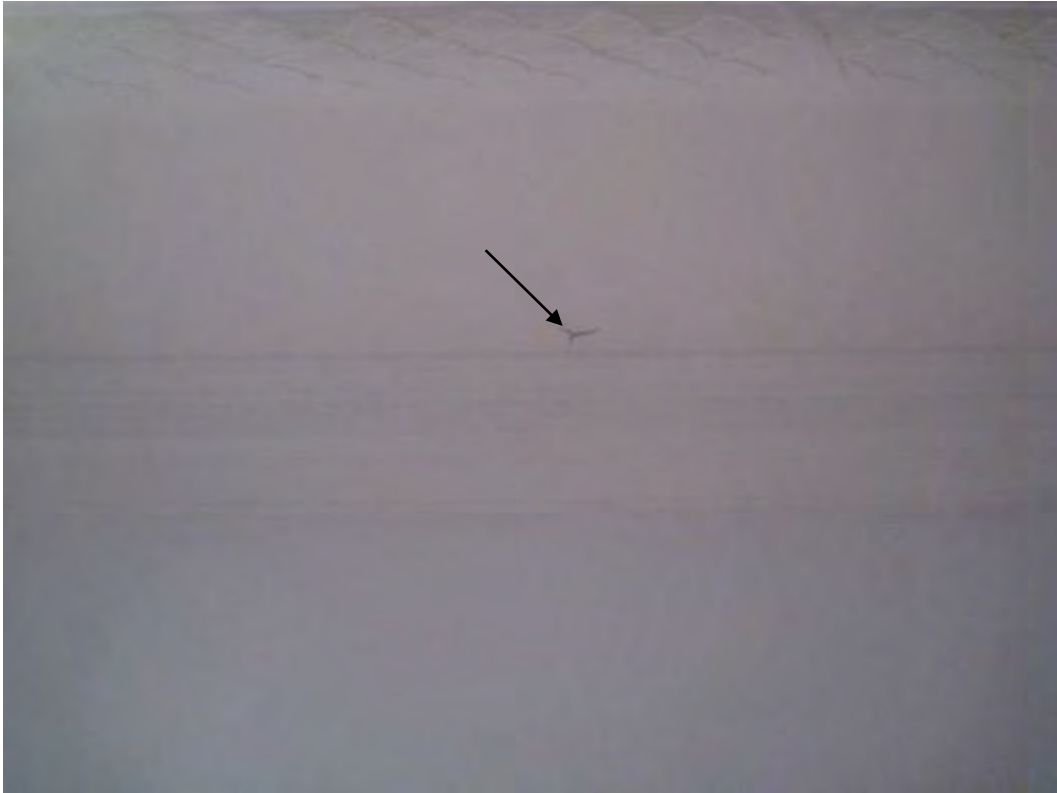
We noted a minor area [nominal 20mm x 20mm] of flaking paint to the ceiling above the squared arch way to the Dining room. **[Photograph 15]**

**Photograph 15** shows flaking paint to the ceiling of the Living room above the squared arch to the Dining room

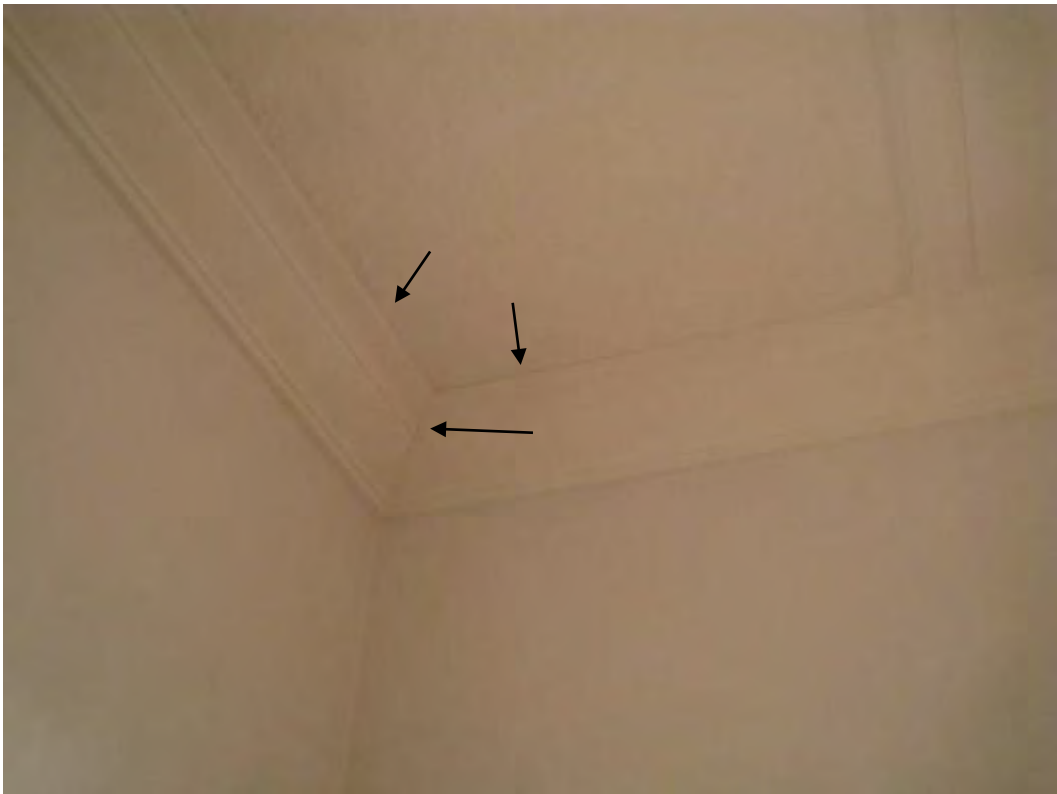
Notwithstanding this, we noted a hairline separation crack [ $<1.0\text{mm}$ ] between the cornice and ceiling lining including a hairline crack to the mitre joint to the cornice to the northern corner of the room.

**Photograph 16** shows a separation crack between the cornice and the ceiling and a hairline crack to the cornice to the northern corner of the Dining room

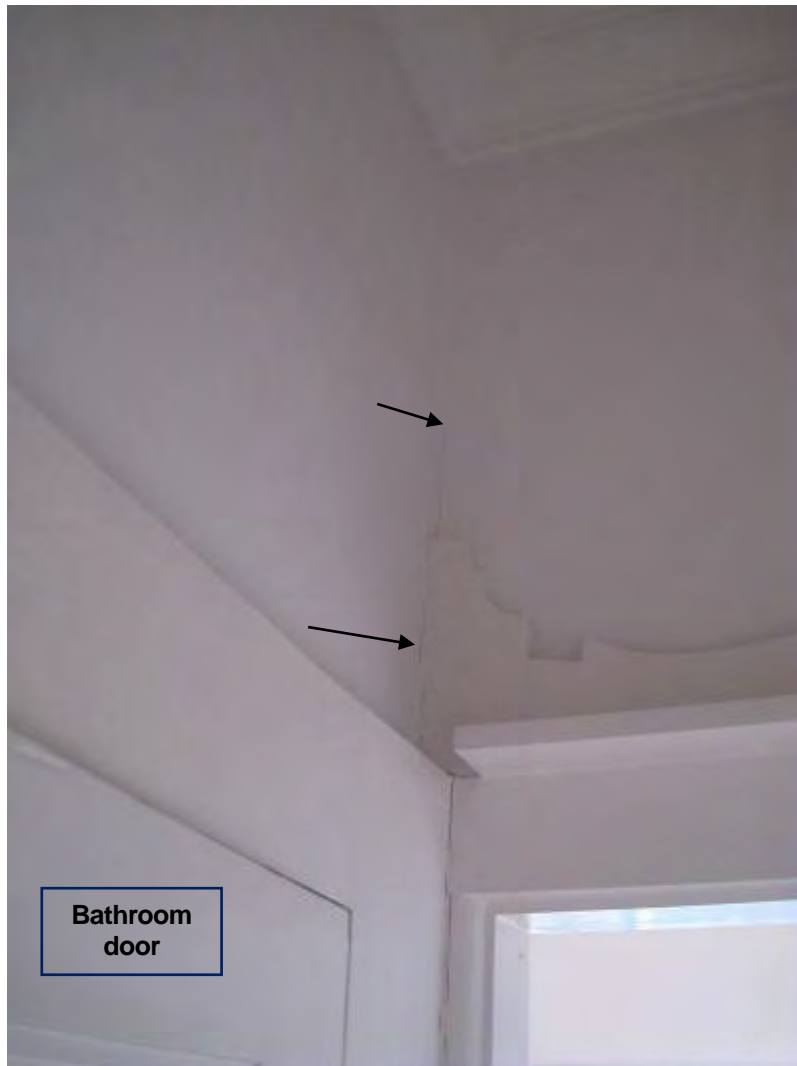
Notwithstanding this, we noted a hairline vertical crack [ $<1.0\text{mm}$ ] to the eastern corner extending from above the door head towards the cornice. **[Photograph 17]**

**Photograph 17** shows a vertical hairline crack to the eastern corner of the Hallway

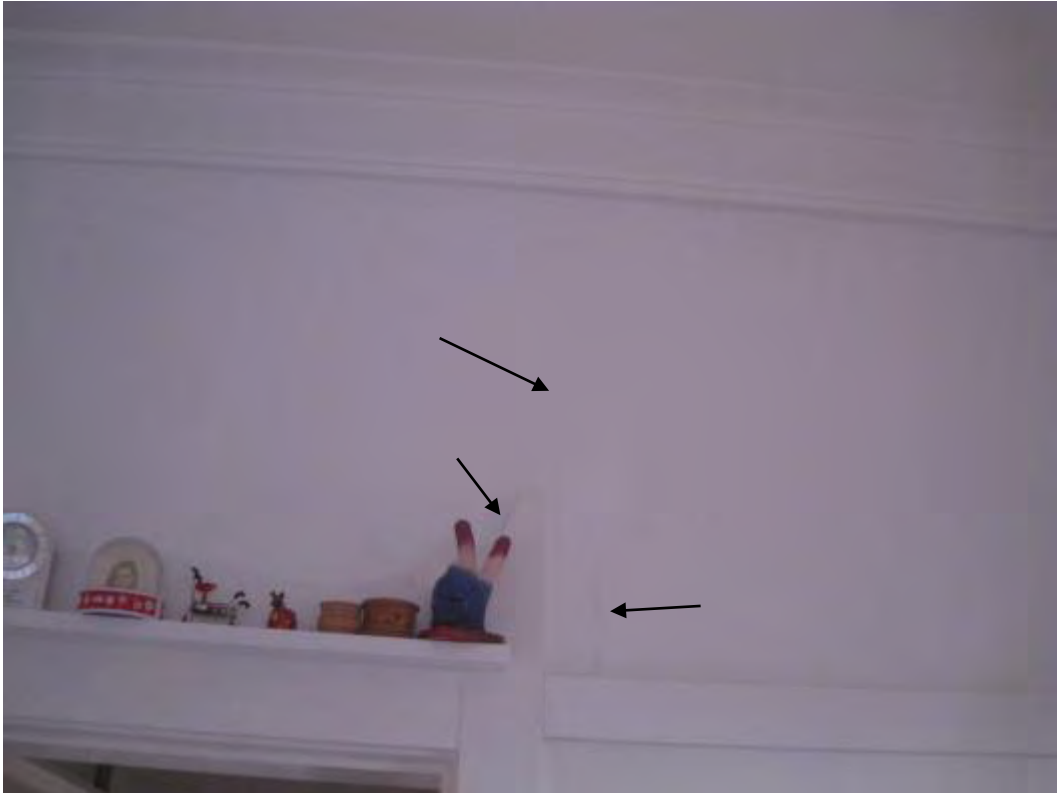
We noted two hairline vertical cracks [ $<0.5\text{mm}$ ] extending from right hand side of the door head towards the cornice. **[Photograph 18]**

**Photograph 18** shows a vertical crack above the picture rail to the right hand side of the doorhead to Bedroom 1

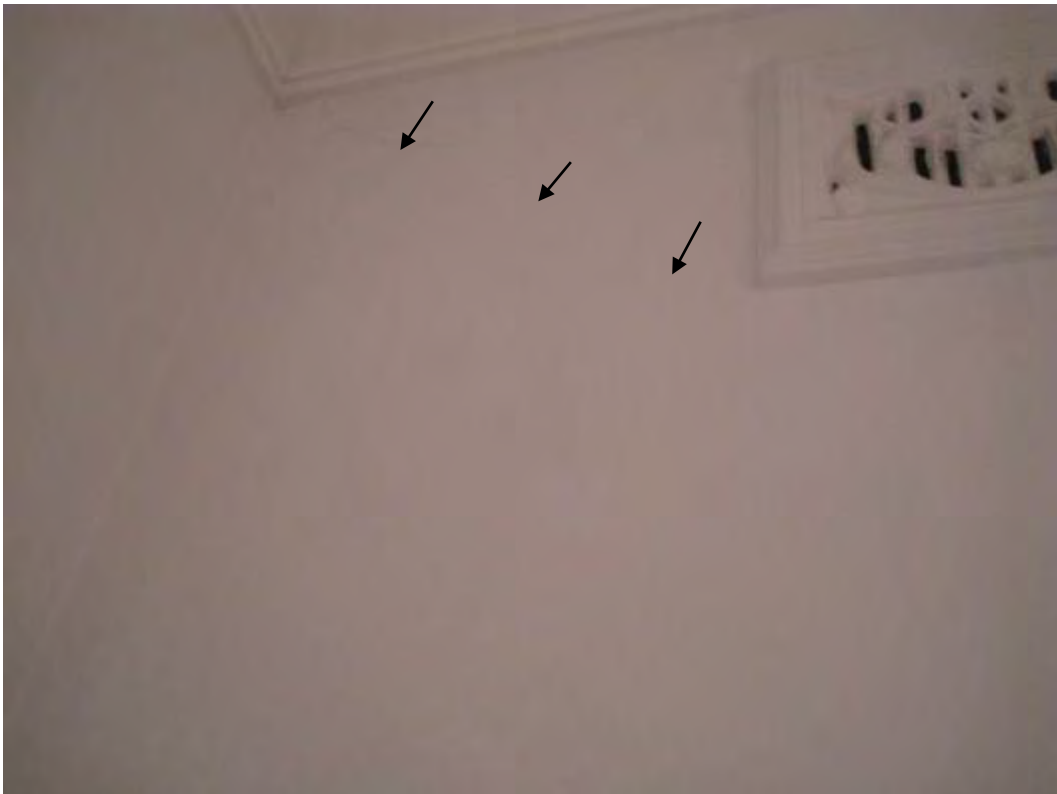
We noted a hairline crack [ $<0.5\text{mm}$ ] extending from the external wall vent towards the cornice to the northern corner of the room. **[Photograph 19]**

**Photograph 19** shows a radial hairline crack extending from the wall unit towards the cornice to the northern corner of the front Bedroom 1

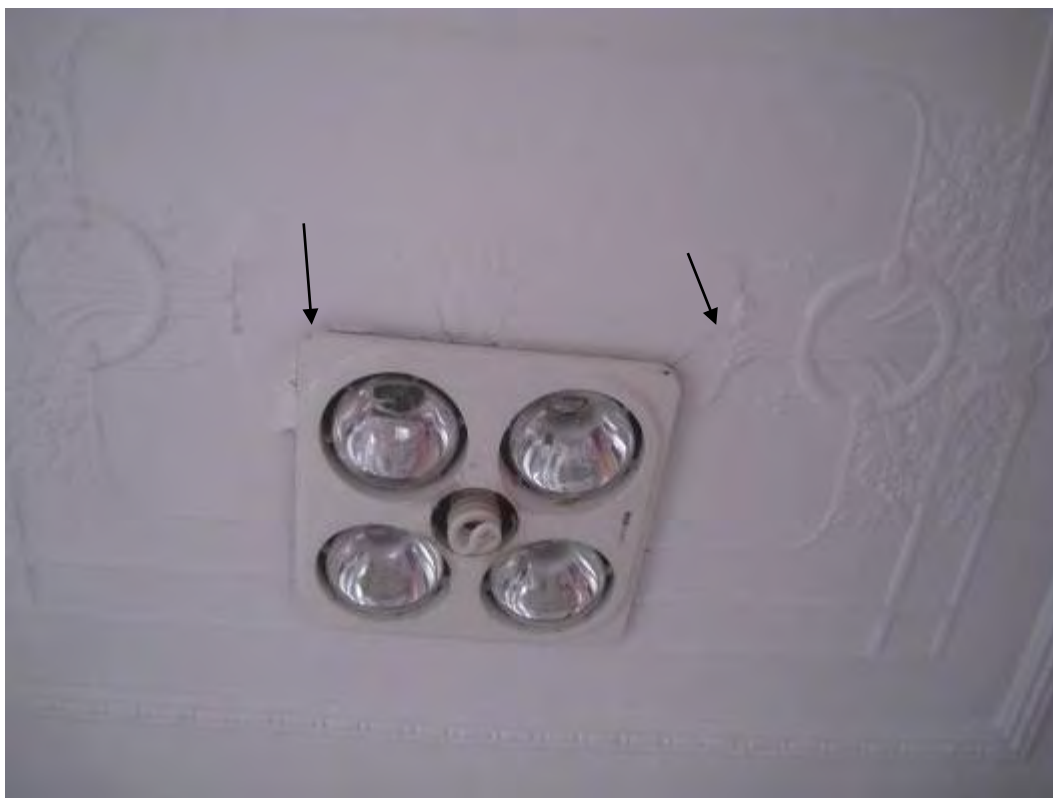
Notwithstanding this, we noted cracking to the ceiling adjacent to the fan / heater/ light fitting in the ceiling. **[Photograph 20]**

**Photograph 20** shows cracks to the ceiling abutting the heater / light fitting to the Bathroom

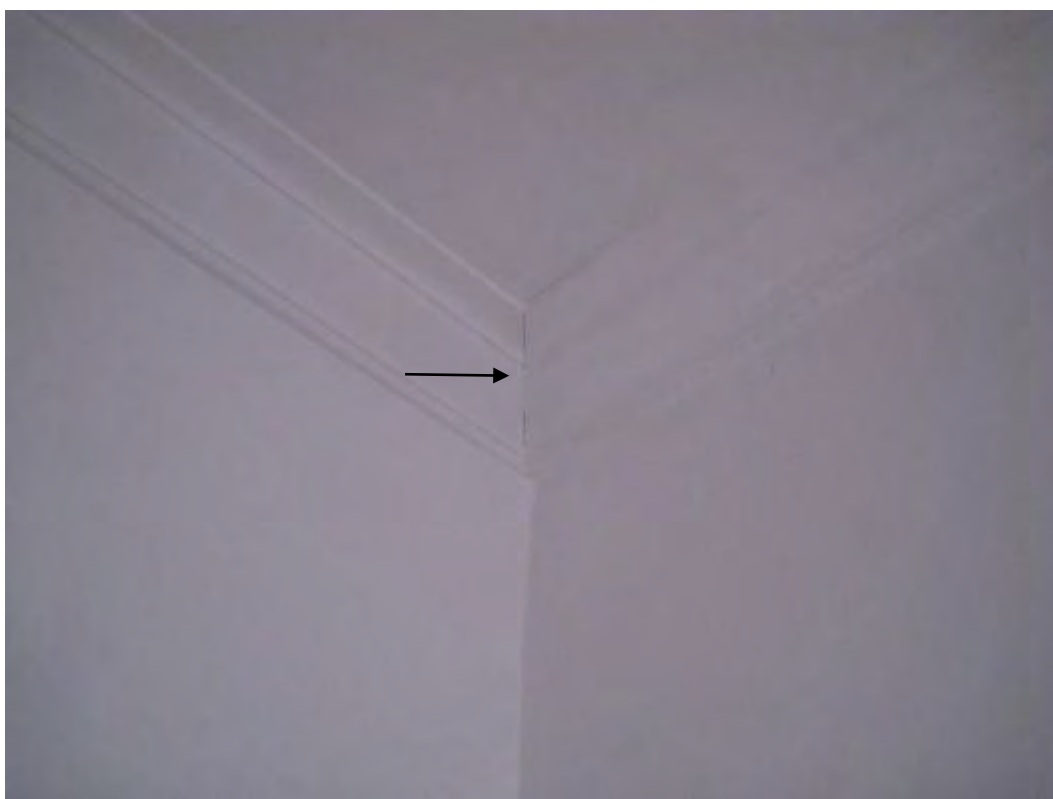
We also noted a hairline crack to the mitre joint to the cornice to the western corner of the room. **[Photograph 21]**

**Photograph 21** shows a hairline crack to the mitre joint in the cornice to the western corner of the Bathroom

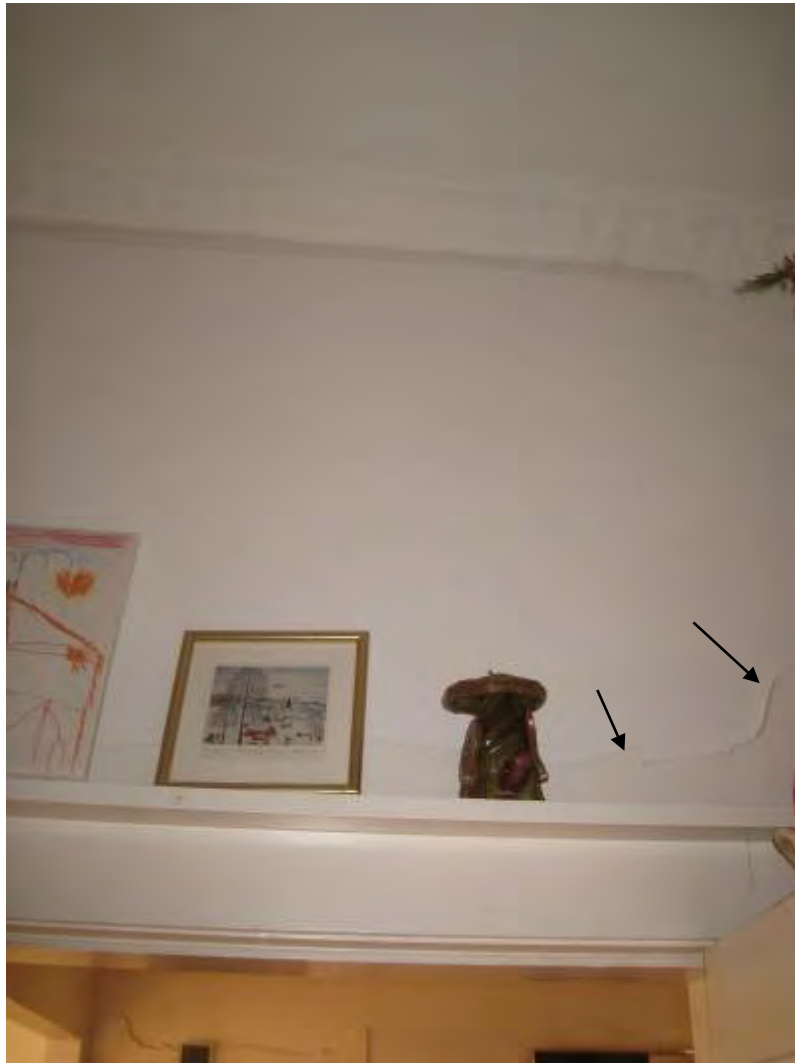
We noted a vertical crack [ $<1.0\text{mm}$ ] above the door opening extending towards the cornice.  
**[Photograph 22]**

**Photograph 22** shows a hairline vertical crack above the doorway in Bedroom 2

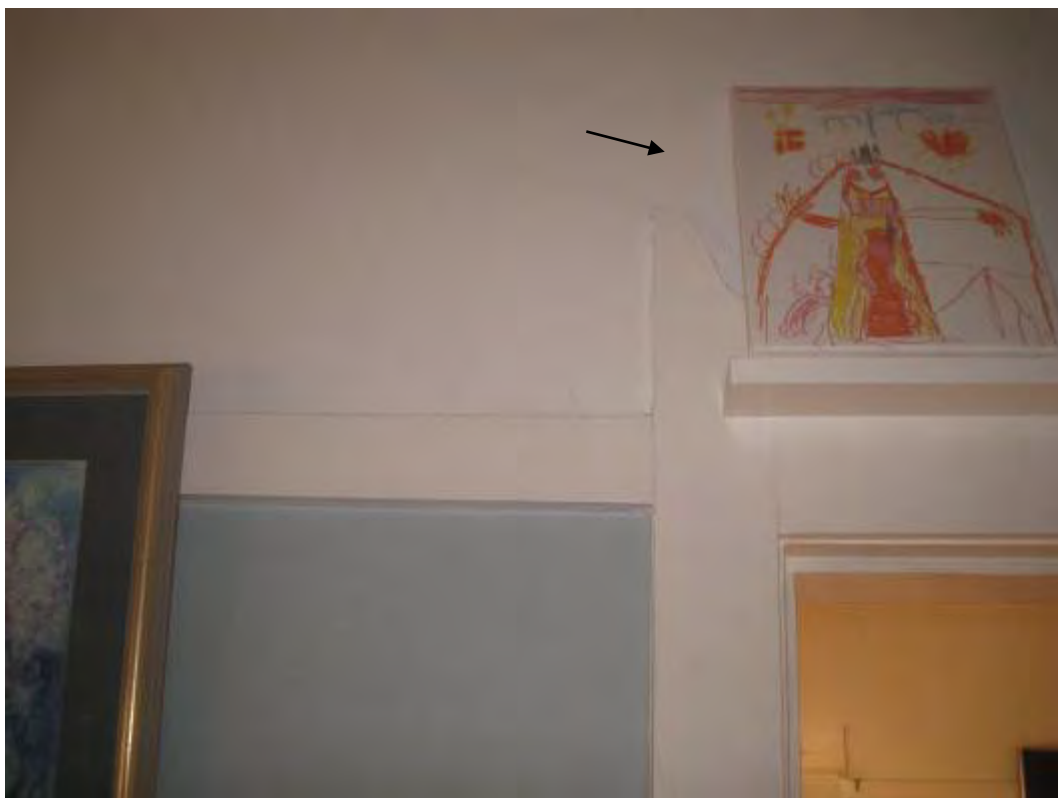
We noted a nominal 100mm long radial crack [ $<1.0\text{mm}$ ] to the left hand side of the door head.  
**[Photograph 23]**

**Photograph 23** shows a vertical crack above the picture rail to the left hand side of the doorway head in Bedroom 2

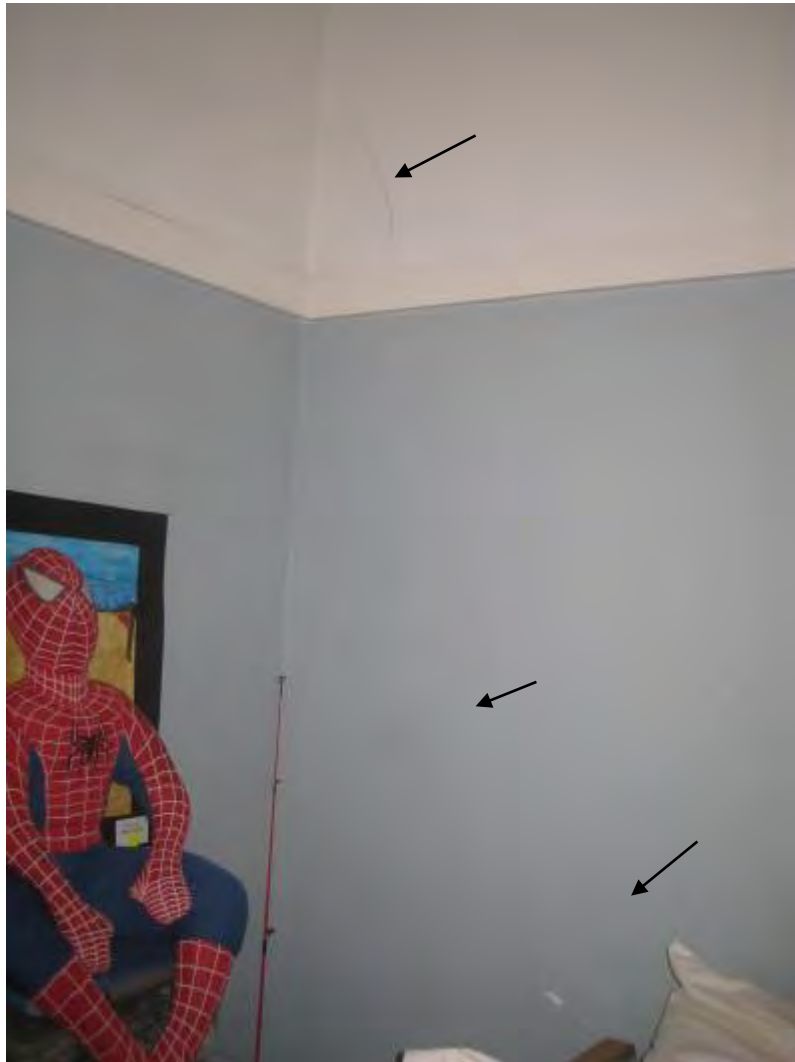
Notwithstanding this, we noted a stepped and radial crack [ $<1.0\text{mm}$ ] to the northern corner of the room **[Photographs 24, 25 and 26]**

**Photograph 24** shows a radial stepped crack to the northern corner of Bedroom 3

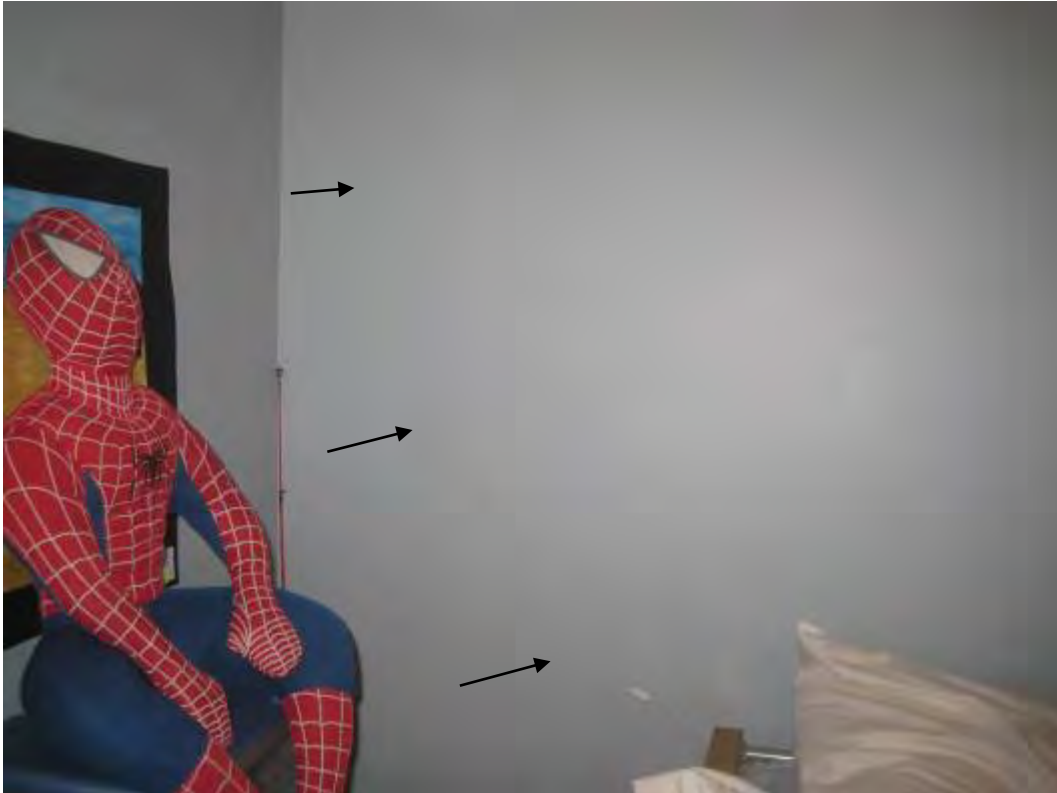
**Photograph 25** shows a stepped hairline crack to the rear northern corner of Bedroom 3
