## Dilapidation Assessment Report

Job address: Unit 6 / 59 Gould Street, Bondi Beach NSW 2026

Date of assessment: 11<sup>th</sup> March 2015

**Re: Dilapidation Report – Unit 6 / 59 Gould Street, Bondi Beach**

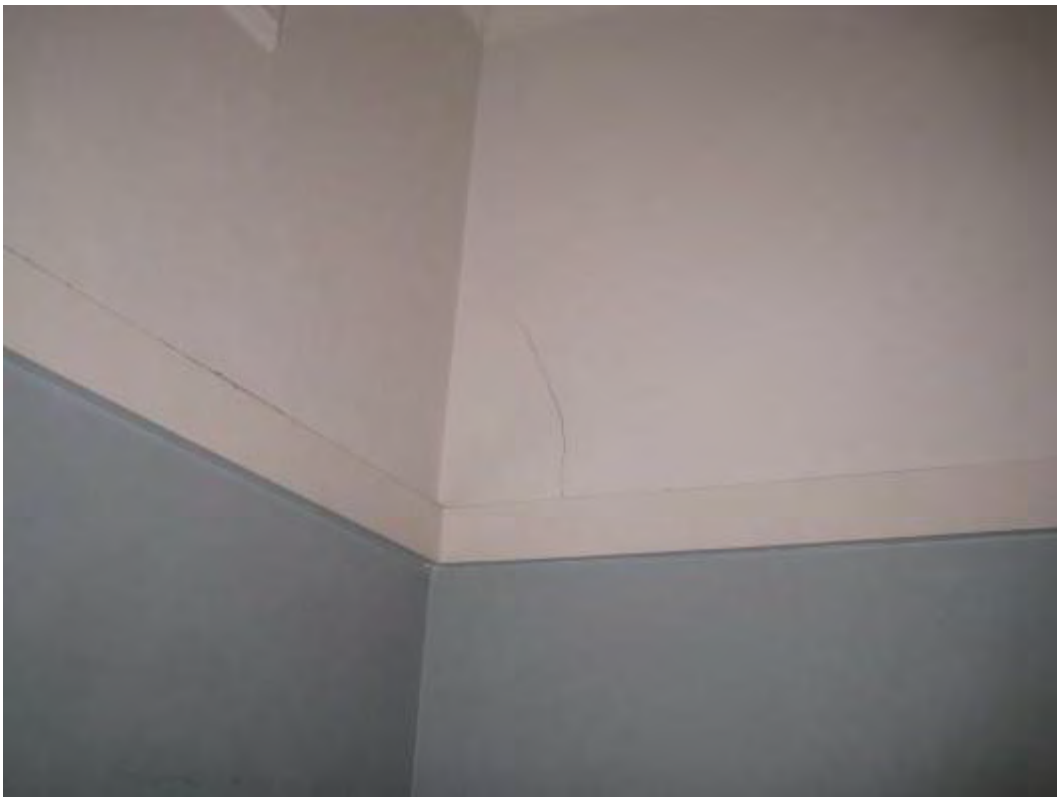
Notwithstanding this, we noted a stepped and radial crack [ $<1.0\text{mm}$ ] to the northern corner of the room **[Photographs 24, 25 and 26]**

**Photograph 26** shows a radial crack above the picture rail to the rear northern corner of Bedroom 3

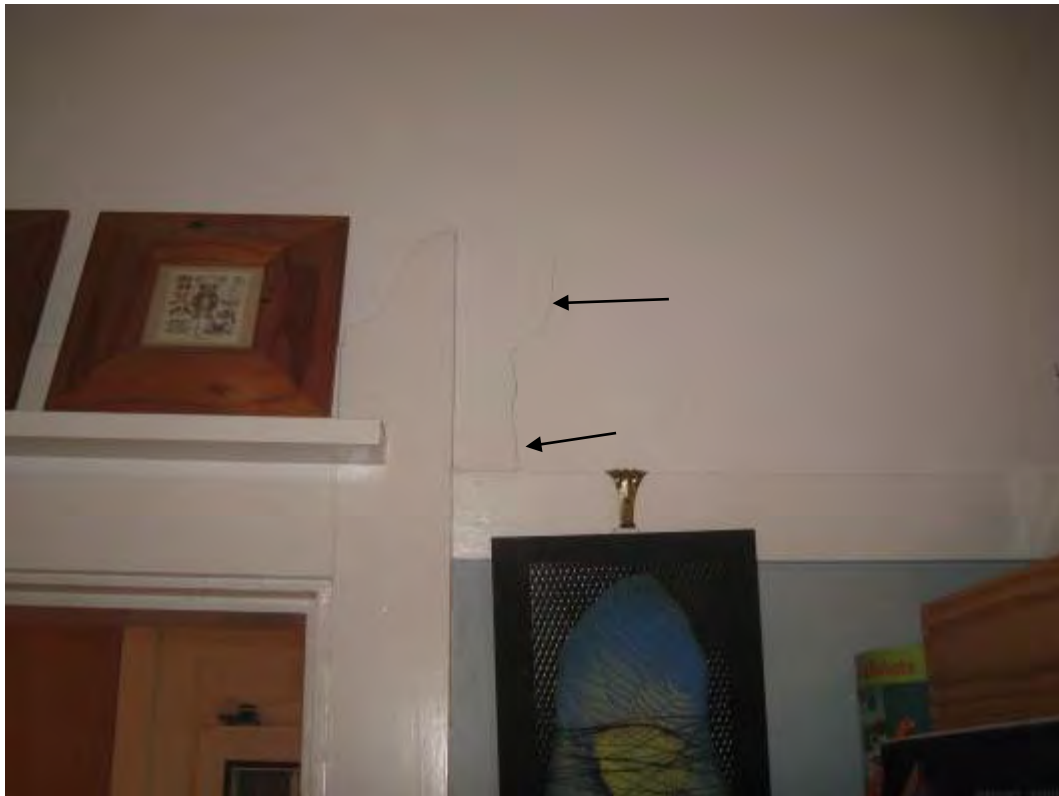
We also noted a vertical hairline crack [ $<1.0\text{mm}$ ] to the right hand side of the doorhead. **[Photograph 27]**

**Photograph 27** shows a vertical crack above the picture rail to the right hand side of the door in Bedroom 2
