## **HAZARDOUS MATERIALS ASSESSMENT REPORT**

**Job details:** Owner/s: Mr. A. King & Ms. K. Lyons  
Location: 13 Fourth Avenue, Lane Cove NSW

**Date of assessment:** 16<sup>th</sup> December 2015

**Our reference:** HM04461215

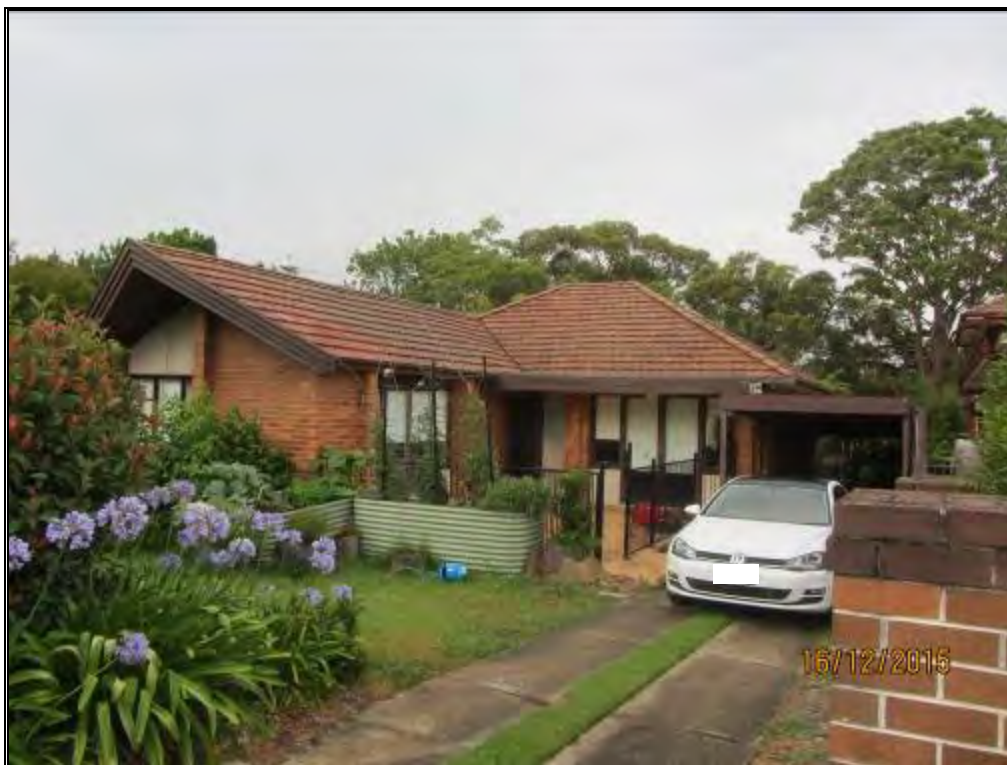
Front eastern elevation of the residence
