HAZARDOUS MATERIALS ASSESSMENT REPORT

Job details: Owner/s: Mr. M. & Mrs. S. Weeding
Location: 3 Irvine Street, Kingsford NSW

Our reference: HM03611214

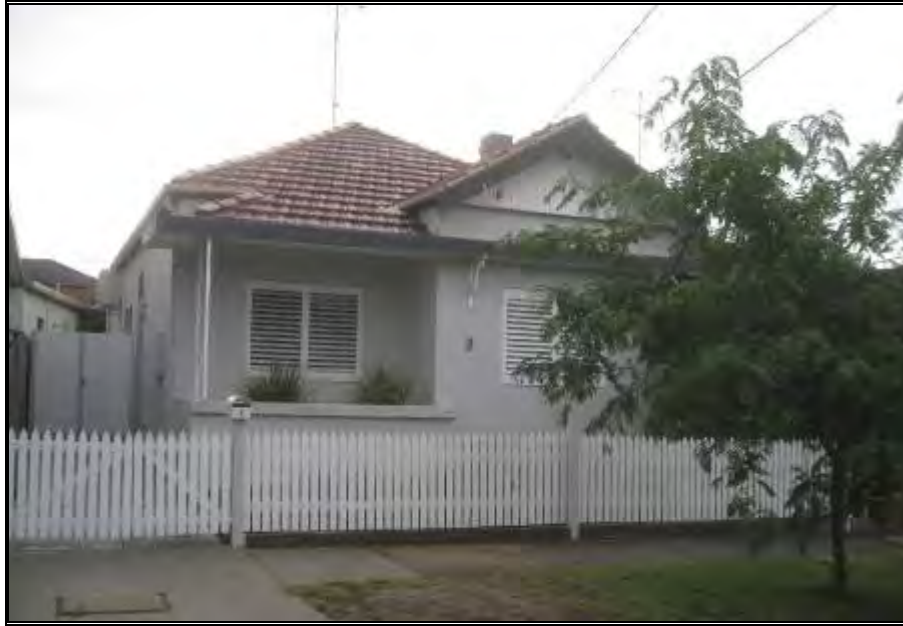
Front western elevation of the residence
