HAZARDOUS MATERIALS ASSESSMENT REPORT

Client: Cape Cod Australia Pty. Limited

Job details: Owner: Mr. A. & Mrs. S. Quinn.
Location: 37 Varna Street, Clovelly.

Our reference: HM05810717

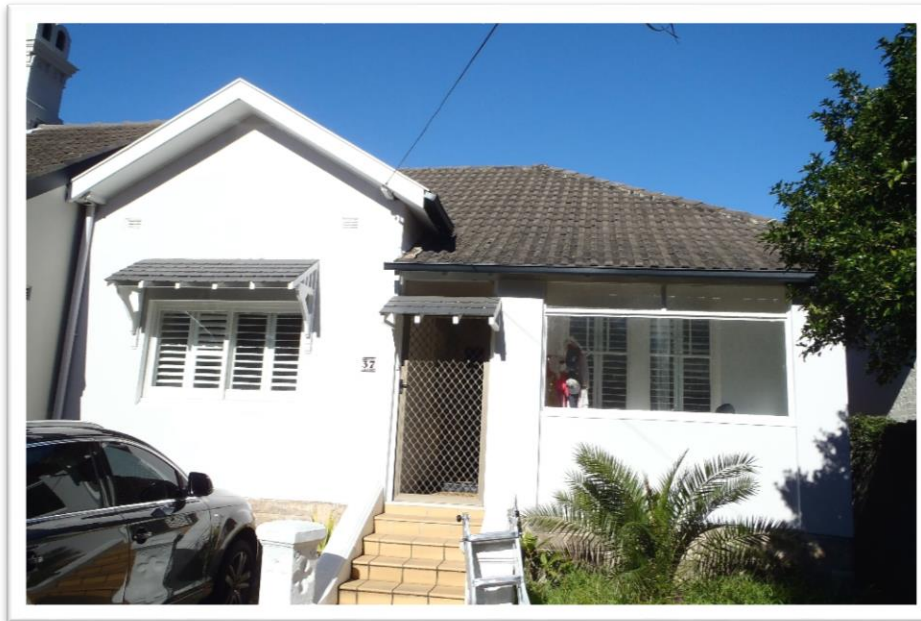
Front northern elevation of the residence
