Dilapidation Assessment Report

Prepared for: Cape Cod Australia Pty. Limited
Job address: 7 Jacques Street, Kingsford.
Property Owner/s: Unknown. Access via Mr. Andrew Yong.
Raine & Horne, Kingsford.
Report reference: **RANDWICK CITY COUNCIL**
Development Application No: not available
Date of assessment: 29th August 2016

Re: Dilapidation Report

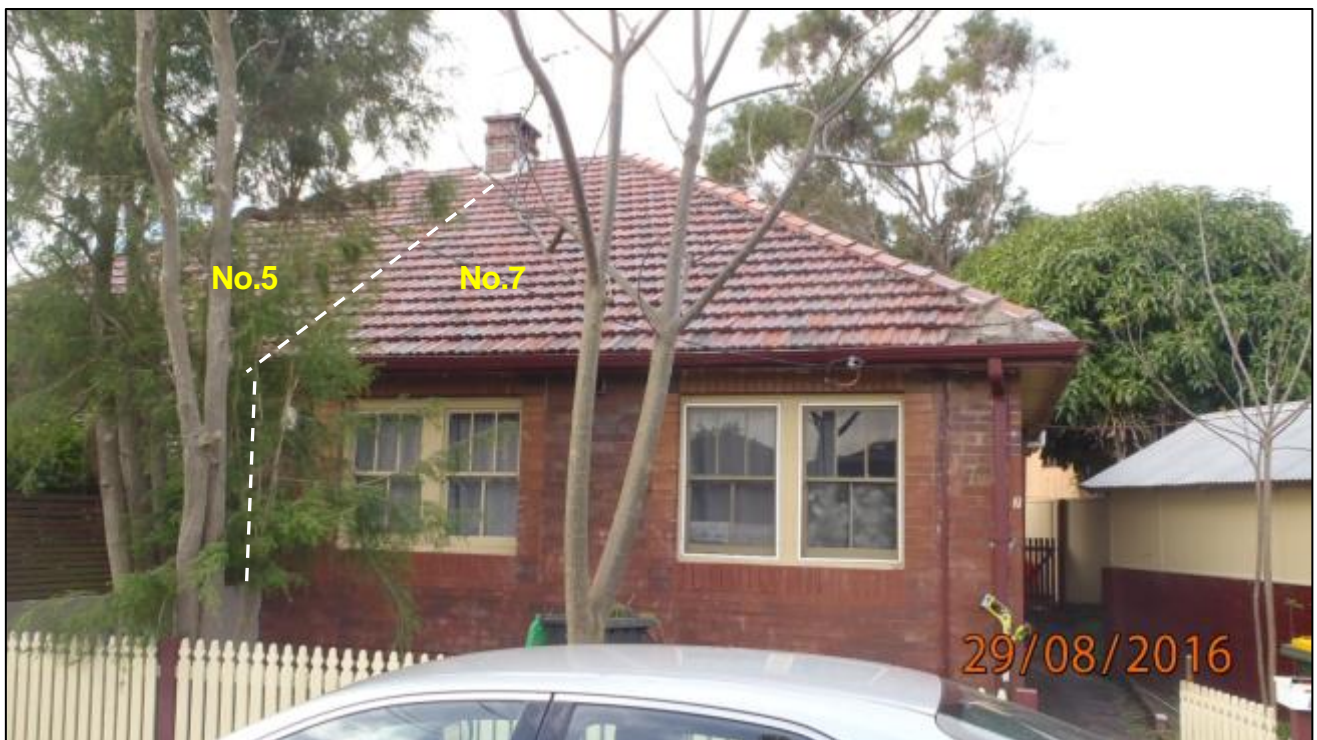
Shows the front south eastern elevation of the adjoining properties:
No.5 and No.7 Jacques Street, Kingsford.

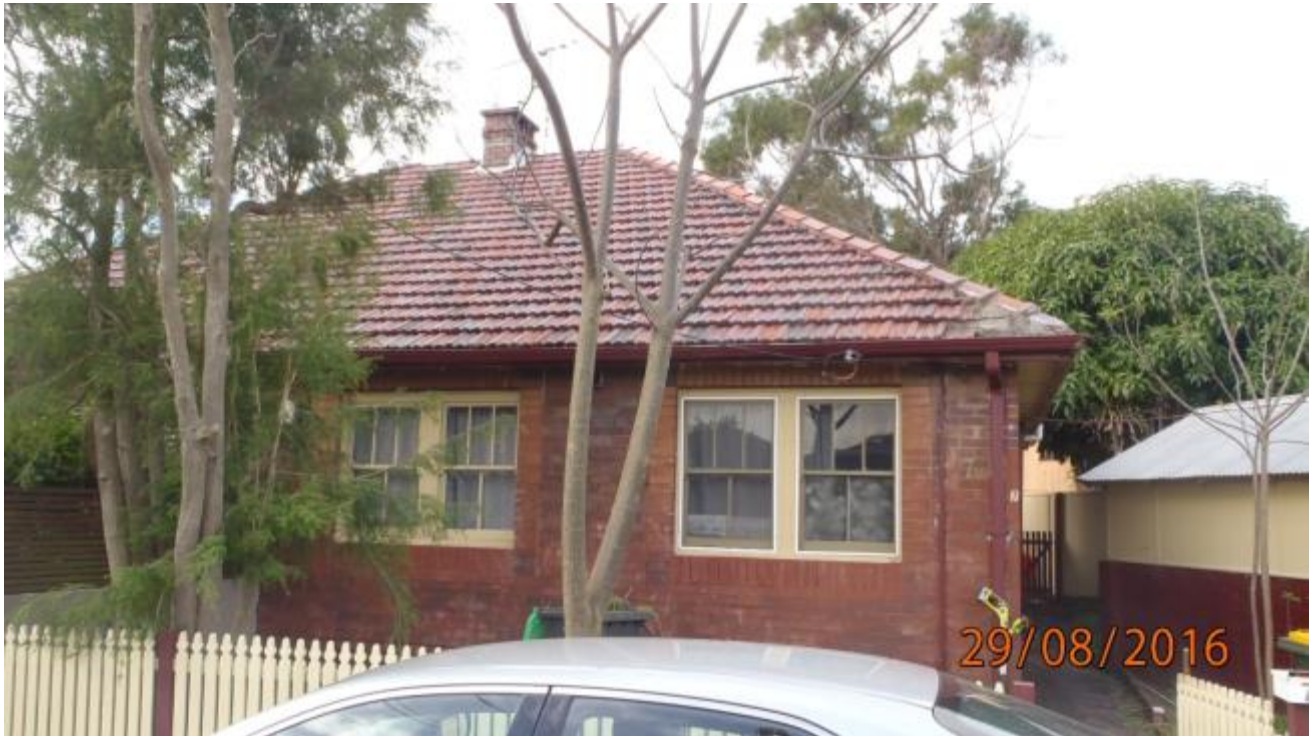
We observed that the terracotta roof tiles to the roof surface are generally interlinked and securely bedded, in our opinion forming a weather resistant cover to the residence. **[Photographs 1 & 2]**

We noted that the ridge pointing shows signs of deterioration to the front eastern corner above Bedroom 1 **[Photograph 1]**, the rear southern corner above the Kitchen **[Photograph 3]** and the rear southern corner above the external Laundry **[Photographs 4 & 5]**

Photograph 1 shows the general condition of the roof surface to the front elevation.

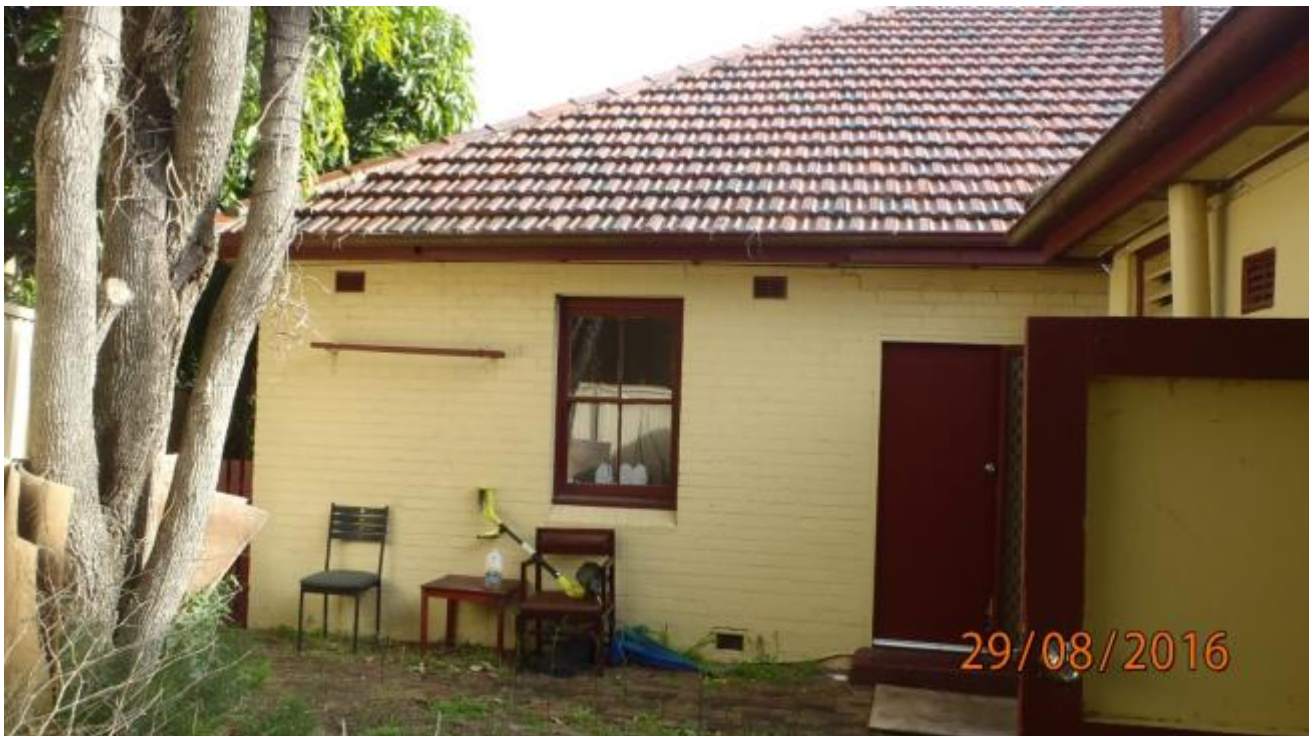
We noted that the rear external wall was constructed of clay masonry brickwork and that the brickwork is surface coated. **[Photograph 2]**

Photograph 2 shows the general condition of the roof surface to the rear elevation.

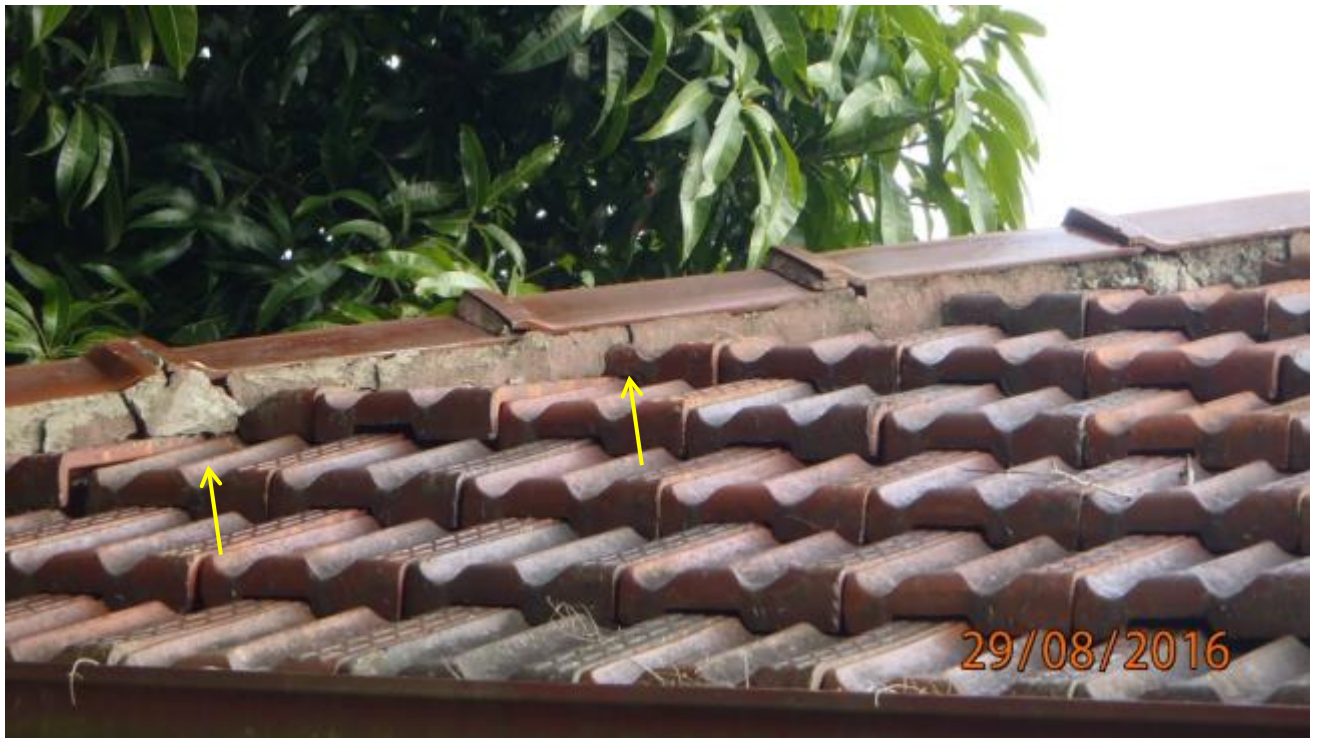
Photograph 3 shows the damage to the ridge pointing above the Kitchen.

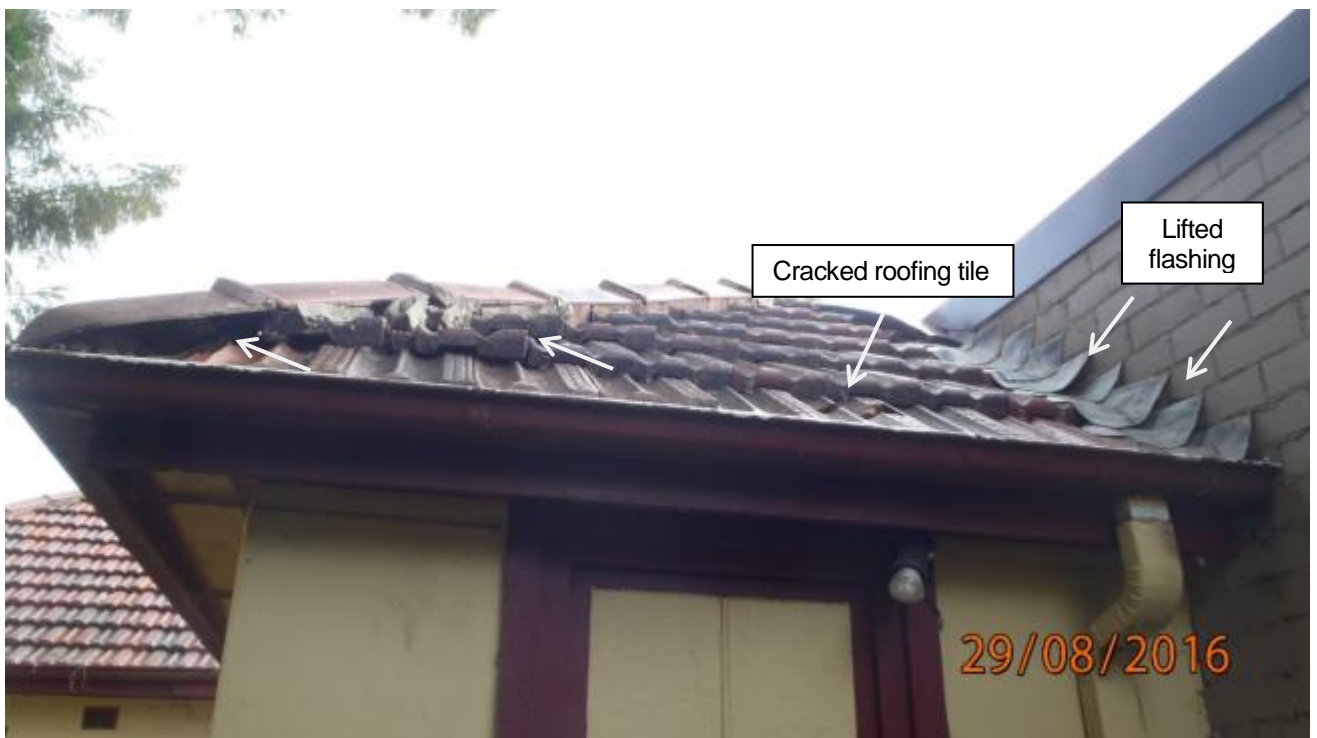
We also noted cracked and lifted tiles to the roof surface above the external Laundry **[Photograph 4]**

We further noted that the flashing was lifted at the junction between the common party wall with the adjoining property; No.5 Jacques Street, Kingsford. **[Photograph 4]**

Photograph 4 shows the damage to the ridge pointing above the Laundry, lifted flashing from the *common* party wall, and cracked tiles.

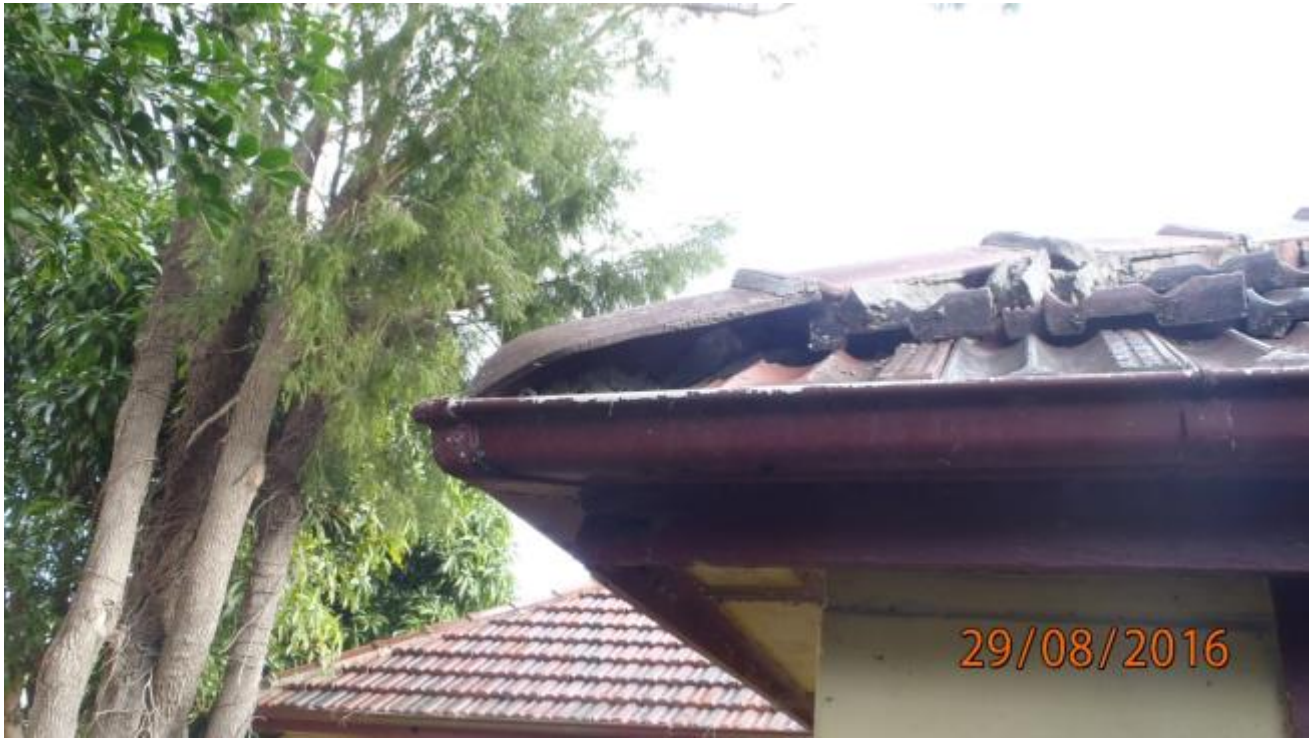
Photograph 5 shows the damage and deterioration of the ridge pointing above the Laundry.

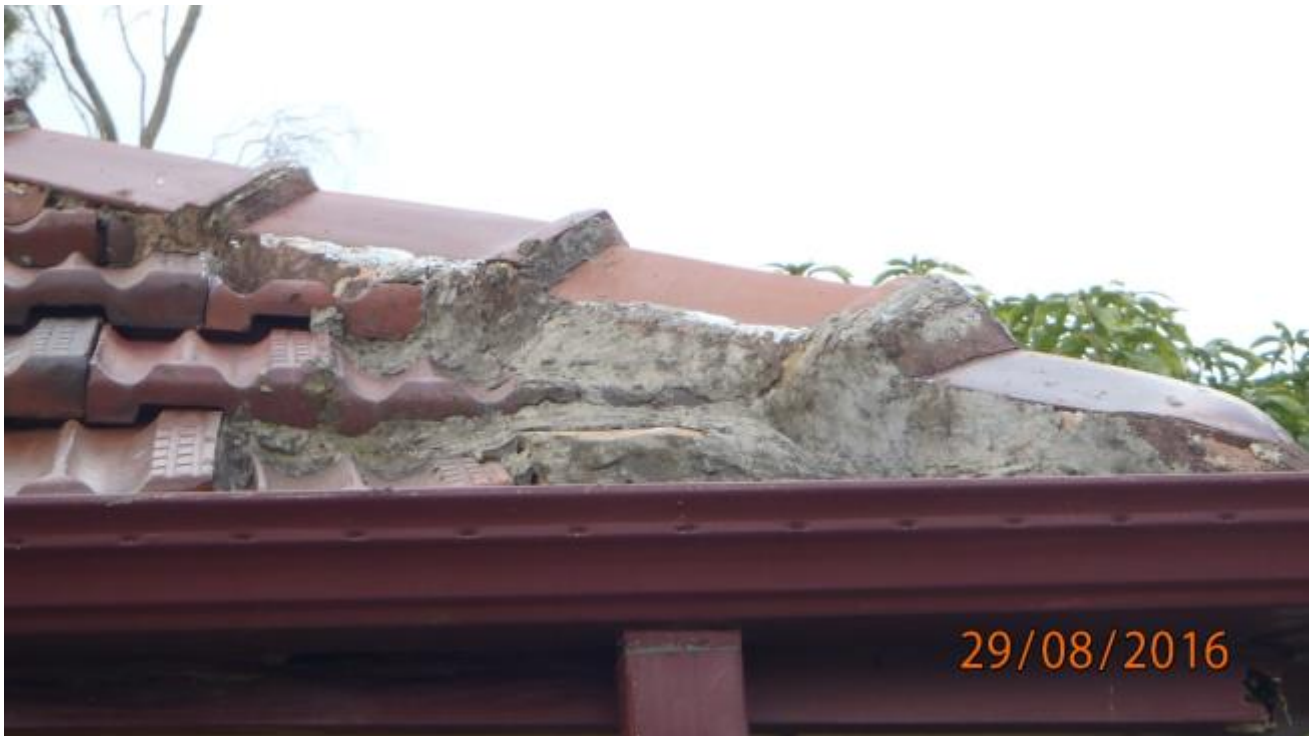
We also noted evidence of a previous repair to the ridge pointing to the front eastern corner above Bedroom 1 **[Photograph 6]**

Photograph 6 shows a previous repair to the frontal elevation ridge pointing above Bedroom 1.

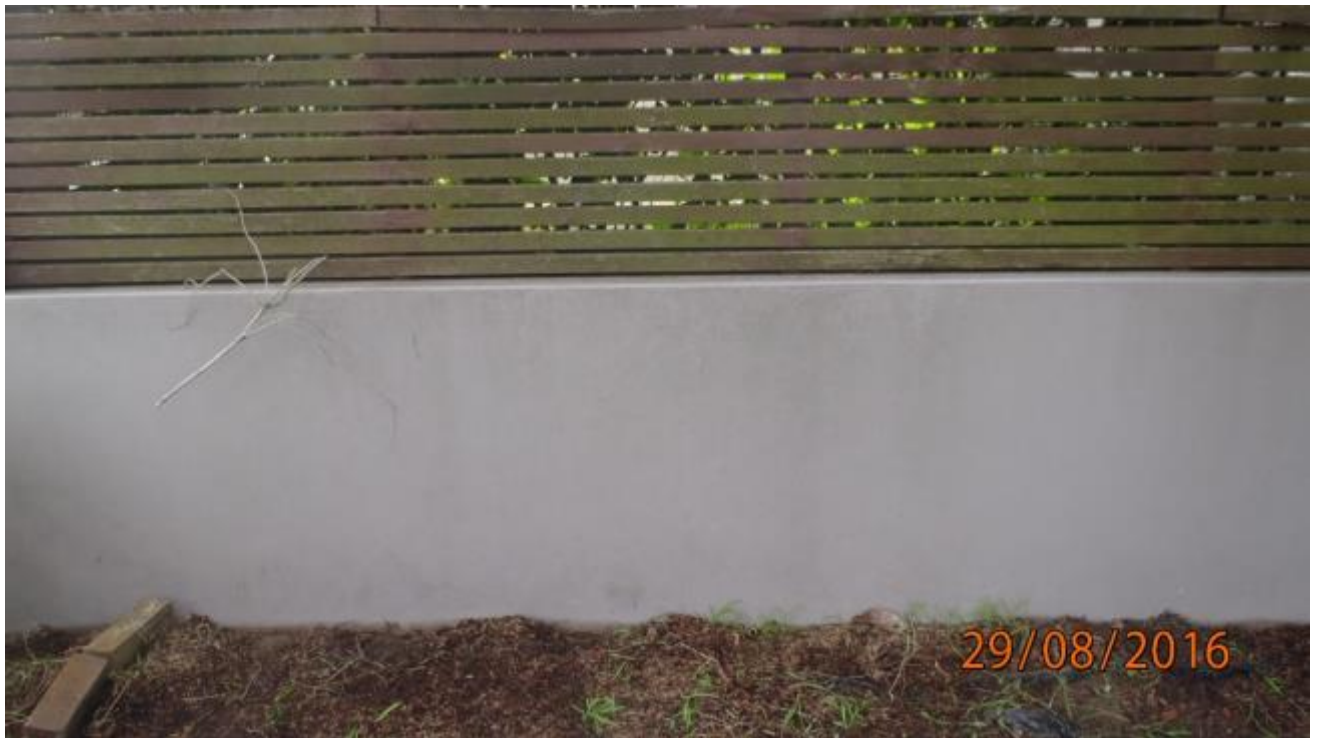
We noted that the common boundary fence with No.5 Jacques Street, Kingsford is surface coated brick construction with a timber extension above. **[Photograph 7]**

Photograph 7 shows the general condition of the from *common* boundary fence.

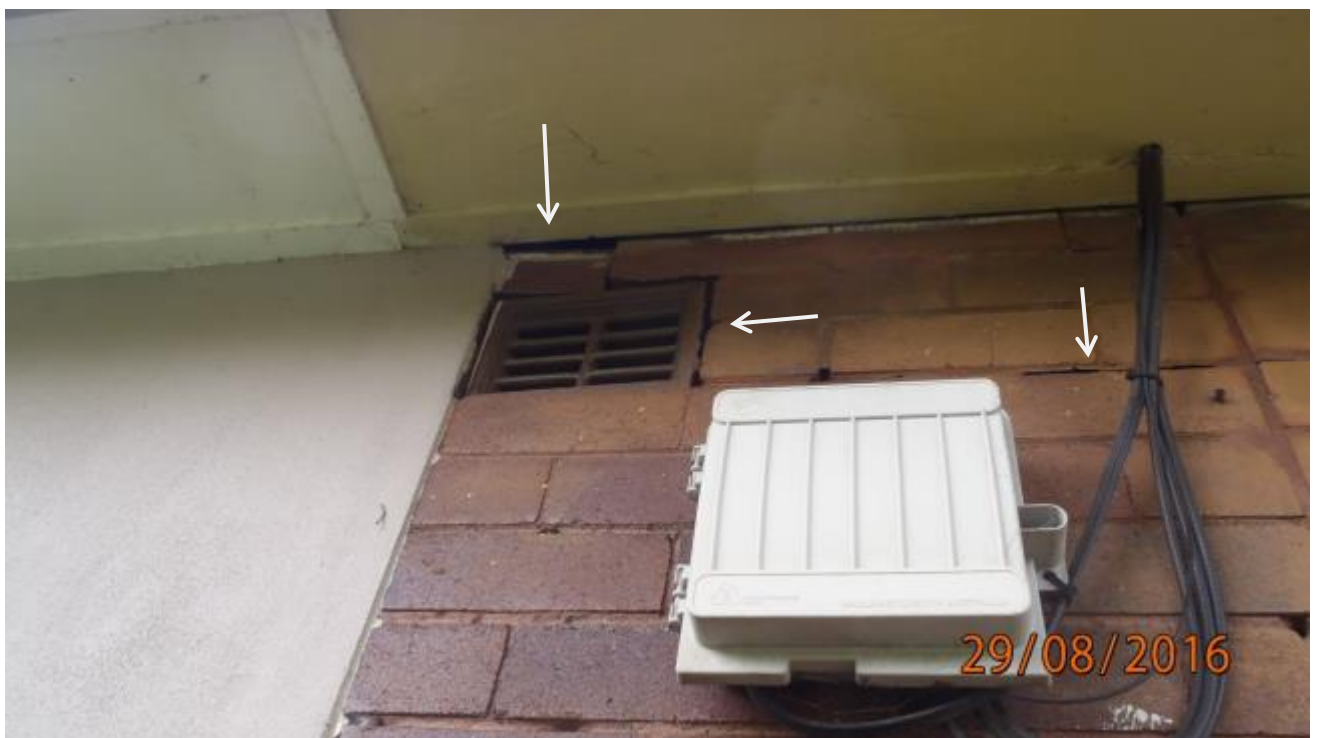
We noted cracked mortar, displaced mortar and displaced brickwork around the wall vent outside Bedroom 2 (adjacent to the *common* wall with No.5 Jacques Street, Kingsford. **[Photograph 8]**

Photograph 8 shows cracked mortar, displaced mortar and displaced brickwork around the wall vent outside Bedroom 2.

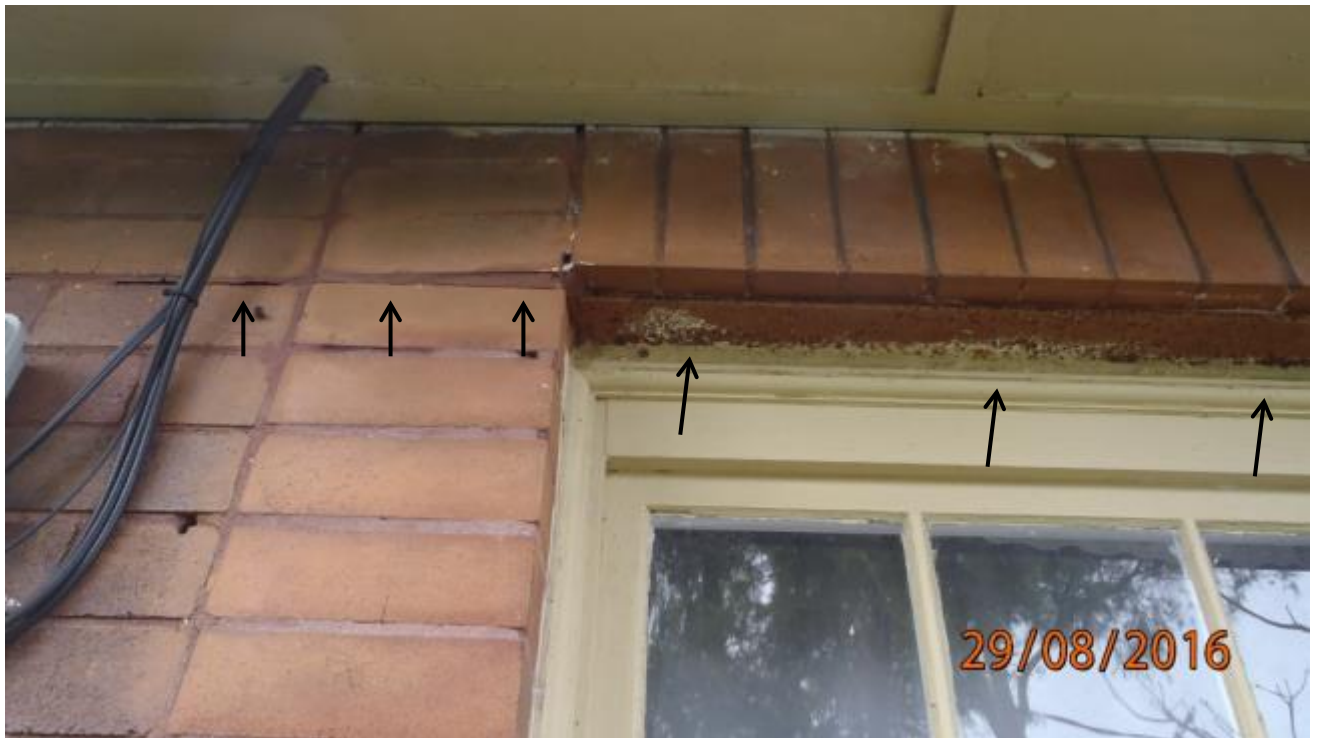
We noted a rusted lintel above the Bedroom 2 window and horizontal cracking to the mortar as a result. We also noted previous repointing to the mortar around the window. **[Photograph 9]**

Photograph 9 shows a rusted lintel above the Bedroom 2 window and horizontal cracking to the mortar adjacent as a result.

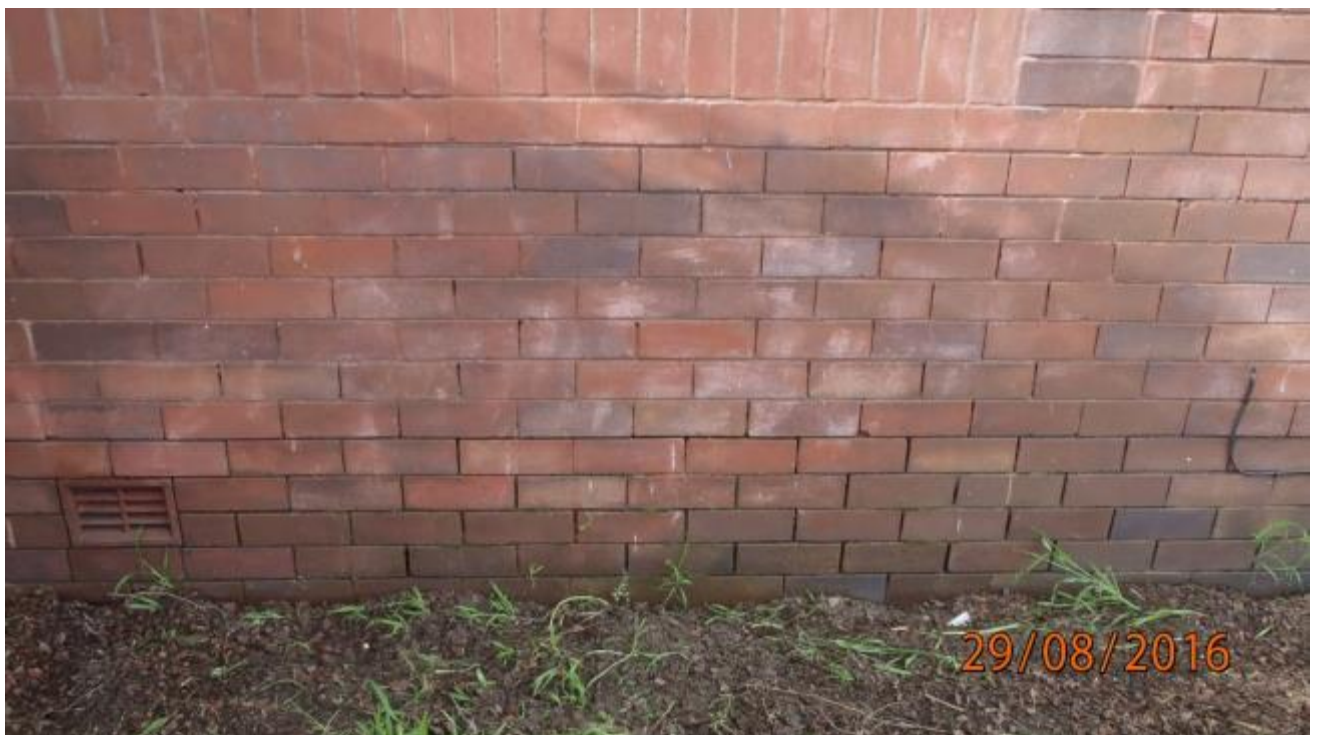
We observed general displacement of the mortar (fretting) under the Bedroom 2 window. **[Photograph 10]**

Photograph 10 shows general displacement of the mortar under the Bedroom 2 window.

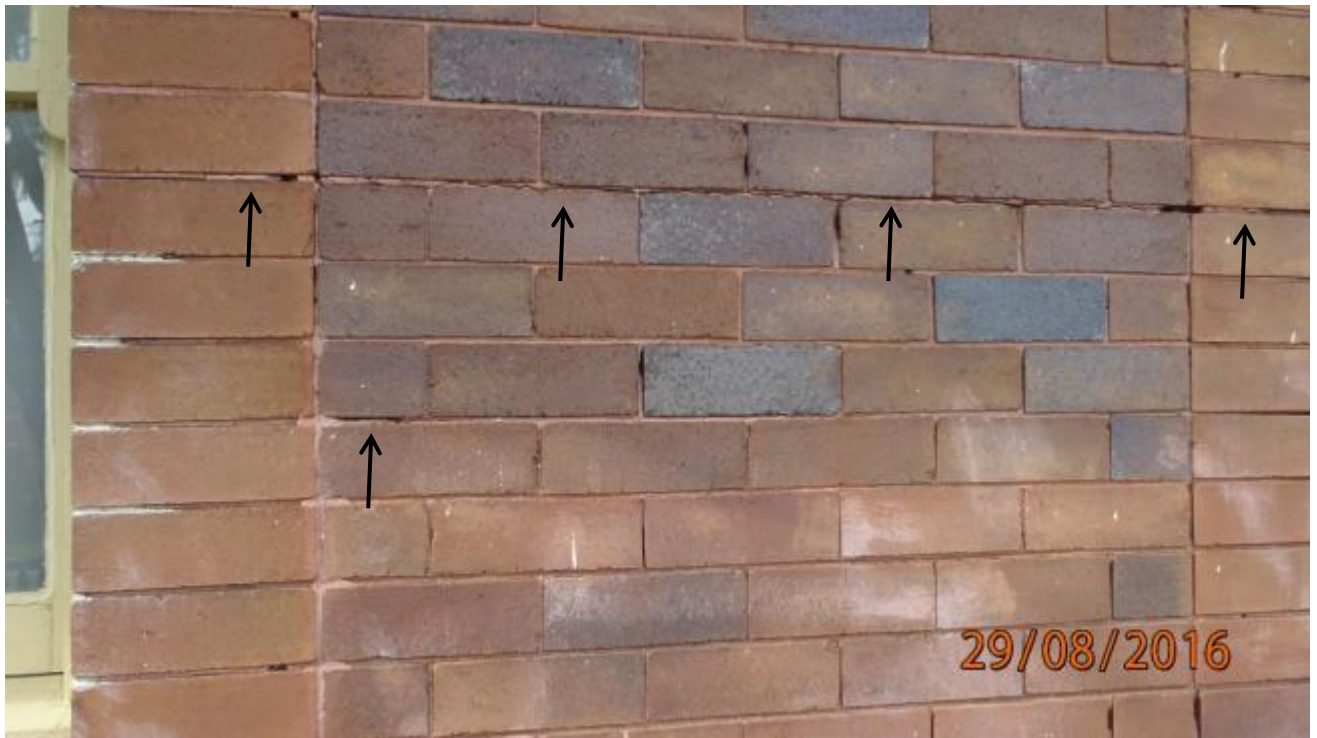
We noted horizontal, step cracking and repointing to the mortar between Bedroom 1 and Bedroom 2. **[Photograph 11]**

Photograph 11 shows horizontal, step cracking and repointing to the mortar between Bedroom 1 and Bedroom 2.

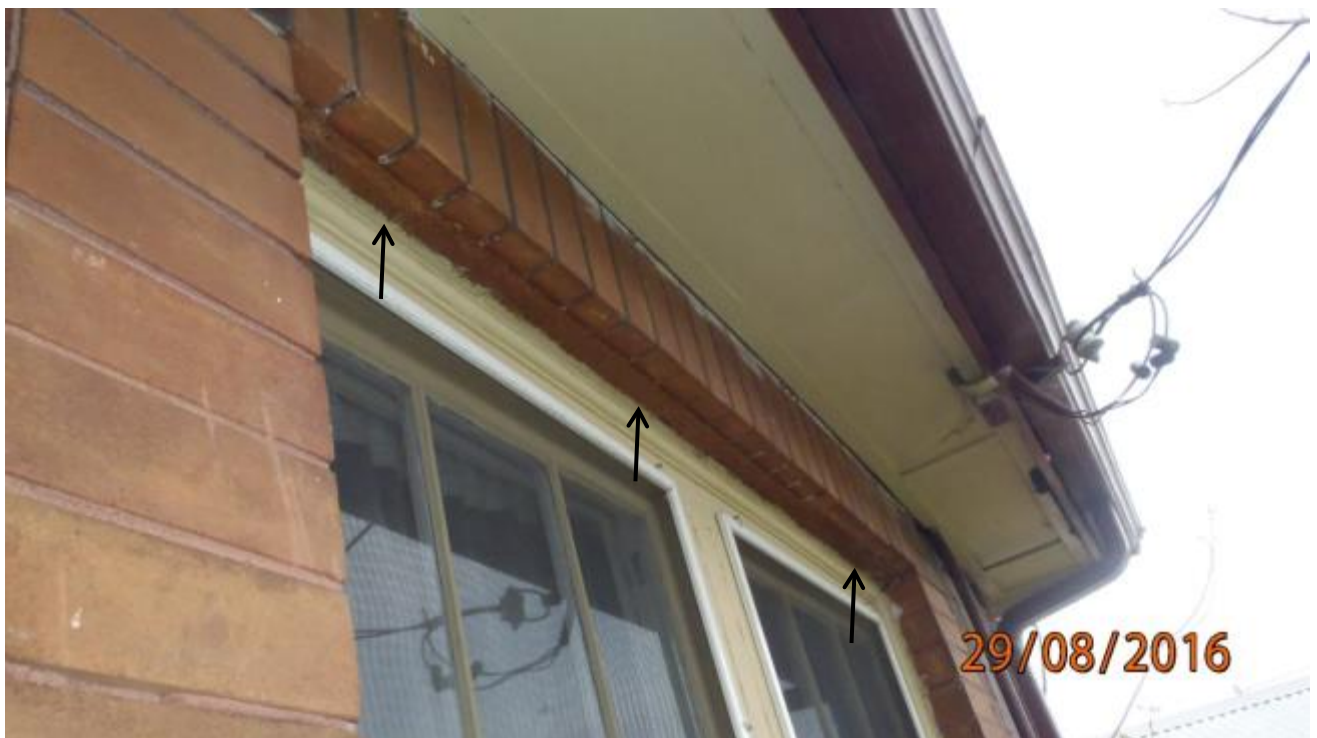
We noted a rusted lintel above the Bedroom 1 window and previous repointing to the mortar around the window. **[Photograph 12]**

Photograph 12 shows a rusted lintel above the Bedroom 1 window and previous repointing to the mortar around the window.

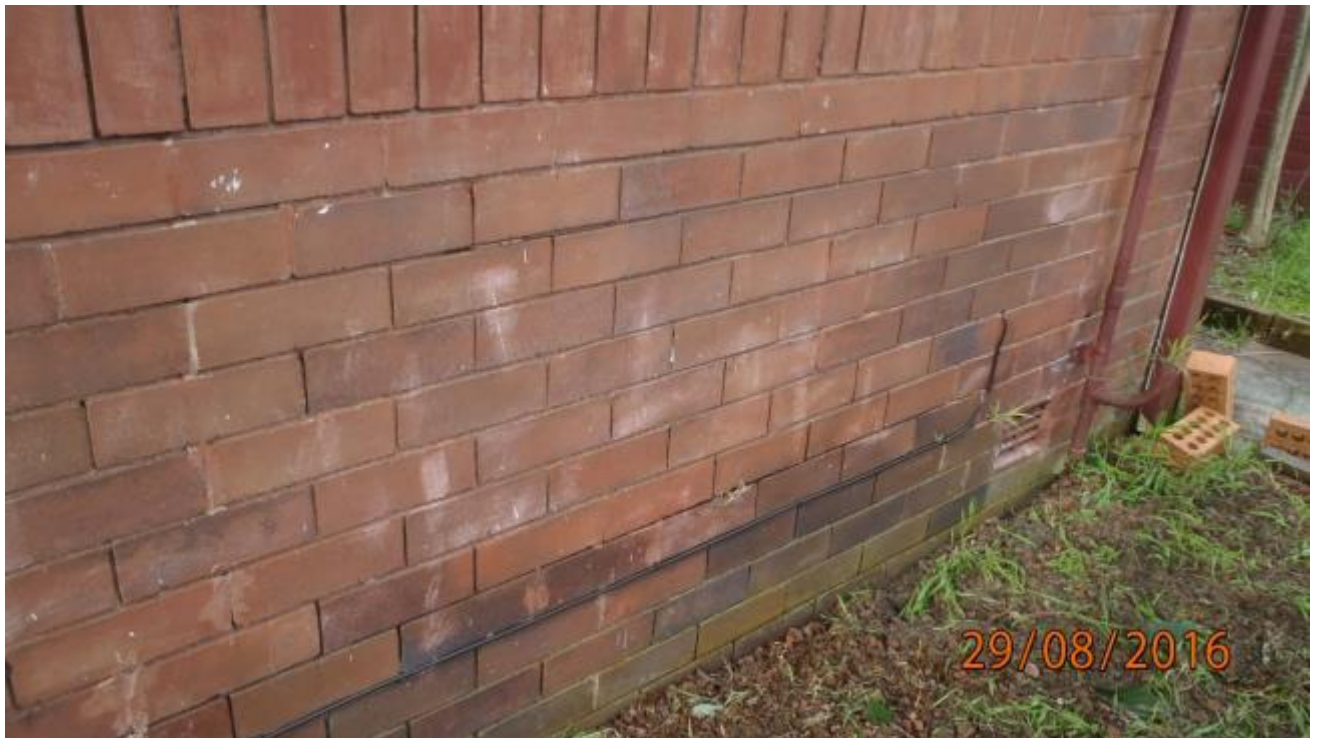
We observed general displacement of the mortar (fretting) under the Bedroom 1 window. **[Photograph 13]**

Photograph 13 shows the general displacement of the mortar under the Bedroom 1 window.

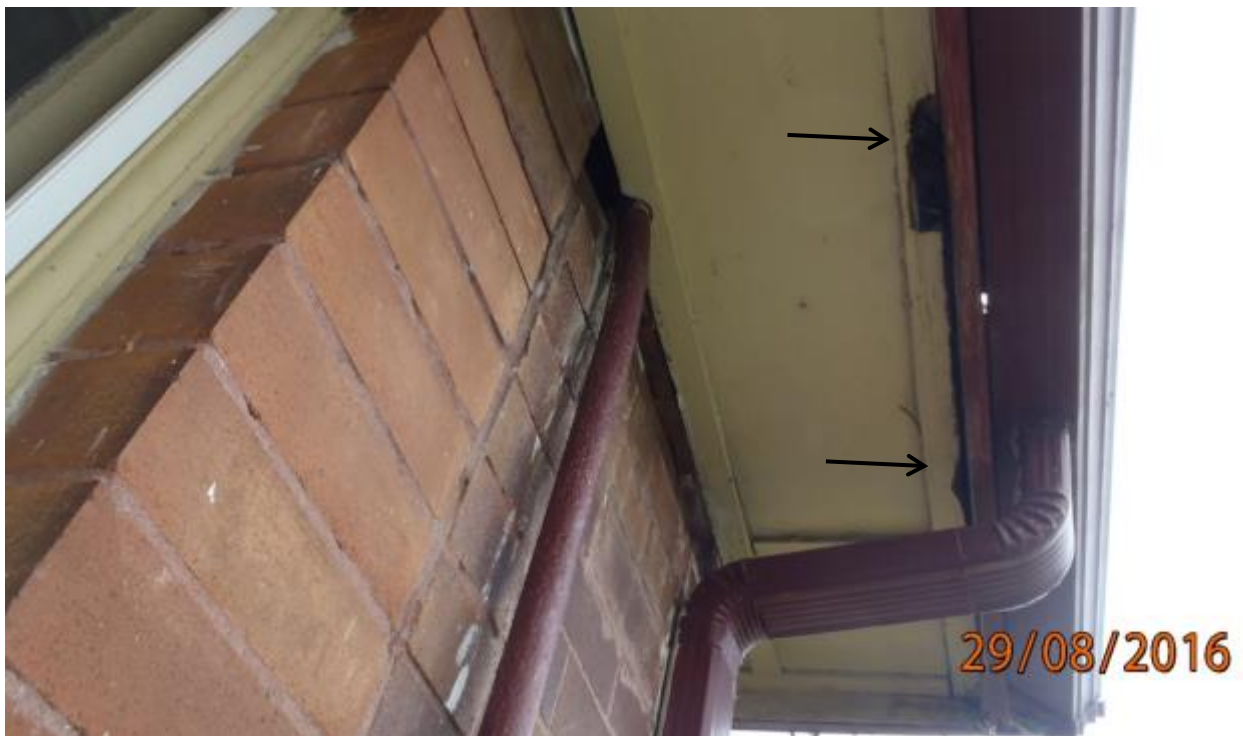
We noted damage and rotting to the eave soffit trim adjacent to the fascia board outside the Bedroom 1 window. **[Photograph 14]**

Photograph 14 shows damage and rotting to the eave soffit trim adjacent to the fascia board outside Bedroom 1 window

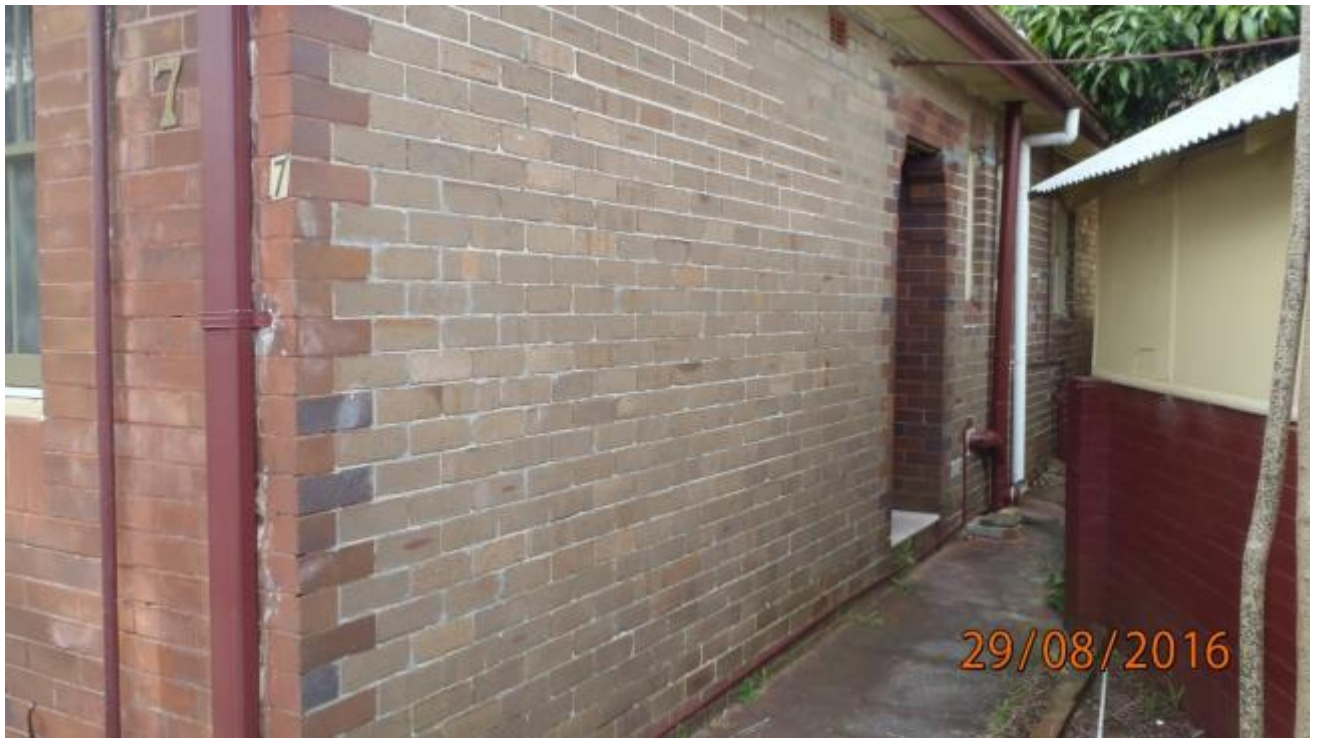
We noted that the side external wall was constructed of clay masonry brickwork. **[Photograph 15]**

Photograph 15 shows the general condition of the side elevation external wall.

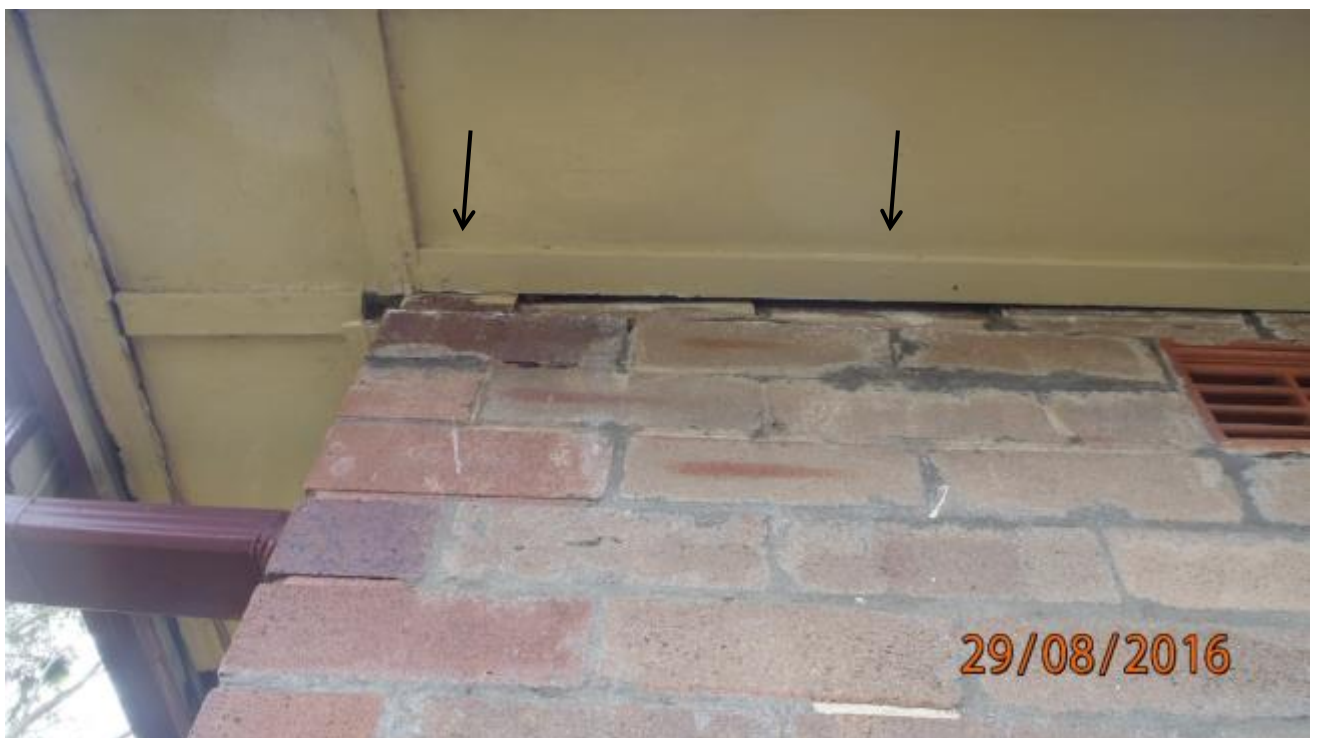
We observed displaced brickwork and repointing to the mortar on the eastern corner outside Bedroom 1. **[Photograph 16]**

Photograph 16 shows displaced brickwork and repointing to the mortar on the eastern corner outside Bedroom 1.

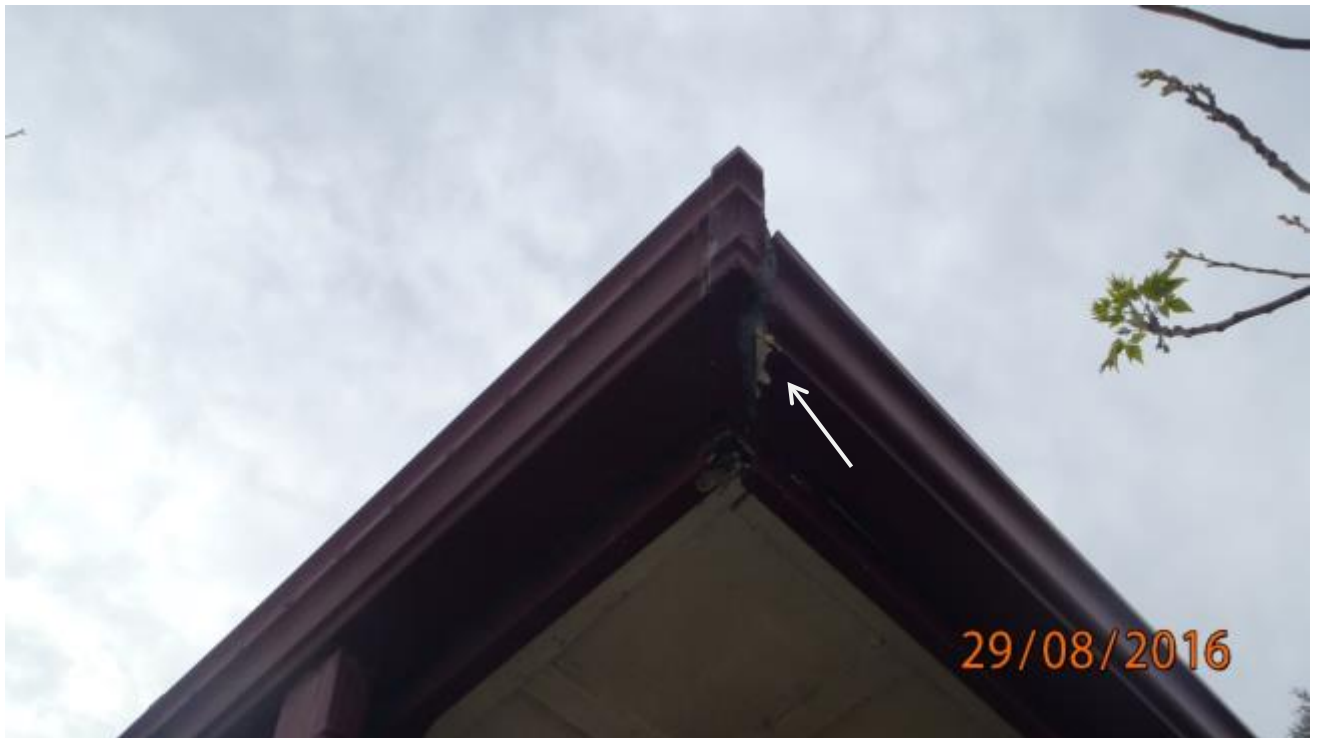
We noted damage to the fascia board and the gutter to the north eastern corner. **[Photograph 17]**

Photograph 17 shows damage to the fascia board and the gutter to the north eastern corner.

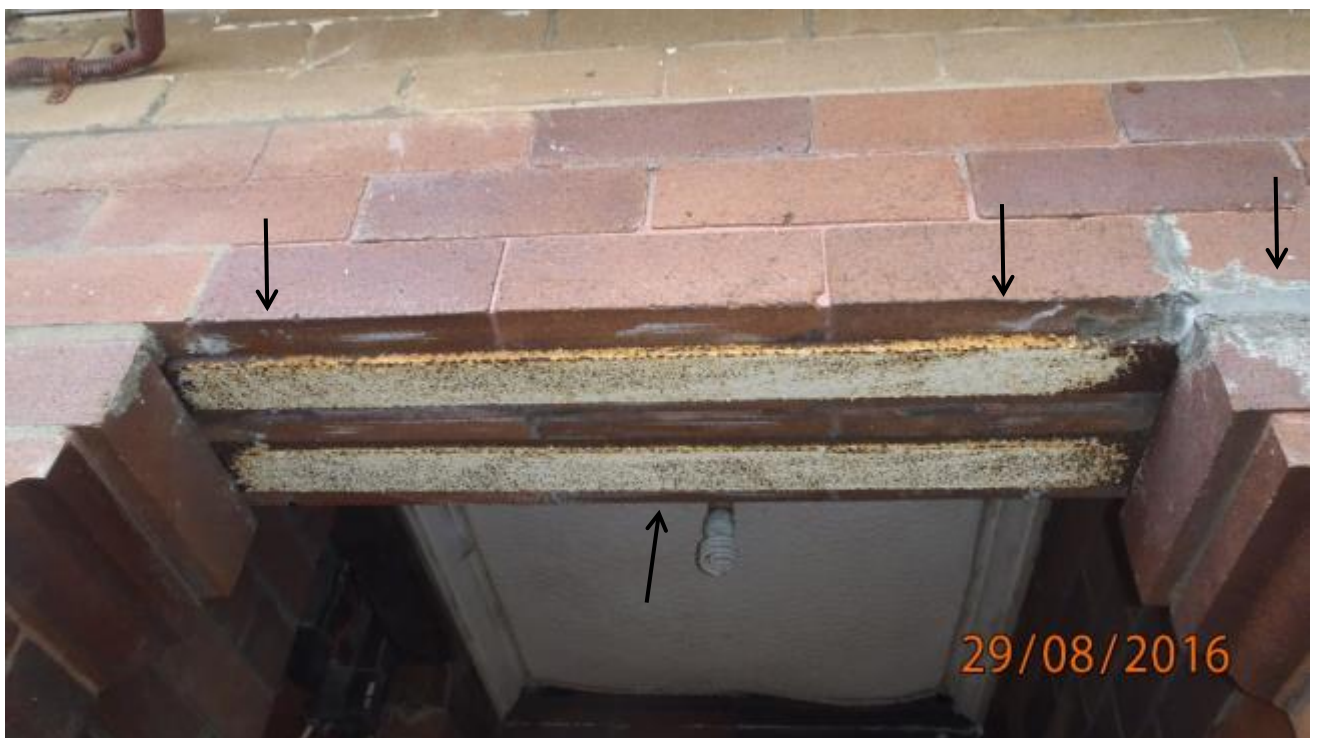
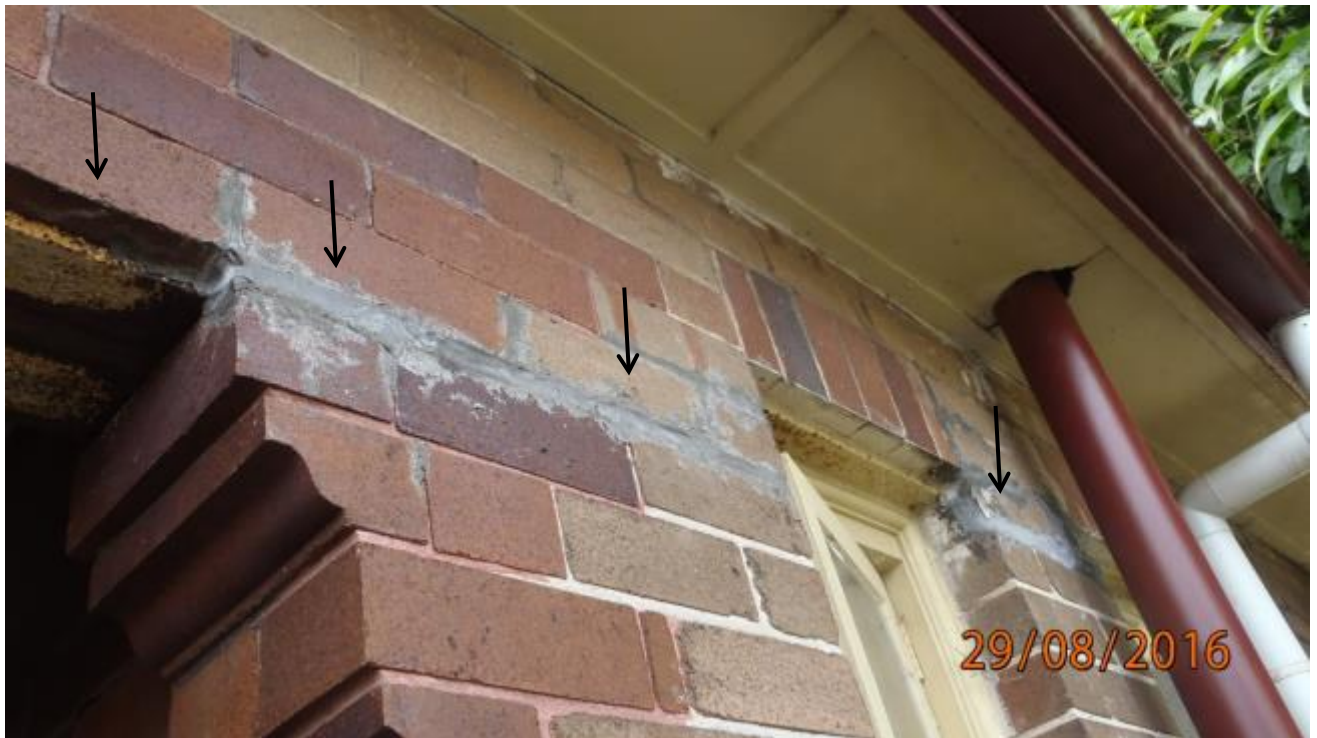
We noted rusted lintel bars above the Front Porch and the Bathroom window and evidence of previous repairs as a result. **[Photographs 18 and 19]**

Photograph 18 shows rusted lintel bars above the Front Porch and the Bathroom window.

Photograph 19 shows rusted lintel bars above the Front Porch and the Bathroom window and evidence of previous repairs as a result.

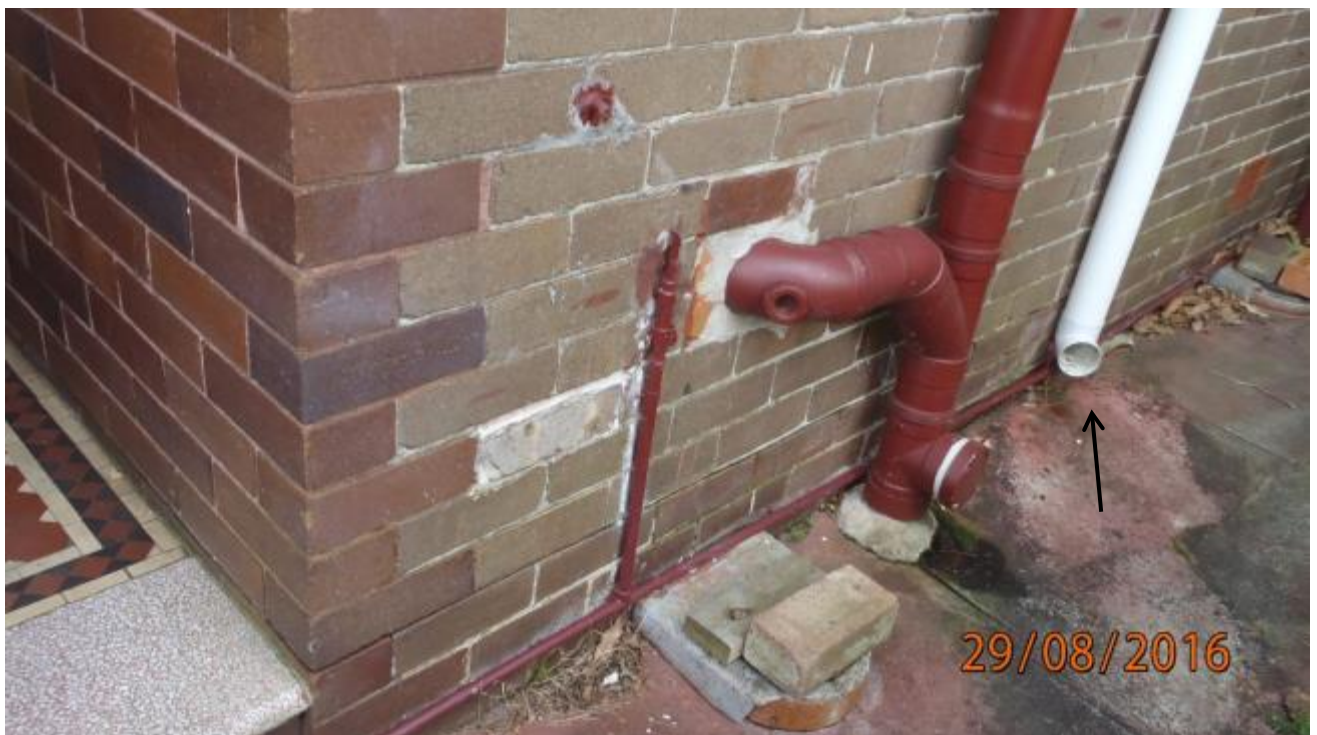
We noted evidence of a previous repair to the brickwork and around the pipe adjacent to the front entry. We also noted that the gutter system downpipe discharged directly onto the concrete pathway. **[Photograph 20]**

Photograph 20 shows evidence of a previous repair to the brickwork and around the pipe adjacent to the front entry. It also shows the downpipe being discharged directly onto the concrete side pathway

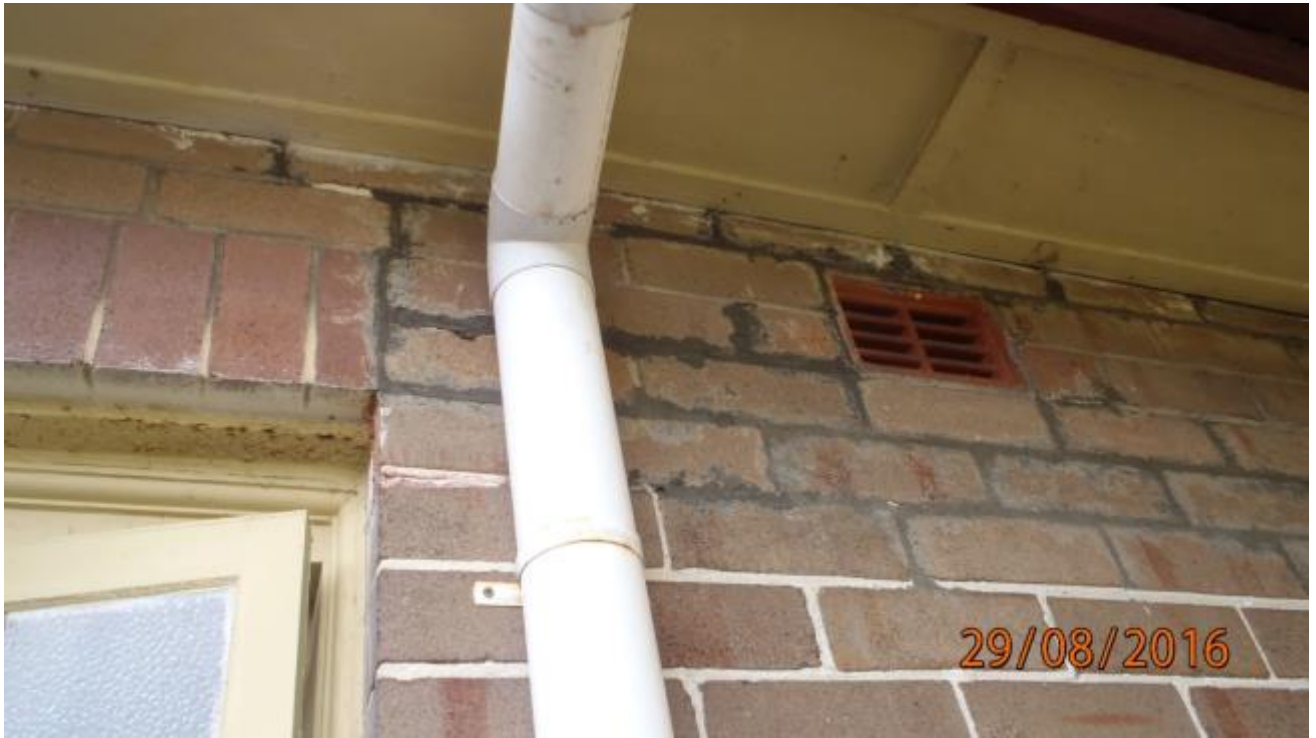
We noted repointing of the mortar adjacent to the Bathroom window and around the wall vent. **[Photograph 21]**

Photograph 21 shows repointing of the mortar adjacent to the Bathroom window and around the wall vent.
