Dilapidation Assessment Report

Prepared for: Cape Cod Australia Pty. Limited
Job address: 7 Jacques Street, Kingsford.
Property Owner/s: Unknown. Access via Mr. Andrew Yong.
Raine & Horne, Kingsford.
Report reference: **RANDWICK CITY COUNCIL**
Development Application No: not available
Date of assessment: 29th August 2016

Re: Dilapidation Report

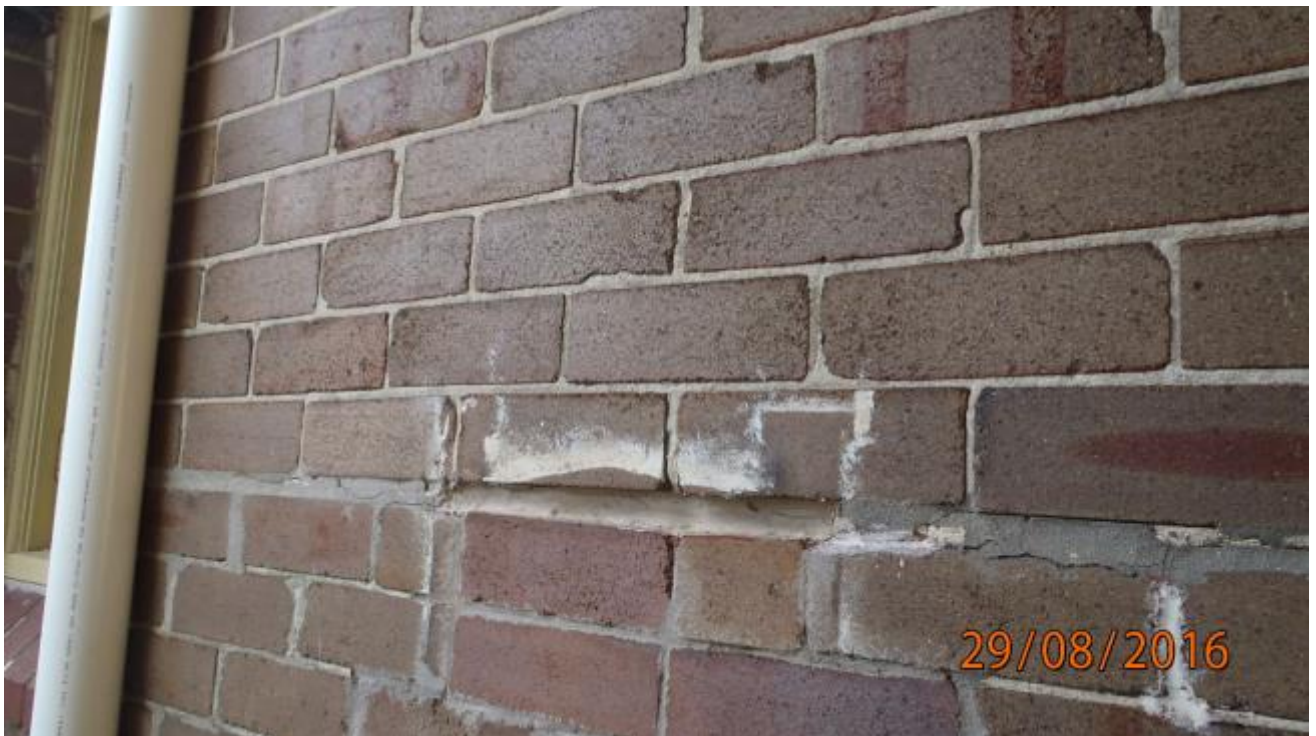
We noted step cracking, repointing of the mortar and evidence of previous repairs between the Bathroom and Kitchen window. **[Photograph 22]**

Photograph 22 shows repointing of the mortar and evidence of previous repairs between the Bathroom and Kitchen window.

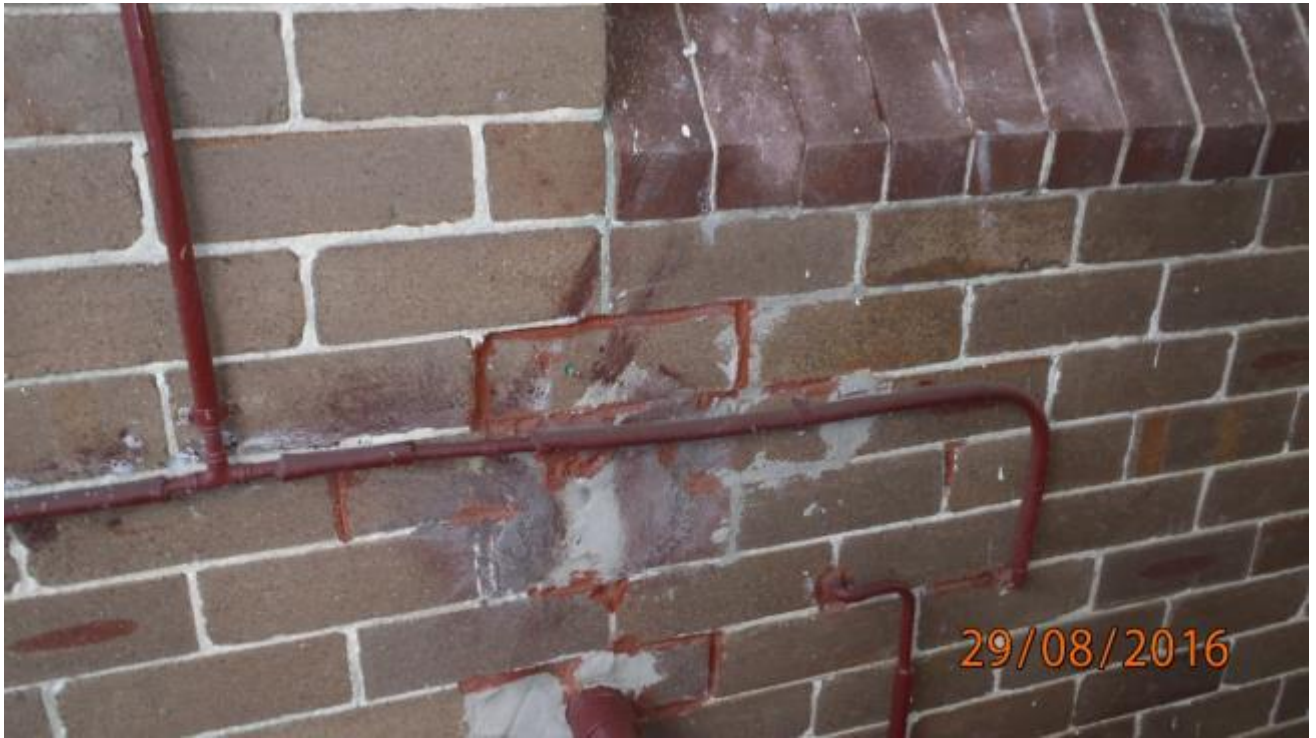
We noted step cracking, repointing of the mortar and evidence of previous repairs outside the Kitchen window. **[Photograph 23]**

Photograph 23 shows step cracking, repointing of the mortar and evidence of previous repairs outside the Kitchen window.

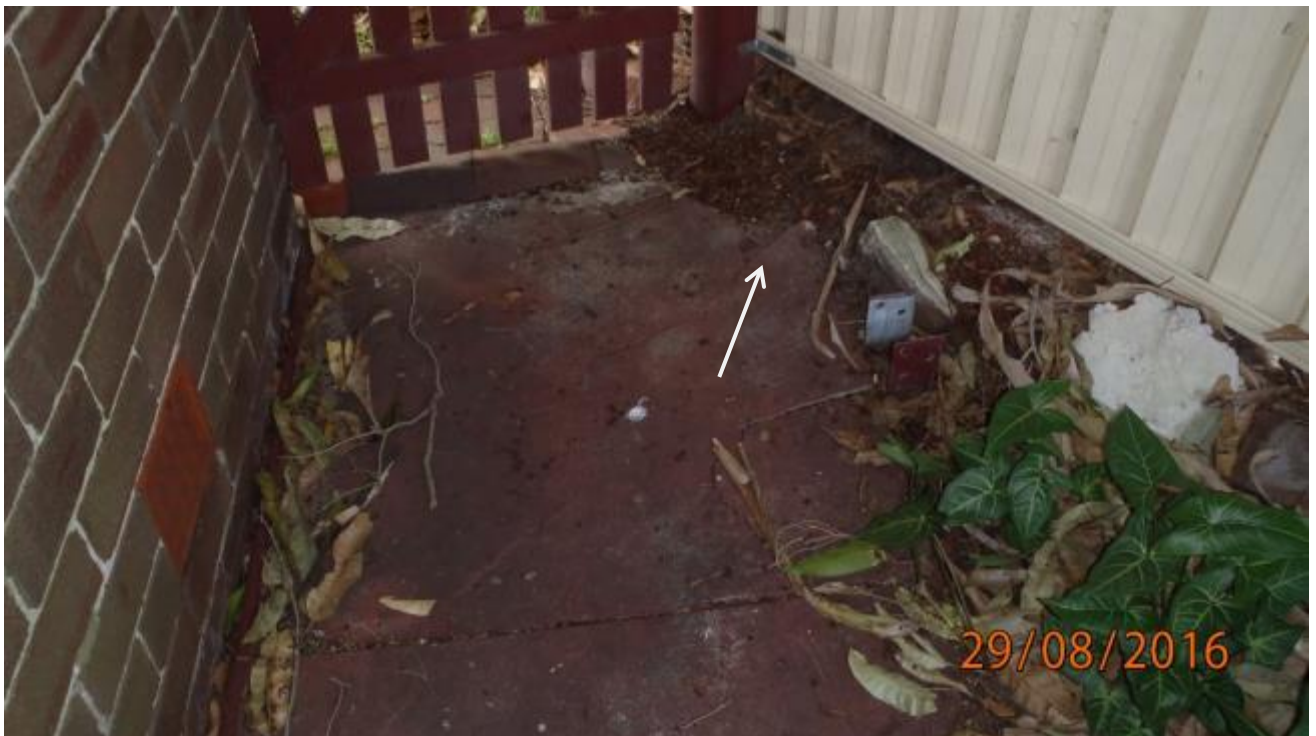
We noted cracked and raised concrete to the side pathway adjacent to the side gate. **[Photograph 24]**

Photograph 24 shows cracked and raised concrete to the side pathway adjacent to the side gate.

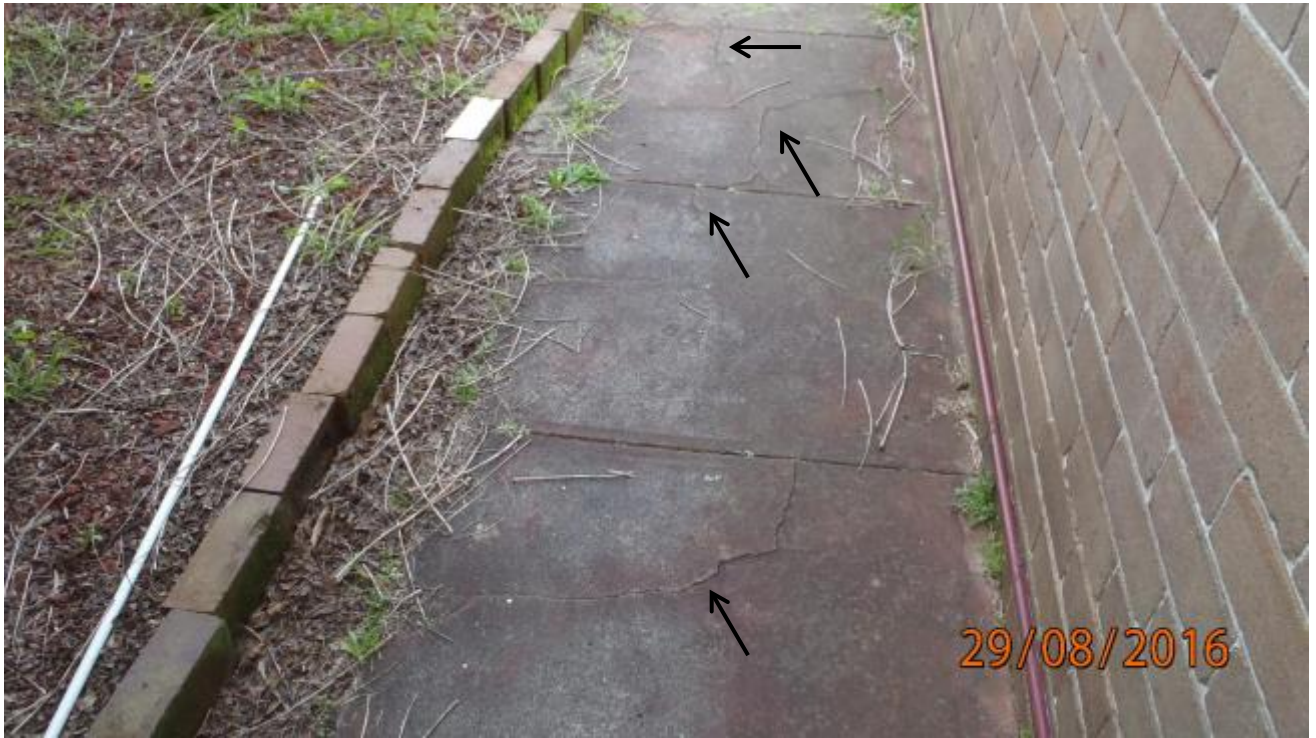
We noted general settlement cracking to concrete side pathway and that the pathway is lined with a paver edging. **[Photograph 25]**

Photograph 25 shows cracking to the concrete pathway at the side.

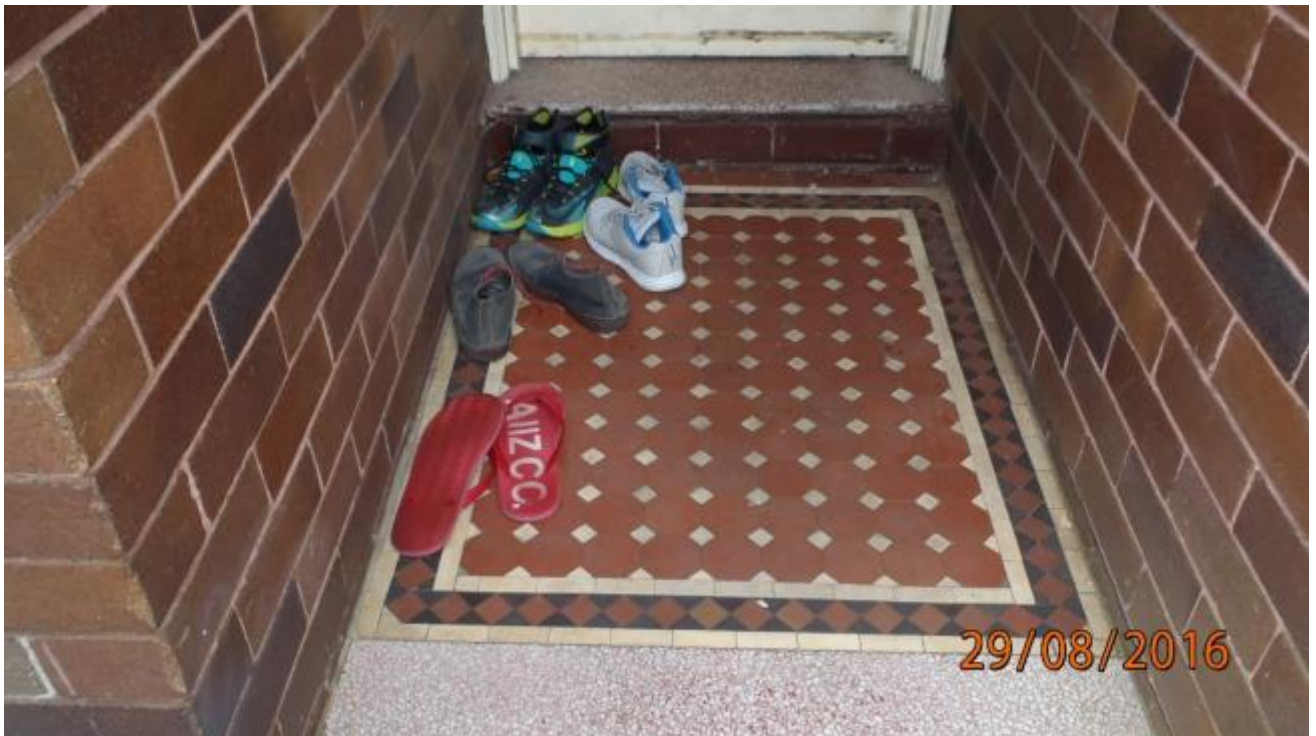
We noted that the concrete slab porch is lined with tessellated pattern tiles. We did not observe any recent cracking to the tiled surface. **[Photograph 26]**

Photograph 26 shows the general condition of the front porch tiles.

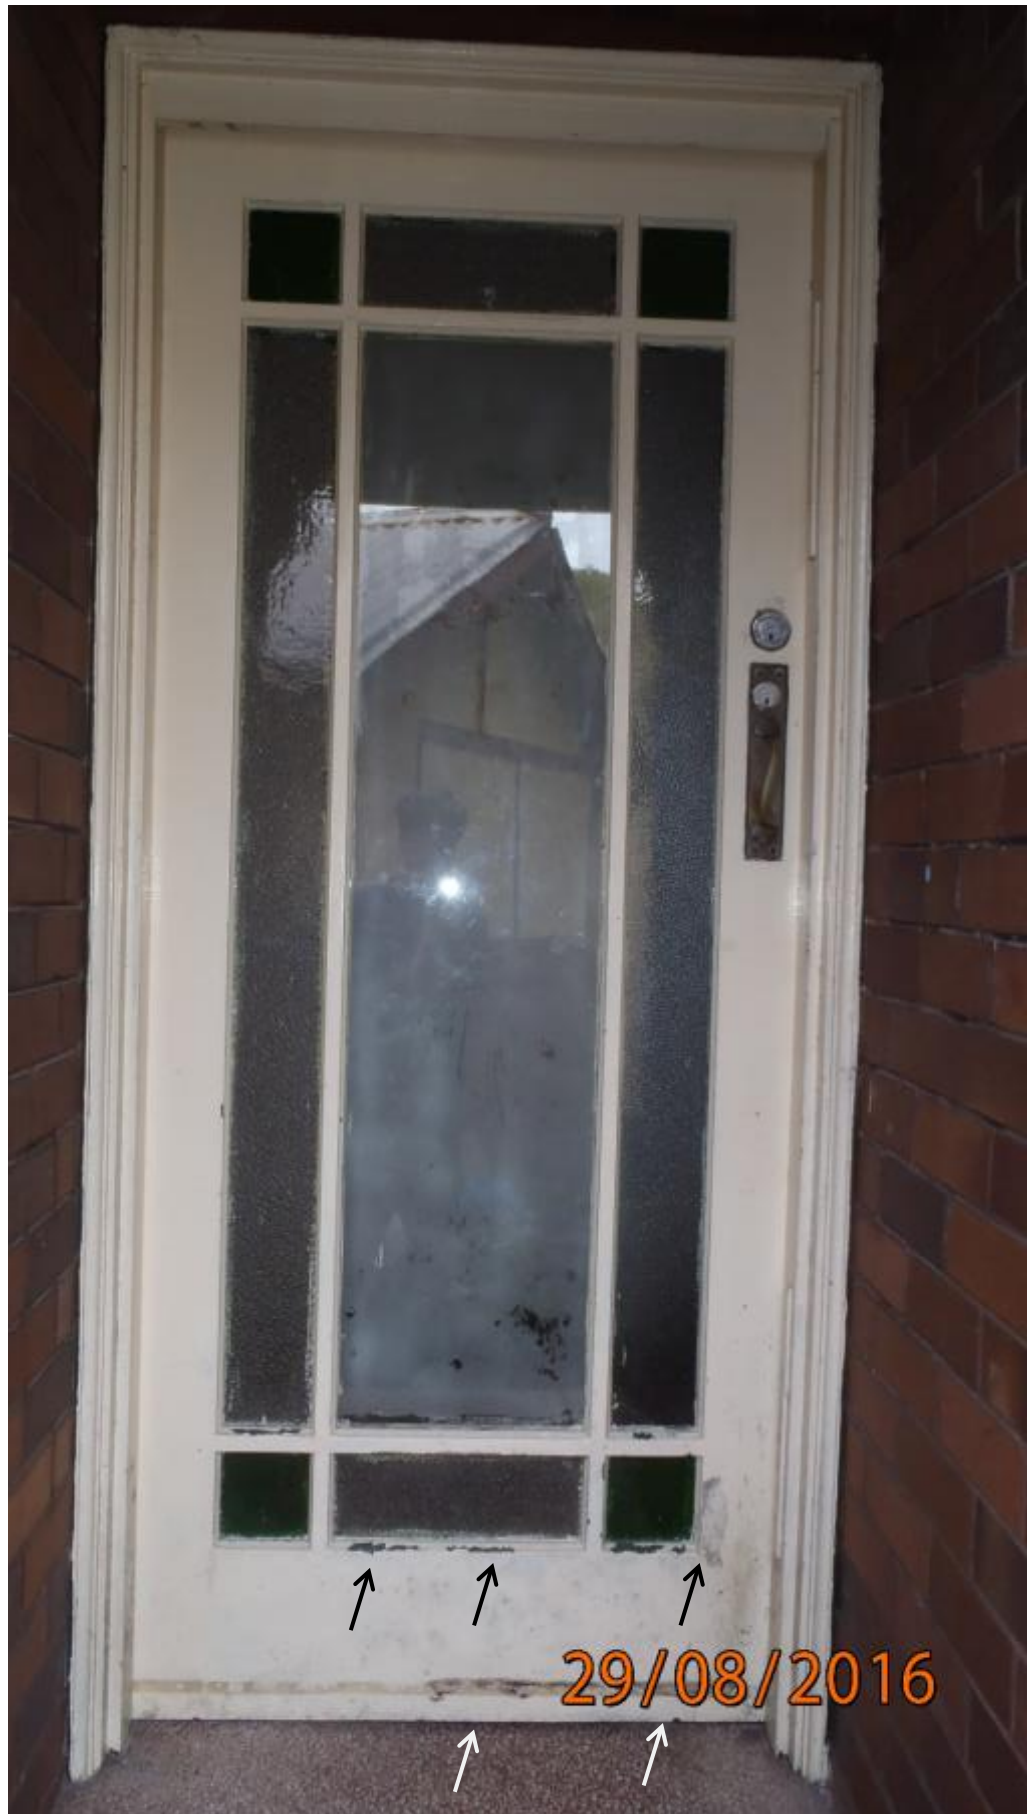
We noted flaking paint and rotting to the front door. **[Photograph 27]**

Photograph 27 shows flaking paint and rotting to the front door.

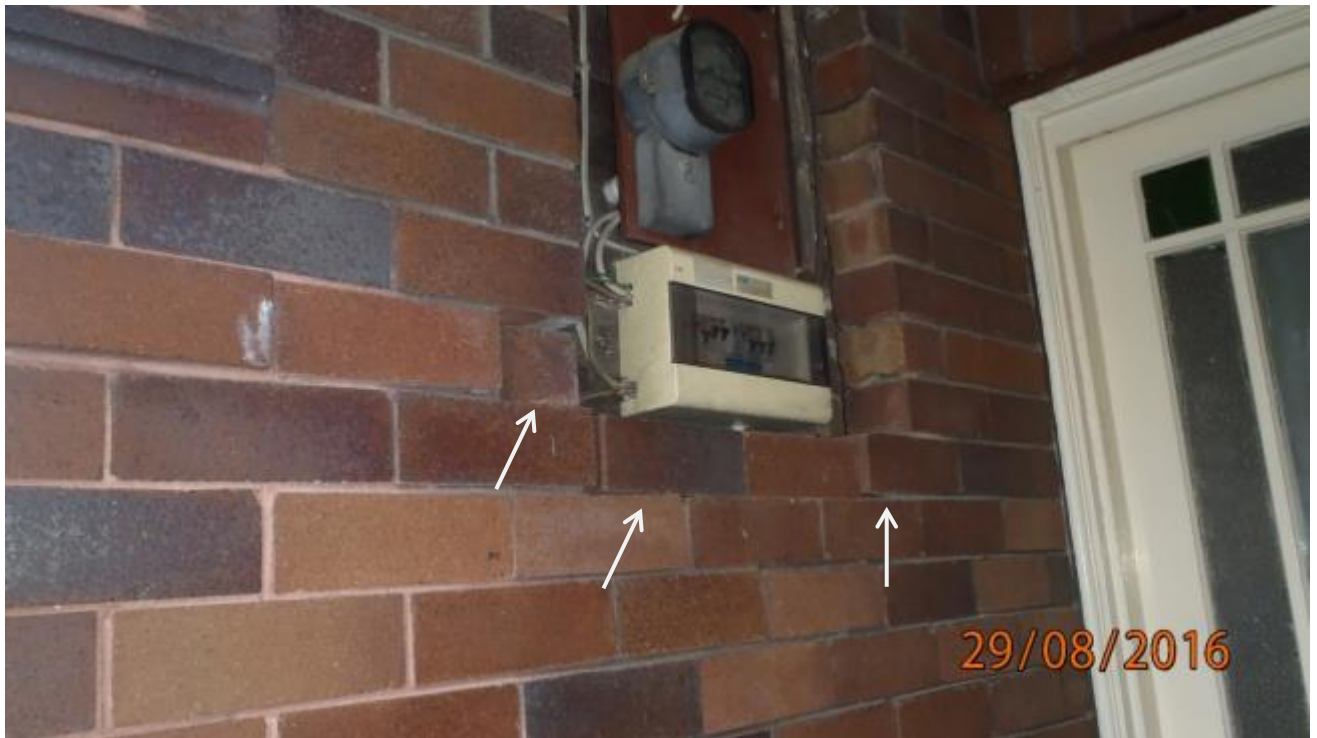
We noted displaced brickwork around the electrical meter board cavity on the eastern wall. **[Photograph 28]**

Photograph 28 shows displaced brickwork around the electrical meter board cavity.

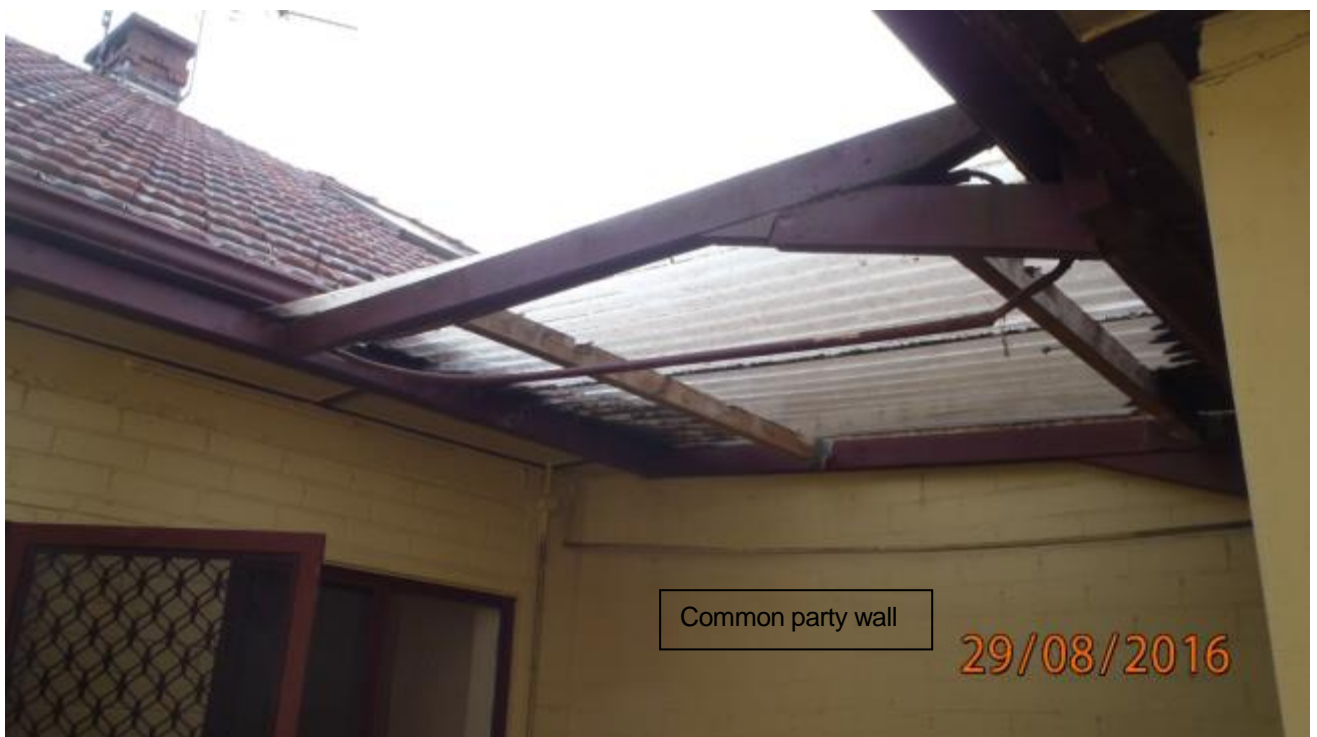
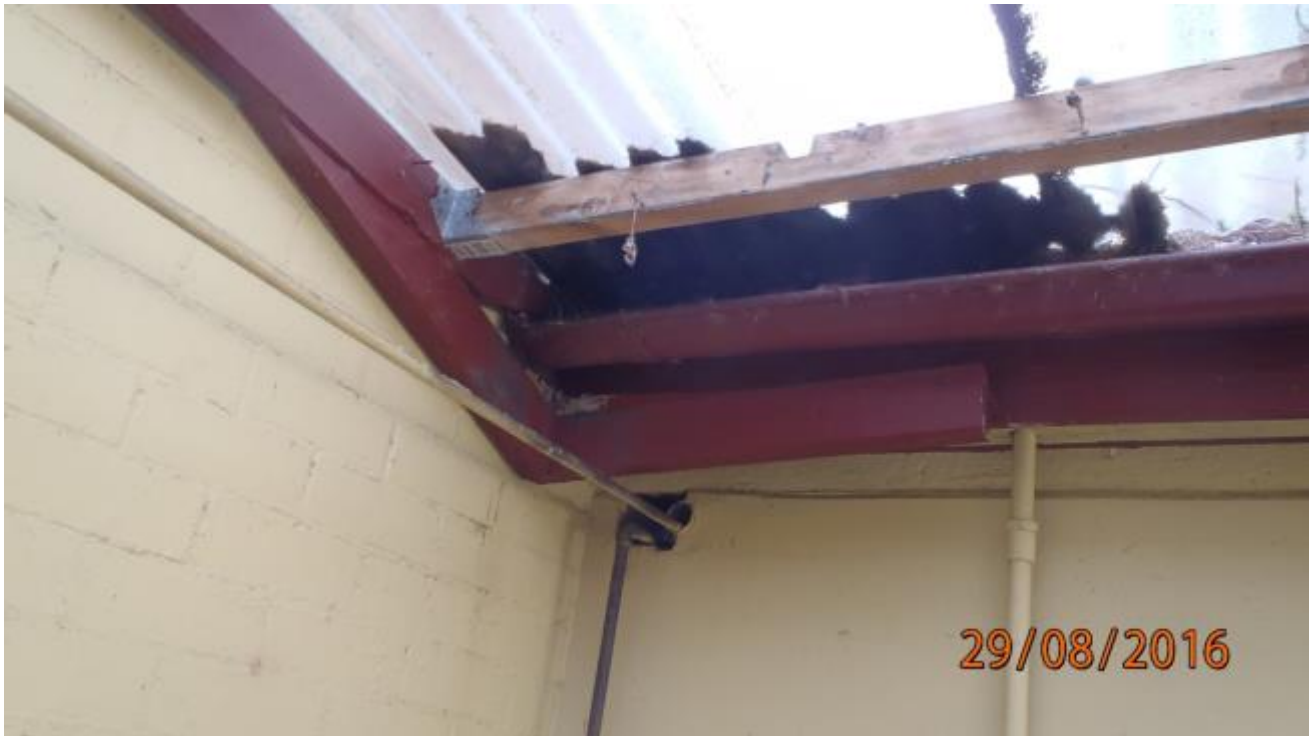
We noted that there was an attached timber awning with acrylic roof joining the main residence to the external Toilet and Laundry. We also noted that there was debris collected in the gutter system, and that the gutter was rusted above the Toilet, adjacent to the *common party / separation wall* with the adjoining property; No.5 Jacques Street, Kingsford. **[Photographs 29 and 30]**

Photograph 29 shows the general condition of the back awning.

Photograph 30 shows rusting to the gutter and debris collected in the gutter.

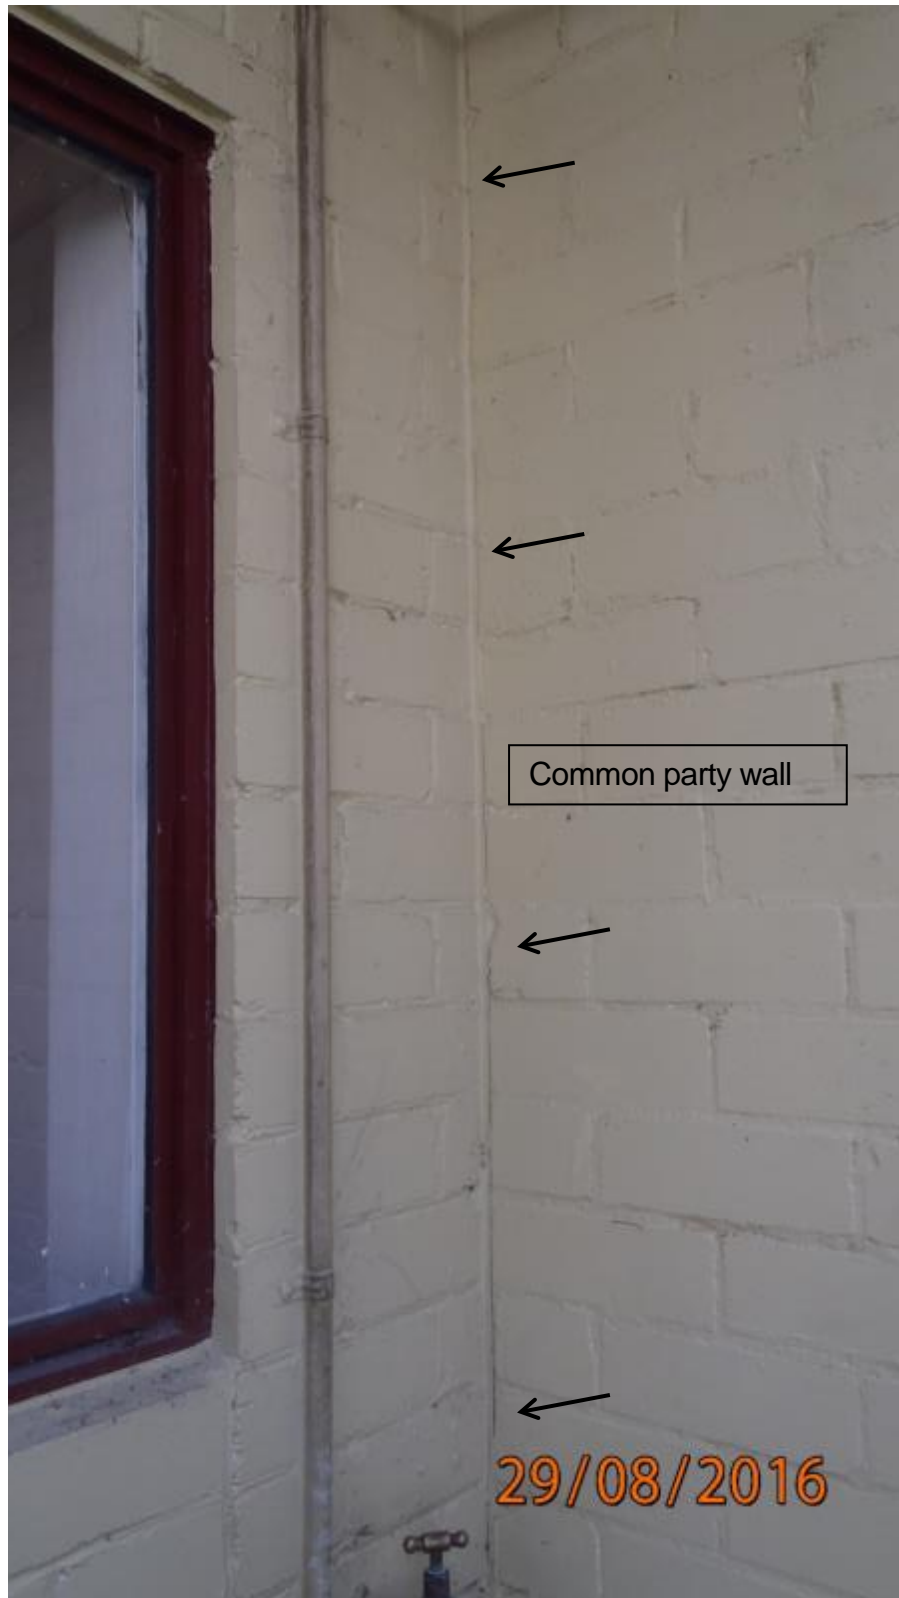
We noted a vertical crack at the brick wall to wall junction adjacent to the sunroom window. We also noted that this wall is the *common party / separation wall* with the adjoining property; No.5 Jacques Street, Kingsford. **[Photograph 31]**

Photograph 31 shows vertical crack at the brick wall to wall junction adjacent to the sunroom window. Note: Common party separation wall.

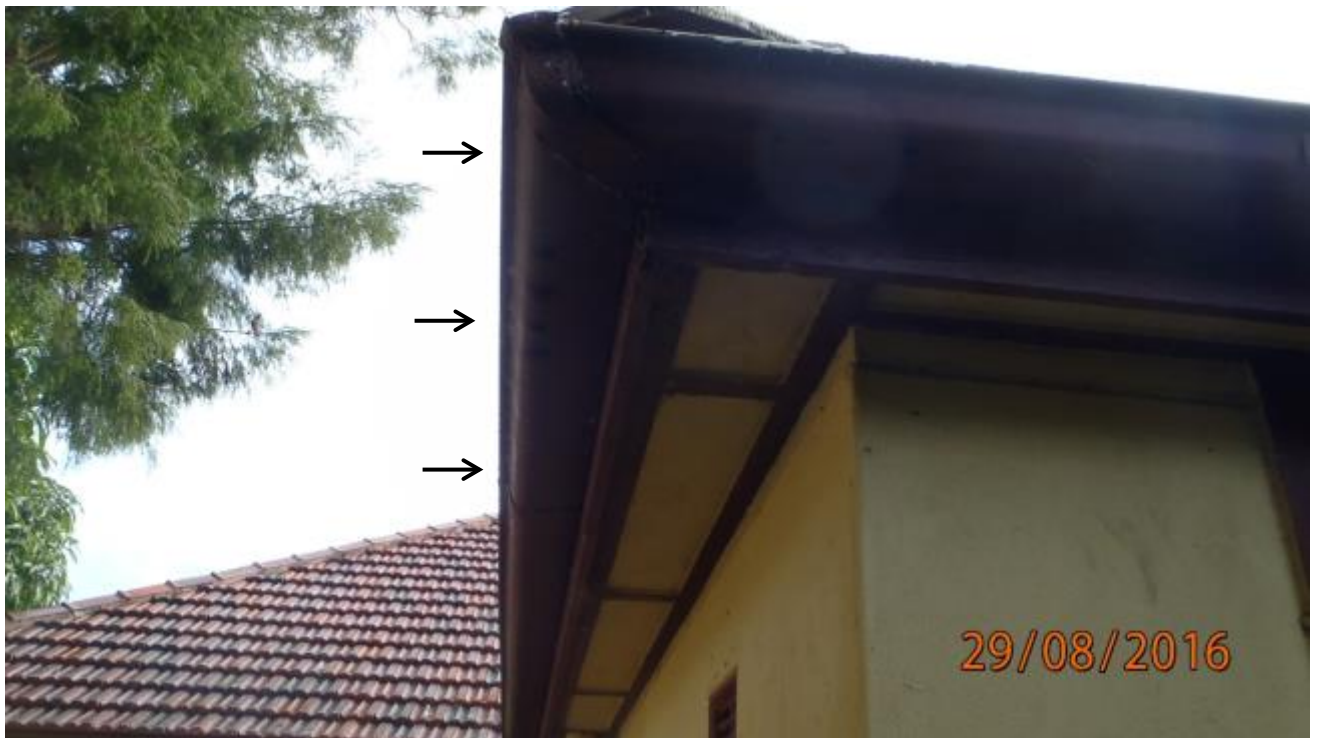
We noted rusting to the gutter system outside the external Laundry. **[Photograph 32]**

Photograph 32 shows rusting to the gutter system outside the external Laundry.

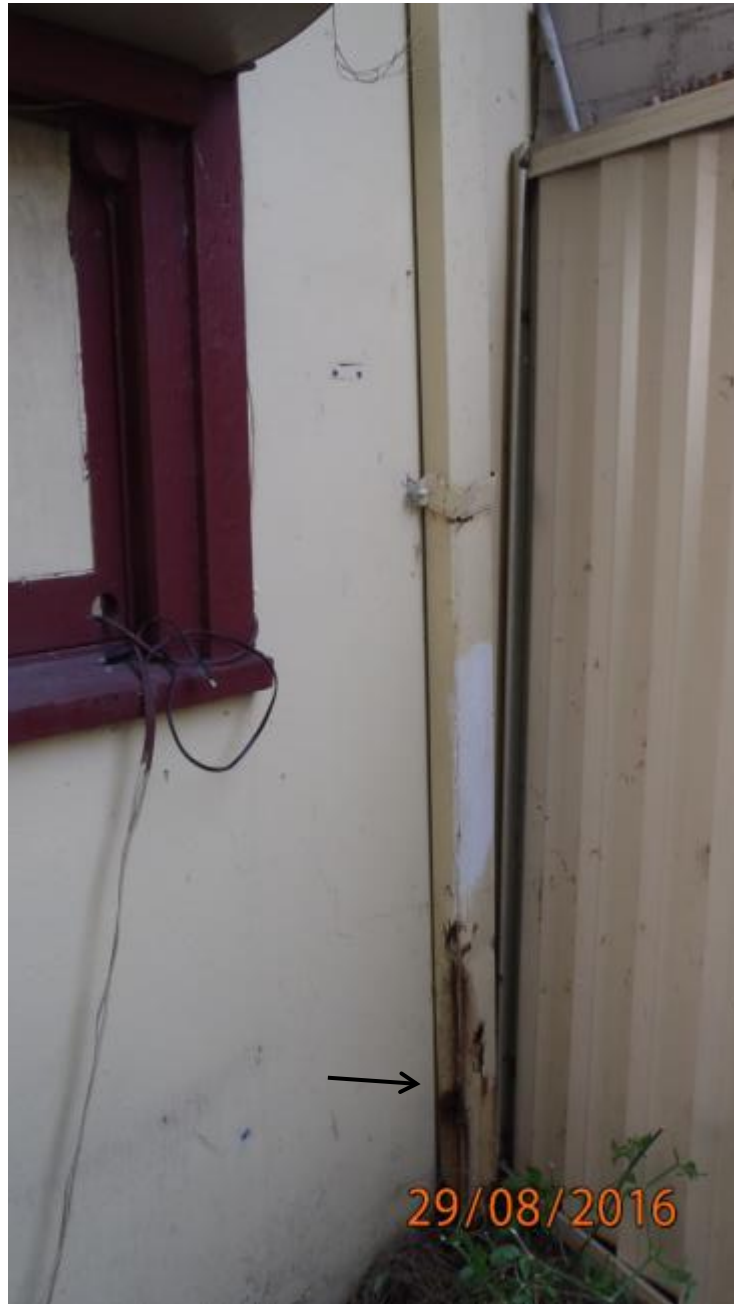
We noted rusting to the downpipe to the northern corner of the Laundry adjacent to the *common* boundary fence with the adjoining property; No.5 Jacques Street, Kingsford. **[Photograph 33]**

Photograph 33 shows rusting to the downpipe to the northern corner of the Laundry.

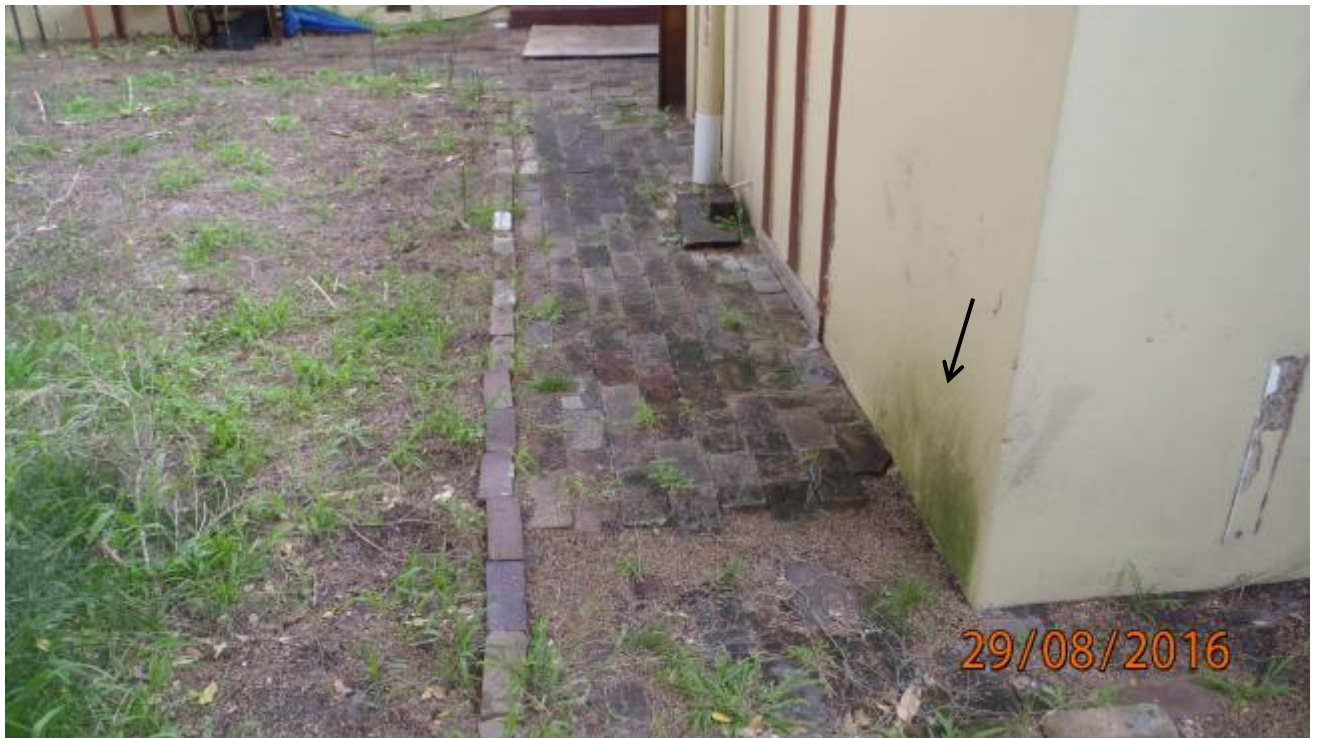
We noted a paved path surrounding the rear of the property with displaced pavers throughout. **[Photograph 34]**

We also noted mildew / lichen growth to the external Laundry wall on the north eastern corner. **[Photograph 34]**

Photograph 34 shows the general condition of the rear paved pathway and mildew / lichen growth to the external wall.

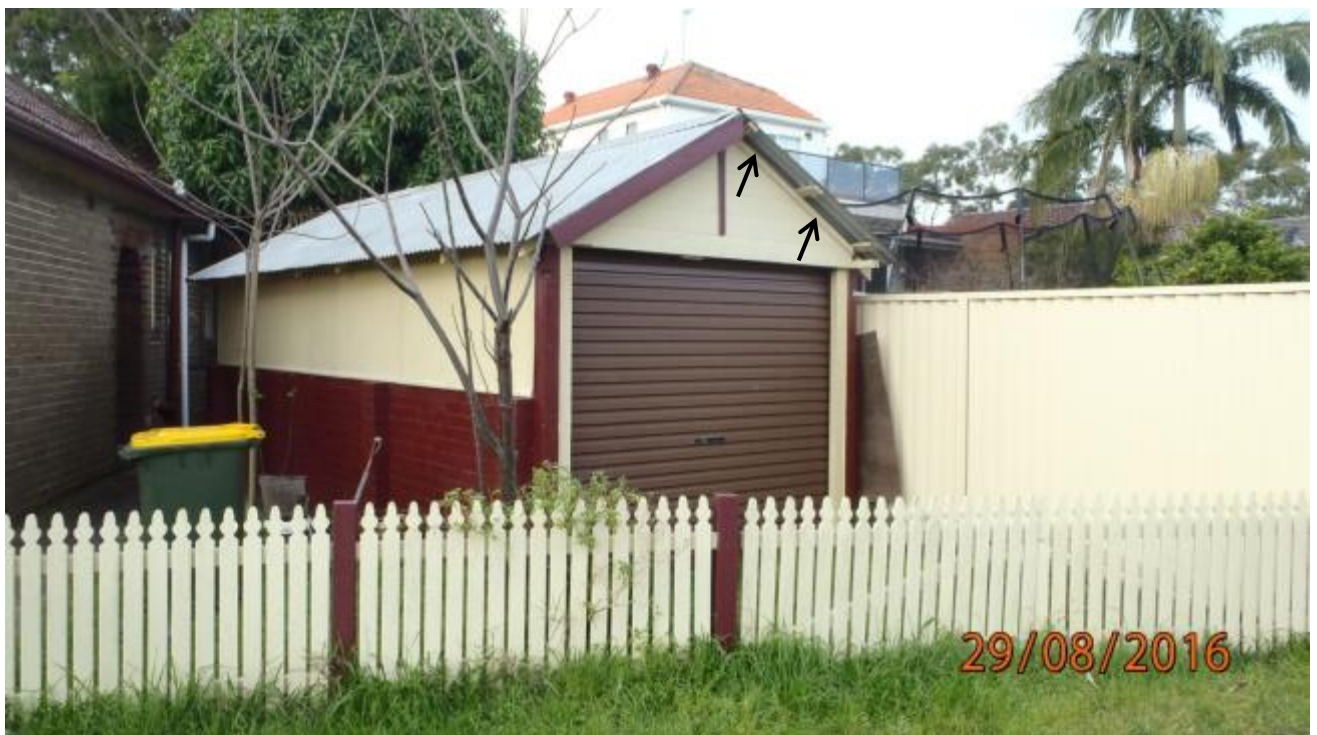
We noted a freestanding combination surface coated brick, weatherboard and 'fibro' structure. We also noted that the roof is corrugated profile sheet metal roofing. **[Photograph 35]**

We noted a missing barge board to the front elevation above the garage door. **[Photograph 35]**

We noted that the garage structure had no gutter system and that the surface water discharged directly to the ground. **[Photograph 35]**

Photograph 35 shows the missing barge board to the garage.

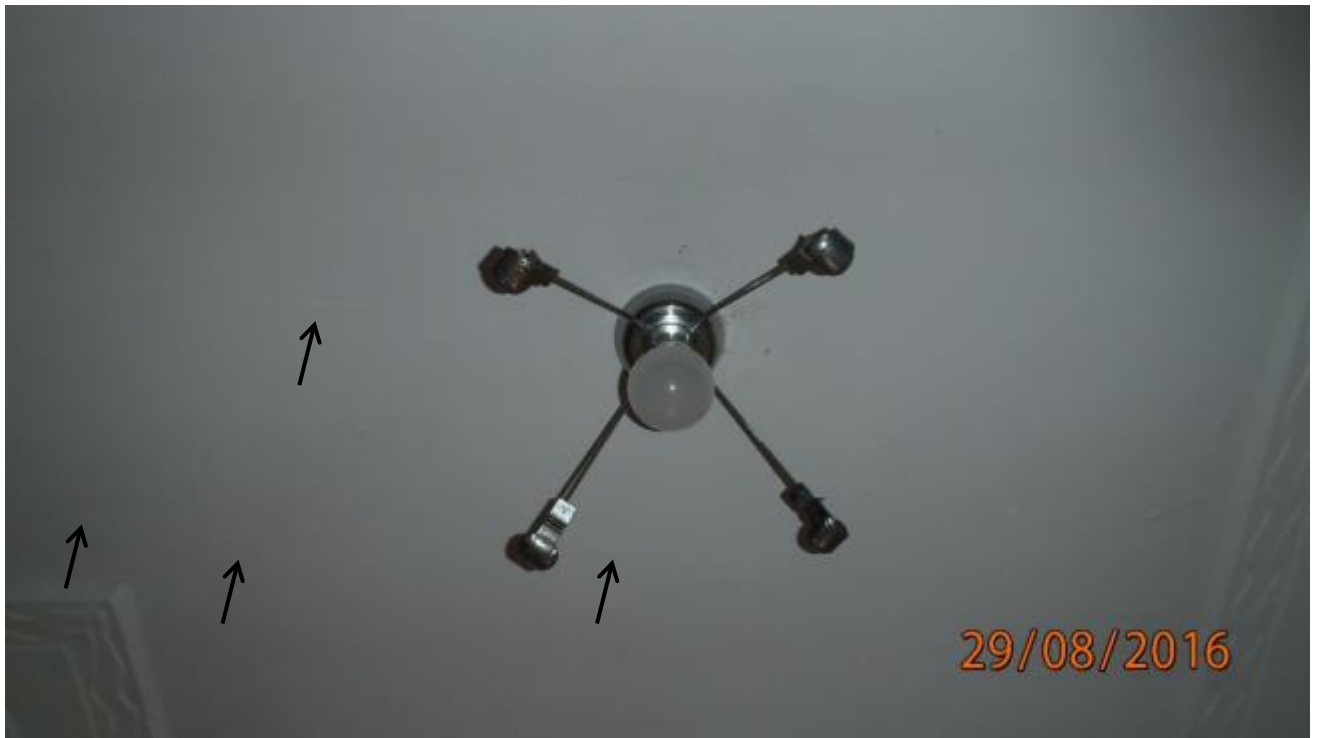
We noted a previous repair to the plaster ceiling lining around the light fitting. **[Photograph 36]**

Photograph 36 shows evidence of a previous repair to the plaster ceiling lining around the light fitting.

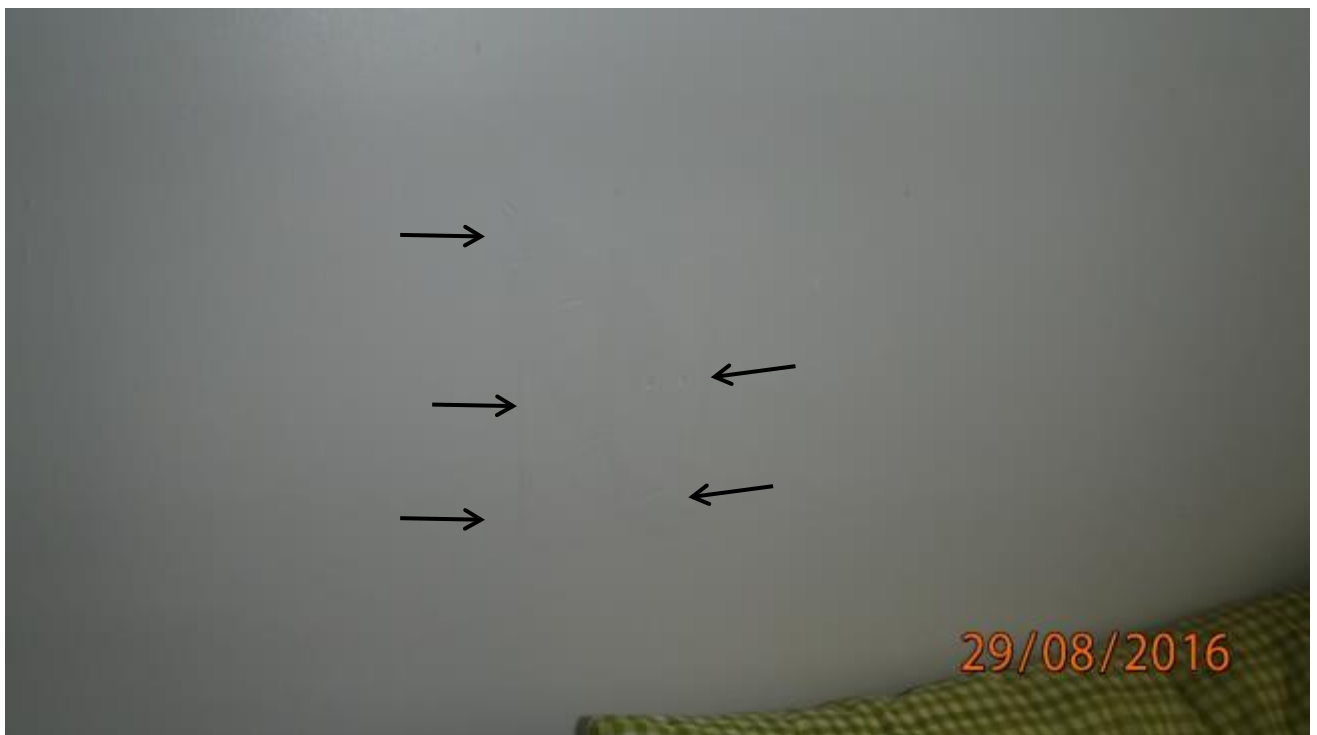
We noted evidence of a previous repair to the northern wall **[Photograph 37]**

Photograph 37 shows evidence of a previous repair to the northern wall.

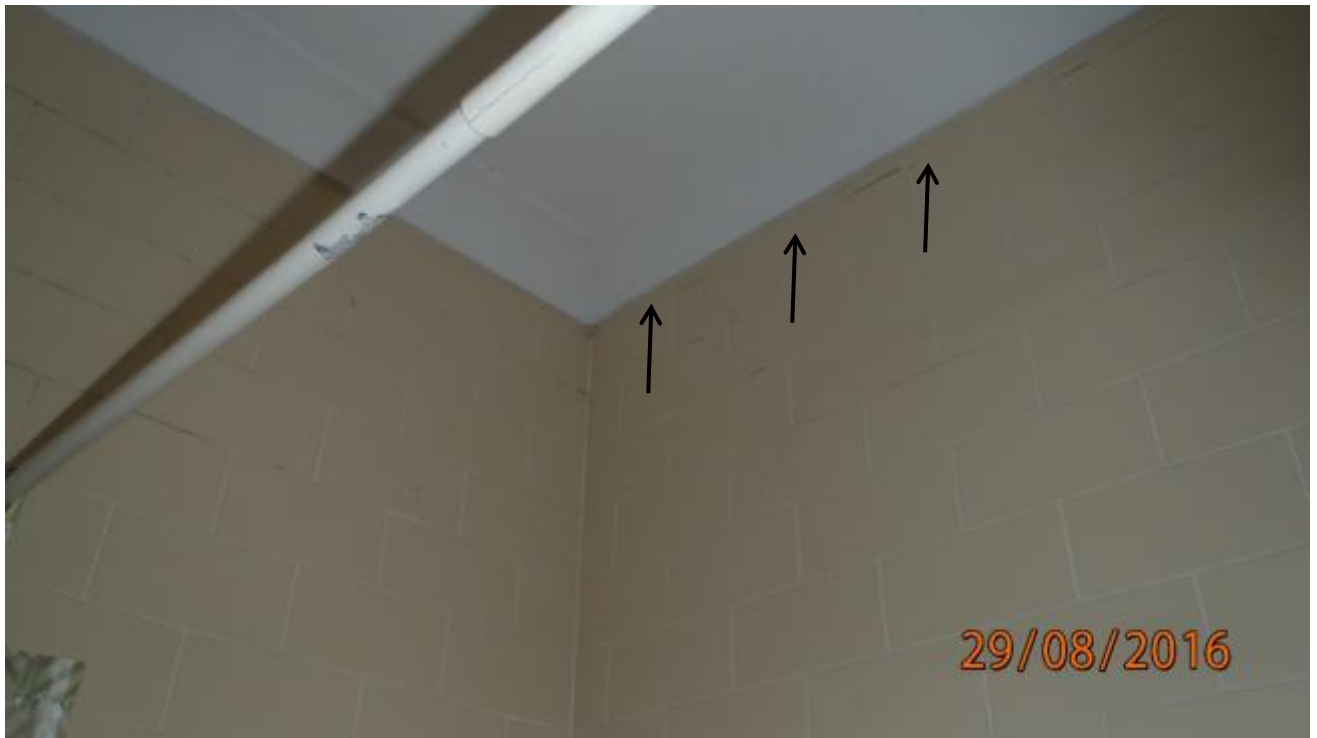
We noted hairline separation cracking [$<1.0\text{mm}$] to the tiled wall / cornice junction in the western corner of the shower. **[Photograph 38]**

Photograph 38 shows noted hairline separation cracking the tiled wall /cornice junction in the western corner of the shower.

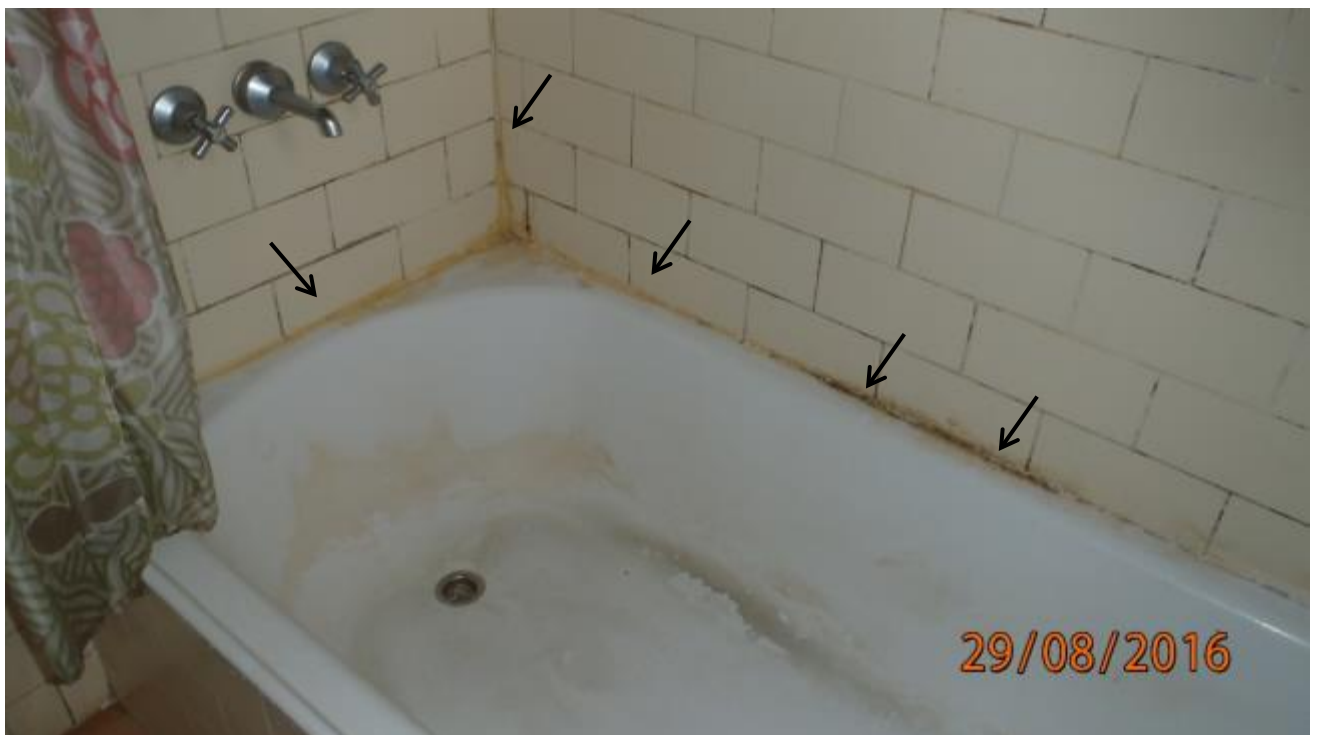
We noted that the grout to the wall and floor tiles is complete and that the wall and floor tiles when randomly "tap" tested appeared to be sound. We did not observe any recent cracking to the tile grout at the wall / wall, wall / floor junctions. However, we did note significant mould/mildew growth to the tile grout and the corners of the bath fixture **[Photograph 39]**

We also noted staining and discolouration to the bath surface. **[Photograph 39]**

Photograph 39 shows mould/mildew growth to the tile grout and the corners of the bath fixture and staining to the bath surface.

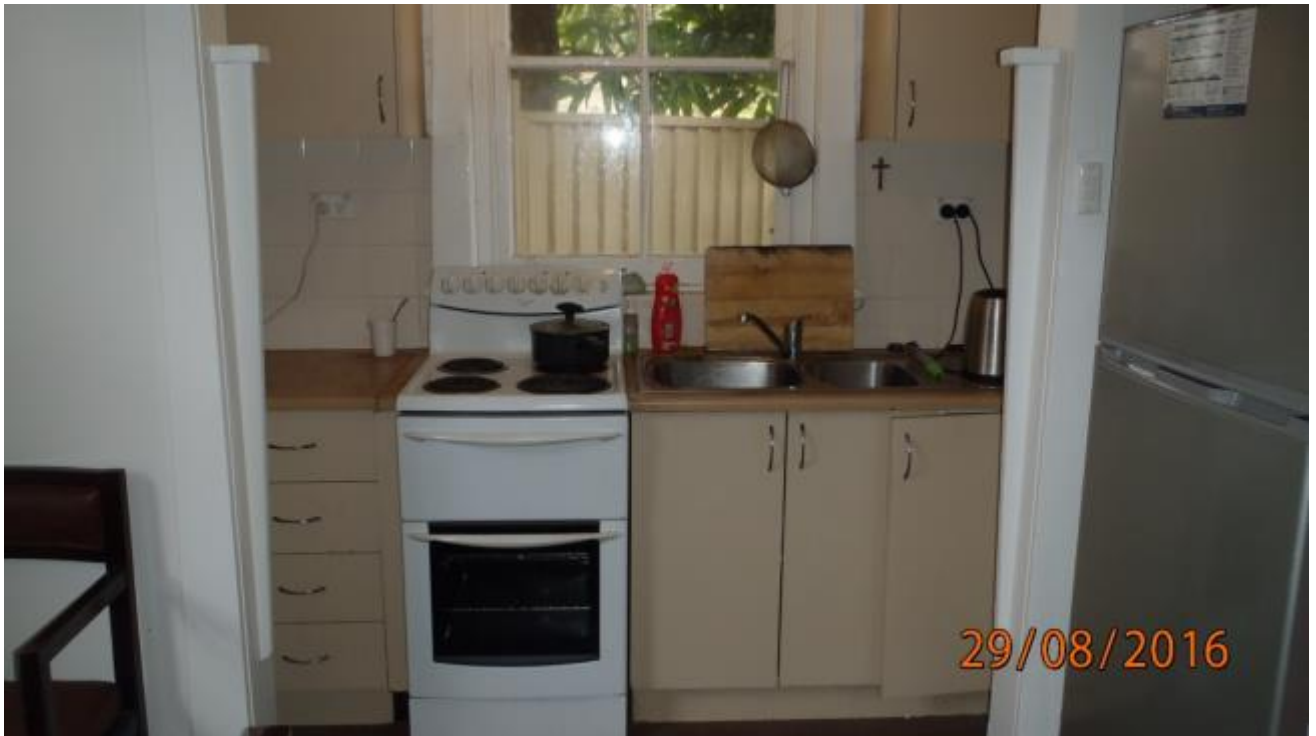
We noted that the kitchen bench was situated along the external wall of the premises and that the walls were tiled to splashback level. **[Photograph 40]**

Photograph 40 shows the general condition of the Kitchen.

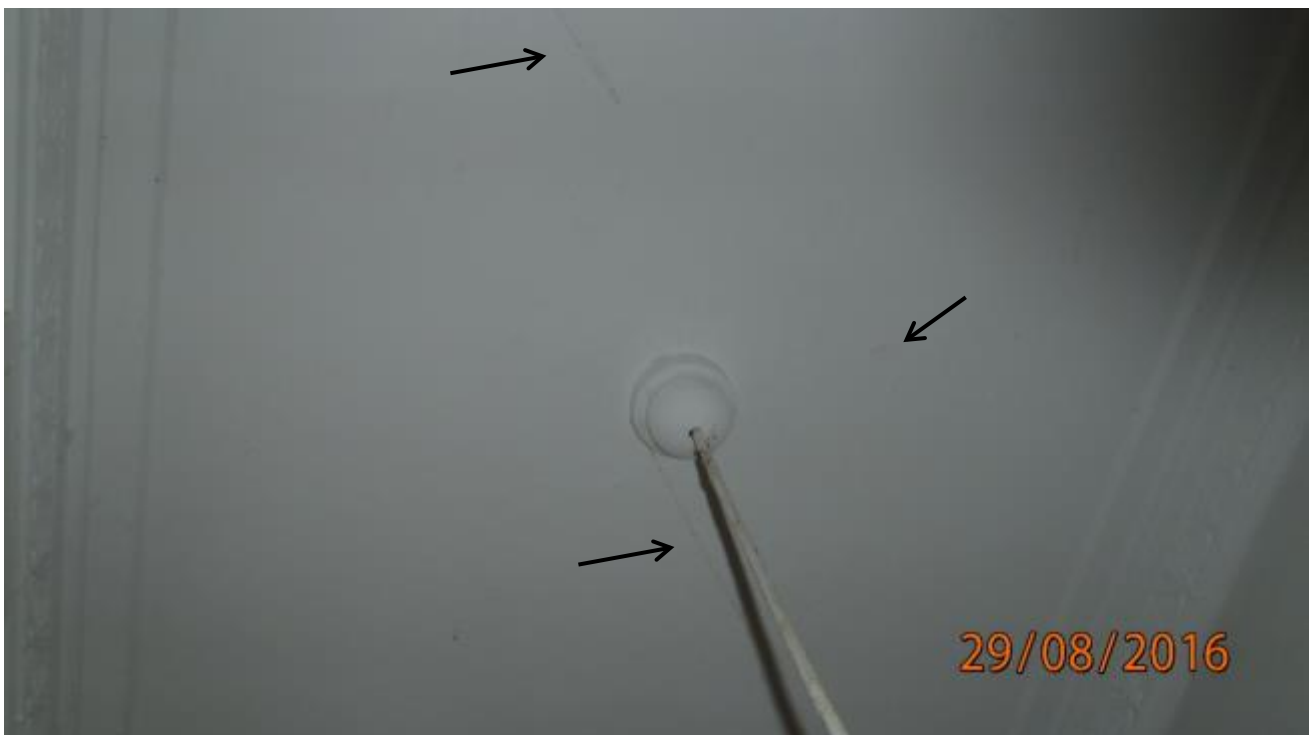
We noted evidence of a previous repair to the ceiling lining around the light fitting. **[Photograph 41]**

Photograph 41 shows evidence of a previous repair to the ceiling lining around the light fitting.
