Dilapidation Assessment Report

Prepared for: Cape Cod Australia Pty. Limited
Job address: 7 Jacques Street, Kingsford.
Property Owner/s: Unknown. Access via Mr. Andrew Yong.
Raine & Horne, Kingsford.
Report reference: **RANDWICK CITY COUNCIL**
Development Application No: not available
Date of assessment: 29th August 2016

Re: Dilapidation Report

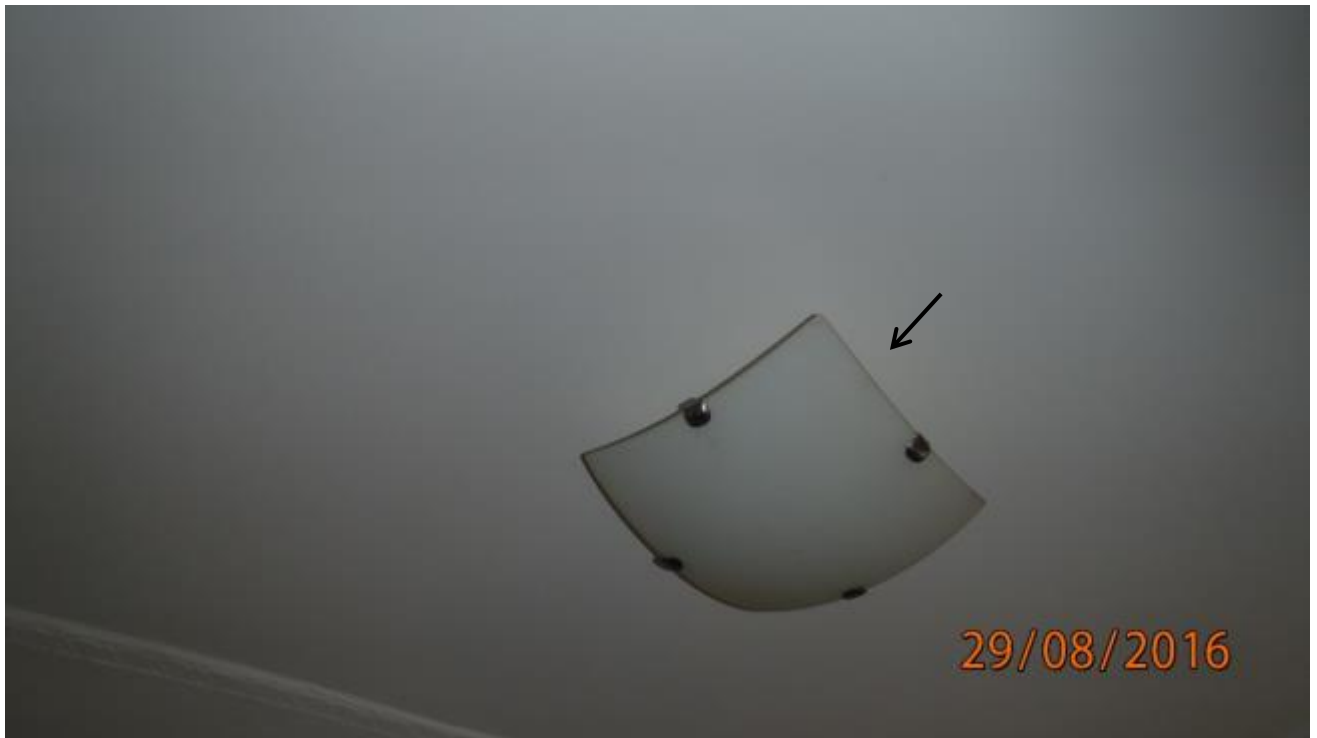
We noted evidence of previous repairs to the ceiling lining and around the light fitting. **[Photograph 42]**

Photograph 42 shows evidence of previous repairs to the ceiling lining and around the light fitting.

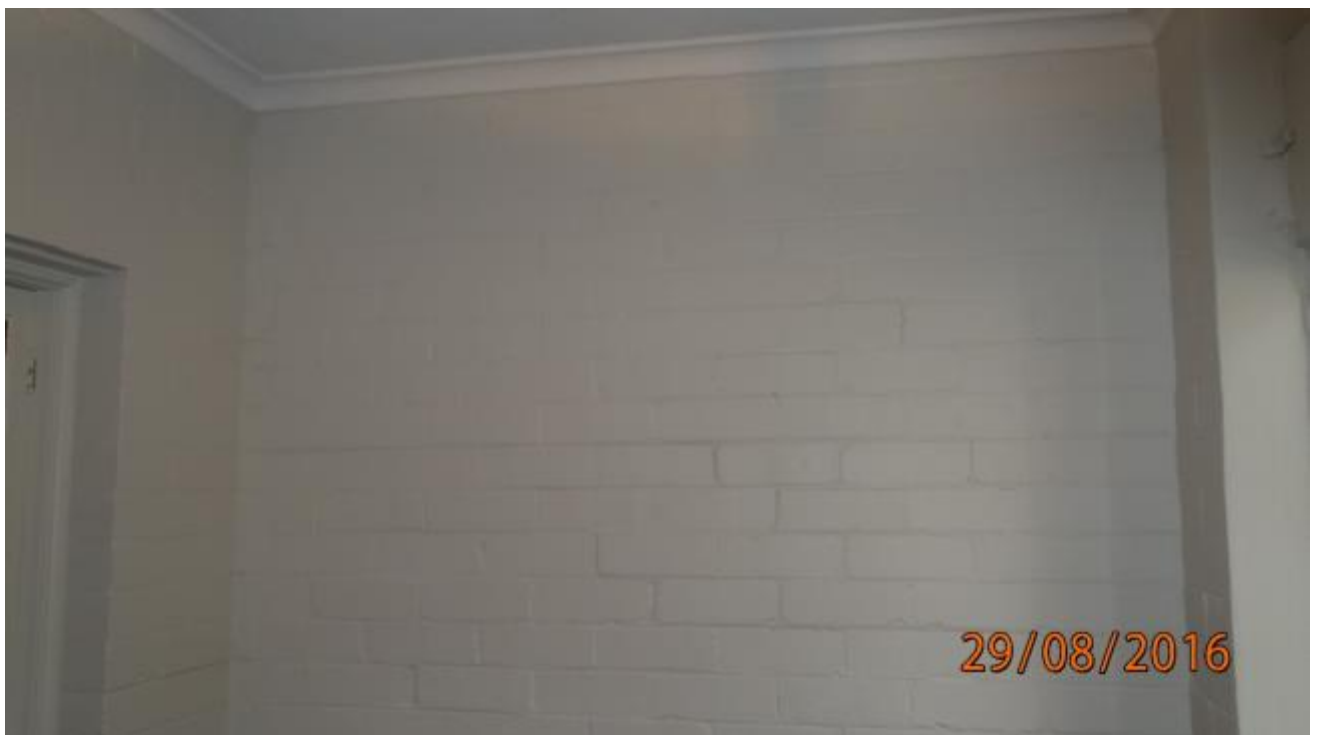
We did not observe any recent cracking to the surface coated clay masonry wall, the plaster ceiling lining or to the cove profiled plaster cornice **[Photograph 43]**

Photograph 43 shows the general condition of the *common party / separation wall* in the sunroom.

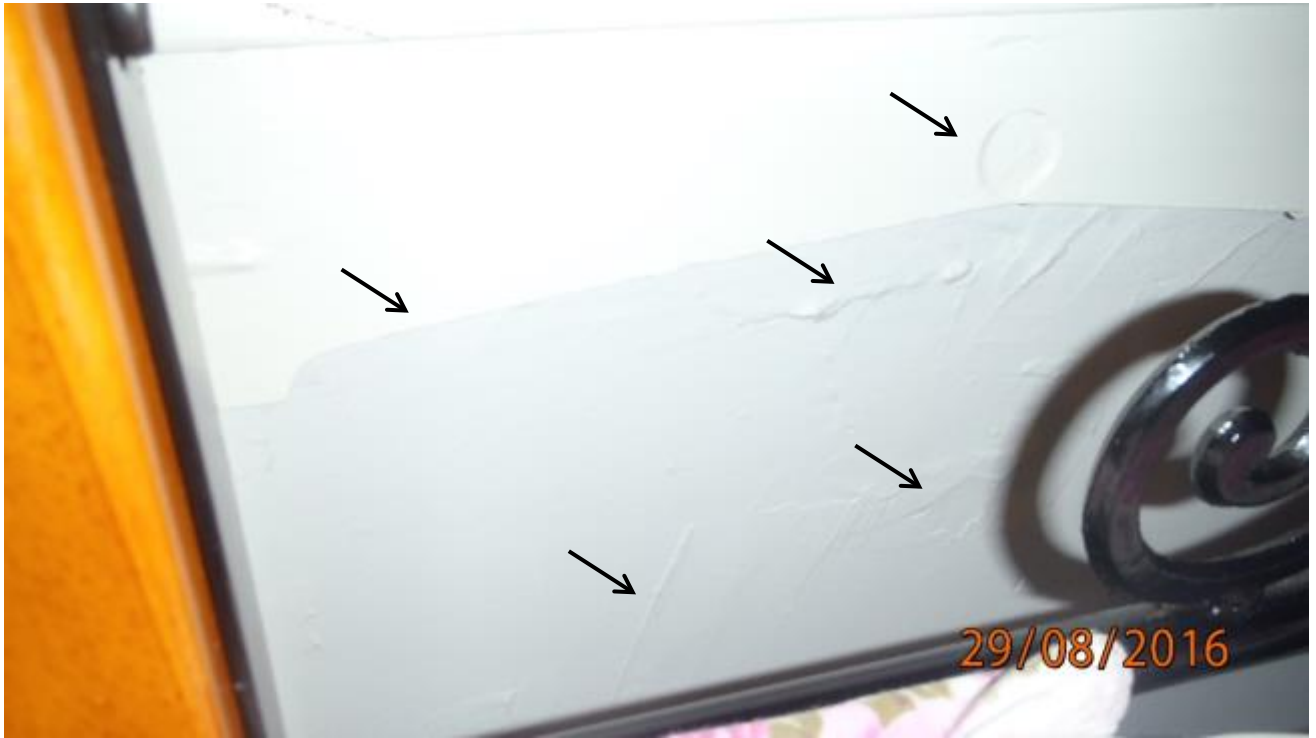
We noted evidence of previous repairs to the painted cement rendered wall under the window common with the sunroom. **[Photograph 44]**

Photograph 44 shows noted evidence of previous repairs to the painted cement rendered wall under the window common with the sunroom.

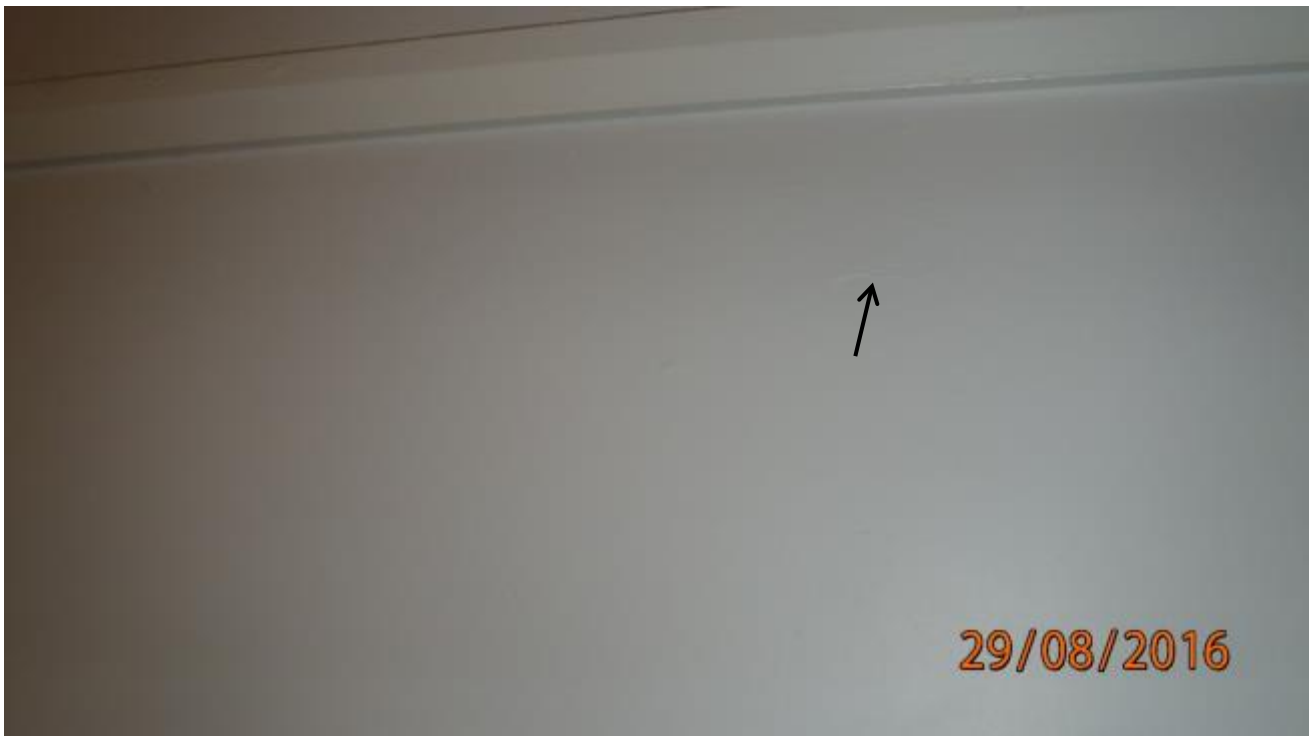
We noted evidence of previous repairs to the painted cement rendered *common party / separation wall* with the adjoining property; No.5 Jacques Street, Kingsford. **[Photograph 45]**

Photograph 45 shows evidence of previous repairs to the painted cement rendered *common party / separation wall* in Bedroom 3.

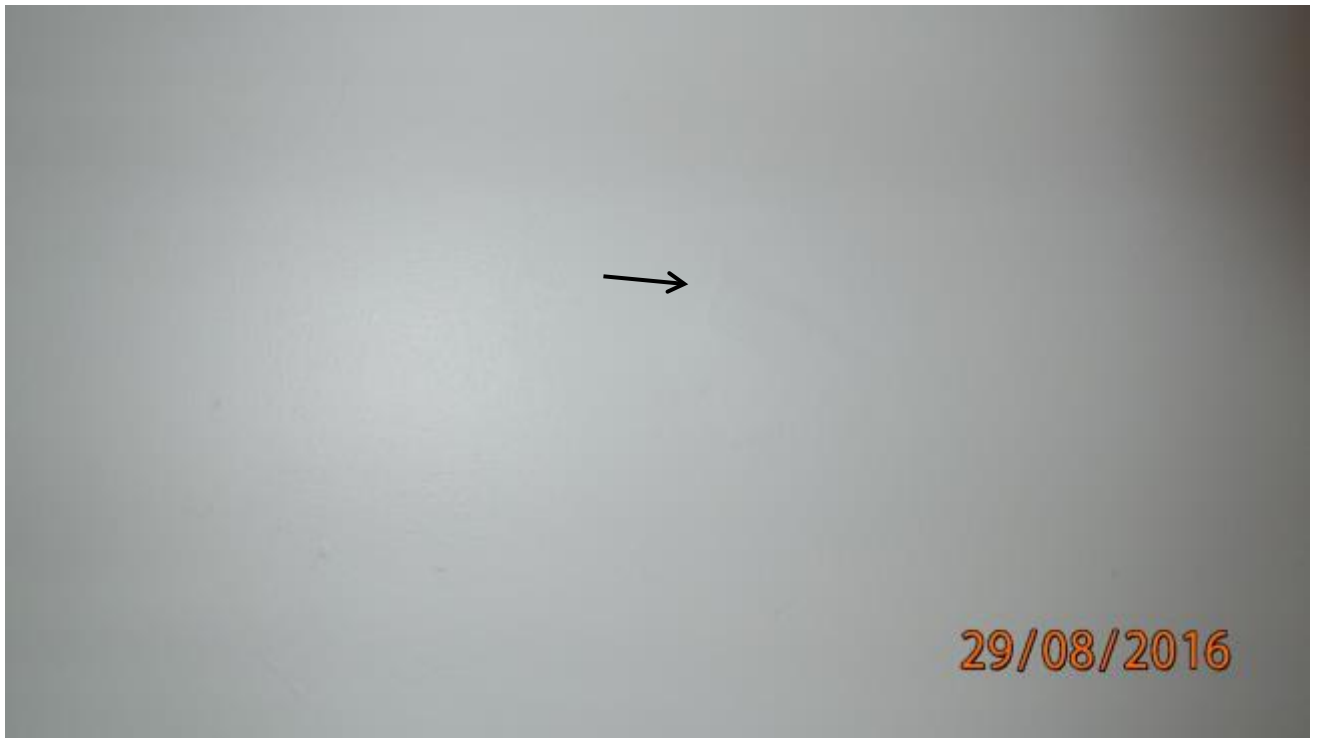
We noted evidence of previous repairs to the painted cement rendered wall common with Bedroom 2. **[Photograph 46]**

Photograph 46 shows evidence of previous repairs to the painted cement rendered wall common with Bedroom 2 in Bedroom 3.

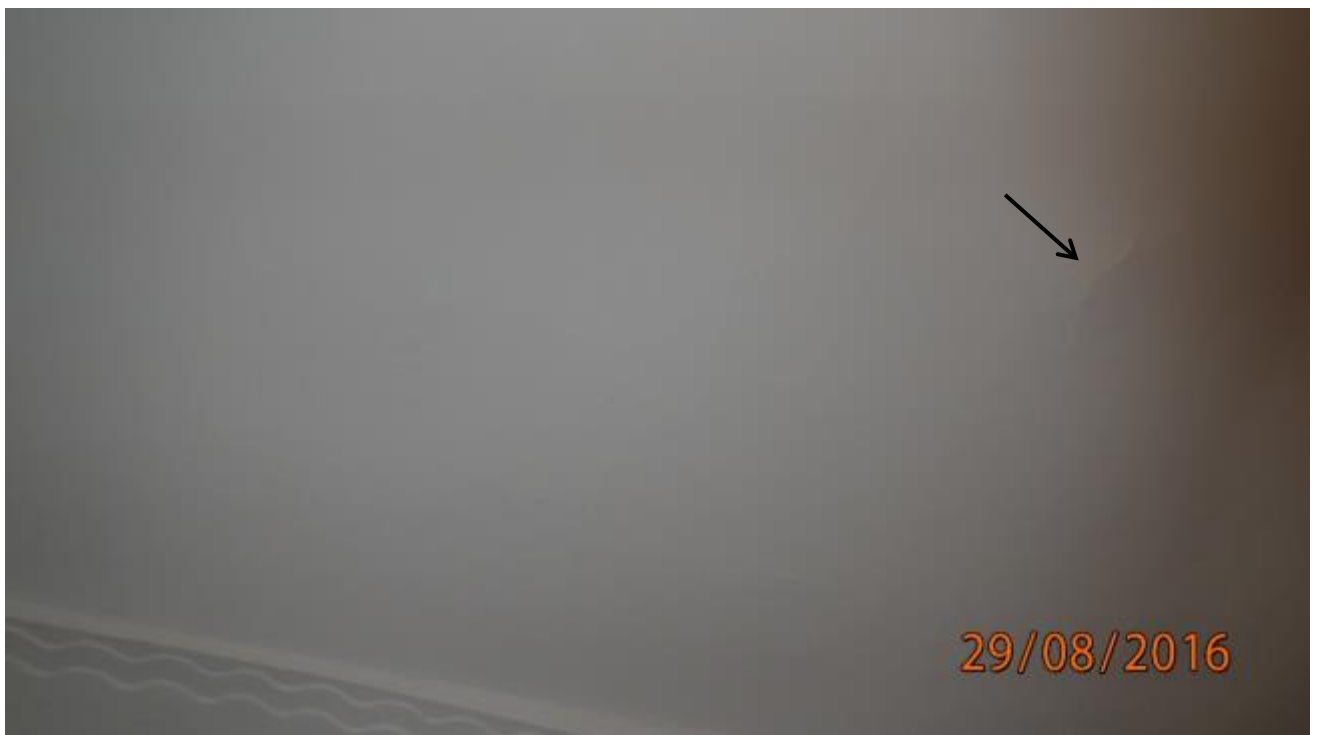
We noted evidence of previous repairs and hairline radial cracking to the plaster ceiling lining. **[Photograph 47]**

Photograph 47 shows evidence of previous repairs and hairline radial cracking to the plaster ceiling lining in Bedroom 3.

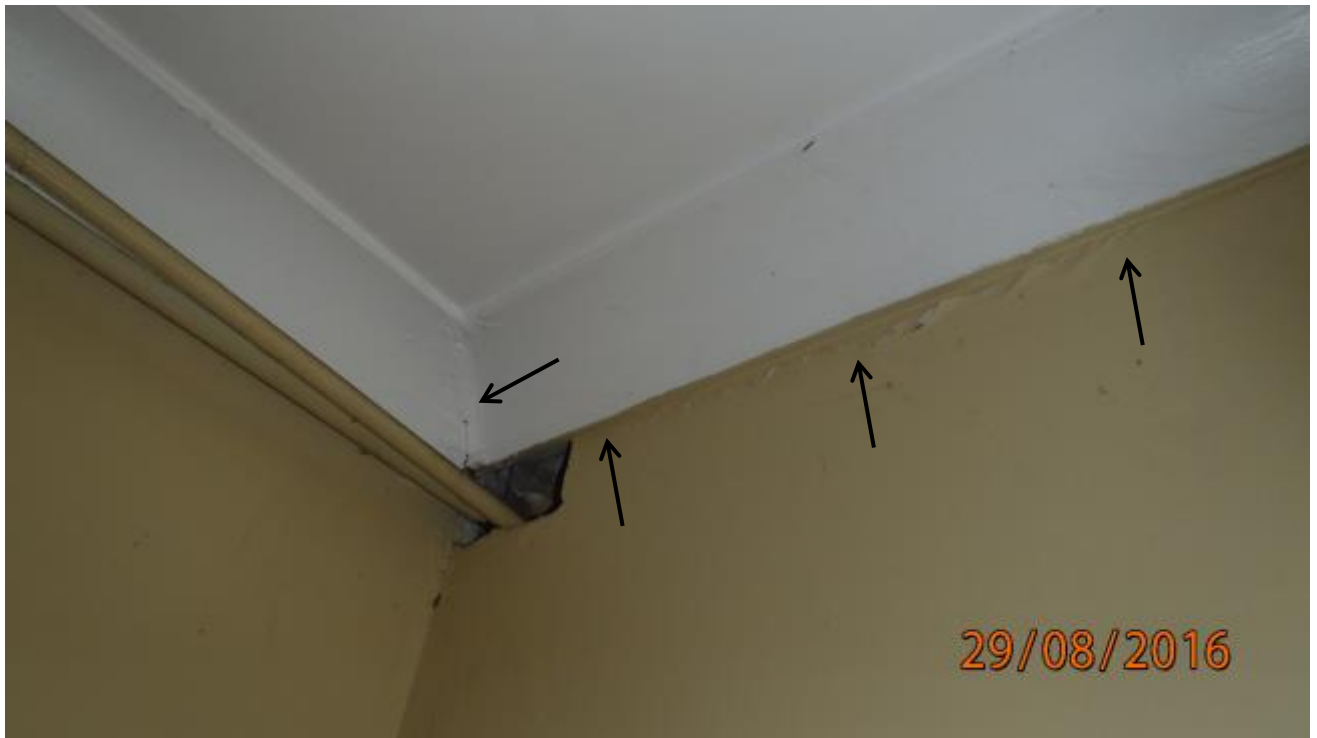
We noted cracking to the mitre joint of the cornice in the northern corner. We also noted a hole in the wall surface for pipework **[Photograph 48] 2002**

We noted separation cracking [1.0mm – 3.0mm] to the wall / cornice junction along the north eastern wall. **[Photograph 48] 2002**

Photograph 48 shows separation cracking the wall / cornice junction along the north eastern wall in the Toilet. It also shows cracking to the cornice mitre joint.

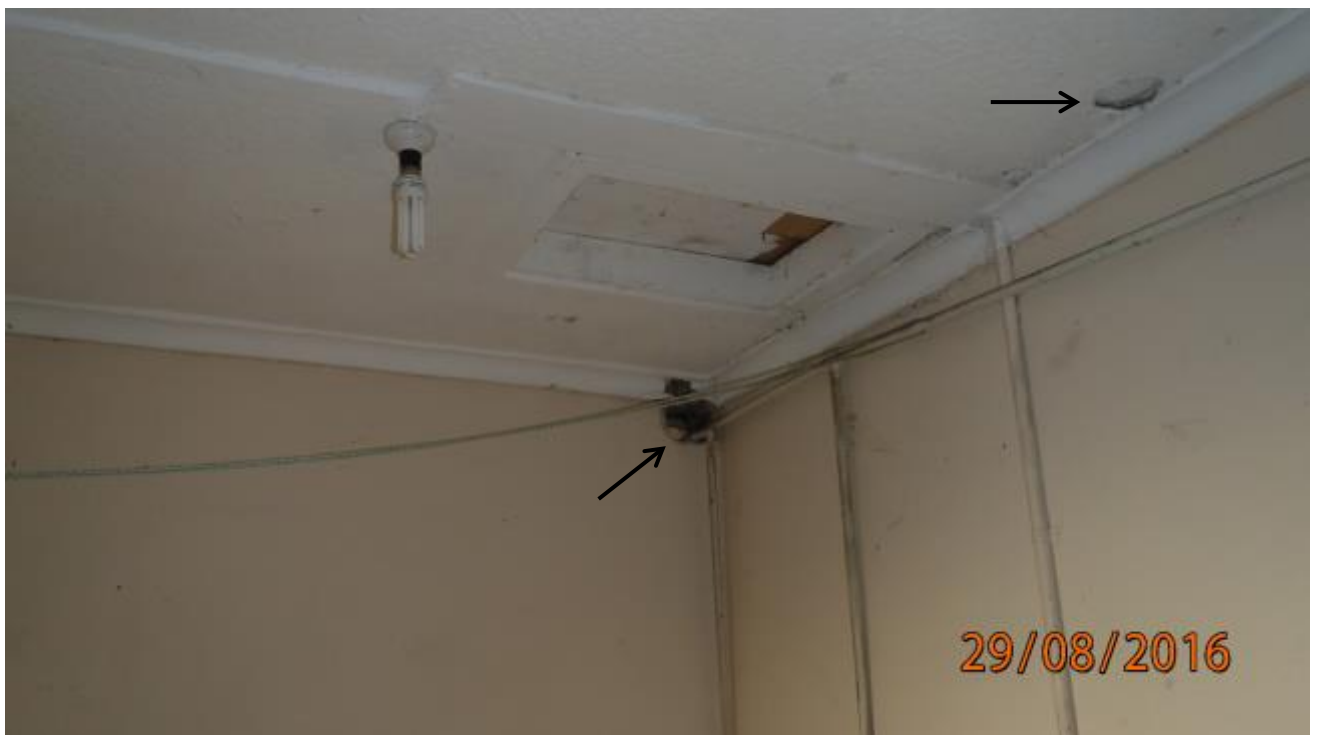
We noted damage to the plaster ceiling lining, flaking paint and noted a hole in the wall surface for pipework **[Photograph 49] 997**

Photograph 49 shows damage to the plaster ceiling lining, flaking paint and noted a hole in the wall surface for pipework

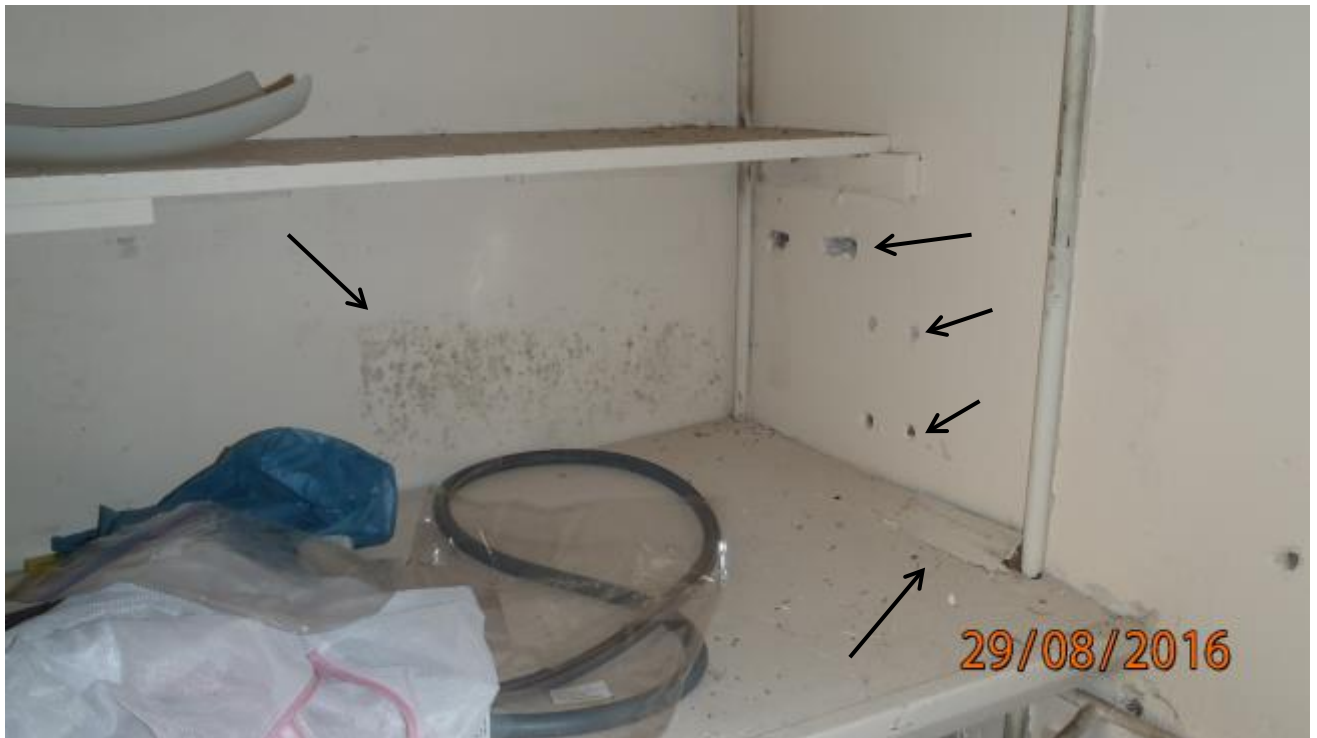
We noted mildew growth to the wall common with the toilet. We also noted holes drilled in the wall surface on the *common* north western wall. **[Photograph 50] 998**

We noted damage to the shelf around the vertical conduit/pipe. **[Photograph 50] 998**

Photograph 50 shows mildew growth to the wall common with the toilet. We also noted holes drilled in the wall surface on the common north western wall in the Laundry.

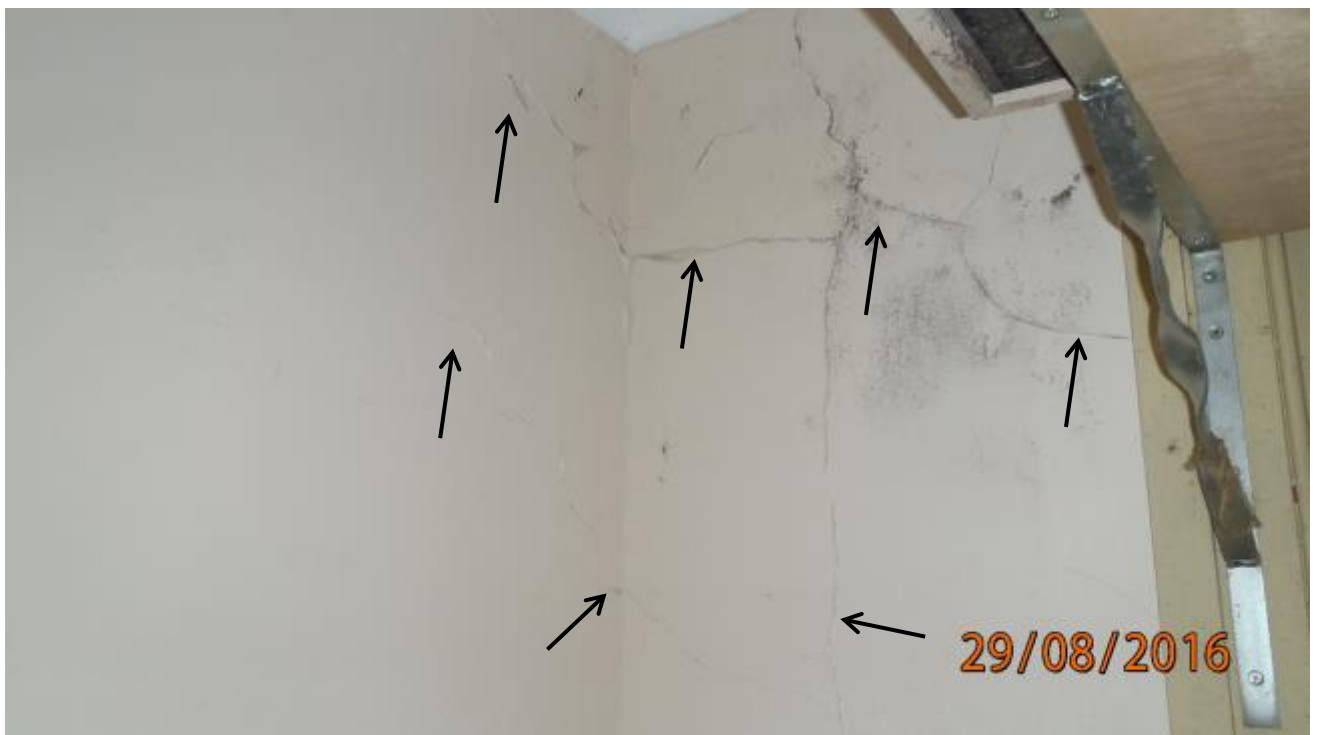
We noted flaking paint and hairline radial cracking [<1.0mm] to the northern corner **[Photograph 51] 999**

Photograph 51 shows flaking paint and hairline radial cracking to the northern corner in the Laundry.

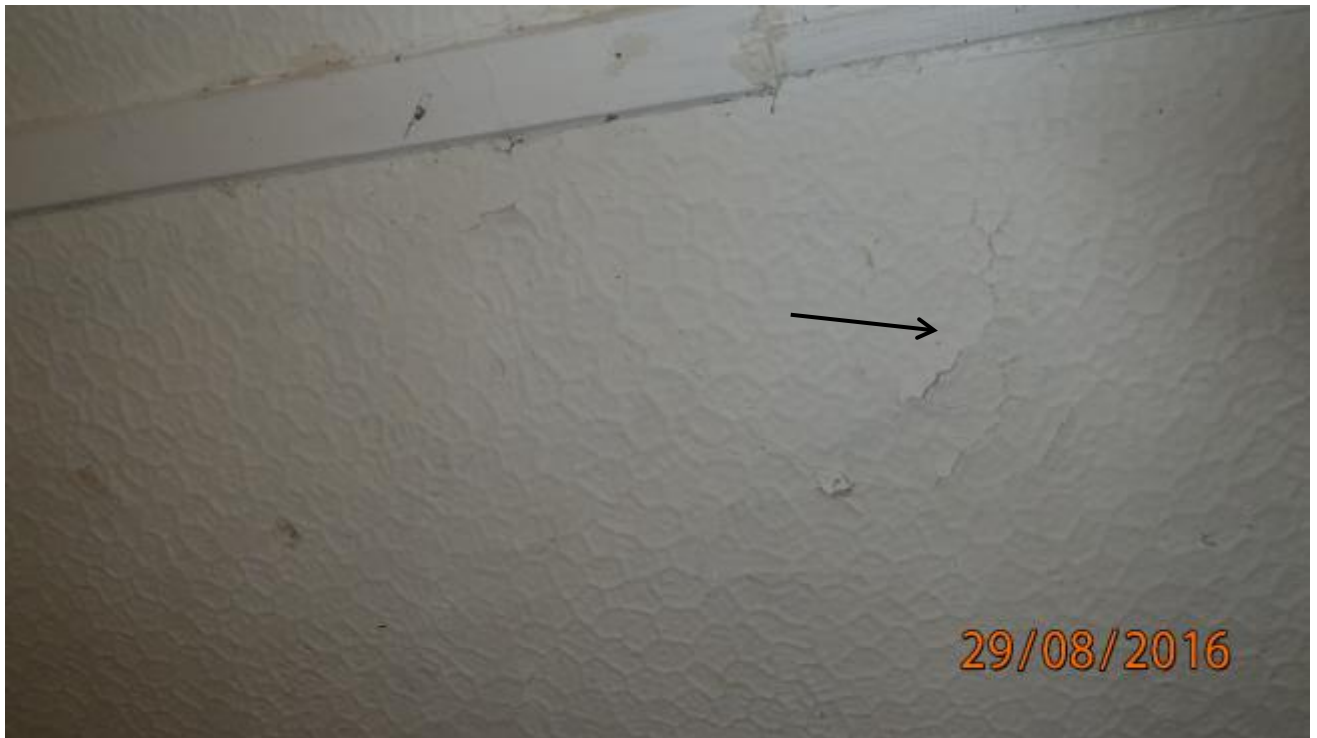
We noted flaking paint to the ceiling in the eastern corner **[Photograph 52] 2001**

Photograph 52 shows flaking paint to the ceiling in the eastern corner of the Laundry.

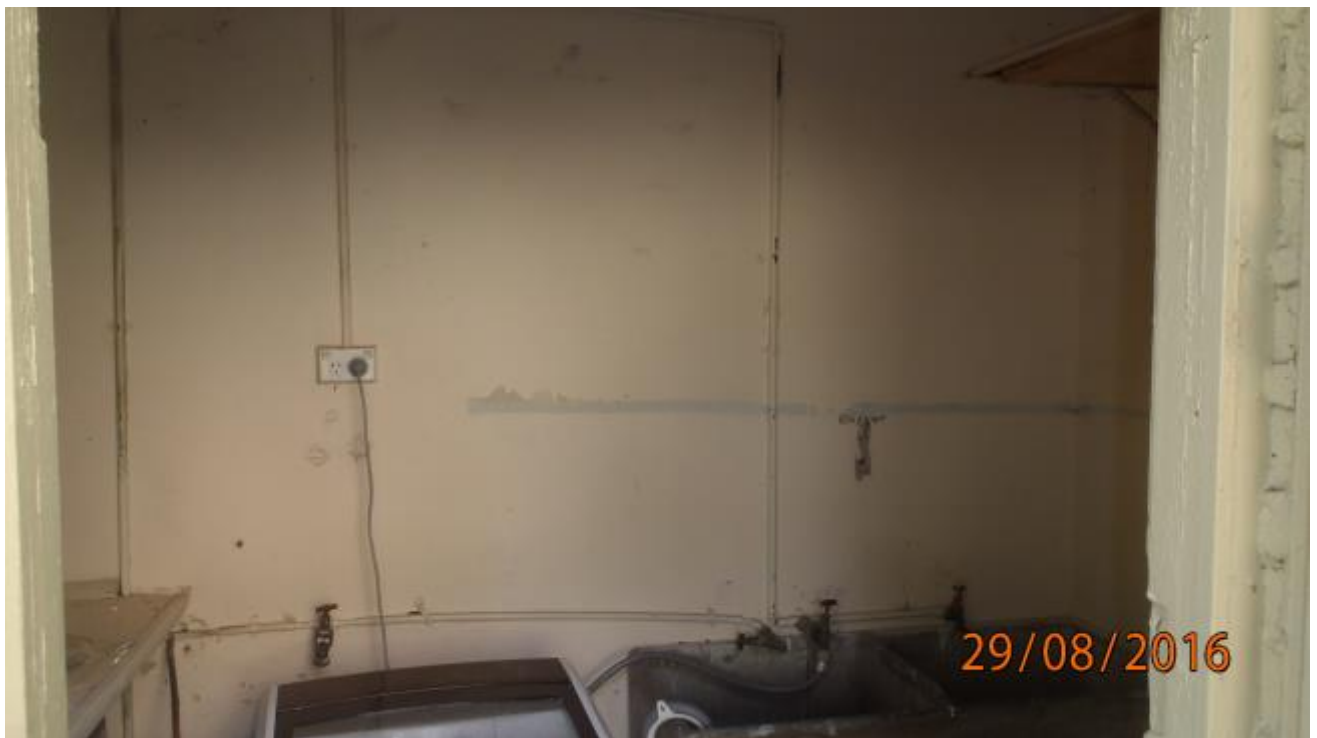
Photograph 53 shows the general condition of the external Laundry.
