Dilapidation Assessment Report

Prepared for: Cape Cod Australia Pty. Limited
Job address: No.74 Simpson Street, Bondi Beach.
Property Owner/s: Mrs. Wendy Charell.
Report reference: **WAVERLEY COUNCIL**
Development Application No: not available
Date of assessment: 8th June 2017

Re: Dilapidation Report – No. 74 Simpson Street, Bondi Beach.

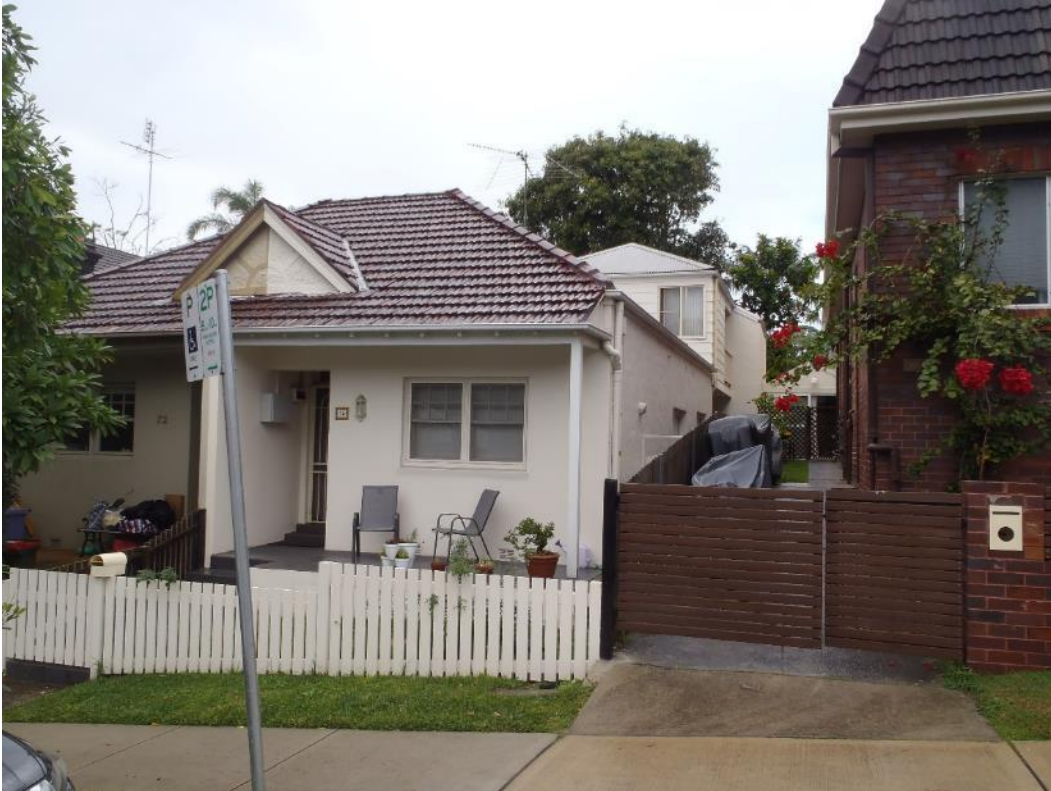
We observed that the terra cotta roof tiles to the original roof surfaces are generally interlinked and securely bedded, in our opinion forming a weather resistant cover to the residence. **[Photograph 1]**

Photograph 1 shows the general condition of the tiled roof surface.

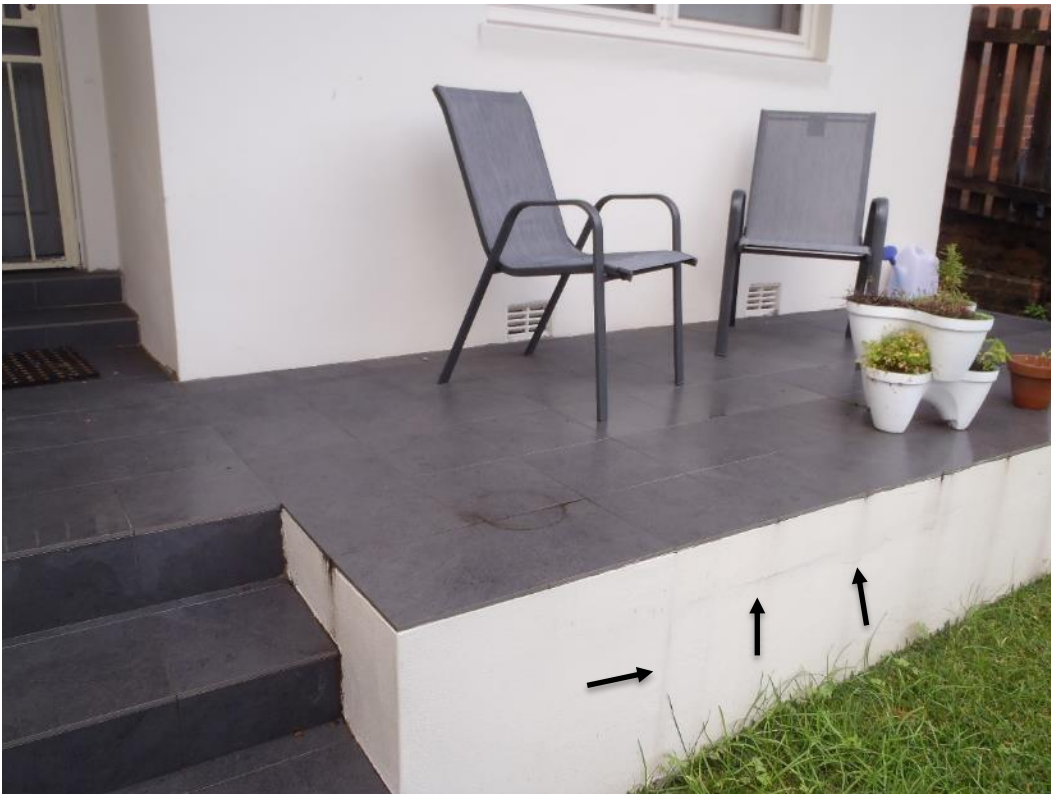
We noted cracking to the cement rendered front porch support wall. **[Photograph 2]**

We noted that the floor tiles to the front patio were generally sound with the grout complete. **[Photograph 2]**

Photograph 2 shows the cracking to the cement rendered front porch support wall.

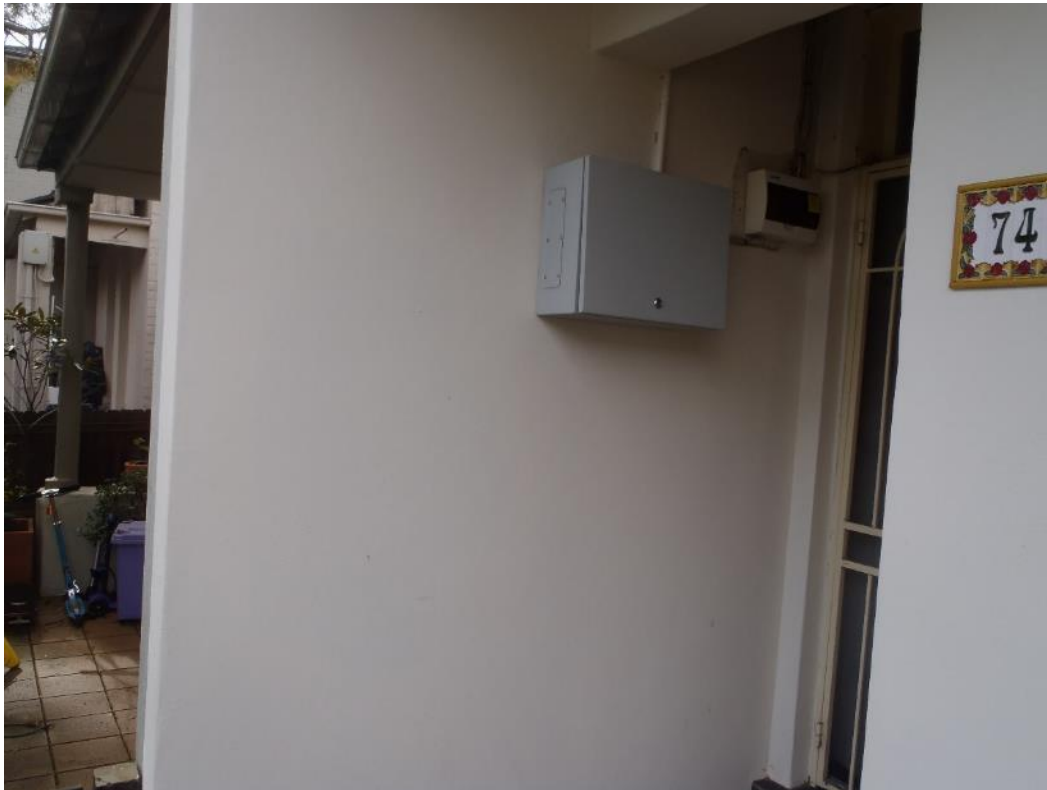
We did not observe any recent cracking to the surface coated clay masonry brickwork of the common privacy wall with the adjoining residence, No. 72 Simpson Street, Bondi Beach. **[Photograph 3]**

Photograph 3 shows the general condition of the front *common* privacy wall with the adjoining residence, No. 72 Simpson Street, Bondi Beach

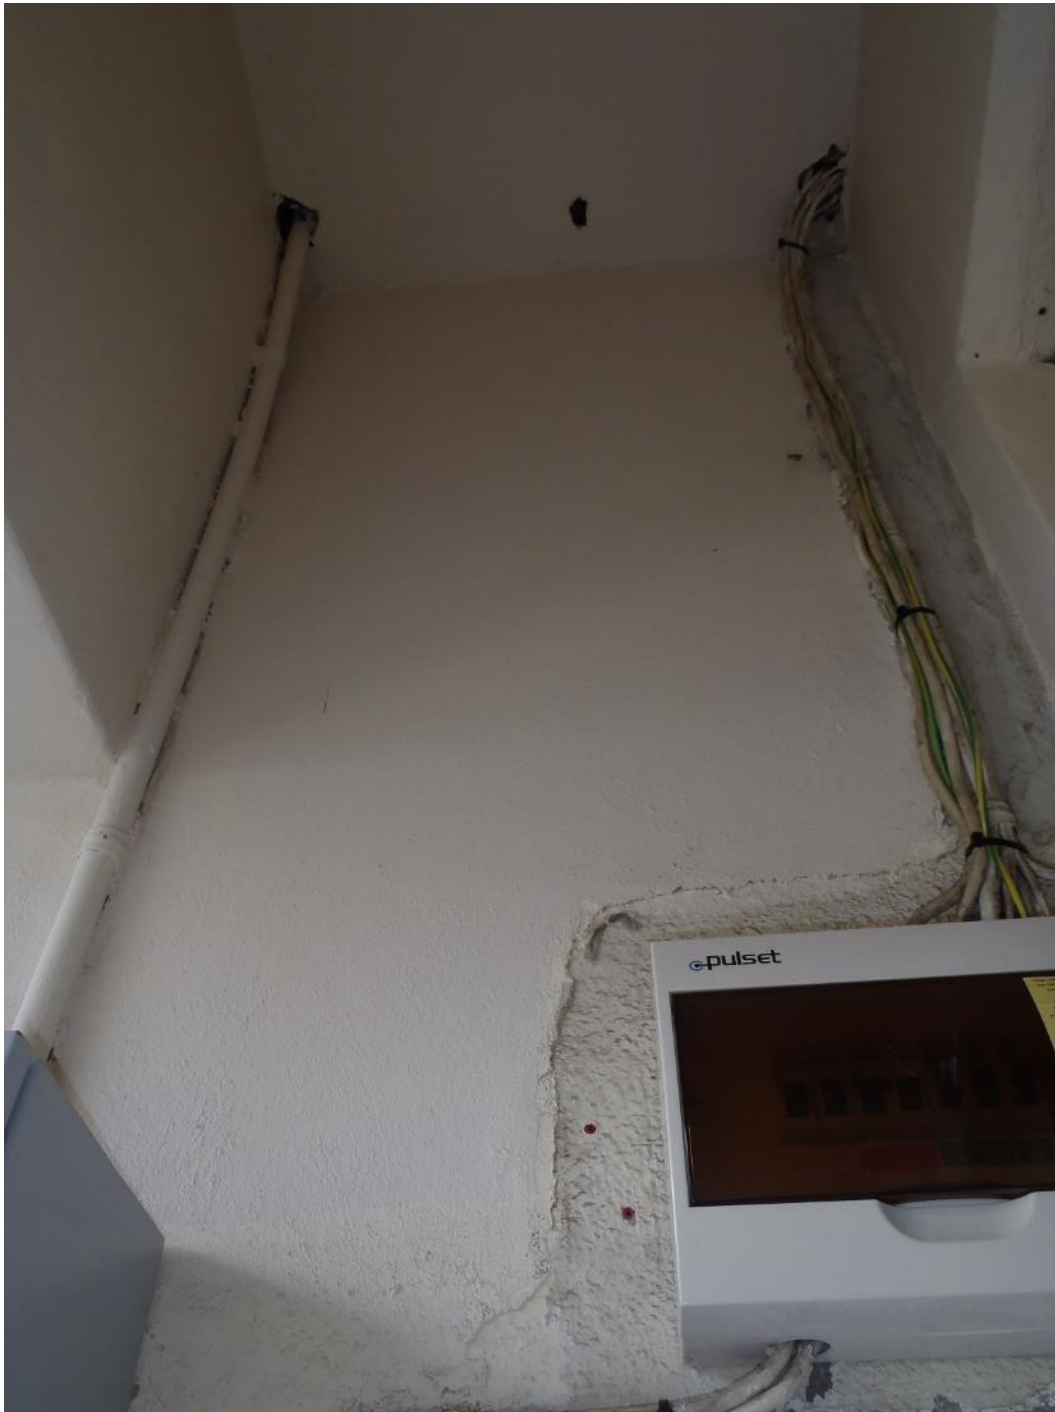
We further noted that the electrical meter board was located on the wall. **[Photograph 4]**

Photograph 4 shows the common privacy wall above the electrical meter board.

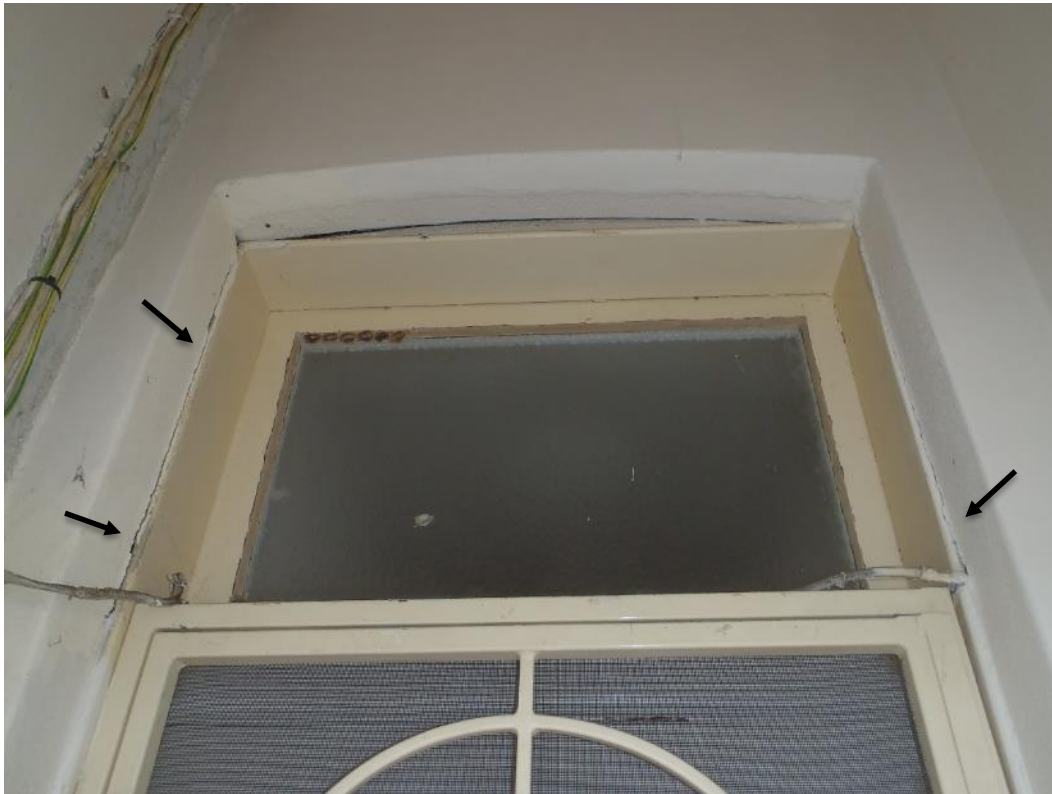
We noted separation cracking [$<1\text{mm}$] between the door jamb / window frame and the cement rendered wall around the window above the front entry door. **[Photograph 5]**

Photograph 5 shows separation cracking around the window above the front entry door.

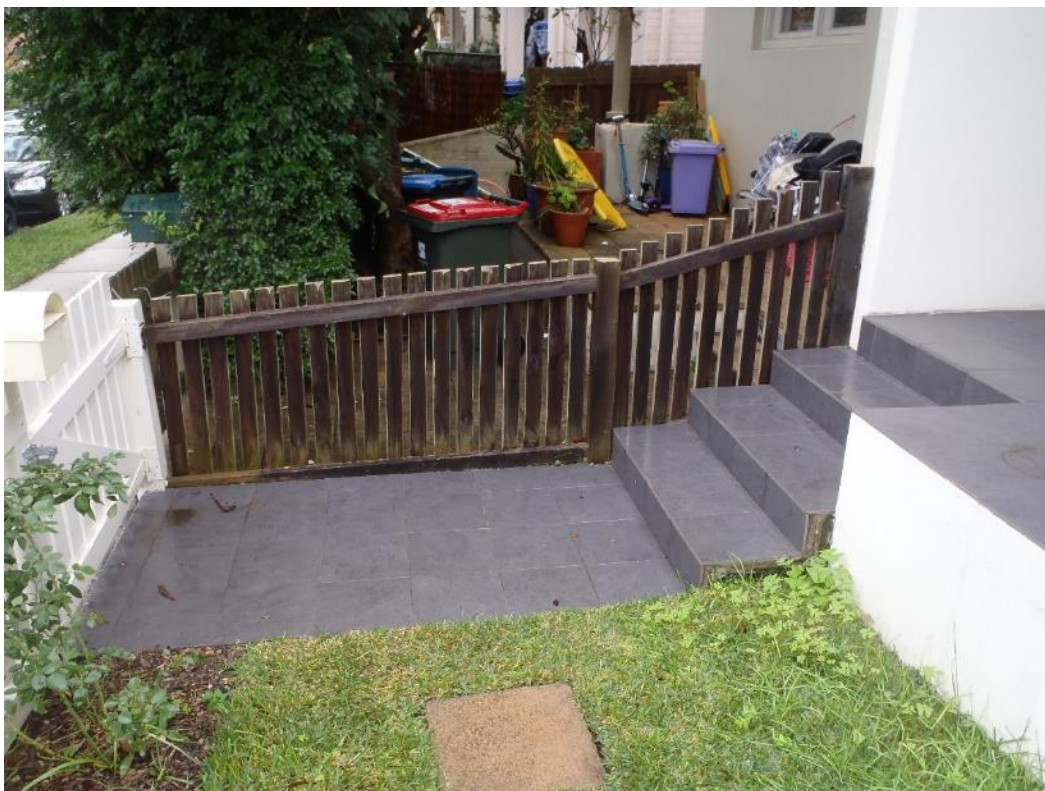
We noted that the front common boundary fence with the adjoining residence, No. 72 Simpson Street, Bondi Beach was of timber post and rail construction. **[Photograph 6]**

Photograph 6 shows the front common boundary fence with the adjoining residence, No. 72 Simpson Street, Bondi Beach.

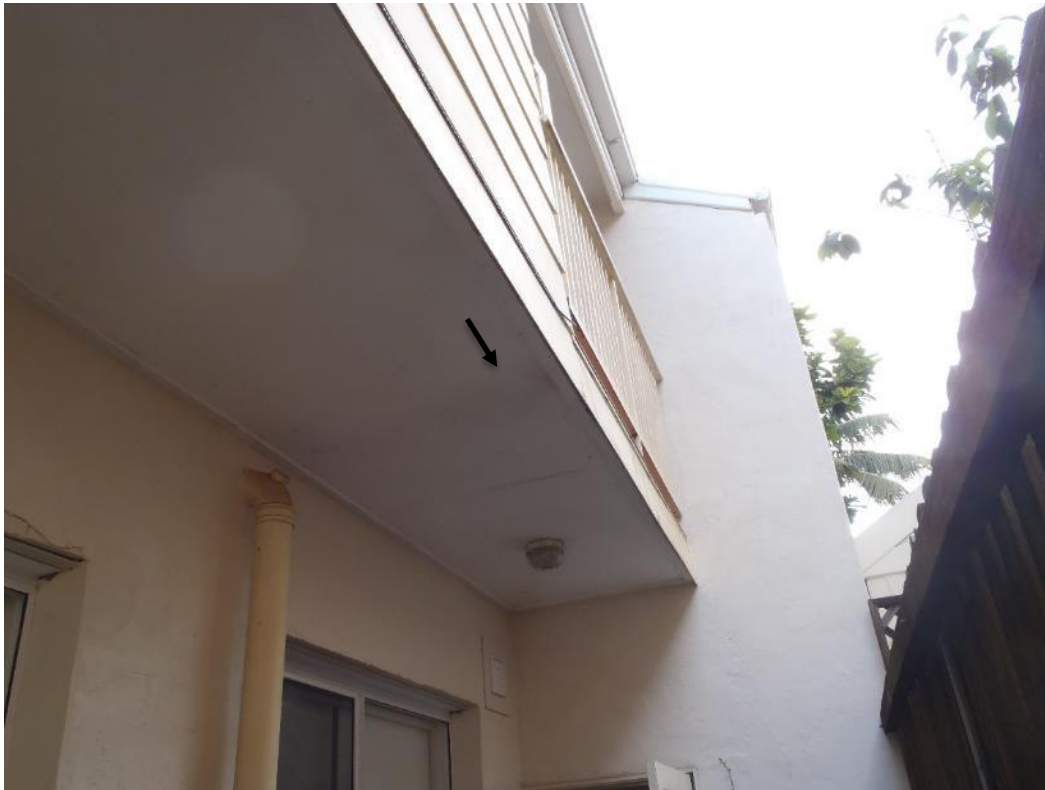
We noted staining to the soffit lining underside of the upstairs side balcony and Bedroom.

Photograph 7 shows staining to the soffit lining underside of the upstairs side balcony and Bedroom.

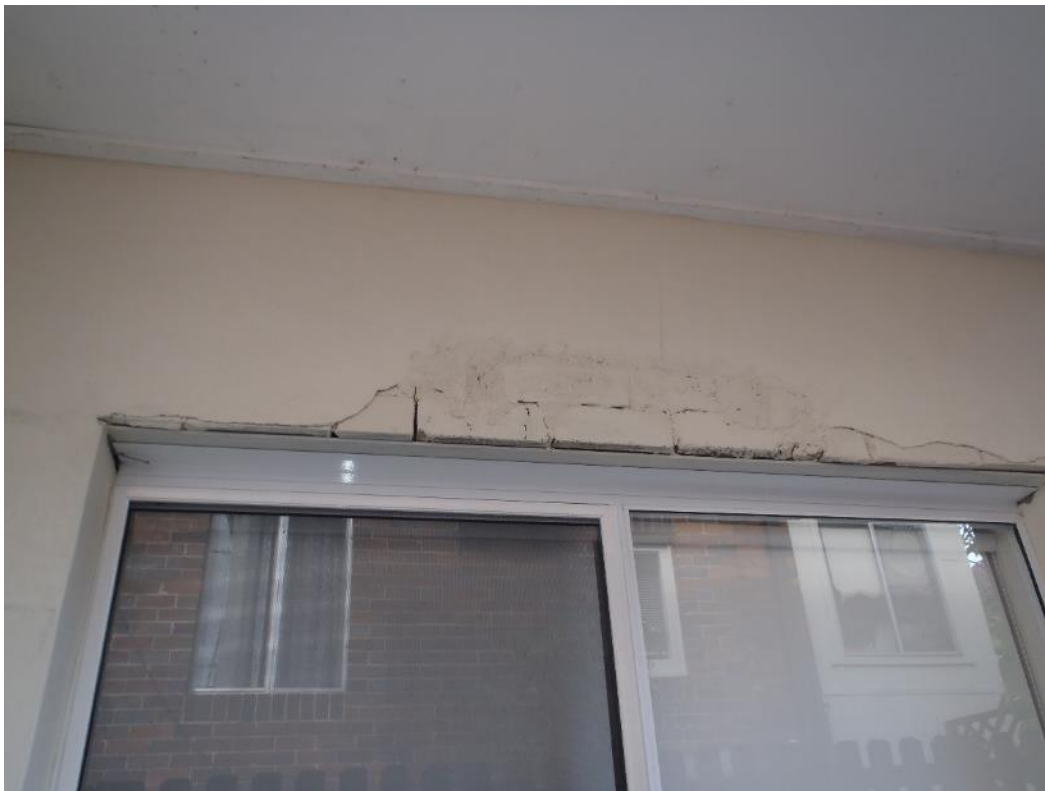
We noted damage to the cement rendered surface and evidence of previous repairs above the Dining Room window head. **[Photograph 8]**

Photograph 8 shows damage to the cement rendered surface and evidence of previous repairs above the Dining Room window head.

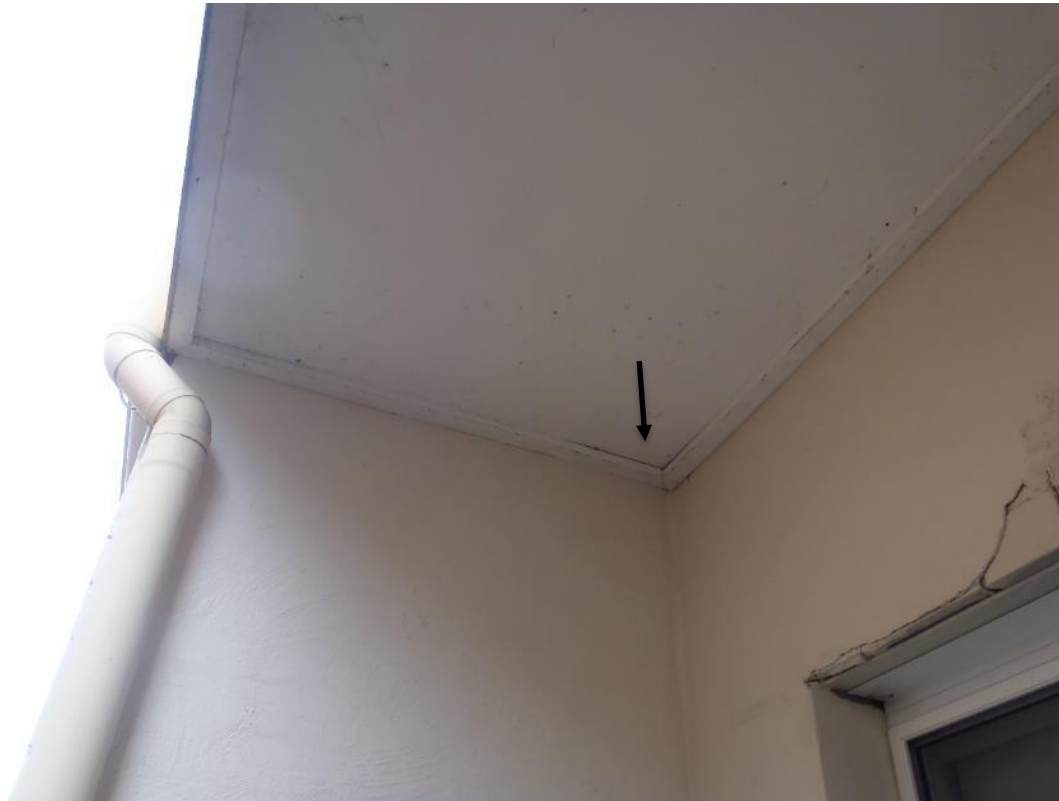
We noted separation gaps between the soffit lining and the timber mould outside the Dining Room window. **[Photograph 9]**

Photograph 9 shows separation gaps between the soffit lining and the timber mould outside the Dining Room window.

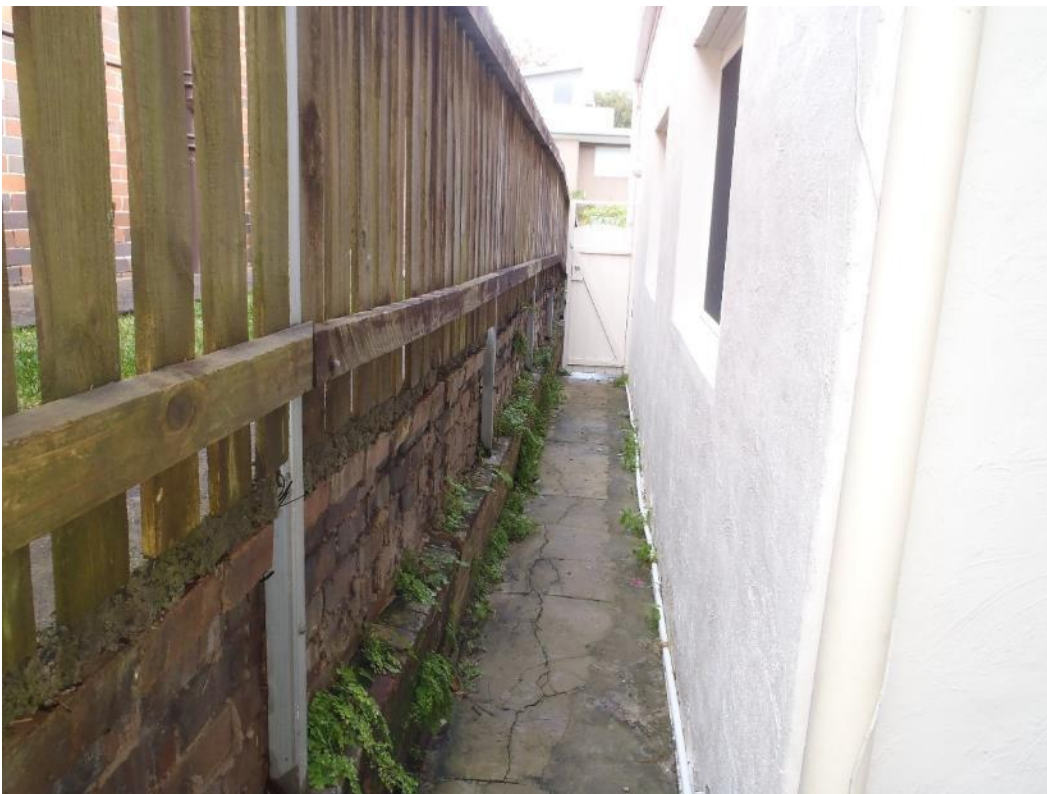
We noted cracking to the side concrete pathway of the residence. **[Photograph 10]**

We noted lichen and vegetation growth to the surface of the pavement and the external rendered wall surface of the residence. **[Photograph 10]**

Photograph 10 shows cracking to the side concrete pathway of the residence, lichen and vegetation growth.

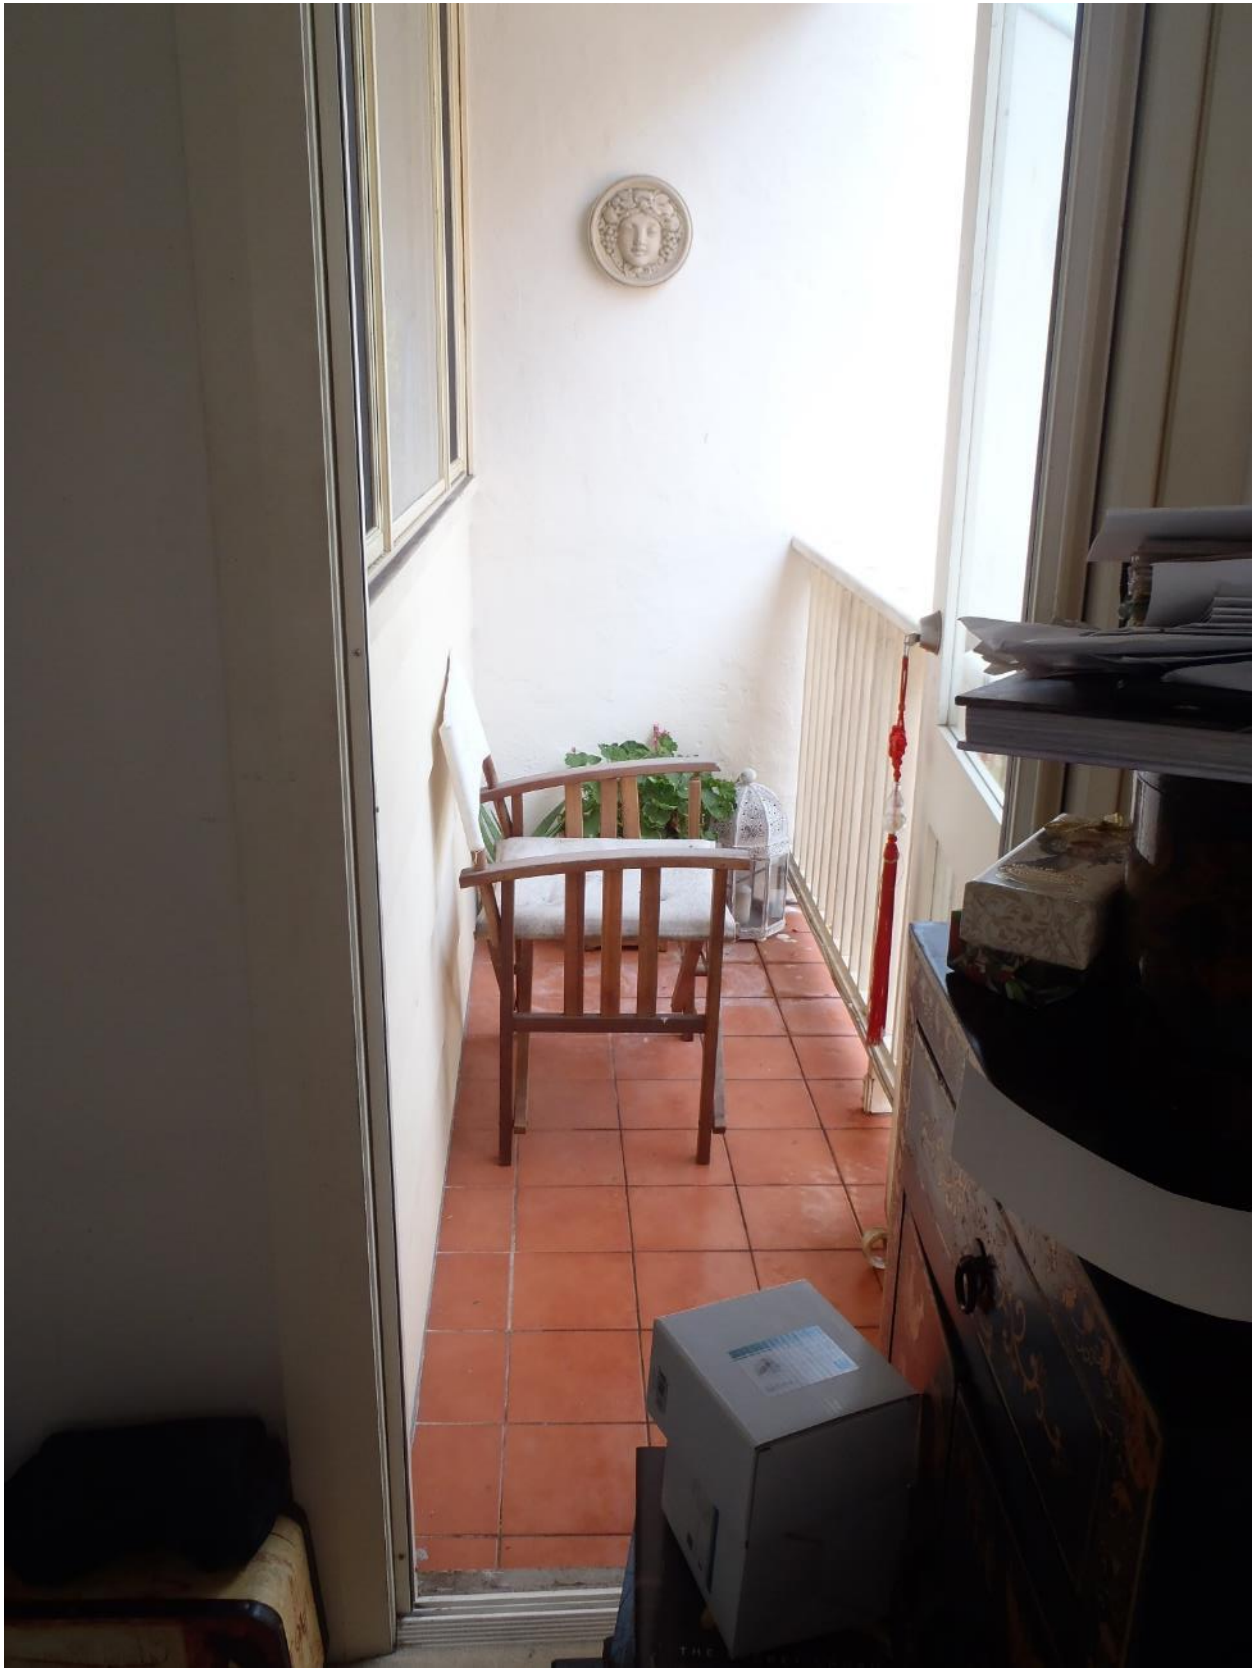
We noted that the side balcony outside the upstairs bedroom was tiled with a timber balustrade and handrail. We further noted that the floor tiles to the balcony were generally sound with the grout complete. **[Photograph 11]**

Photograph 11 shows the general condition of the side balcony.

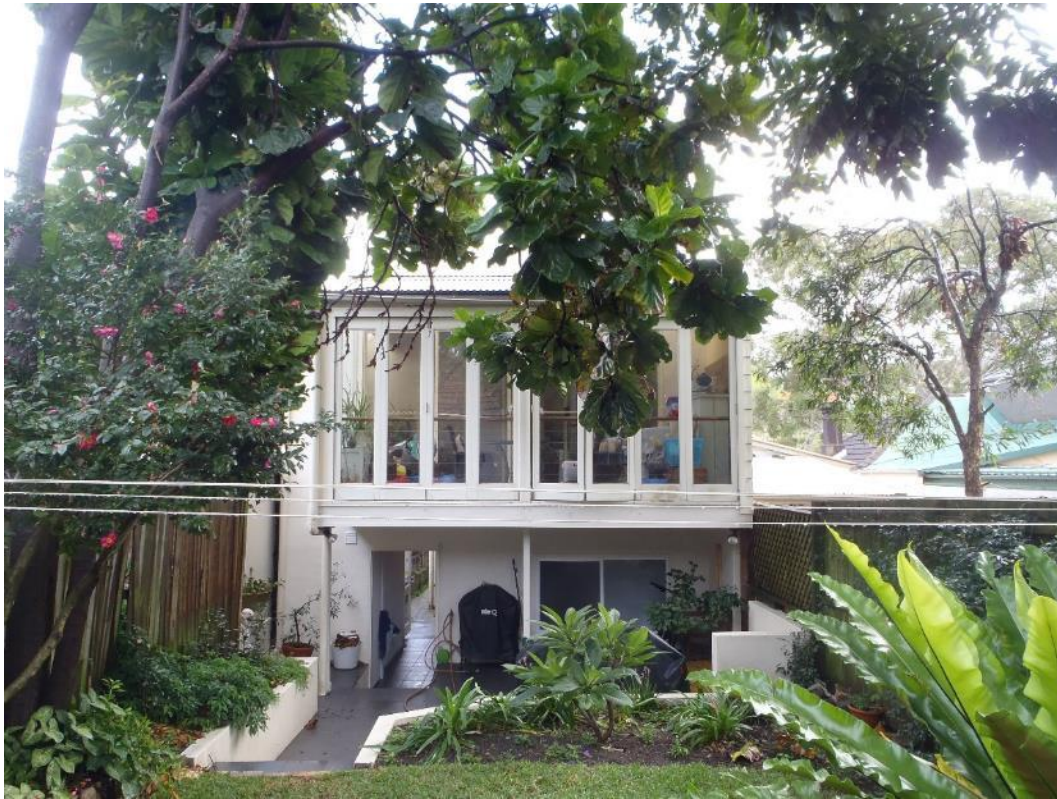
We noted that the rear elevation has a tiled courtyard. **[Photograph 12]**

Photograph 12 shows the general condition of the rear elevation.

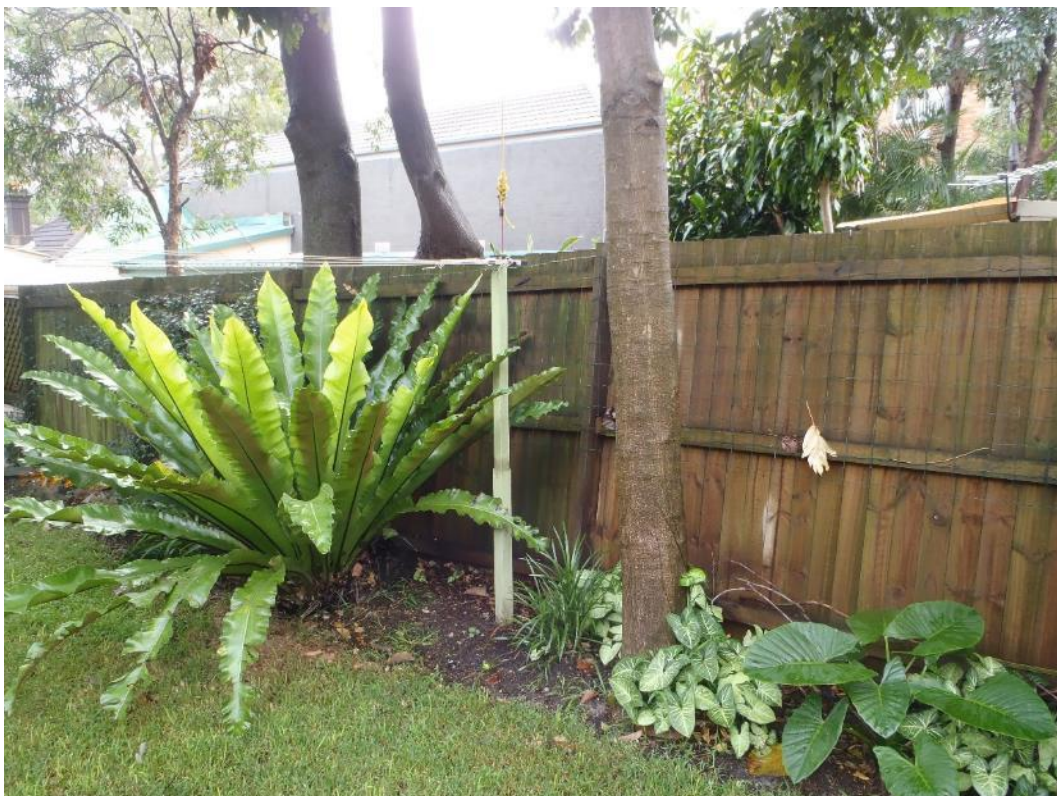
We noted that the side *common* boundary fence boundary fence with the adjoining residence, No. 72 Simpson Street, Bondi Beach was of timber post and rail construction. **[Photograph 13]**

Photograph 13 shows the general condition of the rear *common* boundary fence boundary fence with the adjoining residence, No. 72 Simpson Street, Bondi Beach

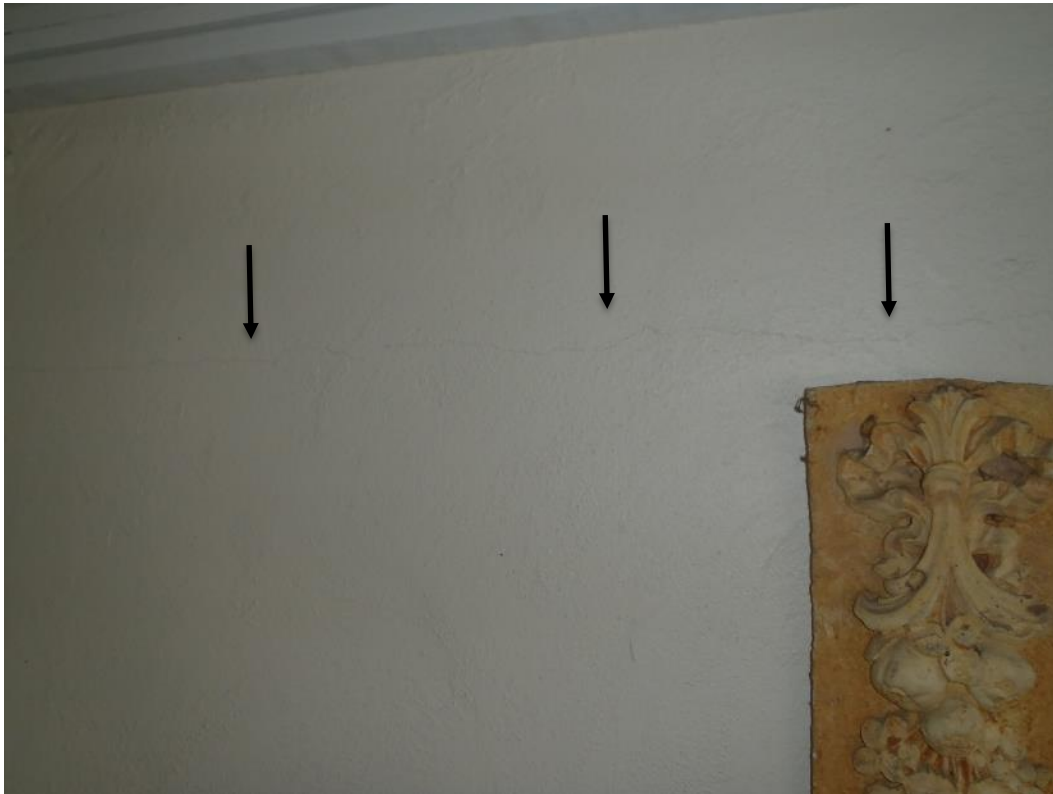
We noted horizontal cracking [$<1\text{mm}$] to the cement rendered privacy wall with the adjoining residence, No. 72 Simpson Street, Bondi Beach. **[Photograph 14]**

Photograph 14 shows horizontal cracking to the cement rendered privacy wall with the adjoining residence, No. 72 Simpson Street, Bondi Beach.

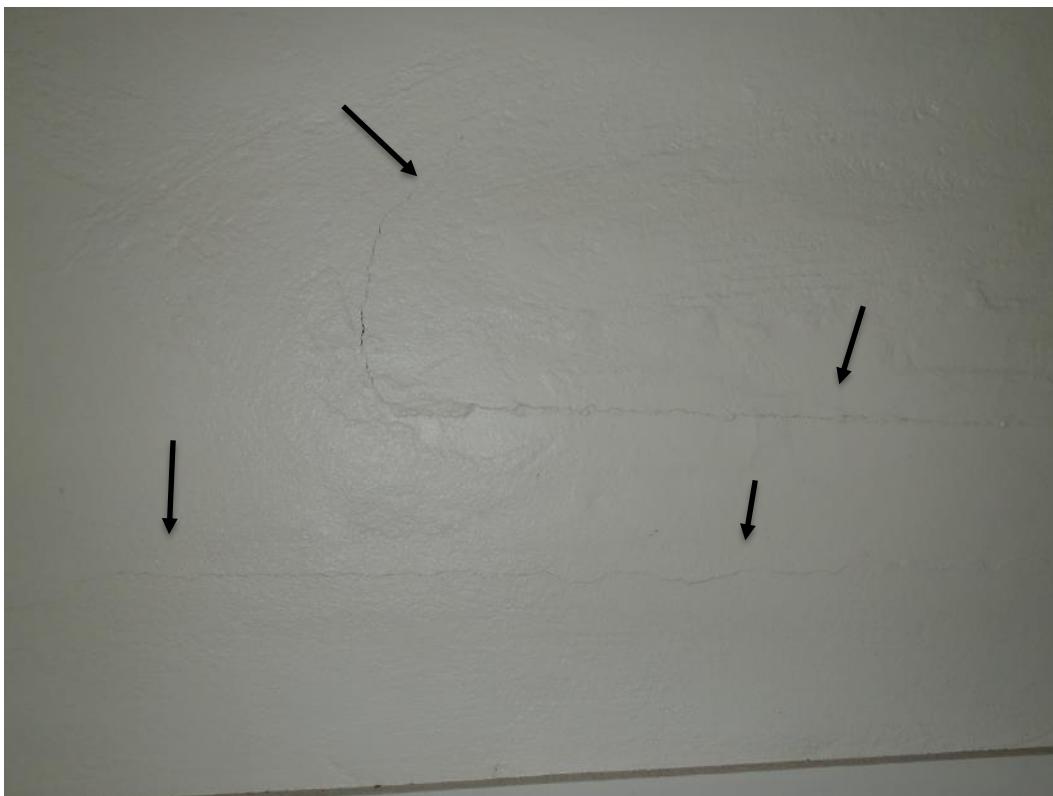
We noted cracking [$<1\text{mm}$] and evidence of previous repairs to the cement rendered wall above the Bathroom window. **[Photograph 15]**

Photograph 15 shows cracking and evidence of previous repairs to the cement rendered wall above the Bathroom window.

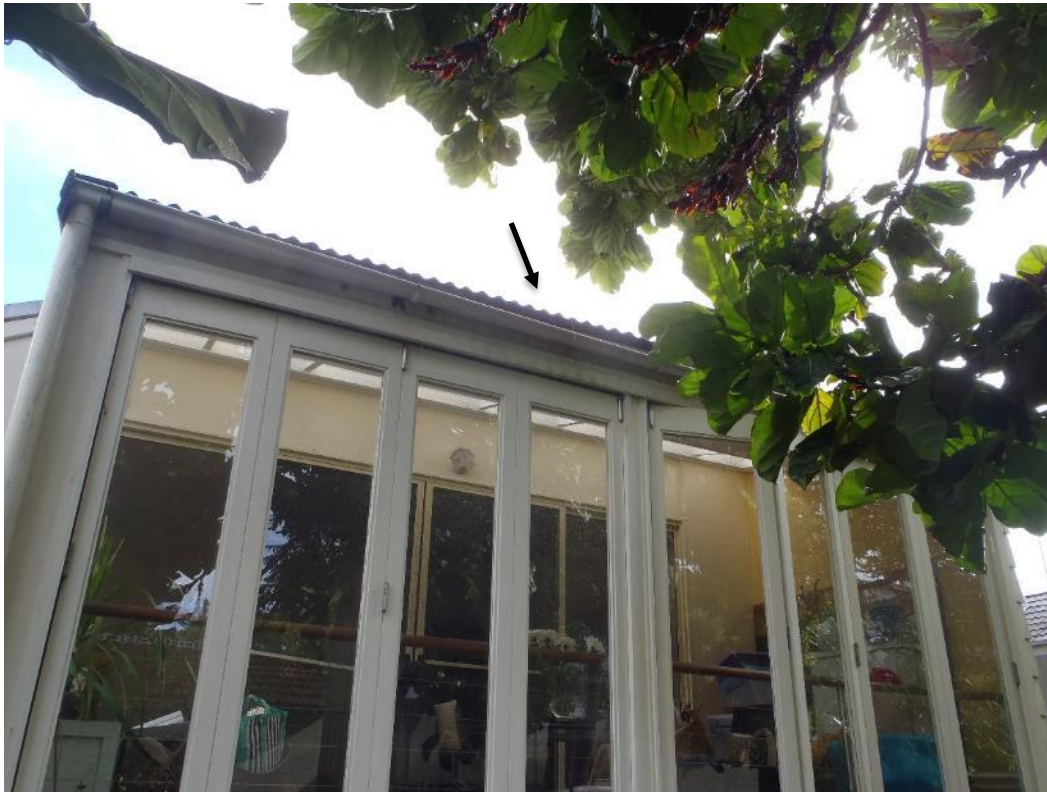
We noted damage to the rear gutter system of the upstairs extension. **[Photograph 16]**

Photograph 16 shows damage to the rear gutter system of the upstairs extension.

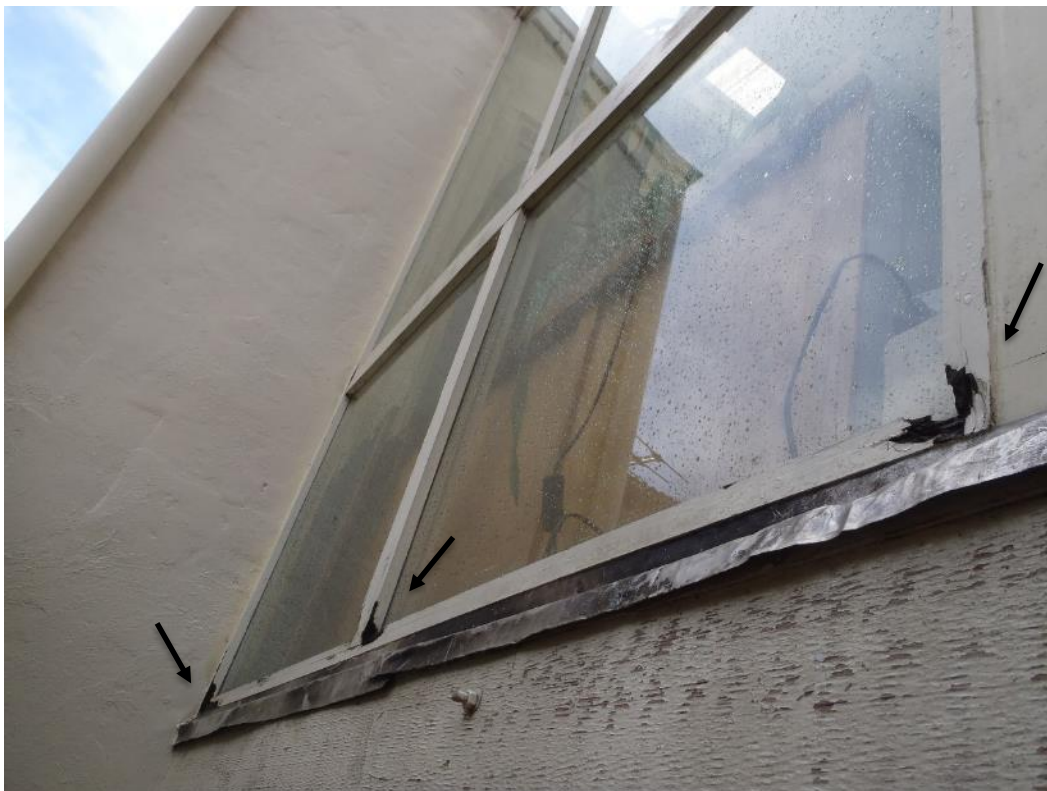
We noted deterioration to the timber window surrounds outside the sunroom. **[Photograph 17]**

Photograph 17 shows deterioration to the timber window surrounds outside the sunroom.

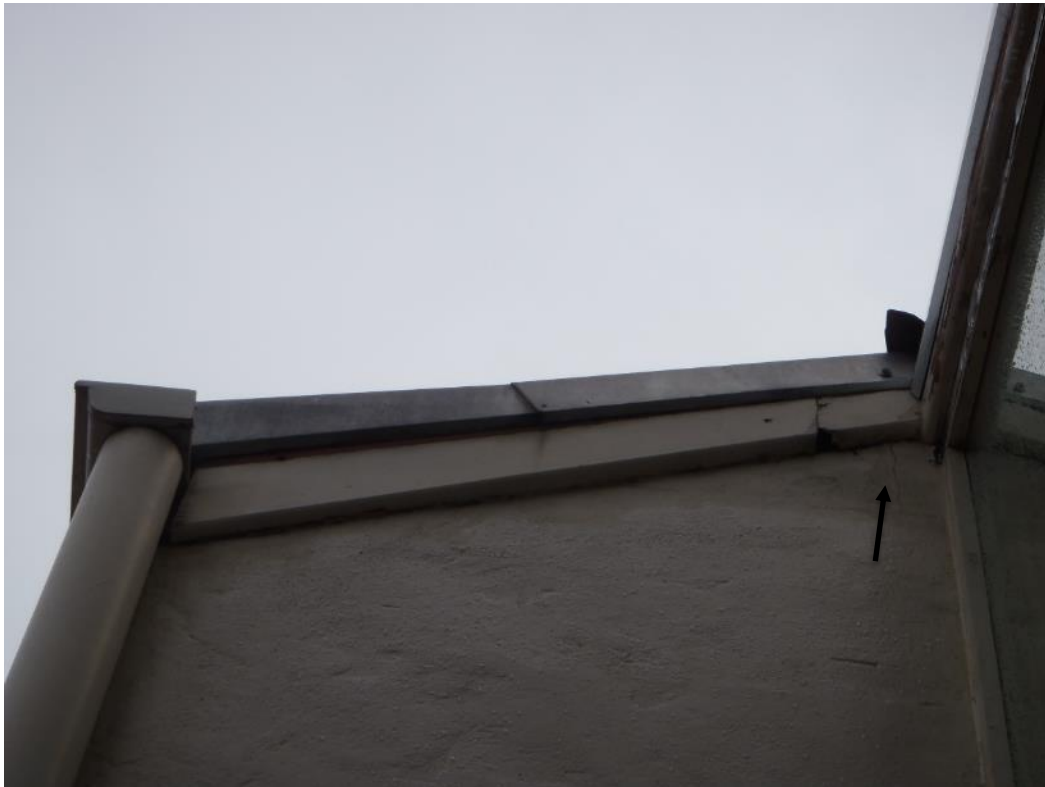
We noted step cracking [$<1\text{mm}$] to the cement rendered wall outside the stairwell. We further noted deterioration to the timber barge. **[Photograph 18]**

Photograph 18 shows step cracking to the cement rendered wall outside the stairwell and deterioration to the timber barge.

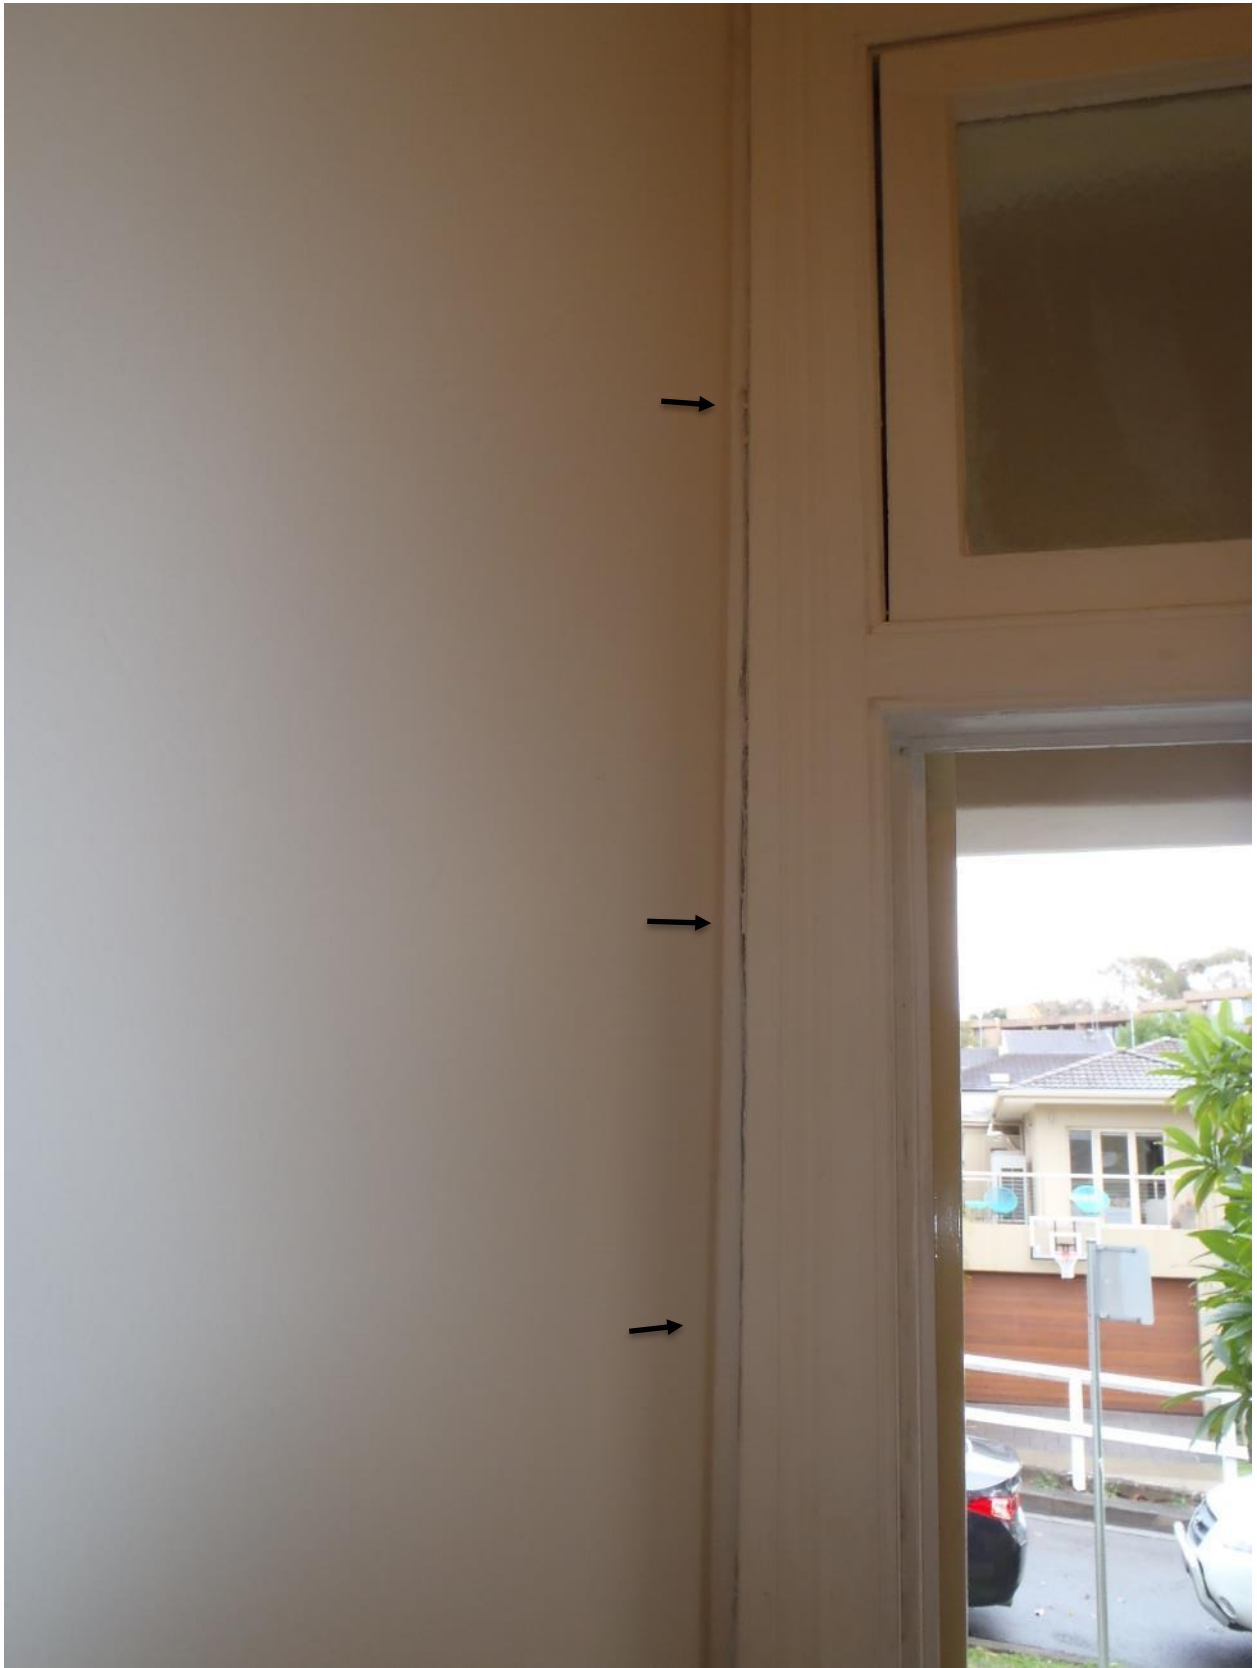
We noted a gap and separation cracking [1-3mm] beside the entry door architrave. **[Photograph 19]**

Photograph 19 shows gaps and separation cracking beside the entry door architrave.

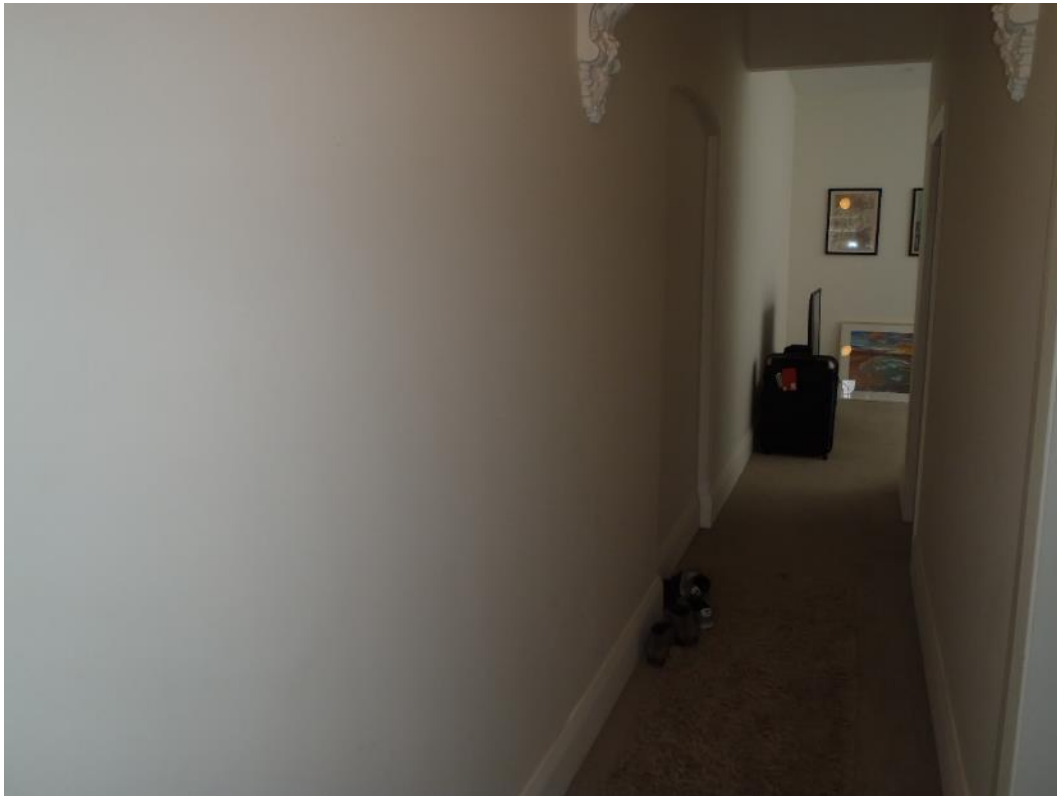
We noted that the north-western wall is the *common party / separation* wall with the adjoining residence, No. 72 Simpson Street, Bondi Beach. **[Photograph 20]**

Photograph 20 shows the general condition of the *common party / separation* wall with the adjoining residence, No. 72 Simpson Street, Bondi Beach.

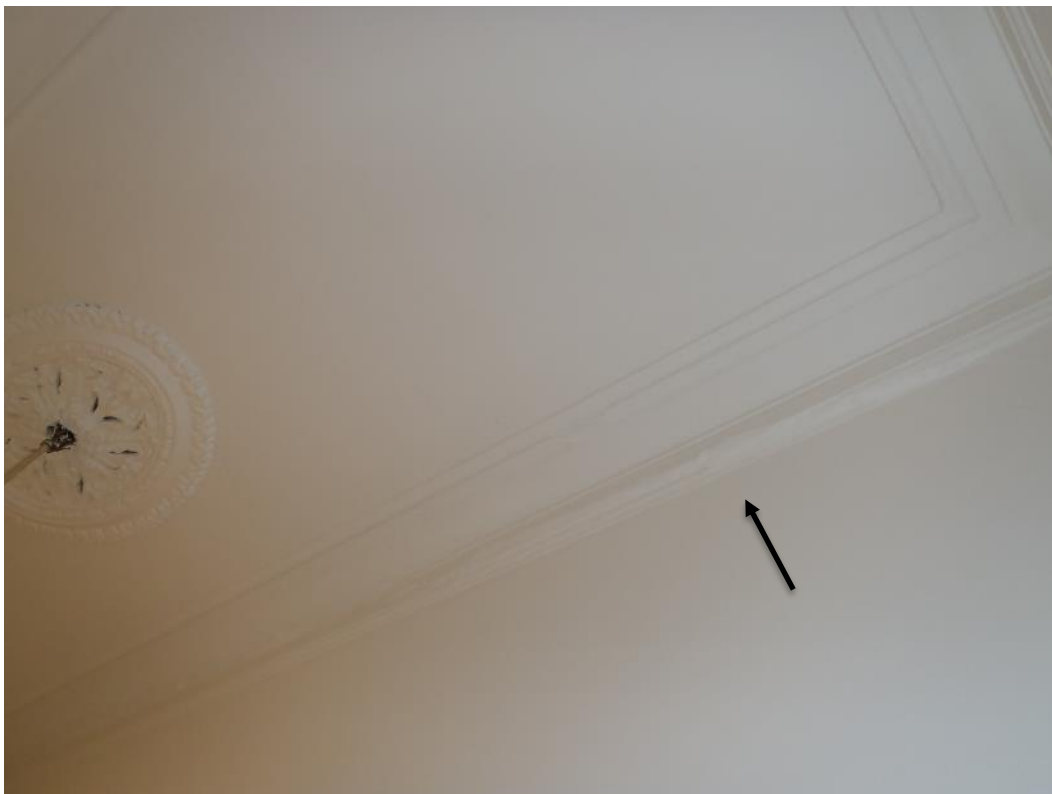
We noted evidence of previous repairs to the decorative plaster cornice between the plaster ceiling rose and the hallway arch along the *common party / separation* wall with the adjoining residence, No. 72 Simpson Street, Bondi Beach. **[Photograph 21]**

Photograph 21 shows evidence of previous repairs to the decorative plaster cornice between the plaster ceiling rose and the hallway arch along the *common party / separation* wall with the adjoining residence, No. 72 Simpson Street, Bondi Beach.

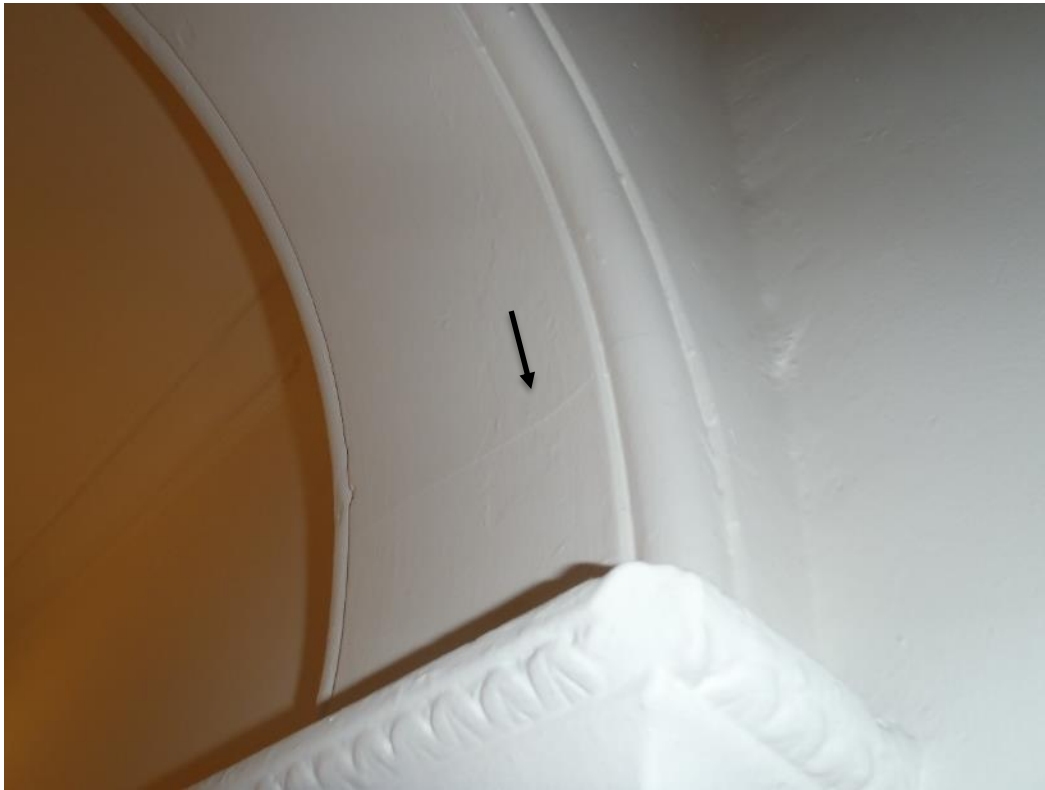
We noted horizontal and radial cracking through the hallway arch. **[Photograph 22]**

Photograph 22 shows horizontal and radial cracking through the hallway arch.
