Dilapidation Assessment Report

Prepared for: Cape Cod Australia Pty. Limited
Job address: No.74 Simpson Street, Bondi Beach.
Property Owner/s: Mrs. Wendy Charell.
Report reference: **WAVERLEY COUNCIL**
Development Application No: not available
Date of assessment: 8th June 2017

Re: Dilapidation Report – No. 74 Simpson Street, Bondi Beach.

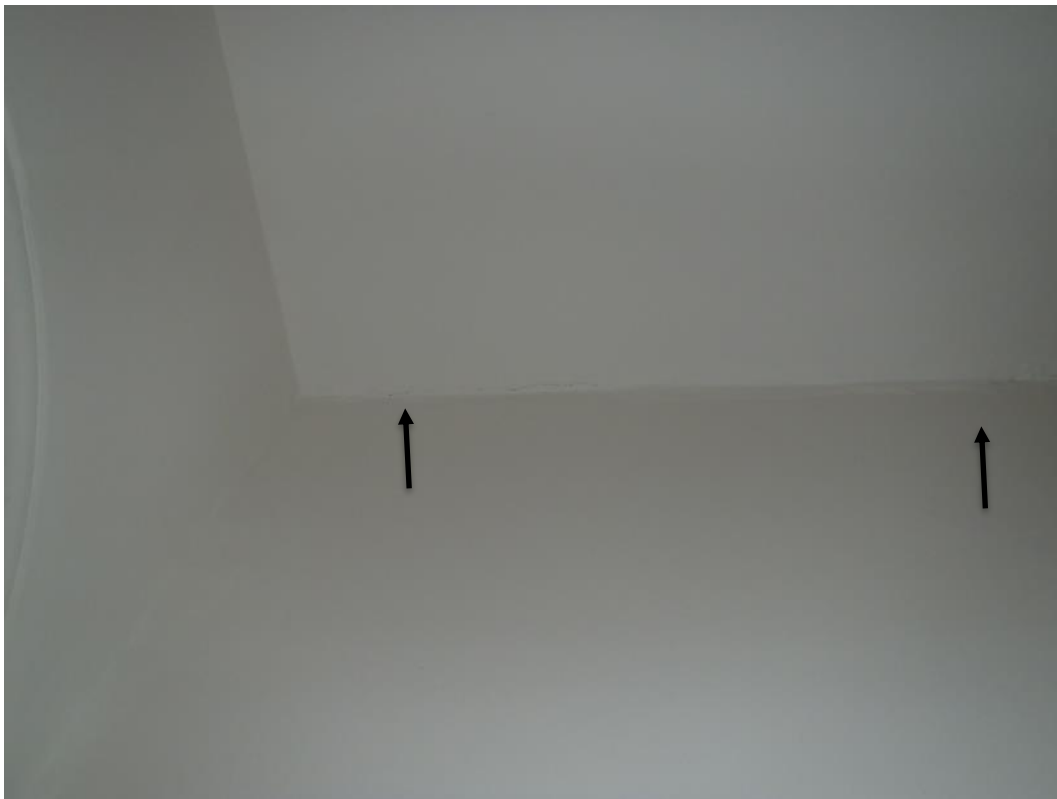
We noted separation cracking [<1mm] to the square set junction between the plaster ceiling and the wall outside Bedroom 2 on the *common party / separation* wall with the adjoining residence, No. 72 Simpson Street, Bondi Beach. **[Photograph 23]**

Photograph 23 shows separation cracking the square set junction between the plaster ceiling and the wall outside Bedroom 2 on the *common party / separation* wall with the adjoining residence 72 Simpson Street, Bondi Beach

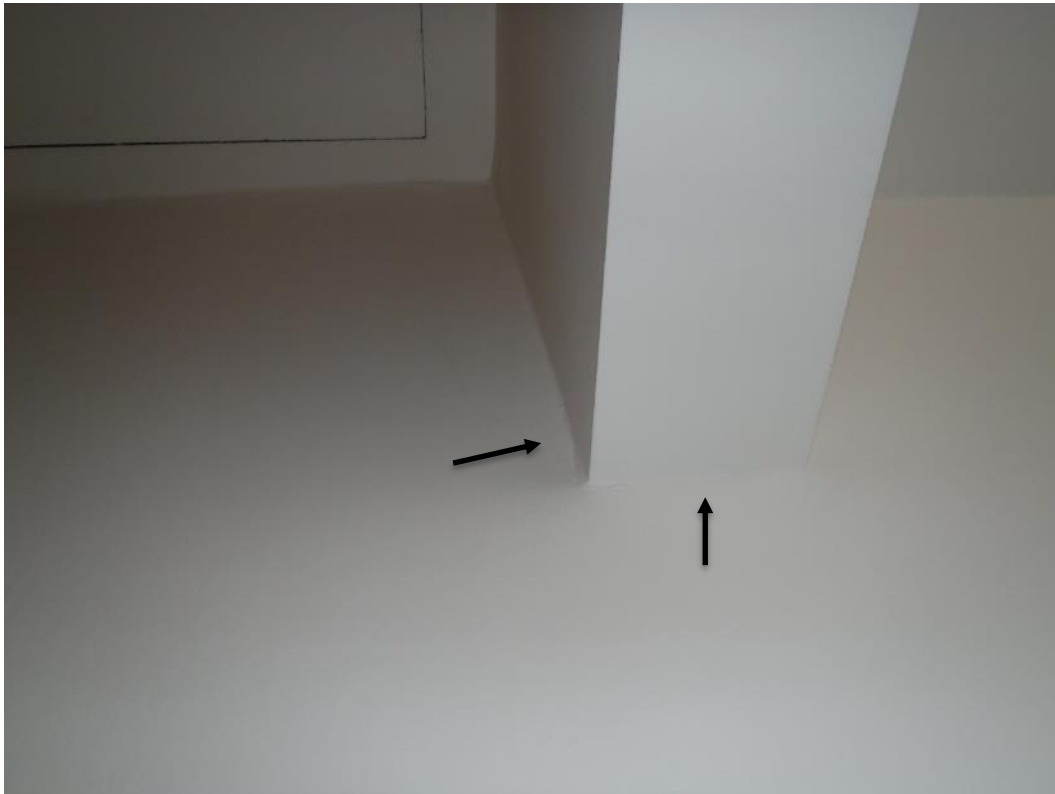
We noted separation cracking [<1mm] to the square set junction around the bulkhead on the *common party / separation* wall with the adjoining residence, No. 72 Simpson Street, Bondi Beach. **[Photograph 24]**

Photograph 24 shows separation cracking to the square set junction around the bulkhead on the *common party / separation* wall with the adjoining residence, No. 72 Simpson Street, Bondi Beach.

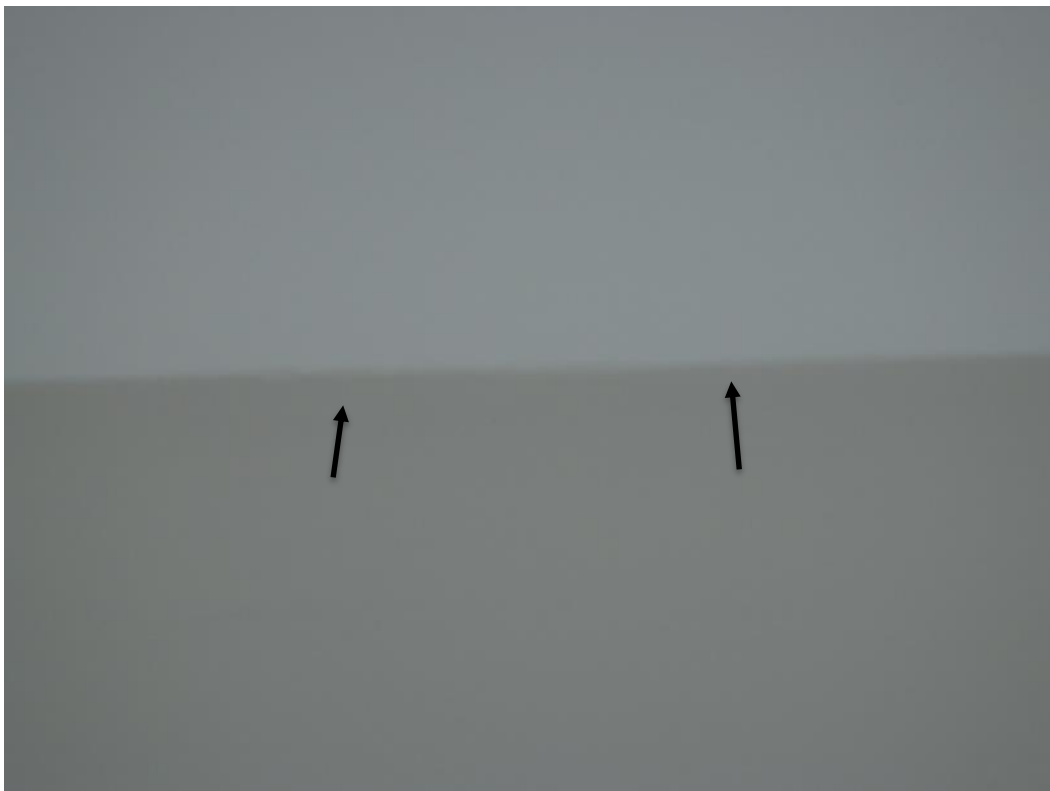
We noted hairline separation cracking to the square set wall / ceiling junction above the cupboard. **[Photograph 25]**

Photograph 25 shows hairline separation cracking to the square set wall / ceiling junction above the cupboard in the front Bedroom 1.

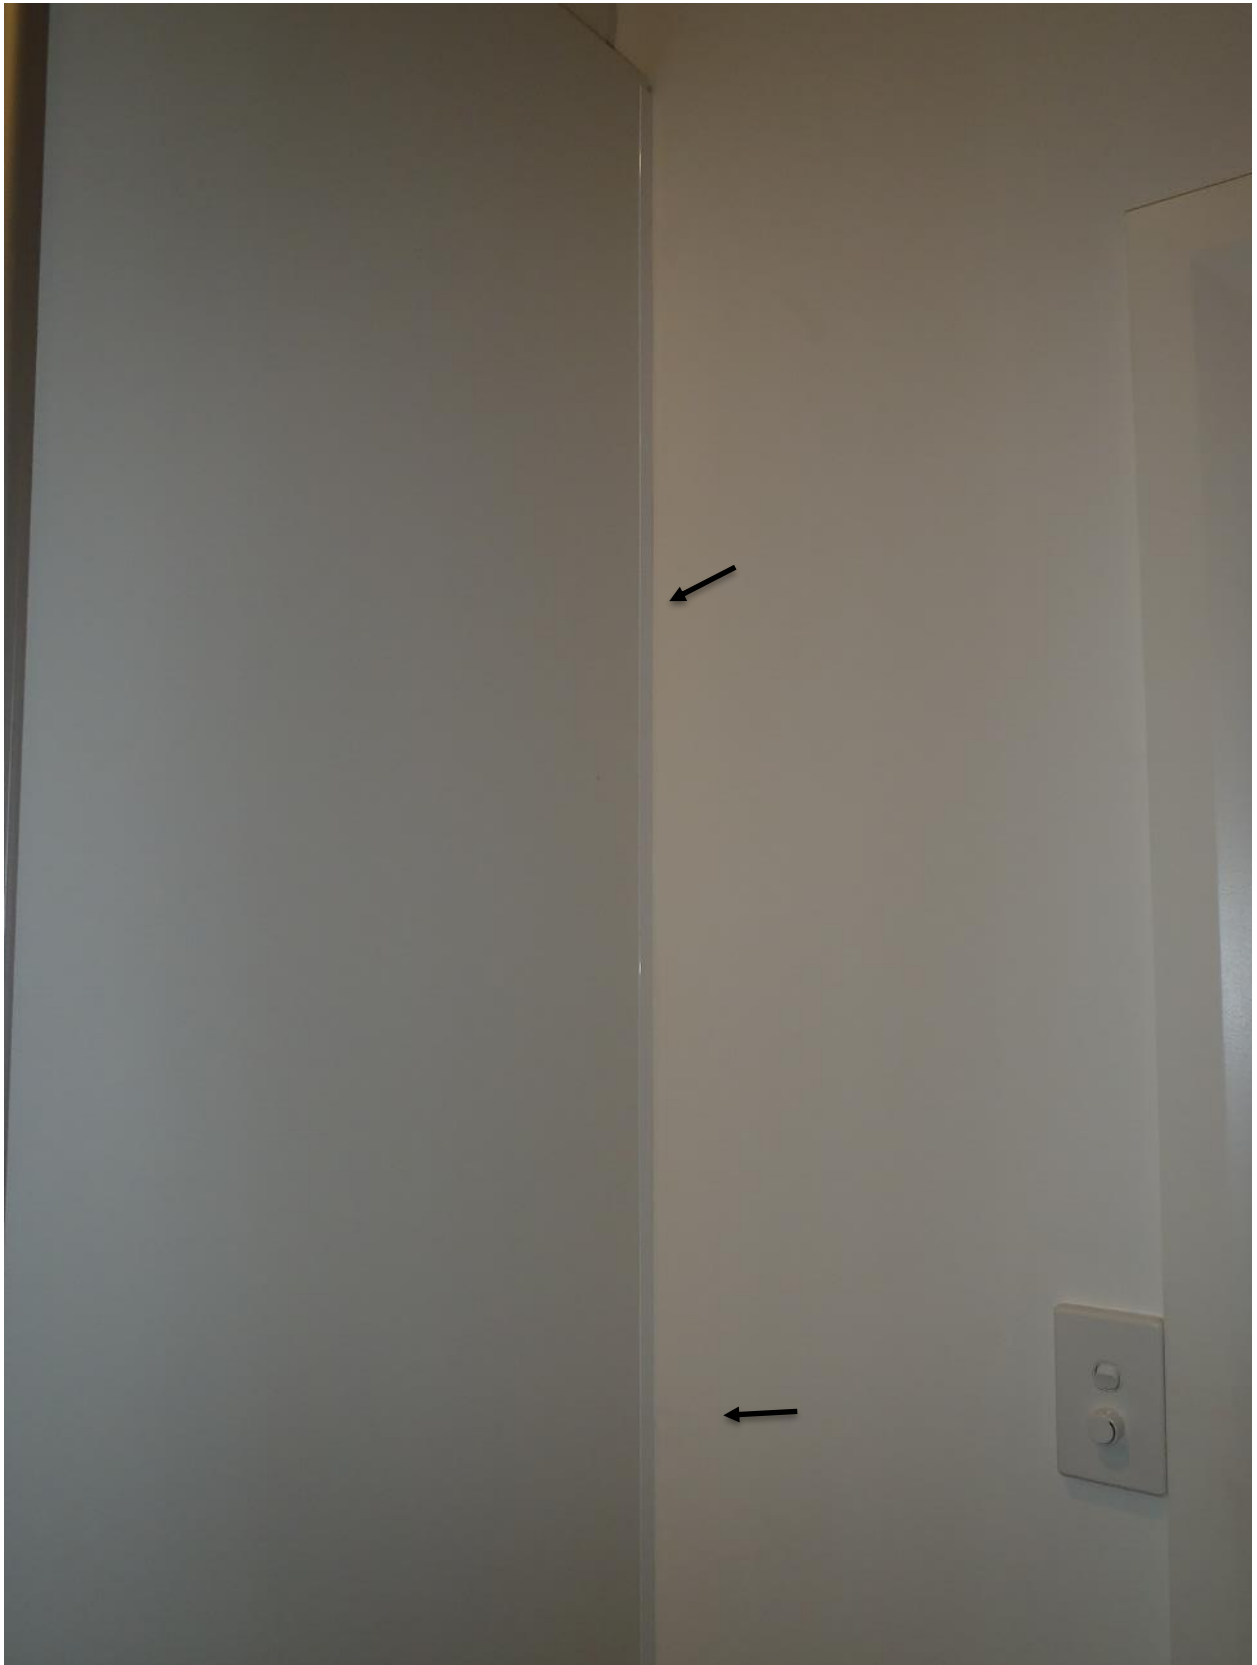
We noted evidence of previous repairs to the painted cement rendered wall adjacent to the cupboard. **[Photograph 26]**

Photograph 26 shows evidence of previous repairs to the painted cement rendered wall adjacent to the cupboard in the front Bedroom 1.

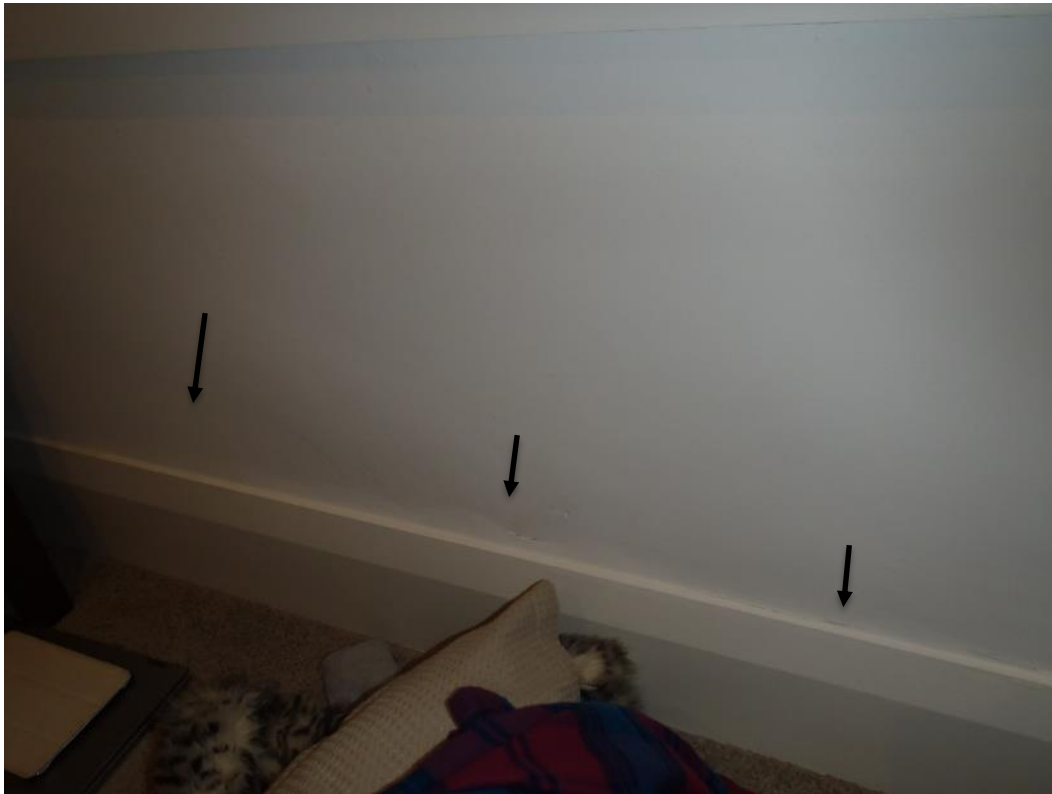
We noted evidence of previous repairs to the cement rendered wall under the window and separation cracking [$<1\text{mm}$] to the wall / skirting junction. **[Photograph 27]**

Photograph 27 shows evidence of previous repairs to the cement rendered wall under the window and separation cracking to the wall / skirting junction in Bedroom 2.

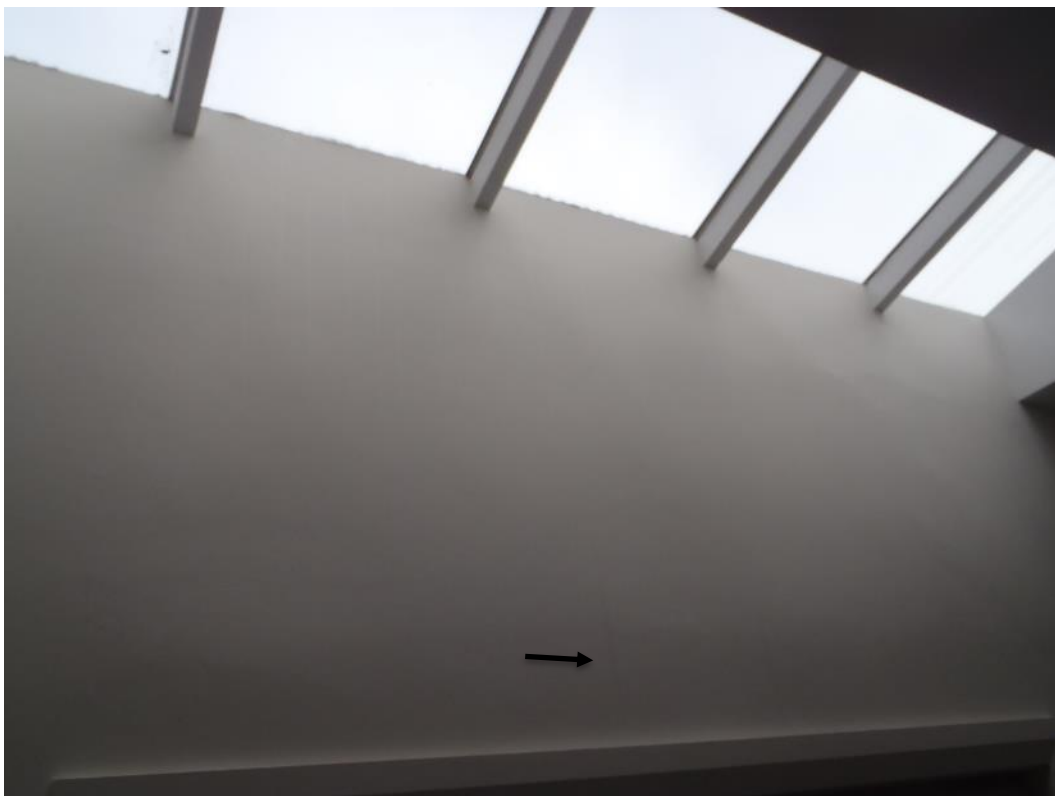
We noted that the south-eastern ceiling is built into a skylight. We further noted evidence of water leakage down the cement rendered wall. **[Photograph 28]**

Photograph 28 shows evidence of water leakage down the cement rendered wall from the skylight in the Lounge Room.

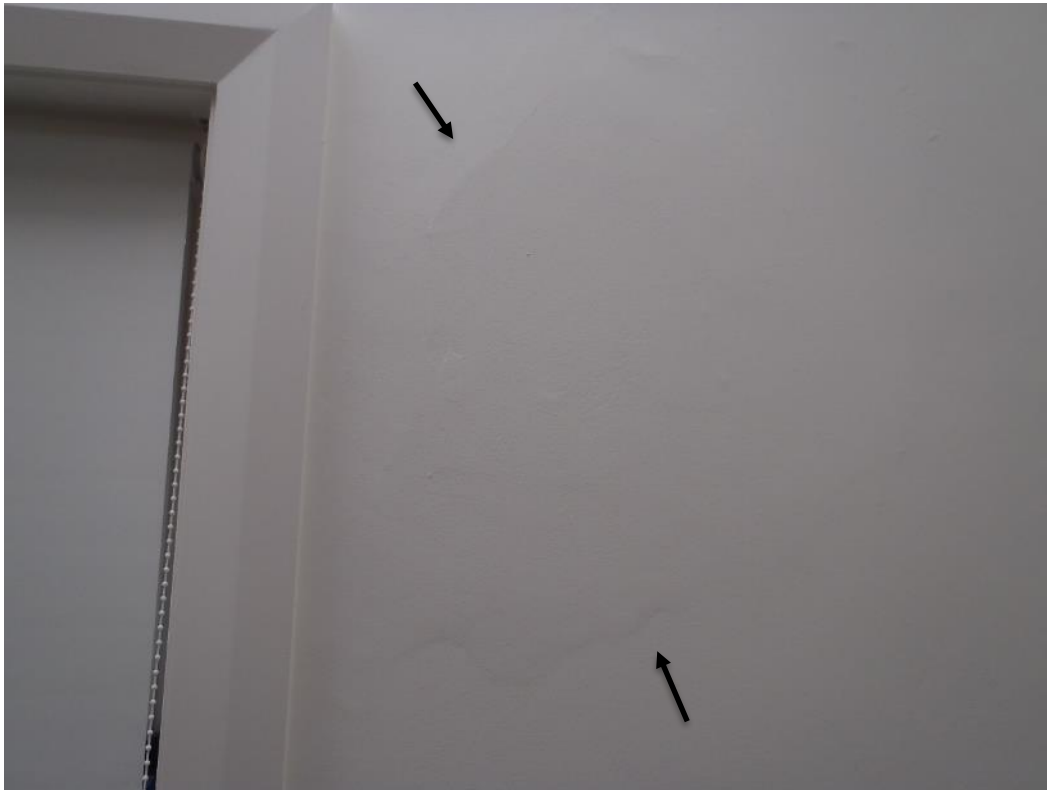
We noted evidence of a previous repair of the rendered wall adjacent to the window. **[Photograph 29]**

Photograph 29 shows evidence of a previous repair of the rendered wall adjacent to the window in the Lounge Room.

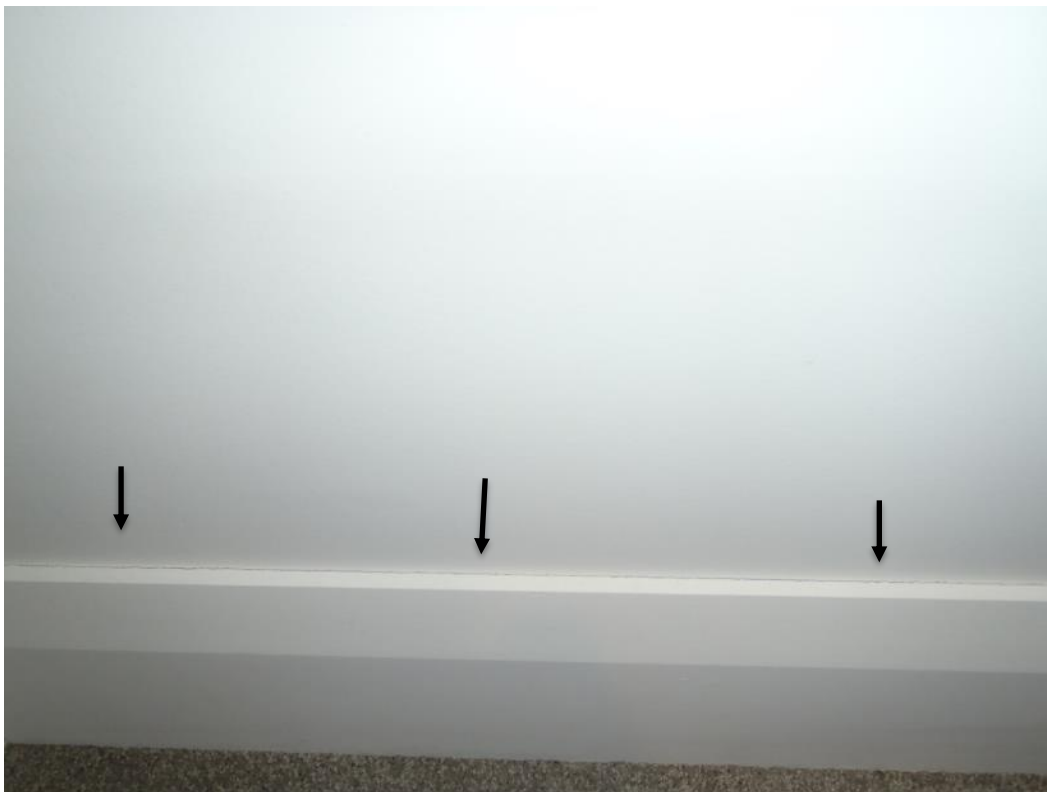
We noted hairline separation cracking [$<1\text{mm}$] to the wall / skirting junction along the *common party / separation* wall with the adjoining residence, No. 72 Simpson Street, Bondi Beach. **[Photograph 30]**

Photograph 30 shows hairline separation cracking to the wall / skirting junction along the common party / separation wall with the adjoining residence, No. 72 Simpson Street, Bondi Beach.

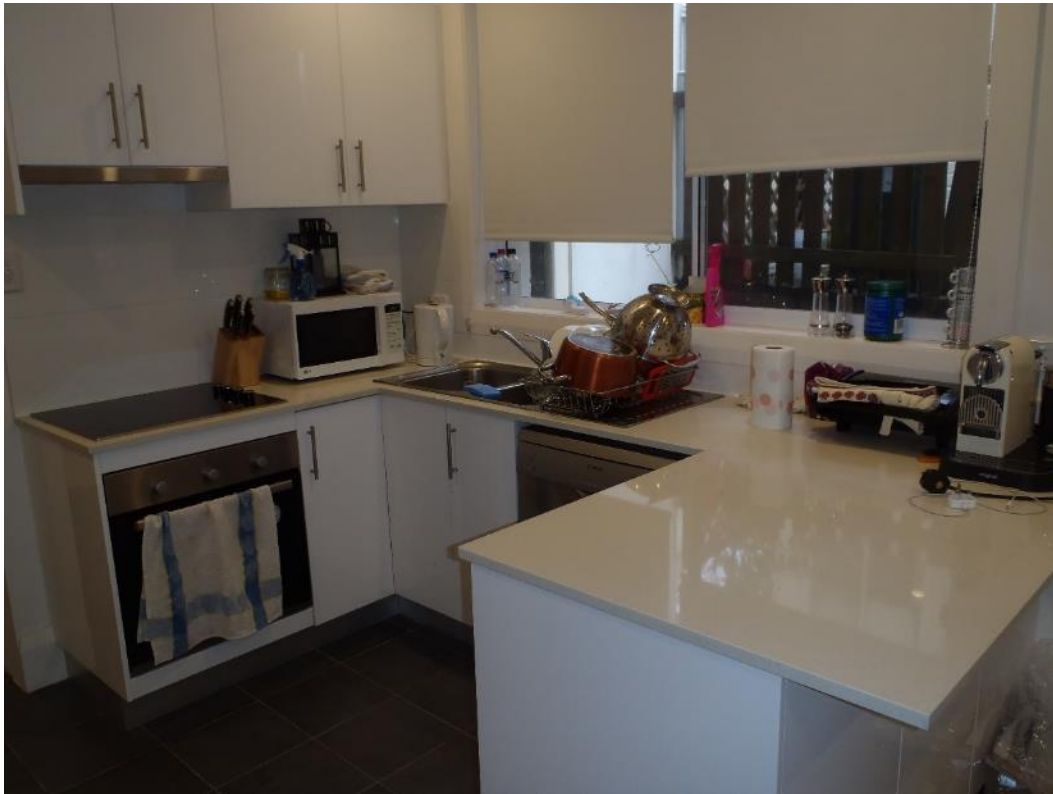
We noted that the grout to the wall and floor tiles is complete and that the wall and floor tiles when randomly “tap” tested appeared to be sound. We did not observe any recent cracking to the tile grout at the wall / wall, wall / floor junctions. **[Photograph 31]**

Photograph 31 shows the general condition of the Kitchen.

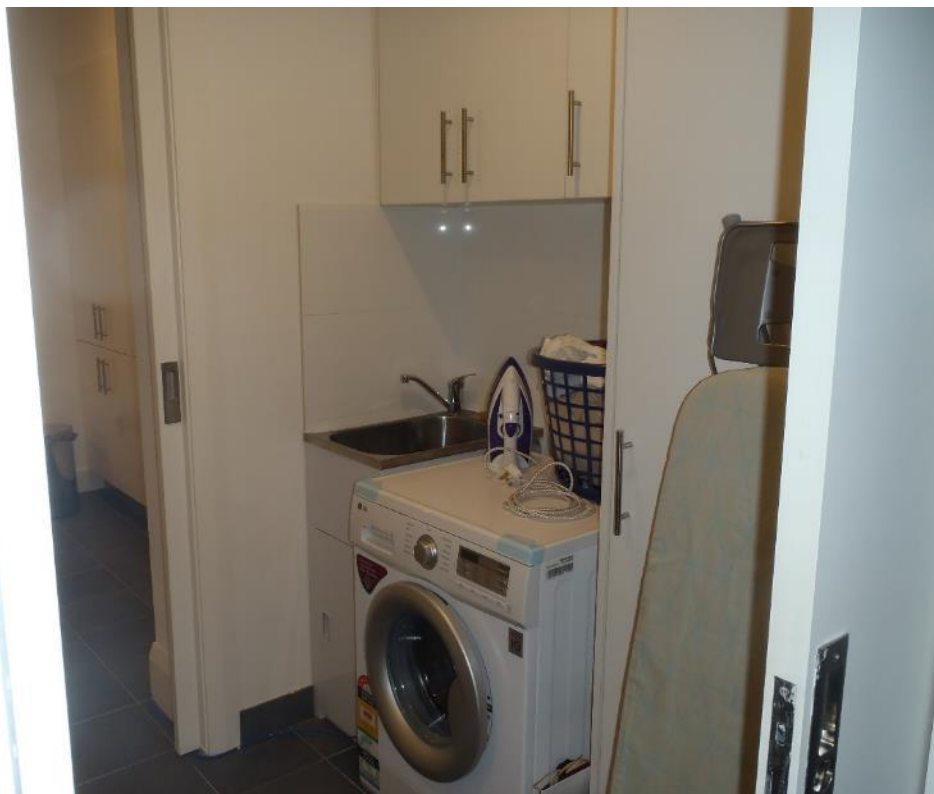
We did not observe any recent cracking to the tiled surfaces and that the wall and floor tiles when randomly “tap” tested appeared to be sound. **[Photograph 32]**

Photograph 32 shows the general condition of the Laundry.

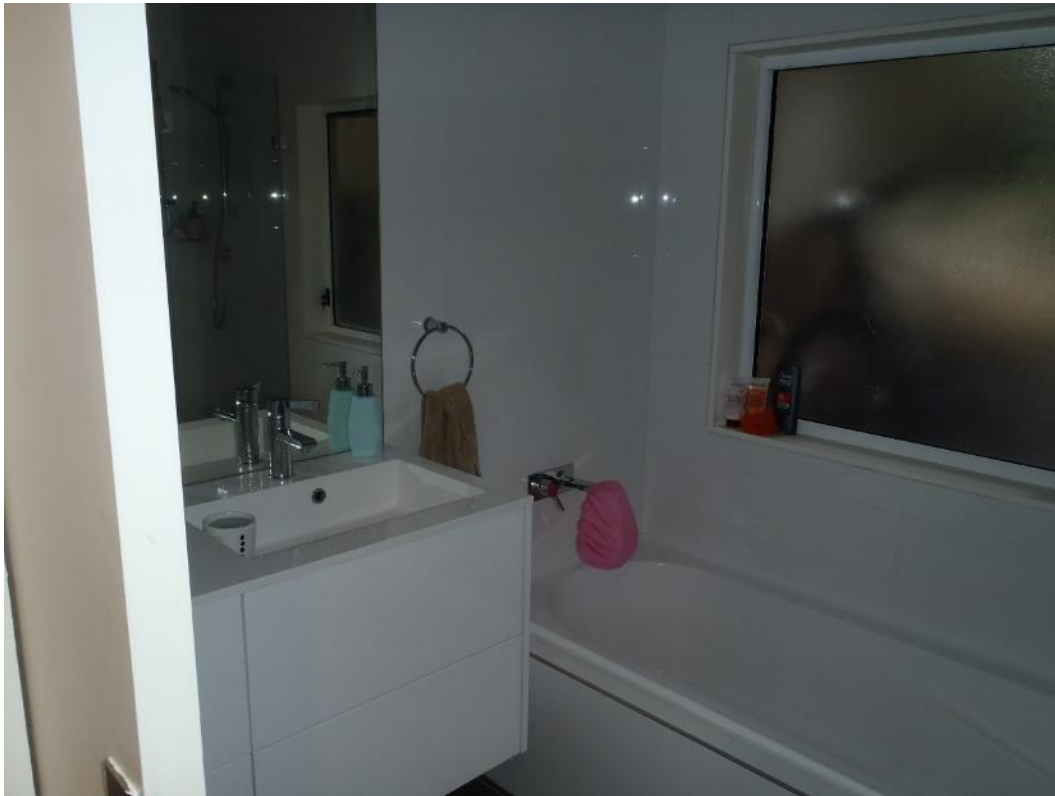
We did not observe any recent cracking to the tiled surfaces and that the wall and floor tiles when randomly “tap” tested appeared to be sound. **[Photograph 33]**

Photograph 33 shows the general condition of the Bathroom.

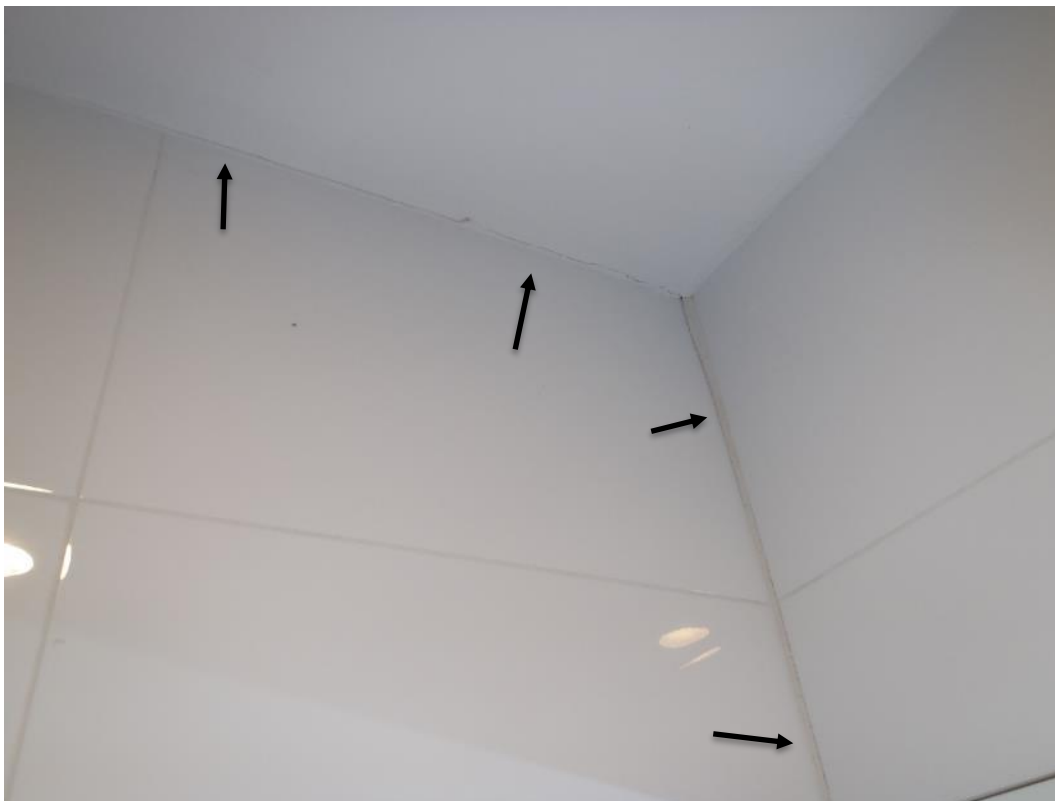
We noted vertical cracking [$<1\text{mm}$] to the tile grout and separation cracking [$<1\text{mm}$] to the square set wall / ceiling junction in the western corner. **[Photograph 34]**

Photograph 34 shows vertical cracking to the tile grout and separation cracking to the square set wall / ceiling junction in the western corner in the Bathroom.

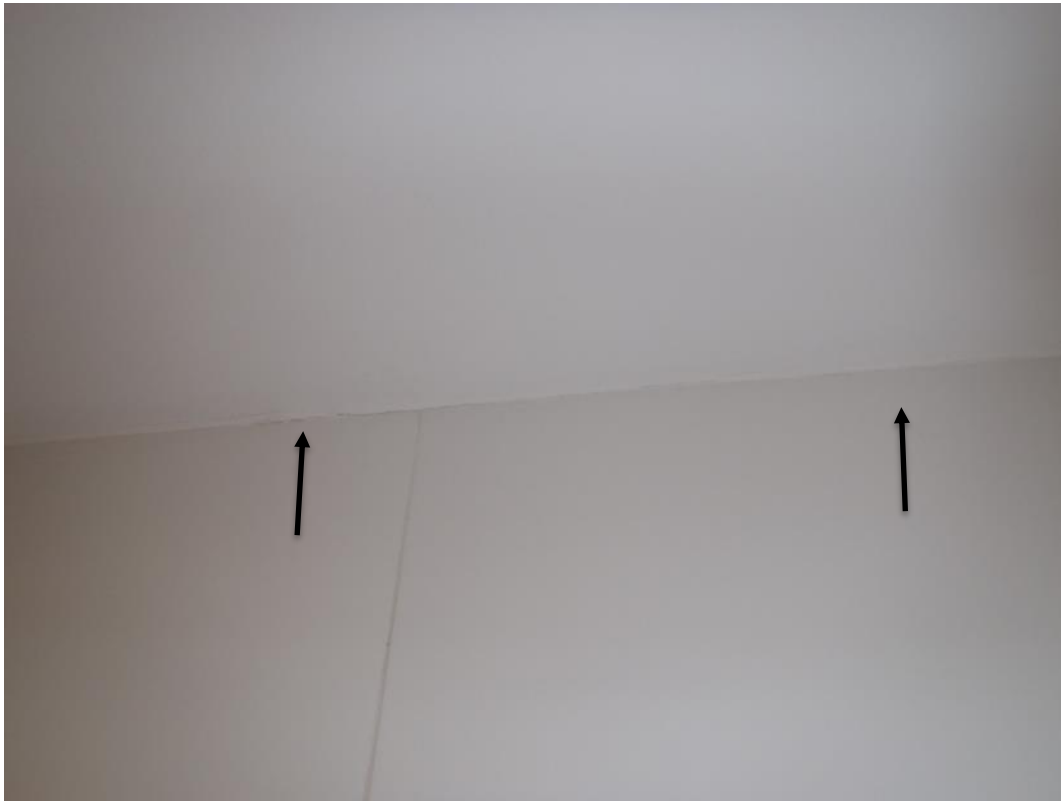
We noted separation cracking [$<1\text{mm}$] to the square set wall / ceiling junction along the south-western wall. **[Photograph 35]**

Photograph 35 shows separation cracking to the square set wall / ceiling junction along the south-western wall in the Bathroom.

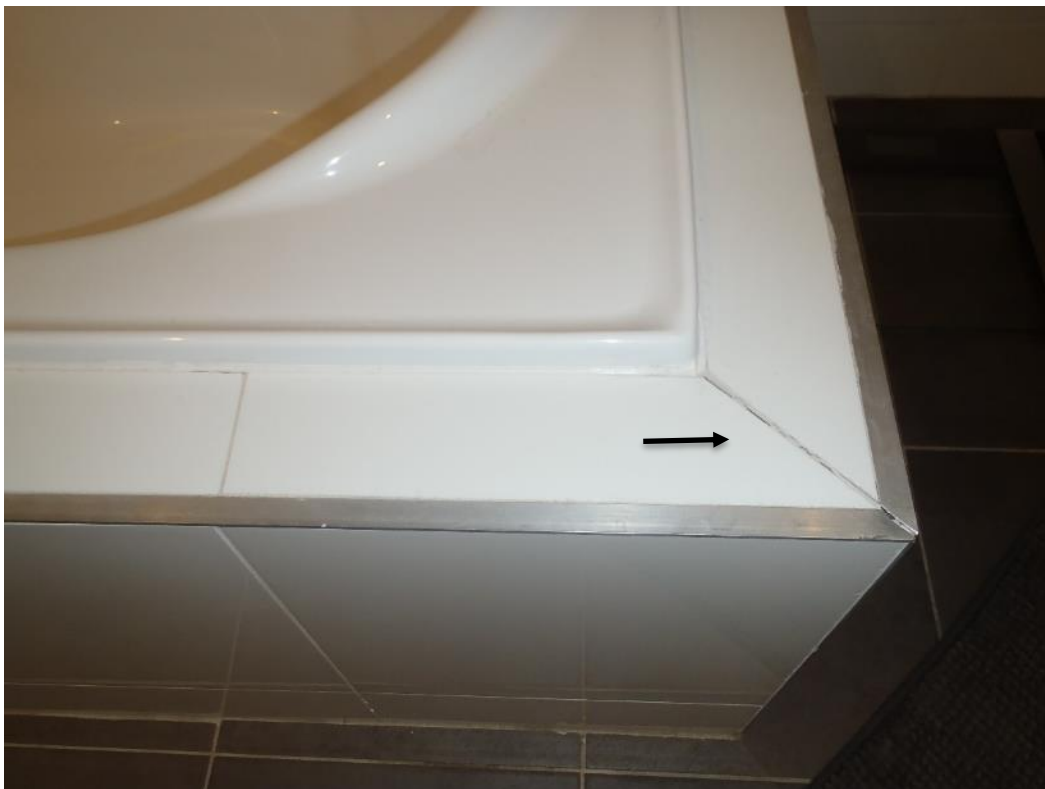
We noted separation cracking [$<1\text{mm}$] to the grout on the southern corner of the bath. **[Photograph 36]**

Photograph 36 shows separation cracking to the grout on the southern corner of the bath.

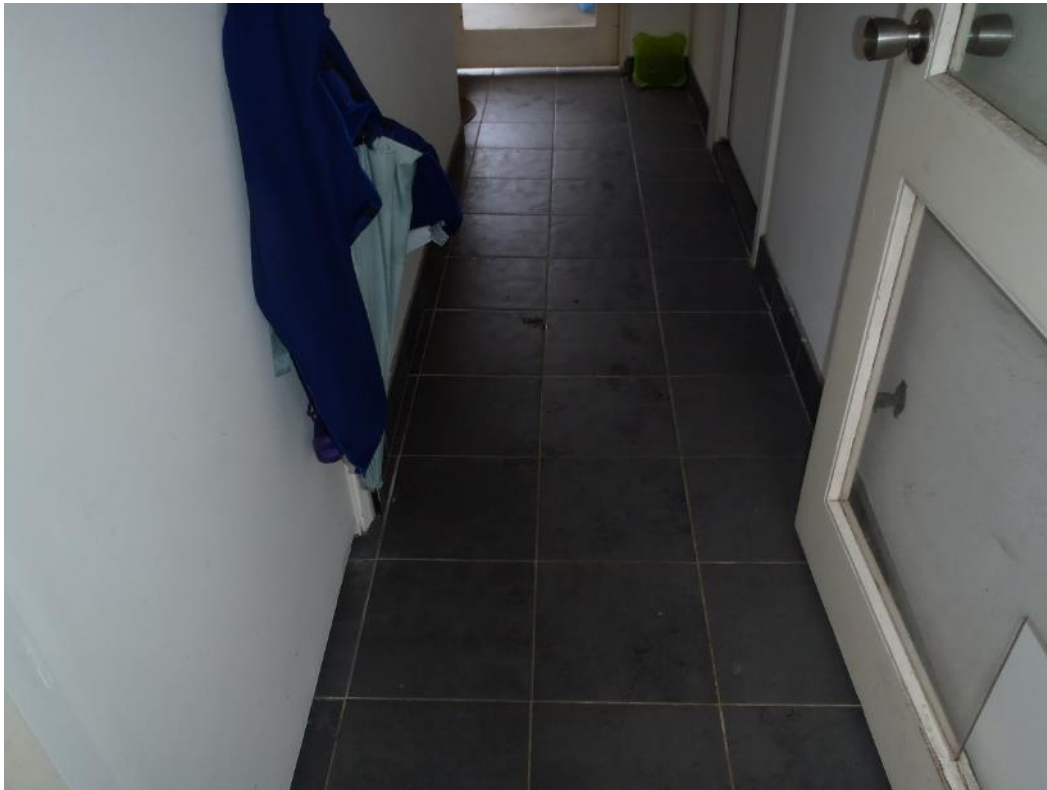
We noted that the floor is finished with ceramic tiles and that the wall and floor tiles when randomly “tap” tested appeared to be sound. **[Photograph 37]**

Photograph 37 shows the general condition of the side entry to the upstairs stairwell.

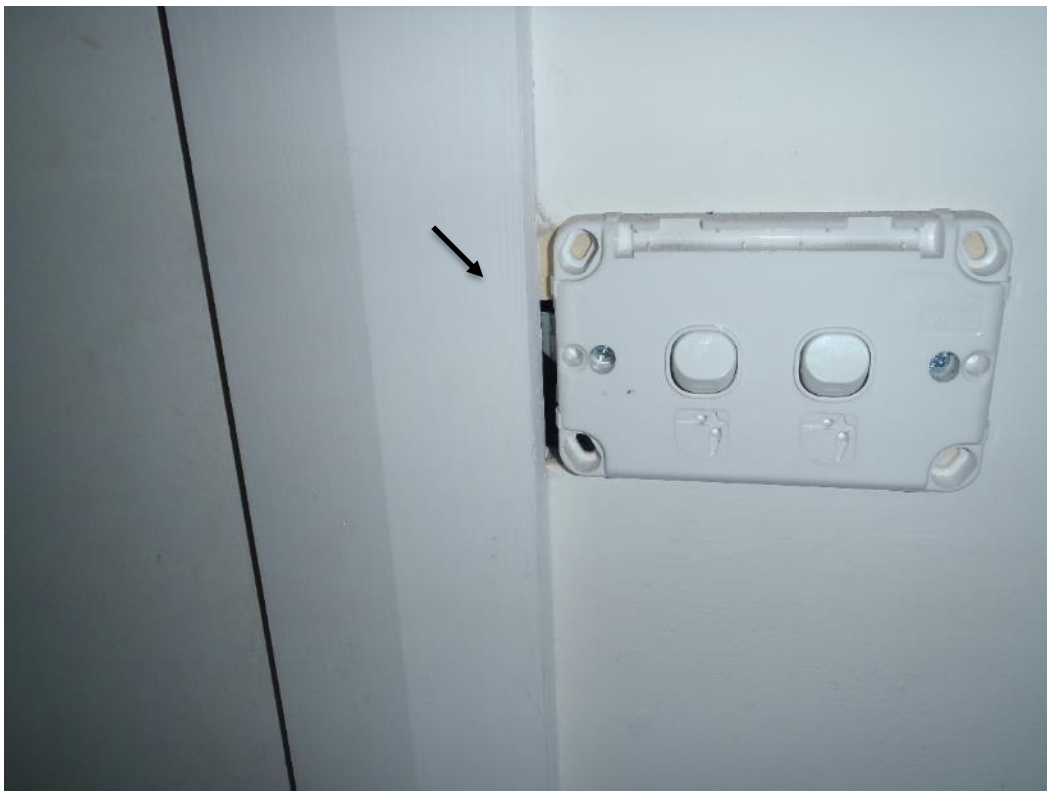
We noted a gap beside the Light switch adjacent to the under-stair cupboard door. **[Photograph 38]**

Photograph 38 shows a gap beside the Light switch adjacent to the under stair cupboard door.

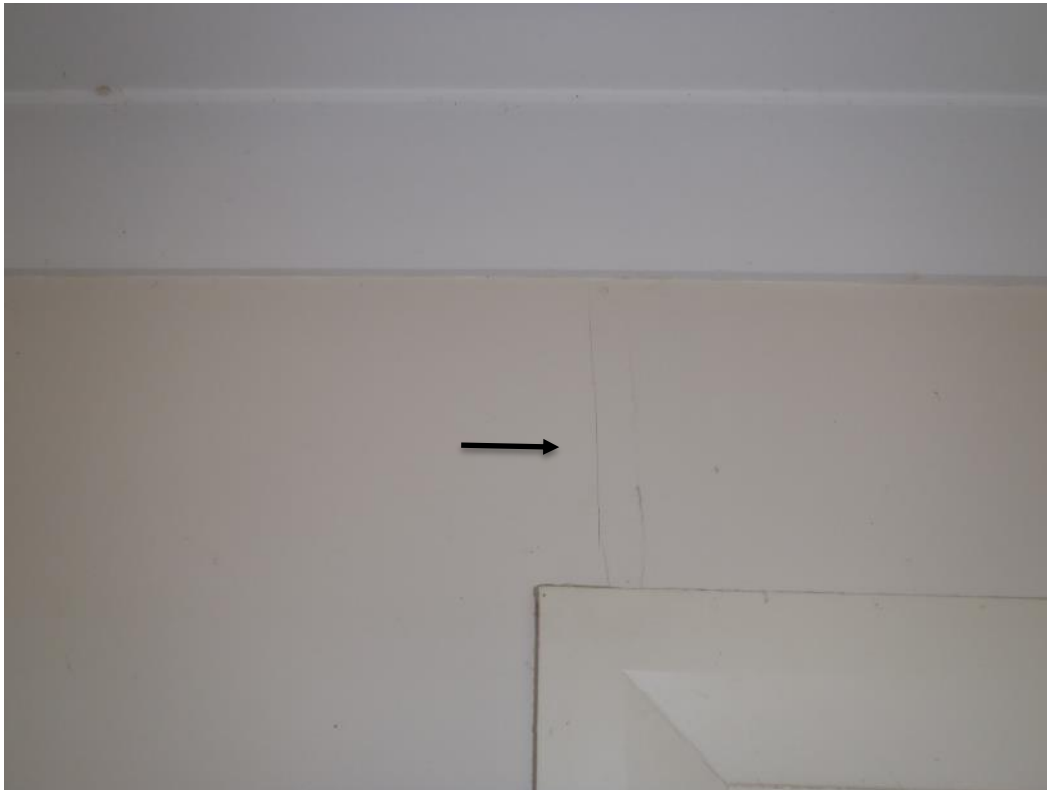
We noted hairline vertical cracking [$<1\text{mm}$] above the balcony door head. **[Photograph 39]**

Photograph 39 shows hairline vertical cracking above the balcony door head in the upstairs Bedroom.

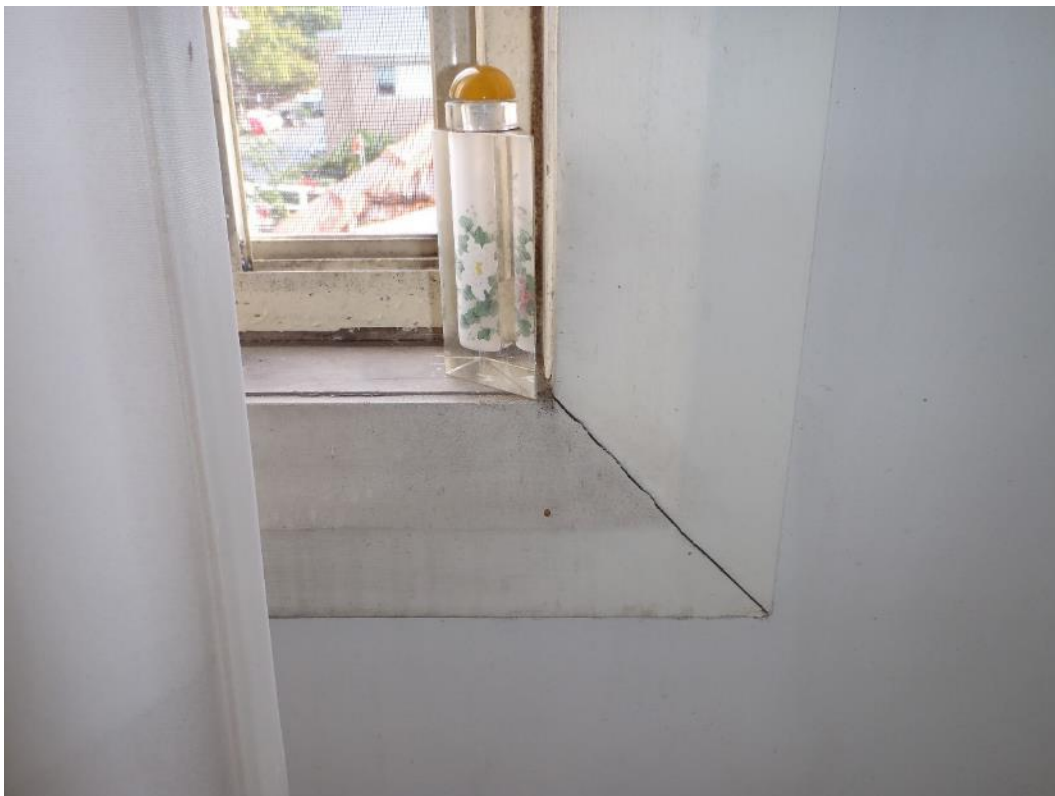
We noted separation cracking [$<1\text{mm}$] to the architrave mitre joint to the bottom of the window. **[Photograph 40]**

Photograph 40 shows separation cracking to the architrave mitre joint to the bottom of the window in the upstairs Bedroom.

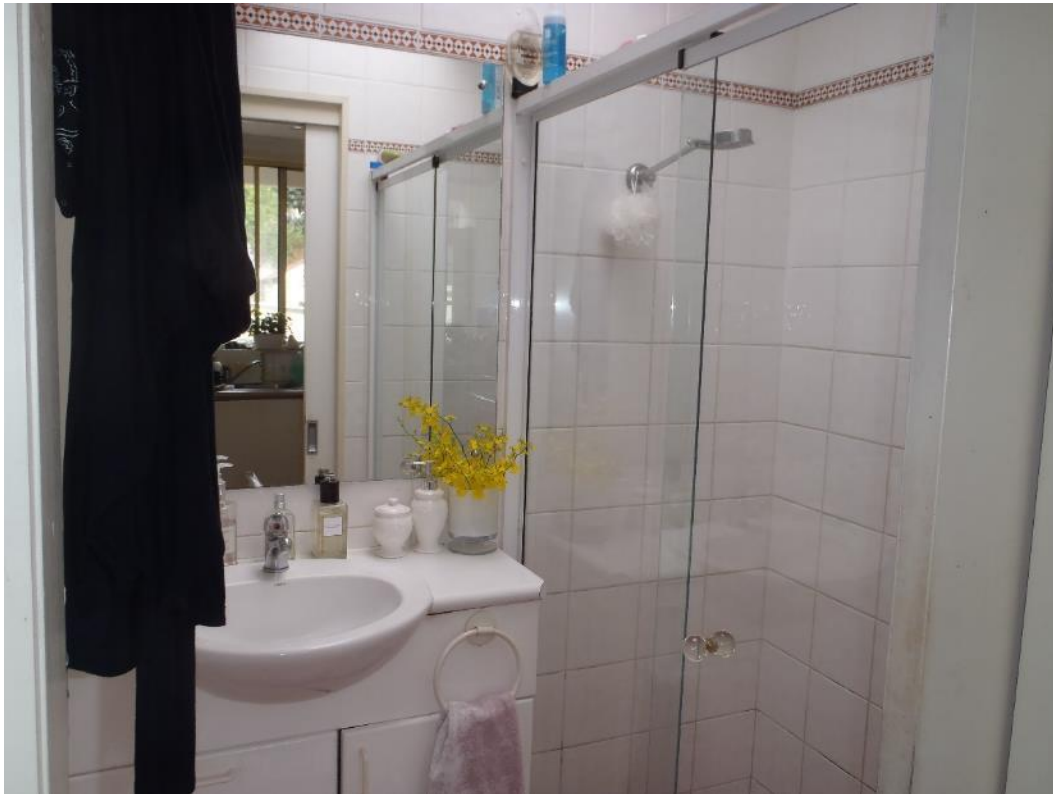
We did not observe any recent cracking to the tiled surfaces and that the wall and floor tiles when randomly “tap” tested appeared to be sound. **[Photograph 41]**

Photograph 41 shows the general condition of the upstairs Bathroom.

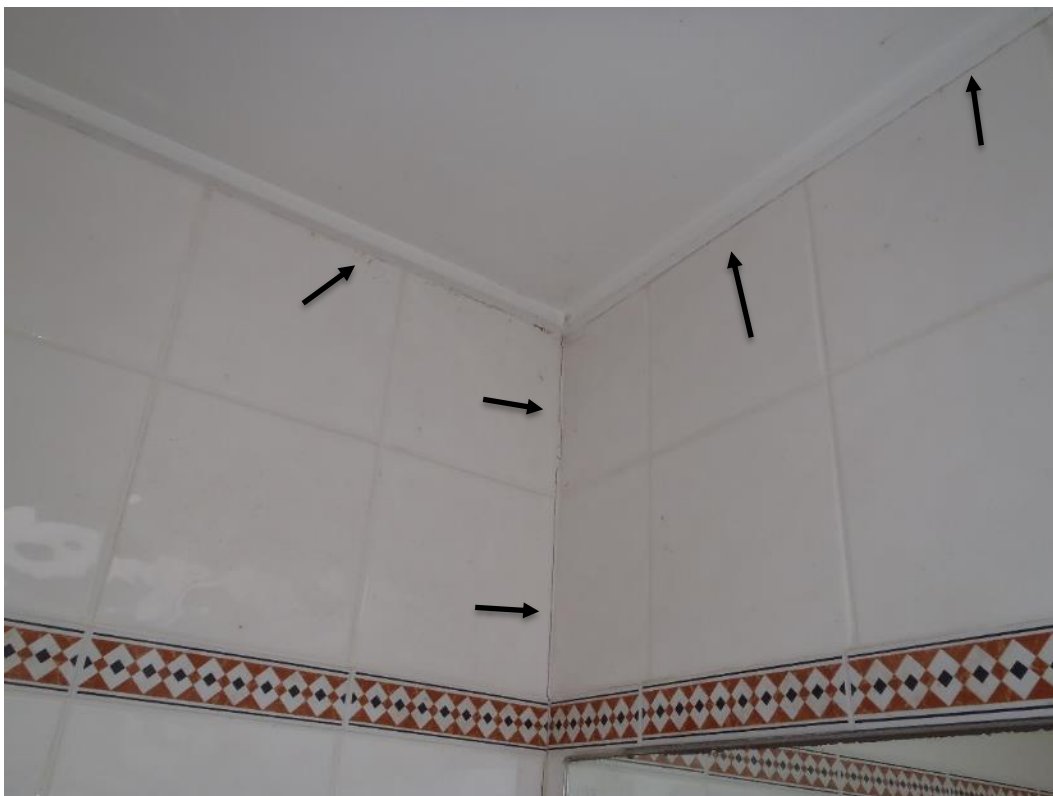
We noted vertical cracking [$<1\text{mm}$] to the tile grout and separation cracking [$<1\text{mm}$] between the timber mould cornice and the tiled wall surface in the western corner. **[Photograph 42]**

Photograph 42 shows vertical cracking to the tile grout and separation cracking between the timber mould cornice and the tiled wall surface in the western corner of the upstairs Bathroom.

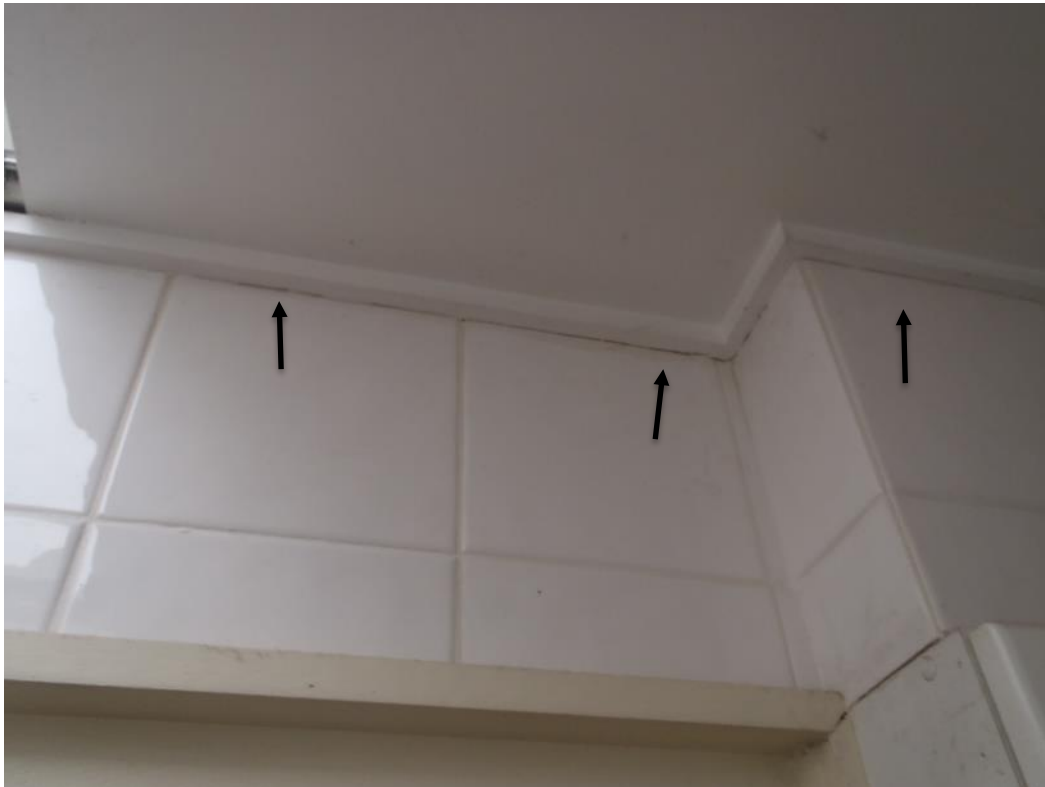
We noted separation cracking [$<1\text{mm}$] between the timber mould cornice and the tiled wall surface above the door opening. **[Photograph 43]**

Photograph 43 shows separation cracking between the timber mould cornice and the tiled wall surface above the door opening of the upstairs Bathroom.

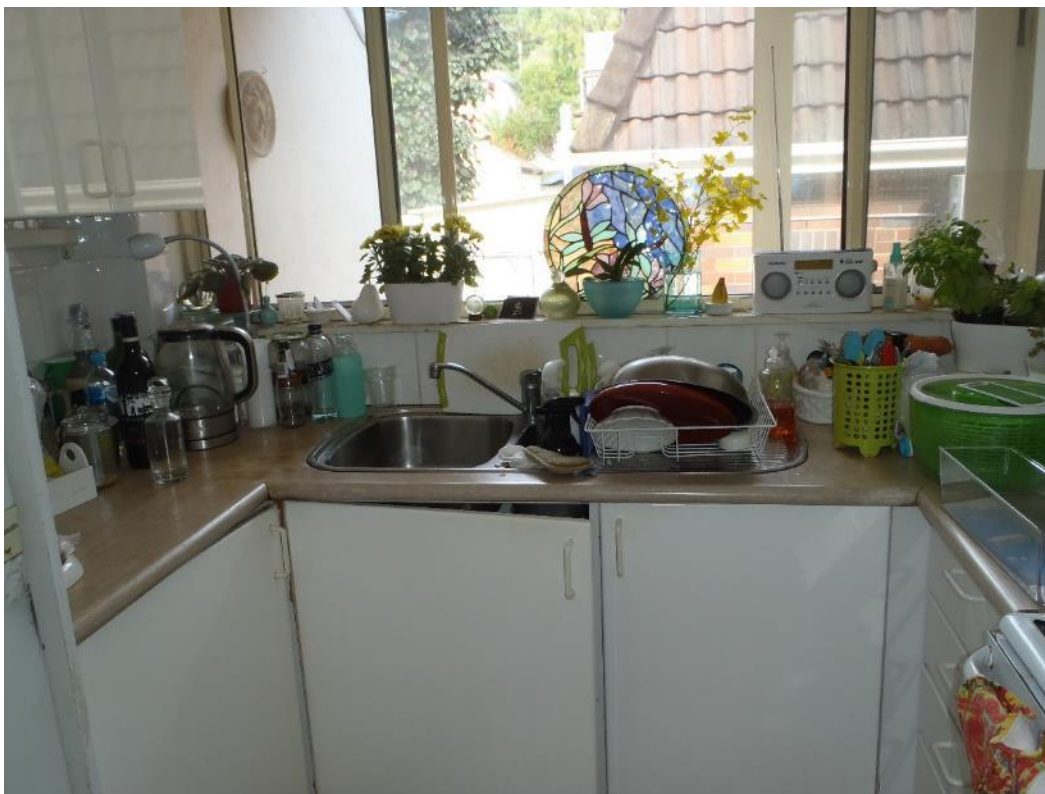
We noted that the grout to the wall tiles is complete and that when randomly “tap” tested appeared to be sound. We did not observe any recent cracking to the tile grout at the wall / wall junctions.

Photograph 44 shows the general condition of the upstairs Kitchen.

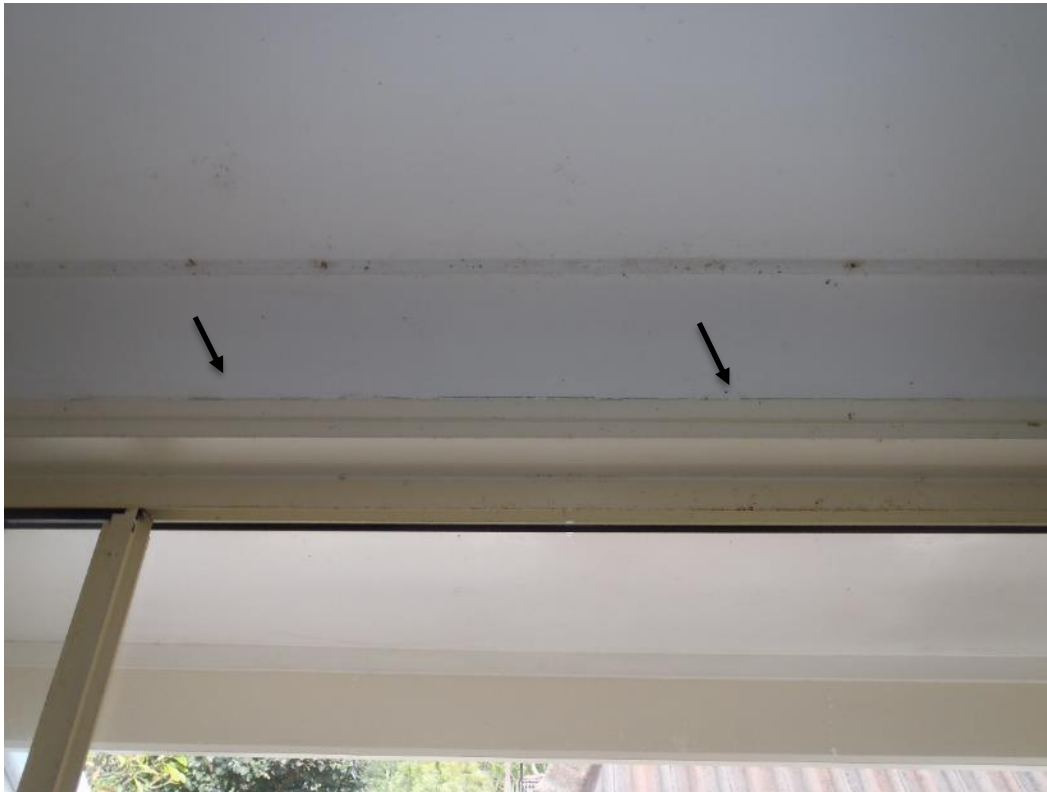
We noted separation cracking [$<1\text{mm}$] between the cove profiled cornice and the window head.

Photograph 45 shows separation cracking between the cove profiled cornice and the window head in the upstairs Kitchen

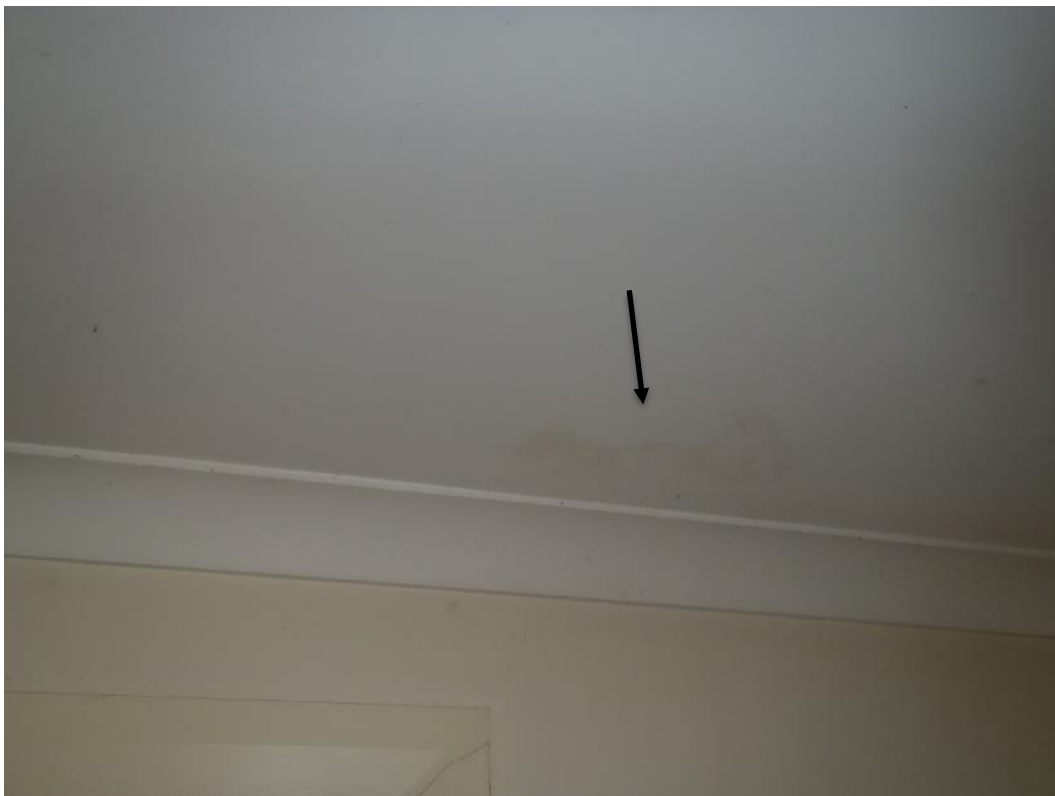
We noted staining to the plaster ceiling lining above the bathroom door opening. **[Photograph 46]**

Photograph 46 shows staining to the plaster ceiling lining above the upstairs bathroom door opening.
