Dilapidation Assessment Report

Prepared for: Cape Cod Australia Pty. Limited
Job address: No.74 Simpson Street, Bondi Beach.
Property Owner/s: Mrs. Wendy Charell.
Report reference: **WAVERLEY COUNCIL**
Development Application No: not available
Date of assessment: 8th June 2017

Re: Dilapidation Report – No. 74 Simpson Street, Bondi Beach.

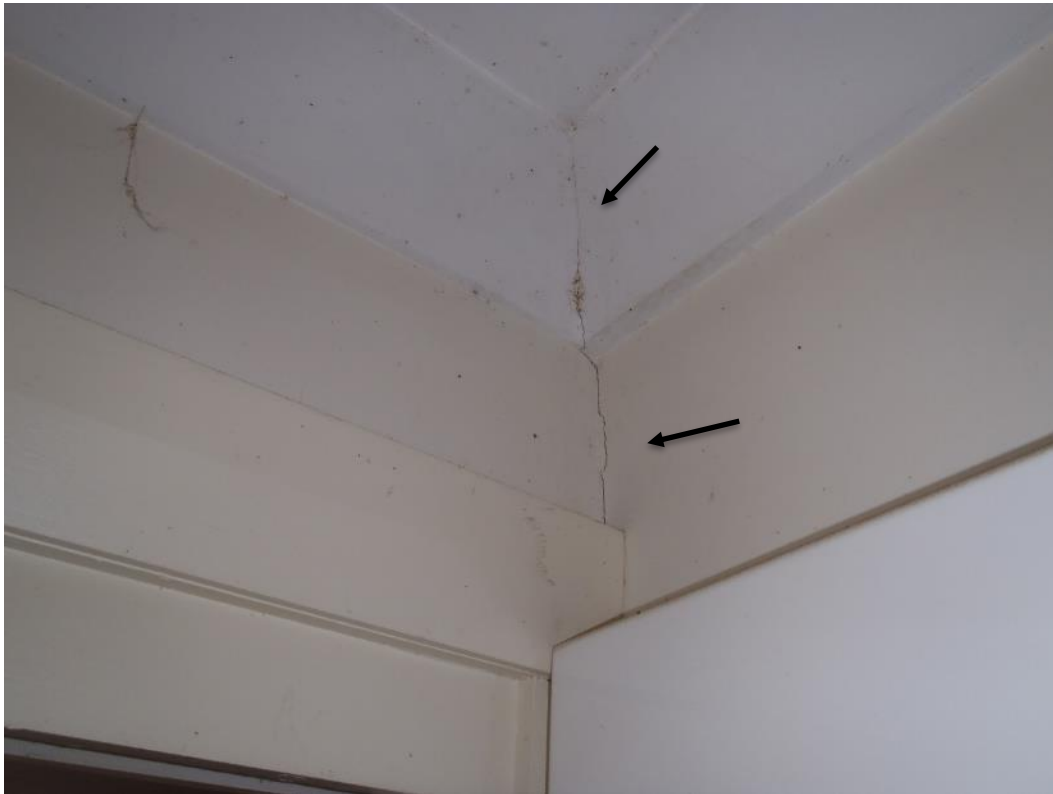
We noted vertical cracking to the wall / wall junction and to the mitre joint in the cove profiled plaster cornice in the northern corner. **[Photograph 47]**

Photograph 47 shows vertical cracking to the wall / wall junction and to the mitre joint in the cove profiled plaster cornice in the northern corner of the upstairs hallway.

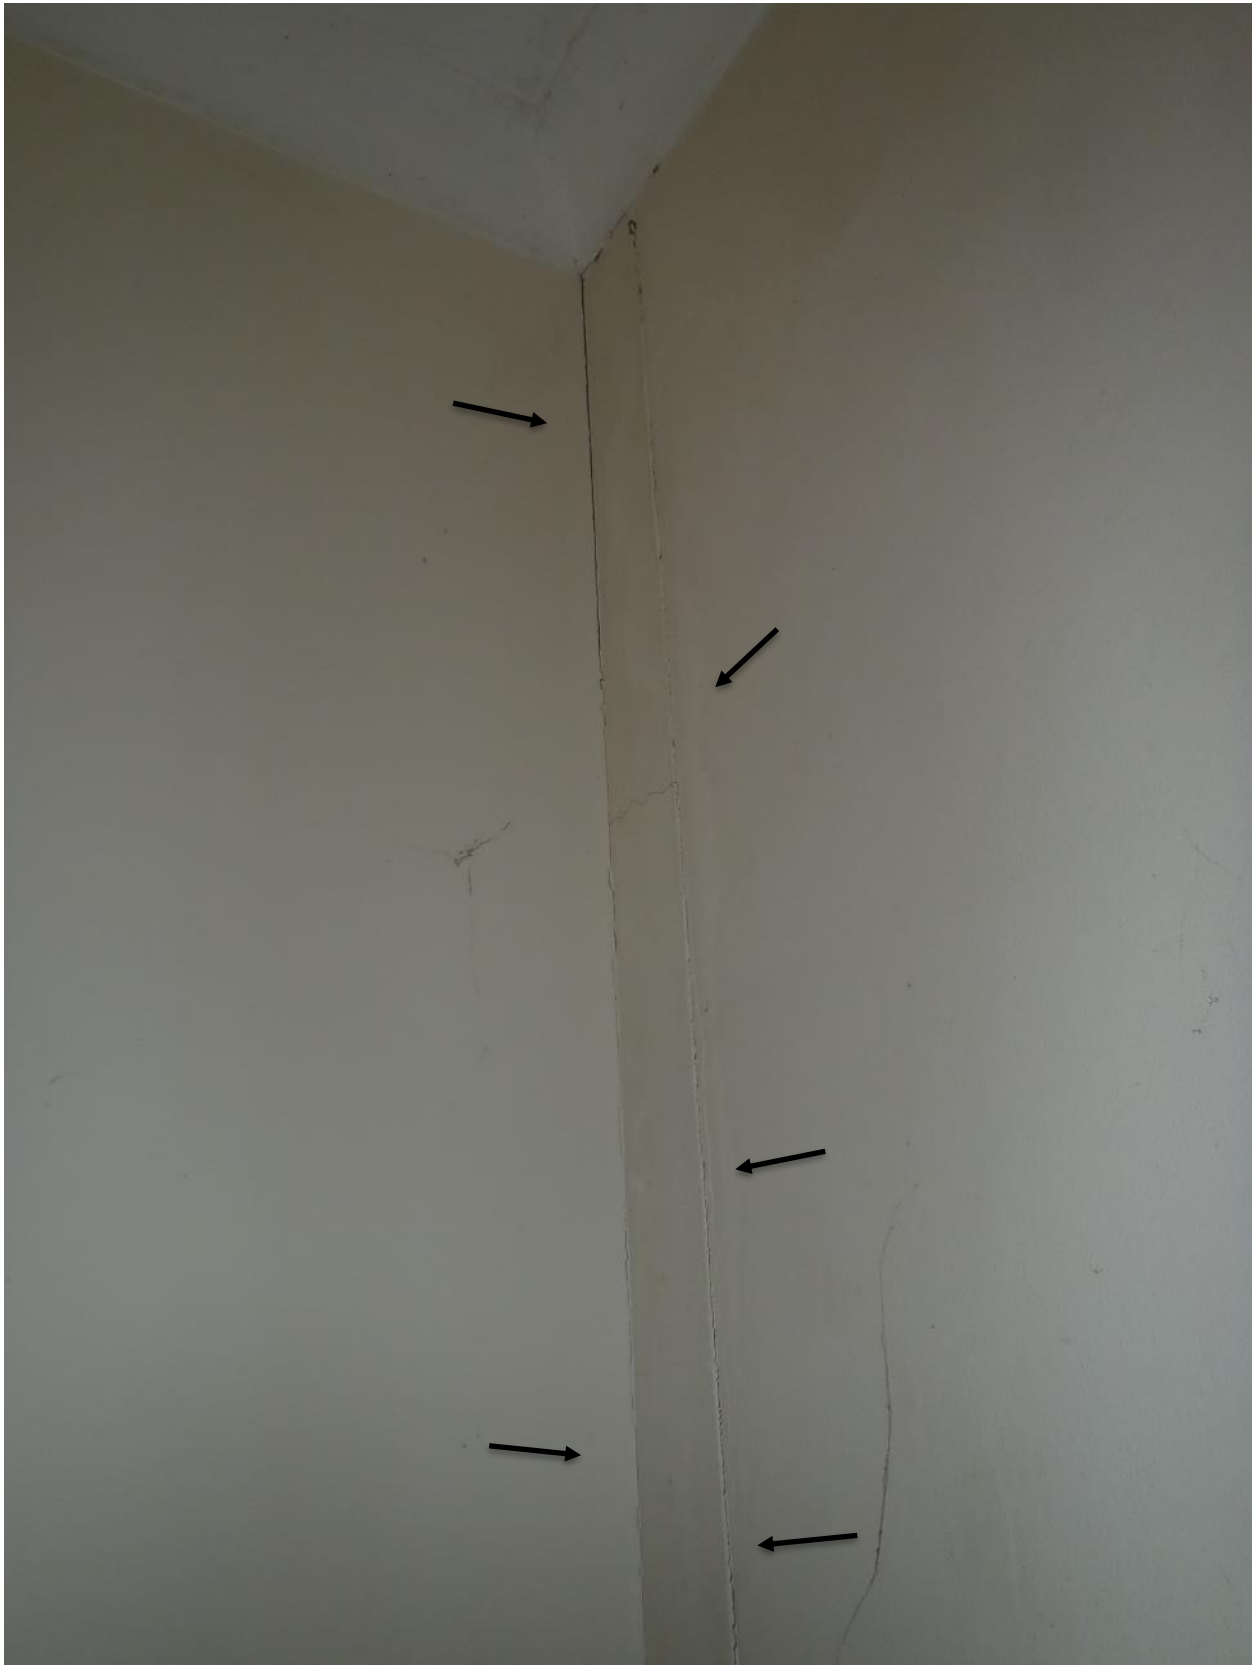
We noted vertical cracking [$<1\text{mm}$] to the cement rendered wall in the western corner.

Photograph 48 shows vertical cracking to the cement rendered wall in the western corner of the upstairs Lounge Room.

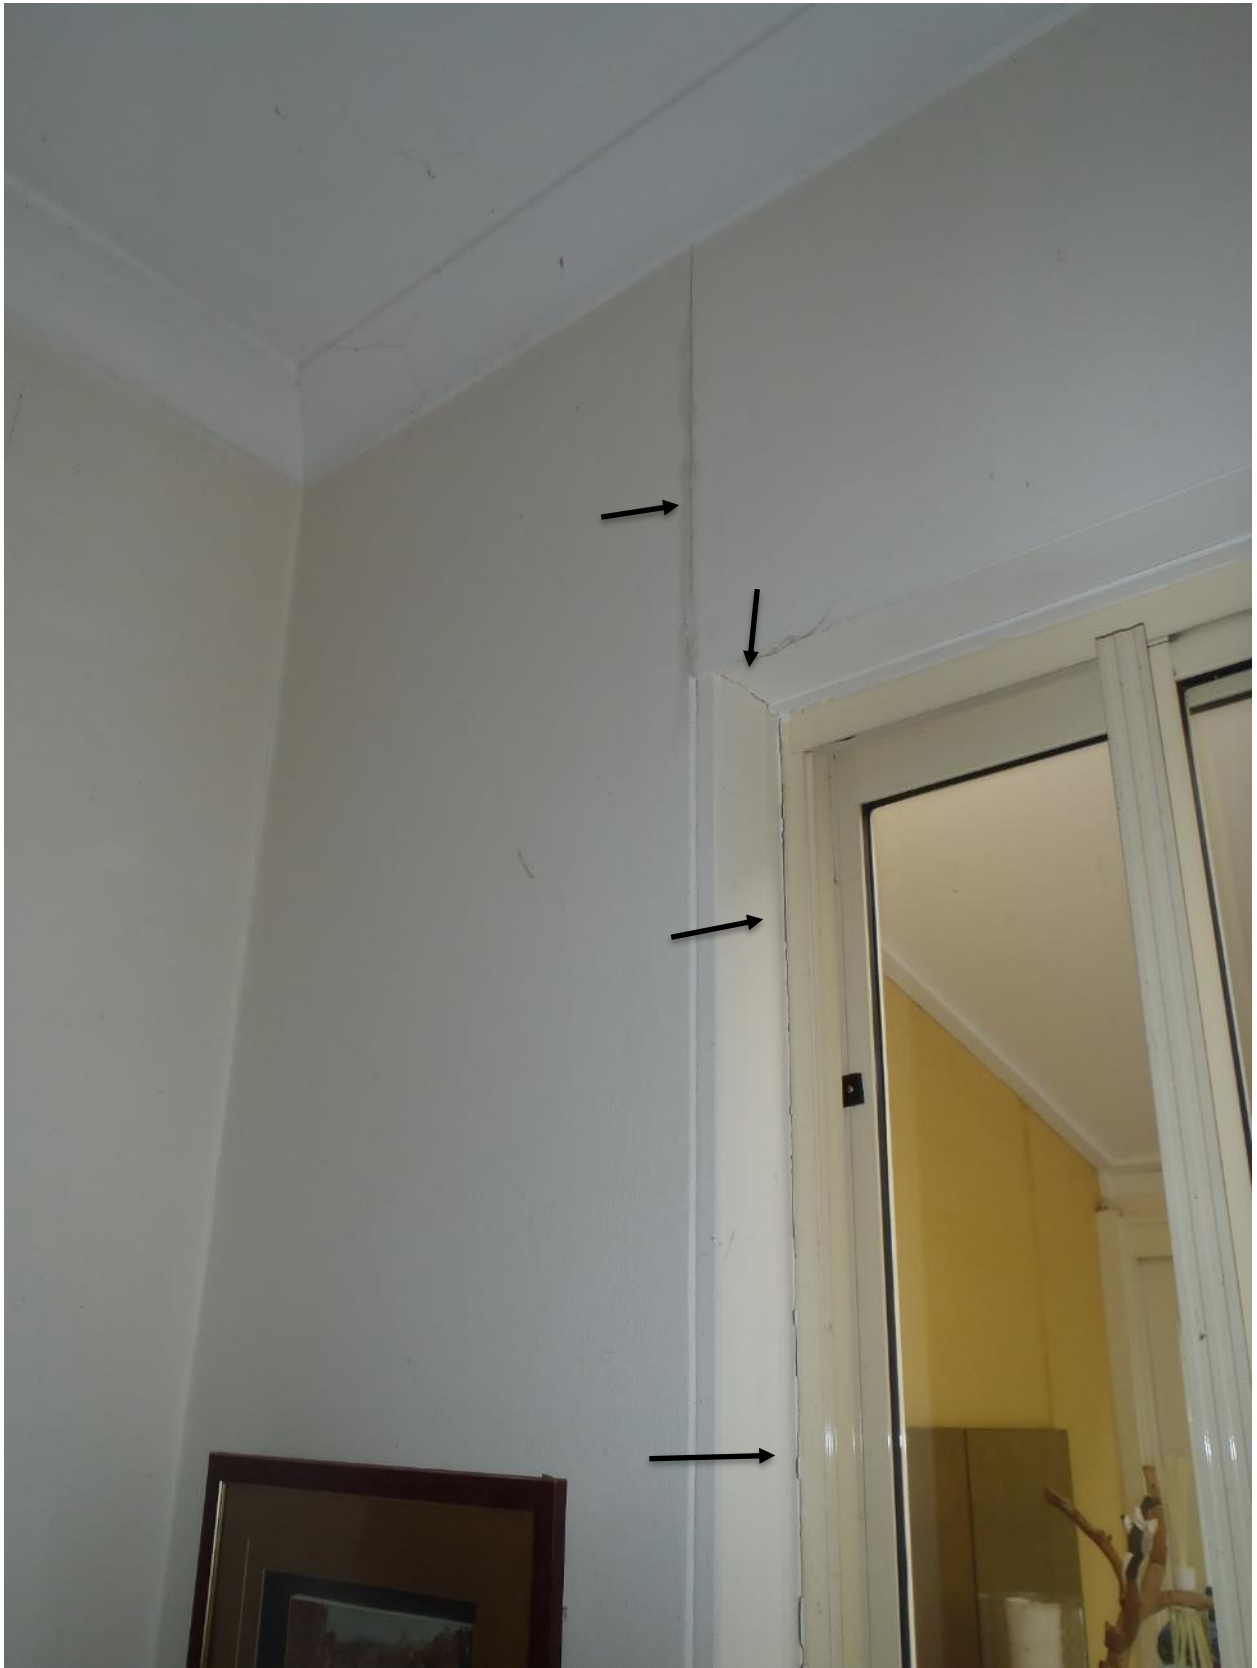
We noted vertical cracking to the wall above the sliding door head to the sunroom. We further noted separation cracking around the door architrave. **[Photograph 49]**

Photograph 49 shows vertical cracking to the wall above the sliding door head to the Sunroom and separation cracking around the door architrave.

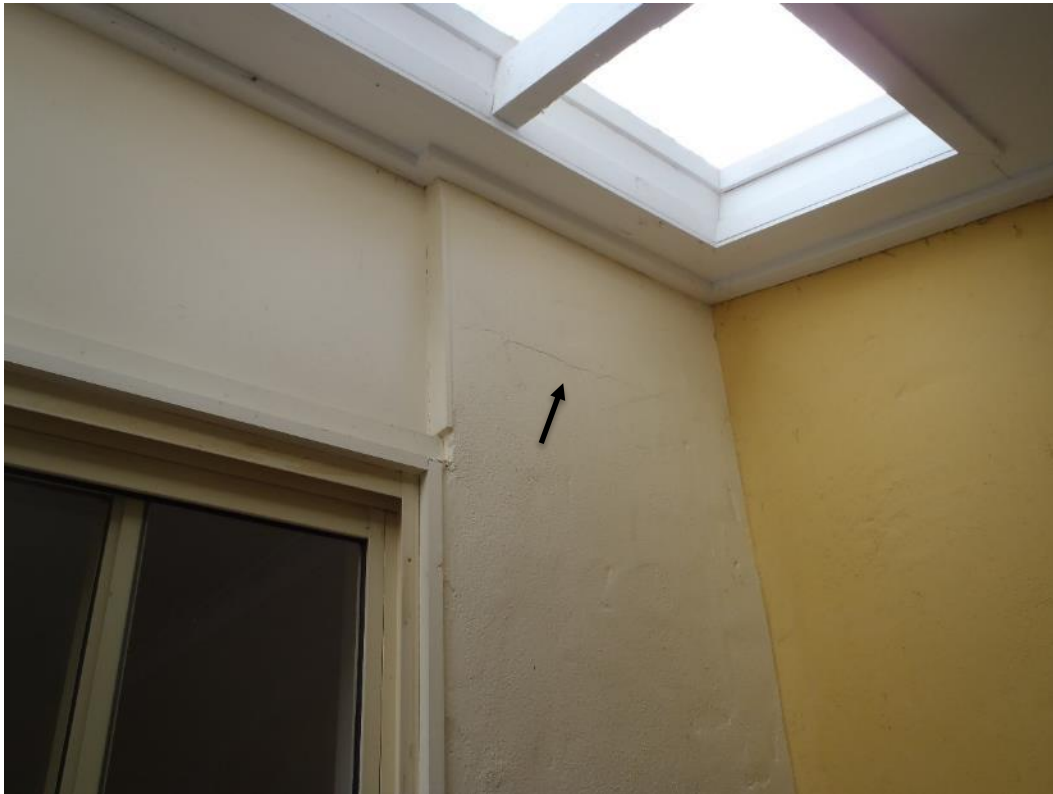
We noted horizontal cracking [$<1\text{mm}$] to the cement rendered wall adjacent to the sliding door.

Photograph 50 shows horizontal cracking to the cement rendered wall adjacent to the sliding door in the upstairs Sunroom.

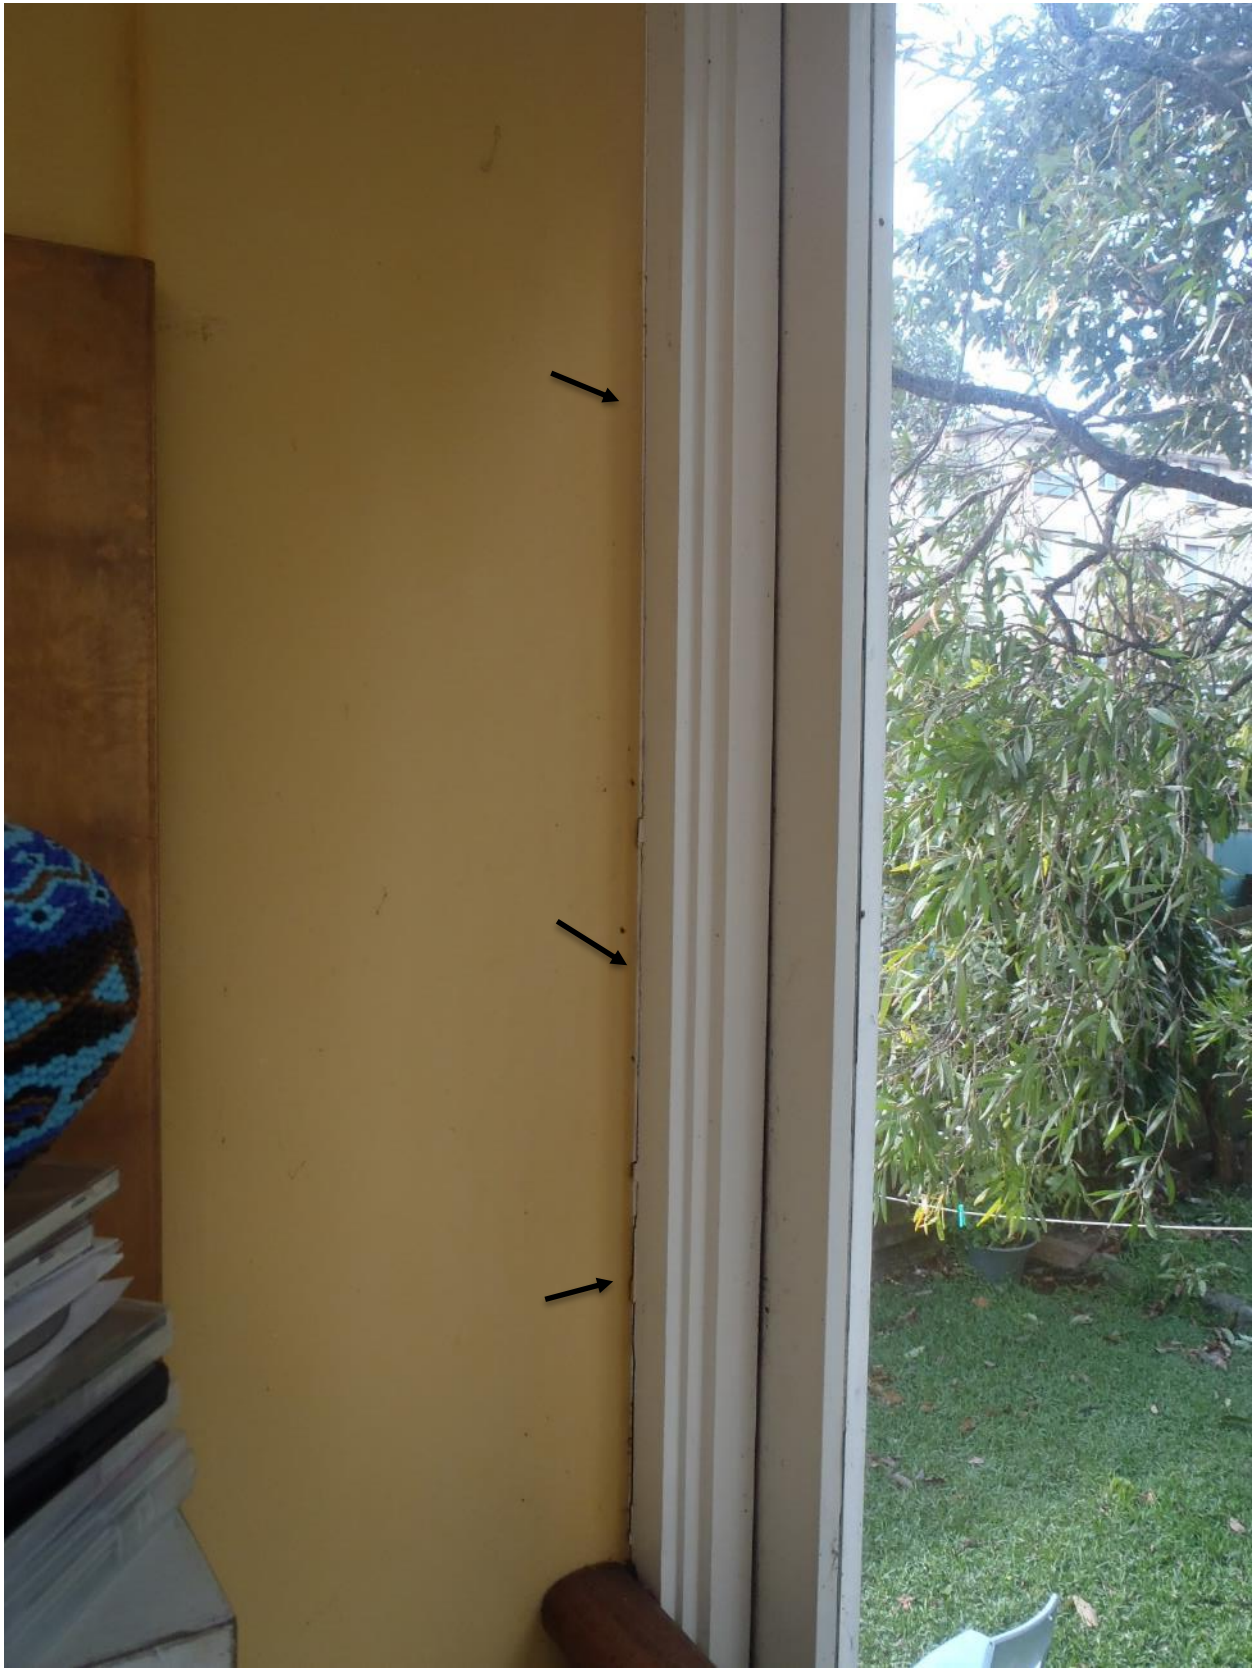
We noted vertical separation cracking [$<1\text{mm}$] between the wall and window architrave.

Photograph 51 shows vertical separation cracking between the wall and window architrave in the upstairs Sunroom.

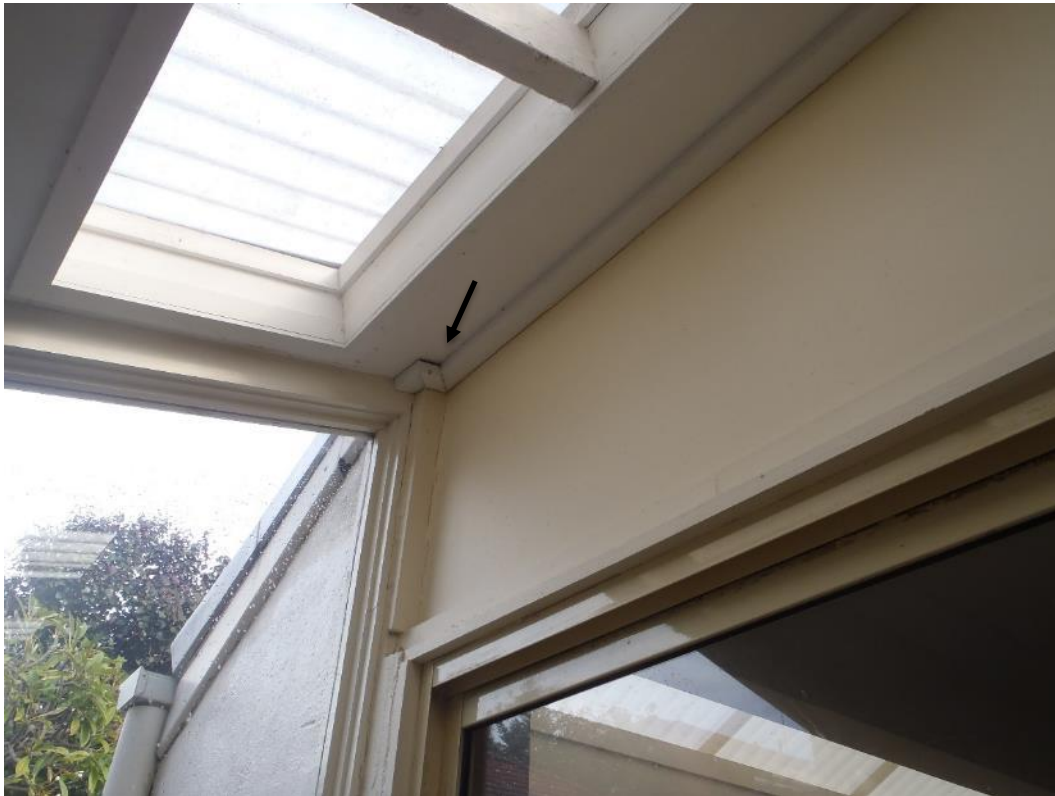
We noted separation cracking around the timber mouldings adjacent to the window in the southern corner. **[Photograph 52]**

Photograph 52 shows separation cracking around the timber mouldings adjacent to the window in the southern corner of the Sunroom.

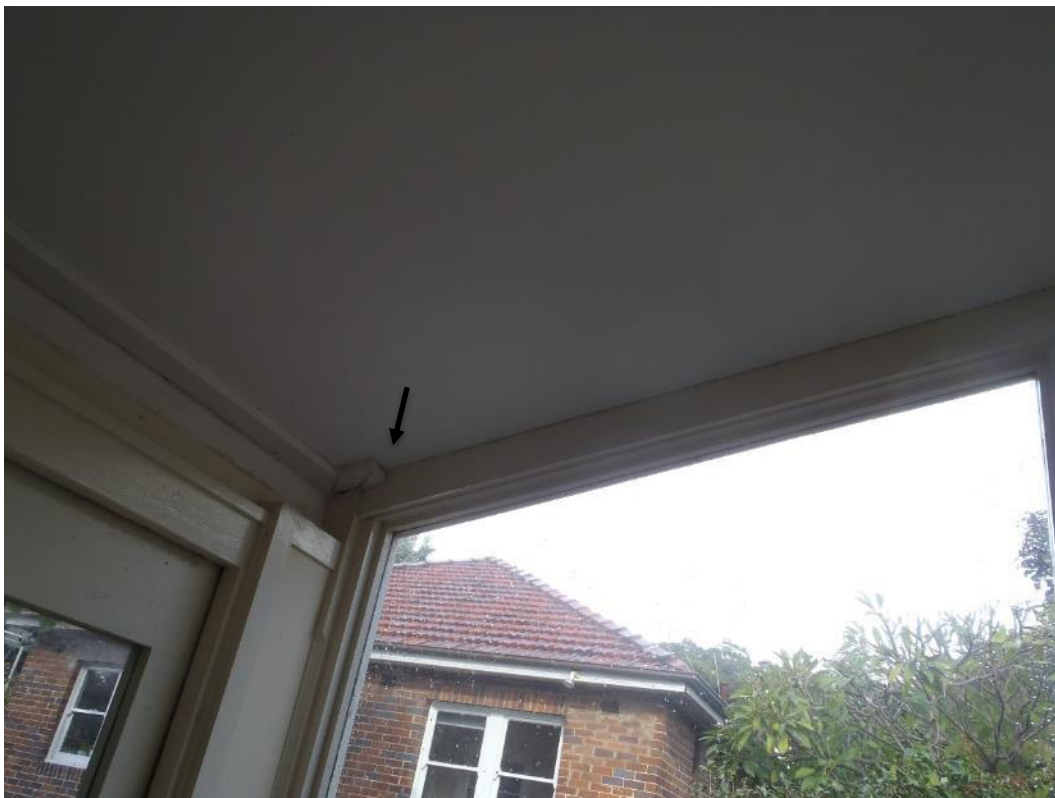
We noted separation cracking around the timber mouldings above the window in the eastern corner.

Photograph 53 shows separation cracking around the timber mouldings above the window in the eastern corner of the Sunroom.
