## Dilapidation Assessment Report

Prepared for: Cape Cod Australia Pty. Limited  
Job address: 70 Middle Street, Kingsford.  
Property Owner/s: Mrs. Jessica Mander-Jones.  
Report reference: **RANDWICK COUNCIL**  
Development Application No: not available  
Date of assessment: 15<sup>th</sup> September 2017.

**Re: Dilapidation Report – No. 70 Middle Street, Kingsford.**

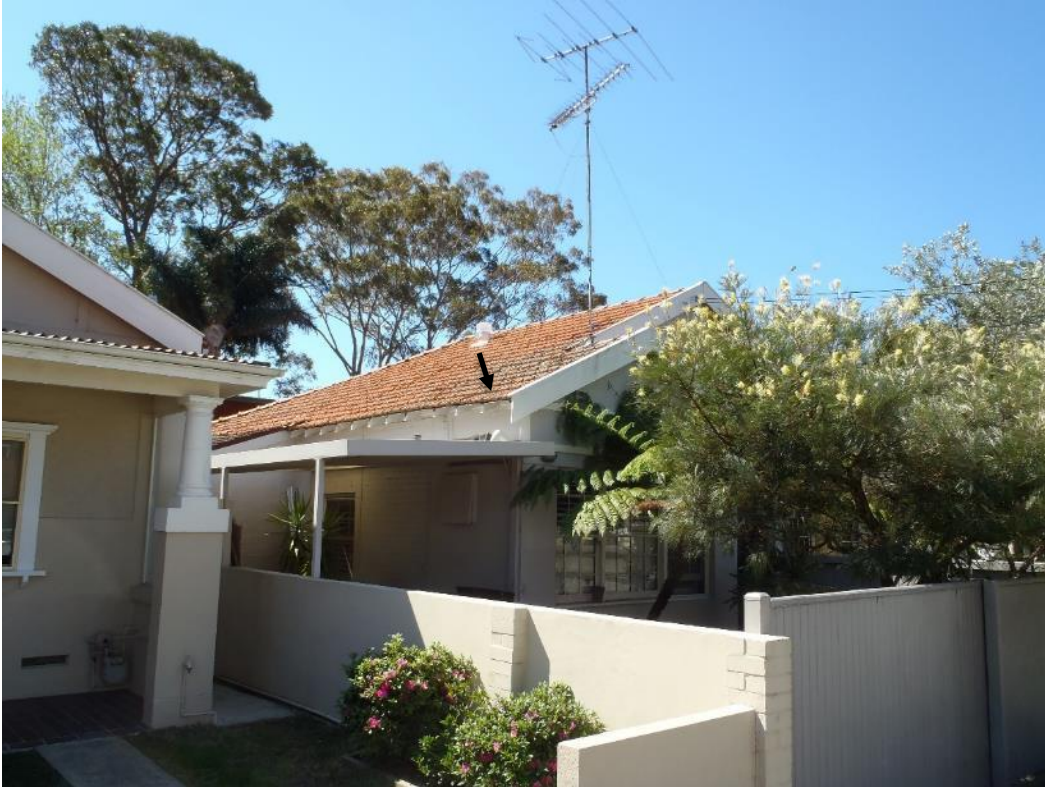
We observed that the terracotta roof tiles to the original roof surfaces are generally interlinked and securely bedded, in our opinion forming a weather resistant cover to the residence. **[Photograph 1]**

We noted sagging to the roof surface to the front south-western corner [Bedroom 1] of the residence. **[Photograph 1]**

**Photograph 1** shows the general condition of the front western roof surfaces. Note. Sagging to the south-western corner.

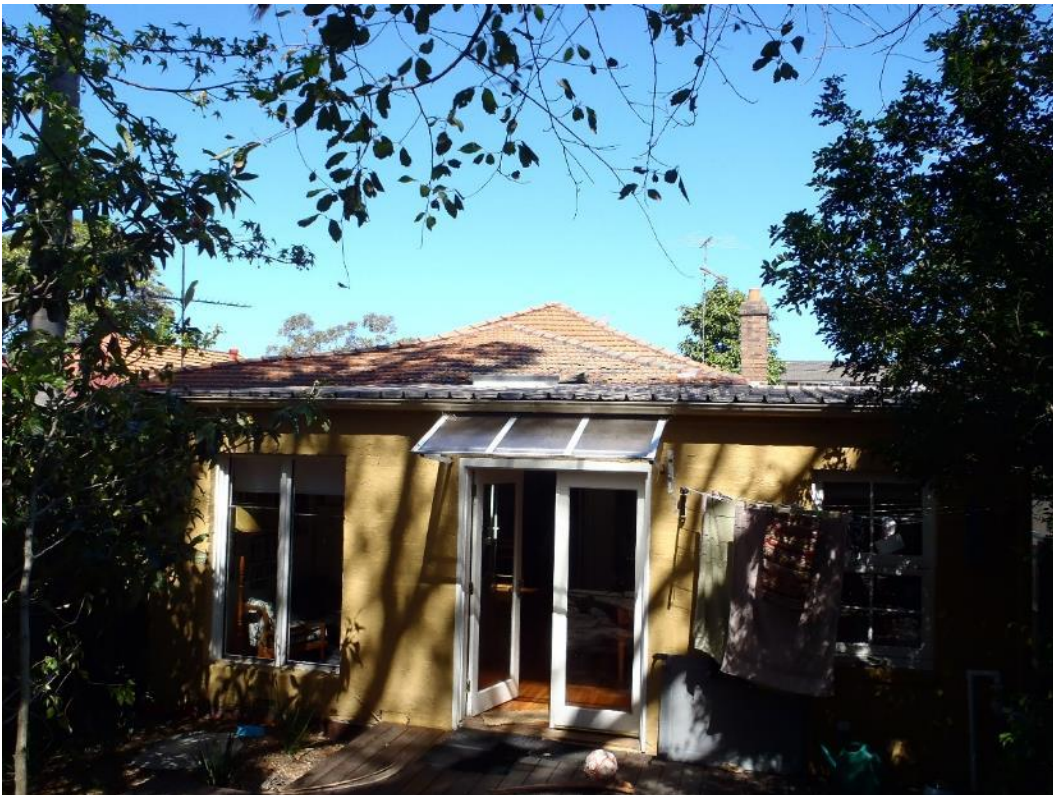
We noted that the pan profile sheet metal roofing to the rear addition roof surfaces is in good condition and is securely fixed, in our opinion forming a weather resistant cover to the rear addition. **[Photograph 2]**

**Photograph 2** shows the general condition of the rear roof surfaces.

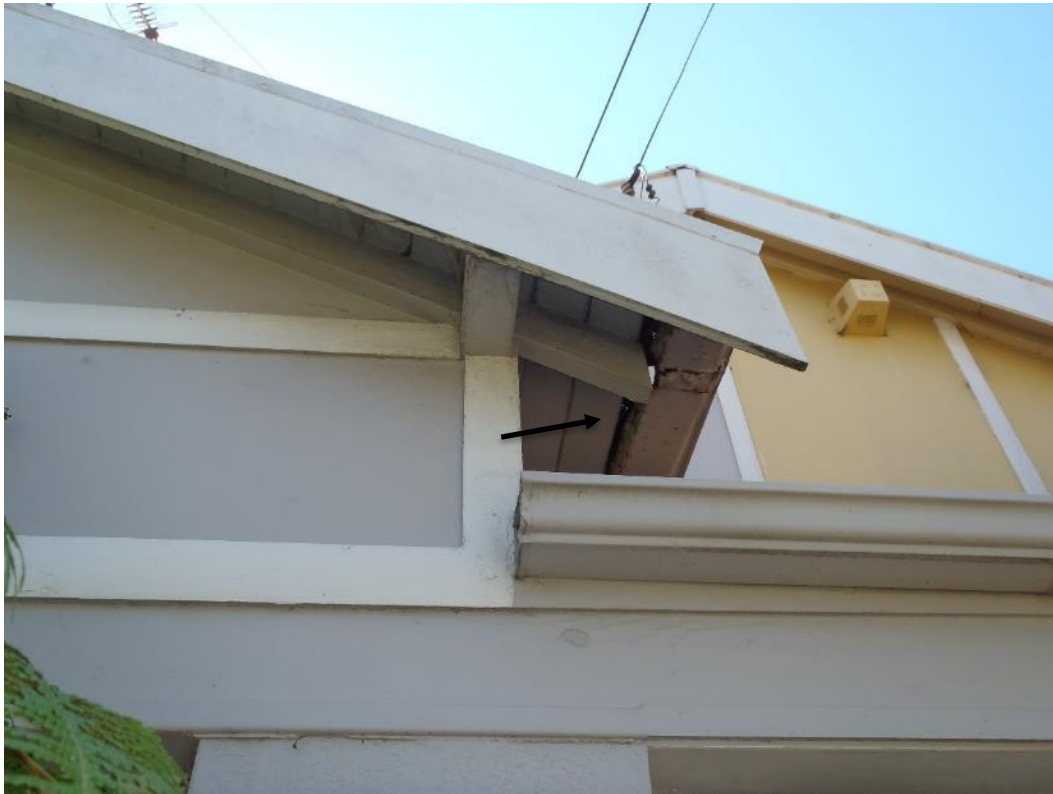
We noted deterioration and rusting of the gutter system to the front eastern side of the gable end. **[Photograph 3]**

**Photograph 3** shows deterioration and rusting of the gutter system to the front eastern side.

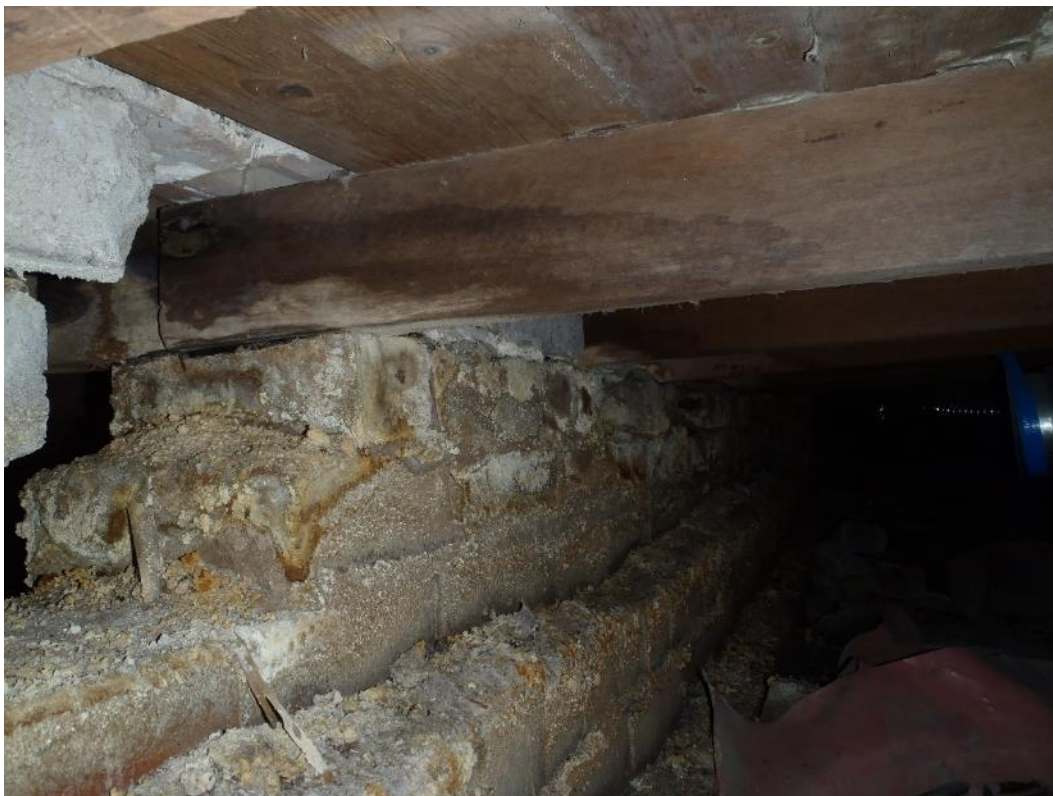
We noted that there are areas of dampness [ground water seepage] in the under-floor area including along the common party wall with the adjoining property, No. 72 Middle Street. We noted that the dampness is rising up through the base brickwork and piers. **[Photographs 4 & 5]**

**Photograph 4** shows the general condition of the *common party/ separation* wall in the under-floor space and the flooring members.

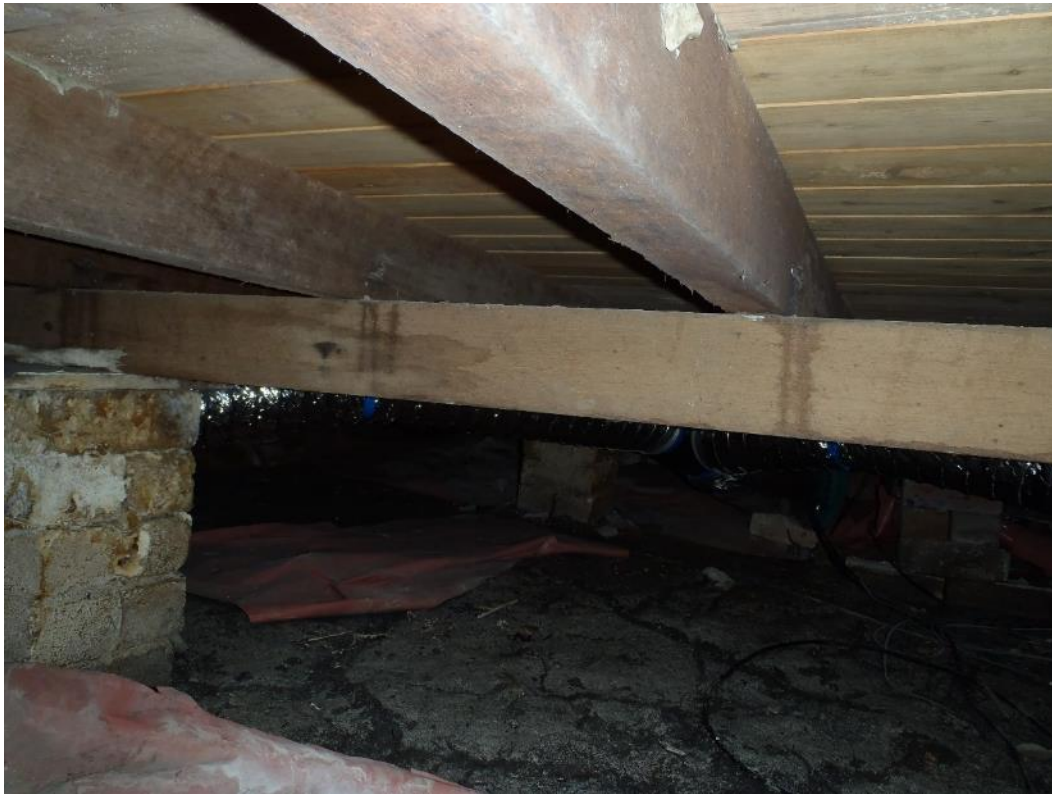
We noted that there is no evidence of termite protection to the structural timbers built into or supported upon the base brickwork. **[Photograph 5]**

We further noted that there some deterioration to the flooring members and that some of the original flooring appears to have been replaced. **[Photograph 5]**

**Photograph 5** shows the general condition of the *common party/ separation* wall in the under-floor space and the flooring members.

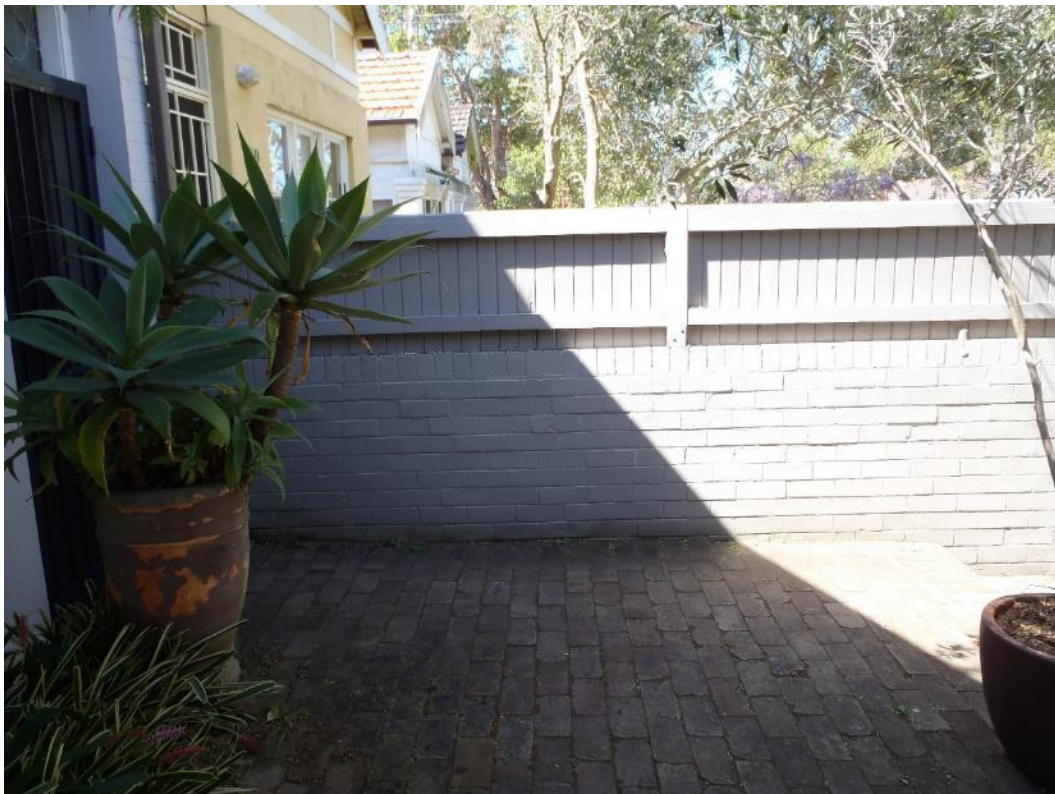
We noted that the front *common* boundary wall with the adjoining property No. 72 Middle Street is of clay masonry brick construction with a timber post and rail privacy fence above. We further noted that the wall is surface coated. **[Photograph 6]**

**Photograph 6** shows the front *common* boundary wall with the adjoining property No. 72 Middle Street, Kingsford.

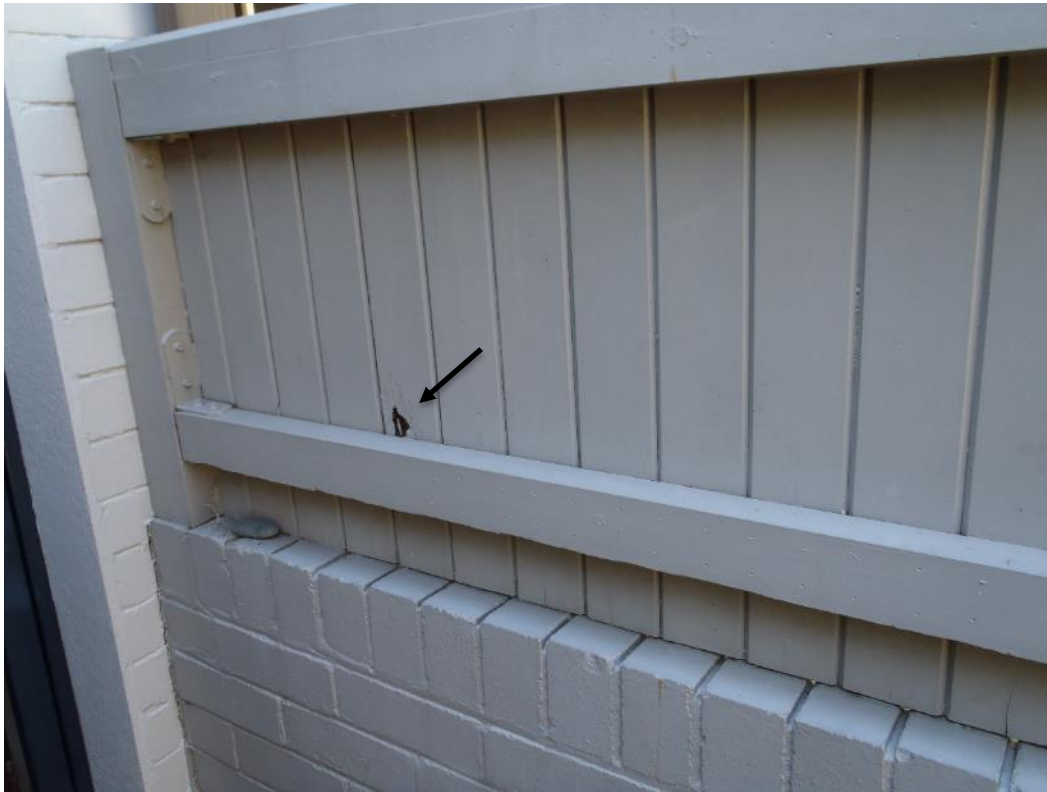
We noted some deterioration the timber privacy fence above the *common* boundary wall with the adjoining property No. 72 Middle Street. **[Photograph 7]**

**Photograph 7** shows deterioration to the timber privacy fence above the front *common* boundary wall.

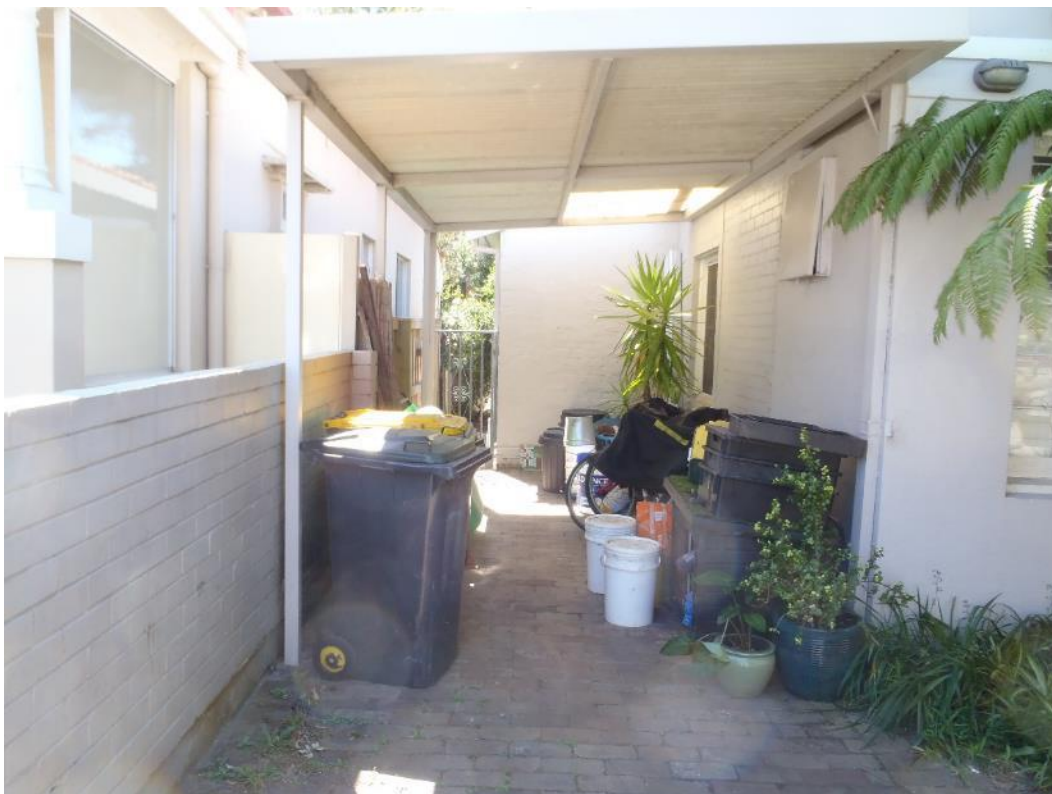
We noted that the front courtyard and carport was a paved surface. We further noted some displacement of the paved surface and vegetation growth through the pavers. **[Photographs 8 & 9]**

**Photograph 8** shows the general condition of the front carport structure and paved surface.

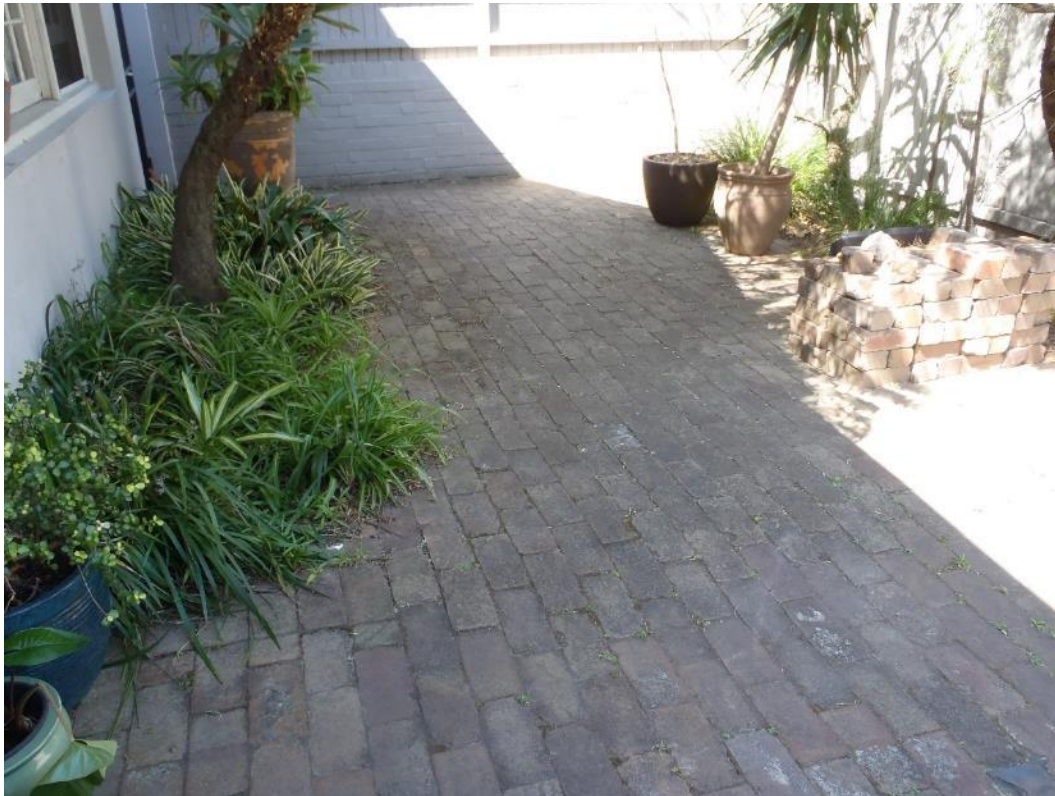
**Photograph 9** shows the general condition of the front courtyard and paved surface.

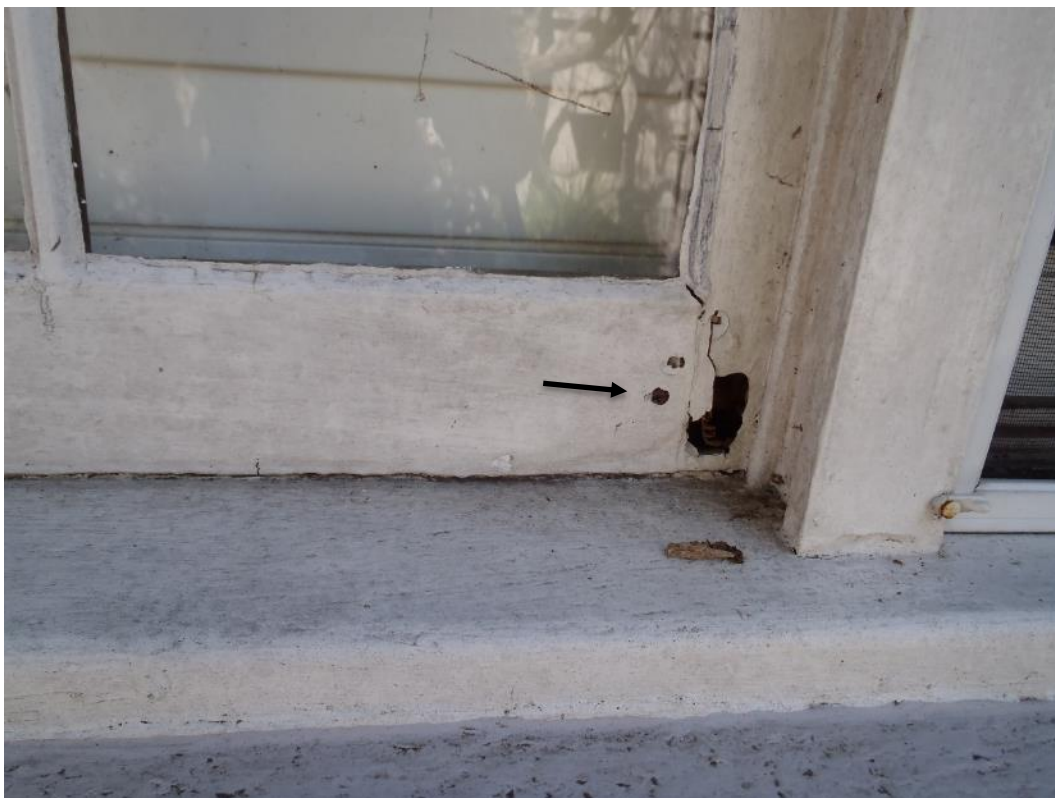
We noted deterioration and flaking paint to the window outside Bedroom 1. **[Photograph 10]**

**Photograph 10** shows deterioration and flaking paint to the window outside Bedroom 1

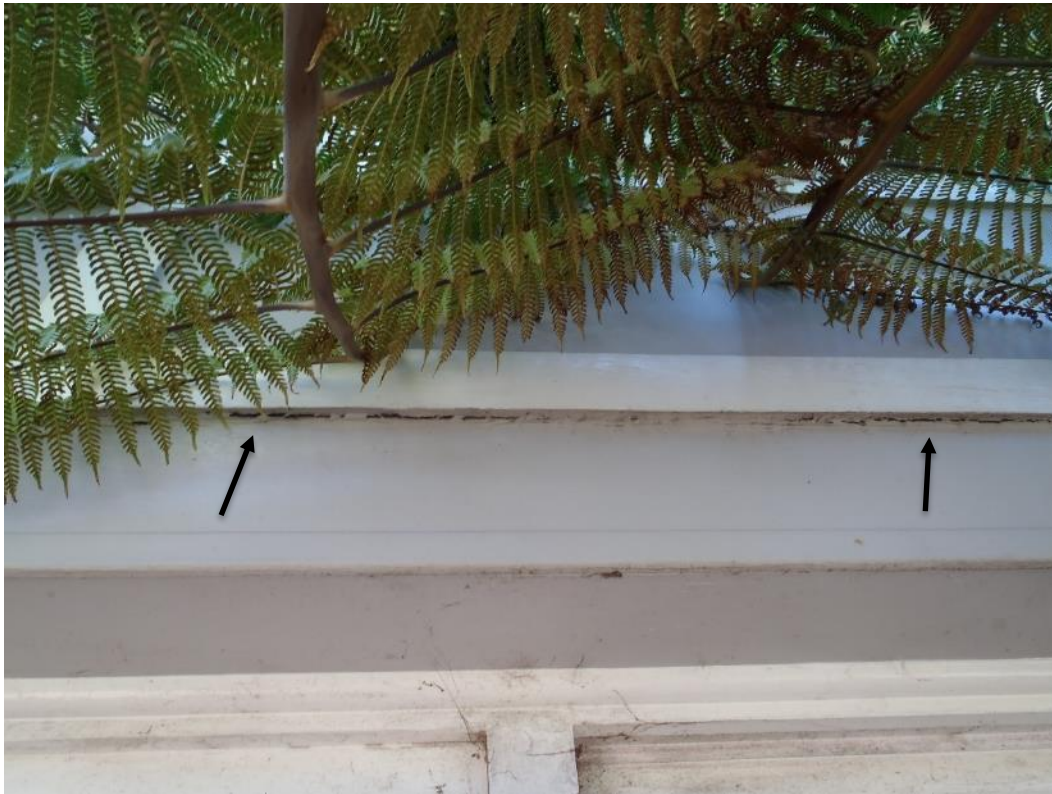
We noted separation cracking [1 mm – 3 mm] above the Bedroom 1 window. **[Photograph 11]**

**Photograph 11** shows separation cracking above the Bedroom 1 window

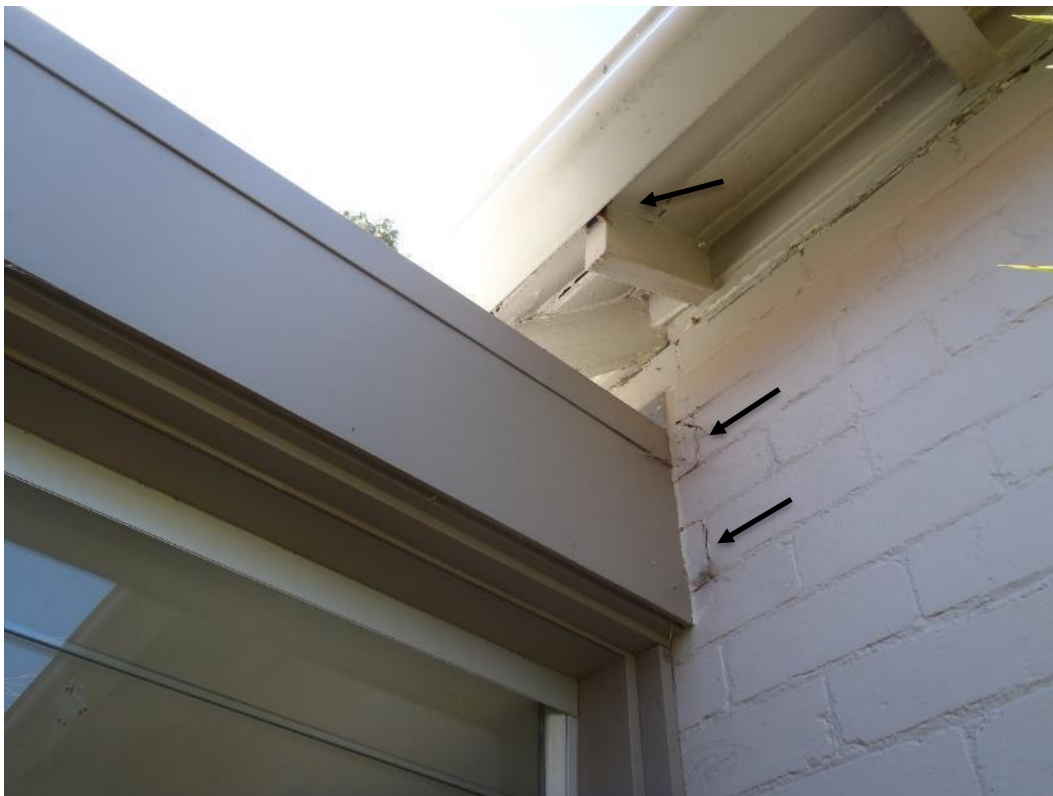
We noted gaps to the timber lined eave soffits above the kitchen. **[Photograph 12]**

We noted step cracking [ $< 1$  mm] to the surface coated clay masonry brickwork outside the kitchen. **[Photograph 12]**

**Photograph 12** shows step cracking to the surface coated clay masonry brickwork and gaps to the lining boards on the eave soffit outside the Kitchen.

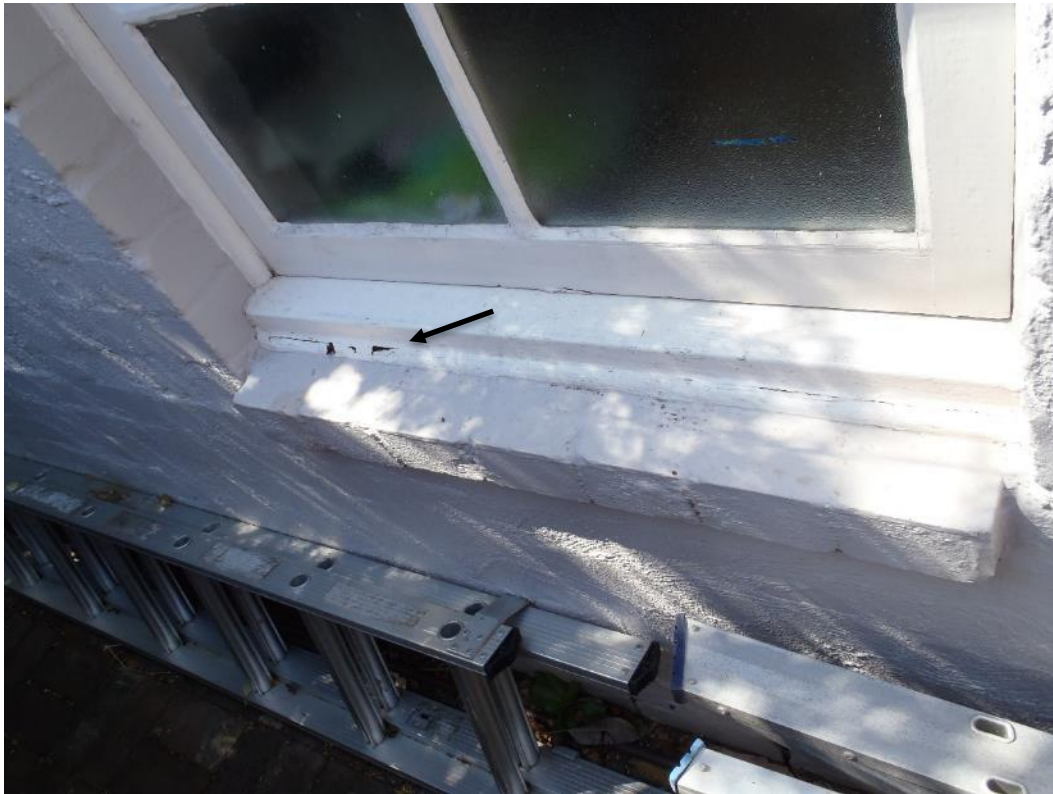
We noted deterioration and flaking paint to the window outside the Bathroom. **[Photograph 13]**

**Photograph 13** shows deterioration and flaking paint to the window outside the Bathroom.

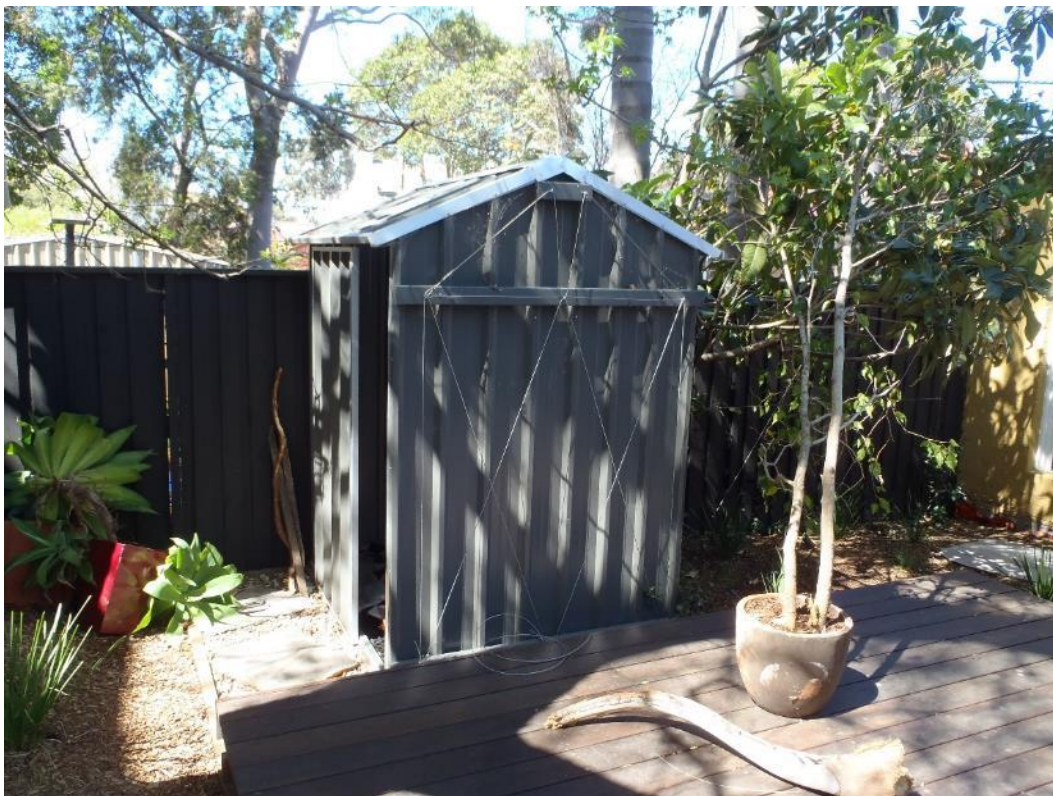
We noted that the rear *common* boundary fence with the adjoining property No. 72 Middle Street is a timber post and rail construction. We further noted that the fence is surface coated. **[Photograph 14]**

We noted that there is an attached timber deck structure built out from the rear exit door. **[Photographs 2 & 14]**

**Photograph 14** shows the general condition of the rear *common* boundary fence with the adjoining property No. 72 Middle Street.

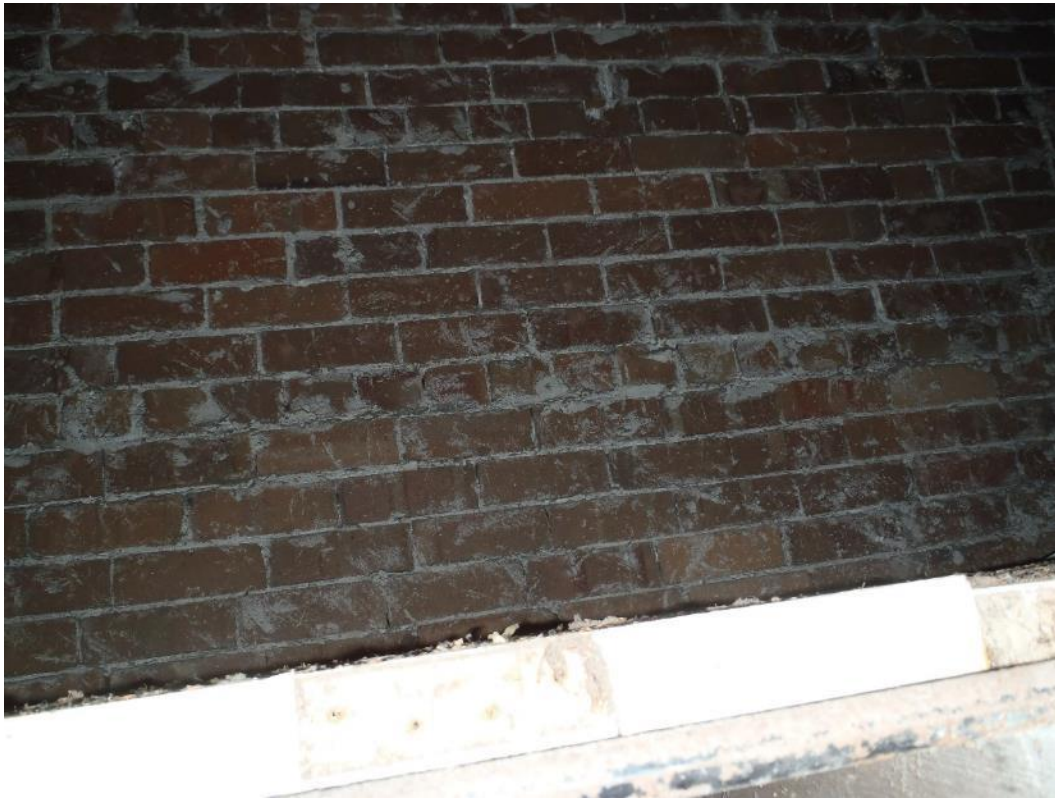
We noted that the timber ceiling joists are built into the *common party / separation* wall. We further noted that the *common* ridge to the roof is located over the common party wall. **[Photograph 15]**

**Photograph 15** shows the general condition of the *common party / separation* wall in the roof space.  
**Note:** Photograph taken from No. 72 Middle Street, Kingsford.

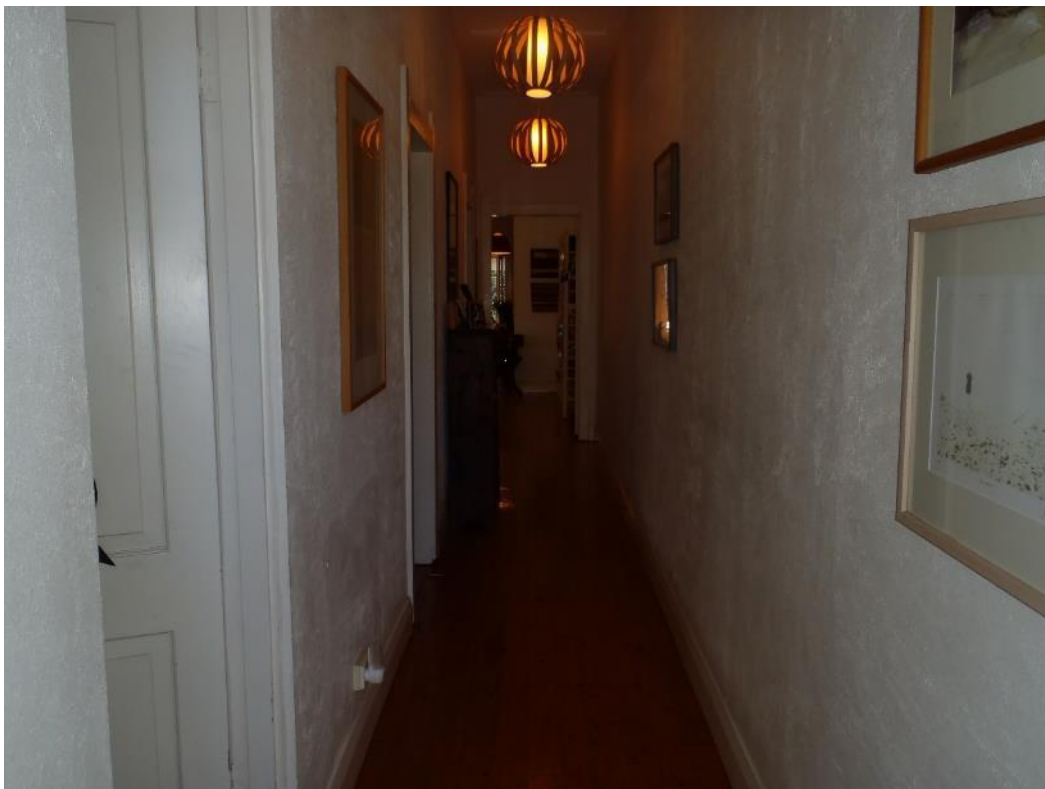
We noted that the eastern wall is the *common party / separation* wall with the adjoining property, No. 72 Middle Street, Kingsford. **[Photograph 16]**

**Photograph 16** shows the general condition of the *common party / separation* wall with the adjoining property, No. 72 Middle Street, Kingsford.

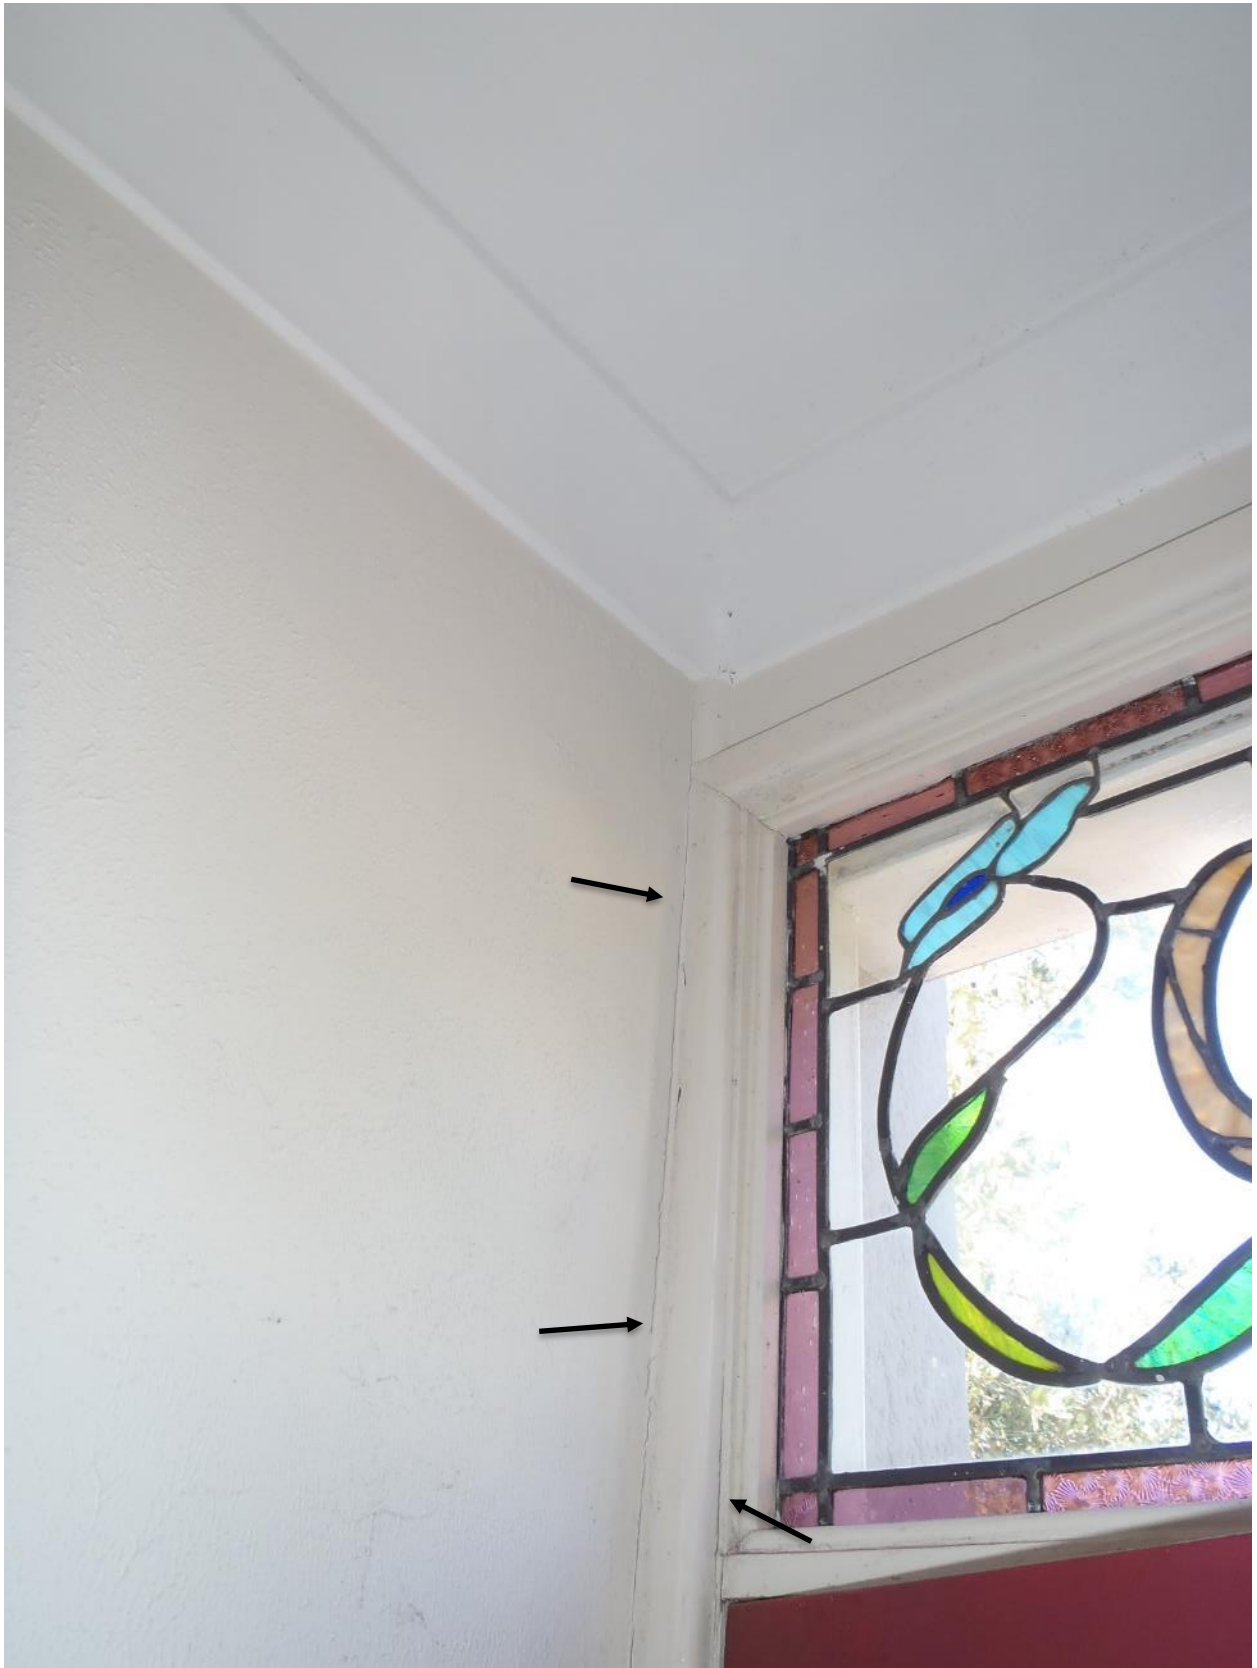
We noted separation cracking [ $< 1$  mm] between the door jamb and the wall surface and the architrave around the front entry door. We further noted some hairline cracks to the glass panelling in the stained-glass window on the entry door. **[Photograph 17]**

**Photograph 17** shows separation cracking between the door jamb and the wall surface and the architrave around the front entry door.

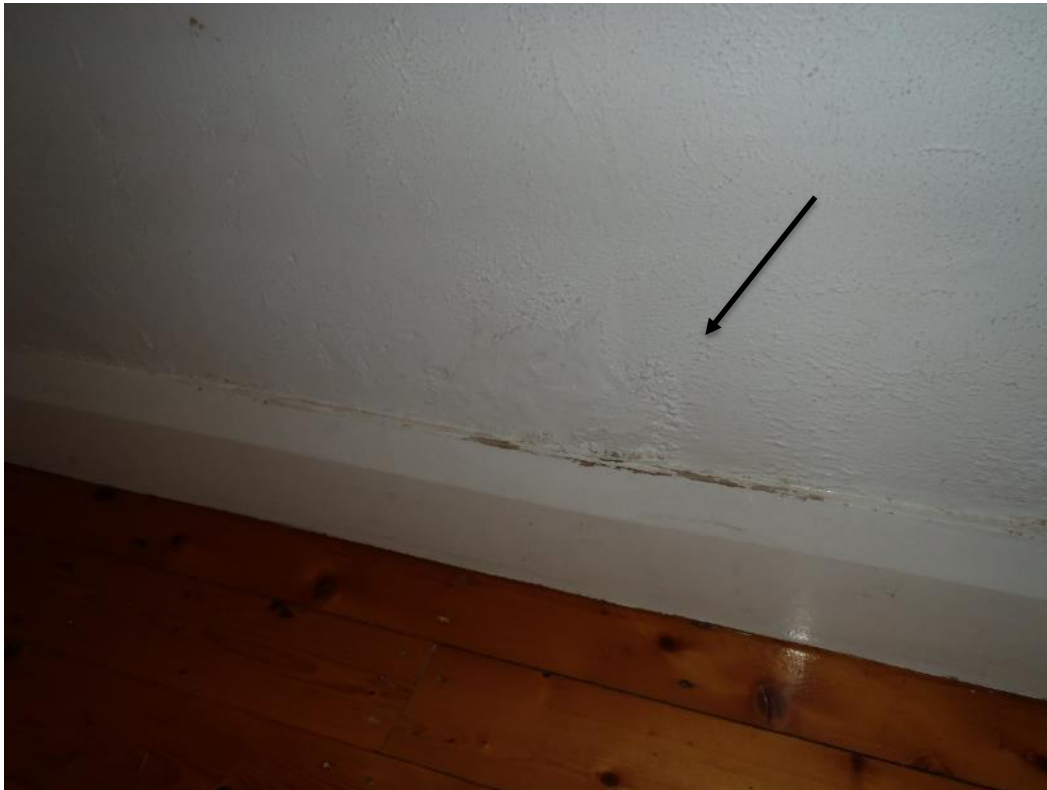
We noted evidence of a previous repair to the base of the *common party / separation* wall with the adjoining property, No. 72 Middle Street, Kingsford opposite the doorway to Bedroom 1.

**Photograph 18** shows evidence of a previous repair to the base of the *common party / separation* wall with the adjoining property, No. 72 Middle Street, Kingsford opposite the doorway to Bedroom 1.

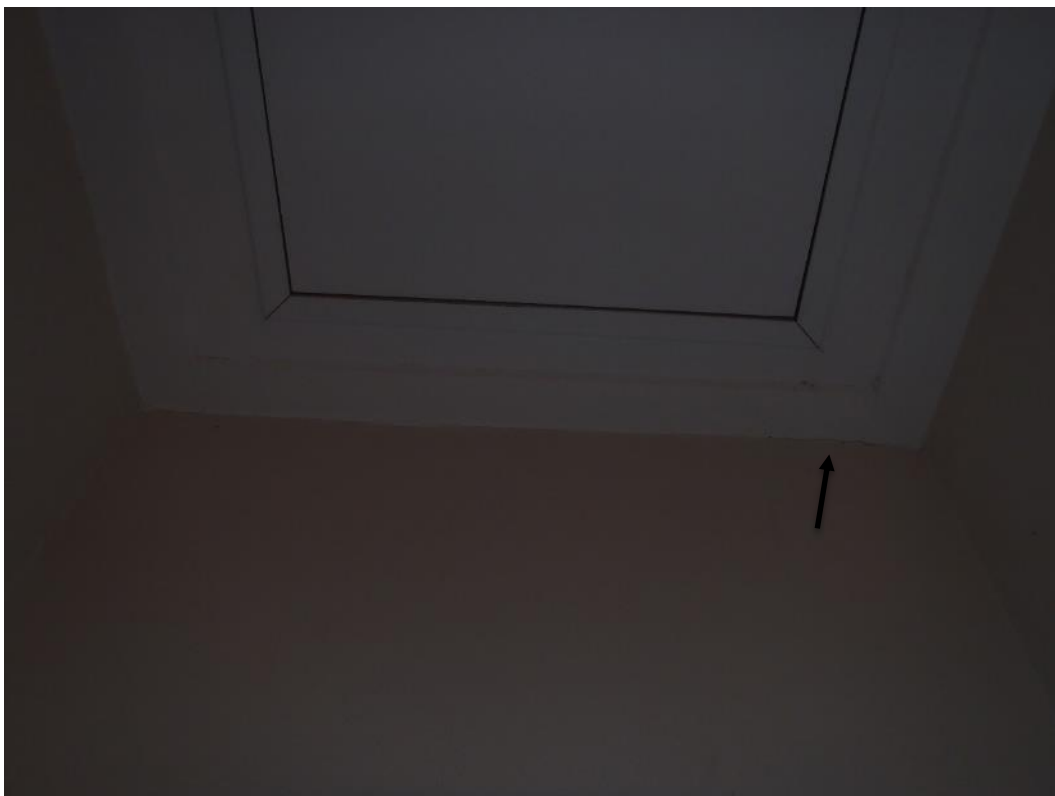
We noted separation cracking [ $< 1$  mm] between the timber trim and the wall surface above the bulkhead adjacent to the attic ladder access. **[Photograph 19]**

**Photograph 19** shows separation cracking between the timber trim and the wall surface above the bulkhead adjacent to the attic ladder access.

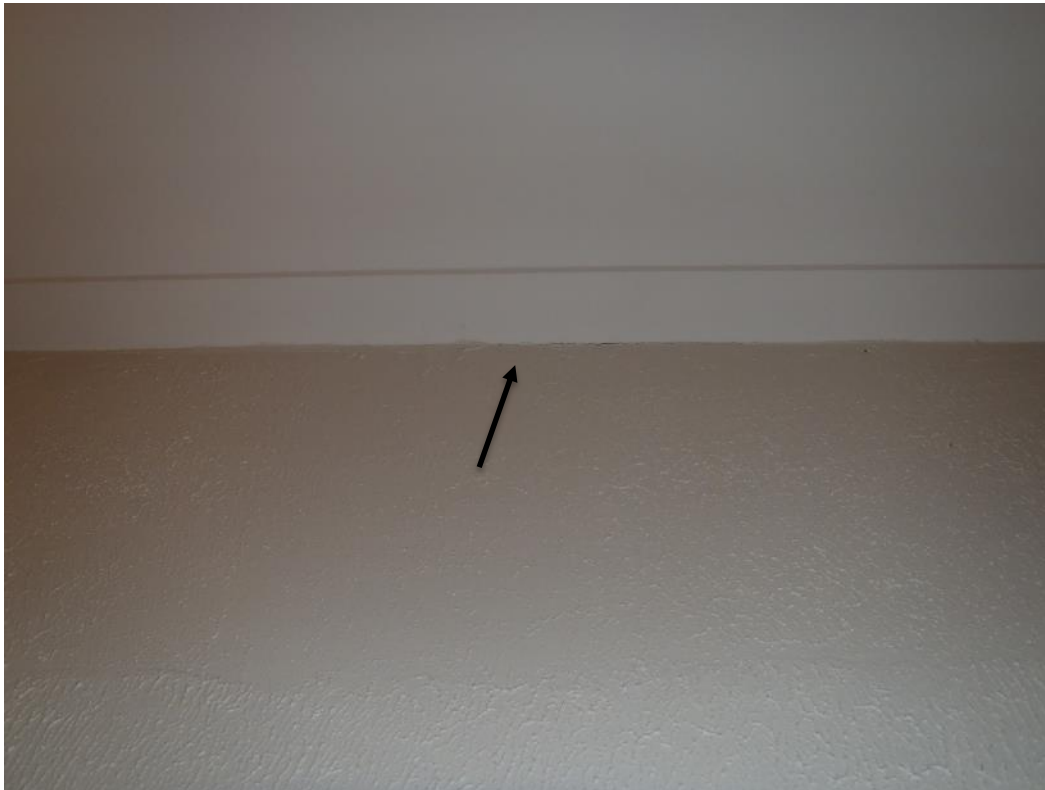
We noted separation cracking [ $< 1$  mm] between the timber trim and the wall surface along the *common party / separation* wall with the adjoining property, No. 72 Middle Street, Kingsford.

**Photograph 20** shows separation cracking between the timber trim and the wall surface along the *common party / separation* wall with the adjoining property, No. 72 Middle Street, Kingsford.

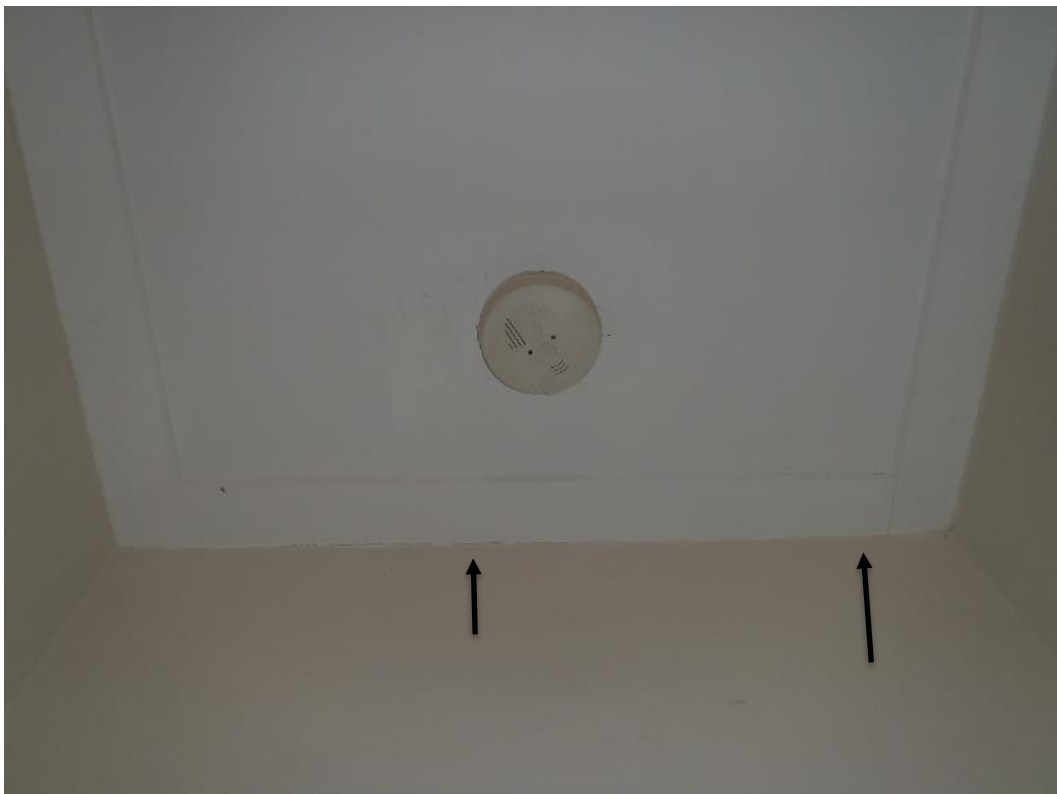
We noted separation cracking [ $< 1$  mm] between the timber trim and the wall surface adjacent to the smoke alarm. We further noted hairline cracking to the fibrous plaster ceiling lining extending from the smoke alarm towards the *common party / separation* wall with the adjoining property, No. 72 Middle Street, Kingsford. **[Photograph 21]**

**Photograph 21** shows separation cracking between the timber trim and the wall surface adjacent to the smoke alarm in the Hallway.

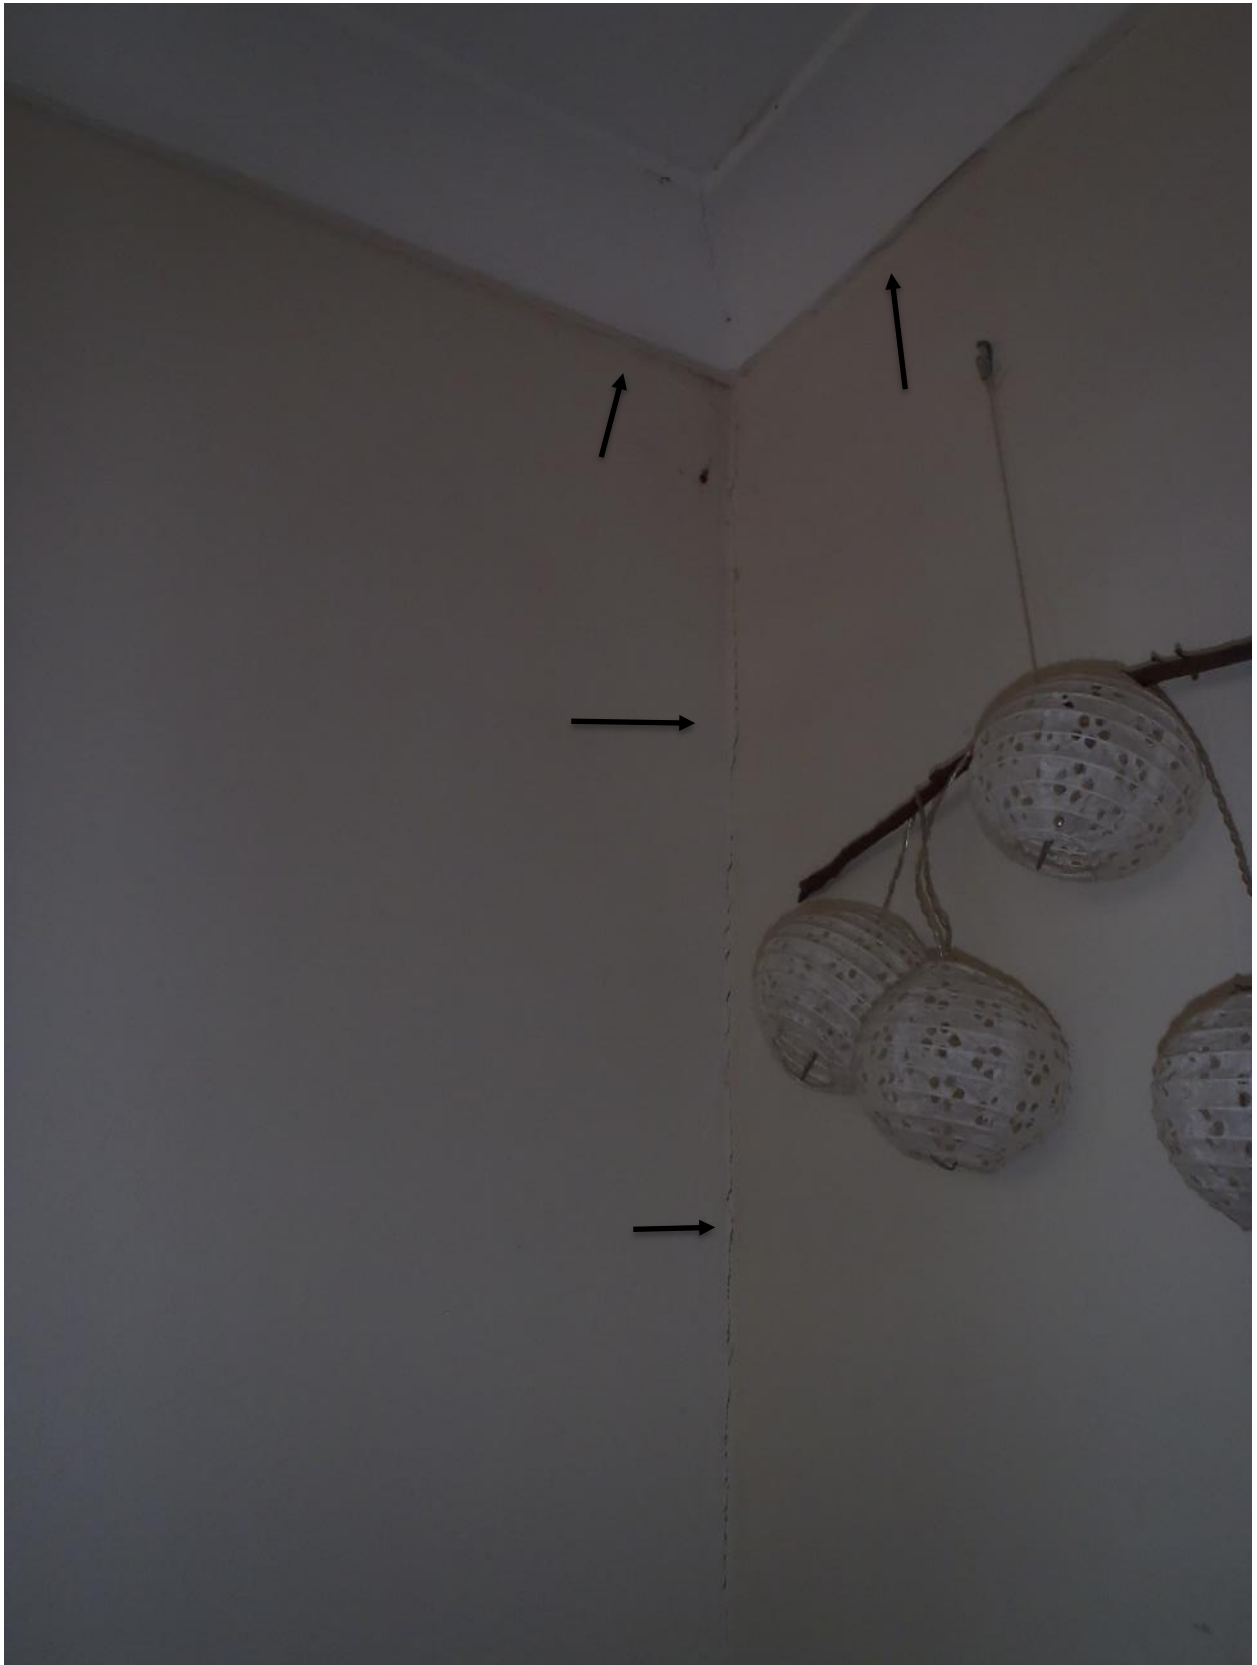
We noted separation cracking [ $< 1$  mm] between the wall to wall junction in the north-western corner. We further noted separation cracking [ $< 1$  mm] between the wall surface and the cove profiled plaster cornice. **[Photograph 22]**

**Photograph 22** shows separation cracking between the wall to wall junction in the north-western corner & separation cracking between the wall surface and the cove profiled plaster cornice in Bedroom 1.
