## Dilapidation Assessment Report

Prepared for: Cape Cod Australia Pty. Limited  
Job address: 70 Middle Street, Kingsford.  
Property Owner/s: Mrs. Jessica Mander-Jones.  
Report reference: **RANDWICK COUNCIL**  
Development Application No: not available  
Date of assessment: 15<sup>th</sup> September 2017.

**Re: Dilapidation Report – No. 70 Middle Street, Kingsford.**

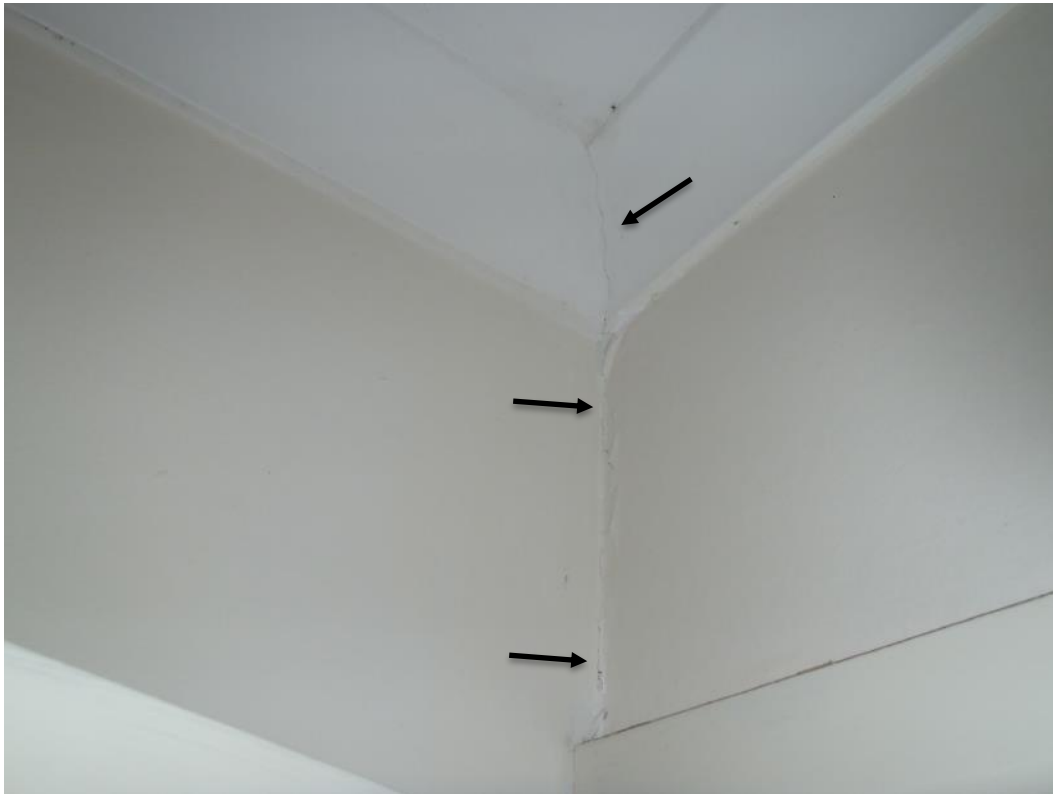
We noted separation cracking [ $< 1$  mm] between the wall to wall junction in the north-eastern corner above the door. We further noted separation cracking [ $< 1$  mm] to the mitre joint of the cove profiled plaster cornice. **[Photograph 23]**

**Photograph 23** shows separation cracking between the wall to wall junction in the north-eastern corner above the door & separation cracking to the mitre joint of the cove profiled plaster cornice in Bedroom 1.

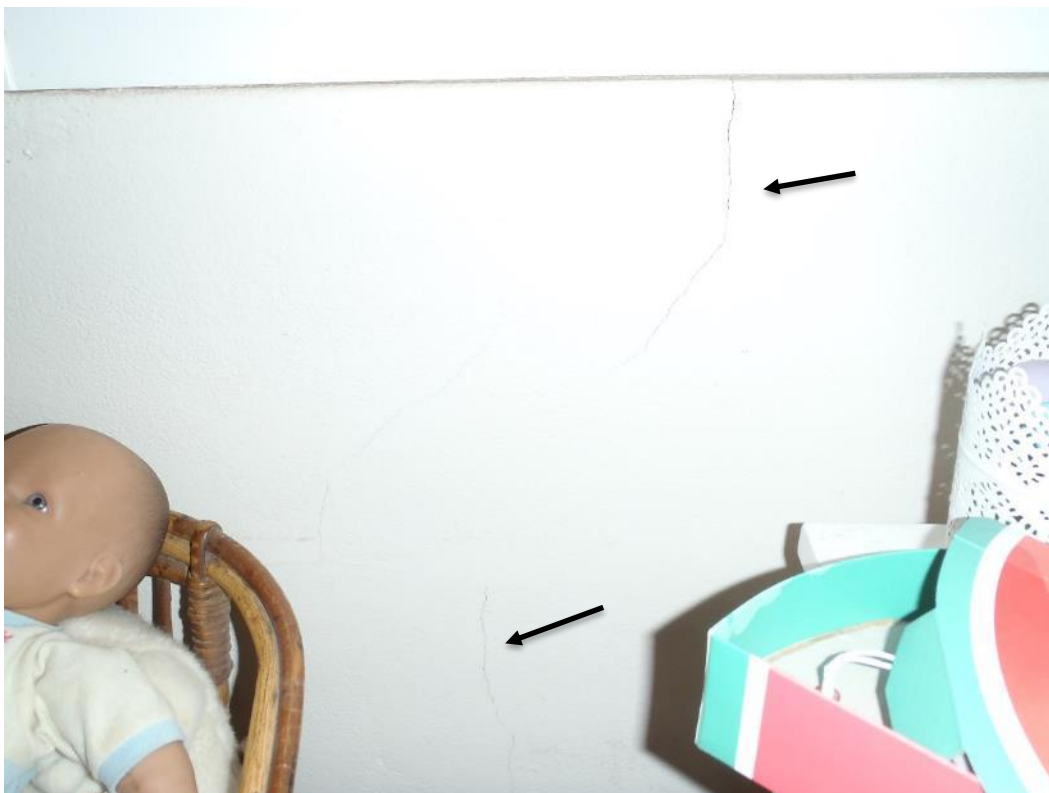
We noted radial cracking [ $< 1$  mm] extending from the window sill towards the floor. **[Photograph 24]**

**Photograph 24** shows radial cracking extending from the window sill towards the floor in Bedroom 2.

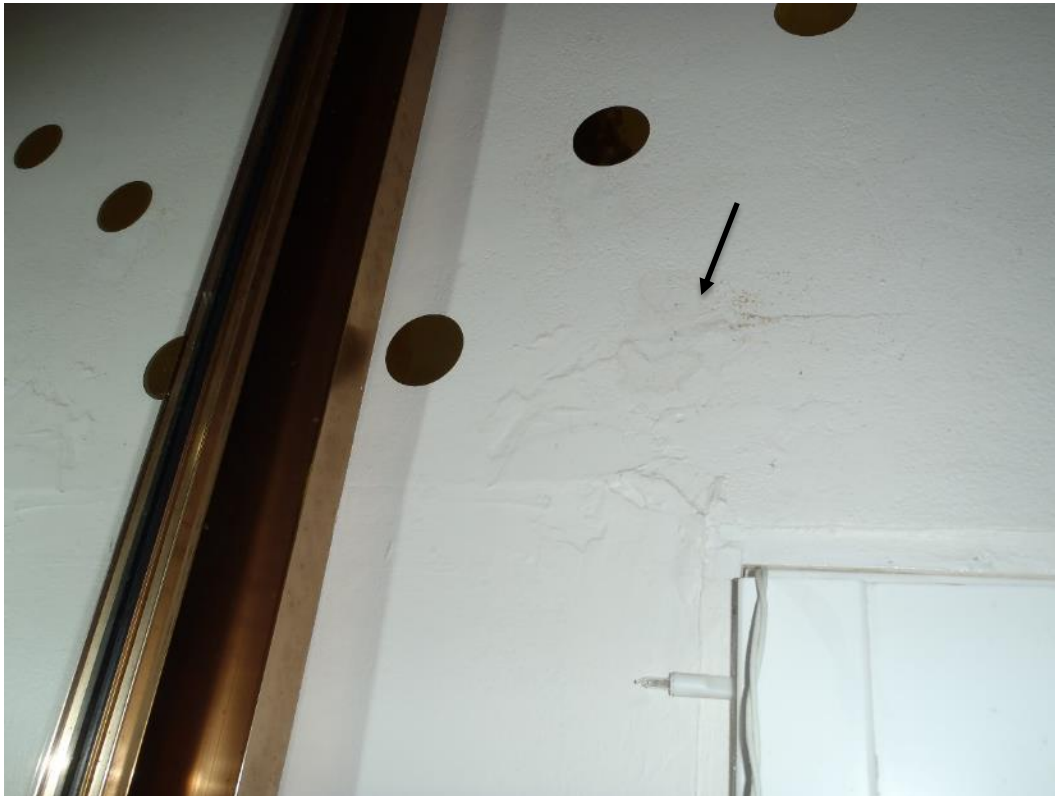
We noted evidence of a previous repair adjacent to the window head. **[Photograph 25]**

**Photograph 25** shows evidence of a previous repair adjacent to the window head in Bedroom 2.

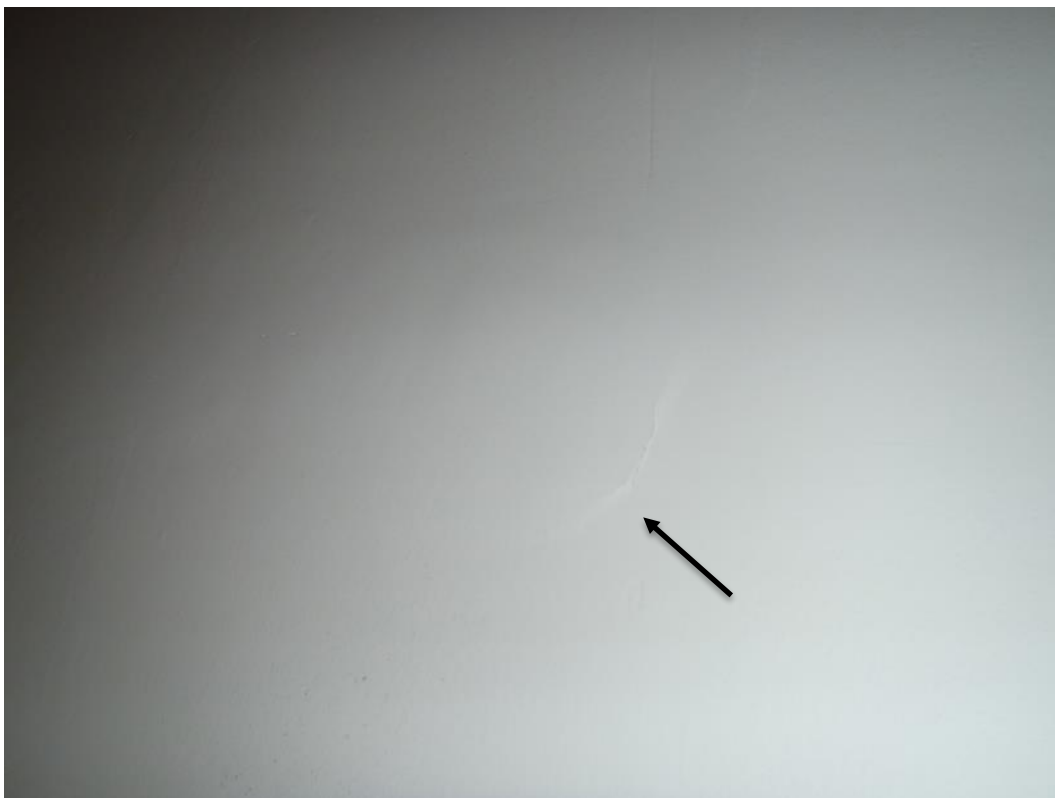
We noted evidence of a previous repair to the northern wall. **[Photograph 26]**

**Photograph 26** shows evidence of a previous repair to the northern wall in Bedroom 3.

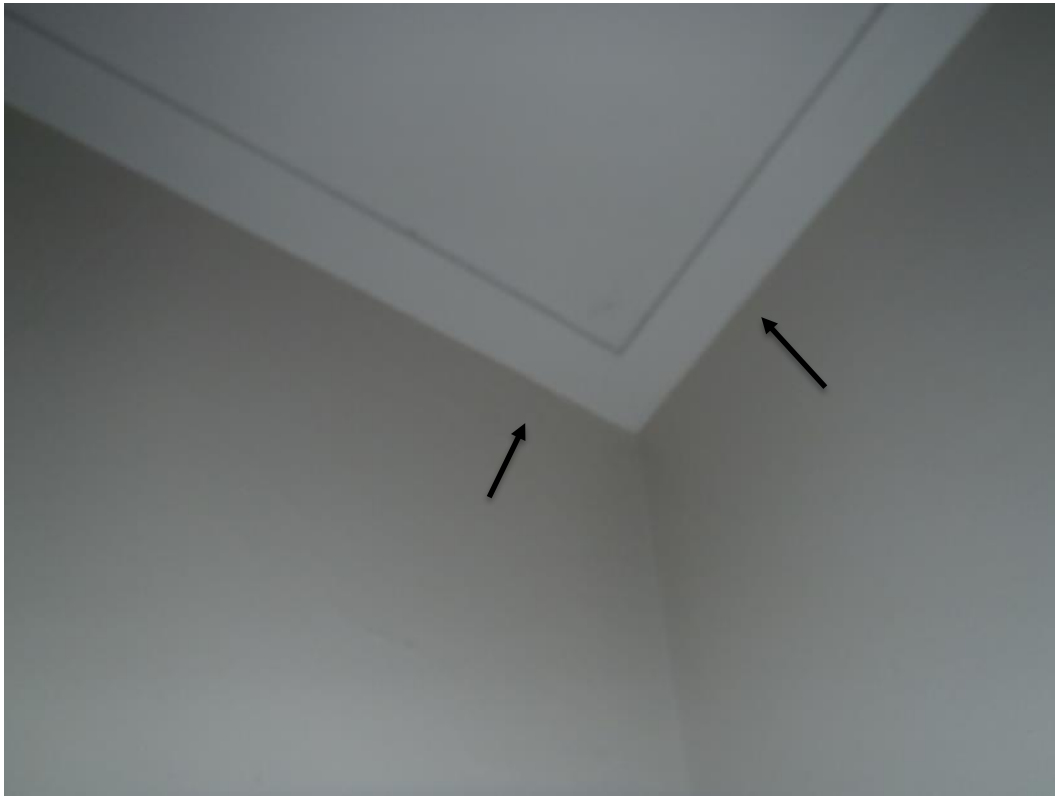
We noted separation cracking [ $< 1$  mm] between the timber trim and the wall surface in the south-western corner. **[Photograph 27]**

**Photograph 27** shows separation cracking between the timber trim and the wall surface in the south-western corner in Bedroom 3.

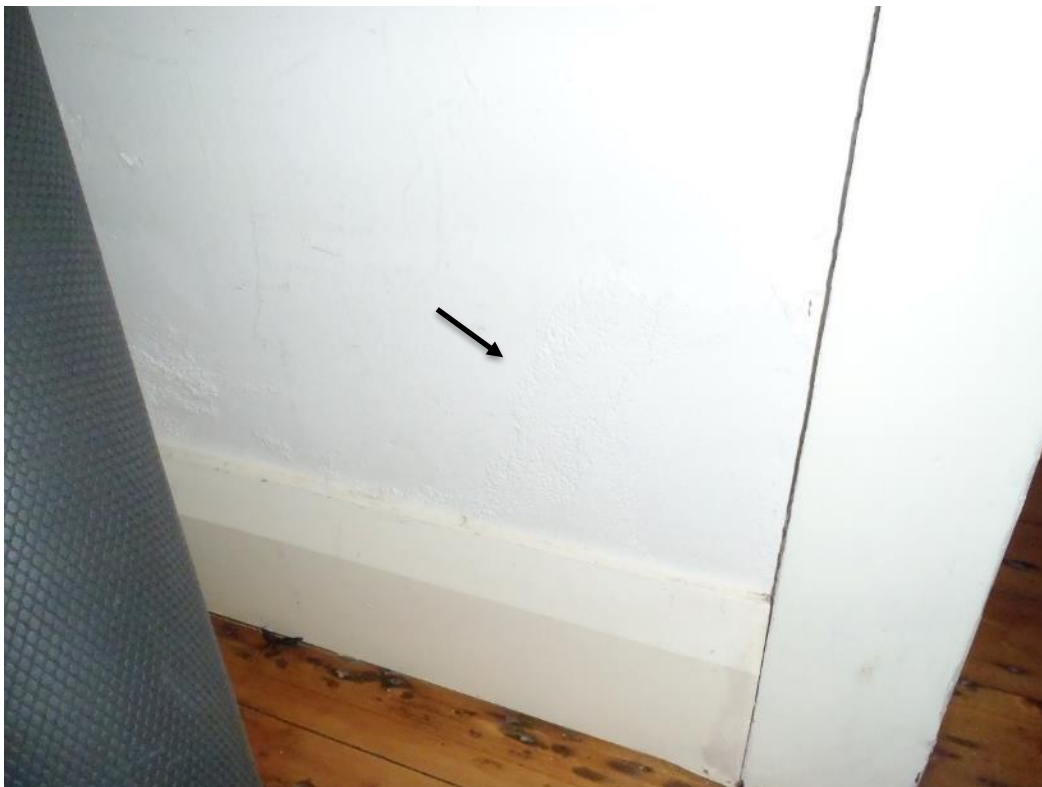
We noted evidence of a previous repair to the eastern wall adjacent to the door. **[Photograph 28]**

**Photograph 28** shows evidence of a previous repair to the eastern wall in Bedroom 3.

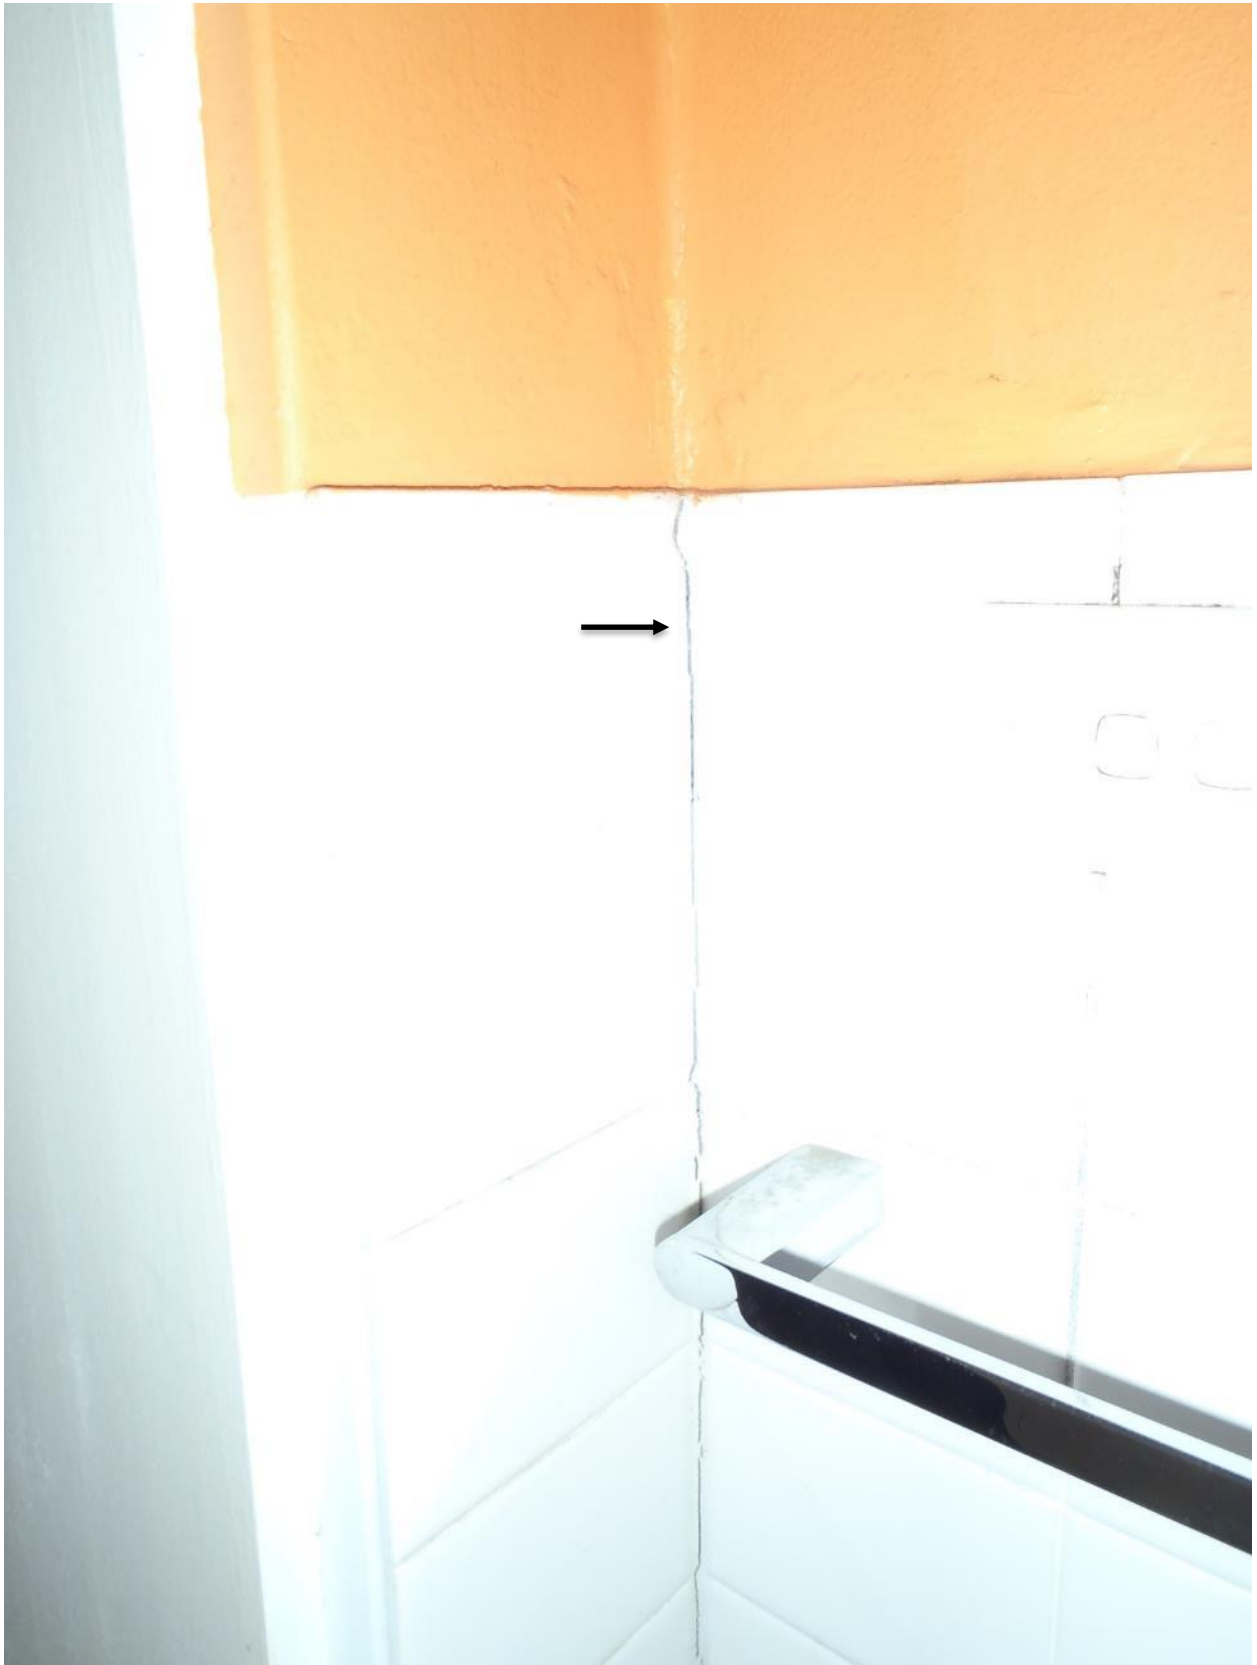
We noted separation cracking the tile grout at the wall to wall junction in the south-eastern corner adjacent to the door. **[Photograph 29]**

**Photograph 29** shows separation cracking the wall tile grout at the wall to wall junction in the south-eastern corner adjacent to the door in the Ensuite.

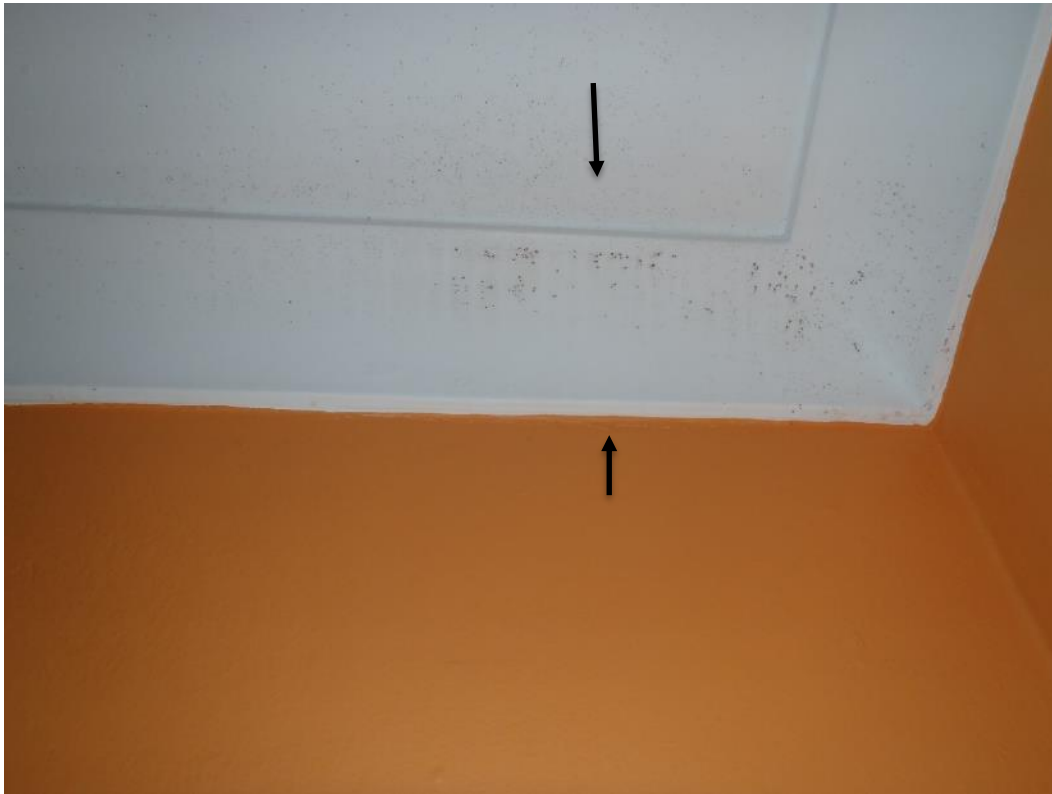
We noted mould growth and separation cracking [ $< 1$  mm] between the cove profiled plaster cornice and the wall surface in the north-western corner. **[Photograph 30]**

**Photograph 30** shows mould growth and separation cracking between the cove profiled plaster cornice and the wall surface in the north-western corner in the Ensuite.

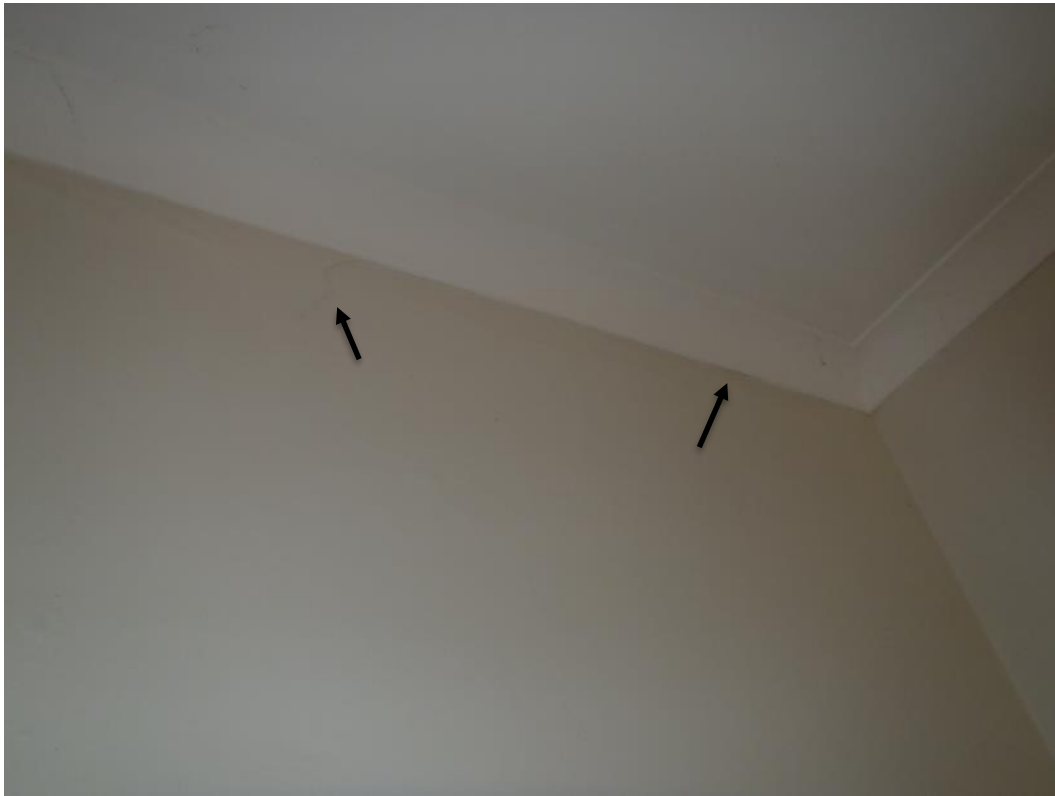
We noted radial cracking [ $< 1$  mm] to the *common party / separation* wall with the adjoining property, No. 72 Middle Street, Kingsford in the south-eastern corner. We further noted separation cracking [ $< 1$  mm] between the wall surface and the cove profiled plaster cornice. **[Photograph 32]**

**Photograph 32** shows radial cracking to the wall surface and separation cracking between the wall surface and the cove profiled plaster cornice in the Lounge Room.

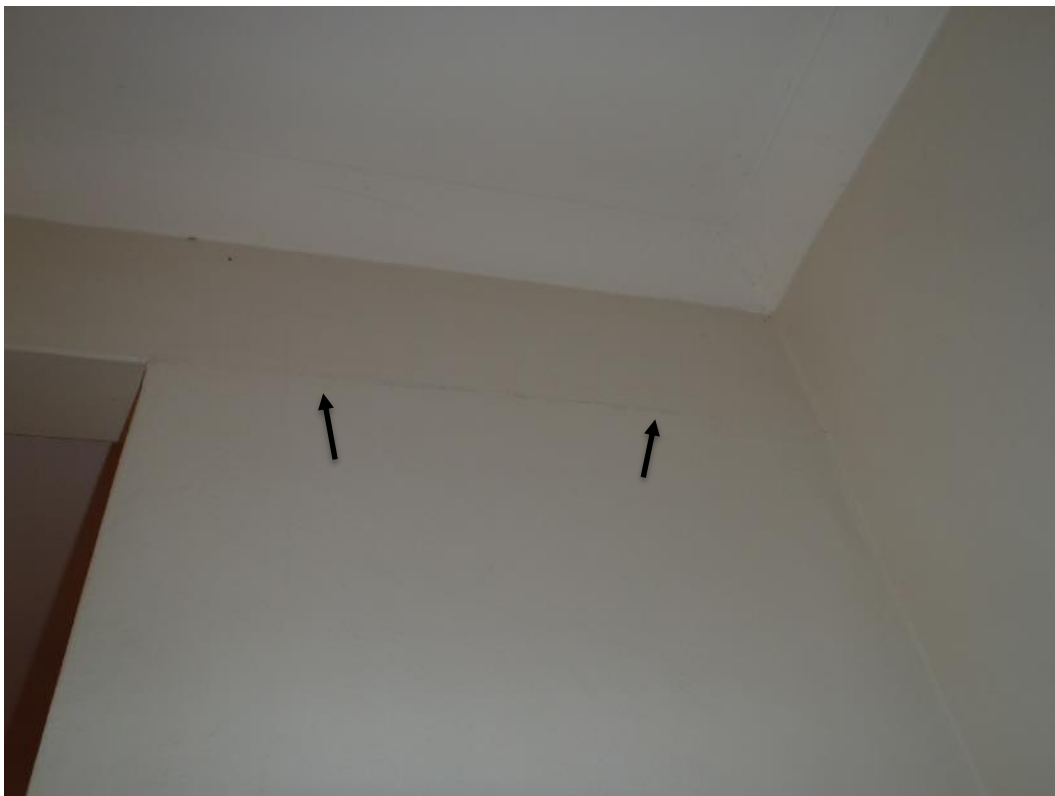
We noted horizontal cracking [ $< 1$  mm] extending towards the *common party / separation* wall with the adjoining property, No. 72 Middle Street, Kingsford from the doorway head in the north-eastern corner. **[Photograph 33]**

**Photograph 33** shows horizontal cracking from the doorway head in the north-eastern corner of the Lounge Room.

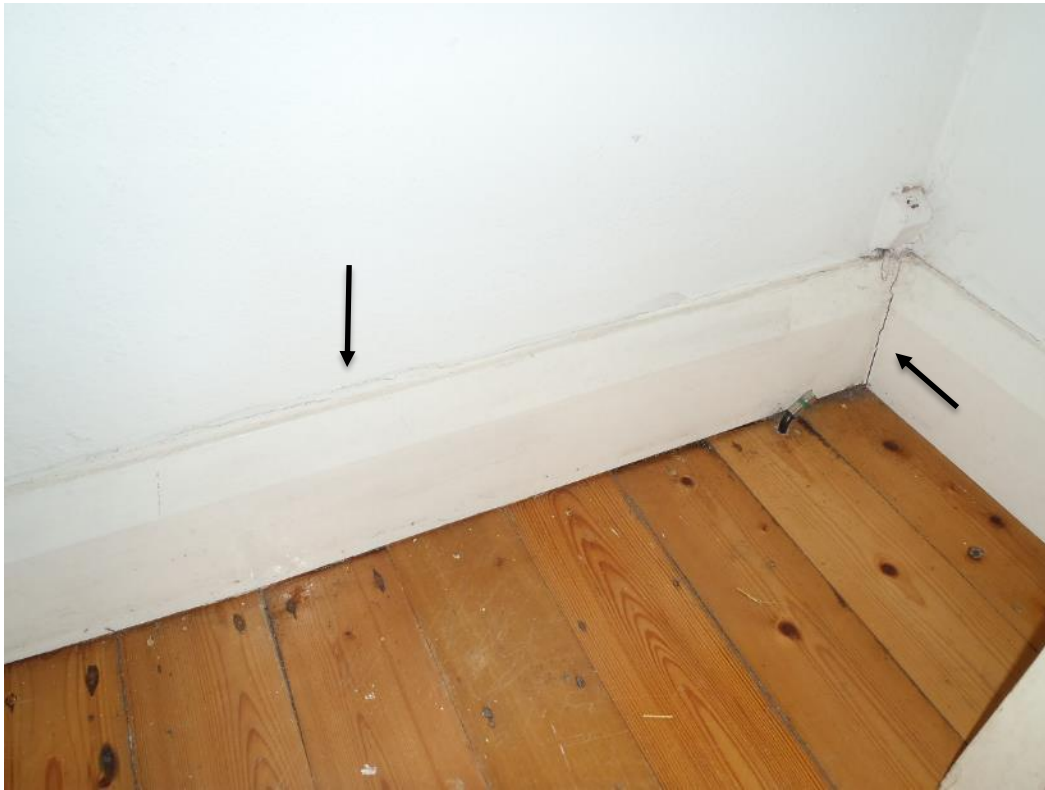
We noted separation cracking [ $< 1$  mm] between the wall surface and the skirting in the north-eastern corner. We further noted separation cracking [ $< 1$  mm] to the mitre joint in the skirting. **[Photograph 34]**

**Photograph 34** shows separation cracking between the wall surface and the skirting in the north-eastern corner & to the mitre joint in the skirting in the Lounge Room.

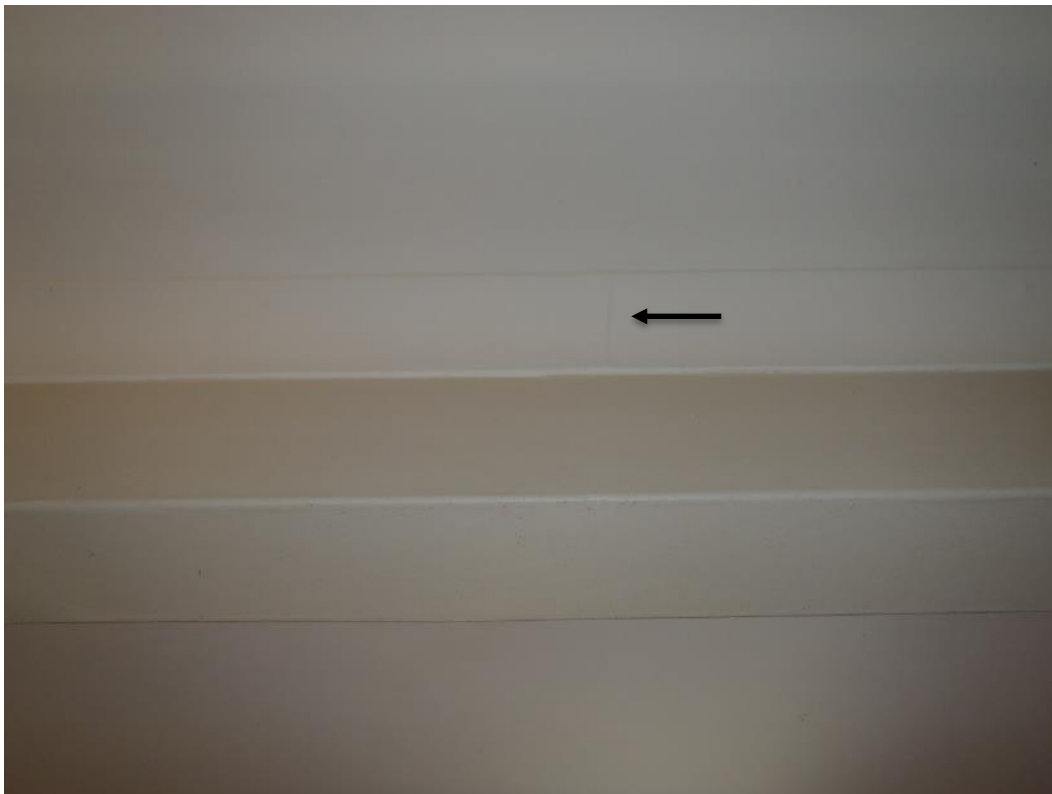
We noted vertical cracking [ $< 1$  mm] to the cove profiled cornice on the northern wall above the doorway. **[Photograph 35]**

**Photograph 35** shows vertical cracking to the cove profiled cornice on the northern wall above the doorway in the Lounge Room.

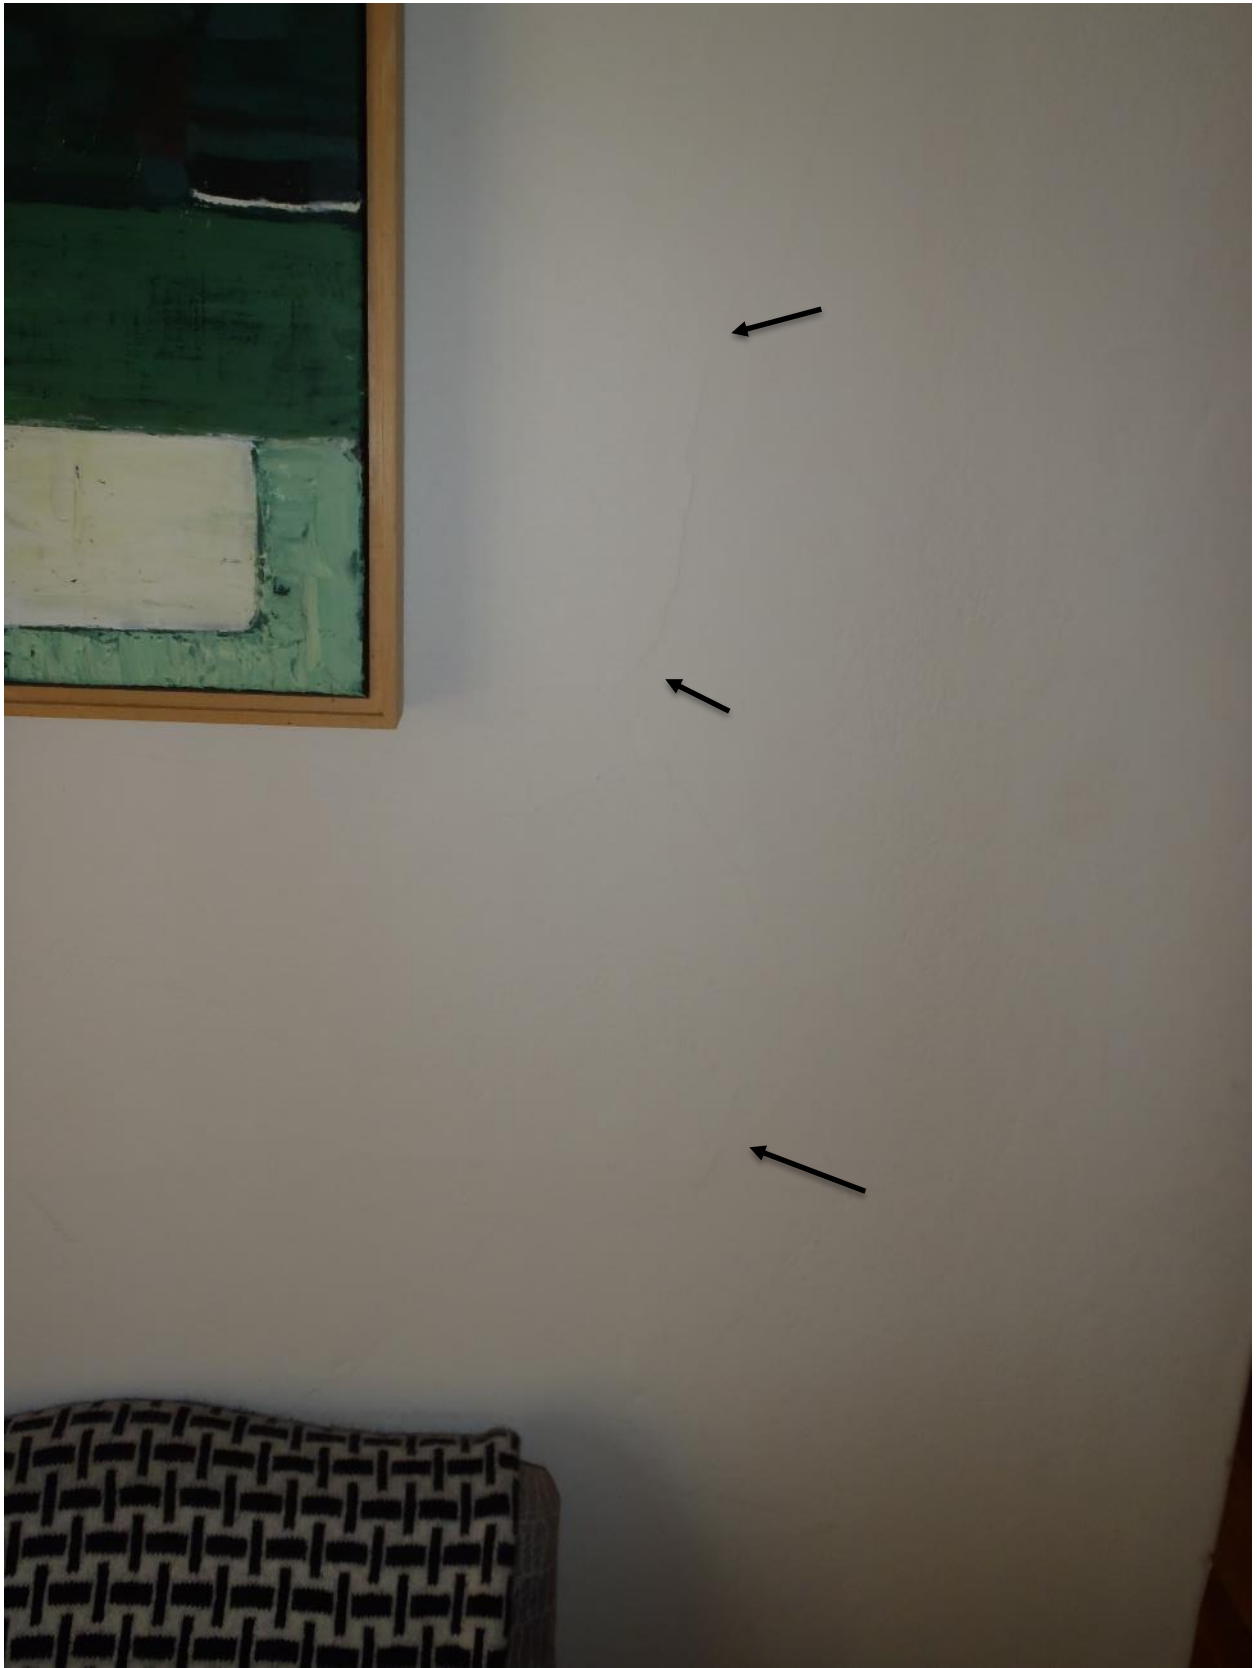
We noted radial cracking [ $< 1$  mm] adjacent to the doorway opening to the Kitchen. **[Photograph 36]**

**Photograph 36** shows radial cracking adjacent to the doorway opening to the Kitchen in the Lounge Room.

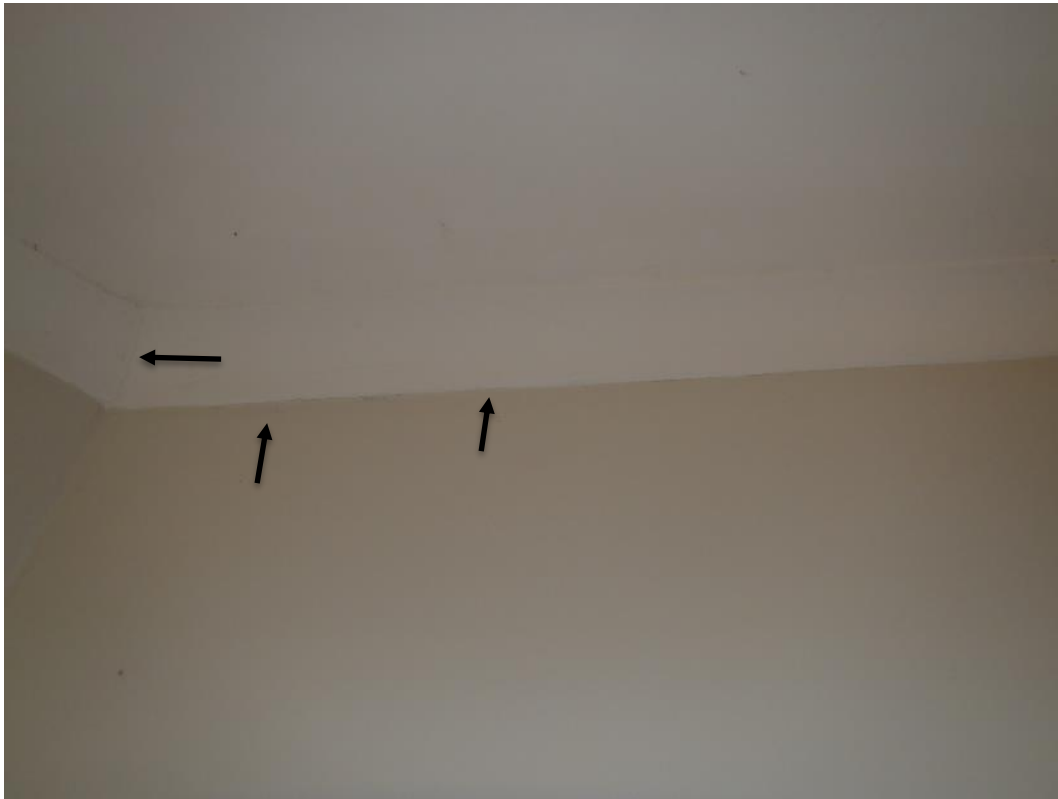
We noted separation cracking [ $< 1$  mm] between to the wall surface and the cove profiled plaster cornice in the north-western corner adjacent to the fireplace. We further noted separation cracking [ $< 1$  mm] to the mitre joint in the cornice. **[Photograph 37]**

**Photograph 37** shows separation cracking between to the wall surface and the cornice adjacent to the fireplace & to the mitre joint in the cornice in the Lounge Room.

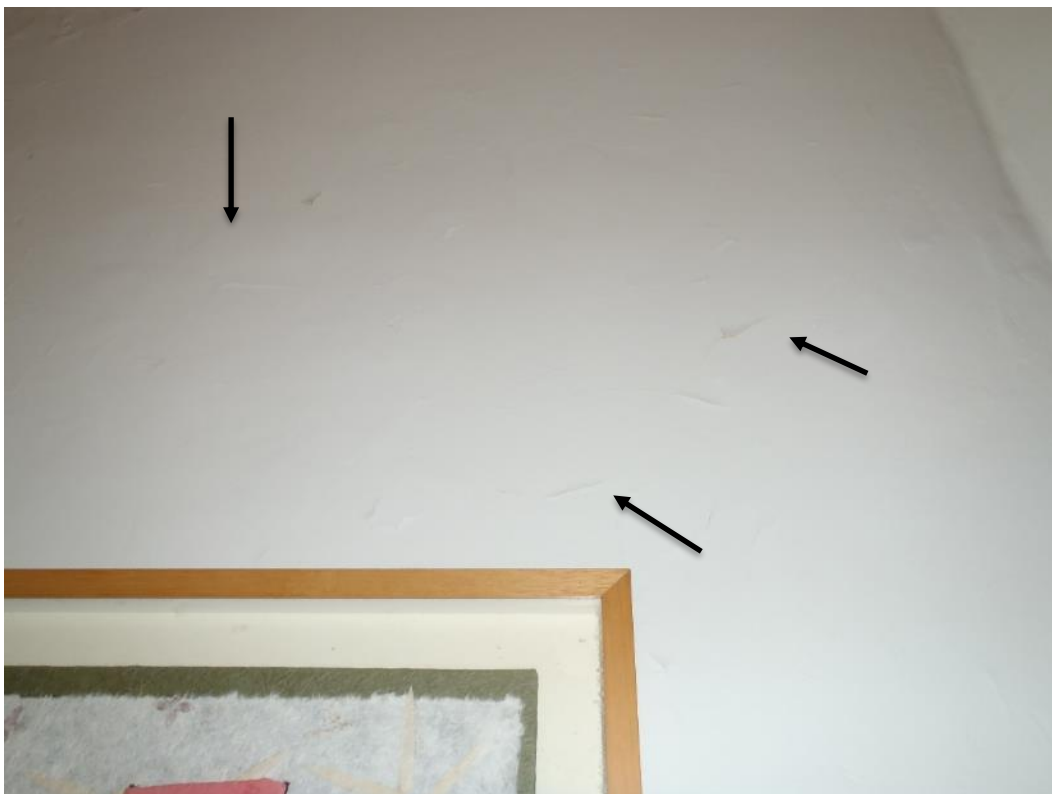
We noted flaking paint to the wall surface above the fireplace. **[Photograph 38]**

**Photograph 38** shows flaking paint to the wall surface above the fireplace in the Lounge Room.

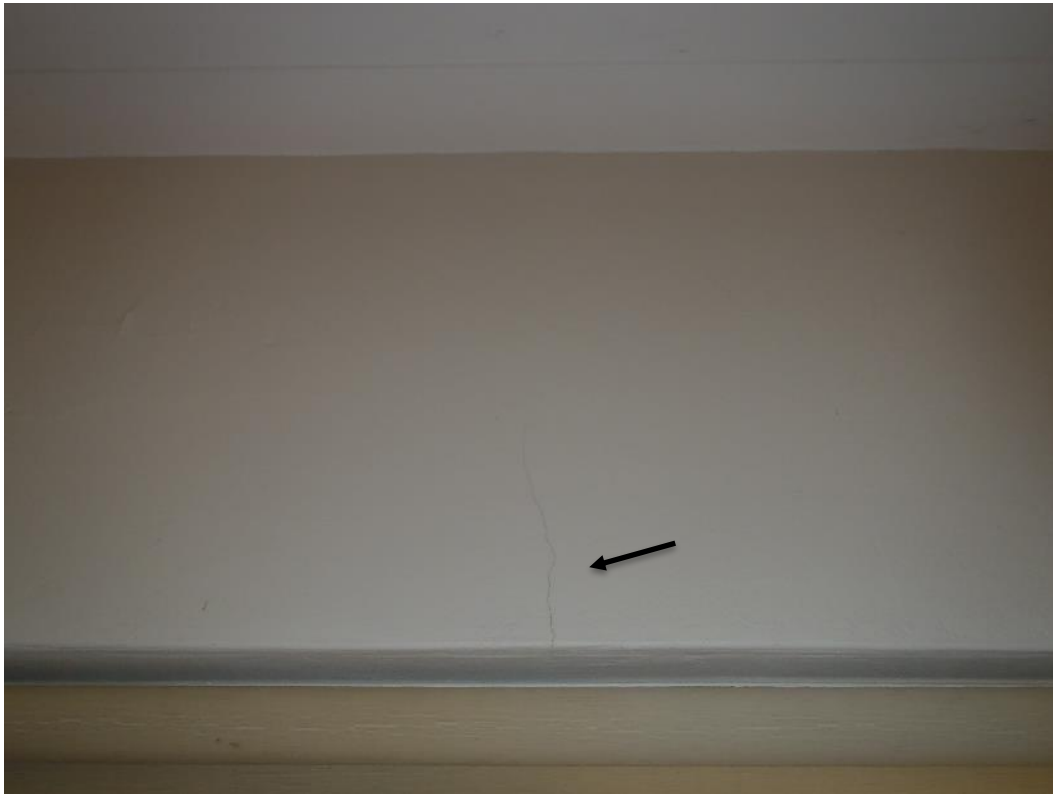
We noted vertical cracking [ $< 1$  mm] to the wall surface above the window. **[Photograph 39]**

**Photograph 39** shows vertical cracking to the wall surface above the window in the Lounge Room.

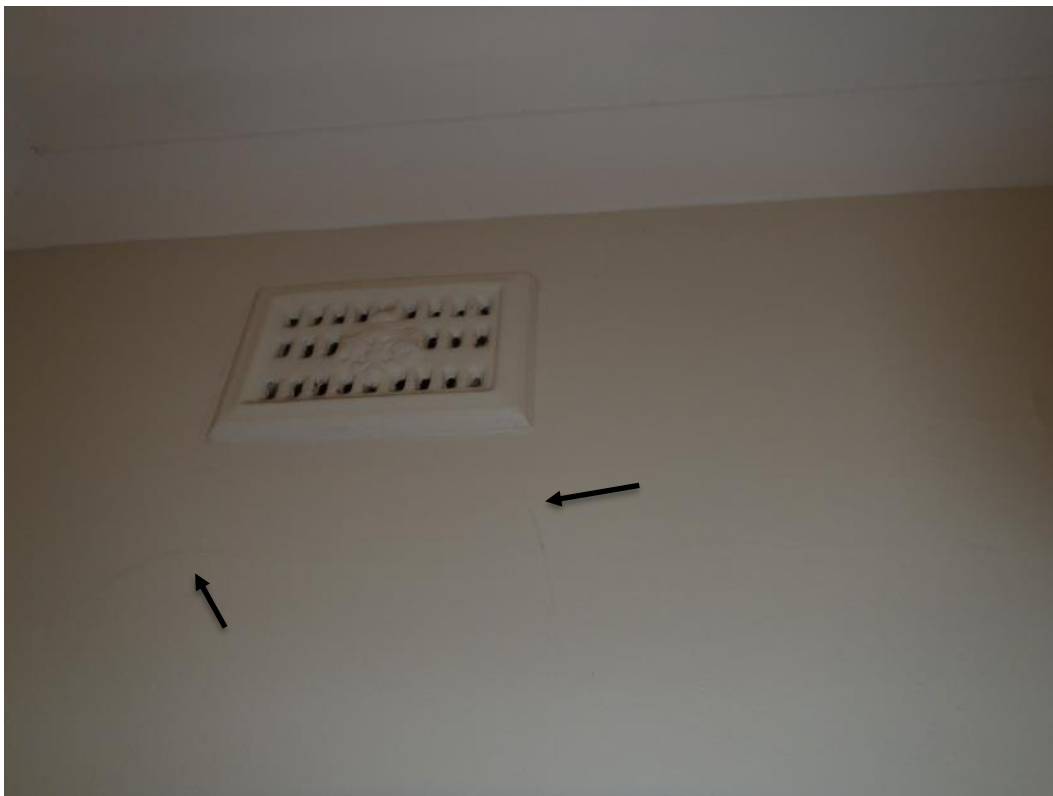
We noted radial cracking [ $< 1$  mm] to the wall surface around the wall vent in the south-western corner. **[Photograph 40]**

**Photograph 40** shows radial cracking to the wall surface around the wall vent in the south-western corner of the Lounge Room.

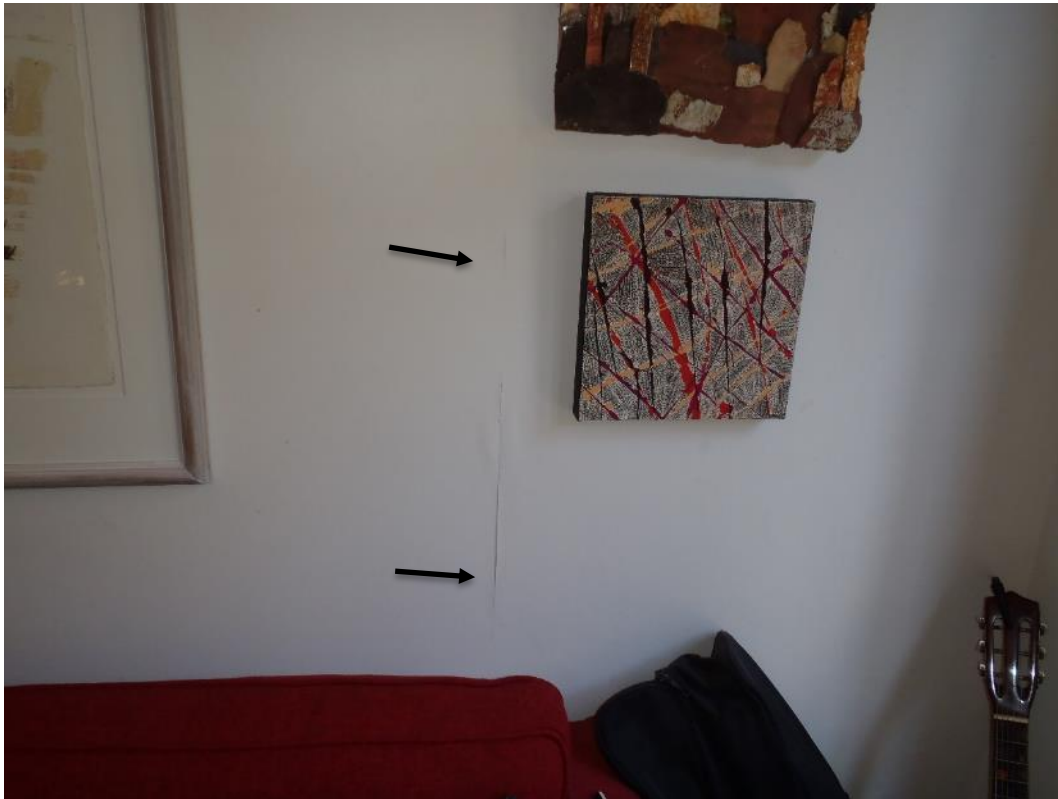
We noted flaking paint and separation cracking to the surface coated cement rendered wall on the southern wall. **[Photograph 41]**

**Photograph 41** shows flaking paint and separation cracking to the wall on the southern wall in the Lounge Room.

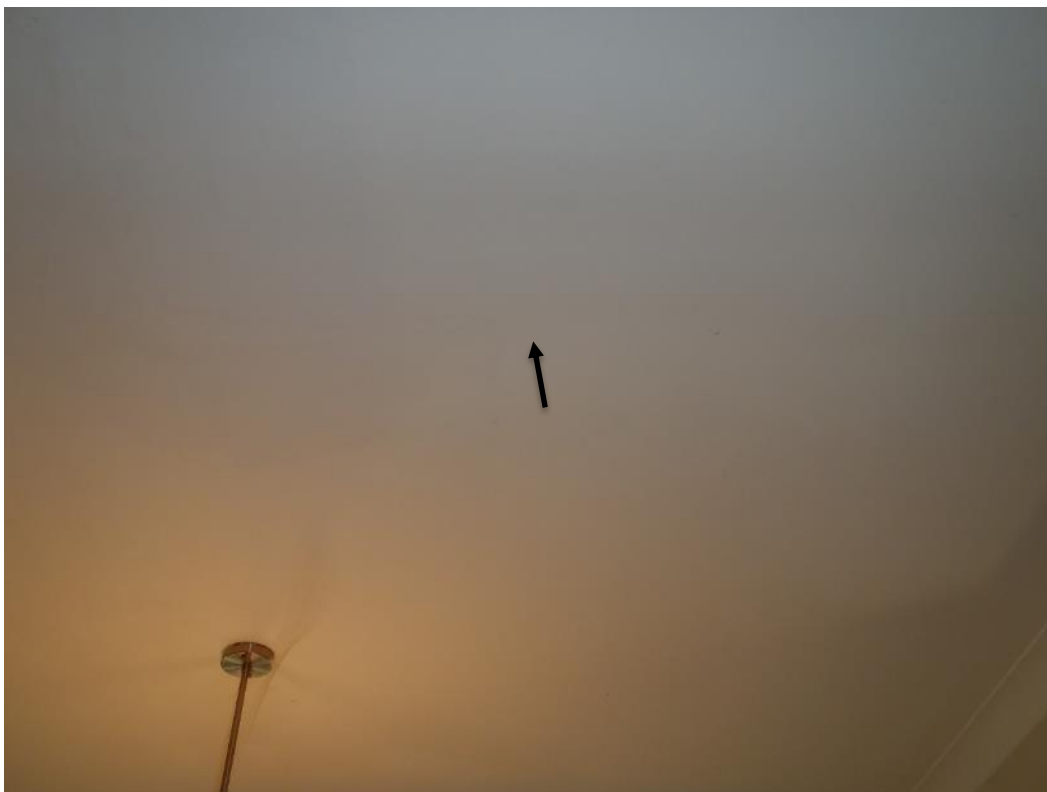
We noted hairline cracking [ $< 1$  mm] to the plaster ceiling lining through the centre of the room adjacent to the light fitting. **[Photograph 42]**

**Photograph 42** shows hairline cracking to the ceiling lining adjacent to the light fitting in the Lounge Room.

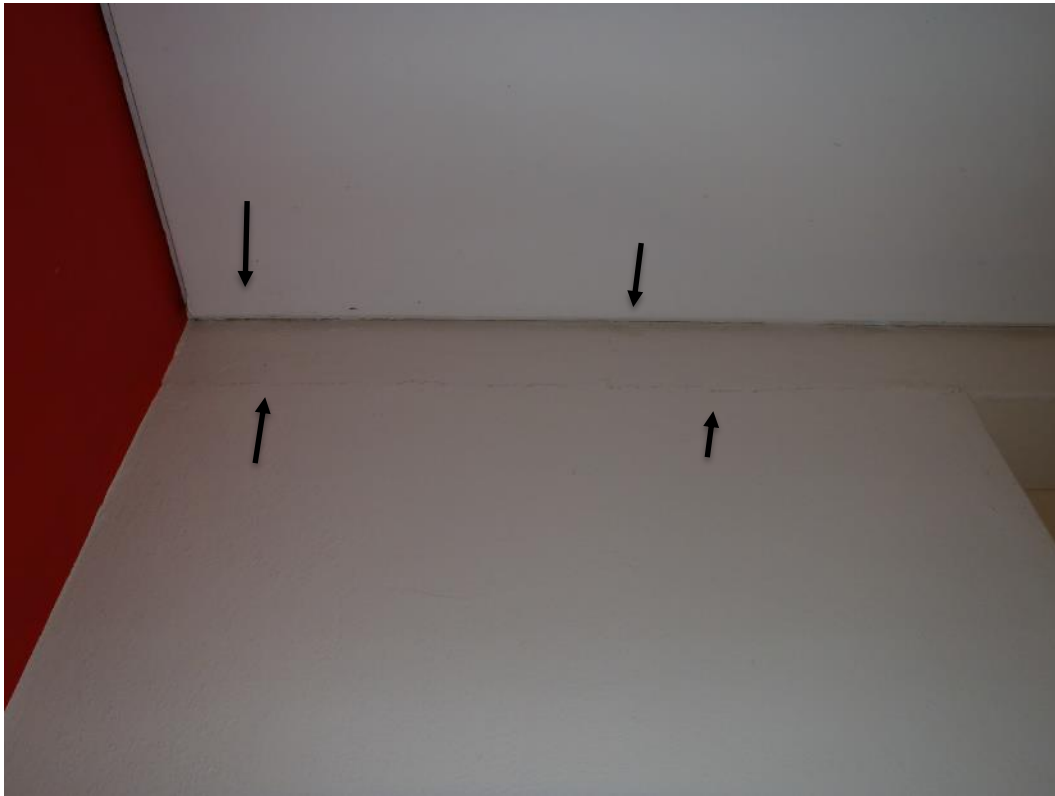
We noted horizontal cracking [ $< 1$  mm] and separation cracking to the shadow set junction adjacent to the *common party / separation* wall with the adjoining property, No. 72 Middle Street, Kingsford in the south-eastern corner. **[Photograph 43]**

**Photograph 43** shows horizontal cracking and separation cracking to the shadow set junction in the south-eastern corner of the Kitchen.

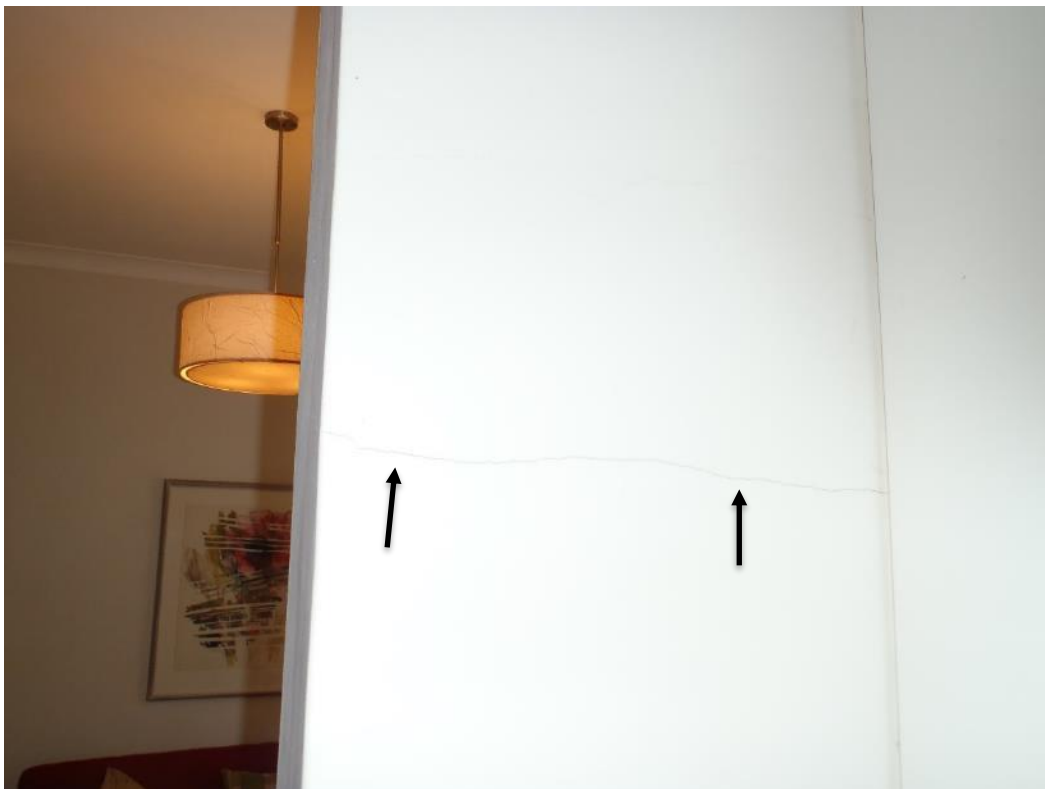
We noted horizontal cracking [ $< 1$  mm] to the wall surface extending from the doorway arch. **[Photograph 44]**

**Photograph 44** shows horizontal cracking to the wall surface extending from the doorway arch in the Kitchen.

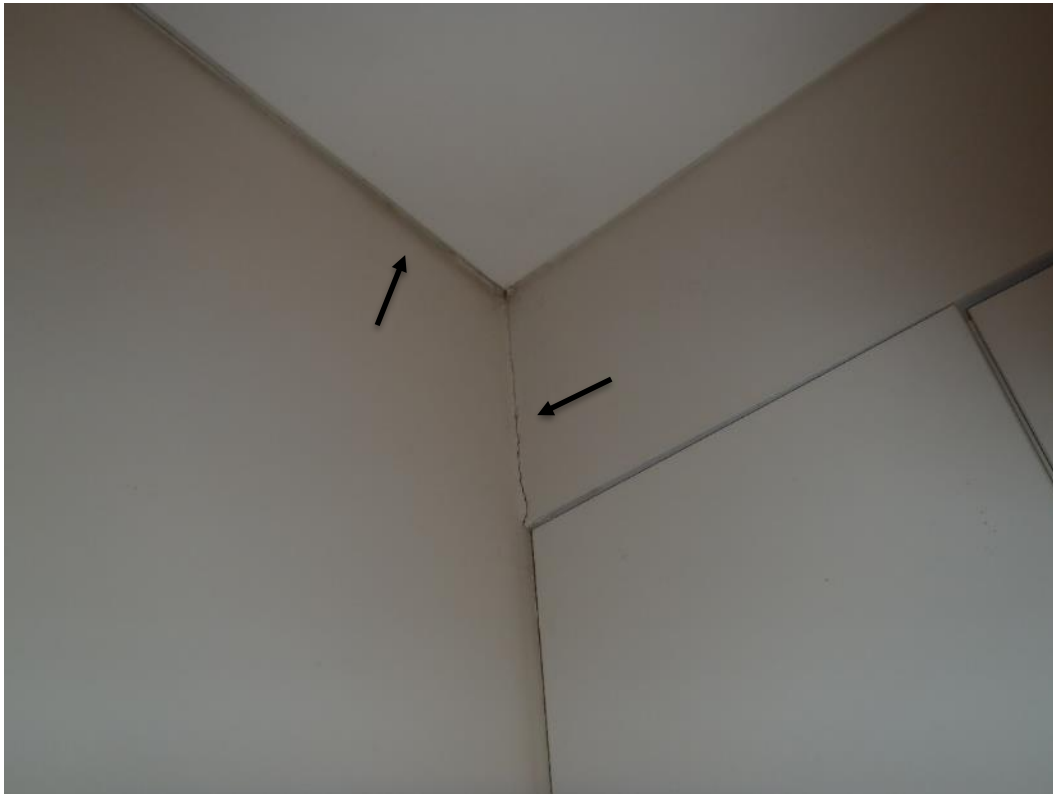
We noted separation cracking [ $< 1$  mm] to the wall to wall junction and separation cracking to the shadow set junction in the south-western corner. **[Photograph 45]**

**Photograph 45** shows separation cracking to the wall to wall junction and separation cracking to the shadow set junction in the south-western corner of the Kitchen.
