## Dilapidation Assessment Report

Prepared for: Cape Cod Australia Pty. Limited  
Job address: 70 Middle Street, Kingsford.  
Property Owner/s: Mrs. Jessica Mander-Jones.  
Report reference: **RANDWICK COUNCIL**  
Development Application No: not available  
Date of assessment: 15<sup>th</sup> September 2017.

**Re: Dilapidation Report – No. 70 Middle Street, Kingsford.**

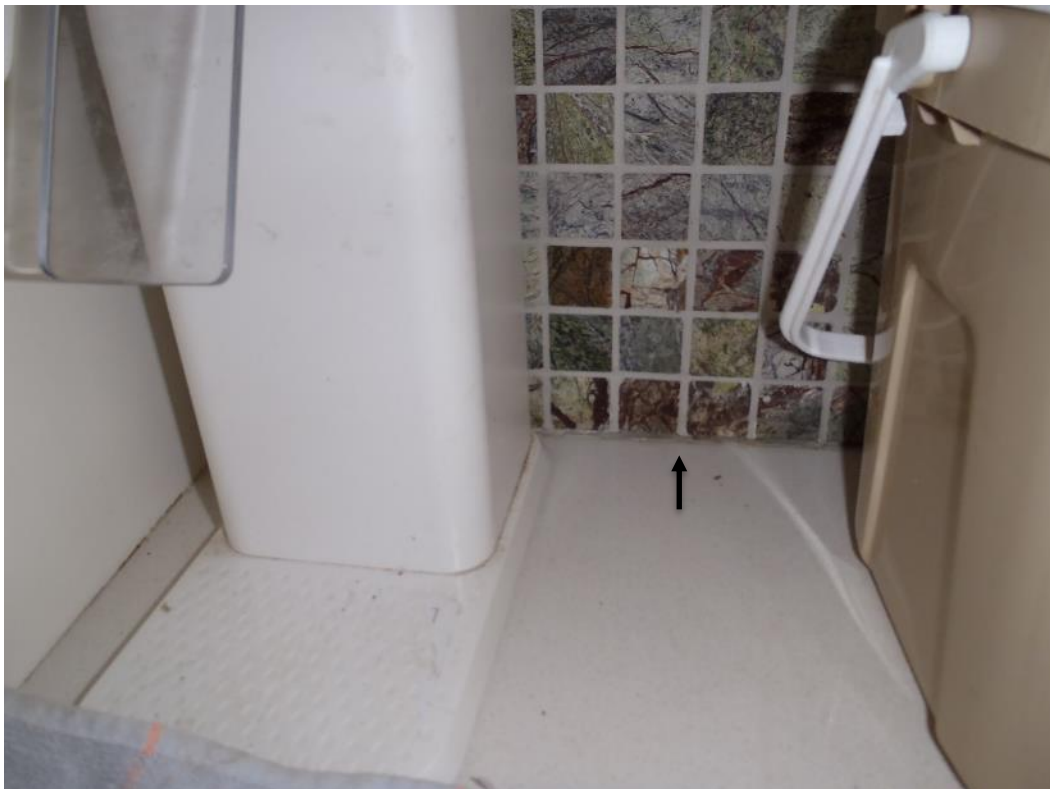
We noted separation cracking the tile grout at the wall to bench junction along the southern wall. **[Photograph 46]**

**Photograph 46** shows separation cracking the tile grout at the wall to bench junction along the southern wall of the Kitchen.

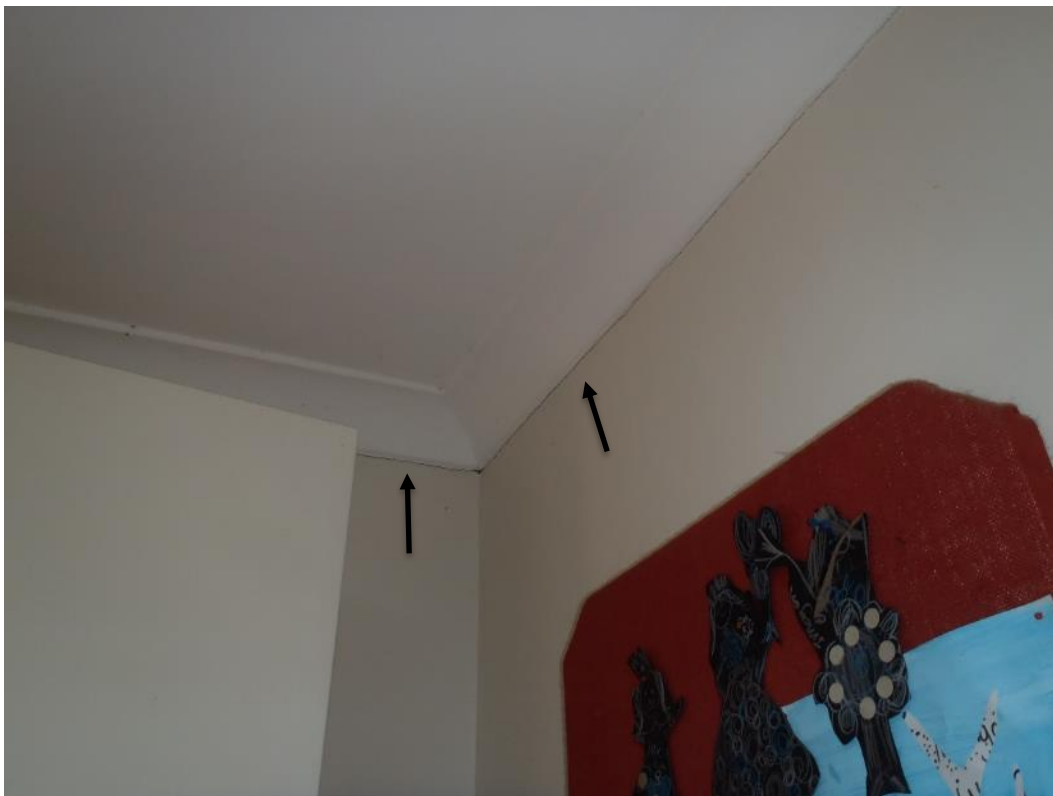
We noted separation cracking [ $< 1$  mm] between the wall surfaces and the cove profiled plaster cornice adjacent to the *common party / separation* wall with the adjoining property, No. 72 Middle Street, Kingsford in the south-eastern corner. **[Photograph 48]**

**Photograph 48** shows separation cracking between the wall surfaces and the cornice in the south-eastern corner of the Family Room.

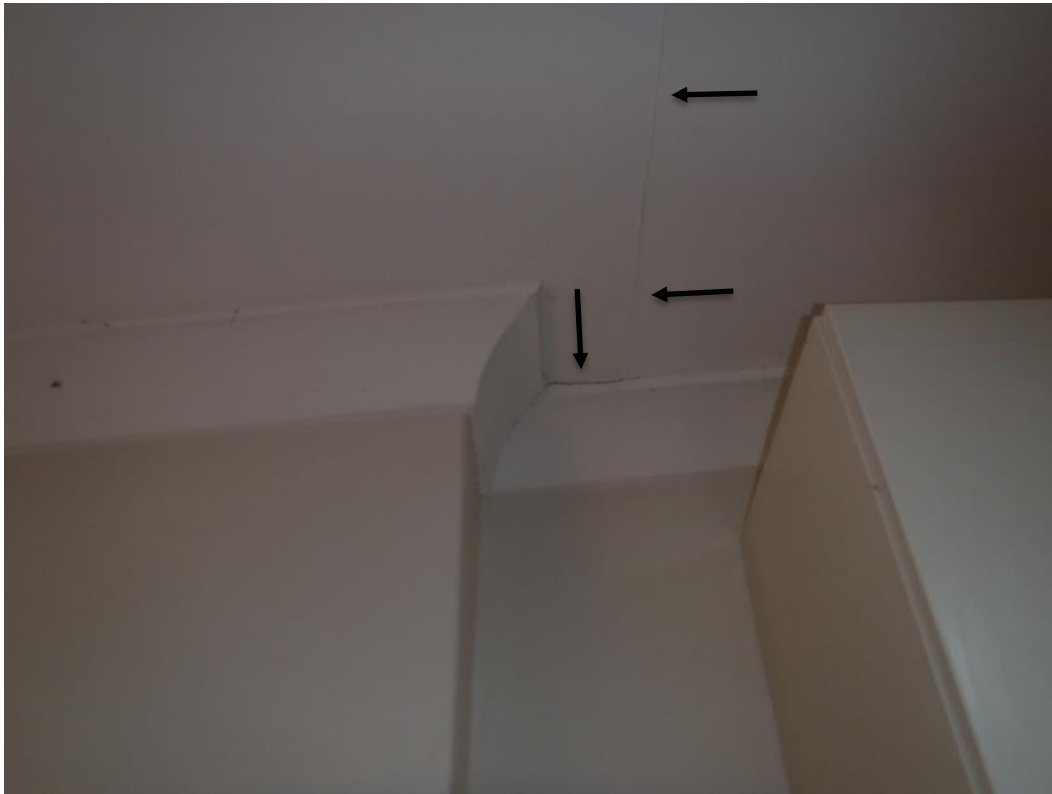
**Photograph 49** shows separation cracking between the ceiling lining and the cornice in the south-eastern corner & cracking to the ceiling lining extending from the *common party / separation* wall in the Family Room.

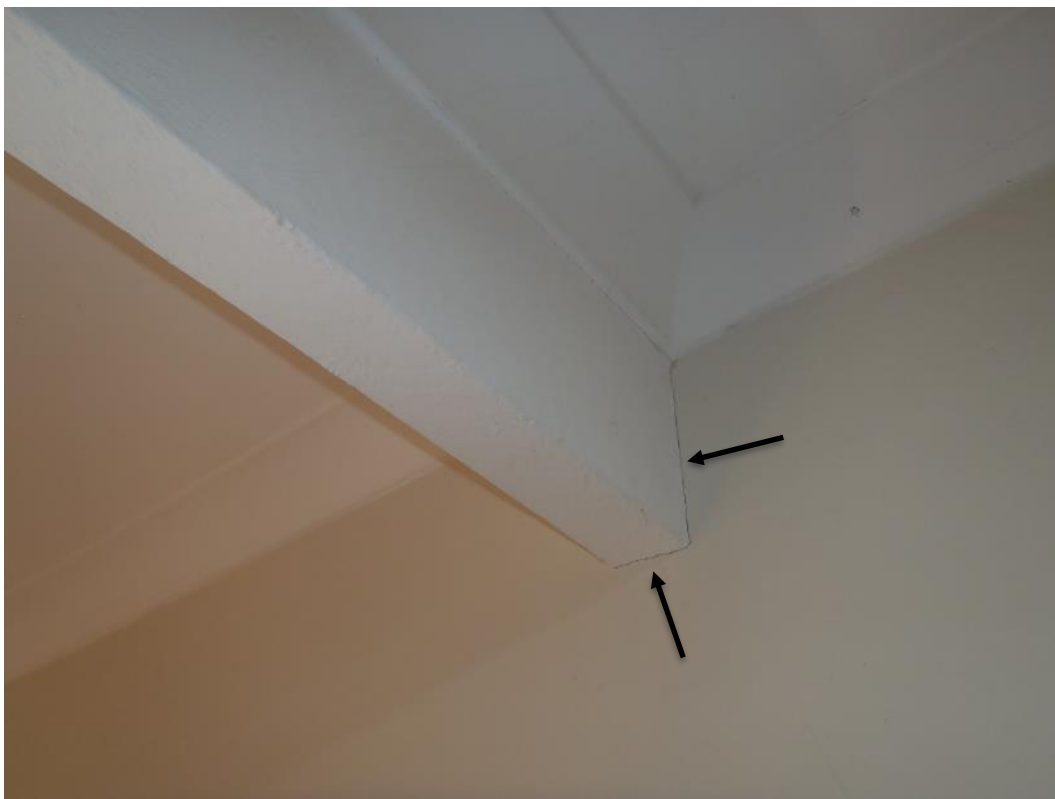
**Photograph 50** shows separation cracking between the bulkhead and the wall surface extending from the *common party / separation* wall with the adjoining property, No. 72 Middle Street, Kingsford.

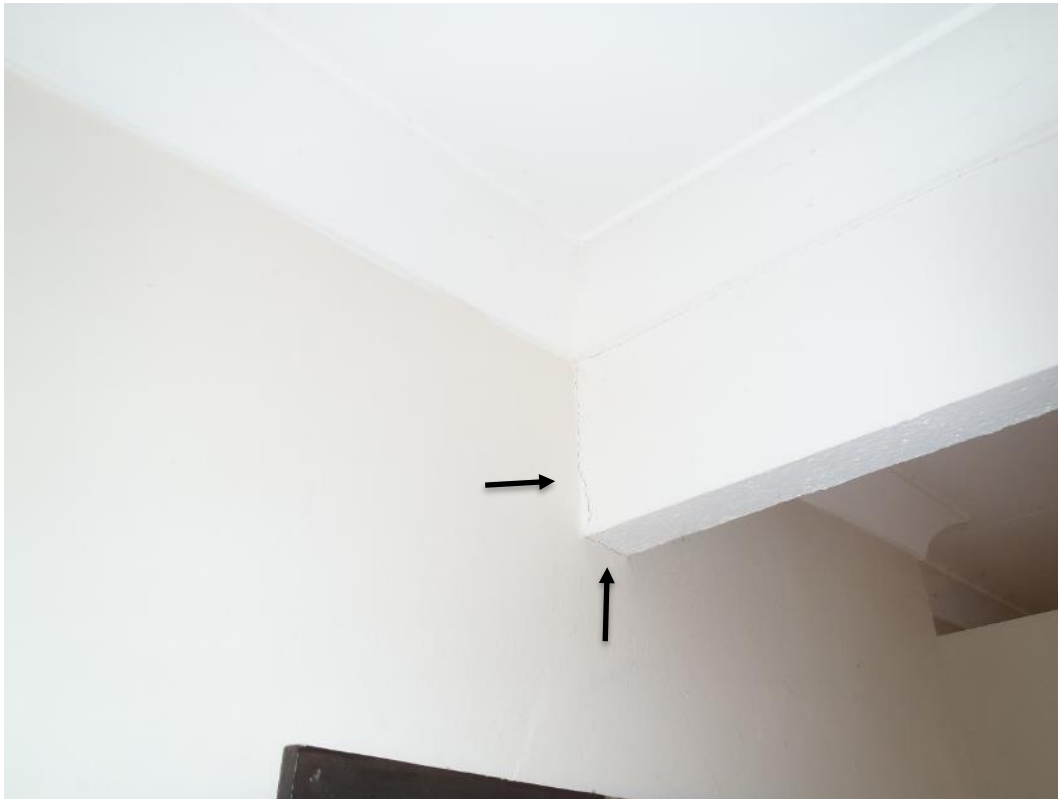
**Photograph 51** shows separation cracking between the bulkhead and the wall surface extending from the *common party / separation* wall with the adjoining property, No. 72 Middle Street, Kingsford.

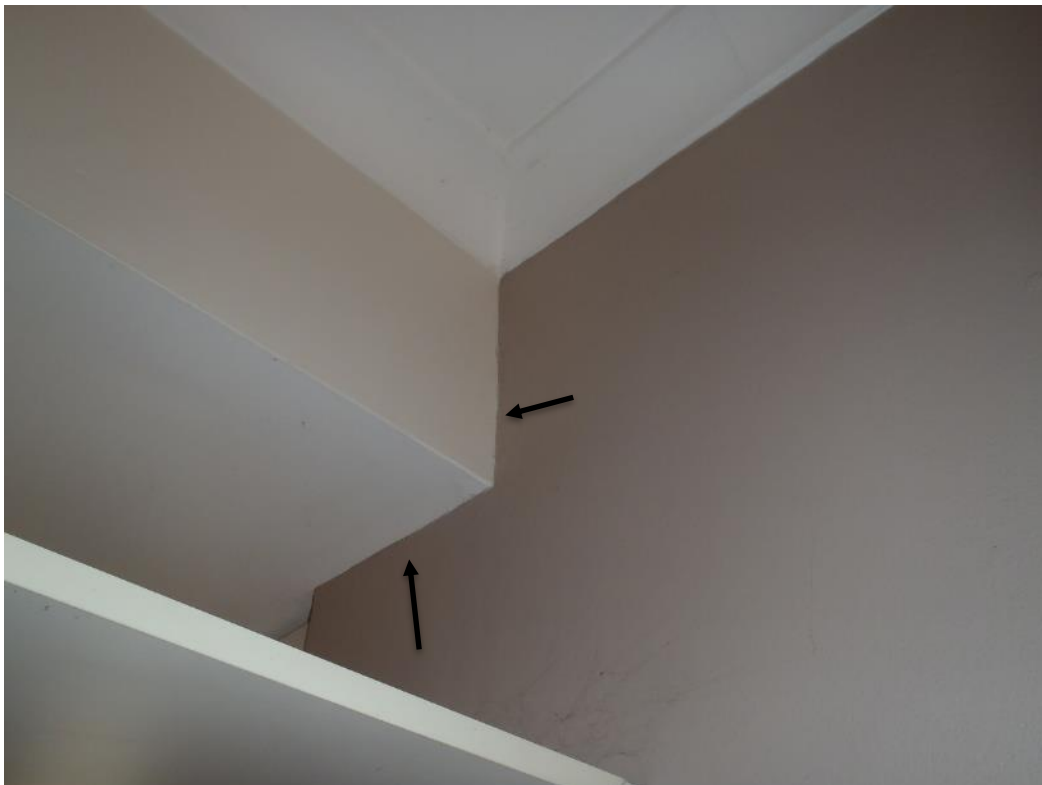
**Photograph 52** shows separation cracking between the bulkhead and the wall surface above the Kitchen Servery in the Family Room.

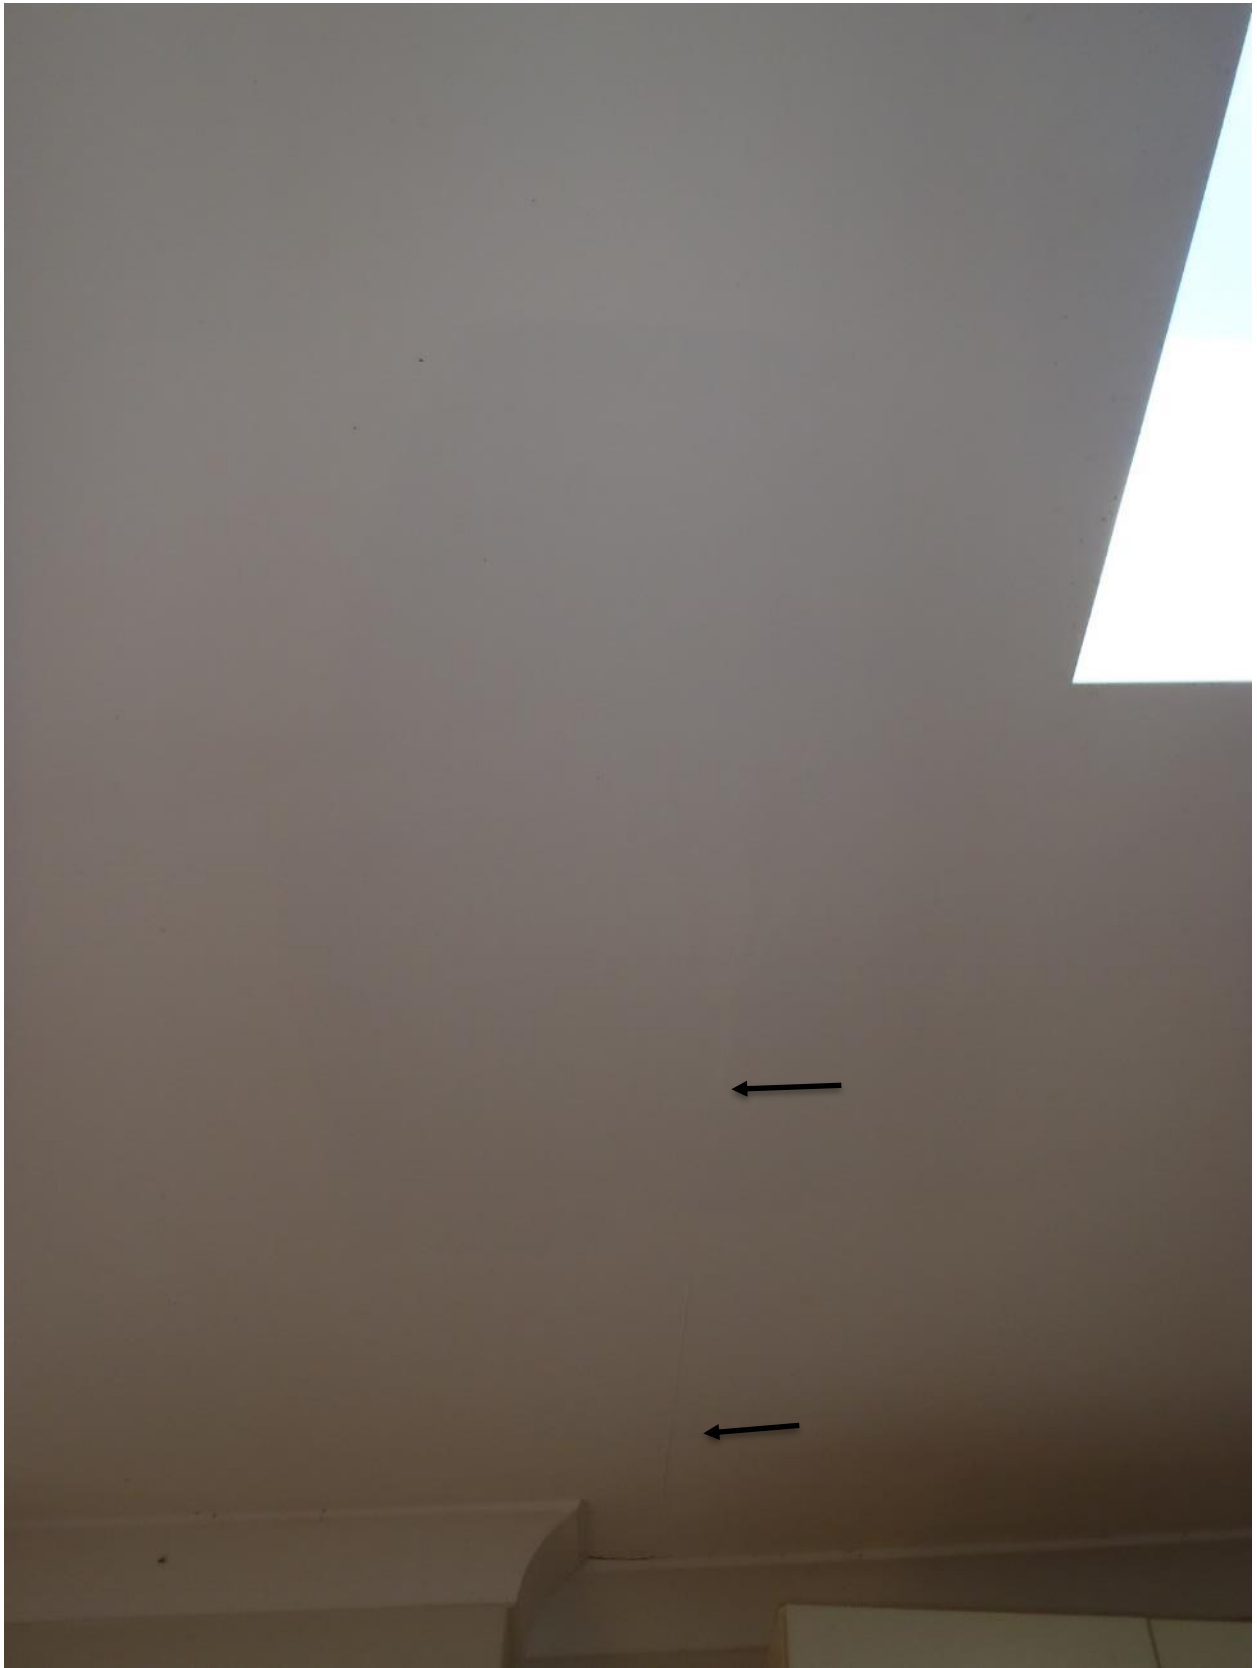
**Photograph 53** shows separation cracking to the plaster ceiling lining adjacent to the skylight in the Family Room.

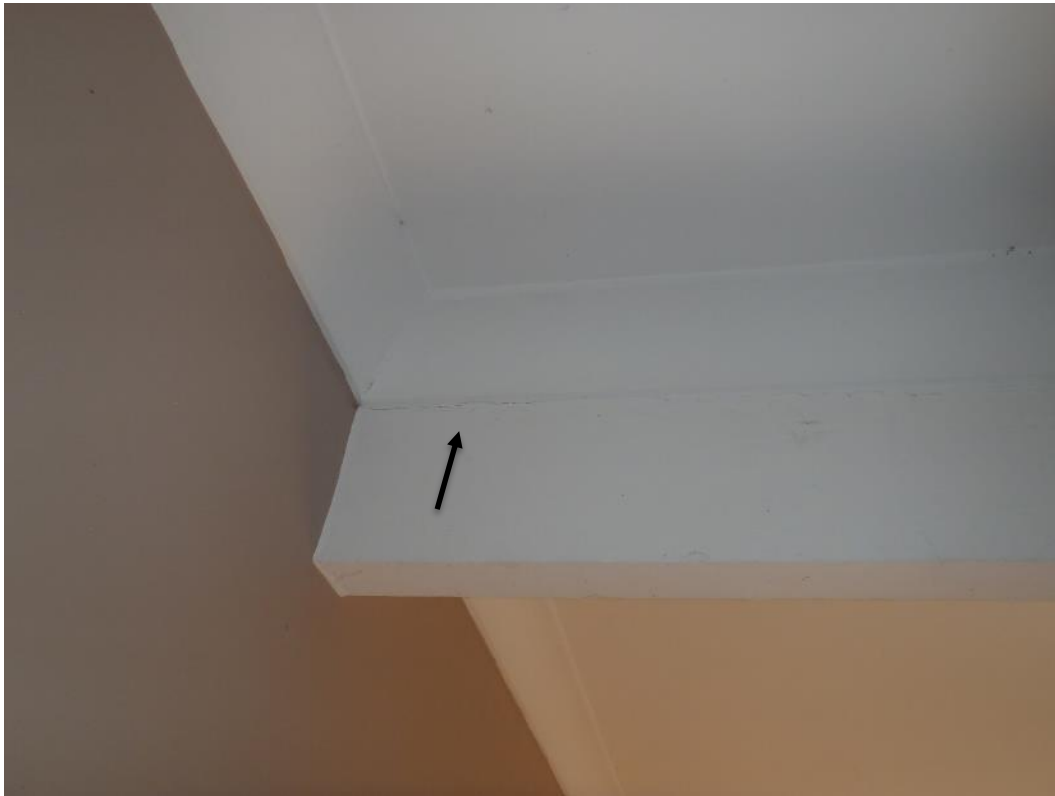
**Photograph 54** shows separation cracking between the bulkhead and the cornice from the western wall in the Family Room.

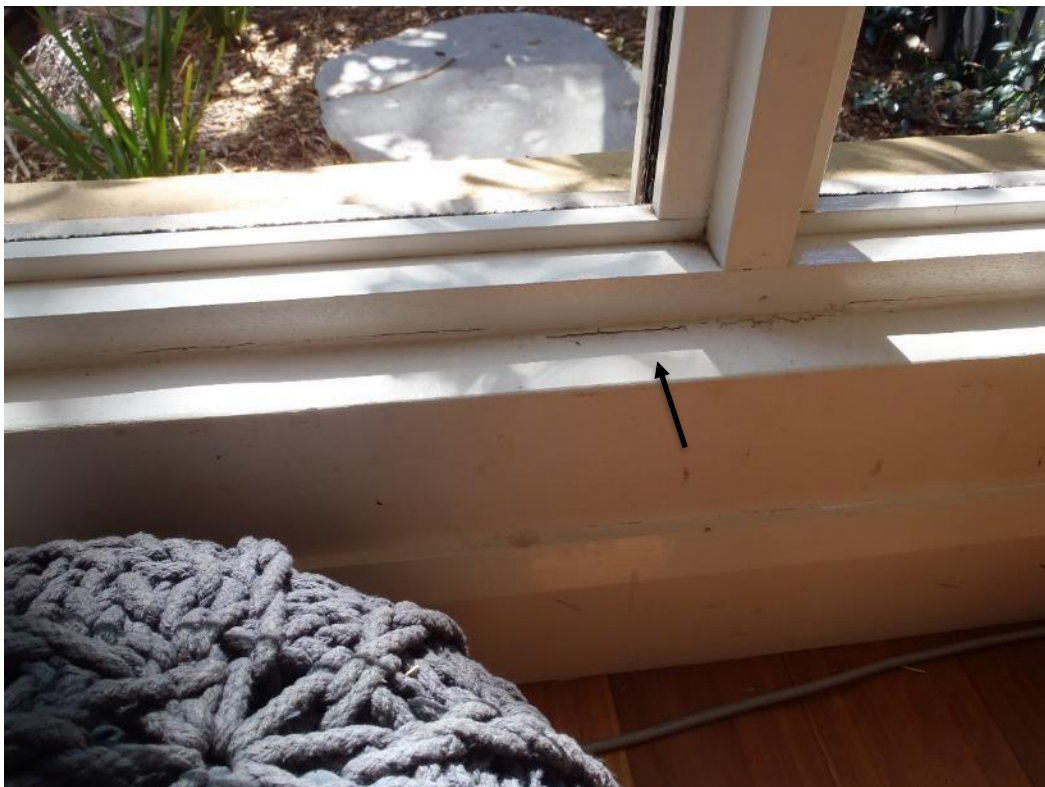
**Photograph 55** shows separation cracking between the window sill and the window trim in the Family Room.

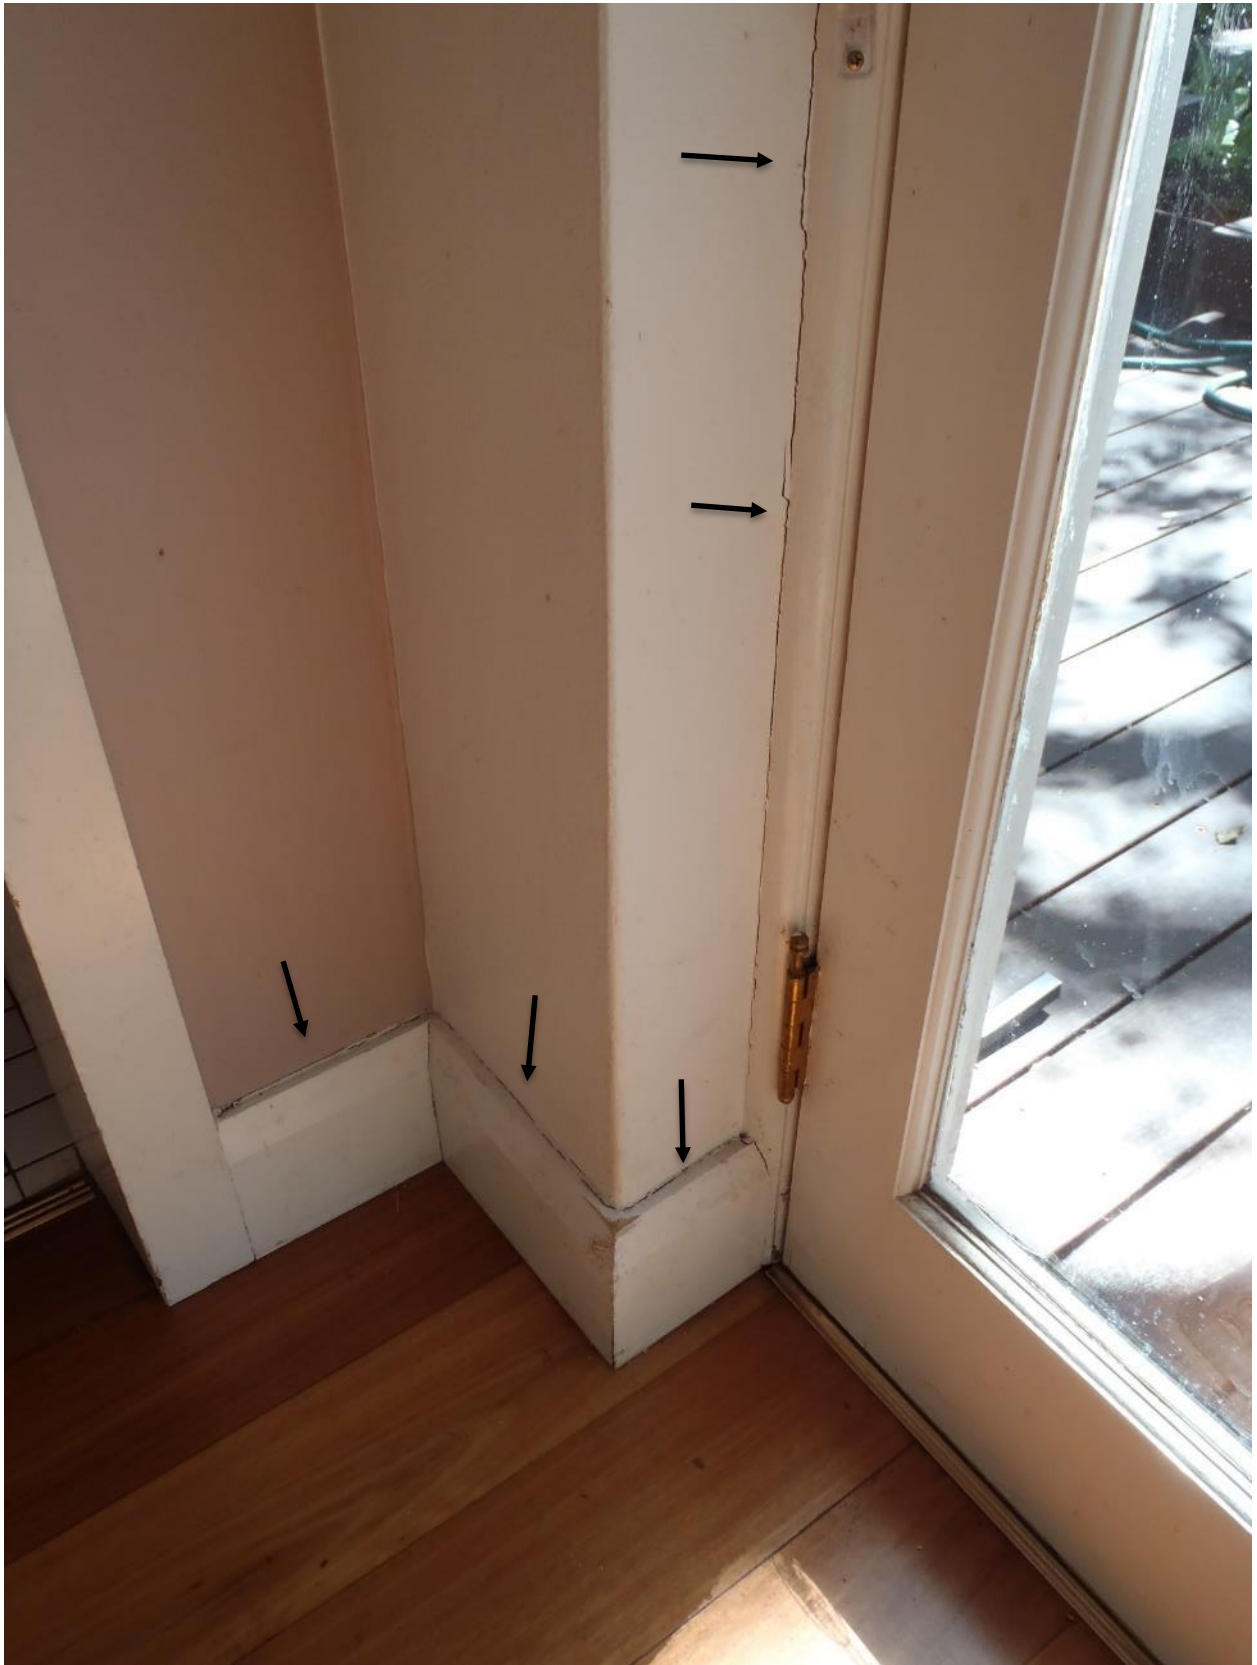
**Photograph 56** shows separation cracking between the door jamb trim and the wall surface & between the wall surface and the skirting in the Family Room.

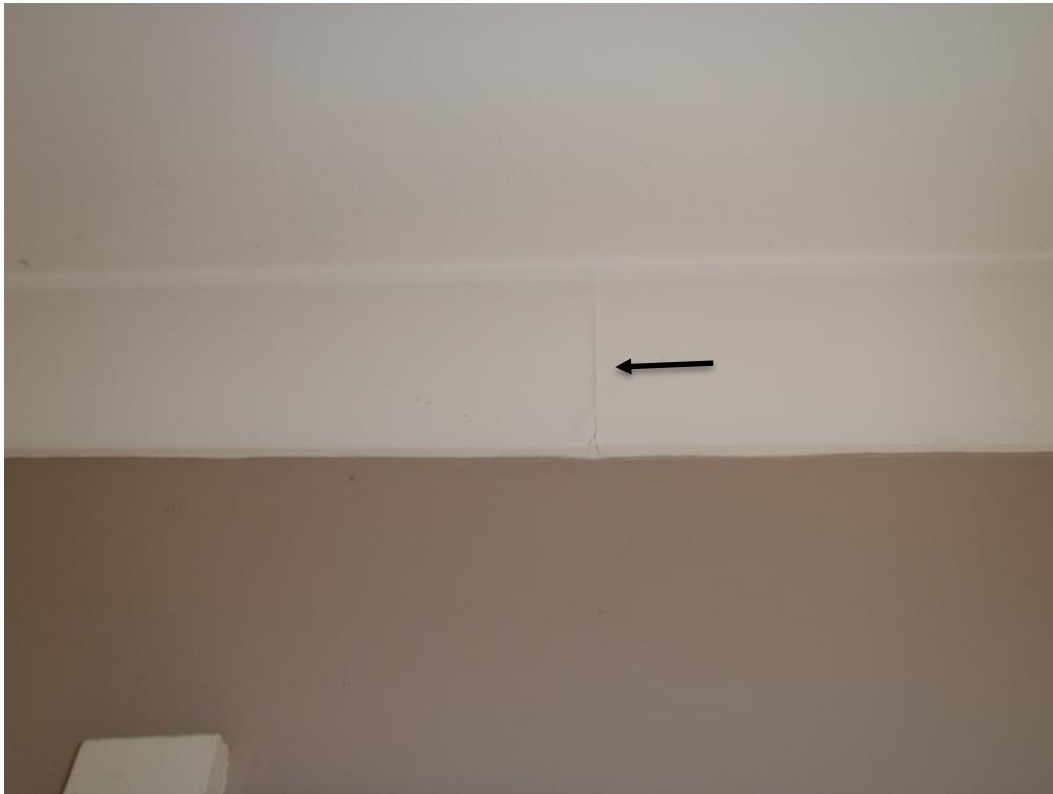
**Photograph 57** shows separation cracking to the cornice above the Laundry door in the Family Room.

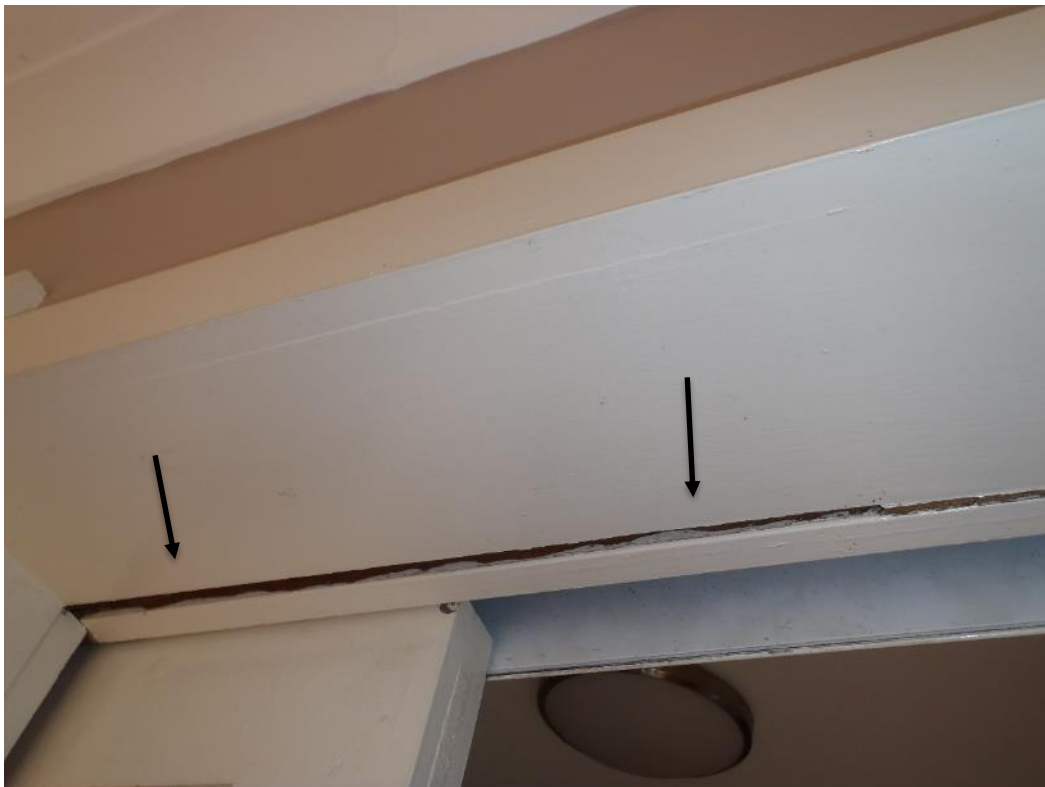
**Photograph 58** shows separation cracking to the sliding door trim above the Laundry door in the Family Room.

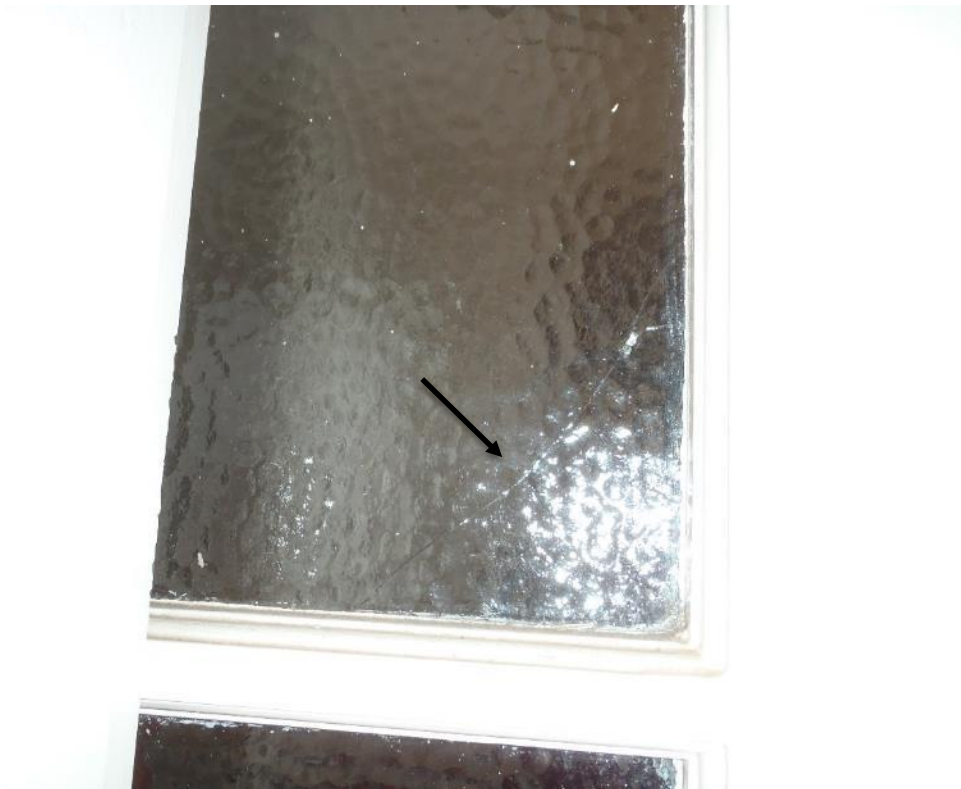
**Photograph 59** shows cracking to the glass infill to the Laundry door.

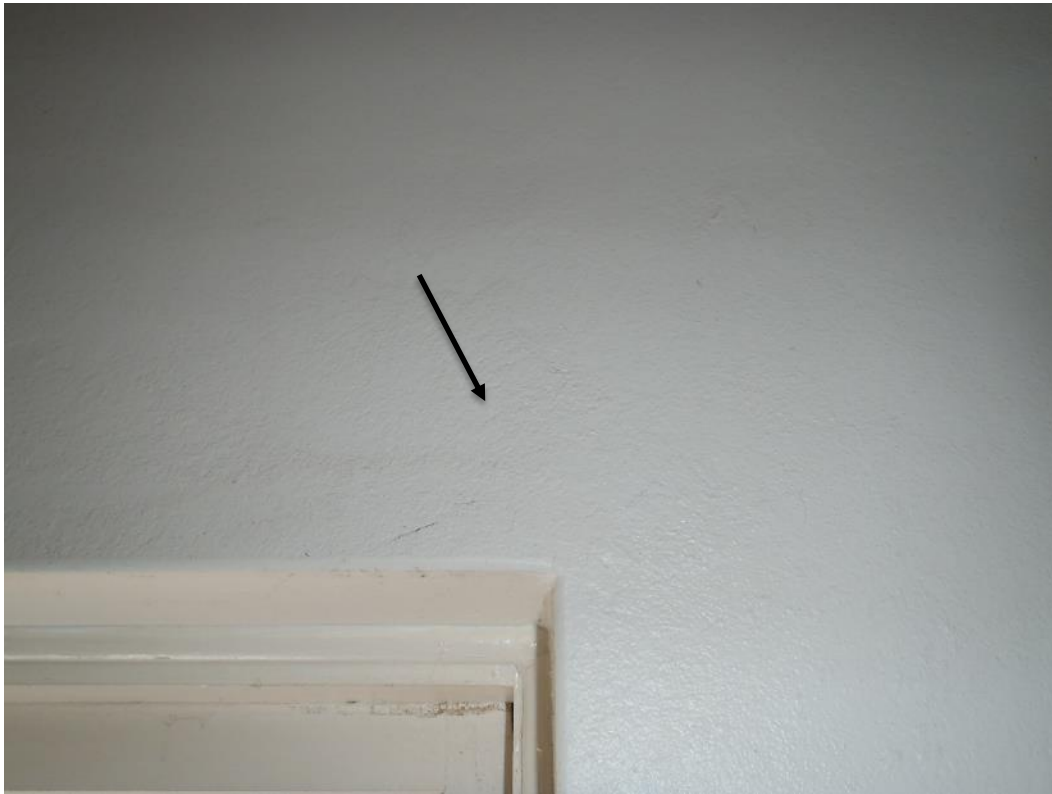
**Photograph 61** shows evidence of a previous repair to the western wall above the window in the Bathroom.

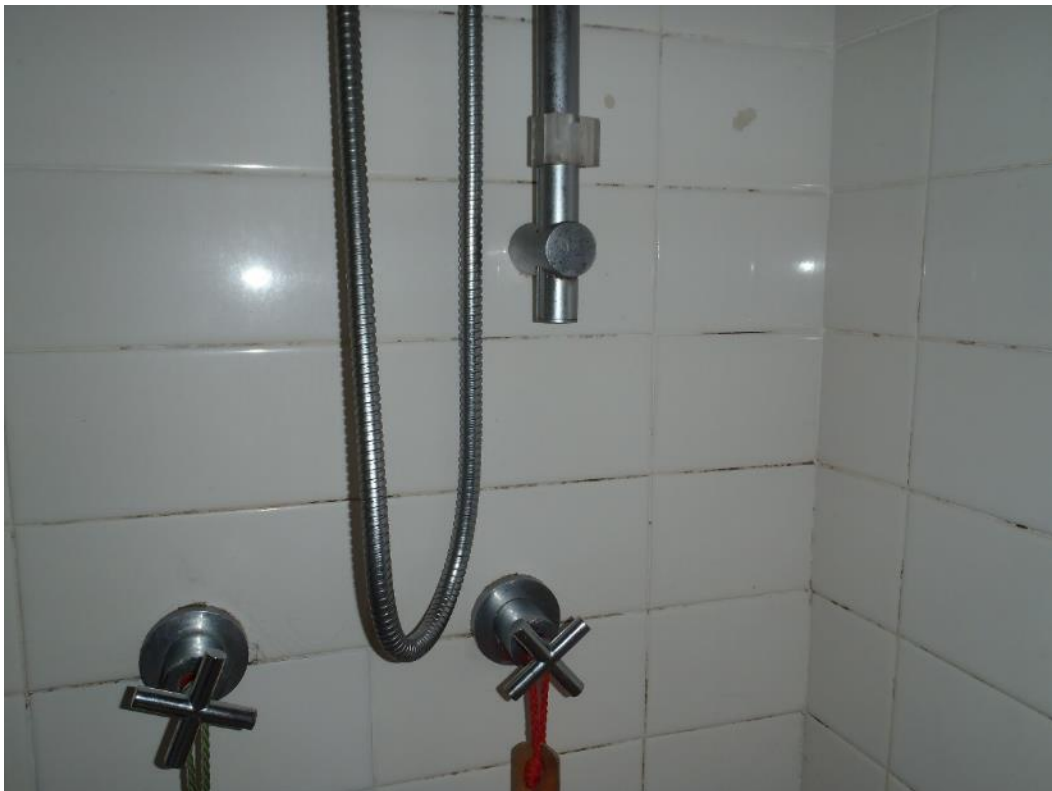
**Photograph 62** shows displaced grout to the floor and wall tiles in the Bathroom shower.

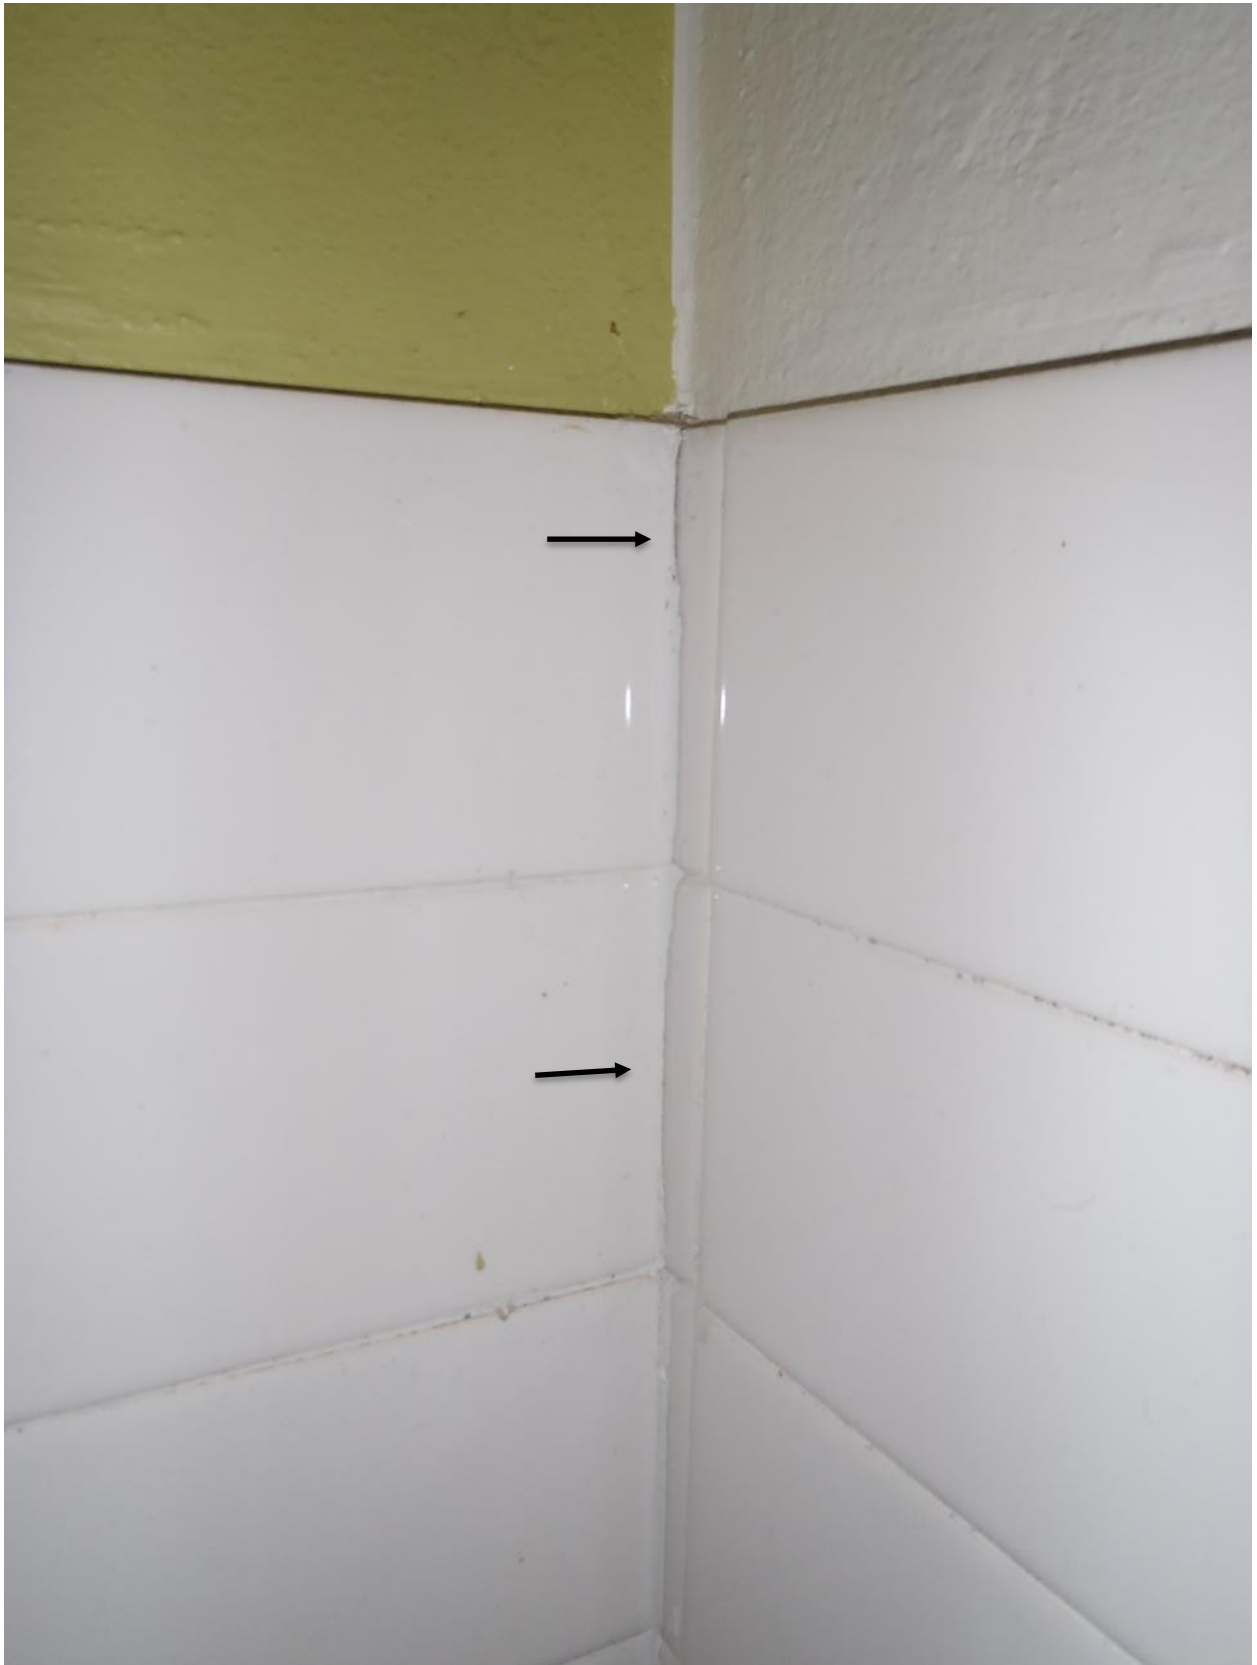
**Photograph 63** shows separation cracking the tile grout at the wall to wall junction in the south-eastern corner of the Bathroom.

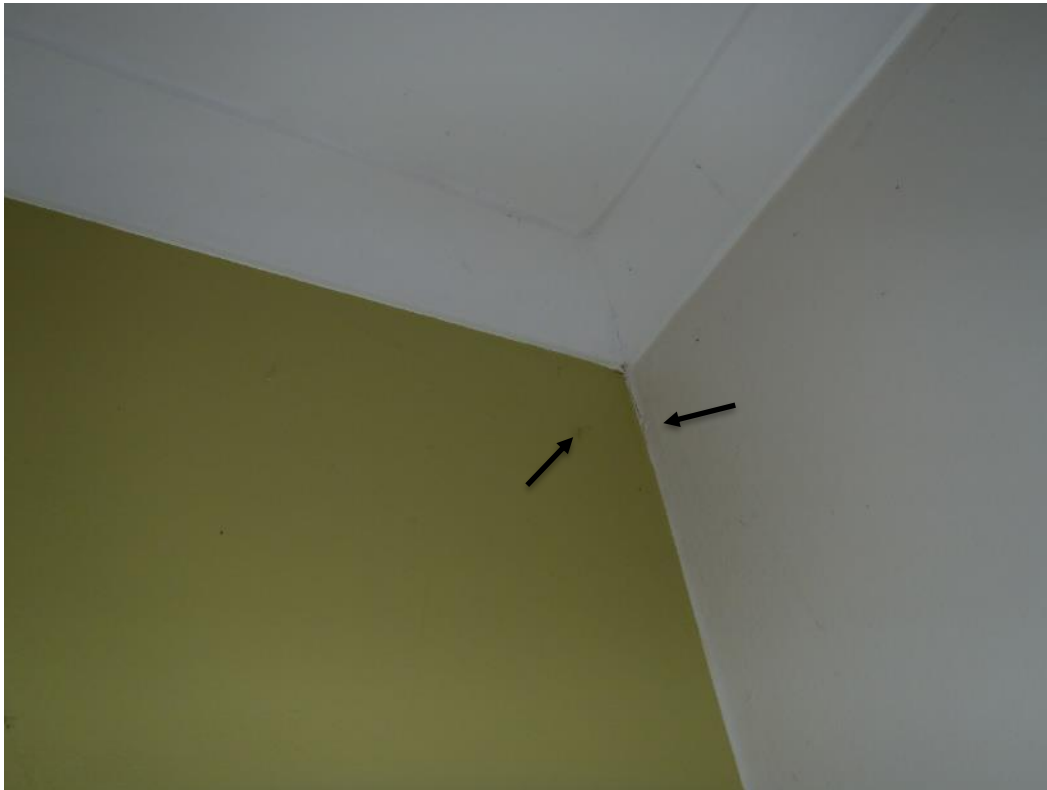
**Photograph 64** shows radial cracking to the wall surface in the south-eastern corner of the Bathroom.

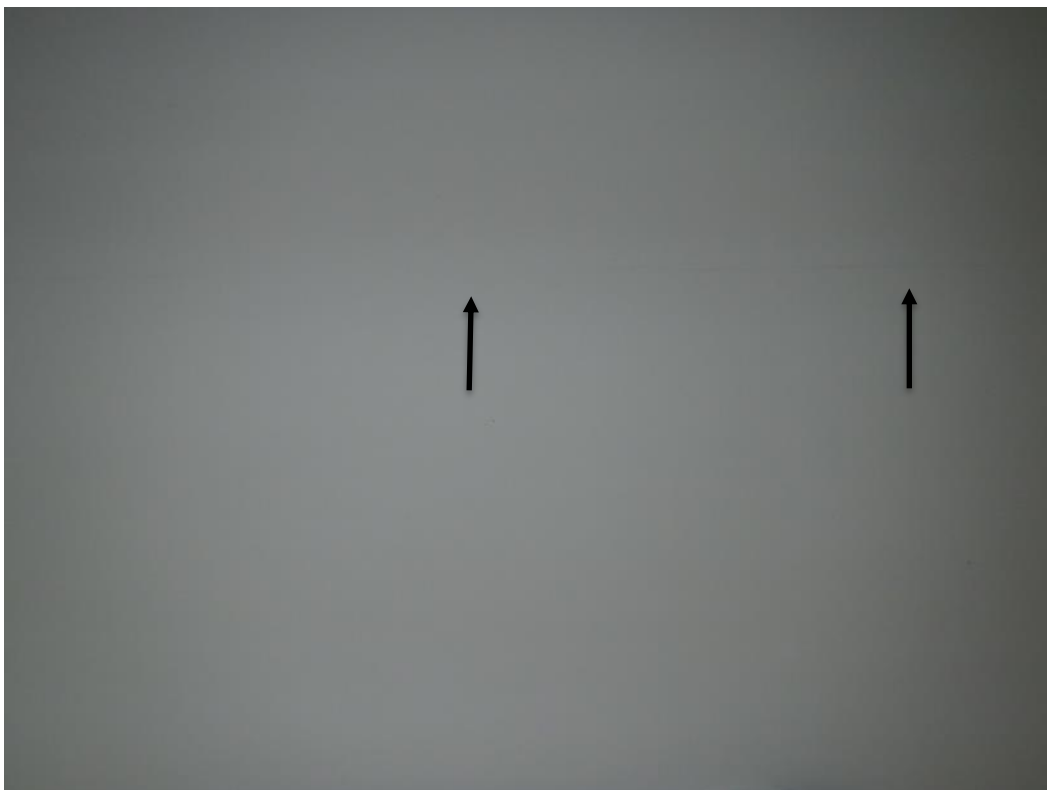
**Photograph 65** shows cracking to the plaster ceiling lining from east to west in the Bathroom.
