Bridge Inspection Report

142270011312090
LP343/CESAR CHAVEZ
over
SHOAL CREEK

Inspection Date: 02/23/2024
Inspected By: Thomas Tu
Inspection Type(s): Routine

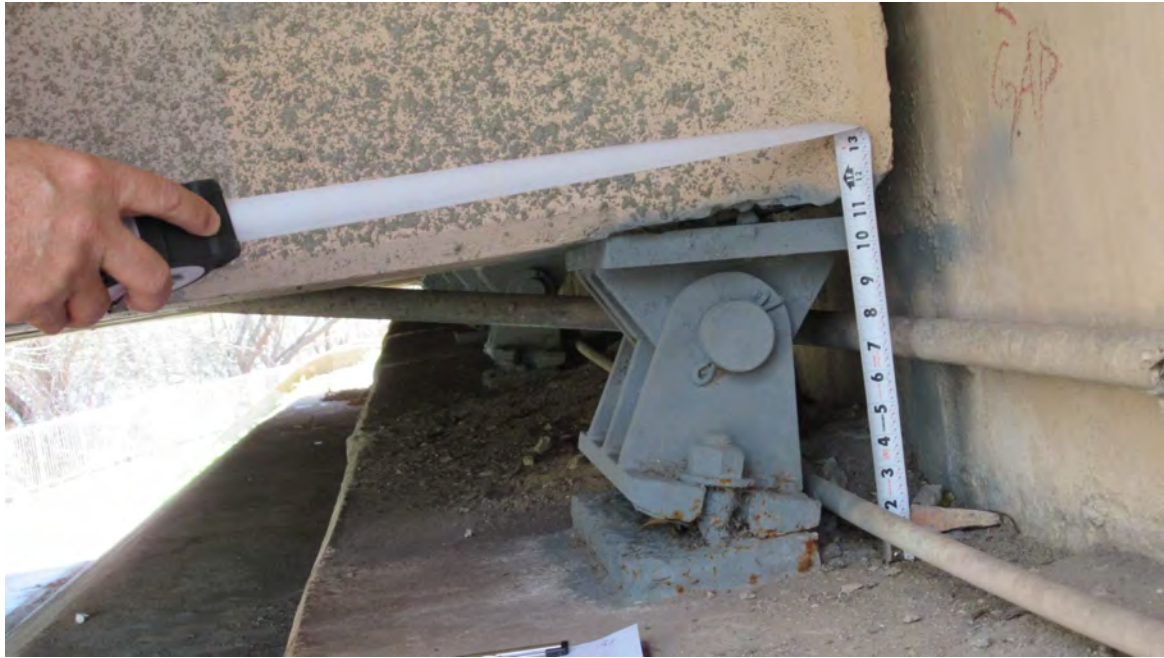
PHOTO 1

BCI for Star Engineering Group 02-2024
 A few rocker bearings over west abutment have over rotated, with 0.5" gaps at interface between sole plates and beams. See photo.
 Monitor condition of rocker bearings over west abutment at routine inspection intervals.

Description ROCKER BEARINGS - LOOKING SOUTHEAST
Note: A Few Rocker Bearings Over West Abutment Have Over Rotated, Resulting In 0.5" Gap At Interface Between Sole Plates And Beams. Condition Rated 6

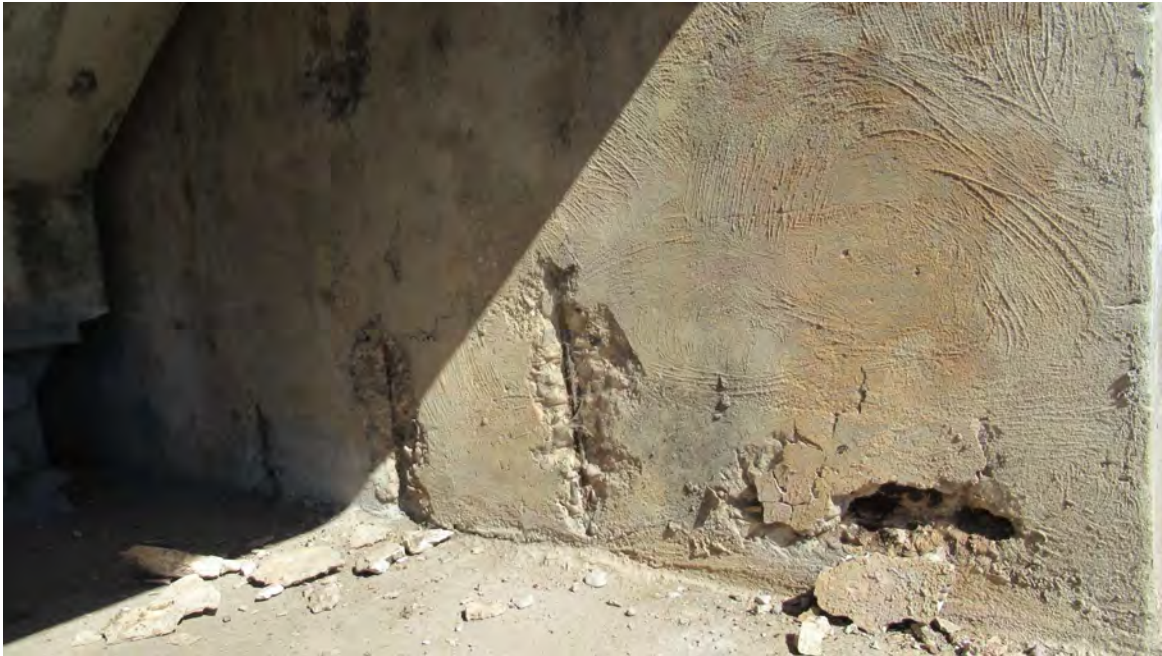
PHOTO 1

Description EAST ABUTMENT BACKWALL - LOOKING NORTHEAST
Note: Moderate Spalls With Exposed Corroded Rebar In East Abutment Backwall Near South End.
Condition Rated 6

BCI for Star Engineering Group 02-2024
 Southwest wingwall has moderate spall with exposed rebar on top at southwest corner of bridge due to impact with deck overhang. East abutment backwall has moderate spalls with exposed corroded rebar at south end. See photos.
 Remove loose concrete and rust, then patch spalls with epoxy modified grout.

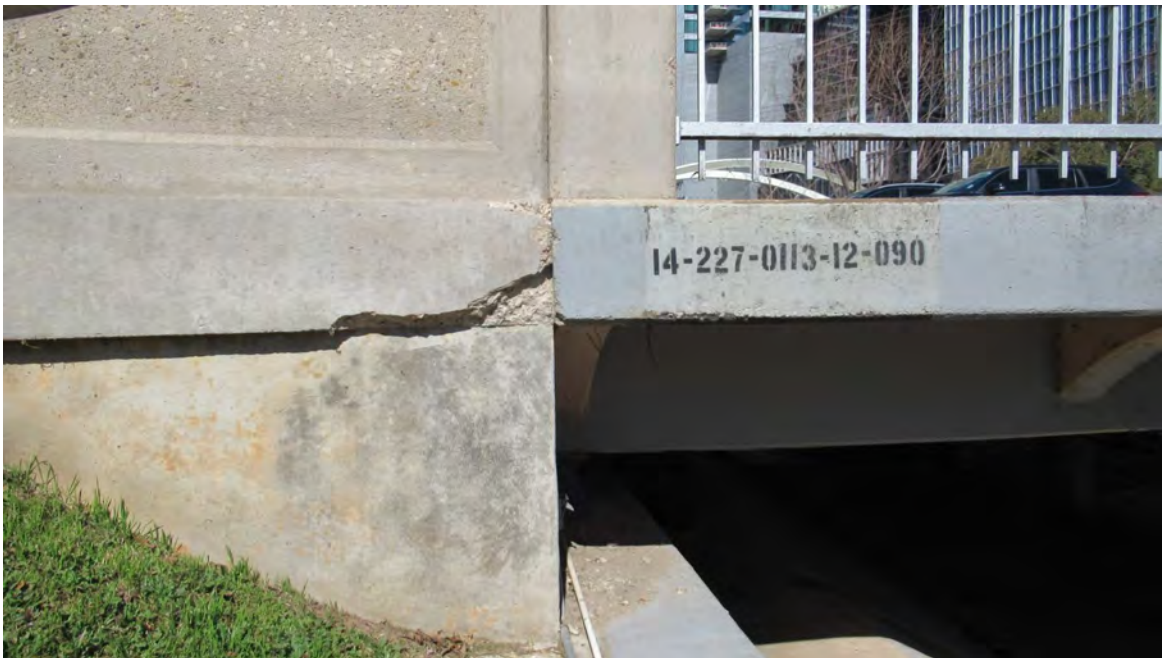
PHOTO 2

Description SOUTHWEST WINGWALL - LOOKING NORTH
Note: Southwest Wingwall Has Moderate Spall In Top Portion Due To Impact With South Deck
Overhang. Condition Rated 6

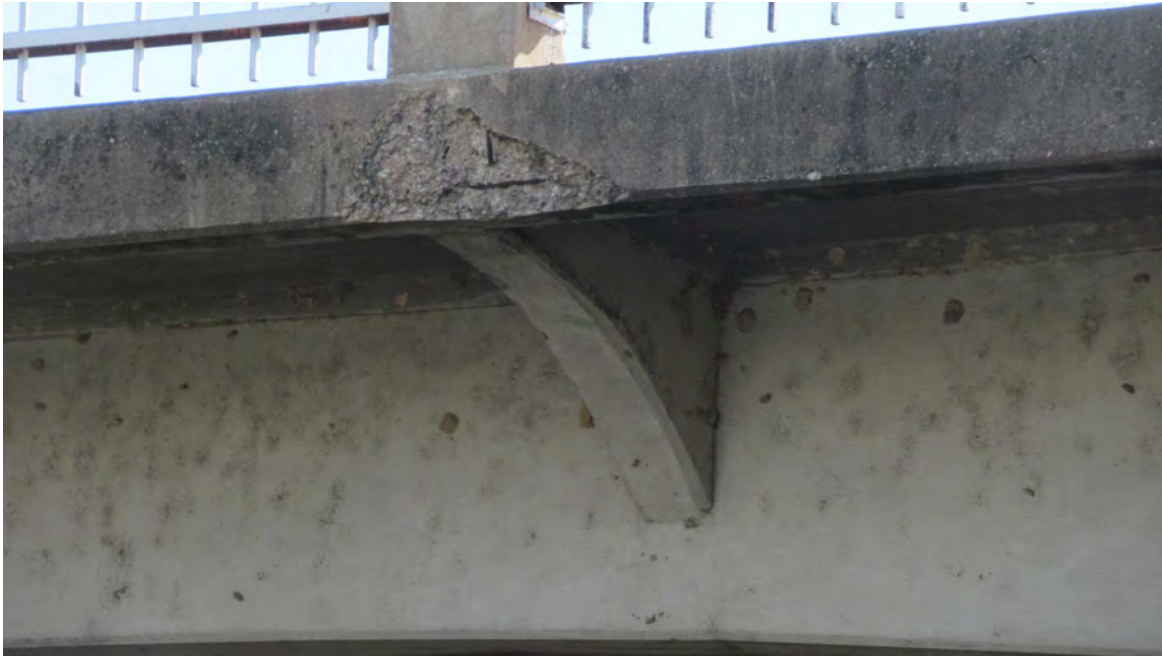
PHOTO 1

Description NORTH DECK OVERHANG - LOOKING SOUTH
Note: North Deck Overhang Of East Span Has A 2 Square Foot Spall With Exposed Rebar In
Facia. Condition Rated 6

BCI for Star Engineering Group 02-2024
 Bridge deck surface has a one square foot spall with exposed rebar adjacent to west deck joint, and a few minor spalls in east span. Both deck overhangs have moderate spalls with exposed rebar bottom edges. See photos.
 Remove loose concrete and rust, then patch spalls with epoxy modified grout.

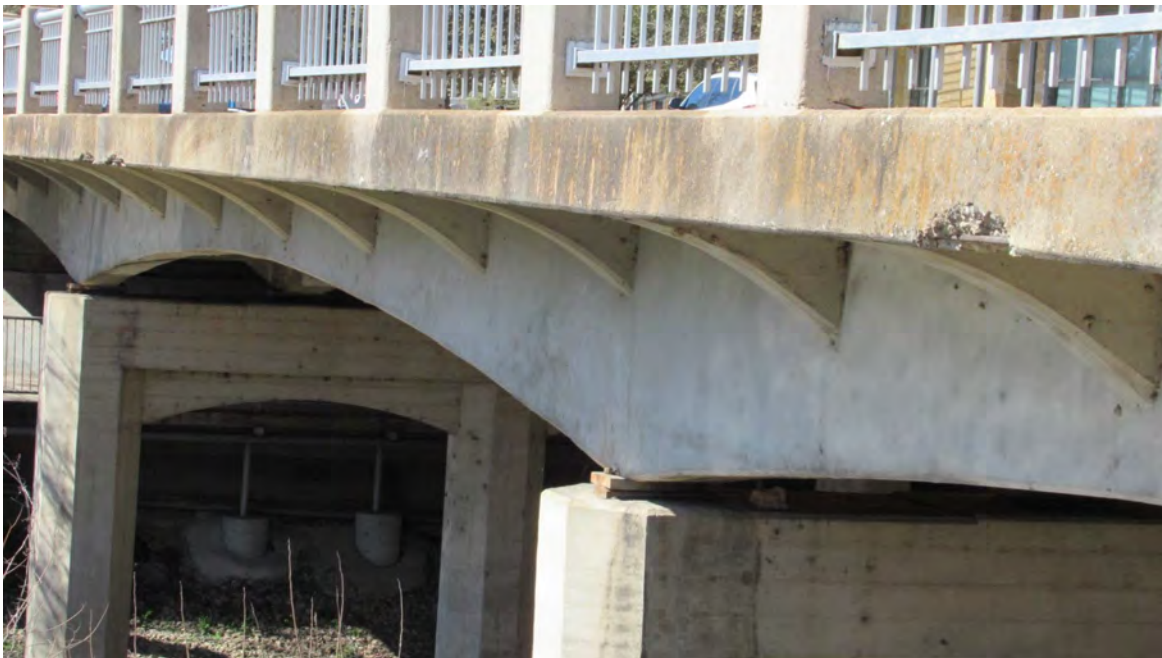
PHOTO 2

Description SOUTH DECK OVERHANG - LOOKING NORTHWEST
Note: Moderate Spalls With Exposed Rebar In Bottom Edge Of South Deck Overhang Of Center
And East Spans. Condition Rated 6

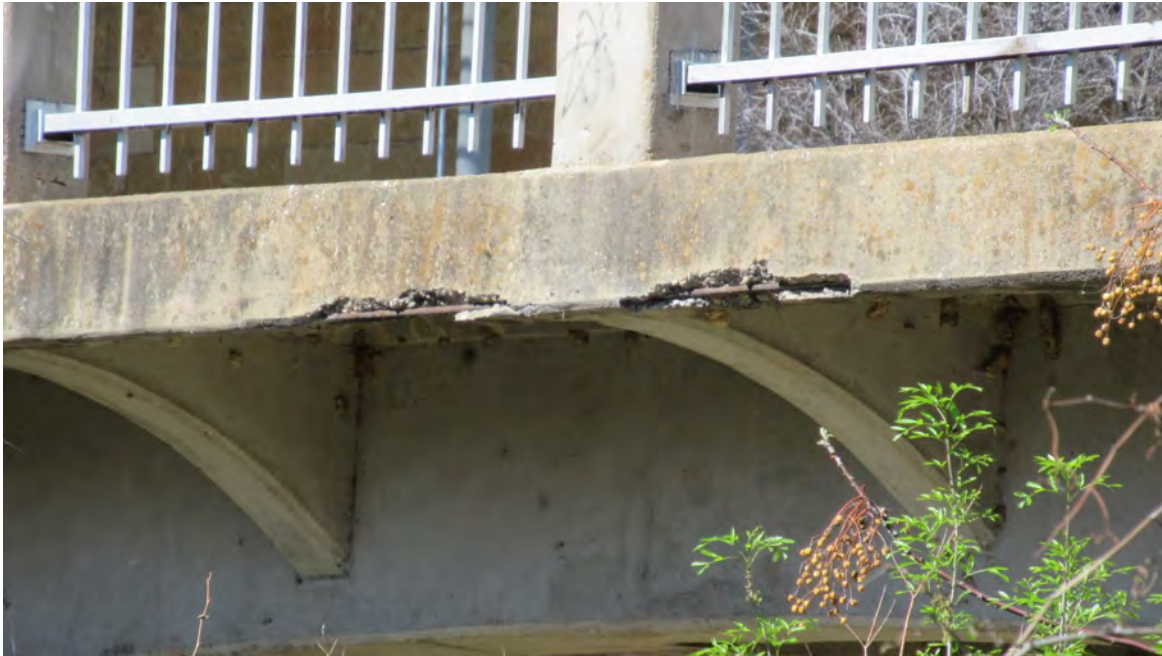
PHOTO 3

Description SOUTH DECK OVERHANG - LOOKING NORTHWEST
Note: Moderate Spalls With Exposed Rebar In Bottom Edge Of South Deck Overhang Of Center Span. Condition Rated 6

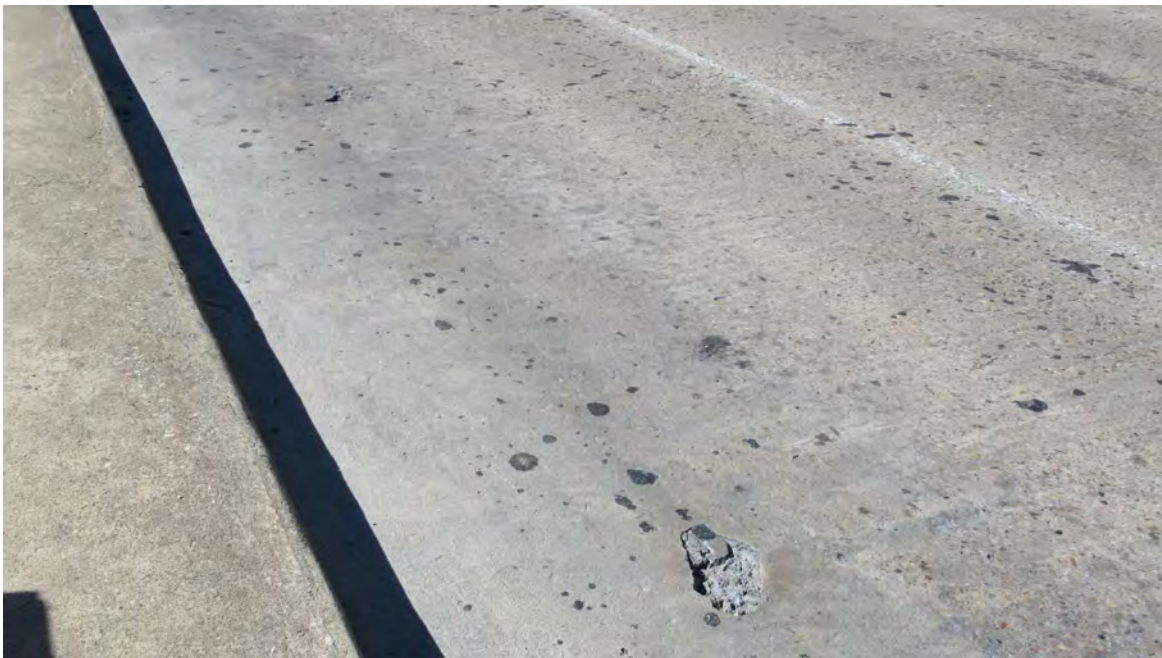
PHOTO 4

Description BRIDGE DECK - LOOKING NORTHWEST
Note: Bridge Deck Of East Span Has A Few Spalls 1" Deep Or Less. Condition Rated 6

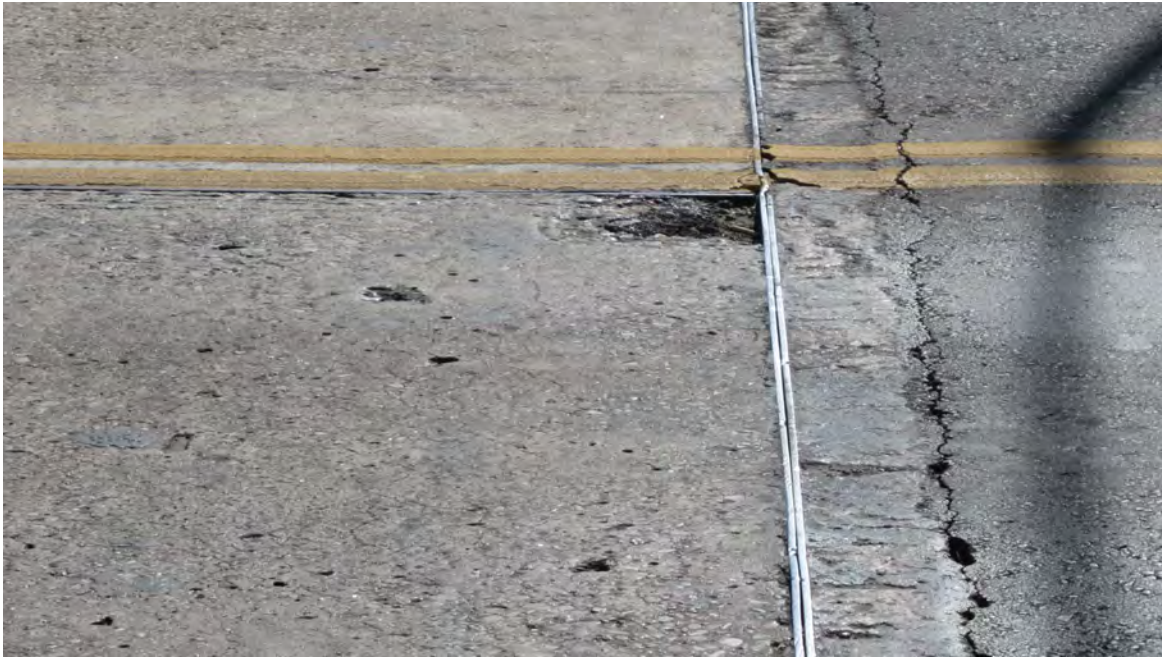
PHOTO 5

Description BRIDGE DECK - LOOKING SOUTH
Note: Bridge Deck Of West Span Has Moderate Scaling And A square Foot Spall With Exposed Rebar Adjacent To Deck Joint. Deck Joint Is Closed. Conditions Rated 6

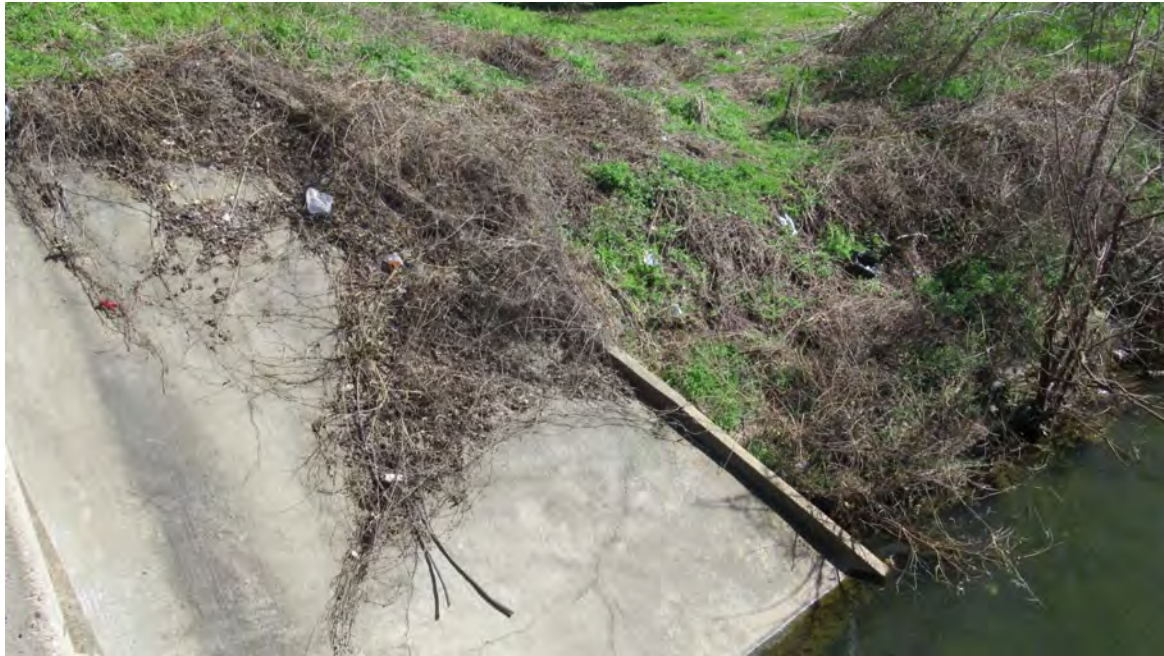
PHOTO 1

Description **SOUTHEAST BANK RIPRAP - LOOKING SOUTHEAST**
Note: Moderate Erosion 24" Deep Along Edge Of Southeast Bank Riprap. Riprap Has Moderate Cracks And Is Undermined At Least 5' Back From Riprap Edge. See Photo 18. Condition Rated 6

BCI for Star Engineering Group 02-2024
 Southeast bank riprap has erosion 24" deep and has been undermined at least 5' back along south edge of east riprap. See photos.
 Pump flowable fill into void under riprap, then place rock or concrete rubble into erosion area along southeast bank riprap edge.

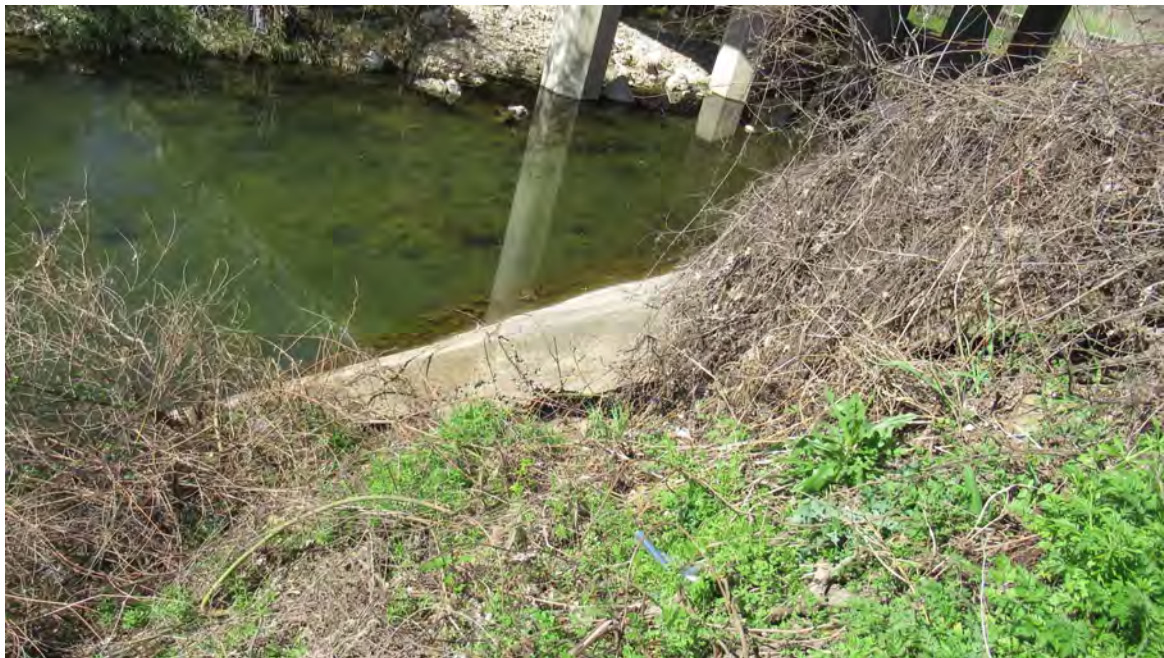
PHOTO 2

Description **SOUTHEAST BANK RIPRAP - LOOKING NORTHWEST**
Note: Moderate Erosion 24" Deep Along Edge Of Southeast Bank Riprap. Riprap Has Moderate Cracks And Is Undermined At Least 5' Back From Riprap Edge. Condition Rated 6

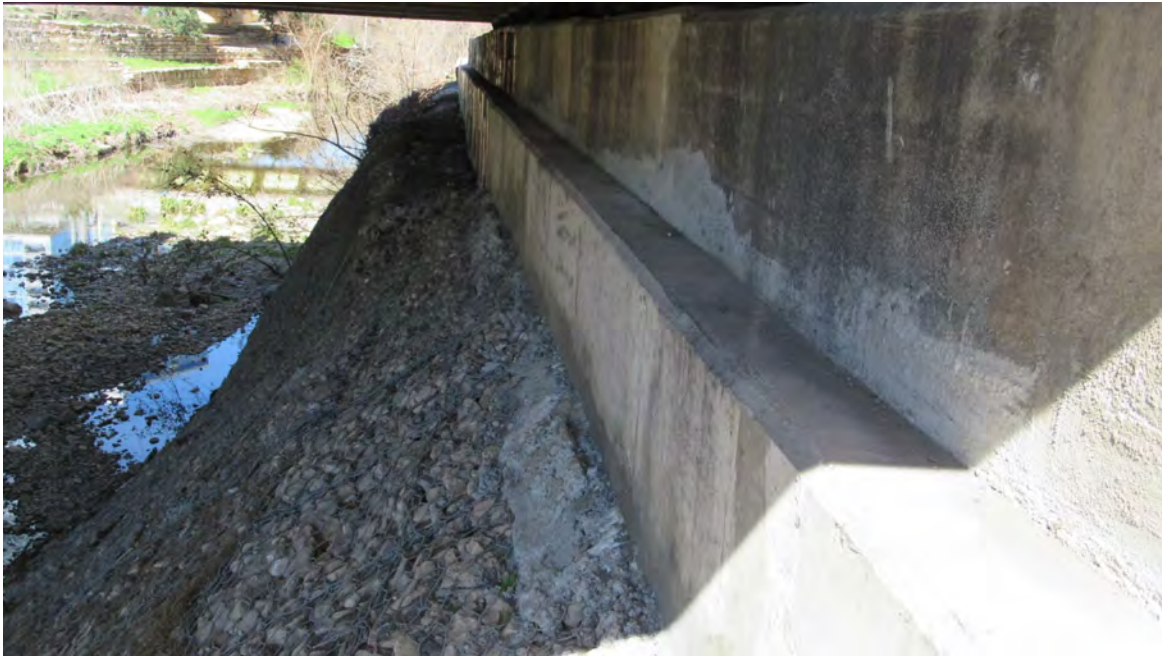
PHOTO 7

Description EAST GABION RIPRAP - LOOKING NORTH
Note: Cement Stabilized Sand Has Been Packed Into Gap Between East Abutment Cap And Top Of Gabion Riprap .

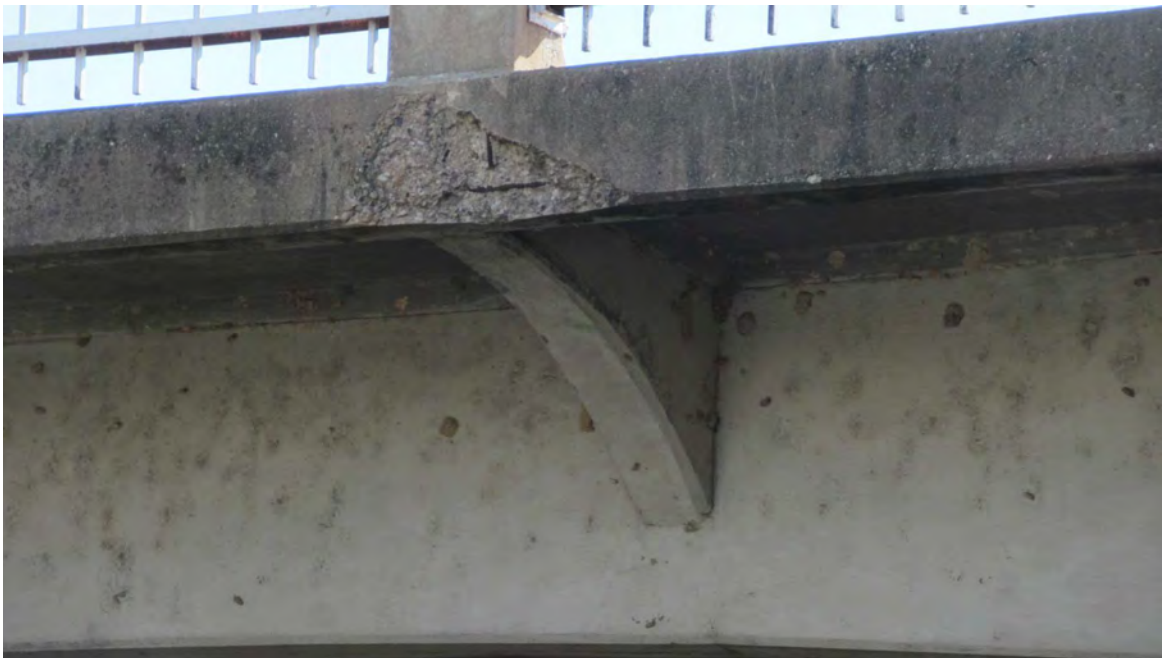
PHOTO 8

Description NORTH DECK OVERHANG - LOOKING SOUTH
Note: North Deck Overhang Of East Span Has A 2 Square Foot Spall With Exposed Rebar In Facia. Condition Rated 6

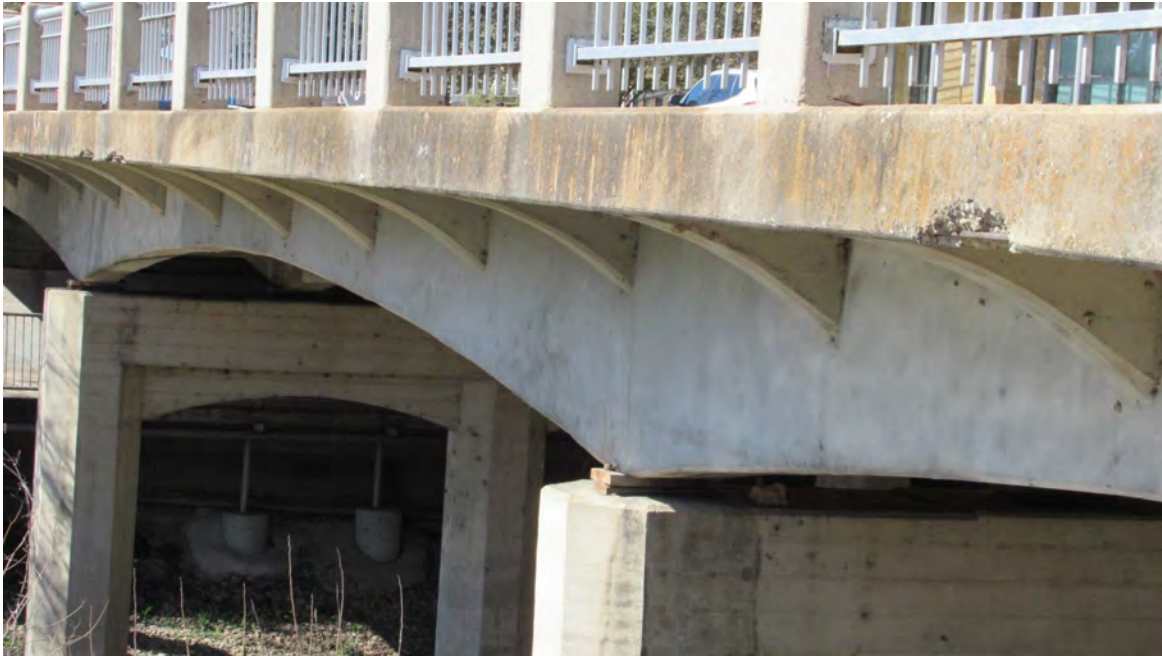
PHOTO 9

Description SOUTH DECK OVERHANG - LOOKING NORTHWEST
Note: Moderate Spalls With Exposed Rebar In Bottom Edge Of South Deck Overhang Of Center And East Spans. Condition Rated 6

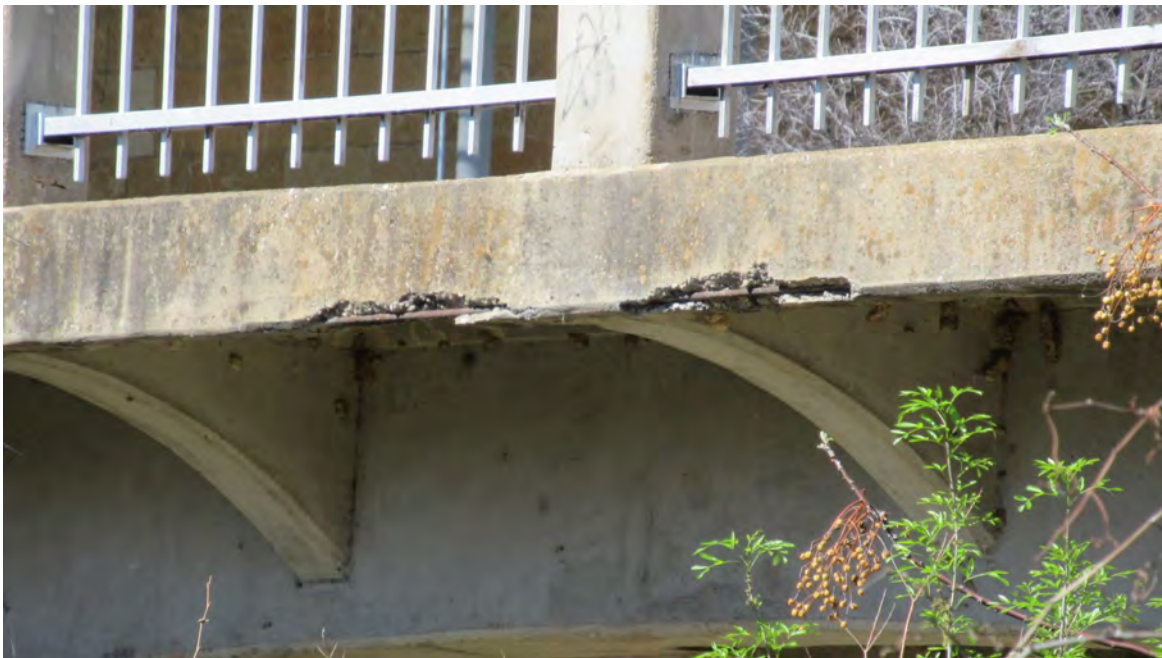
PHOTO 10

Description SOUTH DECK OVERHANG - LOOKING NORTHWEST
Note: Moderate Spalls With Exposed Rebar In Bottom Edge Of South Deck Overhang Of Center Span. Condition Rated 6

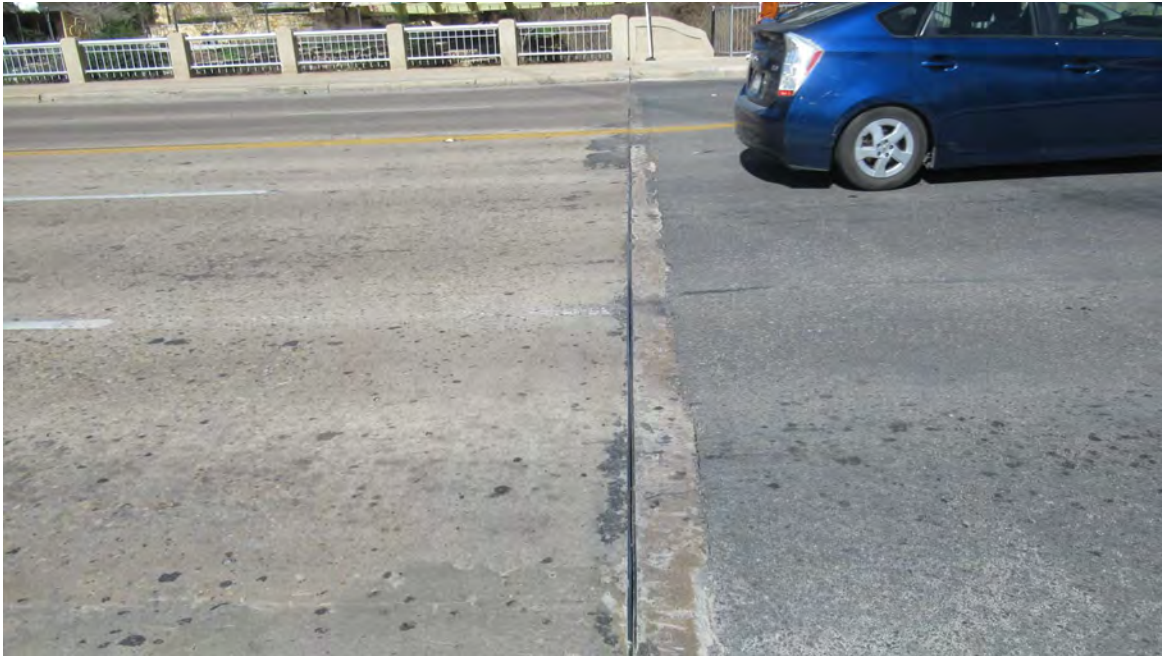
PHOTO 11

Description EAST DECK JOINT - LOOKING NORTH
Note: Deck Open Joints Are Closed. Armor Plates Have Minor Distortions. Deck Has Several Minor Transverse Cracks And Moderate Scaling With Exposed Aggregate. Conditions Rated 6

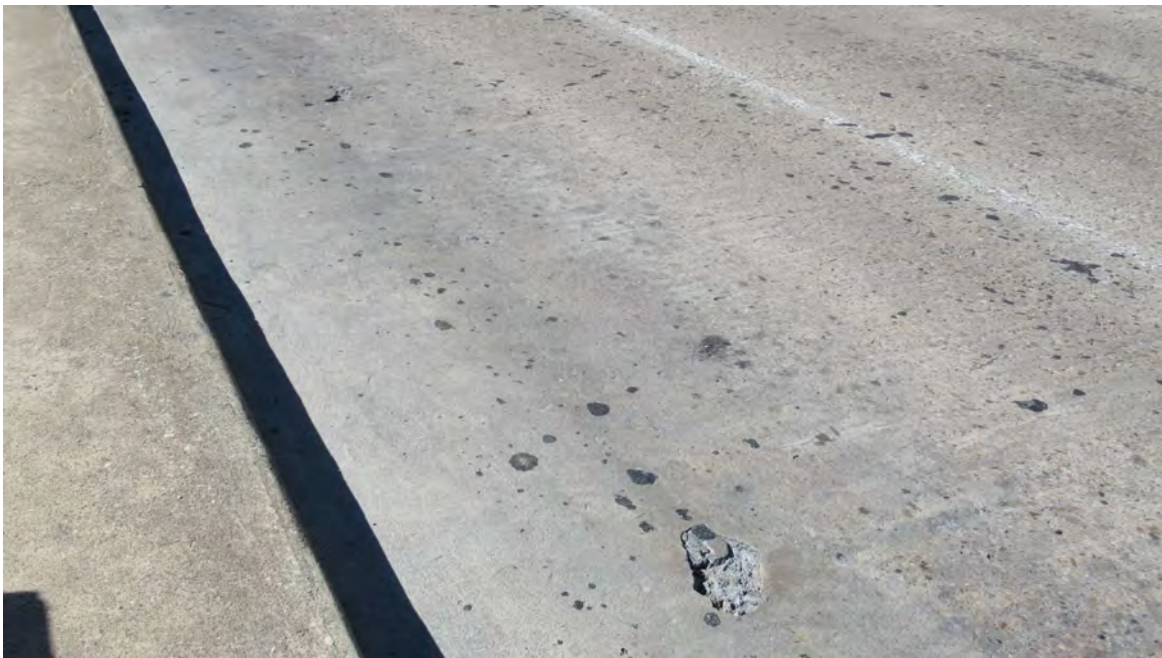
PHOTO 12

Description BRIDGE DECK - LOOKING NORTHWEST
Note: Bridge Deck Of East Span Has A Few Spalls 1" Deep Or Less. Condition Rated 6

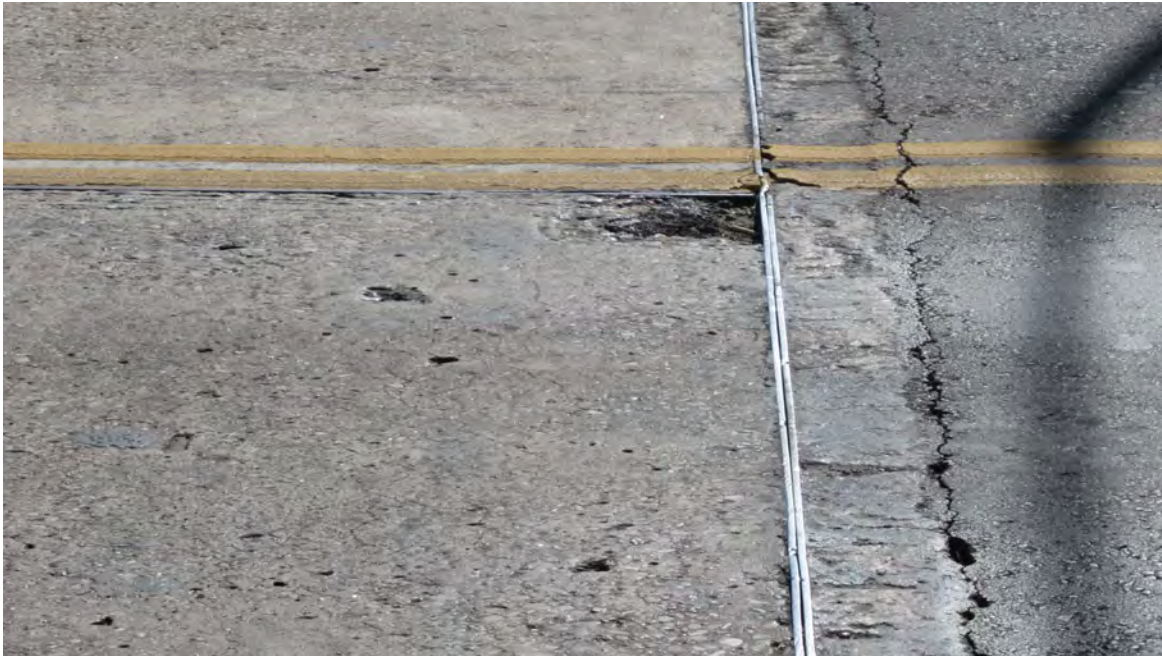
PHOTO 13

Description BRIDGE DECK - LOOKING SOUTH
Note: Bridge Deck Of West Span Has Moderate Scaling And A square Foot Spall With Exposed Rebar Adjacent To Deck Joint. Deck Joint Is Closed. Conditions Rated 6

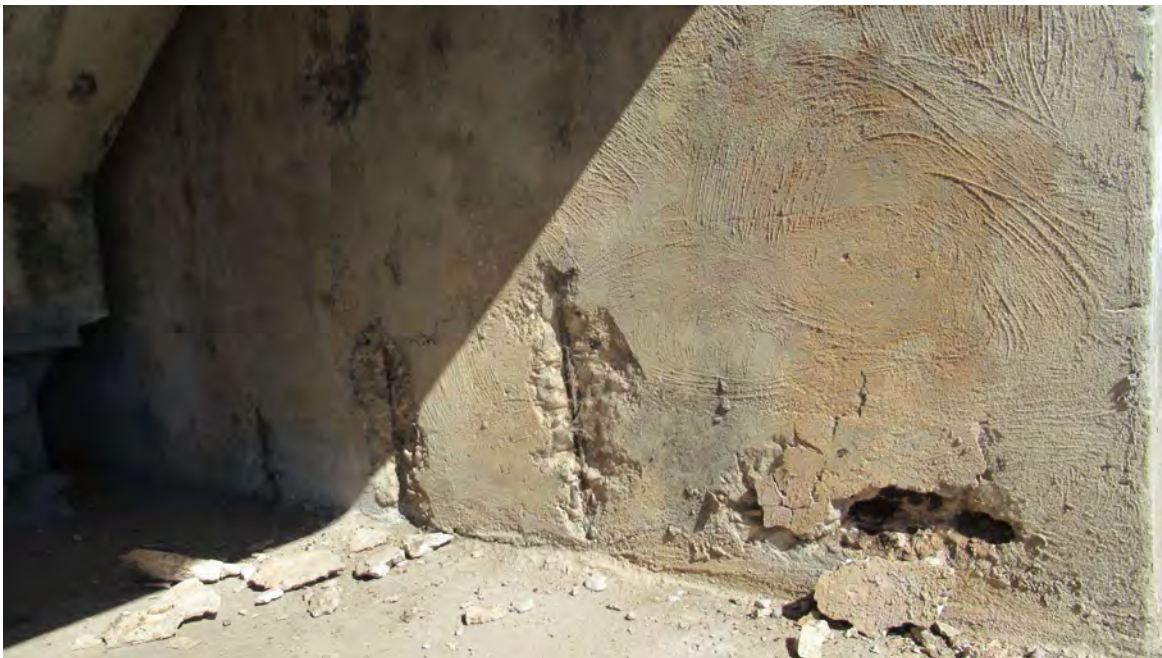
PHOTO 14

Description EAST ABUTMENT BACKWALL - LOOKING NORTHEAST
Note: Moderate Spalls With Exposed Corroded Rebar In East Abutment Backwall Near South End. Condition Rated 6

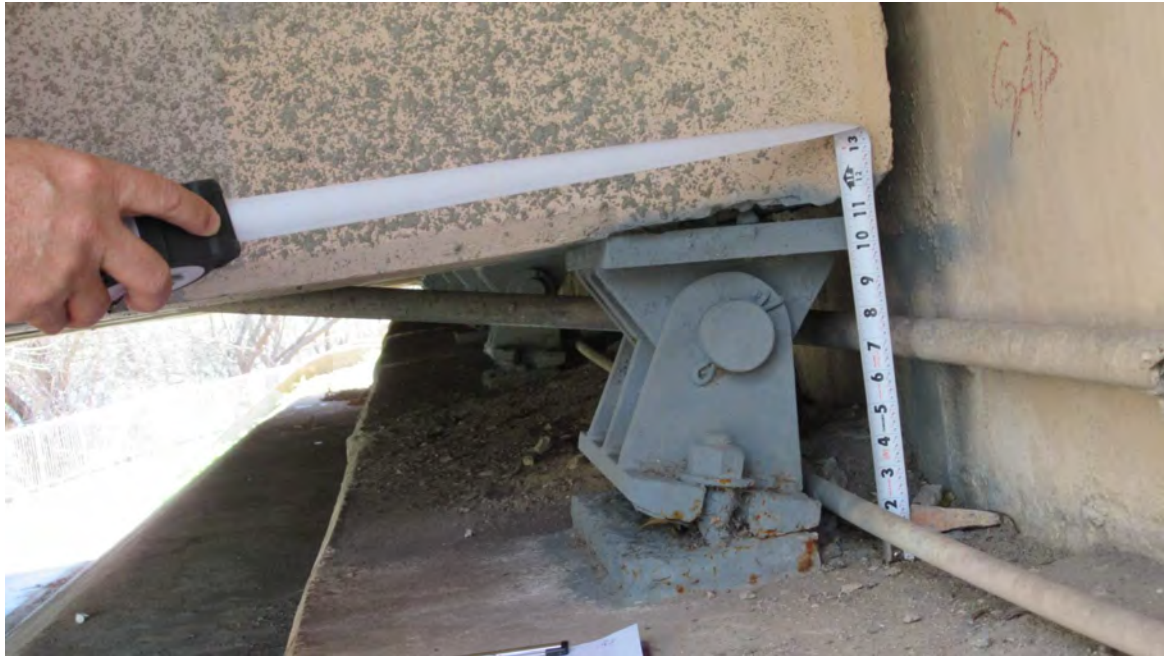
PHOTO 15

Description **ROCKER BEARINGS - LOOKING SOUTHEAST**
Note: A Few Rocker Bearings Over West Abutment Have Over Rotated, Resulting In 0.5" Gap At Interface Between Sole Plates And Beams. Condition Rated 6

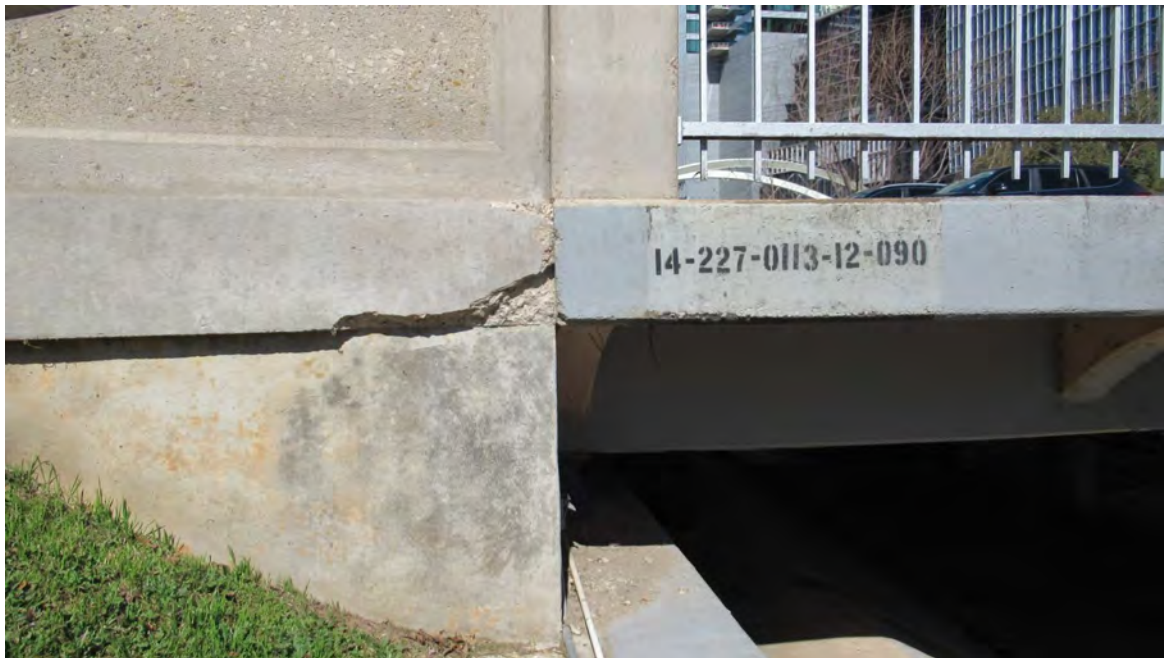
PHOTO 16

Description **SOUTHWEST WINGWALL - LOOKING NORTH**
Note: Southwest Wingwall Has Moderate Spall In Top Portion Due To Impact With South Deck Overhang. Condition Rated 6

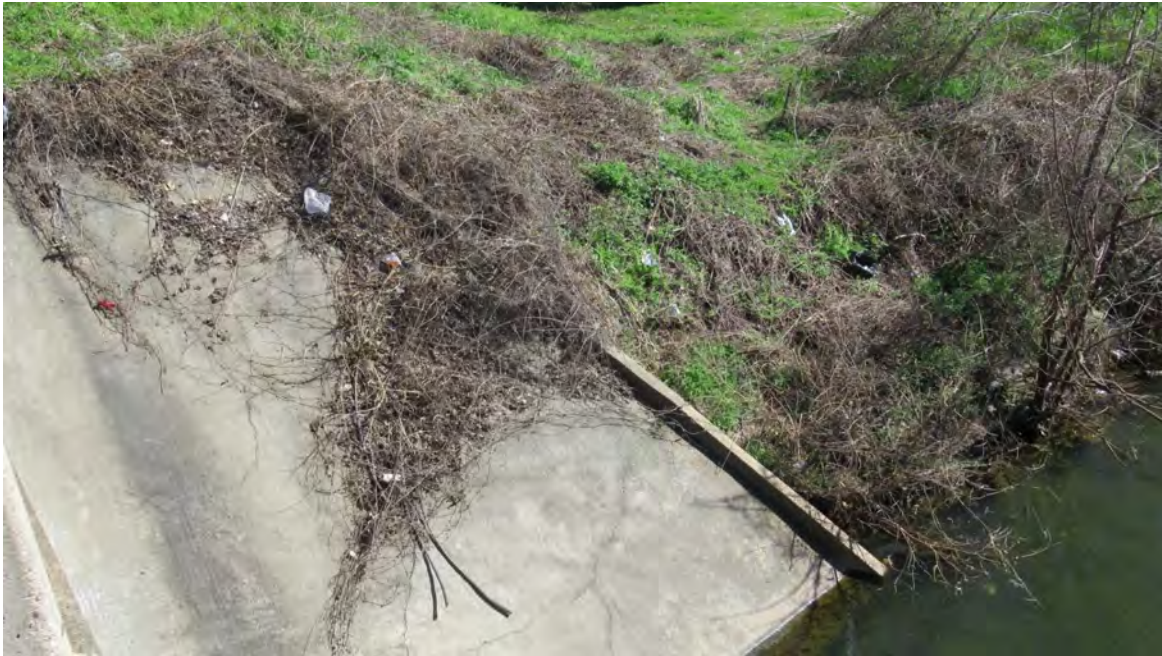
PHOTO 17

Component	Description	Min.	Rating	Comment
Channel Banks		0	6	Southeast bank riprap has erosion 24" deep and has been undermined at least 5' back along south edge of east riprap. See photos 17 and 18. Erosion at northeast corner of bridge has been repaired.
Channel Bed		0	8	
Rip Rap, Toe Walls & Apron		5	6	Southeast bank riprap has erosion 24" deep and has been undermined at least 5' back along south edge of east riprap. See photos 17 and 18. Erosion at northeast corner of bridge has been repaired.
Dikes		5	N	
Jetties		5	N	
Other		-	N	
Overall Component Rating			6

Description **SOUTHEAST BANK RIPRAP - LOOKING SOUTHEAST**
Note: Moderate Erosion 24" Deep Along Edge Of Southeast Bank Riprap. Riprap Has Moderate Cracks And Is Undermined At Least 5' Back From Riprap Edge. See Photo 18. Condition Rated 6

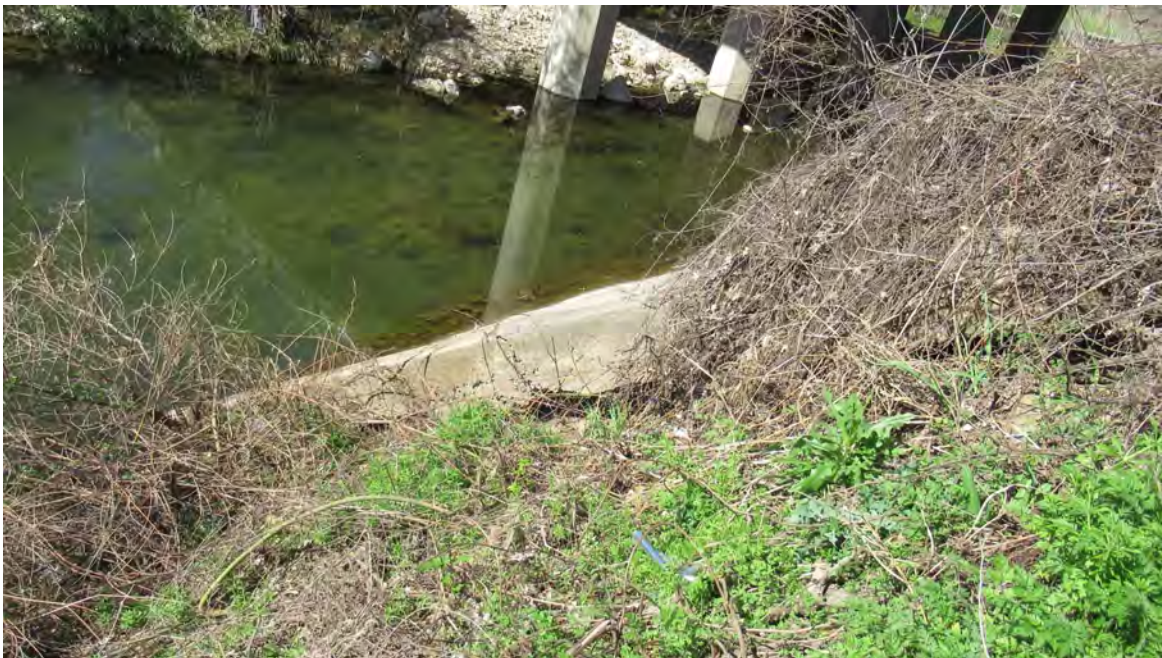
PHOTO 18

Description **SOUTHEAST BANK RIPRAP - LOOKING NORTHWEST**
Note: Moderate Erosion 24" Deep Along Edge Of Southeast Bank Riprap. Riprap Has Moderate Cracks And Is Undermined At Least 5' Back From Riprap Edge. Condition Rated 6
