# The Dead VexRiscv

A bitstream-configuration bug in the openXC7 toolchain

How a dead serial console on the Arty S7 was traced to two missing BRAM width bits — and fixed

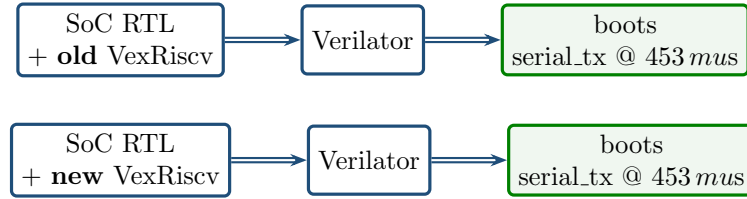
Figure 5: Both CPU netlists execute the BIOS and drive the UART identically in simulation. The version difference is a source-parity wart, not the cause.

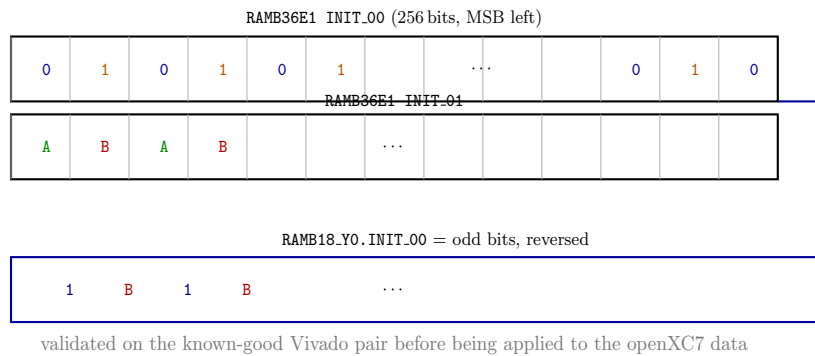
Figure 6: The RAMB36-to-RAMB18 INIT interleave: the decoded **RAMB18\_Y0.INIT\_XX** feature is the odd bits of the **RAMB36 INIT\_XX/INIT\_XX+1** parameters (LSB-first). The transform was first *validated* on the working Vivado build — where the parameters and the decoded bits are both known — and then applied to the openXC7 data.

**Result.** All 144 INIT/INITP parameters of the six ROM cells matched the openXC7 bitstream bit-for-bit. The BIOS is stored correctly. **H3 eliminated** — but the exercise produced two durable assets: the validated INIT transform, and a proven method for content verification.

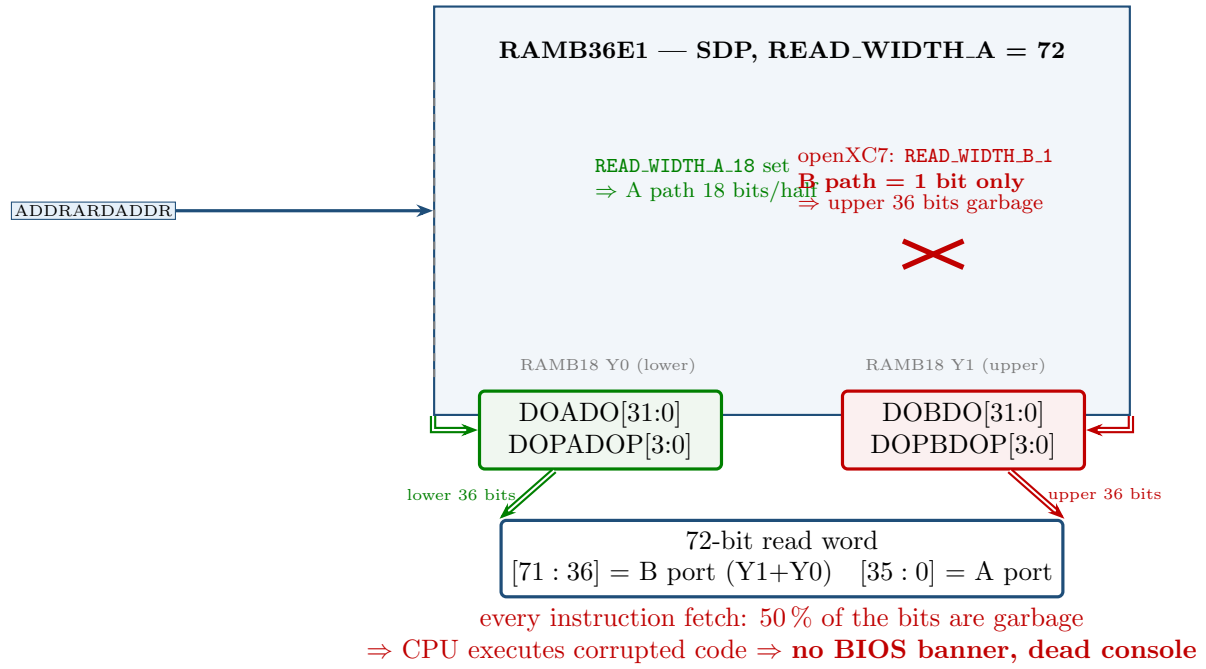
The ROM cells are RAMB36E1 in SDP mode with `READ_WIDTH_A = 72`: each address returns a 72-bit word that is assembled from *four* 18-bit data paths — the A and B read ports of both RAMB18 halves.

Figure 8: The SDP-72 ROM read. Hardware assembles each 72-bit word from the A port (lower 36 bits) and the B port (upper 36 bits). The openXC7 bitstream configured the B-side read path 1 bit wide, so the upper half of every fetch was garbage — the CPU never decoded a valid instruction.

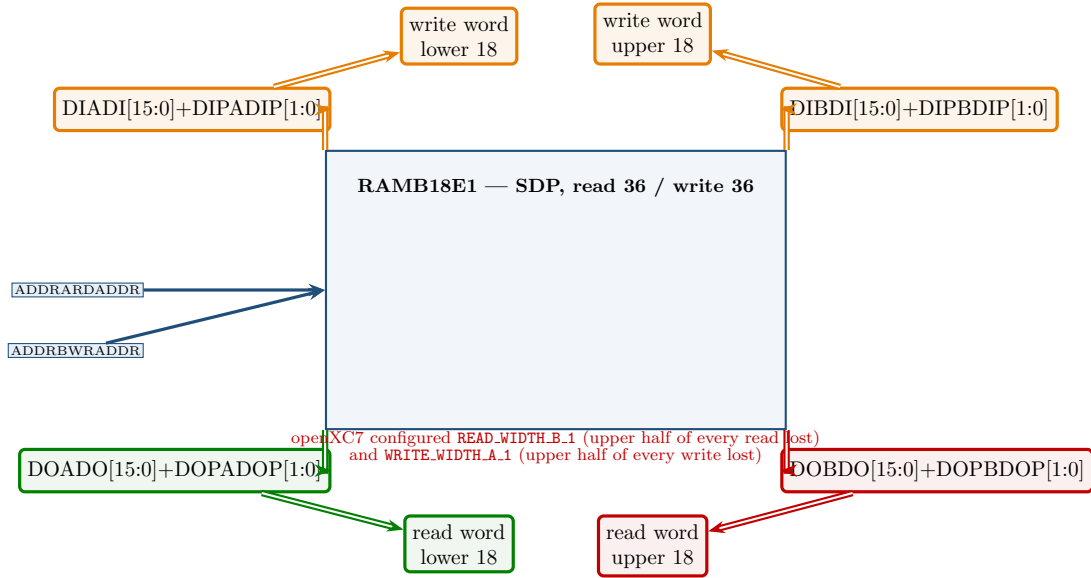
The CPU register file is a RAMB18E1 in SDP mode with a 36-bit read and a 36-bit write. Both ports span the A *and* B sides of the memory: the read is DOADO/DOPADOP (lower 18) plus DOBDO/DOPBDOP (upper 18); the write is DIADI/DIPADIP (lower 18) plus DIBDI/DIPBDIP (upper 18).

Figure 9: The SDP-36 register file. Every 36-bit read needs `READ_WIDTH_B_18` and every 36-bit write needs `WRITE_WIDTH_A_18`; the openXC7 bitstream left both at width 1, so the CPU’s register reads and writes were half-garbage from the first instruction onward.

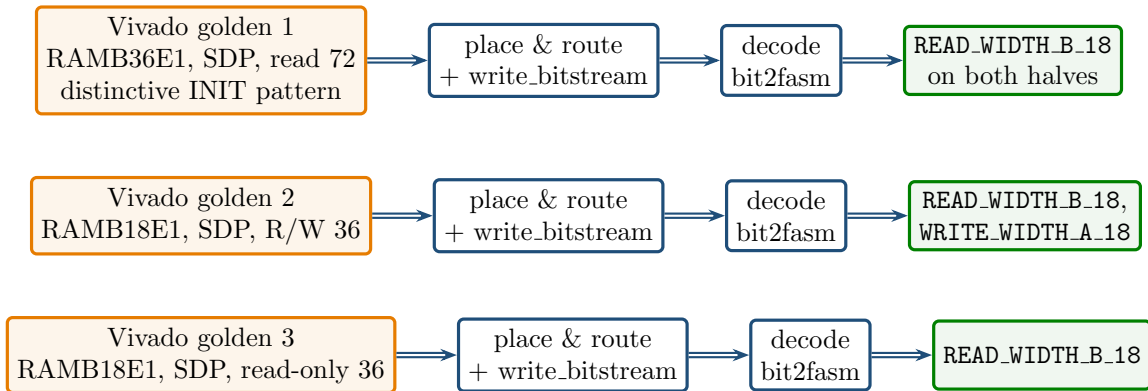
Figure 10: Three purpose-built Vivado golden designs pinned down the hardware truth: Vivado always programs the opposite-side width markers to `_18` in SDP mode — the openXC7 bitstream did not.

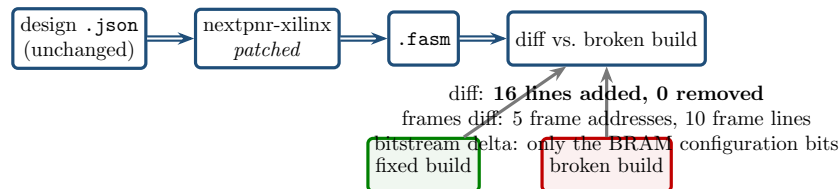
Figure 11: Verification at three levels: the FASM diff is exactly the 16 expected lines, the frames diff is confined to the BRAM configuration frames, and the decoded configuration of every affected tile now matches the Vivado goldens feature-for-feature.

Rebuilding the demo with the patched toolchain changes the FASM by exactly sixteen added lines and nothing else:
