I. Software Guidelines

II. Corrections To The Manual

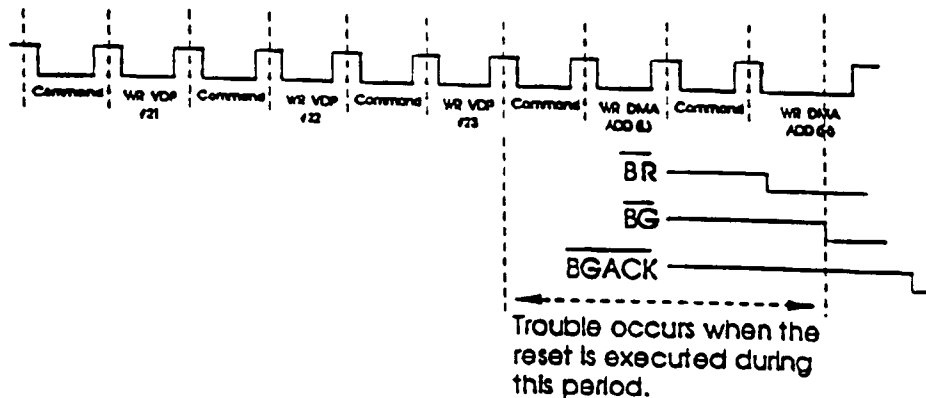
- 2) The problem still persists even after the precautions above are taken.

Diagnosis Of The Problem:

The problem will occur when the reset takes place between the period of time when the CPU has finished setting the parameters to execute the DMA and the actual execution of the DMA itself.

A Fix For The Problem:

On top of the precautions taken in 1), as an example, make sure not to execute a DMA right after a reset.
