<div>ABBOTT ADD</div>	<div>INDEX</div> <div>TECHNICAL SERVICE BULLETIN</div>
--	--

PRODUCT: LCx® Probe System (69)	DATE: 25-AUG-97
------------------------------------	--------------------

SUBJECT:
LCx® Analyzer Version 2 Software Upgrade
(System Software Module Version 2 and
Assay Software Module 2 Version 1.0)

TSB#: 69-005

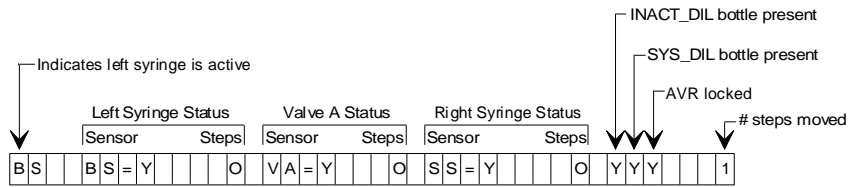
- c. If the display shows YYN, this indicates that the AVR arm is in the open position (not home). Close the AVR arm, the display should change from YYN to YYY. If the display does not change to YYY, this may indicate:
 - 1) the sensor is dirty or obstructed. Clean the sensor or remove the obstruction.
 - 2) the sensor is defective. Replace the AVR arm.
 - 3) the LLS/Analog Cable Assembly is not attached to the AVR or is defective. Reattach the cable to the AVR or replace the LLS/Analog Cable Assembly.
 - 4) the Analog Board is defective. Replace the Analog Board.
- 20. Perform VP-15 Buffer Sensor Check.
- 21. Perform the Total Service Call Procedure.
- 22. Mark the 02 and 03 blocks of the TSB Modification Sticker.
 - U.S.A. - Close the service call in Fieldwatch accordingly:
 - Service Code (03)
 - Trouble Code (03)
 - Repair Code (93)

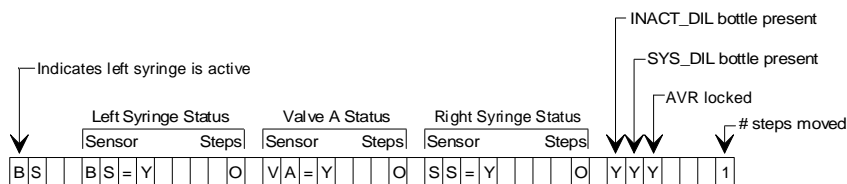
- c. If the display shows YYN, this indicates that the AVR arm is in the open position (not home).
Close the AVR arm, the display should change from YYN to YYY.
If the display does not change to YYY, this may indicate:
 - 1) the sensor is dirty or obstructed. Clean the sensor or remove the obstruction.
 - 2) the sensor is defective. Replace the AVR arm.
 - 3) the LLS/Analog Cable Assembly is not attached to the AVR or is defective. Reattach the cable to the AVR or replace the LLS/Analog Cable Assembly.
 - 4) the Analog Board is defective. Replace the Analog Board.

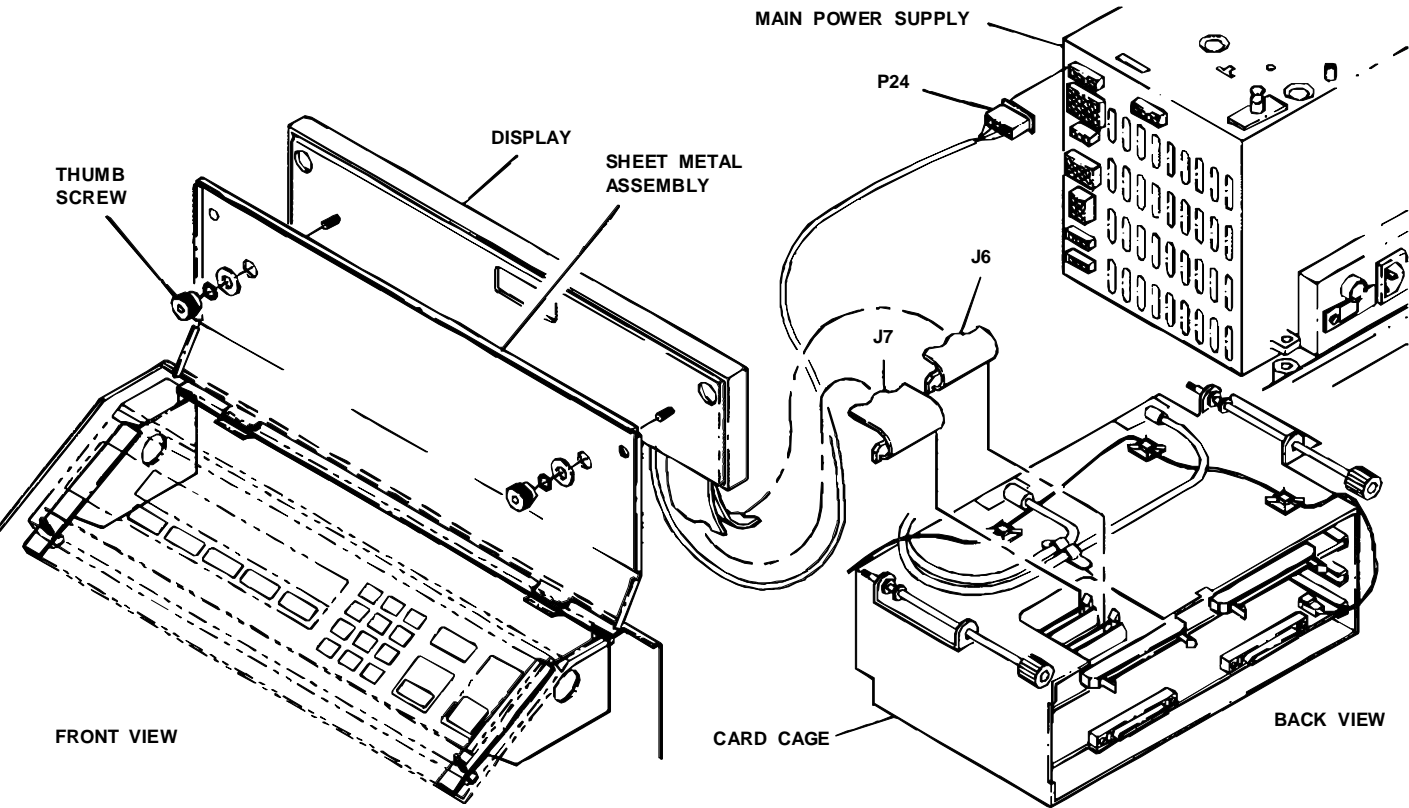
Touchpad Assembly

- I. DISTRIBUTION:
Worldwide
- II. PURPOSE:
To ensure that all LCx® instruments are in CE mark compliance, the Touchpad Assemblies in the above mentioned instrument serial number list are being replaced.
- III. ADMINISTRATIVE NOTES:
