| ABBOTT ADD | INDEX INSTRUMENT SERVICE ADVISORY |

| PRODUCT: TDxFLx® (67) | DATE: 07-JUL-98 |

| <div>ABBOTT ADD</div> | INSTRUMENT SERVICE ADVISORY |

| SUBJECT: TDxFLx® Service Manual | ISA#: 67-025 |

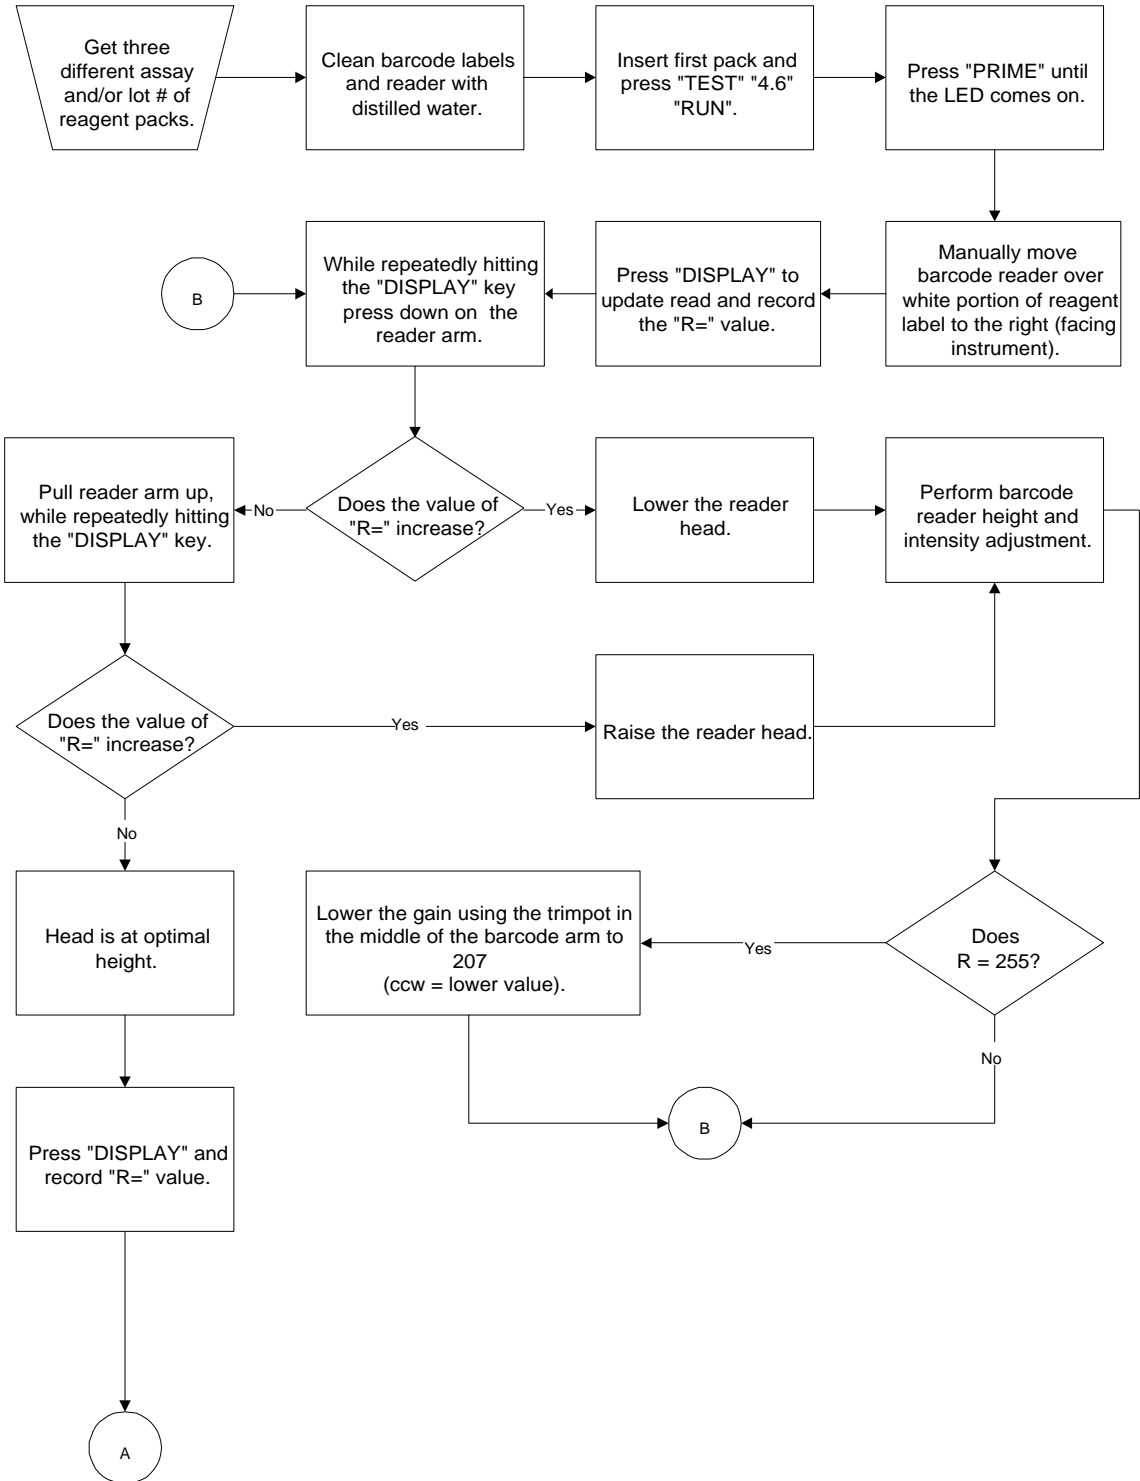
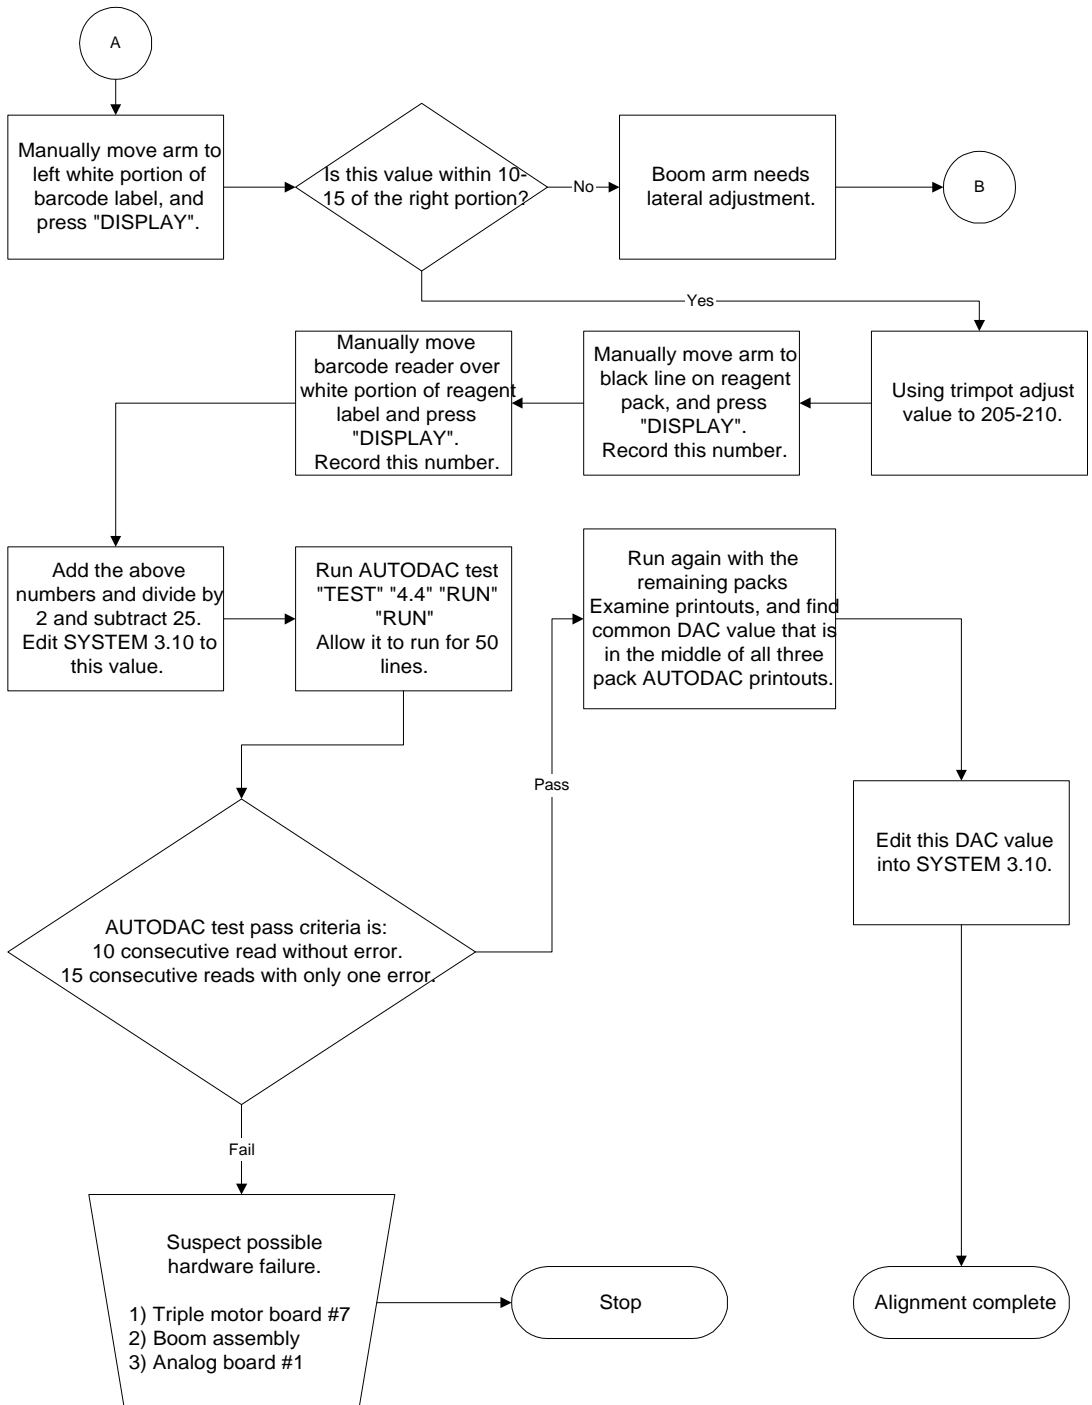
- I. **DISTRIBUTION:**
International and USA
- II. **PURPOSE:**
To provide the field with a guide to adjust the barcode reader for proper operation, and to save time and repeat calls.

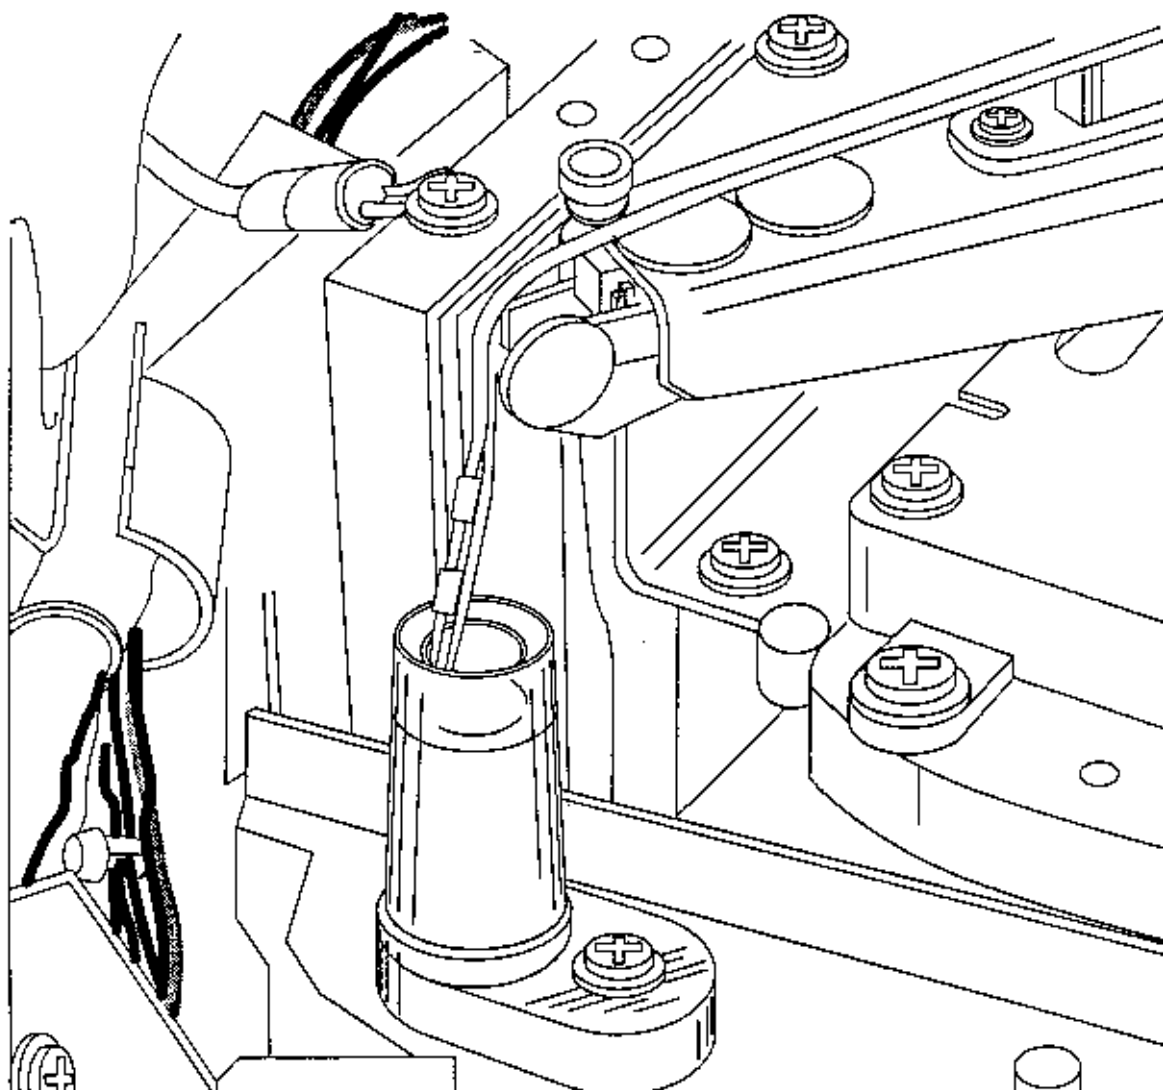
Figure 1

GOAL: Probe assembly should be aligned: (1) left-to-right in the wash station, (2) front-to-back such that washing occurs in the front half of the wash station and (3) vertically so that at least the tip of the electrodes, but no higher than the top of the coating free area on the electrode, is washed. No splashing should be observed during priming of the instrument.

1. Perform either an Auto Boom Calibration (TEST 3.10) or Boom Calibration (TEST 3.2).
 - a. After the carousel barcode has been read and the probe has been centered over the reagent vials, the boom moves the probe over the wash station.
 - b. Carefully remove the batch reagent pack and batch pack adapter.
 - c. Align the probe left - to - right over the wash cup using the "0" or "." keys.
 - d. Align the probe front - to - back in the wash station so that the probe is a probe width (1-2 mm) from the front inside wall of the wash cup, at approximately the 6 o'clock position (Figure 1).
 - e. Loosen the wash station screw and move the wash station front-to-back as required. **DO NOT** loosen the thumb screws that secure the probe holder to the boom arm to align front-to-back.

- f. Tighten the wash station screw when alignment is achieved and press the "STORE" key.

- g. Continue with the carousel probe positioning and level sense portion of the boom calibration.
- 2. After the boom calibration has been performed, the probe should be positioned vertically such that only the tips (non-coated area) of the electrodes are washed when the "PRIME" key is pressed. Edit System parameter 10.6, WSTE ZBM, to adjust vertical height. Increase the parameter value to lower the probe further into the wash station; decrease the parameter value to raise the probe.

- 3. Press the "PRIME" key 3 times. Probe should not hit the inside wall of the wash station as it descends into the wash cup. No splashing should be observed. During washing, the buffer should not rise to the coating on the electrodes.

- 4. If probe hits the inside wall of the wash station or if splashing occurs, repeat the alignment procedure. If splashing still occurs when alignment has been optimized consider replacing the probe, valve block or tubing. Check and tighten all dispense components. Check valve tang alignment. If further troubleshooting is required, consider replacing the pump assembly or board #8.
