**ABBOTT
ADD**

TECHNICAL SERVICE BULLETIN

SUBJECT:
Extended Waste Option

PRODUCT:
AxSYM® (83)

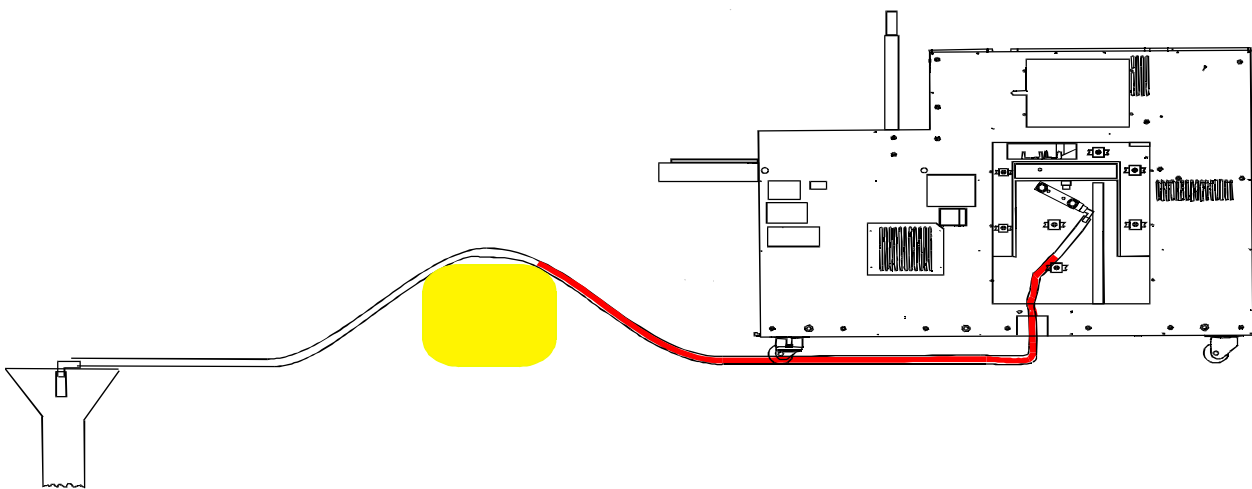
NOTE: As the tubing is routed to the floor drain, it must not be allowed to rise more than 7.5 cm (3") off the floor.

BAD Tubing Routing

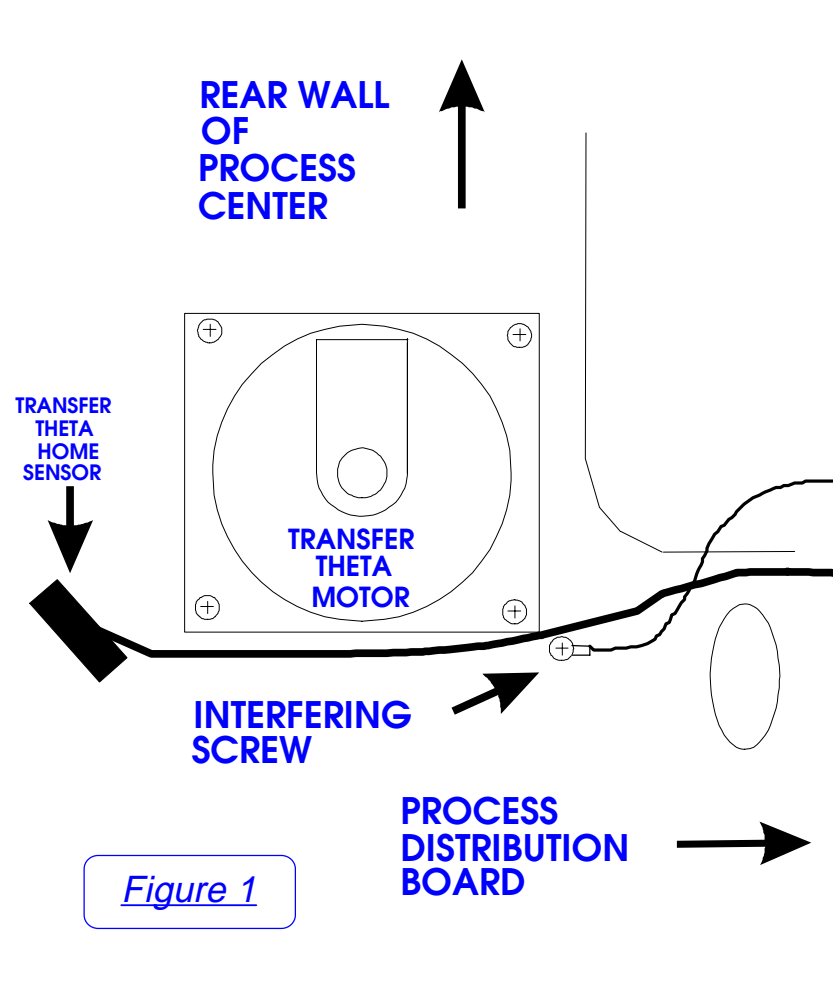
Figure 1

is removed in this illustration to clearly show the location of the screw. The resolution is to remove this screw and replace it with a shorter one. The screws that were initially installed are 10-32 Sems screws, 5/8" long (P/N 14494-310). The screw that replaces the old one is a 10-32 Sems screw,1/2" long (P/N 14494-308).

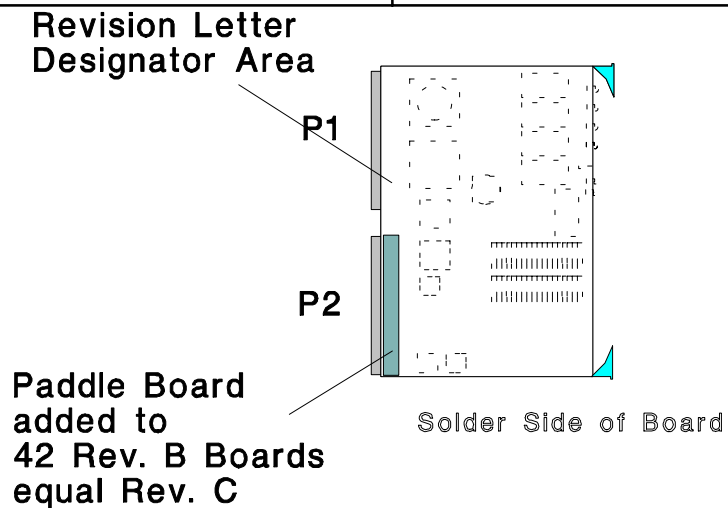
FIGURE 1

1. Power down the AxSYM system in accordance to the shutdown procedure.
2. Remove board 1 from the VME card cage.
3. Examine the solder side of the board and look at the REV. level on the board (It should have 42B or 42A located next to P1 - Refer to Figure 1).
4. If this is a Rev. 42B board without the attached 47pf board it must be replaced with a 4-37333-02 (Rev. 42B or 42C) board with an attached 47pf board. Rev. 42A boards are not affected.

OK	BAD
16 Meg CPU Boards with any of the below Revisions	All 8 Meg Boards
Rev 42A	16 Meg CPU Boards Rev 42B
Rev 42B with P2 Paddle Board	without P2 Paddle Board
Rev 42C

Only 4-37333-01 42B without attached 47pf boards need to be replaced.

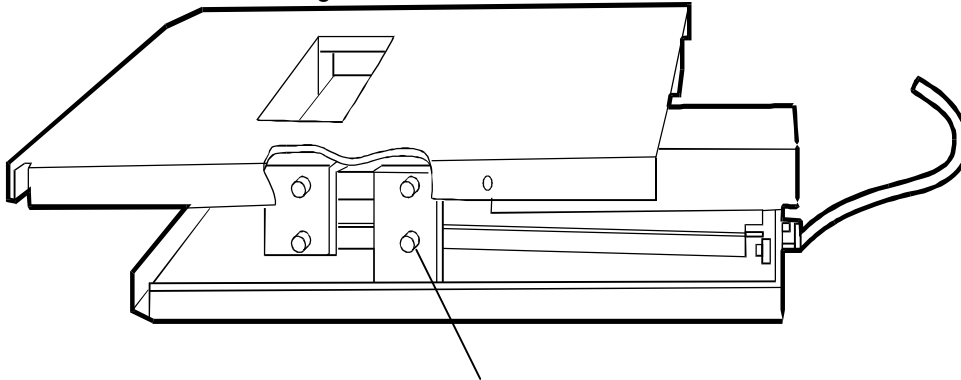
Figure 1

Pivot point were shoulder washers are installed

Where screw and washer secure the counterweight

5. Install the new bellville washers (P/N 14533-002) under the head of the existing shoulder screws, then replace the screws into that pivot point (Refer to Figure 1). This will remove any side to side movement of the platform.

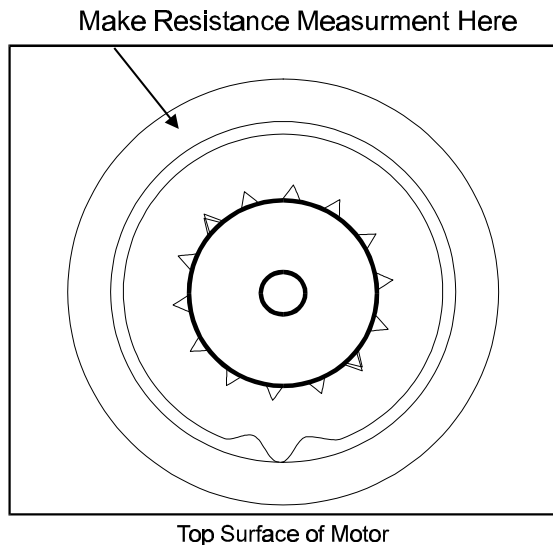
Figure 2

NOTE: If there is a difference between readings, remove the assembly and verify filed surface and ground connections.

1. Check that the ground cables are attached to the filed areas.
2. Refer to the motor orientation noted above. Check to insure that the cable connections are not under stress.
6. Using the OHM feature of the multimeter, check the resistance of your test leads. Measure the resistance between an unpainted surface of the motor and the Sample Plate. The resistance MUST be equal to that of the test leads. Approximately 0 Ohms.
