ABBOTT ADD	INDEX TECHNICAL SERVICE BULLETIN
---	---

PRODUCT: ALCYON (TM) 300 ISE (122)	DATE: 23-SEP-98
--	---------------------------

ALCYON (TM) Rev. 0 Software Release Ver. 261095/0142TSB#: **122-002**ORIGINATOR: **Emile Diou/Bernard Dabosi**APPROVED: **Christie McCain 05/21/98**

Modified Wash Pump With New O-RingTSB#: **122-001**ORIGINATOR: **Gary Tompkins/Bernard Dabosi**

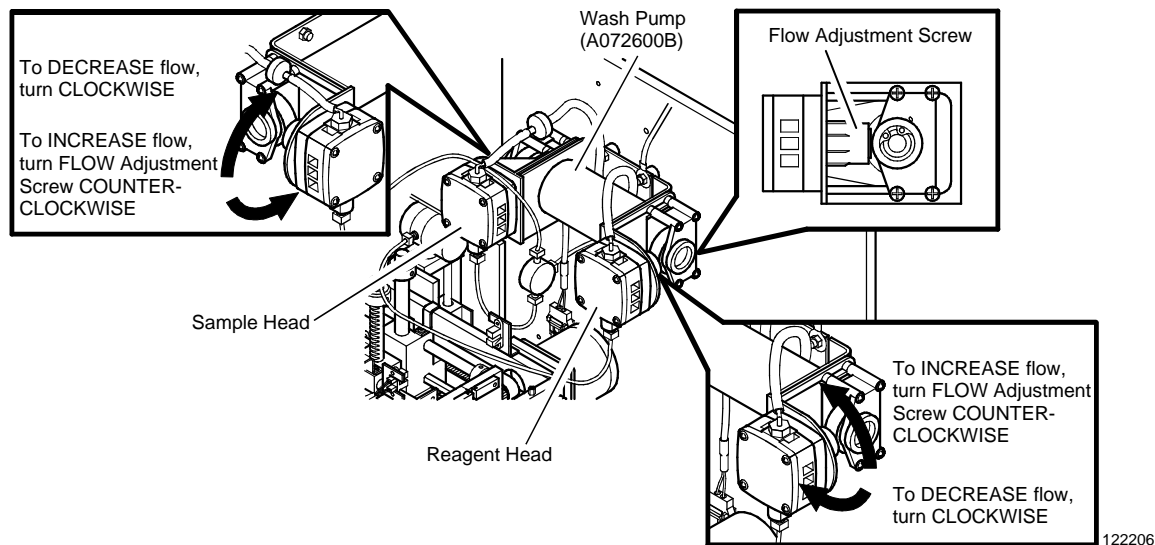
Figure 1

- If the volume from the reagent head is less than 25ml, turn the reagent flow adjustment screw (see **Figure 1**) in the counter-clockwise direction for 1/16 of a turn to increase the flow. Repeat the Flow Check.
- Perform the Solenoid Valve Check to verify that the valve does not leak. If the volume from the reagent head is greater than 25ml and less than 30ml but the solenoid valve leaks, turn the reagent flow adjustment screw (see **Figure 1**) in the clockwise direction for 1/16 of a turn to decrease the flow to 25ml. The pressure may be too high, causing the valve to leak. (More than one adjustment may be necessary.) Repeat the Flow Check.
- Repeat the Solenoid Valve Check. If the reagent solenoid valve continues to leak and the volume is right at the target value of 25ml, replace the valve (A143600B) then repeat all the checks.

- If the volume from the sample head is less than 60ml, turn the sample flow adjustment screw (see **Figure 1**) in the counter-clockwise direction for 1/16 of a turn to increase the flow. Repeat the Flow Check.
- Perform the Solenoid Valve Check to verify that the valve does not leak. If the volume from the sample head is greater than 60ml and less than 80ml but the solenoid valve leaks, turn the sample flow adjustment screw (see **Figure 1**) in the clockwise direction for 1/16 of a turn to decrease the flow. The pressure may be too high, causing the valve to leak. (More than one adjustment may be necessary.) Repeat the Flow Check then the Solenoid Valve Check.
- Repeat the Solenoid Valve Check. If the sample solenoid valve continues to leak and the volume is right at the target value of 60ml, replace the valve (A143500B) then
