ABBOTT ADD	INDEX INSTRUMENT SERVICE ADVISORY
--	--

PRODUCT: ALCYON (TM) 300i Rev 1 (120)	DATE: 17-AUG-1999
---	-----------------------------

ABBOTT ADD	INSTRUMENT SERVICE ADVISORY
--	------------------------------------

SUBJECT: Dual Voltage Heater	ISA#: 120-018
ORIGINATOR: Emil Jivan	PRODUCT: ALCYON® 300i Rev 1 (120)
APPROVED: Kathy Jennings 17-AUG-1999	EFFECTIVITY DATE: 17-AUG-1999

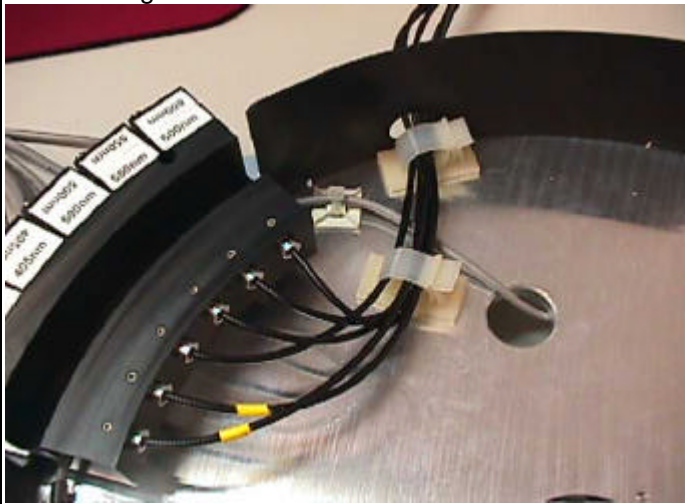
Figure 1

Action		Comments
Removing Old Heater Assembly		
1	Remove all Patient Samples from Sample Carousel.	
2	Perform the Short Term Shutdown found in VP-01.	
3	Perform RR-C1.13 to remove old Heater Assembly.	Unplug Heater Assembly Cable (P203, W23) from the back of the instrument prior to removing Heater Assembly.
Heater Resistance Verification		
1	Check the resistance between the two wires, labelled P184 pin 3 and P120B RLY. Verify that the resistance measures between 76 and 84 Ohms.	
2	Check the resistance between the two wires, labelled P184 pin 4 and P121B RLY. Verify that the resistance measures between 76 and 84 Ohms.	
Installing New Heater Assembly		
1	Perform RR-C1.13 in reverse order to install the new heater.	During installation add an additional Cable Clamp to keep Colorimeter Cables away from the heater. Verify that the cables are not interfering with the heater. See Figure 1.

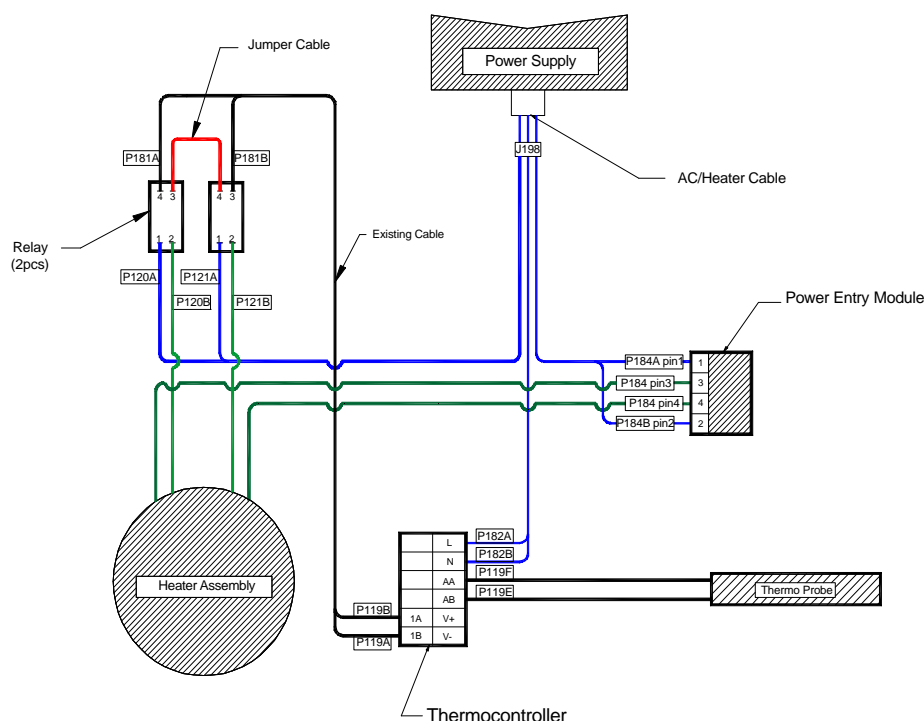
Figure 3
Dual Heater Assembly Wiring Diagram

4	<p>Connect AC/Heater Cable to Both Reaction Temperature Relays as follows:</p> <p>Terminal P120A to Position 1 of the Left Relay</p> <p>Terminal P121A to Position 1 of the Right Relay</p> <p>See Electrical Schematic in Figure 3.</p>	<p>Both Relays have position 1 located at the left - bottom of the Relay.</p>
5	<p>Connect AC/Heater Cable to Temperature Control Module (Thermocontroller) as follows:</p> <p>Terminal P182A to Line</p> <p>Terminal P182B to Neutral</p> <p>See Electrical Schematic in Figure 3.</p>

1	<p>Connect Heater Assembly Cables to Both Reaction Temperature Relays as follows:</p> <p>Terminal P120B to Position 2 of the Left Relay</p> <p>Terminal P121B to Position 2 of the Right Relay</p> <p>See Electrical Schematic in Figure 3.</p>	Both Relays have position 2 located at the right - bottom of the Relay.
2	<p>Connect Heater Assembly Cables to Power Entry Module (PEM) as follows:</p> <p>Terminal P184 pin3 to Position 3 of PEM</p> <p>Terminal P184 pin4 to Position 4 of PEM</p> <p>See Electrical Schematic in Figure 3.</p>

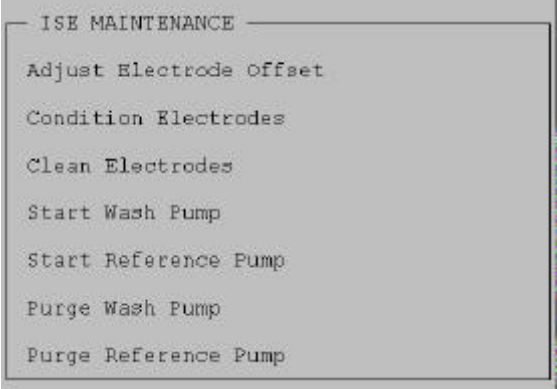
Version 1.5	New Version 1.6
<p>Screens do not appropriately accommodate updated ISE Maintenance procedures.</p> <p>Old screen:</p>

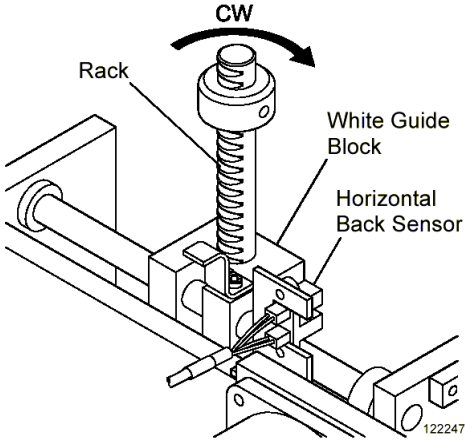
1. Align the vertical rack to the pinion (not seen), by rotating the vertical rack clockwise (counter clockwise for the reagent arm) until rack gear teeth are parallel or slightly off parallel to white guide block. Verify proper alignment by moving the arm up/down when holding current is applied to the motor. If the rack and pinion are properly aligned, the rack should feel stiff and should not have any movement up and down. It is normal to have a slight vertical movement at the end of the horizontal arm when it is properly adjusted.

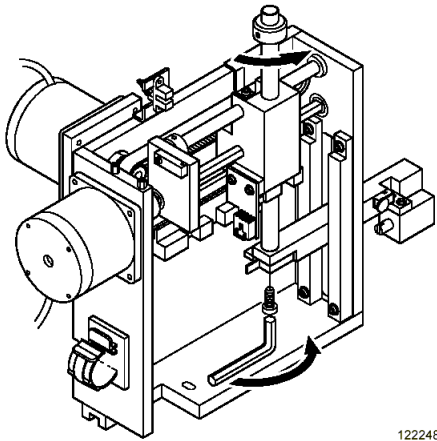
As a result of probe crashes, the hex screw at the bottom of the vertical rack can become loose causing excessive vertical movement of the horizontal arm. When tightening this screw, the vertical rack will rotate counter clockwise. The screw should be tightened until the rack gear teeth are parallel or slightly off parallel to white guide block. Verify proper alignment as described above.

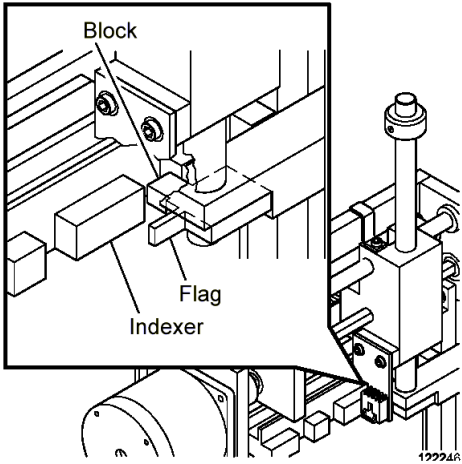
4. Loose screws on the indexer or mis-aligned indexer.

1. Realign the indexer so the block is centered within the indexer. See Transfer Arm Indexer Alignment procedure at the end of this procedure. The indexer is aligned specifically for each instrument. The arm should not rub or contact the indexer during normal operation. A replacement transfer arm will always require the indexer to be aligned for proper position.

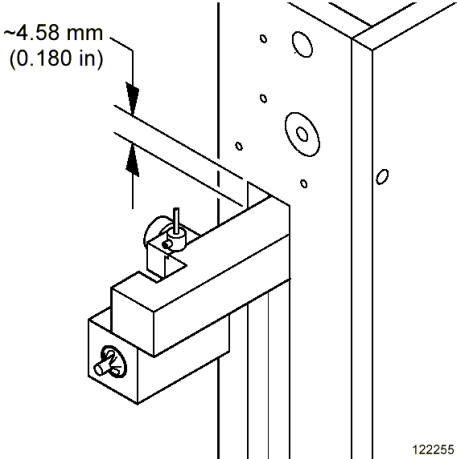
5. The screws that secure the up sensor pcb may be loose causing the flag not to go through this sensor or the flag may be misaligned causing the flag to hit the up sensor.

1. Disengage the holding current to the motor and manually raise the vertical rack shaft until the distance of the horizontal arm is approximately 4.58mm (0.180 in) below the opening.

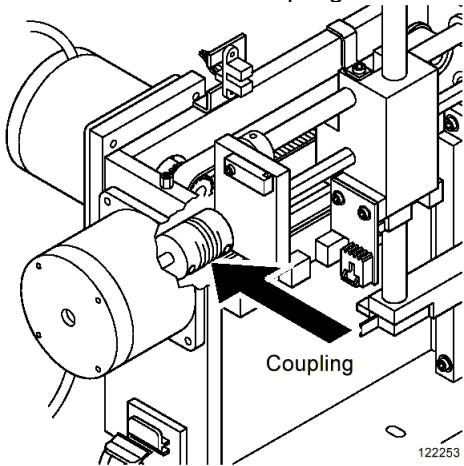
6. If the screws on the coupling (from the vertical motor to the square shaft) are loose, the homing flag may not make it back to the sensor.	1. Tighten the screws on the coupling.

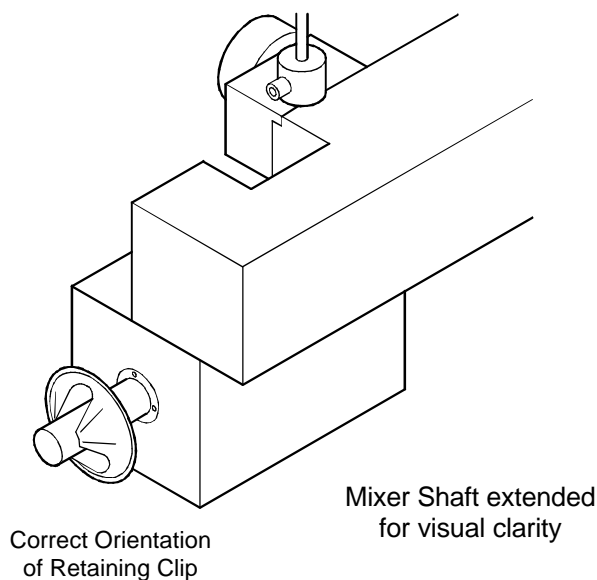
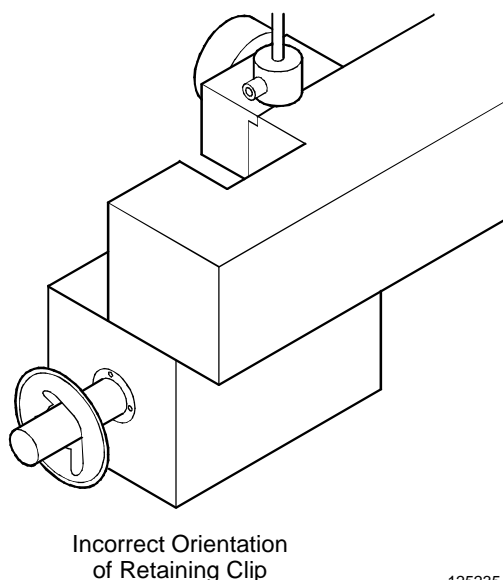
- a) The position and orientation of the clip are important to the Mixer operation. The clip should be positioned 3-4mm from the end of the shaft. If placed too far on the shaft, it will inhibit the operation of the Mixer.
- b) See the figure below for the correct *orientation* of the clip. If oriented incorrectly, the clip may, in time, slide out of position.
